Eastern Busway

EB2 and EB3 Residential

Contaminated Land Effects Assessment

Document Number: EB234-1-PL-RP-ZO-000015

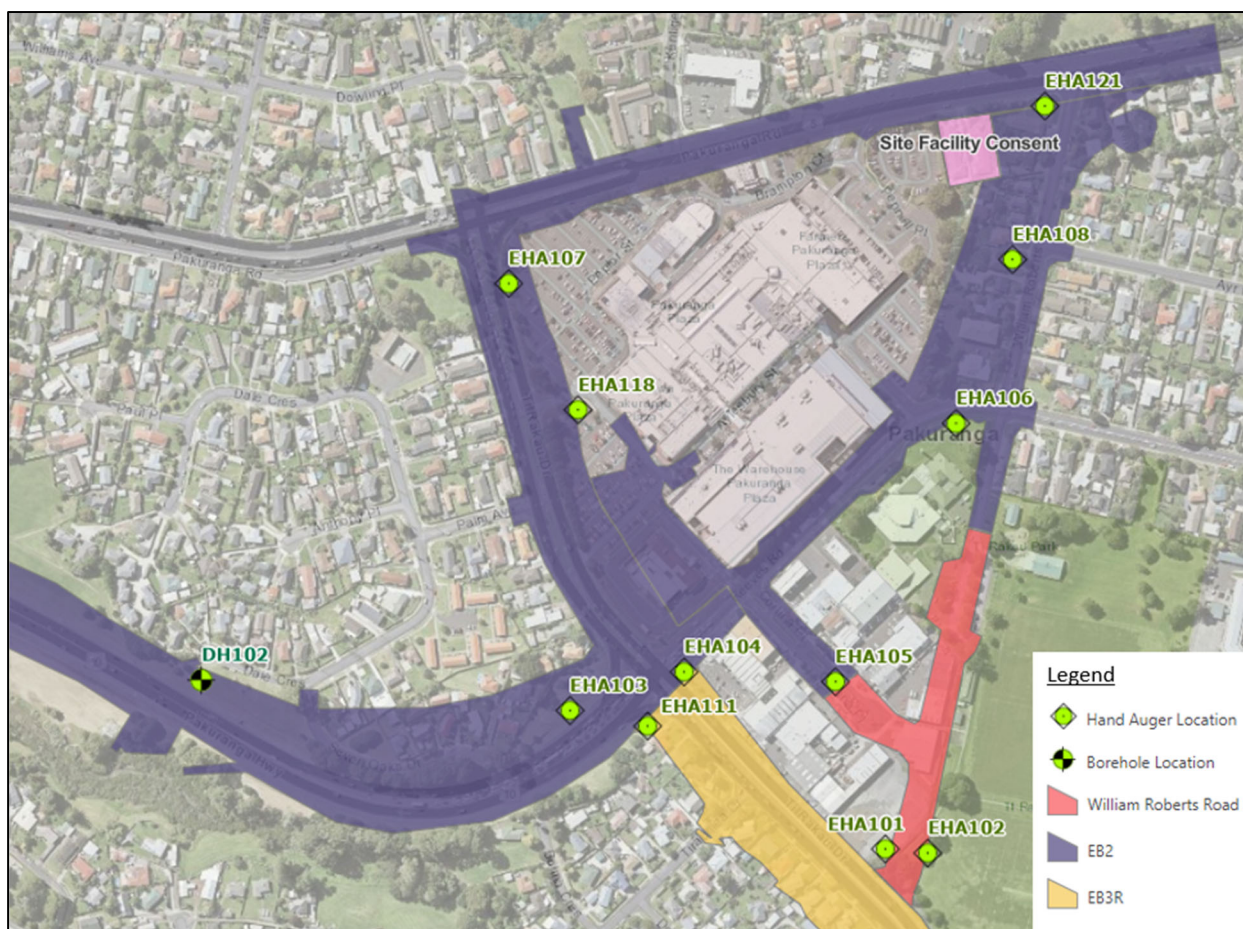
Figure 2: 2018 Environmental Investigation Locations within EB2.

The environmental assessment focussed on the collection of soil samples for laboratory analysis from materials within anticipated areas of soil disturbance. The analytical results from samples collected from locations within the EB2 package are presented in **Table A1** in **Appendix A**. Soil samples were analysed for contaminants associated with the HAIL activities at or in the vicinity of the EB2 package (listed in **Table 2** below). The investigation locations relevant to the EB2 package are presented in **Figure 2** below.

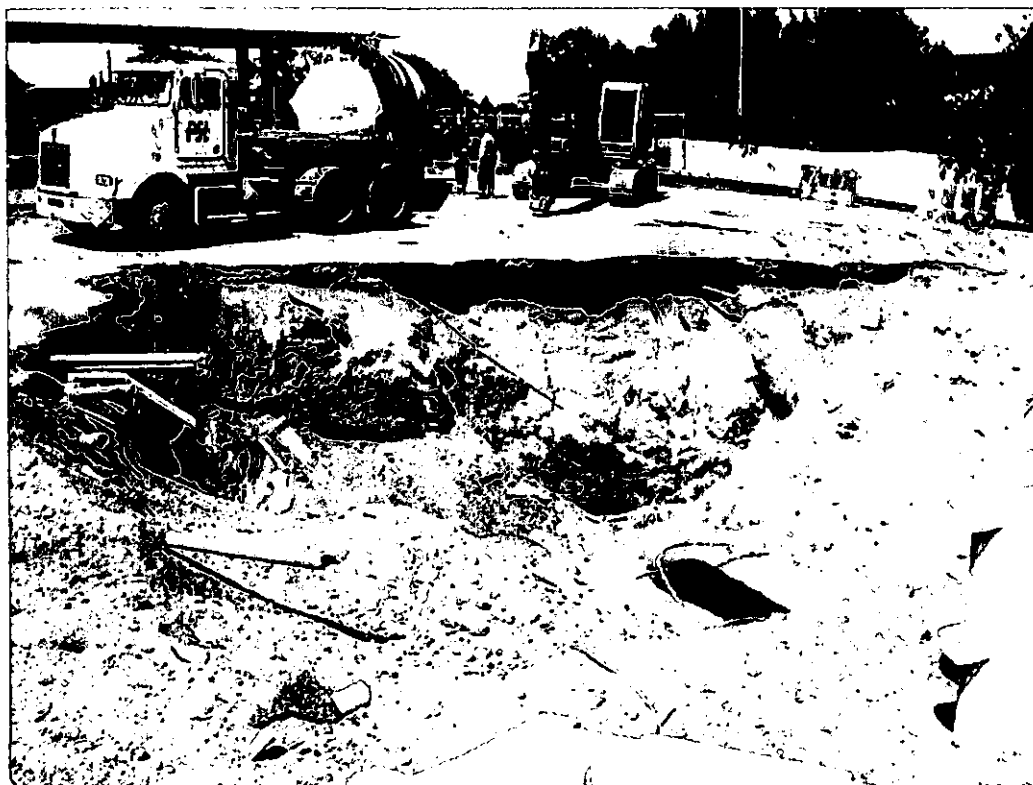
Photograph 4: The tank pit following the removal of Tank 3. The water within the base of the pit was standing water.

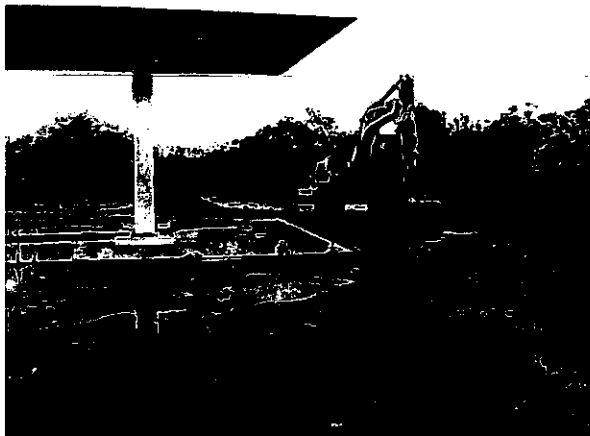
Photo 6. Excavator digging the test pit in location of historic USTs to the east of the existing forecourt area. Samples locations SH01 to SH02.

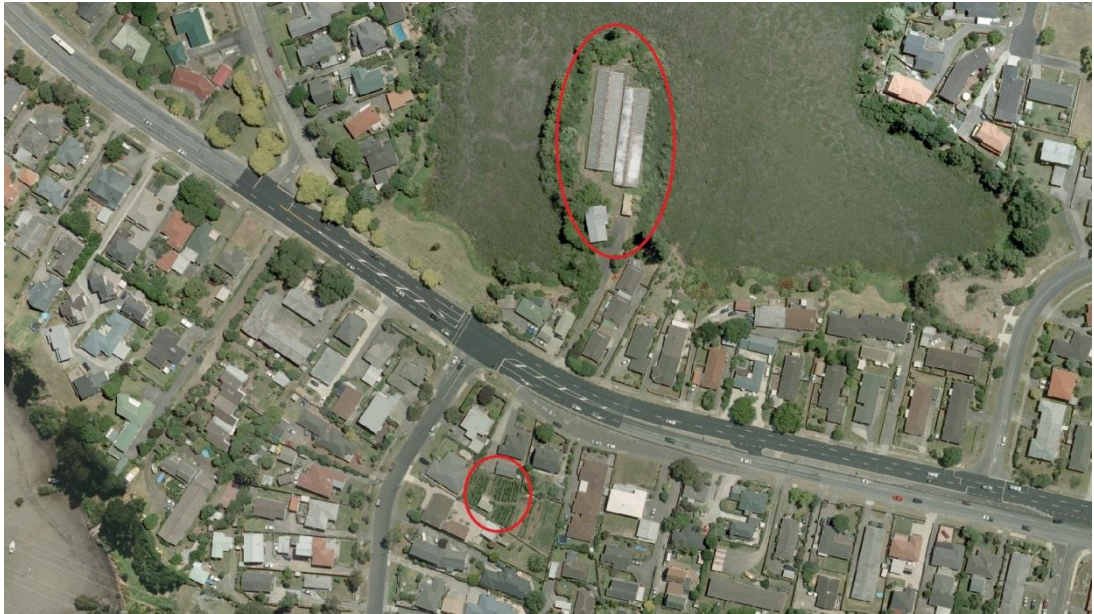
Date	Observations
2008	<p>Glasshouses can be seen on the aerial photo at 24 Pakuranga Road (oval) and a potential small scale orchard in 39 Pakuranga Road (circle) which may present pesticide contamination issues, although both sites are separate from the alignment and therefore not considered likely to affect the project.</p>

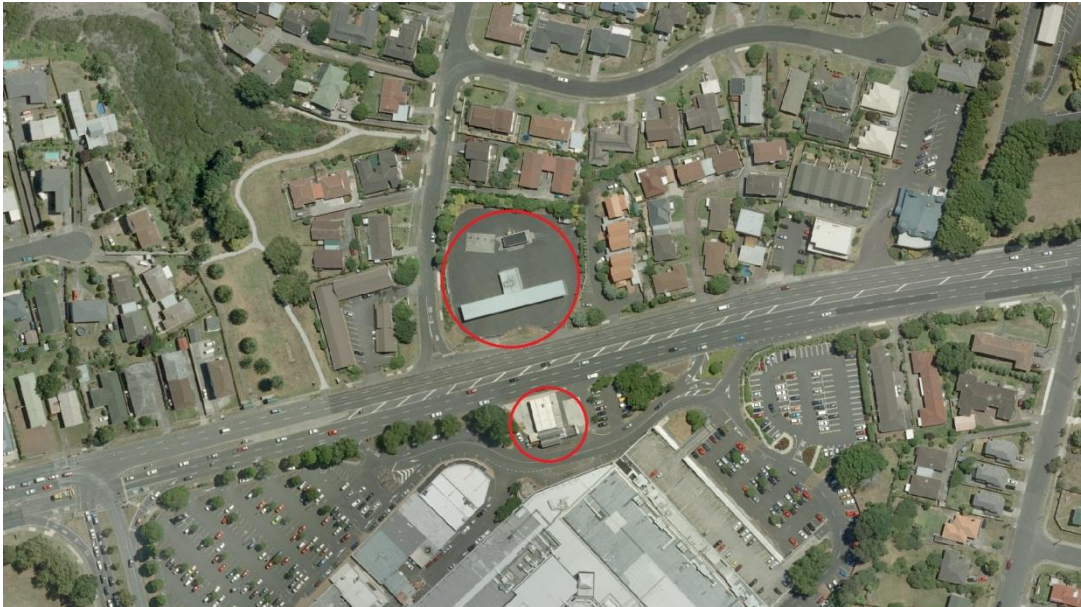
Date	Observations
2008	<p>3 Kentigern Close is the site of a former Mobil branded service station (large circle). This site is currently vacant. A contaminated site investigation was undertaken in 2008 and the report was issued to the former Auckland Regional Council. A copy of the report was requested from Mobil but is yet to be received at the time of writing. A copy was also requested from Auckland Council under the Local Government Official Information and Meetings Act 1987 but the report was not available to read. Directly across the road a BP branded service station is currently in operation (small circle). These sites may present issues relating to hydrocarbon contamination during construction of the alignment.</p>

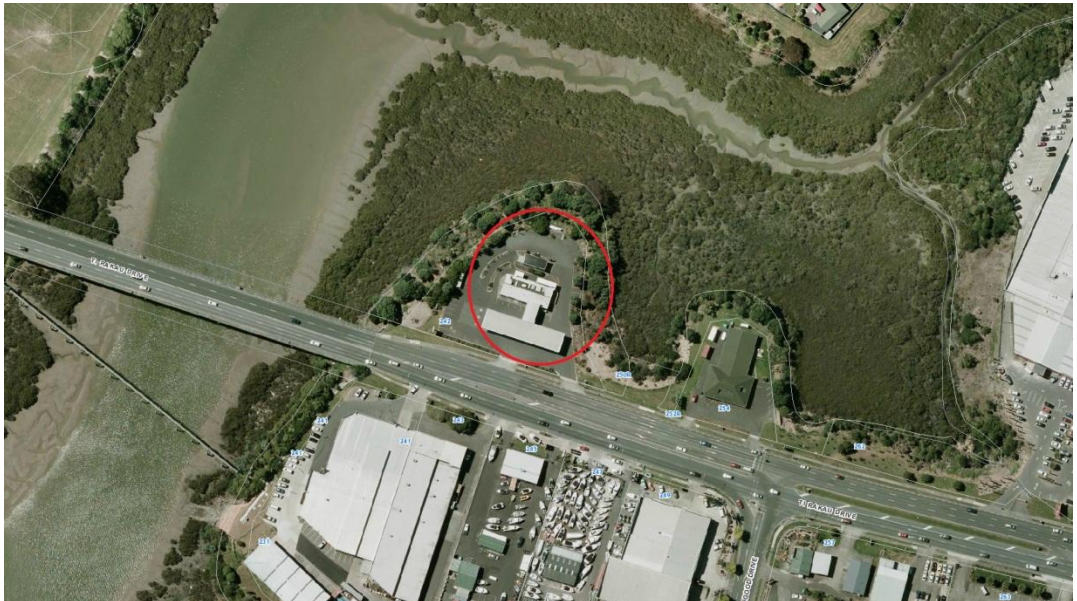
Date	Observations
2010	<p>242 Ti Rakau Drive is currently occupied by a Mobil branded service station and may present issues relating to hydrocarbon contamination to the construction phase of the alignment as a result of fuel storage facilities there. Enquiries with the Auckland Council have not identified any environmental investigation reports available for this site. The Pakuranga Creek flows close to the site.</p>

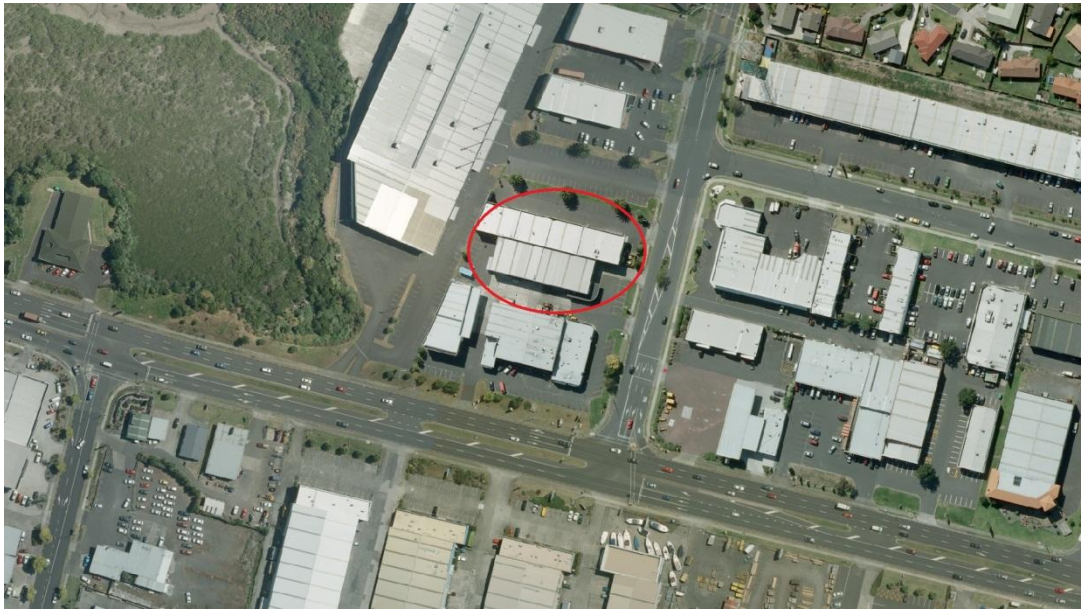
Date	Observations
2008	<p data-bbox="341 412 1426 517">Best Automotive Clinic is located at 245 Burswood Drive. This business may present issues to the proposed alignment with regards hydrocarbon, solvents and trace element contamination as a result of activities relating to vehicle servicing and repair.</p>

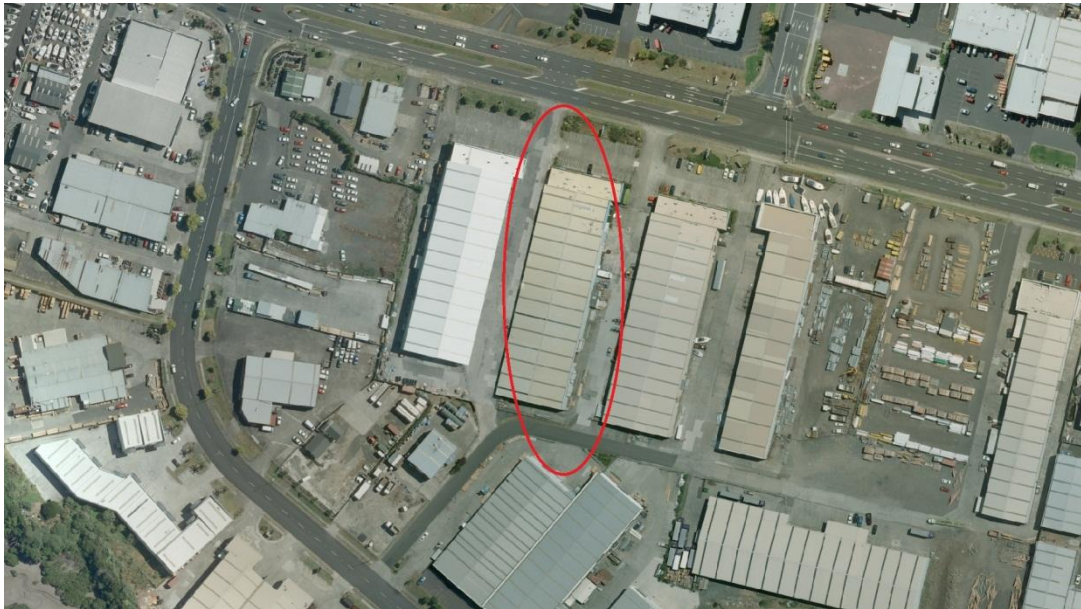
Date	Observations
2008	<p data-bbox="341 412 1426 517">Sandvik Materials Technology is located at 269 Ti Rakau Drive. This business may present issues to the proposed alignment with regards hydrocarbon and trace element contamination as a result of materials processing.</p>

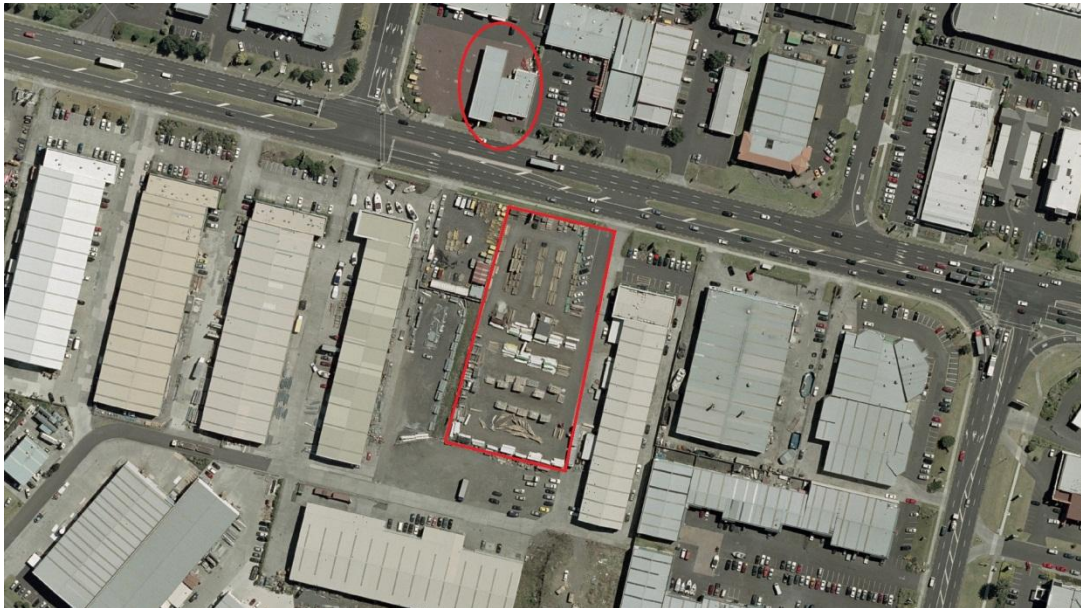
Date	Observations
2006	<p>279 Ti Rakau Drive is the site of a former timber storage yard (rectangular outline). It is currently a buy and sell yard and may host residual contamination relating to timber treatments. Across the road at 284 Ti Rakau Drive a Z branded service station is currently in operation (oval outline) and may also present issues during construction of the alignment relating to hydrocarbon contamination.</p>

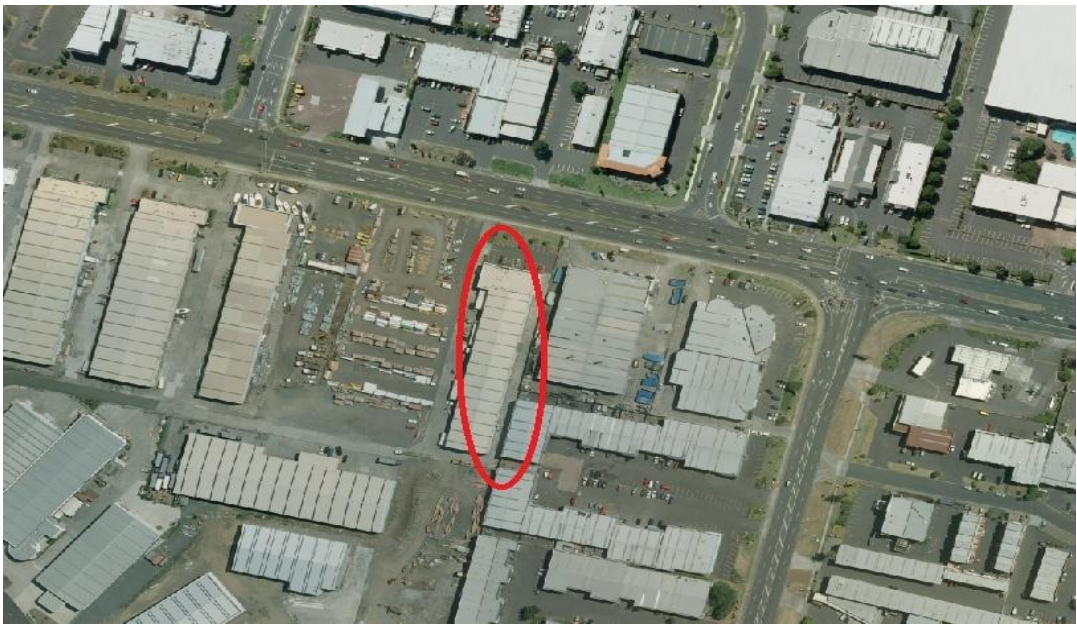
Date	Observations
2008	<p data-bbox="341 409 1428 517">Forging Ahead is located at 293 Ti Rakau Drive. This business may present issues to the proposed alignment with regards hydrocarbon and trace element contamination resulting from foundry operations.</p>

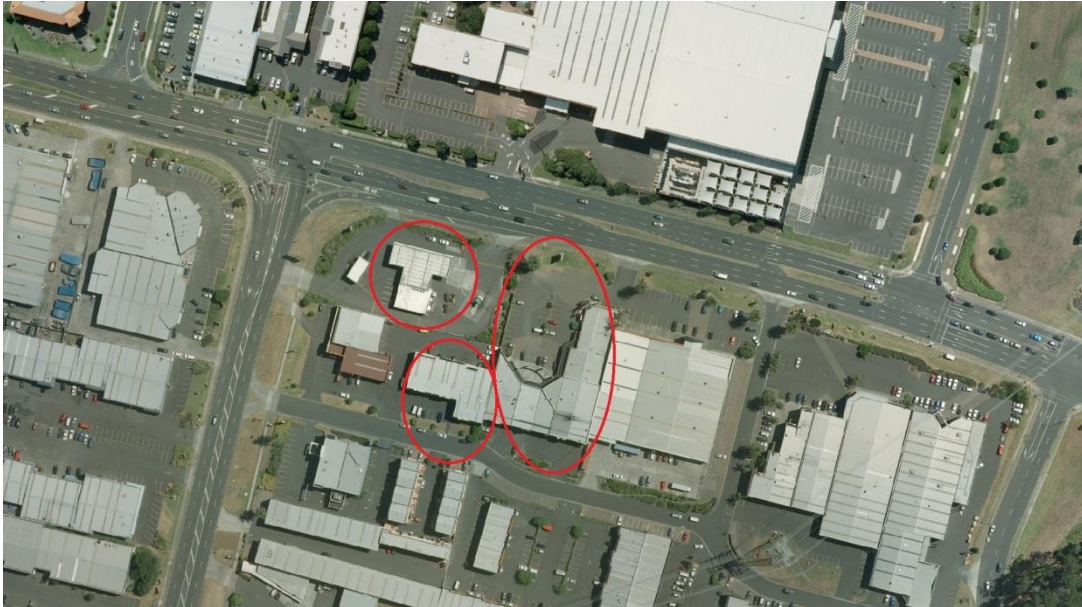
Date	Observations
2008	<p>333 Ti Rakau Drive is occupied by the Blue n Green Dry Cleaners (large oval) whilst next door on the corner of Harris Road and Ti Rakau Drive is a BP branded service station (circle). Behind BP is Jireh Auto Tyres at 179 Harris Road (small oval) dealing in automotive repairs. The service station may present issues to the construction of the alignment relating to hydrocarbon contamination and the dry cleaners may present issues related to chlorinated solvent and VOC contamination. The auto workshop may also have some issues with solvents, hydrocarbons as well as trace elements.</p>

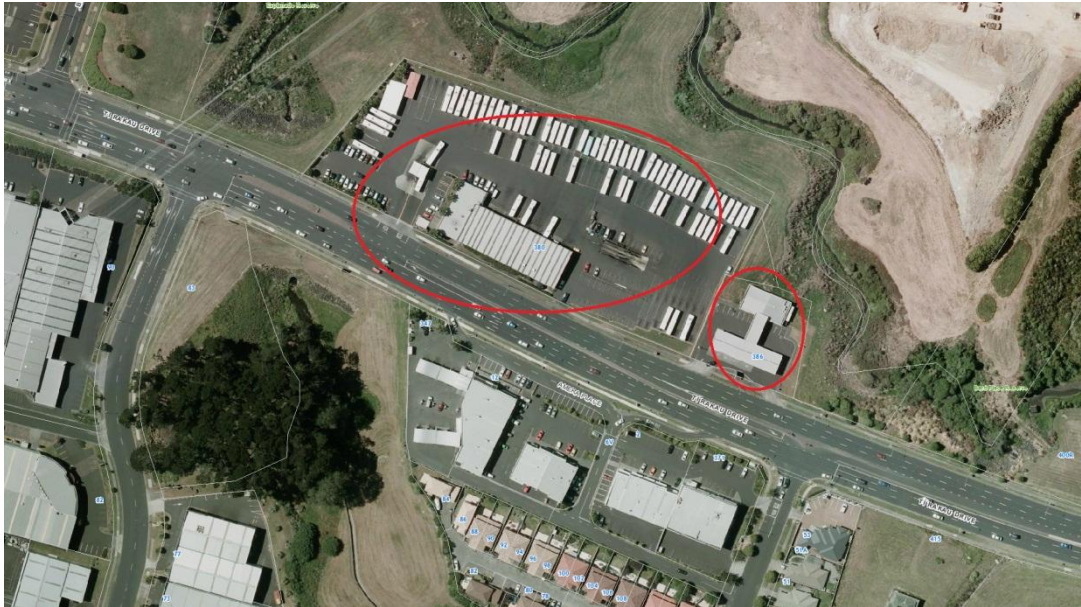
Date	Observations
2010	<p>380 Ti Rakau Drive is occupied by the Howick and Eastern Bus Company whilst next door at 384 is a Gull branded service station. Both of these sites may present issues to the construction of the alignment relating to hydrocarbon contamination as a result of fuel storage facilities at both sites. A tributary of the Pakuranga Creek flows at the back of both properties and could be considered a sensitive receptor. According to council borehole records Chevron have installed a borehole at 380 Ti Rakau Drive for monitoring purposes. A site investigation report was not available from Auckland Council. It is understood that Chevron previously operated a Caltex branded service station at 384 Ti Rakau Drive.</p>

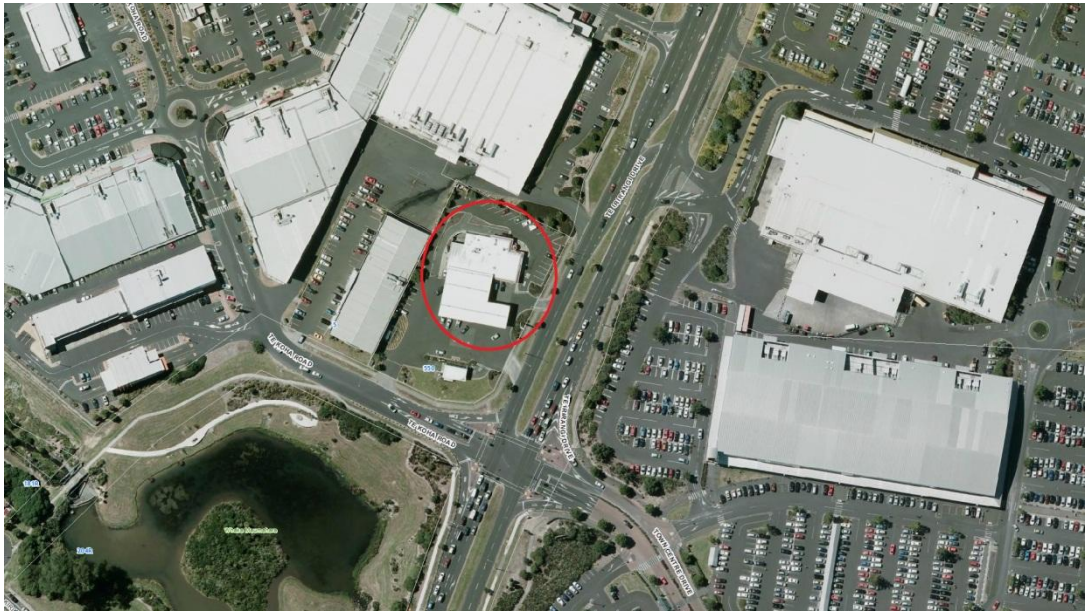
Date	Observations
2010	<p>550 Te Irirangi Drive is currently occupied by a Z branded service station and may present issues relating to hydrocarbon contamination during the construction phase of the alignment along Te Koha Road as a result of fuel storage facilities here.</p>

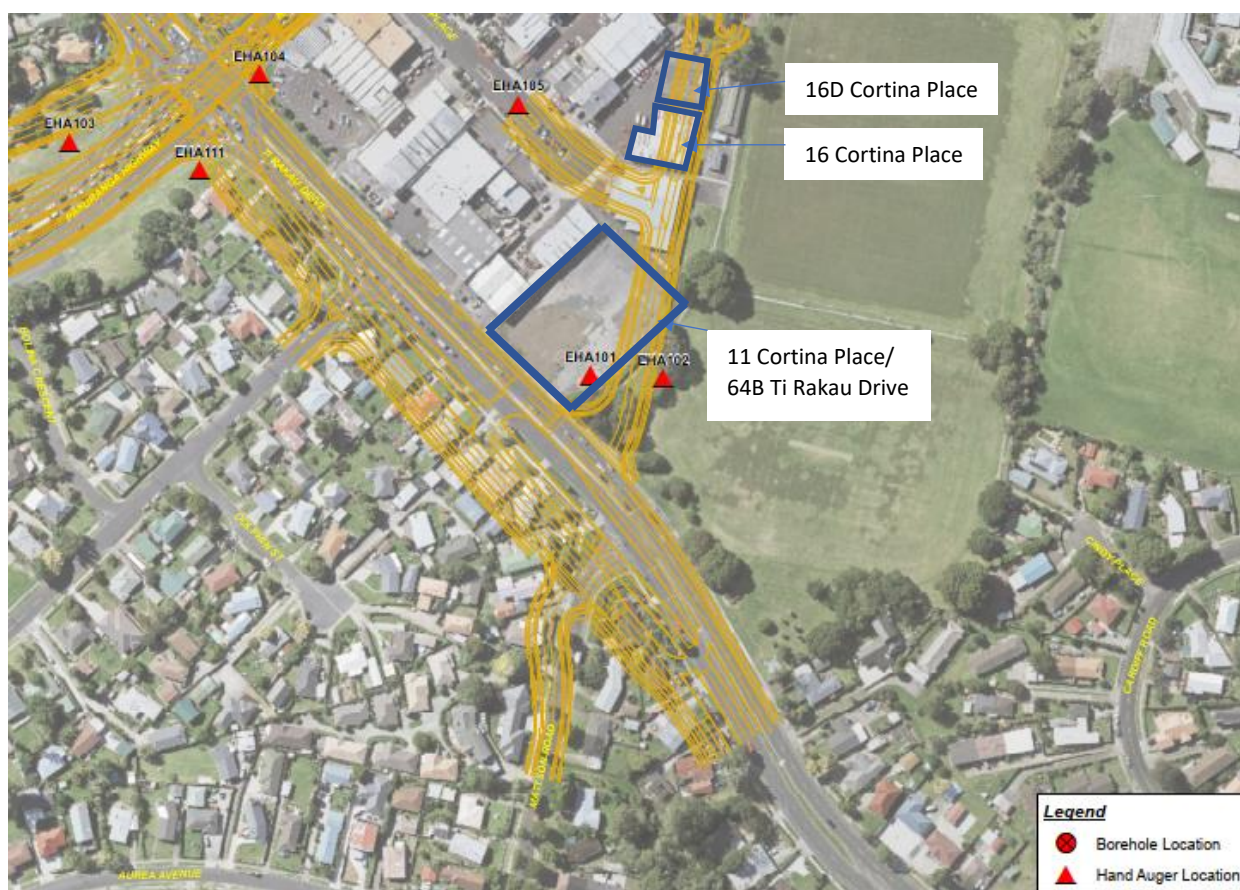
Figure 3 Relevant 2019 Environmental Investigation Locations

The environmental assessment focussed on the collection of soil samples for laboratory analysis from materials within anticipated areas of soil disturbance. The analytical results from samples collected from hand augers EHA101, EHA102 and EHA105 are presented on **Table A1** in **Annexure A**. Soil samples were analysed for contaminants associated with the HAIL activities at or in the vicinity of the proposed alignment (listed in **Table 1** above and shown on **Figure 3** below). The investigation locations relevant to the proposed alignment (EHA101, EHA102 and EHA105) are presented in **Figure 3** below.

In 2019, following recommendations of the 2012 PSI completed by GHD (section 5.1.2), AECOM undertook a Gap Analysis in support of the application for resources consents associated with soil disturbances for the proposed alignment. The Gap Analysis identified areas where further investigation was required. Between April and August 2019 and February 2019, six boreholes (advanced for geotechnical purposes) and thirty-three environmental hand augers were completed within the wider EBA works, of which five soil samples were collected from three hand augers within the proposed alignment (hand augers EHA101, EHA102 and EHA105; Figure 3 below). Samples were analysed for the following contaminants:

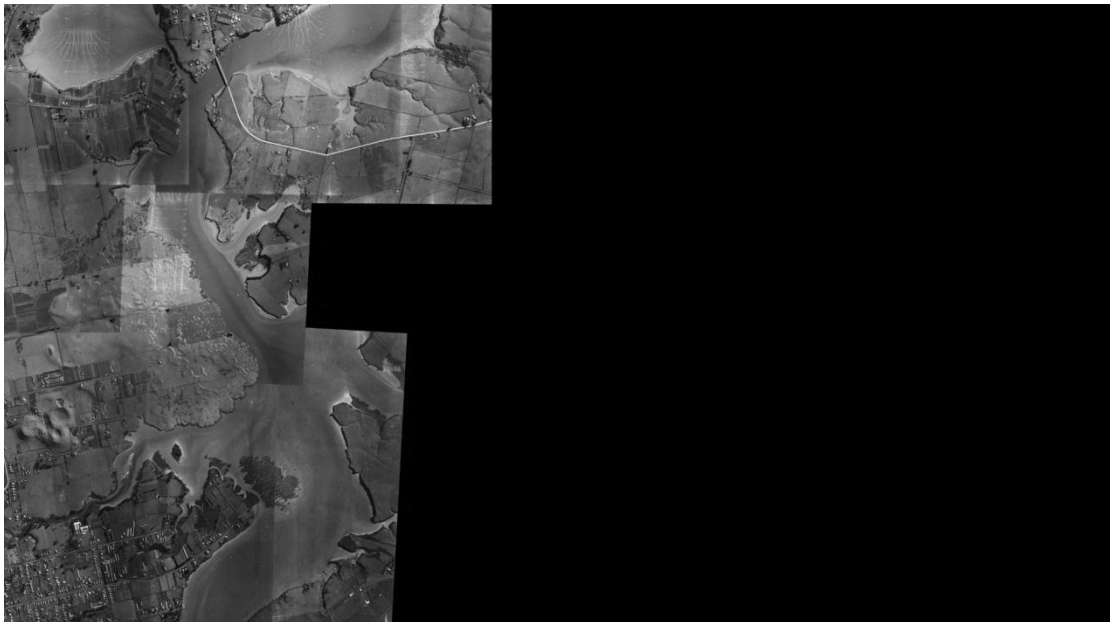
Date	Observations
1940	<p data-bbox="331 504 1445 831">There is limited aerial photography available for this date. The photograph available depicts the land use in Pakuranga to be predominantly farmland dedicated to what appears to be pastoral farming. The road bridge crosses the Tamaki Estuary at Kerswill Road. The Waipuna and the Panmure bridges are yet to be constructed. The blacked out area on the image indicates that aerial photography is not available for this area. Historically, land use in the Pakuranga area consisted of horticultural market gardening activities and as such it is considered likely that trace concentrations of pesticides such as DDT remain in the topsoil and therefore residual risk remains with regard soil disturbance in the area regarding these contaminants.</p>

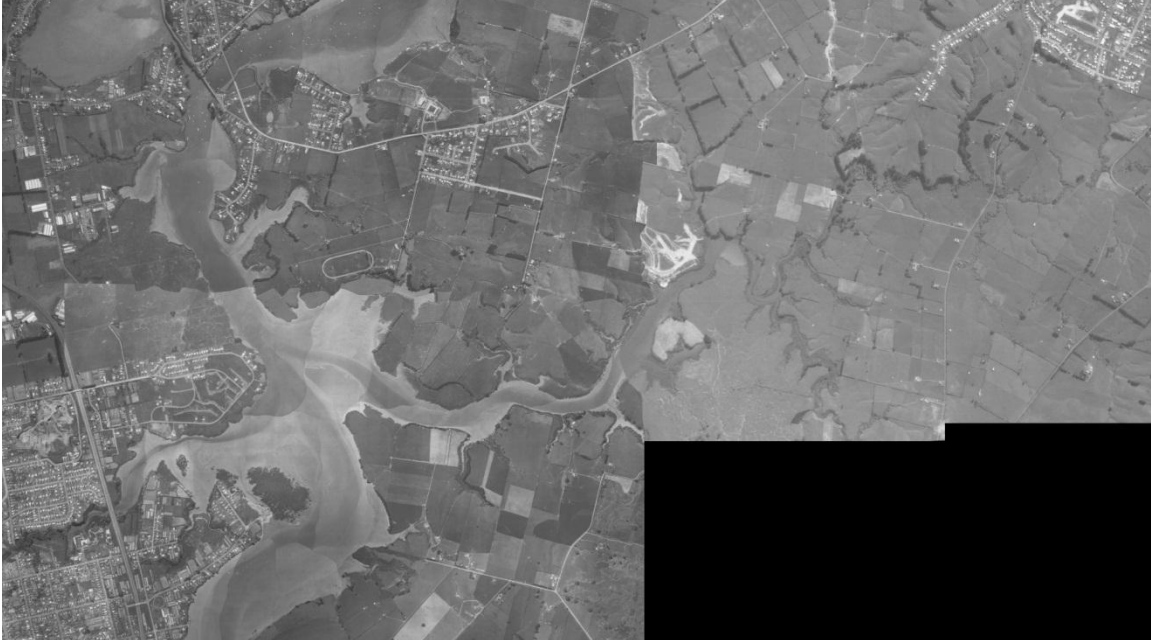
Date	Observations
1959	<p>The aerial image shows that land use has intensified with residential developments in the Pakuranga area as well as along the Tamaki river closest to the bridge. The land use is still predominantly what appears to be pastoral farming. A racing track is located south of what is present day Pakuranga Town Centre. Panmure Bridge has now been constructed over the Tamaki Estuary. The blacked out area on the image indicates that aerial photography is not available for this area.</p>

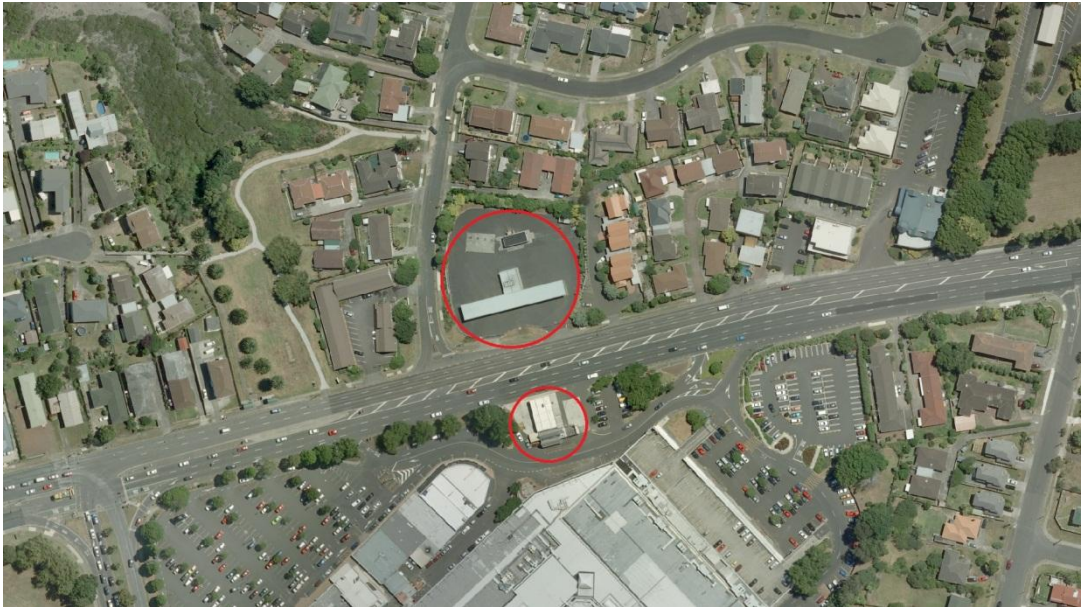
Date	Observations
2008	<p>3 Kentigern Close is the site of a former Mobil branded service station (large circle). This site is currently vacant. A contaminated site investigation was undertaken in 2008 and the report was issued to the former Auckland Regional Council. A copy of the report was requested from Mobil but is yet to be received at the time of writing. A copy was also requested from Auckland Council under the Local Government Official Information and Meetings Act 1987 but the report was not available to read. Directly across the road a BP branded service station is currently in operation (small circle). These sites may present issues relating to hydrocarbon contamination during construction of the alignment.</p>

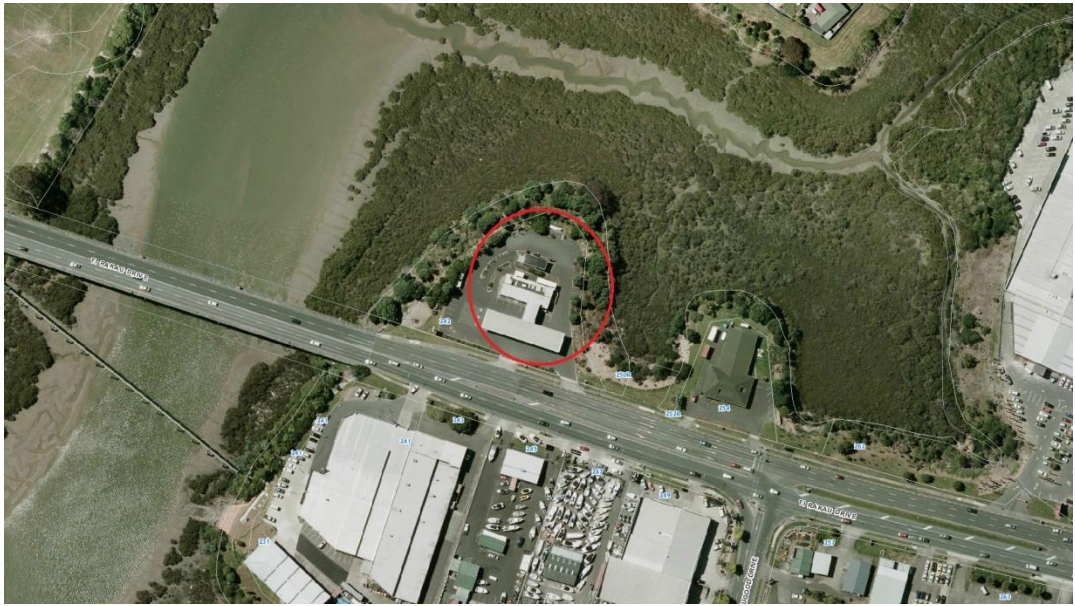
Date	Observations
2010	<p>242 Ti Rakau Drive is currently occupied by a Mobil branded service station and may present issues relating to hydrocarbon contamination to the construction phase of the alignment as a result of fuel storage facilities there. Enquiries with the Auckland Council have not identified any environmental investigation reports available for this site. The Pakuranga Creek flows close to the site.</p>

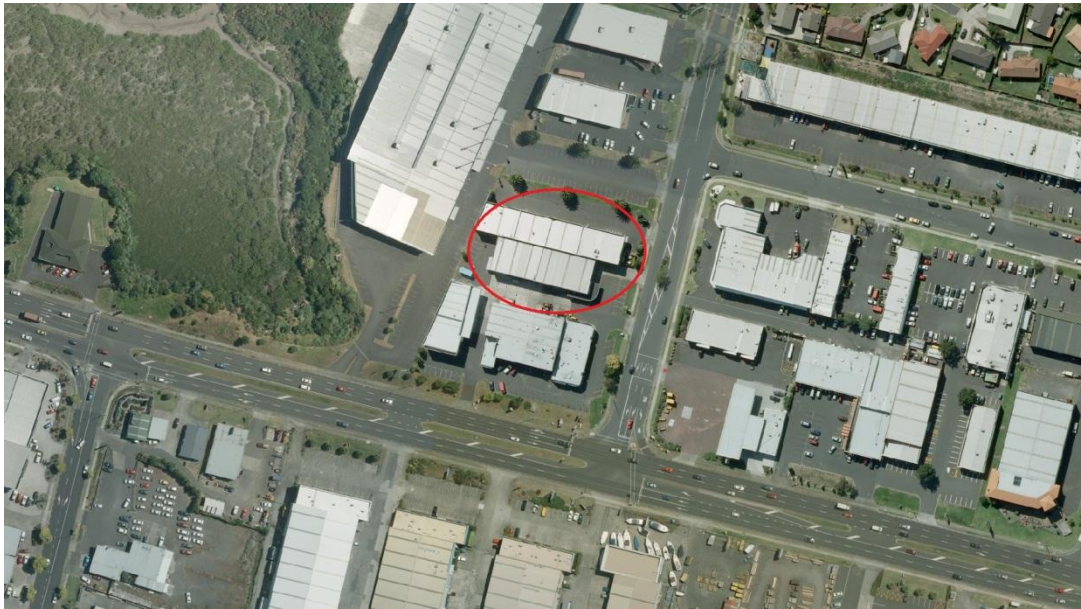
Date	Observations
2008	<p data-bbox="341 409 1426 517">Best Automotive Clinic is located at 245 Burswood Drive. This business may present issues to the proposed alignment with regards hydrocarbon, solvents and trace element contamination as a result of activities relating to vehicle servicing and repair.</p>

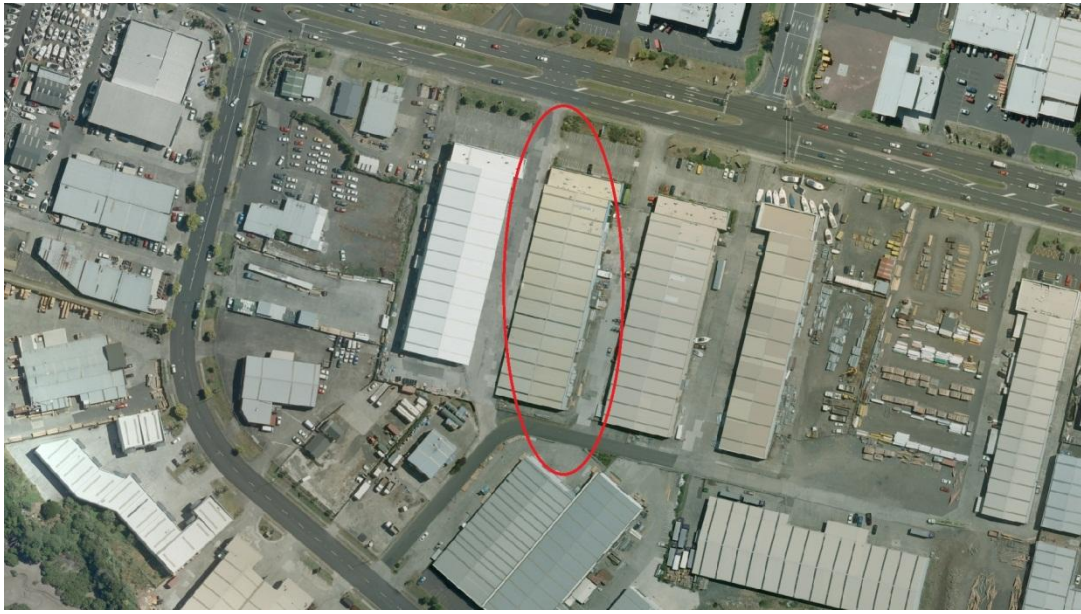
Date	Observations
2008	<p data-bbox="341 412 1426 517">Sandvik Materials Technology is located at 269 Ti Rakau Drive. This business may present issues to the proposed alignment with regards hydrocarbon and trace element contamination as a result of materials processing.</p>

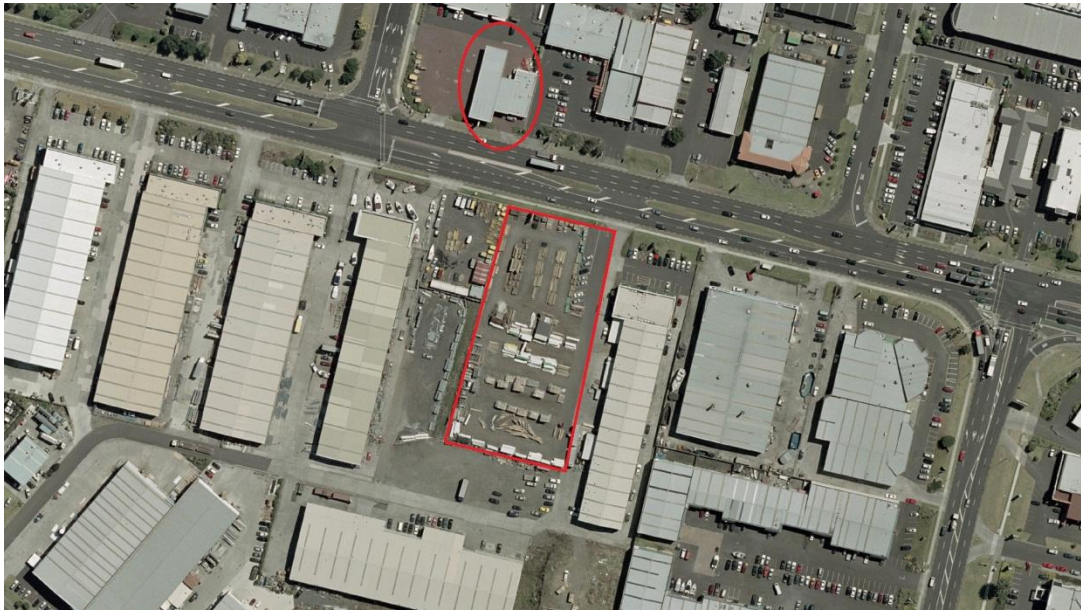
Date	Observations
2006	<p>279 Ti Rakau Drive is the site of a former timber storage yard (rectangular outline). It is currently a buy and sell yard and may host residual contamination relating to timber treatments. Across the road at 284 Ti Rakau Drive a Z branded service station is currently in operation (oval outline) and may also present issues during construction of the alignment relating to hydrocarbon contamination.</p>

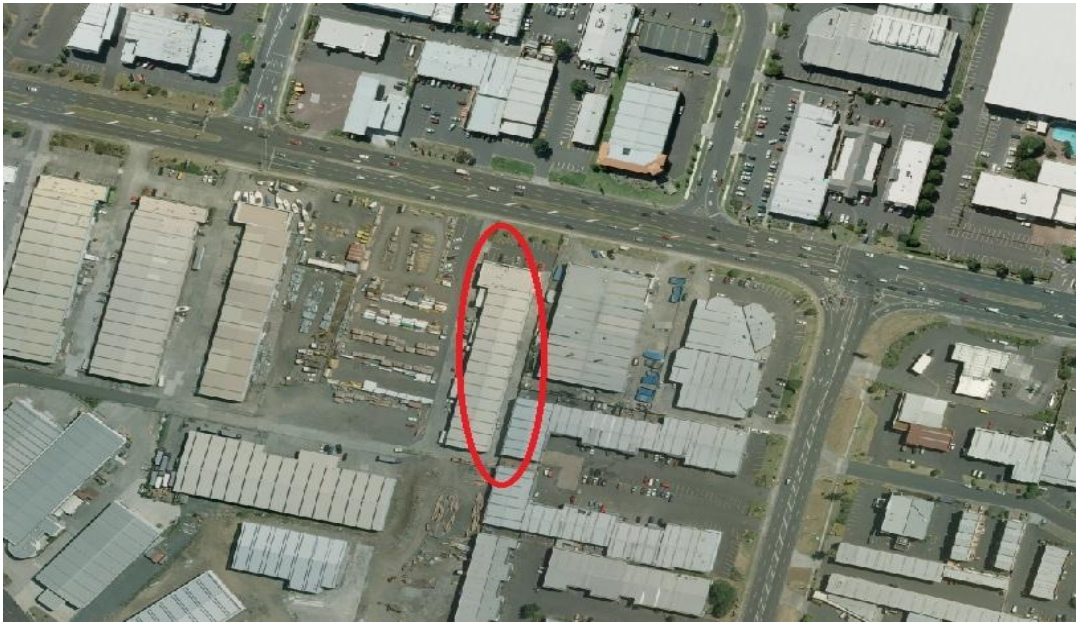
Date	Observations
2008	<p data-bbox="341 409 1428 517">Forging Ahead is located at 293 Ti Rakau Drive. This business may present issues to the proposed alignment with regards hydrocarbon and trace element contamination resulting from foundry operations.</p>

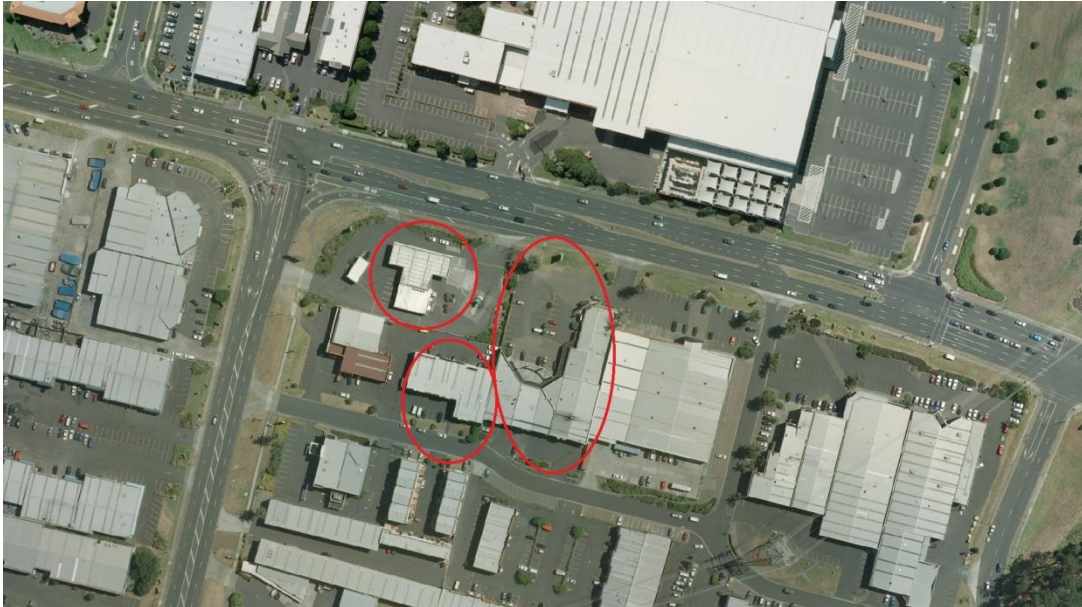
Date	Observations
2008	<p>333 Ti Rakau Drive is occupied by the Blue n Green Dry Cleaners (large oval) whilst next door on the corner of Harris Road and Ti Rakau Drive is a BP branded service station (circle). Behind BP is Jireh Auto Tyres at 179 Harris Road (small oval) dealing in automotive repairs. The service station may present issues to the construction of the alignment relating to hydrocarbon contamination and the dry cleaners may present issues related to chlorinated solvent and VOC contamination. The auto workshop may also have some issues with solvents, hydrocarbons as well as trace elements.</p>

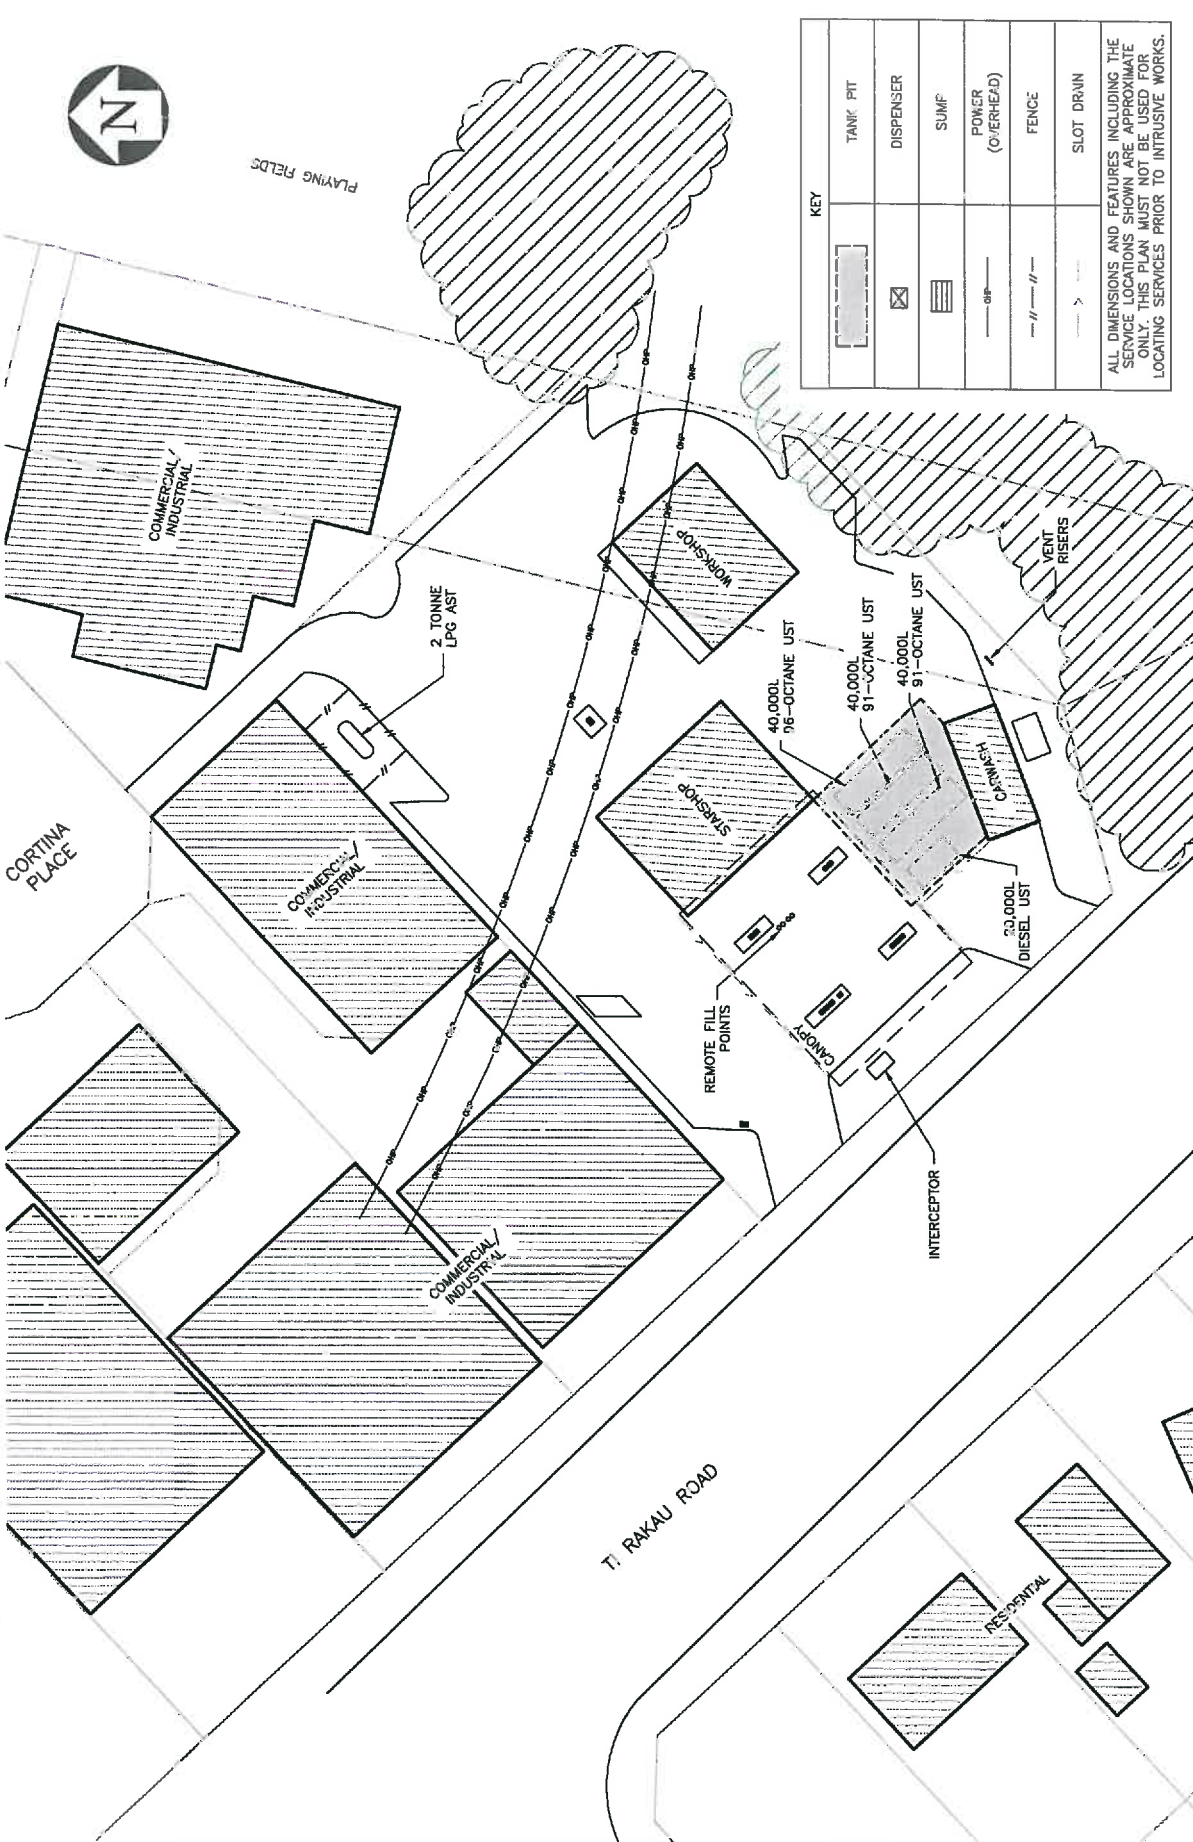
FIGURE 1

**CHEVRON NEW ZEALAND
CALTEX PAKURANGA
SITE LOCATION PLAN**

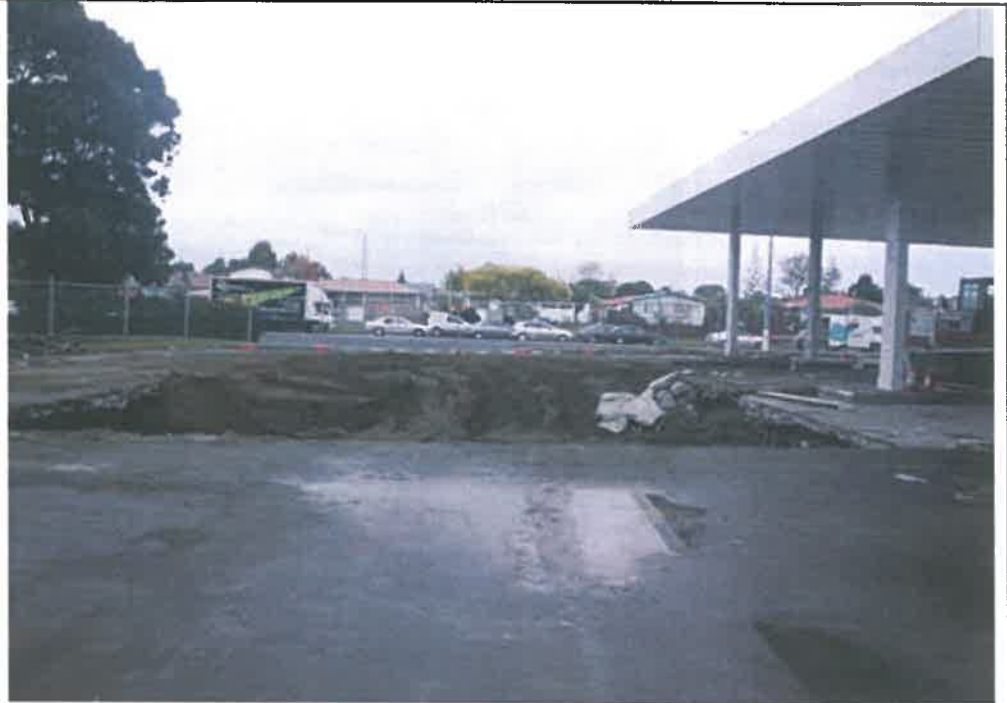
Tank pit in the foreground. Facing south west to Ti Rakau Drive.

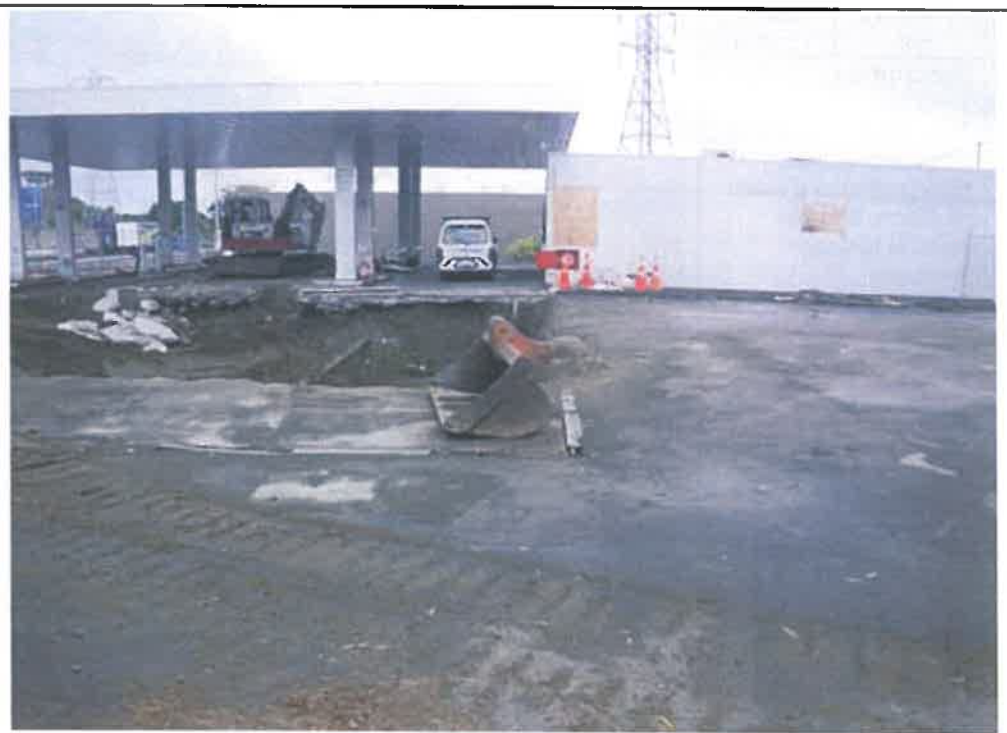
Photo No.
02

Facing west across the site towards car hire company.
