Eastern Busway

EB2 and EB3 Residential

Contaminated Land Effects Assessment

Document Number: EB234-1-PL-RP-ZO-000015

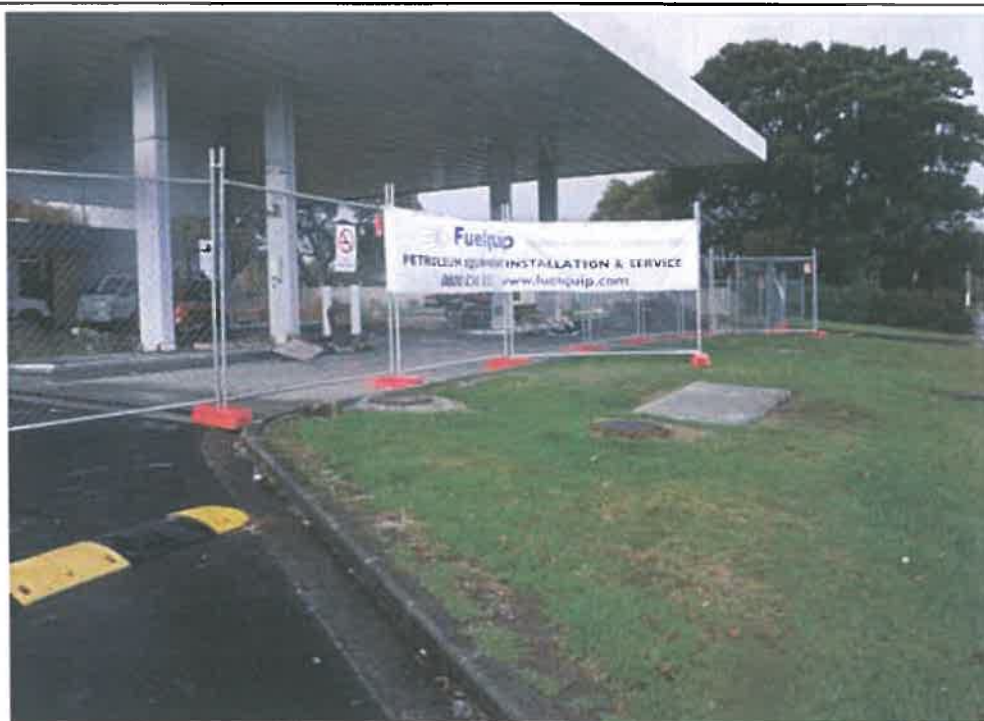
Forecourt facing east across site. Separator in the grass in foreground of photo.

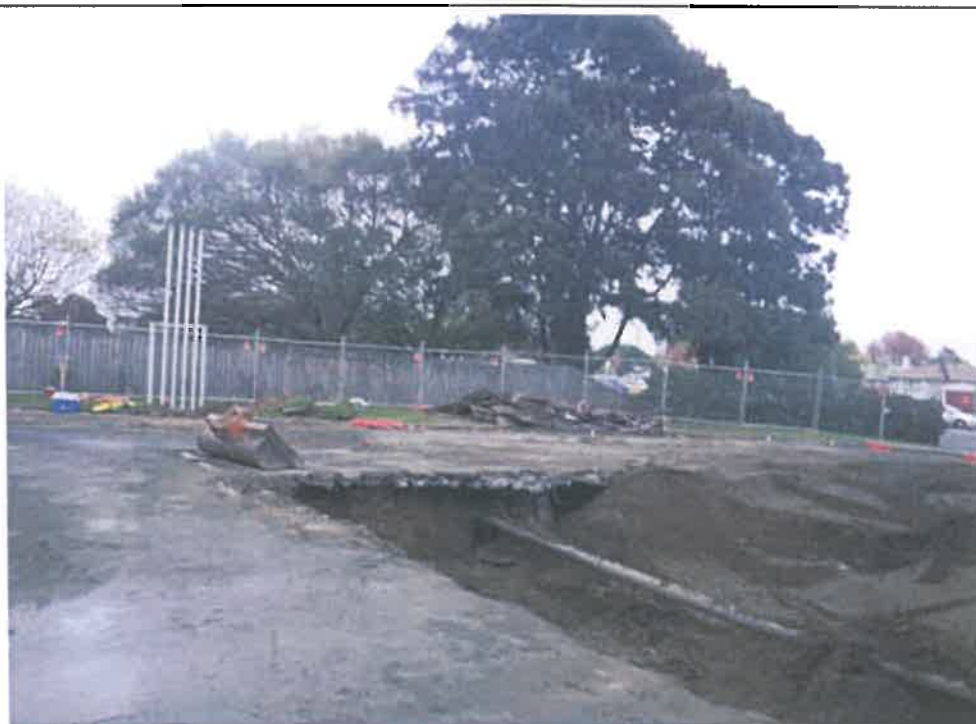
Photo No.
04

Tank pit in foreground and vents in the background in a west direction. Beyond vents is the site boundary.

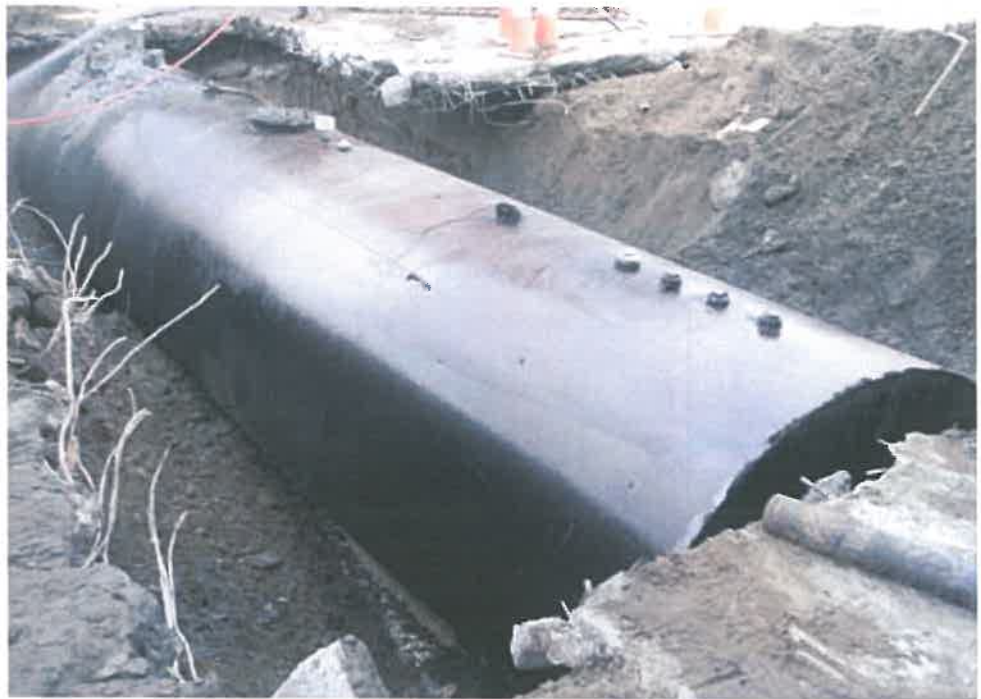
Tank 1 40,000L 96
Octane tank.

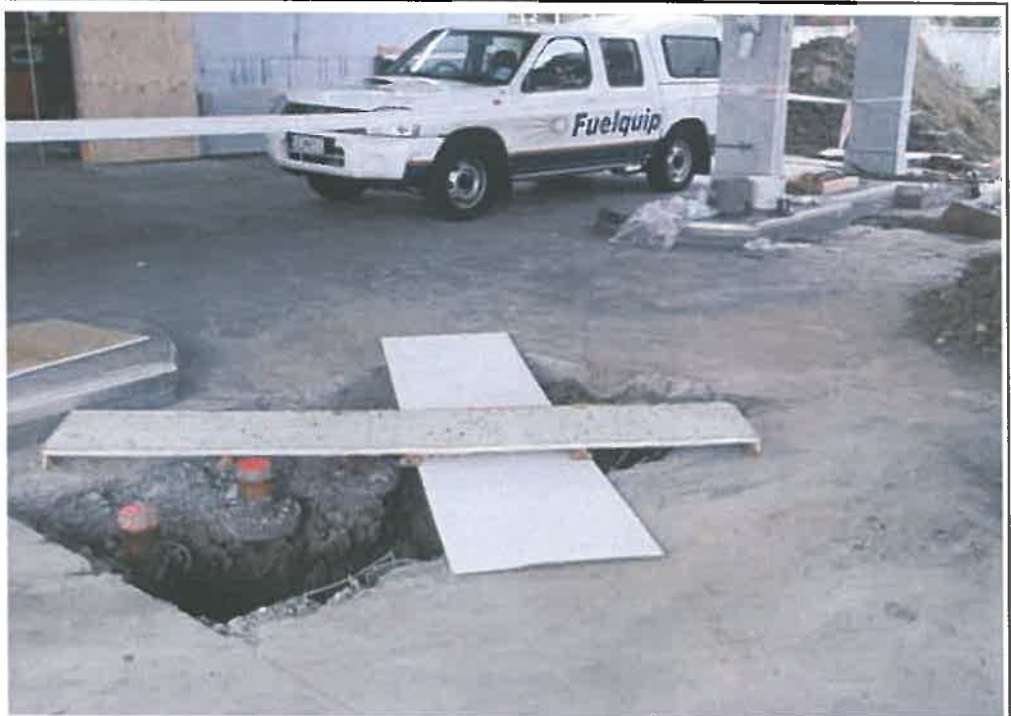
06

Forecourt facing the
former star shop.
Remote fill 1 in the
foreground.

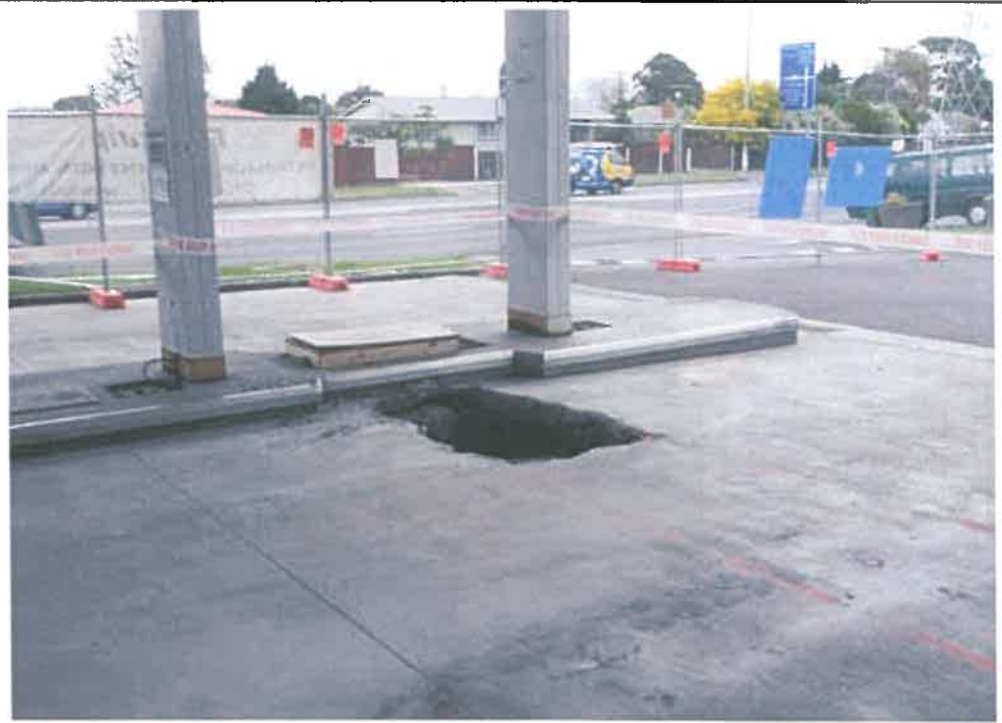
Forecourt facing Ti Raukau Drive, with dispenser 2 in the foreground.

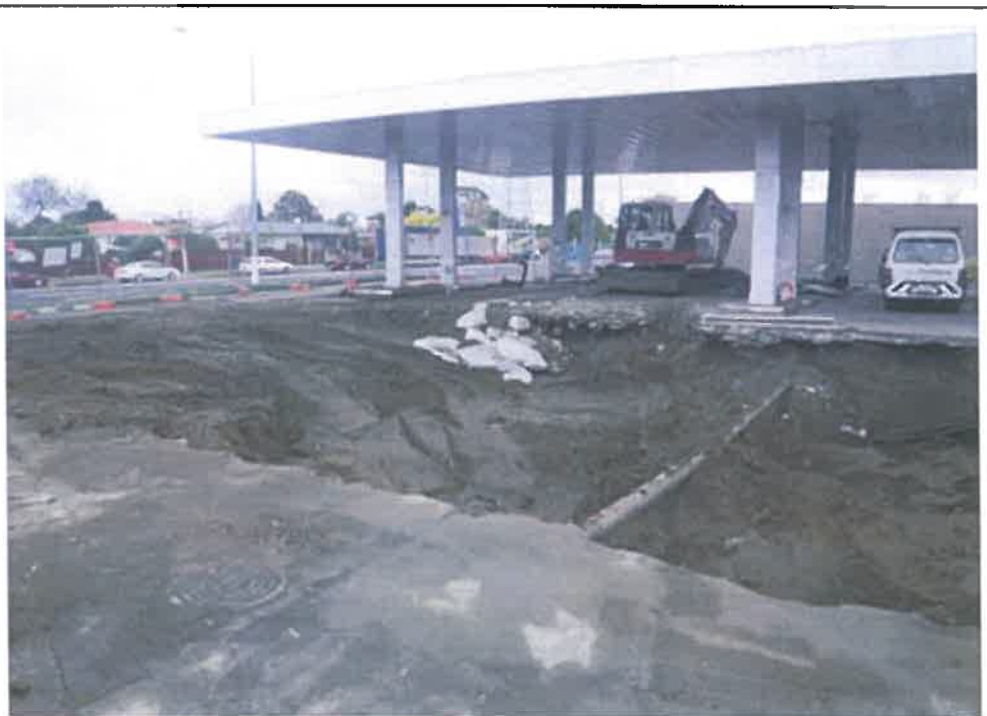
Photo No.
08

Site facing south east, all tanks removed.
