Chapel Downs Primary School

Preliminary Site Investigation

ASC Architects Ltd 31 October 2023

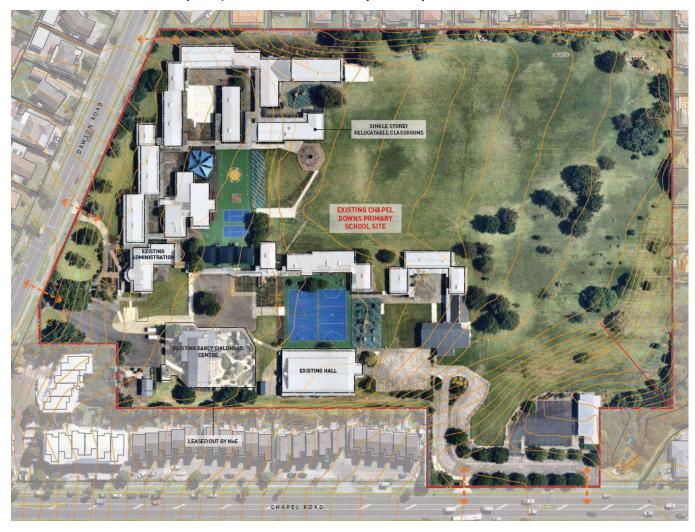
Figure 1 Existing site plan

Chapel Downs Primary School is located within the Auckland suburban area of Flat Bush, South Auckland, approximately 2.8 km northeast of the Manukau City Centre. The Site has an underlying zone of Residential – Mixed Housing Urban Zone under the AUP(OP). The site currently contains 25 teaching spaces and an early childhood centre on the eastern boundary of the site (Figure 1). There are approximately 45 carparks in use by the school on the site accessed by Chapel Road, and 23 used by the early childhood centre.

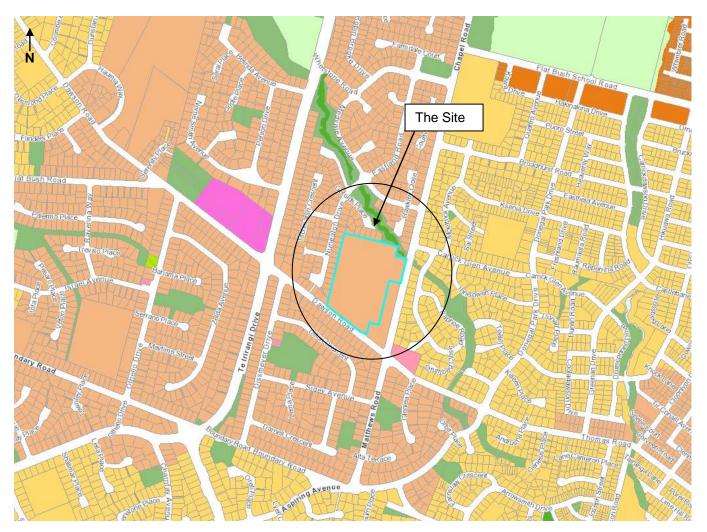
Figure 2 Site location and context

The surrounding environment of the site is predominantly residential, consisting of detached houses. Dawson Primary School is located approximately 900 m northwest of the school. Land along the northern, western, and southern boundaries is zoned Residential – Mixed Housing Urban Zone, with an Open Space – Conservation Zone and Open Space – Informal Recreation Zone located on the northeastern boundary. The properties on the eastern boundary of the site across Chapel Road are zoned Residential – Mixed Housing Suburban Zone. There is an extensive network of parks in the wider area. Barry Curtis Park and Rongomai Park are both located to the northeast of the site off Chapel Road, and Raphoe Park is located to the east off Raphoe Road. Chapel Road is an arterial road, and Dawson Road is a collector road. On-street parking is available on both Dawson and Chapel Roads.

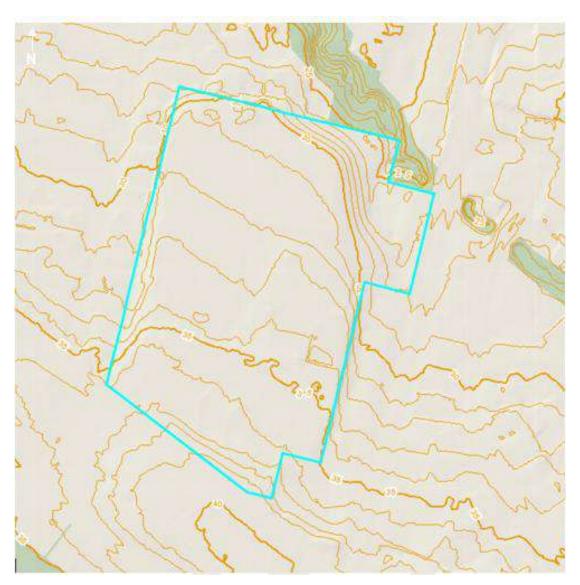
Figure 3 Topography (Auckland Council 2023)

The hill shade plan shows the area which the school buildings occupy to slope gently from north to south. The school fields appear relatively flat and, given the surrounding topography, are likely to have been formed from an earthworks operation. The northeastern corner of the site slopes at 10°. This is shown in figure 4 below.

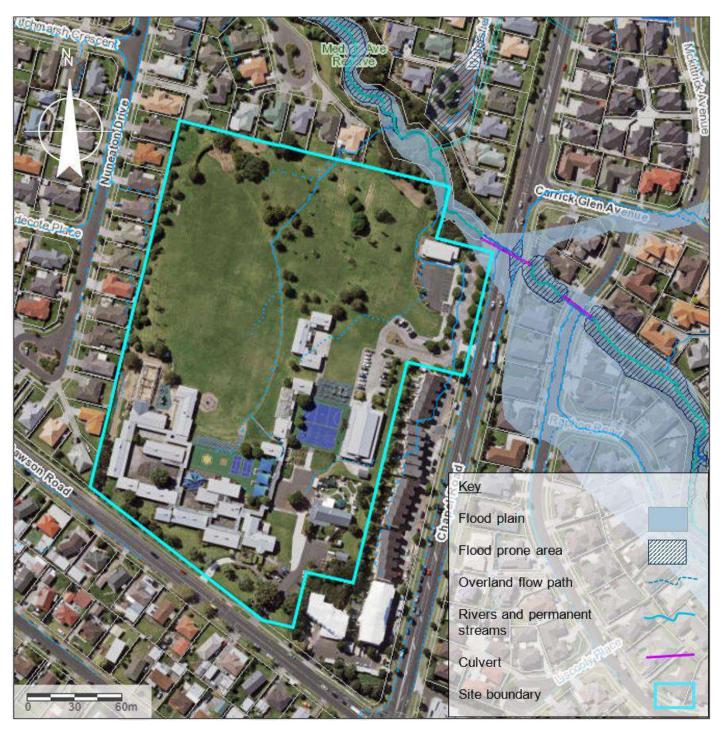
Figure 4 Surface water plan (Auckland Council 2022)

An extract of the Auckland Council Geomaps catchment and hydrology data is included as Figure 5. It shows a permanent stream running southeast to northwest through the northeastern boundary of the site within Medvale Avenue Reserve. The stream is flanked on either side by a flood prone area and a flood plain. Three overland flow paths that run south to north are noted on site.

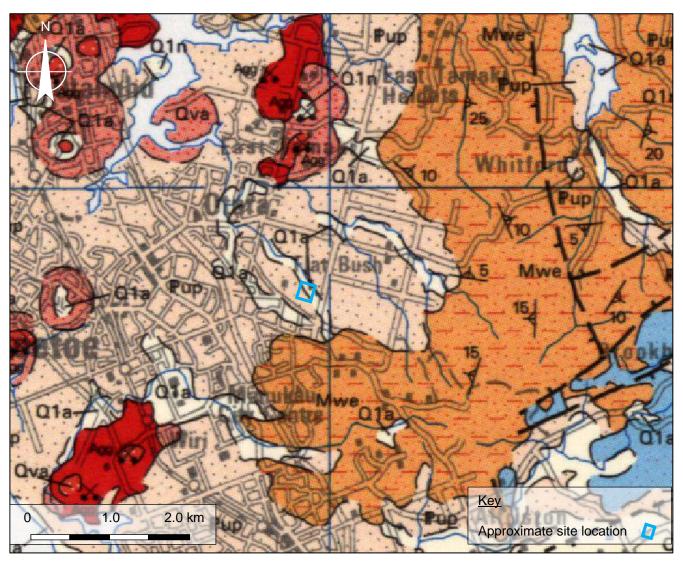
Figure 5 Extract of the 1:250,000 geological map of the Auckland area (Edbrooke 2001)

The published 1:250,000 geological map of the area (Edbrooke 2001) shows the surficial geology of the site to comprise Tauranga Group Puketoka Formation (Pup) with Tauranga Group Holocene Deposits (Q1a) within the northeastern corner of the site. Holocene Deposits are also noted to the south however are not shown to overlap with the site boundary.

An extract of the geological map is presented as Figure 6 with the descriptions as stated on the geological map presented as Table 1.

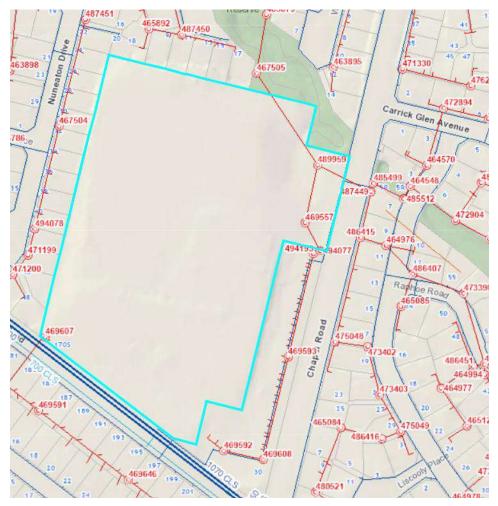
Figure 6: Auckland Council underground infrastructure

Underground utility infrastructure for the Site was searched on the Auckland Council GIS Asset Overlay to identify the presence of any existing public stormwater, reticulated wastewater and potable water networks servicing the Site (refer Figure 6)⁵. No services including wells were detected within the Site aside from a wastewater pipe running through the northeastern section of the Site. Old, buried pipes or operational pipes may also contain asbestos cement, which may contaminate in-situ soil if the pipe is in a deteriorated condition or becomes broken during future redevelopment works.

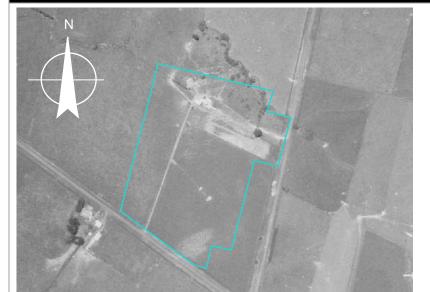
Retrolens - 1939

The Site observed in this 1939 aerial photograph comprises buildings adjacent to the northern boundary, with an access road connecting the buildings to Dawson Road, which appears to have been constricted prior to 1939.

A stream is observed flowing across the north-east section of the Site and ground disturbance to the south of the Stream is observed.

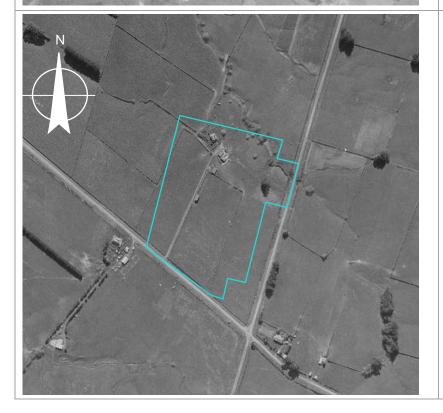
Retrolens - 1960

No significant change in onsite and adjacent land use observed post 1939.

Two buildings are observed to the east of the access road on the Site, constructed between 1939 and 1960.

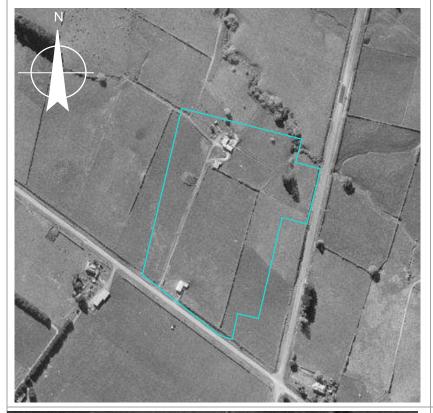
Retrolens - 1980

No significant change in onsite and adjacent land use observed post 1972.

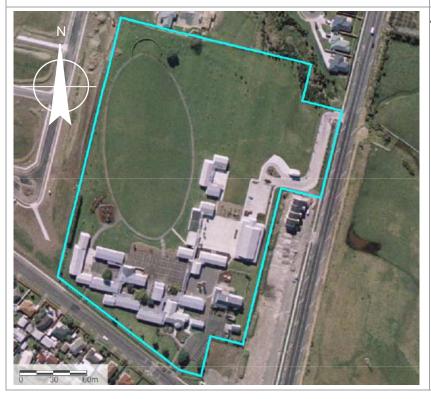
Auckland Council Geomaps - 2001

Post 1996, the school's building footprint had increased to the north along the eastern Site boundary and to the west along the southern Site boundary.

An oval track had been established within the school's playing field, occupying the central and west section of the Site.

Residential land development had increased to the south, east, and north of the Site.

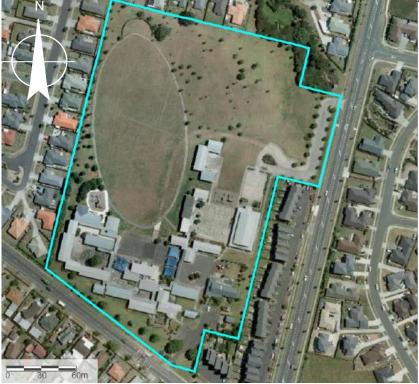
Auckland Council Geomaps - 2010-2011

No significant change in onsite and adjacent land use is observed post 2010-2011.

An additional building and car parking area had been constructed within the north east section of the Site between 2011 and 2016.

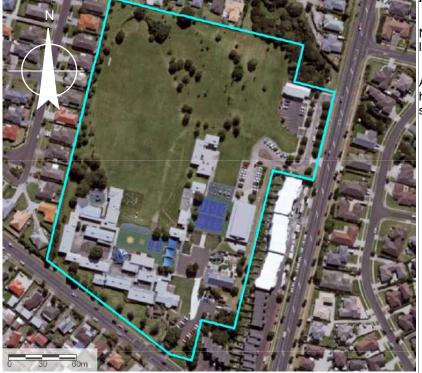
No significant change in onsite and adjacent land use is observed post 2015-2016.

A building is observed to be under construction within the southwest section of the Site.

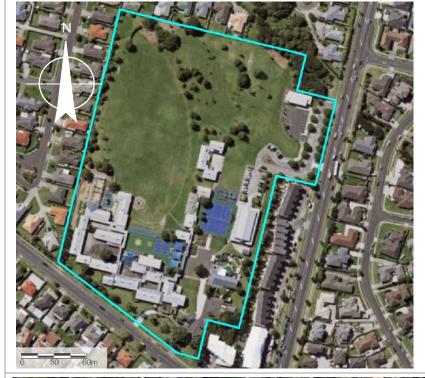
Google Earth - 2022

No significant change in onsite and adjacent land use is observed post 2017.

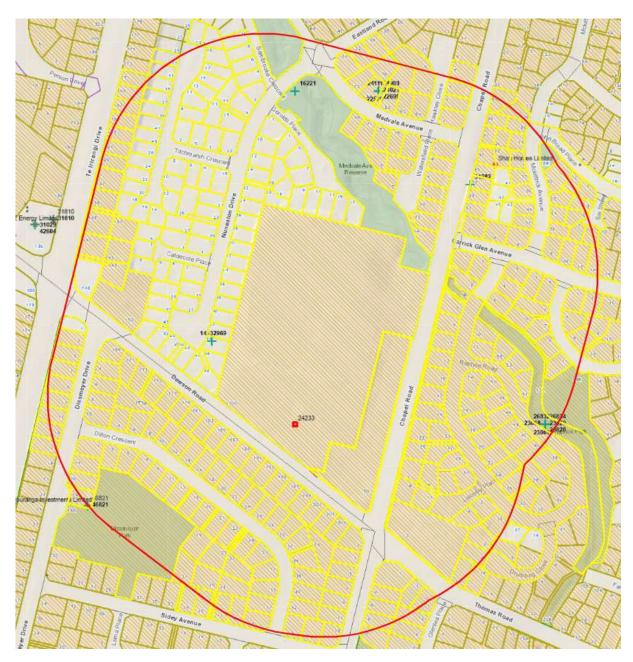
Figure 1: Selected Consents, Incidents and HAIL activities within approximately 200m of the subject site

The Council database was searched for records of the following activities within approximately 200 metres of the site and results are displayed in Figure 1 below:
