## APPENDIX E – ARCHAEOLOGICAL ASSESSMENT

# SH16 IMPROVEMENTS, BRIGHAM CREEK TO WAIMAUKU: PRELIMINARY ARCHAEOLOGICAL ASSESSMENT

Prepared for NZ Transport Agency Safe Roads Alliance

October 2019  
(updated from June 2018)

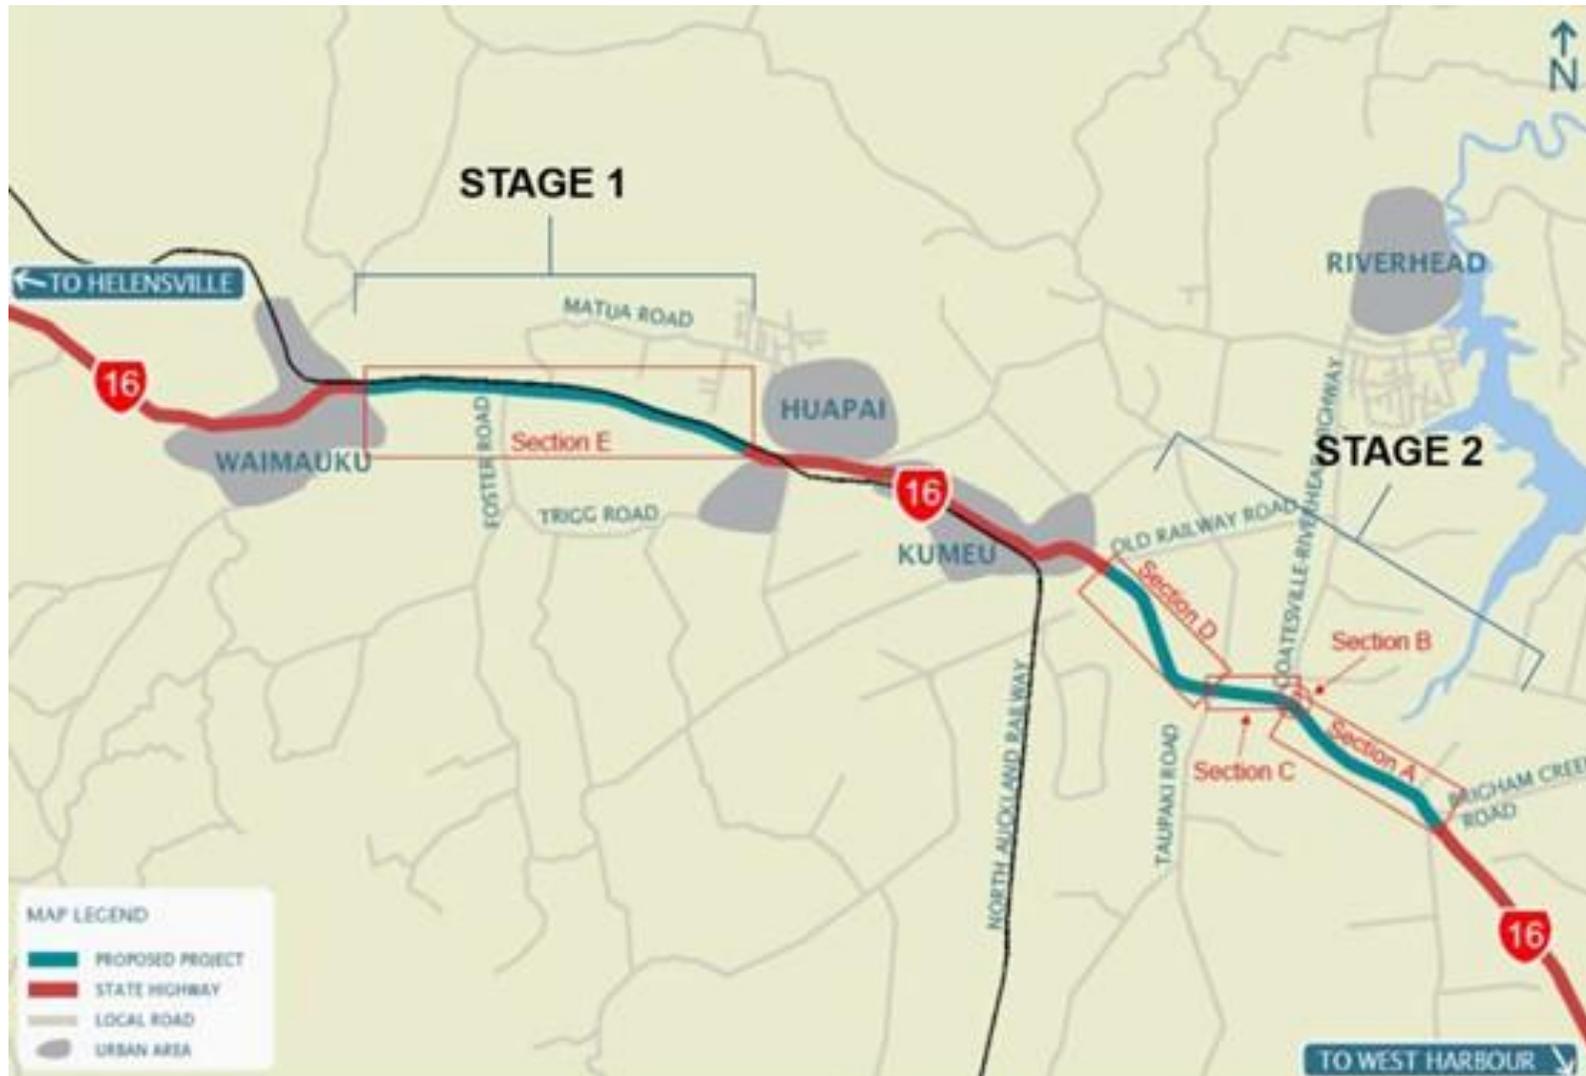
Figure 2. Locality map and development stages and sections

The corridor is further divided into two delivery stages; Stage 1 (Section E) and Stage 2 (Section A-D) (see Figure 2 below).

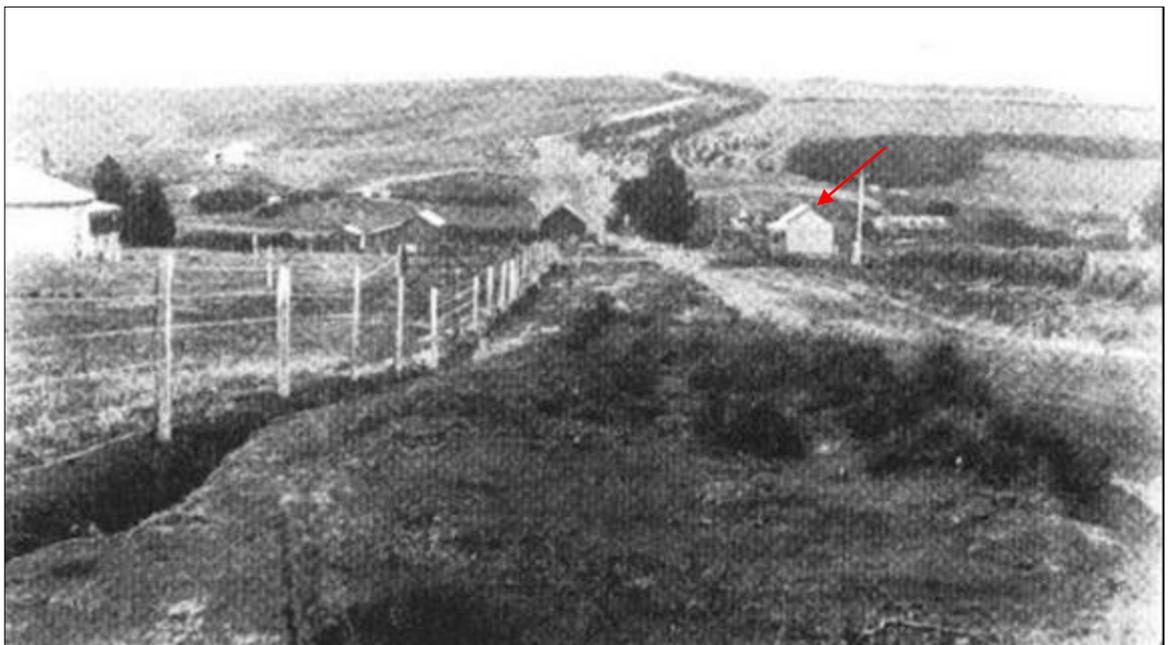
**Figure 8. Looking northwest from eastern side of creek c.1902, showing Alex Sinton's house (left), John Sinton's original house (left background), the Store (arrowed) and beyond it the original house and picket fence on the western side of the creek (from Madden 1966: 122)**

A photograph dated c.1902 shows the location of the first Sinton homestead on the western side of Brigham Creek, north of the Great North Road (now SH16) (Figure 7). There was also a shed close to the road and bridge (Figure 7, Figure 9). Hodder records that after John Sinton and his wife Lillian married in 1901 they lived in a small cottage on the western side of the creek, which is presumably this building (Hodder 1975; n.d.), though prior to this John appears to have lived on the southern side of the road (Figure 8). Most of the Sinton family buildings were located on the eastern side of the creek. These included the store, the gum store, Janet Sinton's house and Alex Sinton's house (Figure 7, Figure 8). The location of the store and gum store are shown on a later (1930) plan (Figure 11, Figure 12).

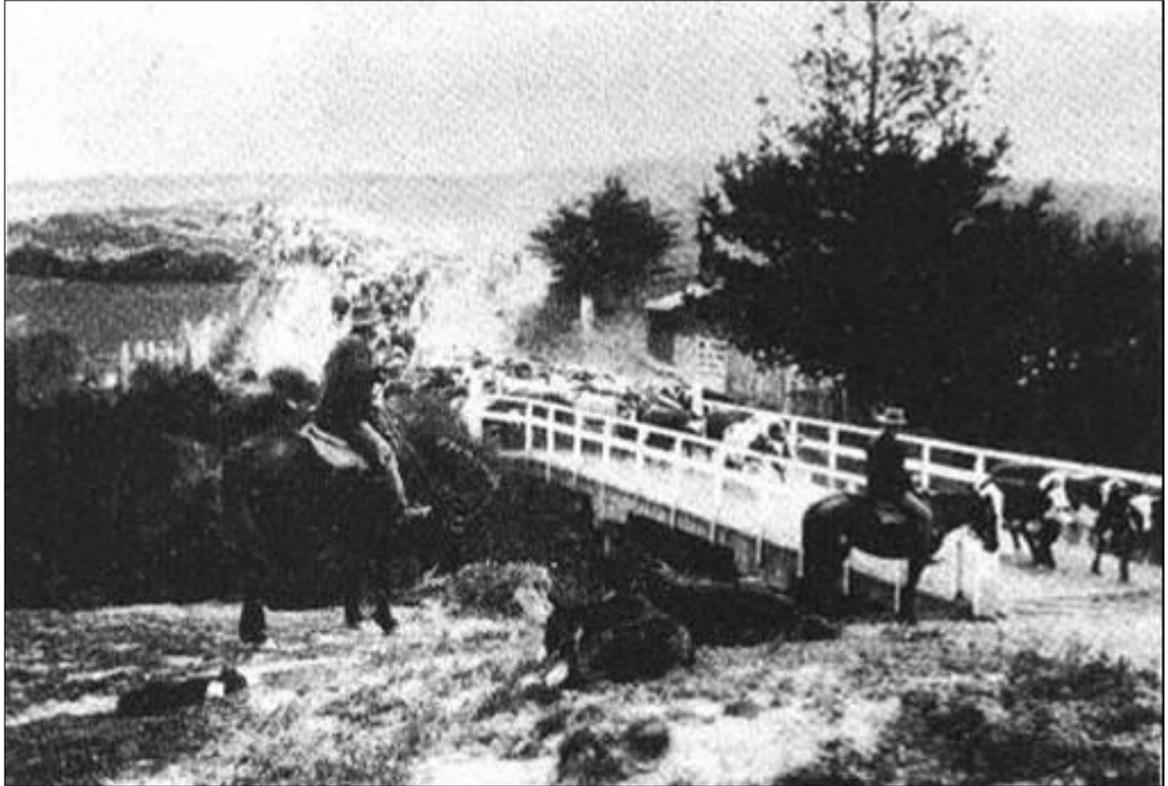
**Figure 9. Cattle drive across the bridge c.1902, looking northwest. The shed near the original homestead on the western bank of the creek is visible on the far side of the bridge (from Madden 1966: 169)**

Part of the Sinton property, including the area where the shed shown in Figure 6 and Figure 9 was located, was taken for road realignment purposes in 1930 (Figure 11, Figure 12).

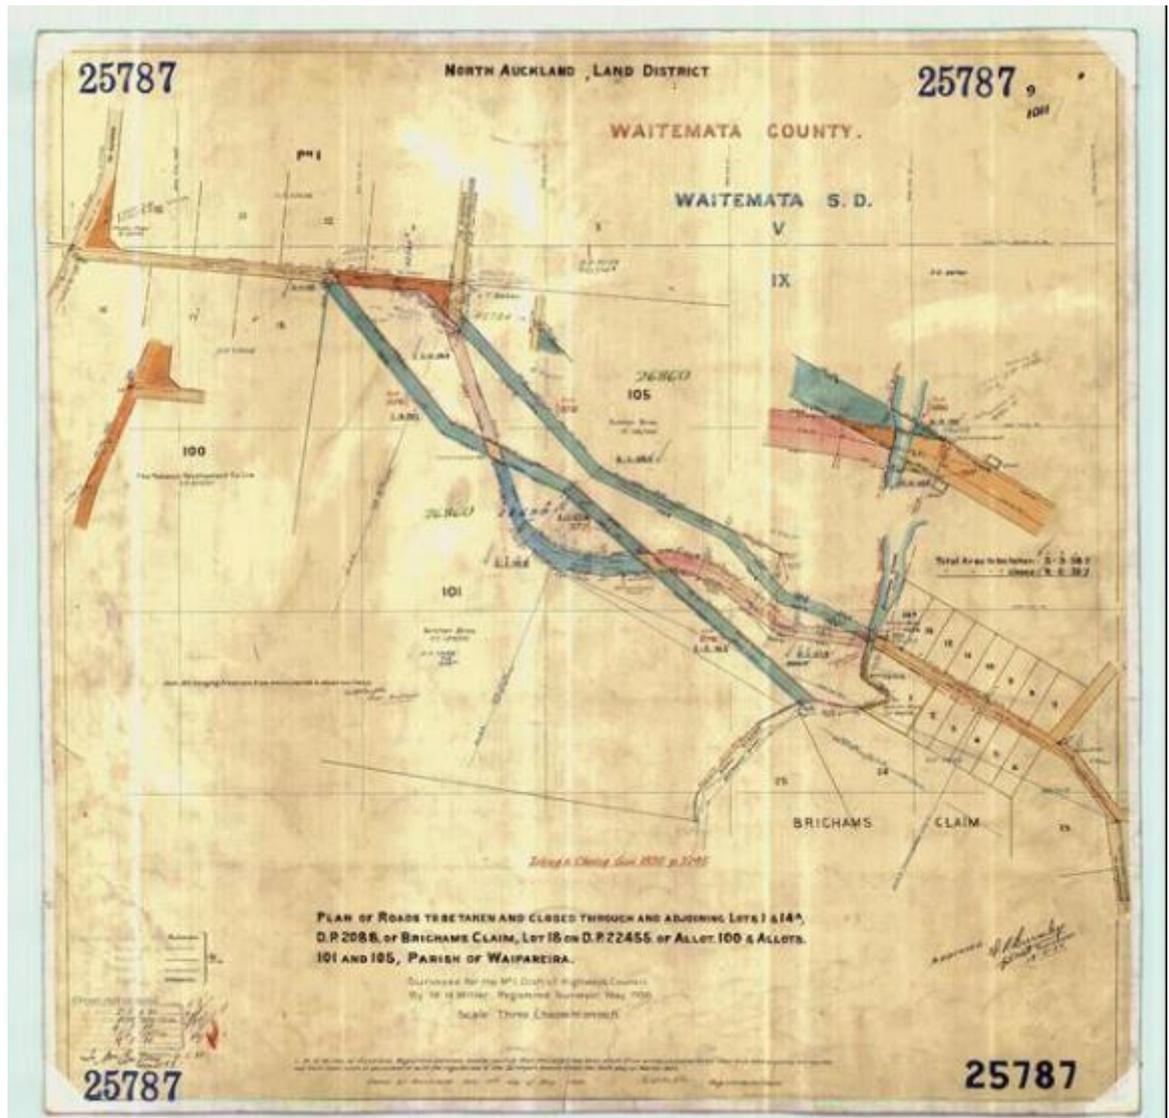
Figure 11. SO 25787 (1930) ‘Plan of Roads to be taken and closed through and adjoining Lots 1 & 14A, D.P. 2088 of Brighams Claim, Lot 18 on D.P. 22455 of Allot. 100 & Allots. 101 and 105, Parish of Waipareira’

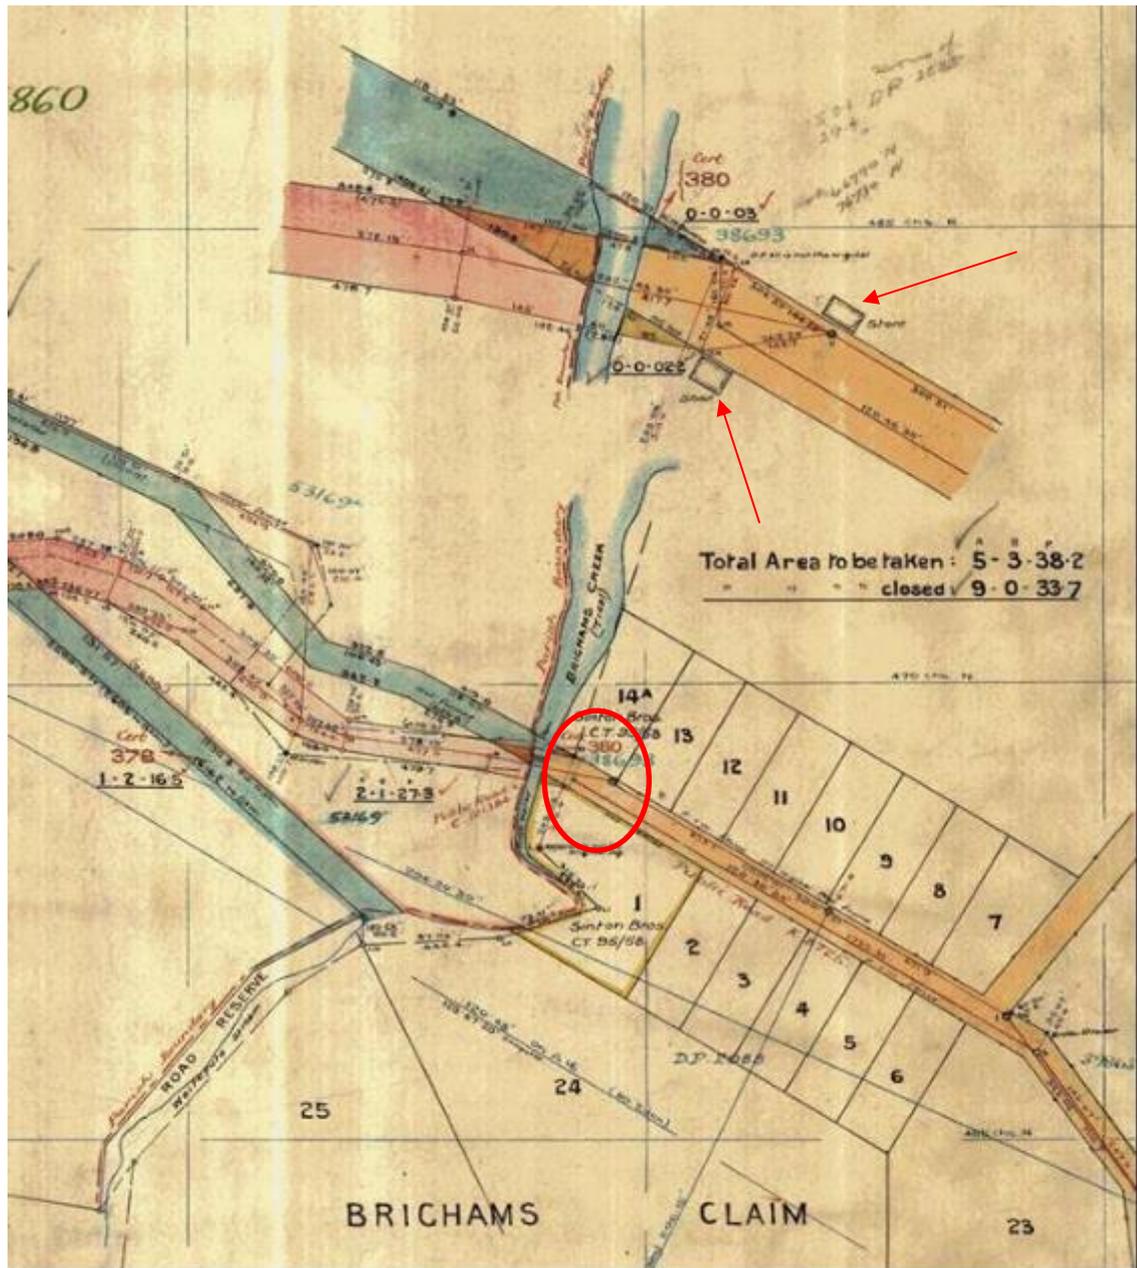
Figure 12. Detail from SO 25787 (1930) showing the locations of the shed and store on the eastern side of the creek

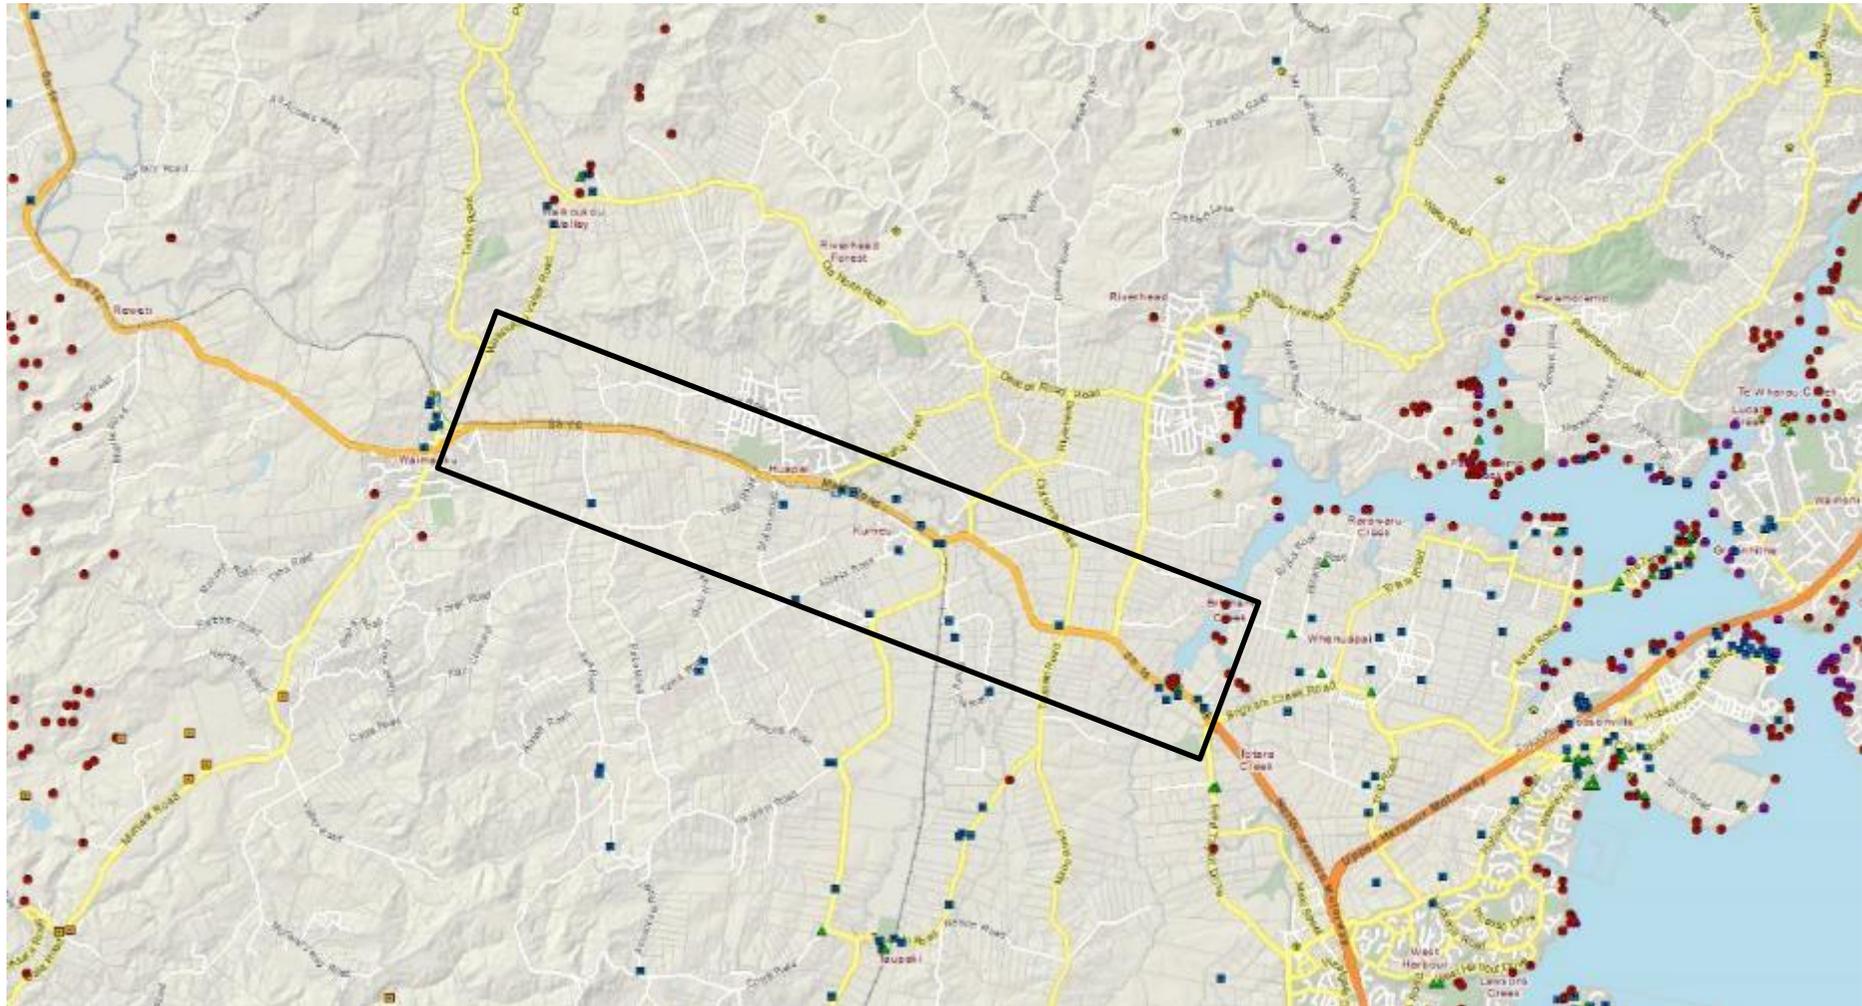
**Figure 13. Showing the general distribution of archaeological sites (red dots) and historic structures (blue squares) in the project area (within box). Source: Auckland Council CHI. Red dots = archaeological sites, blue squares = heritage structures, green triangles = heritage trees, purple dots = maritime sites, yellow pentagons = reported sites**

In addition to the recorded archaeological sites, a number of heritage buildings have been recorded near SH16 between Brigham Creek Road and Factory Road (Figure 13). They are clustered at Huapai/Kumeu and Brigham Creek, with one located at the junction of SH16 with Taupaki Road and Old North Road. Several heritage buildings have also been recorded in Waimauku, but to the west of the project area.

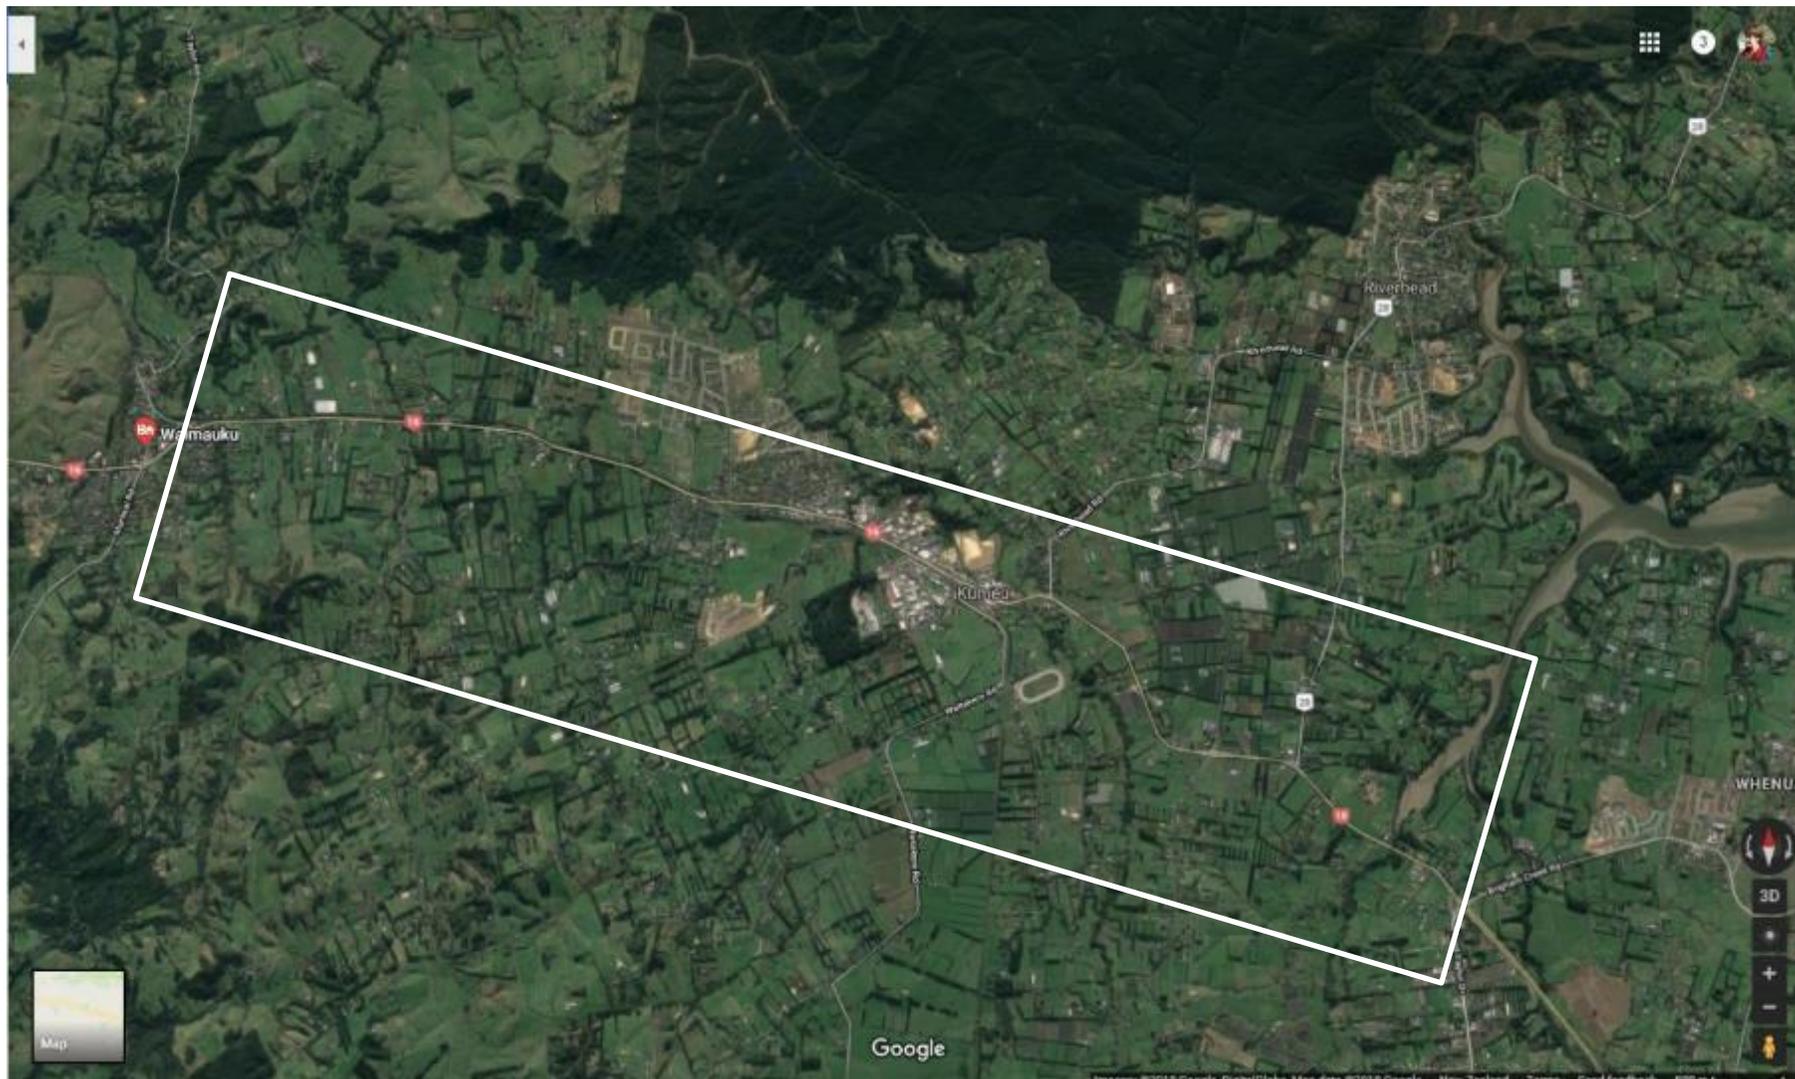
Figure 14. Aerial view of the project area (source: Google Earth)

State Highway 16 between the Brigham Creek Road roundabout and Waimuku runs through predominantly rural residential land apart from the area of urban development at Kumeu/Huapai (Figure 14). The road has been widened and upgraded over the years, including the construction of major roundabouts at the Brigham Creek Road intersection) and Old North Road intersection (Figure 15), within the last decade.

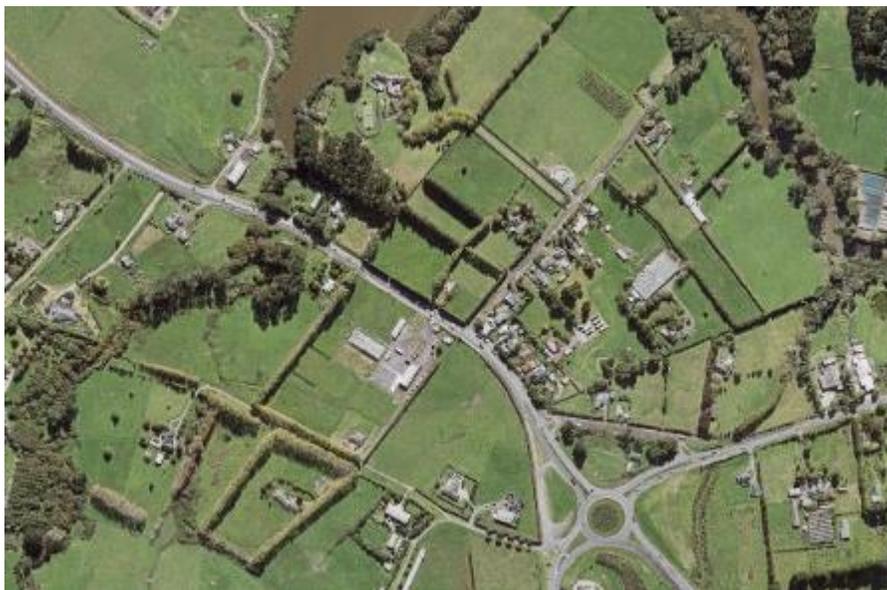
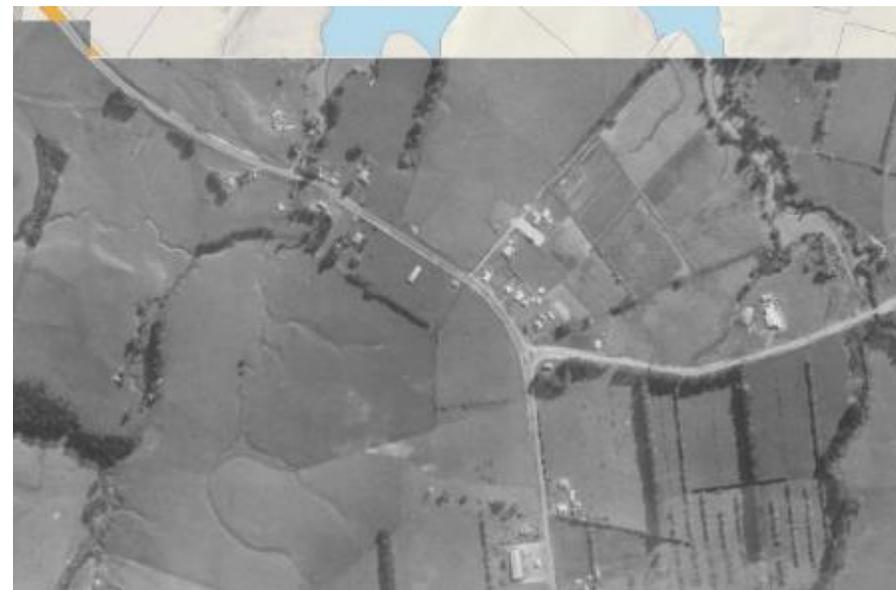
**Figure 15. Brigham Creek Road roundabout in 2017 (left) and Brigham Creek Road turn-off in 1959 (source: Auckland Council GeoMaps)**

None of the recorded heritage buildings will be affected by the proposed works as they are all located well away from proposed works. Nor will there be any effects on the reported site of a Sinton homestead north of SH16 on the eastern side of Brigham Creek (CHI 3379). A second reported site located at the Brigham Creek Road roundabout (CHI 3711) was the location of an early 20th century church which has been relocated to Clarks Lane in Hobsonville. This is not an archaeological site, and its former location has been extensively modified by construction works for the roundabout (Figure 15).

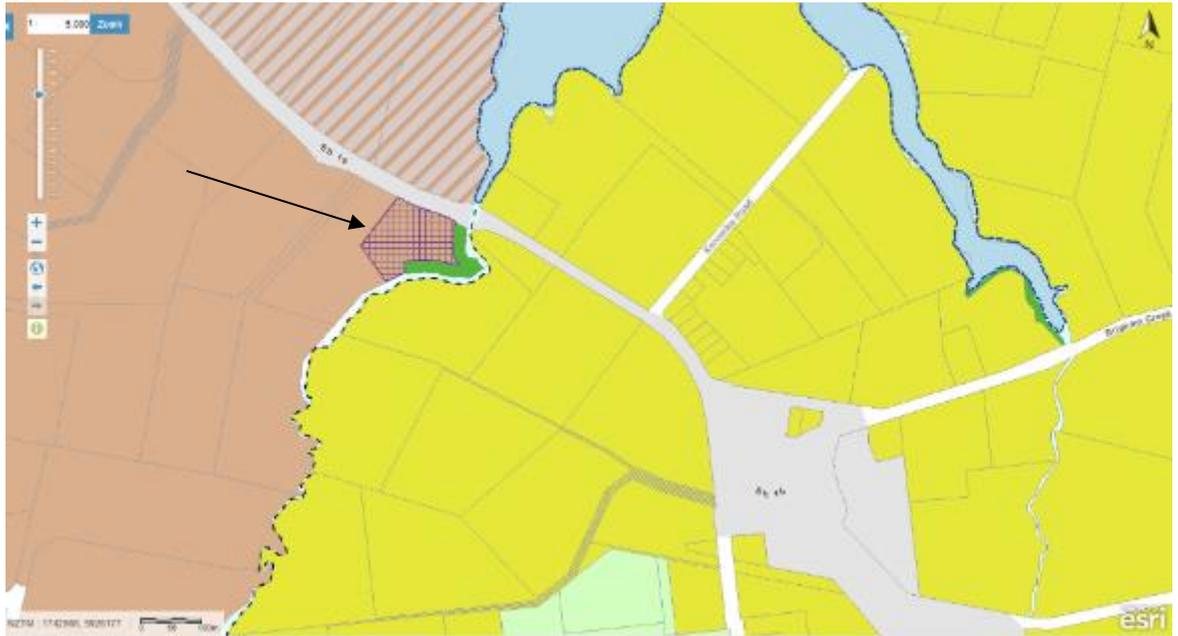
**Figure 20. Extent of place of 525 Sinton House (Former). Source: AUP OP planning maps**

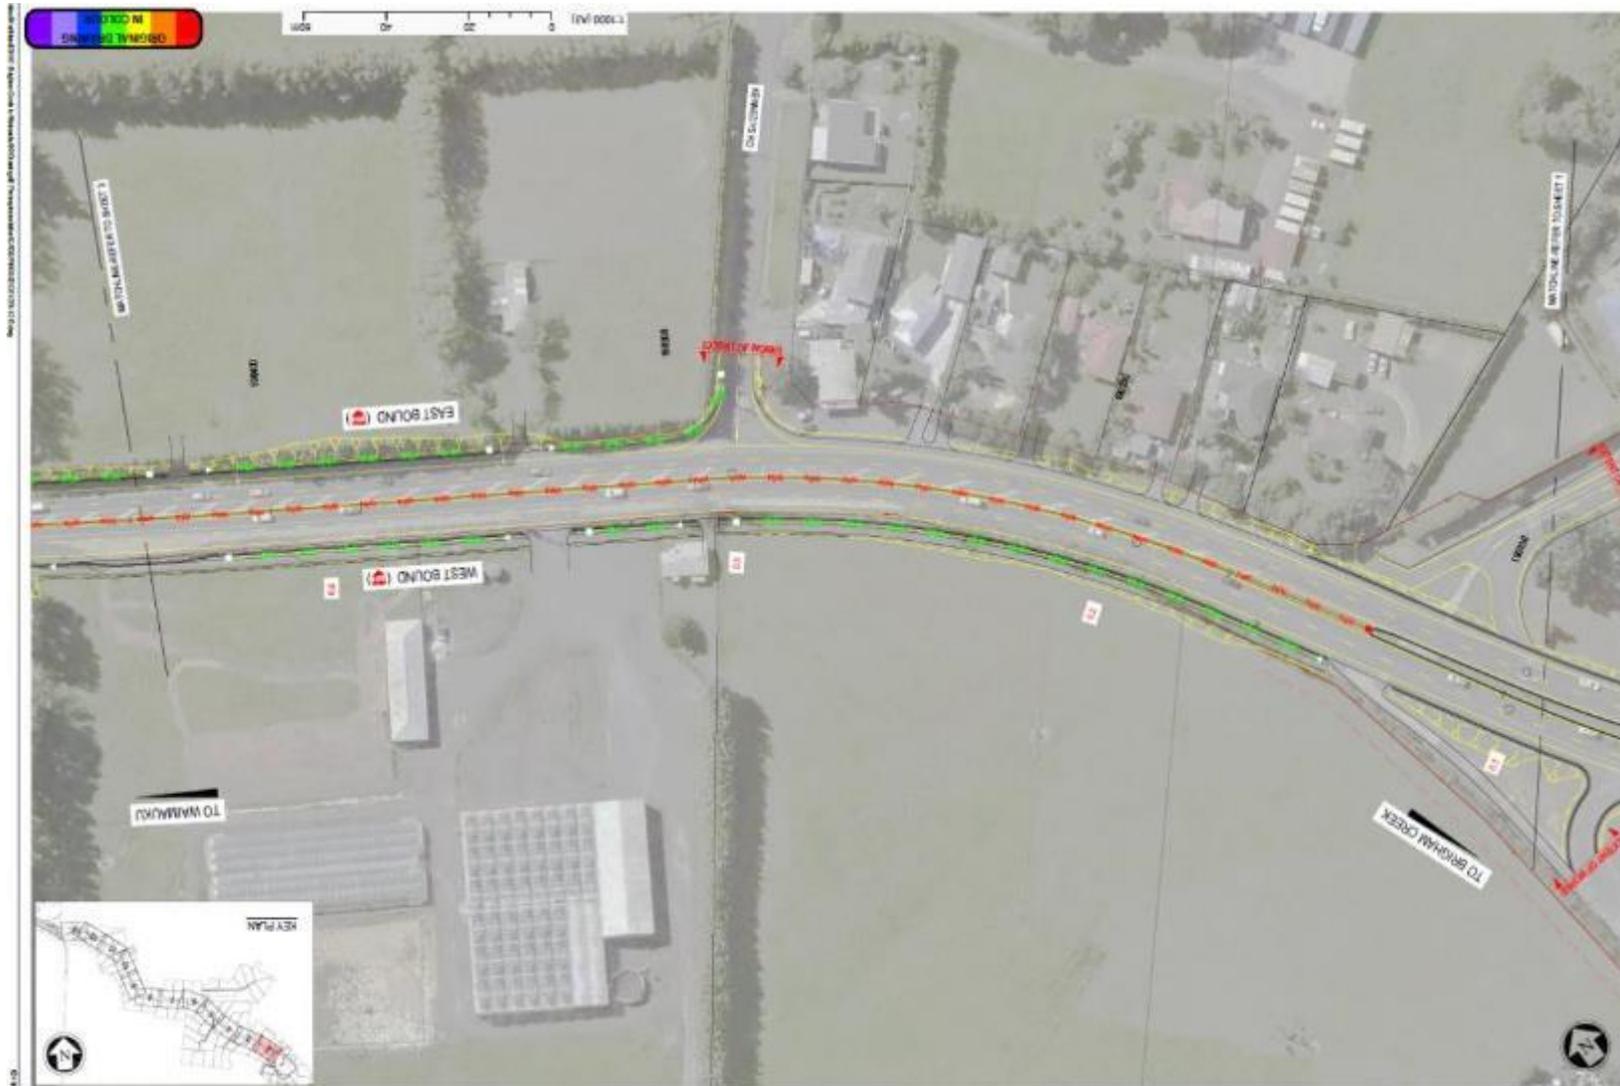
Figure 21. Proposed works at Brigham Creek Road roundabout and around Kennedys Road, Section A (SR1003-02-CE-1201-1213, sheet 2)

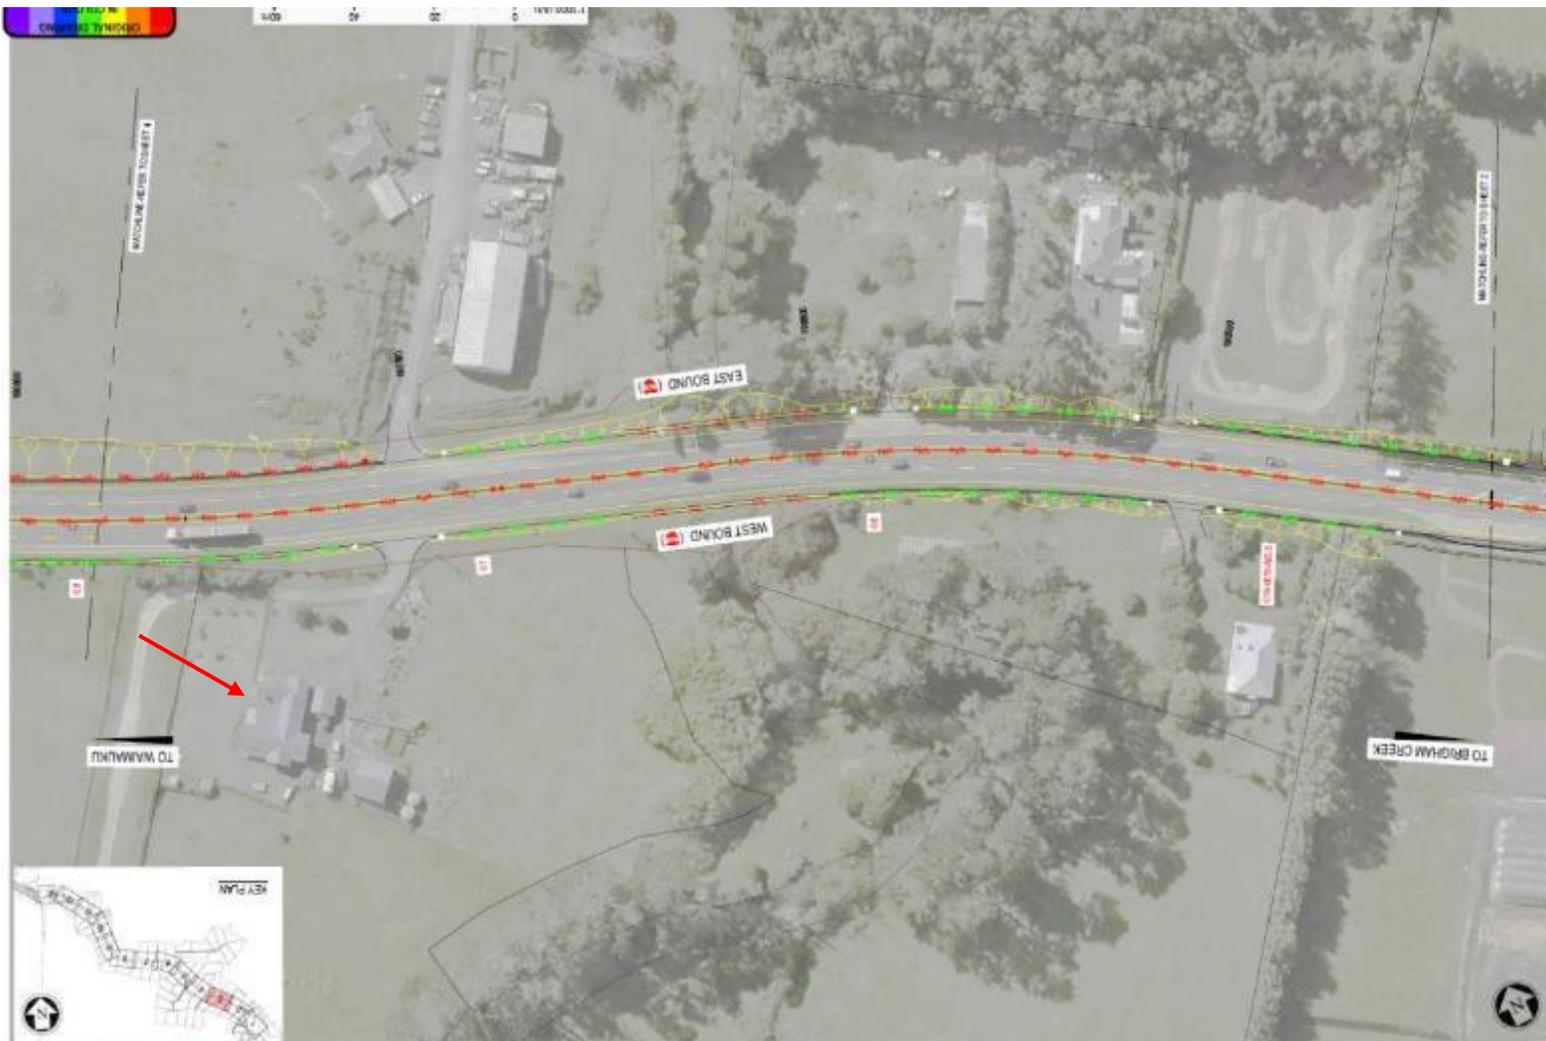
Figure 22. Proposed works in the section that crosses the west branch of Brigham Creek, Section A. The arrow indicates the scheduled building at 238 SH16 (SR1003-02-CE-1201-1213, sheet 3)

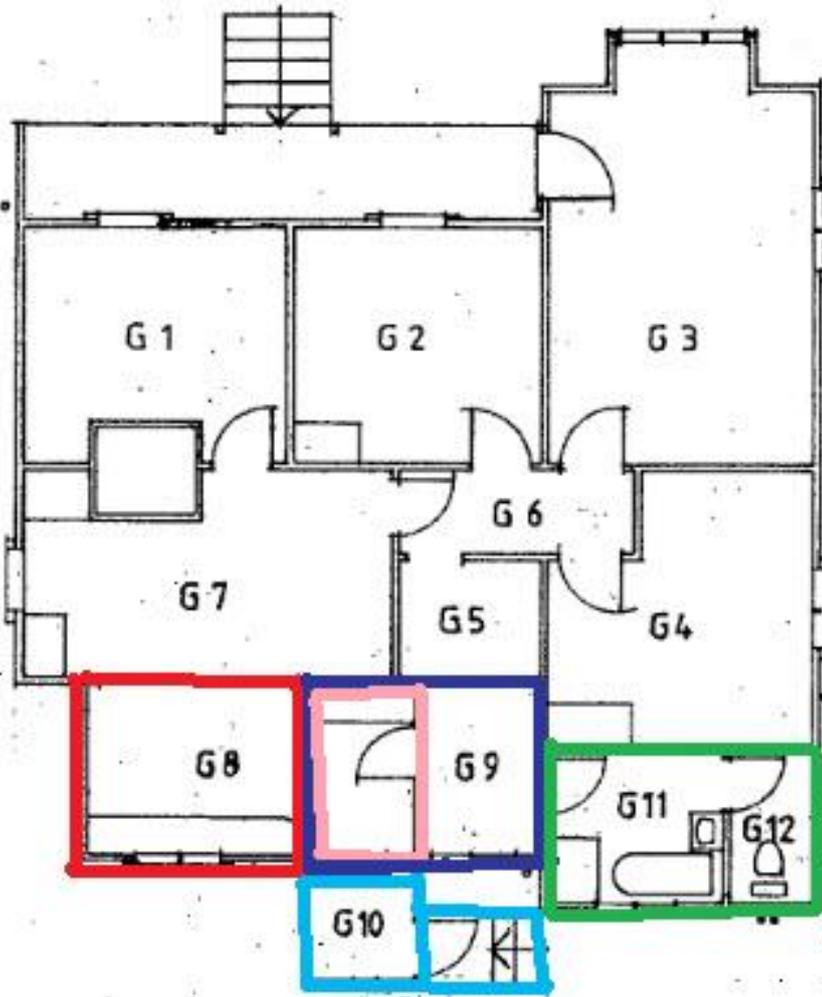
FLOOR PLAN

Current floor plan of the house, the uncoloured area represents the original building, the green the 1923 extensions and the red are the lean-tos to be demolished. Adapted from a plan in Pearson 2003:51 by Brent Druskovich.

The following notes relate to the findings of archaeological monitoring and examination of photographs from the demolition of lean-tos at the back of the house. The lean-tos have now been replaced by an extension to the house that more than doubles the size of the house from the size it was after the 1923 extension.

All evidence revealed during the demolition related to the series of lean-tos themselves. No evidence that indicated where the back door was for the original pre-1900 structure was found and no indications of a formal back yard were observed either. There was however much evidence that has enabled a reconstruction of the phases of lean-to development and a shifting back door location and entrance direction as lean-tos were added on or modified.

The phase 3 and 4 alterations must have occurred post 1959 as they are not present on the aerial photograph of that time. The general style of the fittings associated with these lean-tos, would suggest that they were likely built in the 1960s. The final phase included the building of the G10 lean-to and again the back door is reached from the east. The silver metallic building paper found beneath the floor of this add on would suggest it happened in the late 20th Century.

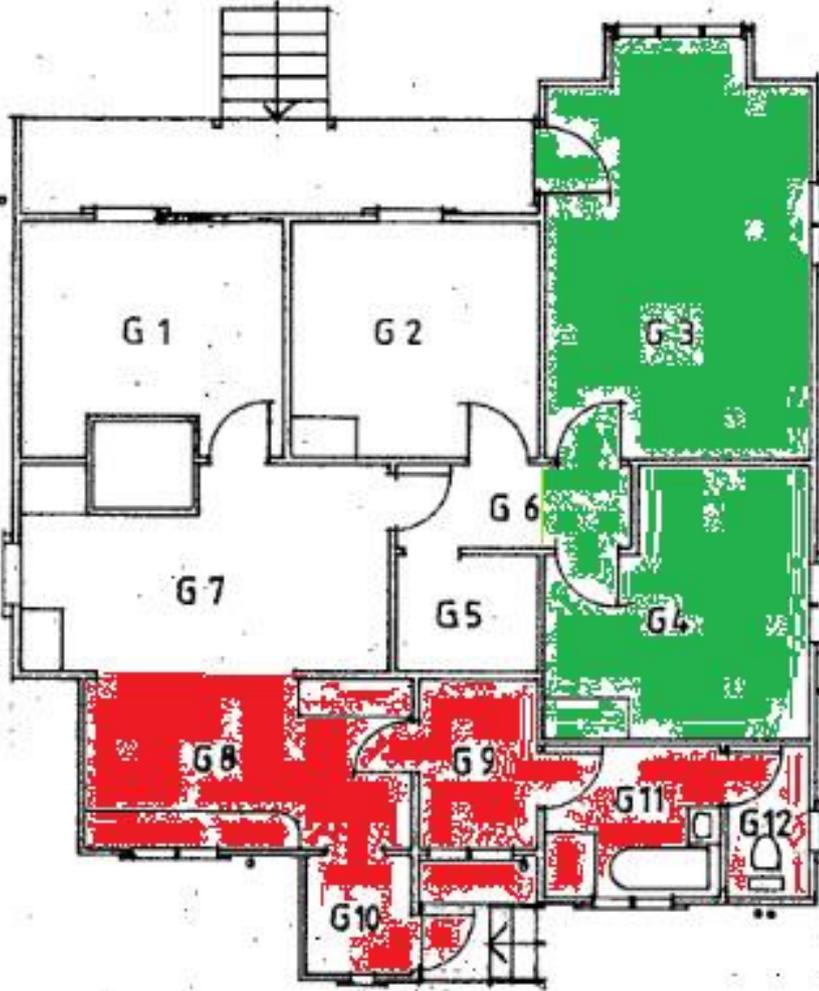
FLOOR PLAN

FORMER SINTON HOUSE
