DRURY ACCESS RAMP PROJECT

Appendix O – Contaminated Land Assessment of Effects

Attachment A – Contaminated Land - Preliminary Site Investigation (PSI)

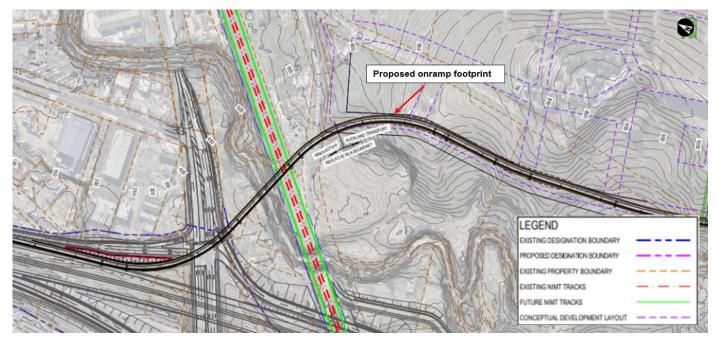
Figure 1-1: Proposed access ramp showing planning environment

The site in relation to the surrounding existing and planned environment is shown in Figure 1-1. The proposed works at the site will comprise:

- Construction of a 245 metre (m) long seven (7) span bridge structure from the southbound lane of State Highway 1 (SH1) to an area off Flanagan Road.
- Foundation piling works for bridge support.
- Cut and fill earthworks for the mechanically stabilised earth wall (MSE) retaining wall at the abutment to the bridge; and
- Establishment of a left-hand shoulder lane on the new bridge (with a minimum width of 2 m) and right -hand shoulder lane (with a minimum width of 1 m) respectively.

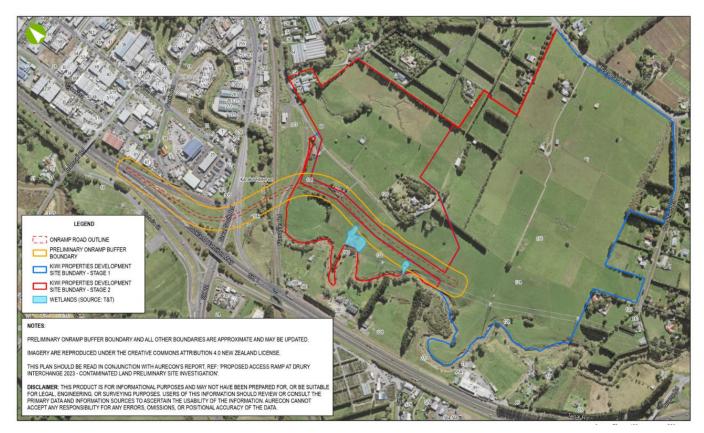
Figure 2-1: Site location

Refer to Figure 2-1 for the site location, an enlarged version of which is provided in *Appendix A*. For this PSI, the site is defined as the area within the orange buffer, as shown in Figure 2-1 to accommodate changes to final piling layout and bridge structure placement, noting detailed design for the project is yet to be completed.

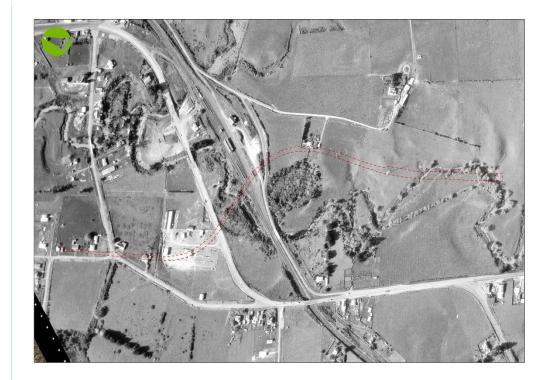
1963 Retrolens

1960 and 1963	A contractor's yard is evident through the centre of alignment to the north of the NIMT, on the northern side of Great South Road. No other significant changes to the site.	No significant changes to the surrounding area. Hingaia Stream has been cleared of the dense vegetation which was noted on the earlier aerial photograph.
1974	The low-lying gully between the NIMT and Great South Road (Karaka Reserve) has been infilled, likely as part of the Drury Interchange construction. The heavily vegetated former river bend at 108 Flanagan Road, immediately to the south of NIMT corridor (within the Kiwi Properties development) has begun to be cleared and re-worked.	The Drury Interchange motorway layout appears to have been redesigned and SH1 has been constructed. The horticultural activity noted at 190 Flanagan Road is no longer visible. Some industrial development is also evident, east of the Great South Road offramp (within the Drury Industrial Estate).

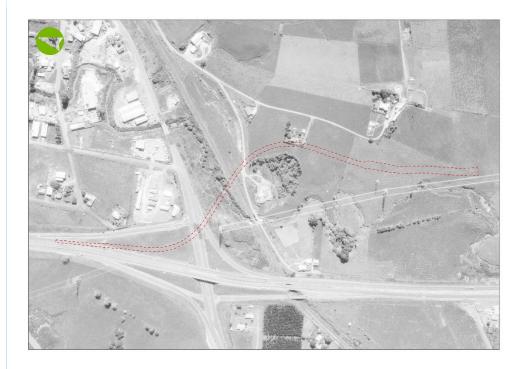
1981	A new residential dwelling has been constructed in the eastern corner of 108 Flanagan Road, and the vegetated river bend continues to be infilled.	No significant changes to surrounding land use.
1996	Landfilling of the former gully/flood plain in these areas has been completed. No other significant changes noted to the site.	Two electrical pylons are visible bordering the site (within the DCP development). Commercial and industrial intensification is evident within the Drury Industrial Estate. The Karaka Reserve appears to have been developed. The area immediately west of the Hingaia Stream (at 190 Flanagan Road) appears to be used as a commercial property. A settlement pond and ancillary buildings are evident scattered throughout this property. Extensive market gardening

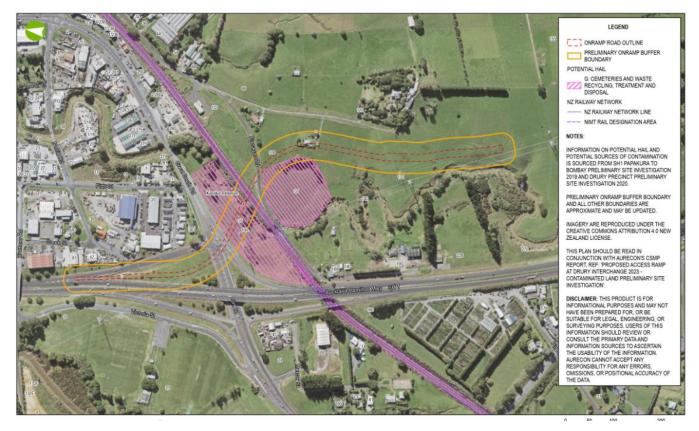
Figure 1: Map showing key management areas

This plan has been prepared based on the findings from the Preliminary Site Investigation report prepared for the site and referenced in Section 1.4 above. The PSI included a review of environmental investigations and/or remediation completed as part of the Papakura to Drury South (P2DS) project and Kiwi Properties' Drury Central Precinct development, the boundaries for which overlap the access ramp footprint. Based on the findings from these investigations, Section 2.1 presents the key risk areas for the site and management of soils within these areas. Refer to *Figure 1* below for site management areas described in *Table 3* below. A figure of all HAIL and potential sources of contamination identified as part of the PSI is also included with this CSMP for reference (refer *Appendix A*).

An area of historic filling is located within the Karaka Reserve, between the NIMT corridor and SH22 (Great South Road). The type and quality of fill material is unknown. One geotechnical borehole (BH003) was completed within this area to support the off-ramp design. Fill material up to 1.8 metres below ground level (m bgl) was noted during the investigation and comprises inert soil material with no evidence of contaminated materials.

A former landfill has been identified on the southern side of NIMT (with filling between mid-1970's to mid-1990's. Some limited soil investigation was undertaken within the landfill as part of the Drury Central Precinct work. Previous investigation for DCP noted that the landfill comprised of topsoil underlain by waste-bearing fill (namely metal, steel,

potential asbestos, brick, and concrete). Heavy metal concentrations above human health criteria (for lead and arsenic) including Polycyclic Aromatic hydrocarbon (PAH) and asbestos were detected in the soil samples analysed. Groundwater was encountered between 1.5 and 2.0 m bgl, with oily sheen and white foam noted during field investigations.

Some works have been completed within the NIMT as part of the P2P Electrification Project which identified soil exceedances above Auckland background concentrations for heavy metals. No exceedance above adopted environmental and human health criteria were noted for heavy metals, Polycyclic Aromatic Hydrocarbon compounds (PAH, in particular, pyrene and benzo (a) pyrene), Total Petroleum Hydrocarbon (TPH) and Organochlorine pesticides (OCPs) or asbestos containing material (ACM) was identified.
