Geotechnical, Flooding and Stormwater Desktop Assessment for Proposed School Development

**1043 Linwood Road, Kingseat**

Job No: 20198 | Revision B | Dated 15 May 2020

**GEOTECHNICAL, OLFP FLOODING  
AND STORMWATER DESKTOP ASSESSMENT  
FOR PROPOSED SCHOOL DEVELOPMENT  
1043 LINWOOD ROAD, KINGSEAT**

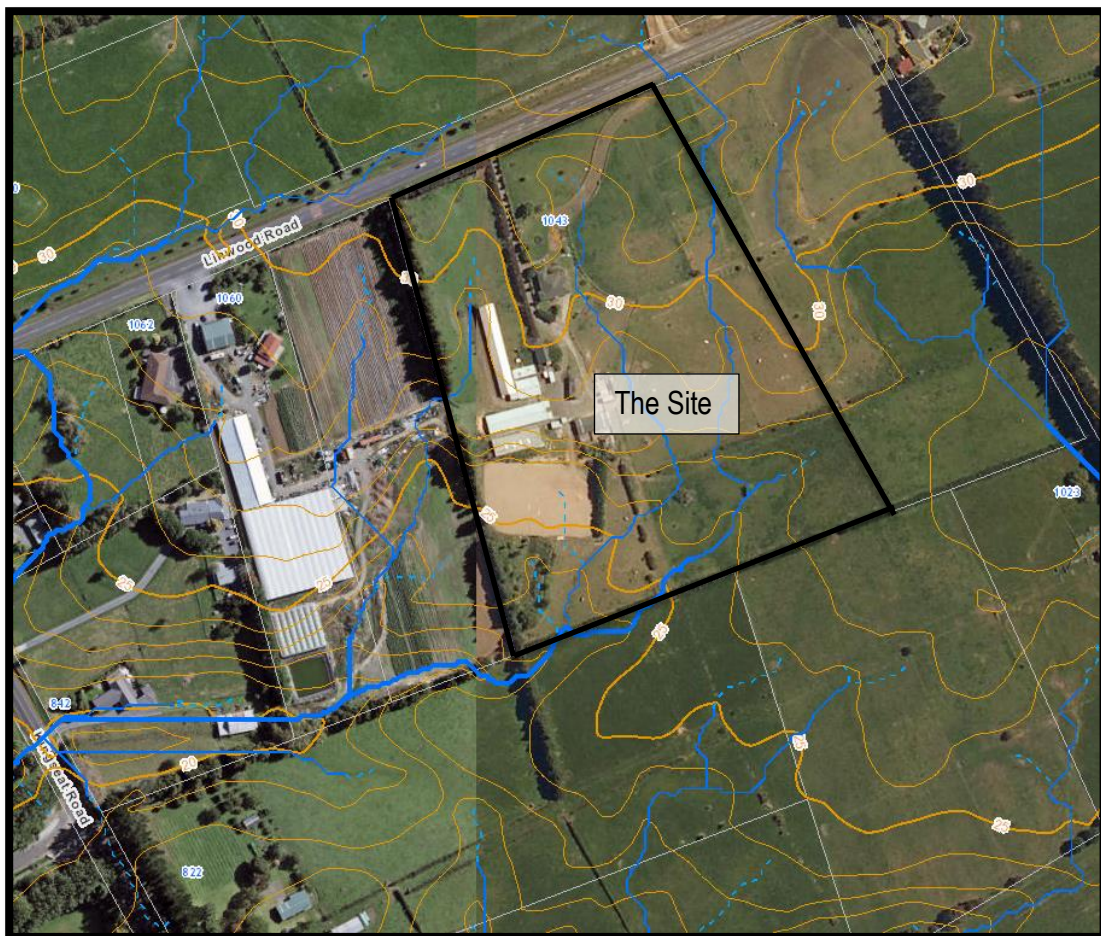
Figure 1: The Site

Built development within the site is comprised of buildings (dwelling and sheds), fences, gravel access and carparking. Vegetation on site comprises grass, shrubs, trees and hedges in places. Based on Council Geomap website, ground surface on site is gentle, generally no steeper than 8° from horizontal.

Overland flow paths (OLFP) are present on site, and are discussed further in Section 6 of this report.

An aerial photograph of the site, from Auckland Council Geomaps website, with contour and OLFP information overlain is shown in Figure 1 below.

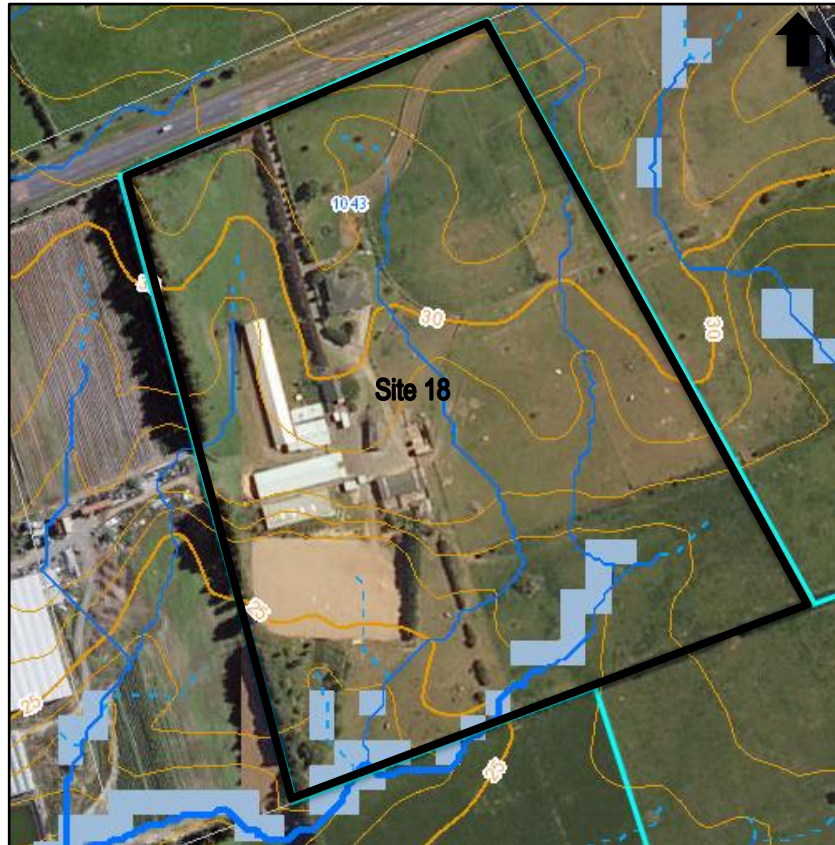
**Figure 3: Overland Flow Paths, Flood Plain and Flood Prone Area**

The Overland Flow Path (OLFP) flooding desktop study is based on publicly available information on the Geomaps platform. OLFP flooding features are shown in Figure 3 below:

Three OLFPs are identified within the site (northern half of 1043 Linwood Road, Kingseat):

- All OLFPs are flowing from the north to south;
- The first OLFP (approximate catchment area of 0.67ha) is present within the western part of the site flowing across the middle of the western site boundary;
- Two of the OLFPs (approximate catchment areas between 2.11ha and 3.10ha) are present within the eastern half of the site, and are associated with a 100-year ARI flood plain at the southern and south-western corner of the site to an elevation between RL 23m and RL 27m;
- OLFPs present within the site are likely to be wide and shallow channel flow;
- Identified OLFPs merge together at the south-eastern corner of the neighboring property at 1060 Linwood Road;

- Flooding risk within the site is considered to be minor, and is likely to be present predominantly at the south-western part of the site.

The presence of the OLFP's and flood plains as shown on Geomaps should be regarded as indicative only as the regional hydrological assessment has utilised LIDAR data which may not be reflective of current ground elevations. Furthermore, the high level (regional scale) hydrological assessment does not recognise localised features that could constrain the development of an OLFP or floodplain. Variation of actual site conditions to those shown can only be determined by detailed site walkover assessment and catchment analysis for each site, as would be required for comprehensive flood risk assessment for future development.

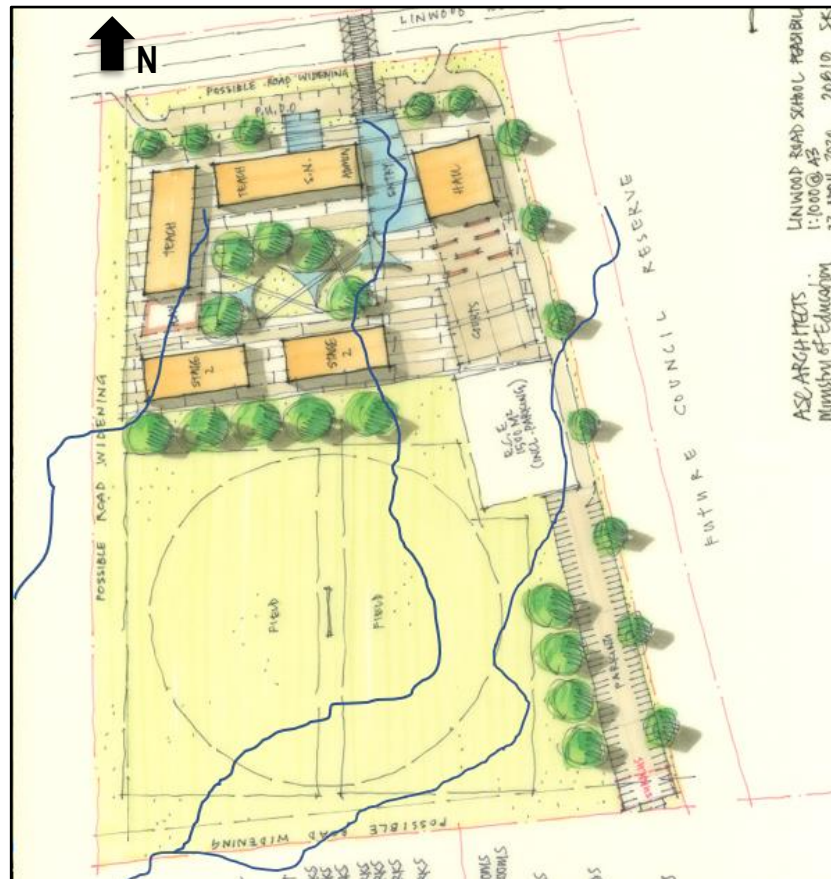
**Figure 4: Feasibility Sketch with Overland Flow Paths**

- The three OLFPs are likely to be slightly obstructed by the currently provided feasibility sketch as shown in Figure 4, however the detailed development design is considered likely to differ from the feasibility sketch in order to OLFP manage site constraints. The potential impact on any future detailed development would largely be in respect to the development layout. Avoiding obstruction of the OLFPs and minimizing the impact of the OLFPs should be taken into consideration during the detailed design process in order to suitably manage the OLFP.

- OLFP diversion and conveyance assessment through the outdoor courtyard area/space between the buildings would be required to confirm the potential flood level and capacity for flow passage for each OLFP in relation to the proposed building (i.e. post-development site condition). Open channel swale will likely be required for OLFP diversion.

- OLFP diversion assessment and design will be required in relation to the currently received feasibility sketch of the proposed development layout.
- The potential impact on future detailed development is considered likely to differ to the provided feasibility sketch, and would largely require variation in respect to the development layout. Avoiding obstruction of the OLFPs and minimising the impact of the OLFPs should be taken into consideration during the detailed design process in order to suitably manage the OLFP.
