**BLUE BARN**  
CONSULTING ENGINEERS

**3094 – 3096 Great  
North Road**

*Infrastructure Investigation and  
Report*

Document Number:  
**J000131-RP-001\_Rev0.1**

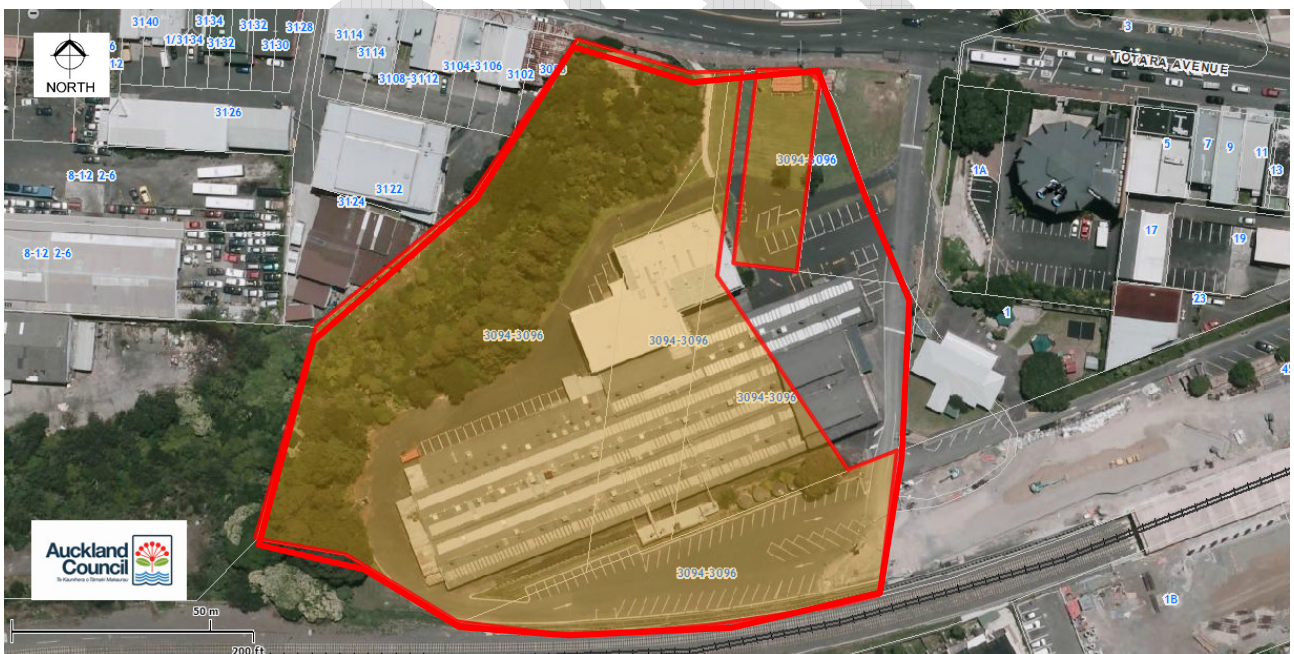
FIGURE 2 – EXISTING SITE PLAN (AERIAL PHOTO DOES NOT SHOW CLARK STREET EXTENSION)

The site is located at 3094-3096 Great North Road, New Lynn. It has the Western Train Line directly to the south, the new Clark Street Extension to the east and Great North Road to the north. A number of small tributary streams (Scroggy Stream, Manawa Stream and Rewarewa Creek) join together at the south-western corner of the site to form the Manawa Stream, which then flows along the western boundary of the site towards the north. The total site area is approximately 1.8Ha, of which, approximately 65% is currently building or car parking (impervious) areas.

The Client's current land-use is as offices and a factory, with car parking adjacent to the train line in the southern section of the site. Access is from the Clark Street Extension (which is not yet shown on aerial photographs).

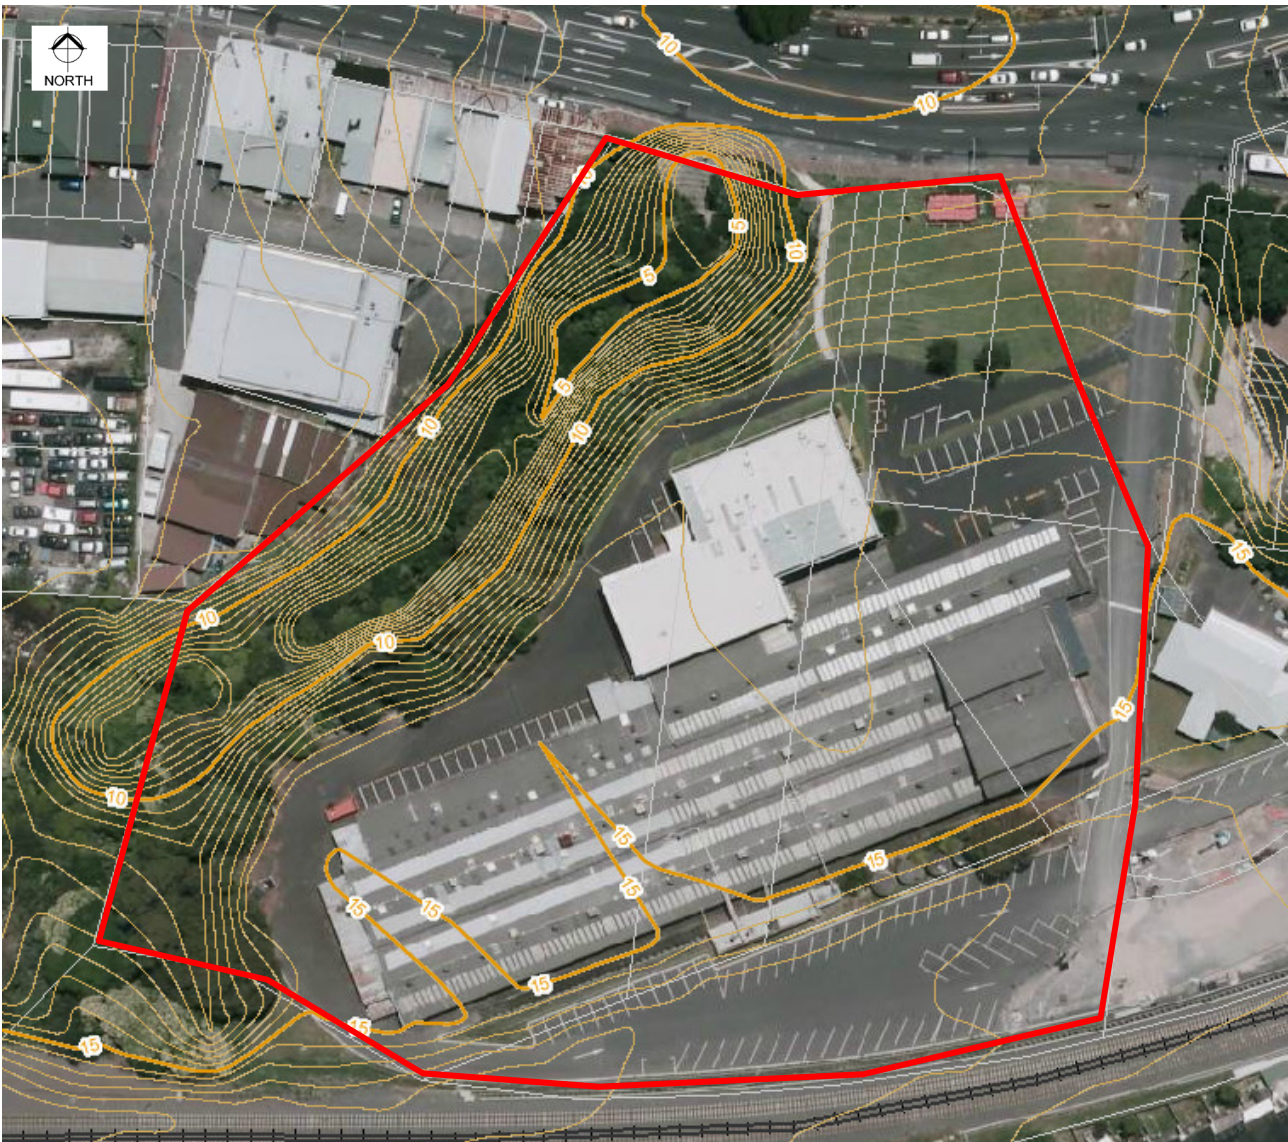
The topography of the site, refer to Figure 4, generally falls from a high point at the rail lines in the south (approximate RL 17m) towards a low point in the northwest at the stream gully alongside Great North Road (RL 5m). A large portion of the site is reasonably flat through the existing car parking and building footprint.

FIGURE 4 – SITE TOPOGRAPHY AND CONTOURS FROM AUCKLAND COUNCIL GIS

It is assumed that, depending on the redevelopment proposal, earthworks volumes could be minor as there is already a significant flat area that currently contains the building platform and car parking area.

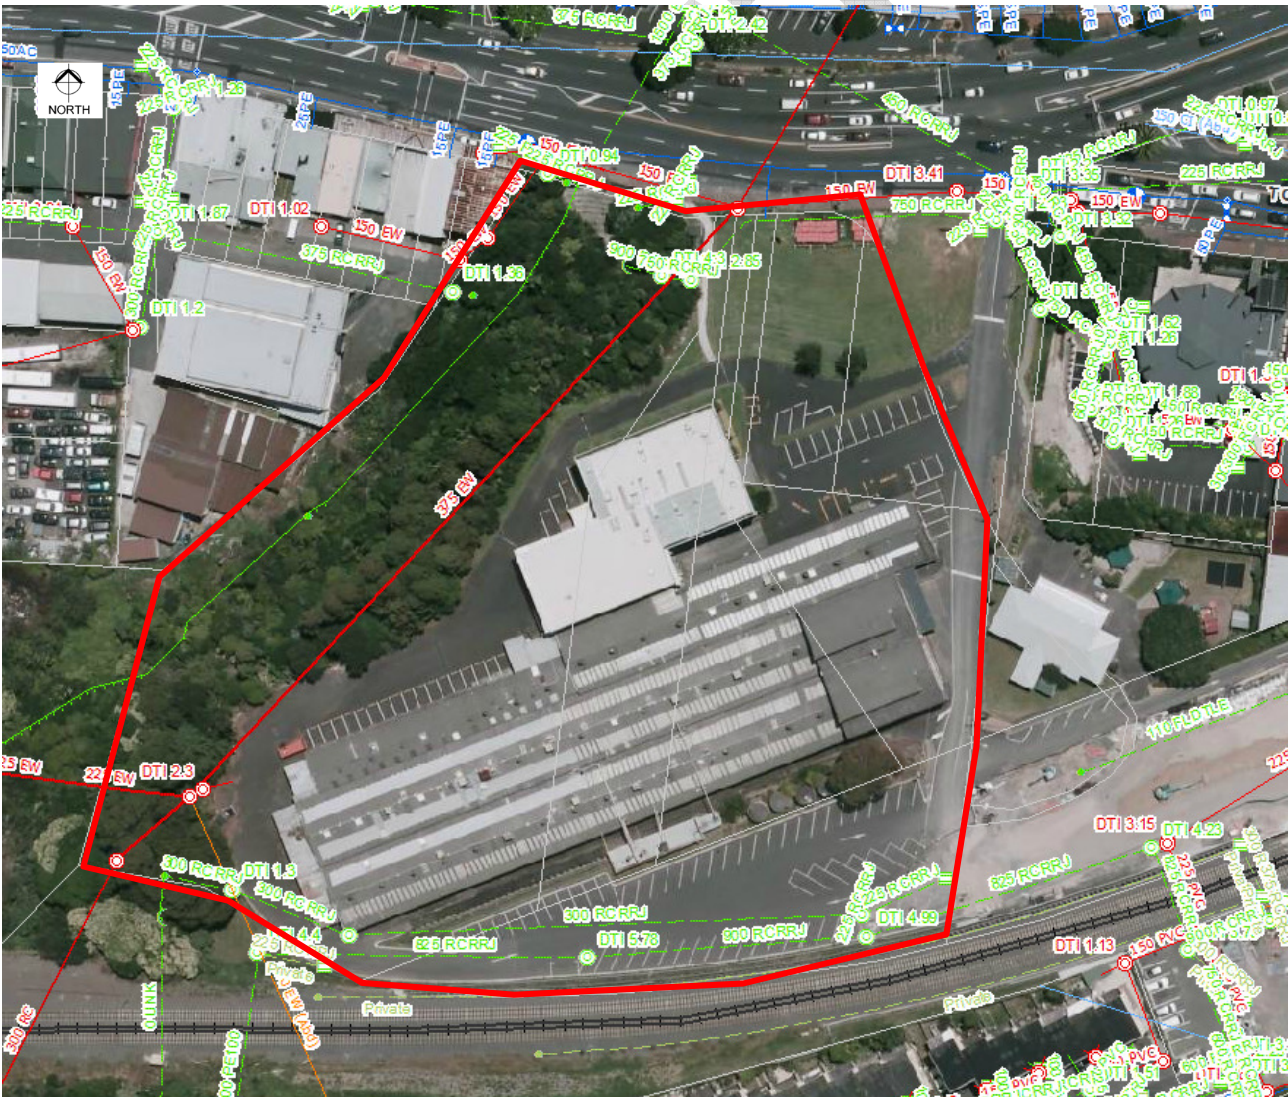
FIGURE 6 – EXISTING SERVICES FROM AUCKLAND COUNCIL’S GIS

All existing public stormwater infrastructure has been extracted from Auckland Council's GIS. Stormwater pipes and manholes are shown in Figure 6 in green.

Through the car park in the south of the site, there are two public stormwater lines heading from east to west. The smaller diameter of the two (225 – 300mm diameter) lines, appears to pick up stormwater from the carpark area within the site and discharge into the Manawa Stream just north of the rail corridor. The larger diameter pipe (800 – 900mm diameter), appears to originate east of the site, collect stormwater from the rail corridor and the Clark Street Extension and then pass under the rail corridor to a discharge location south-west of the site.

In the north of the site, there is a public 750 – 900mm diameter stormwater line which collects stormwater from Totara Road, Totara Triangle and the commercial catchment to the east of the site and follows the boundary of the site to a discharge location alongside Great North Road in the Manawa Stream.

All existing public wastewater infrastructure has been extracted from Auckland Council's GIS. Wastewater pipes and manholes are shown in Figure 6 in red.

A number of pipes (225mm, 300mm, and 300mm [abandoned] diameter) converge in the south-western corner of the site into an existing 375mm diameter earthenware wastewater line along the western side of the site between the buildings and stream gully. This connects to a large diameter 750mm wastewater trunk main approximately 160m north of the site boundary.

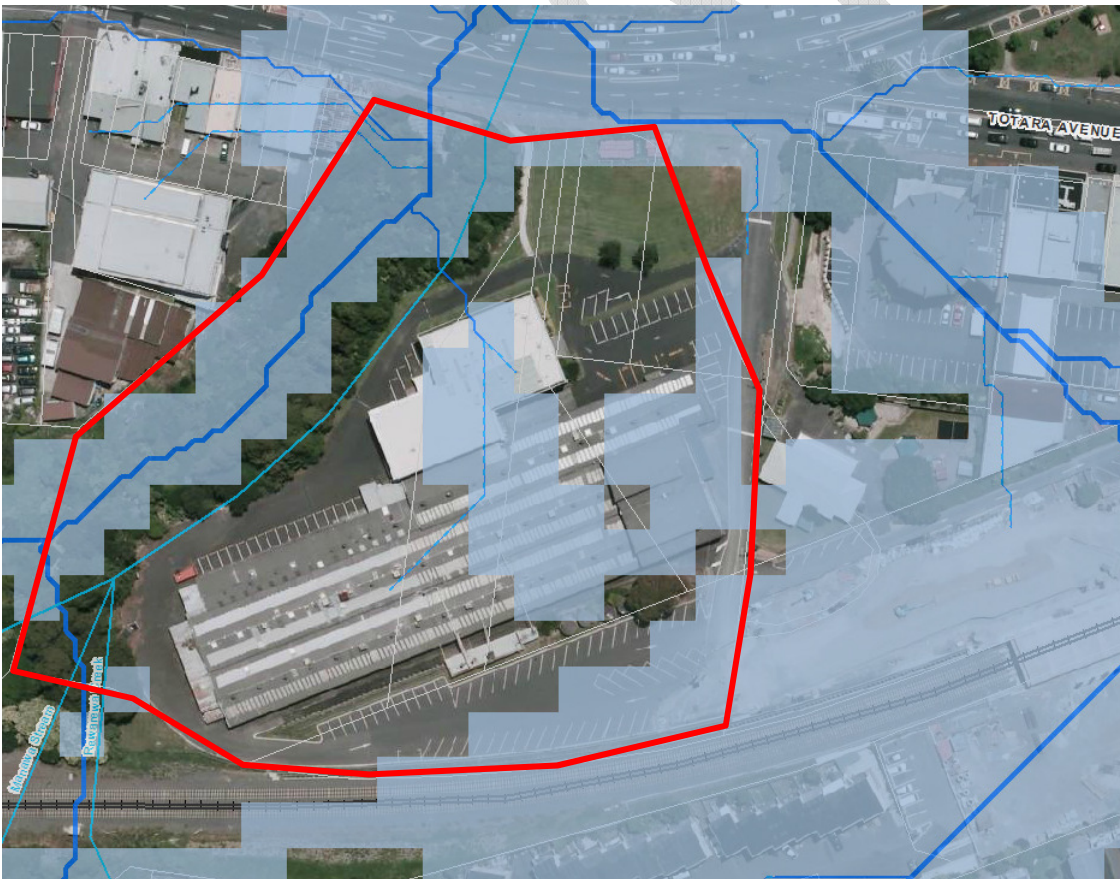
Auckland Council's GIS shows overland flow paths and flooding as modelled by Auckland Council. Overland flow paths, shown as a darker blue lines in Figure 7, indicate where water will flow across the ground surface once the rainfall exceeds the piped stormwater system capacity. The areas in Figure 7 shown covered with light blue shading indicate ponded water during the design, 1 in 100-year, rainfall event.

The GIS maps indicate that overland flow through the Manawa Stream gully in the north west of the site is generally contained within the stream banks and does not reach the car park / external driveway level during the 1 in 100-year rainfall event. While it will have limited impact on the redevelopment site, there appears to be significant ponding across Great North Road as the stream enters a culvert (which may not have adequate capacity for the 1 in 100-year rainfall event) and another overland flow path from Totara Avenue converges at this point.

In the south of the site, ponding is shown to extend approximately half way across the car park area originating from the KiwiRail land in the south and east.

Ponding is also indicated within the building footprint, which is likely a result of the flatness of this area as it appears on the GIS topographic contours. No comment has been sought at this stage, from the Client with respect to any historic flooding around or within, the building.

FIGURE 7 – FLOODING AND OVERLAND FLOW PATHS FROM AUCKLAND COUNCIL GIS

It should be noted that the GIS indicates that the modelling was undertaken in 2009, which is contemporaneous with the construction of the New Lynn Rail Trench. These rail works, which included a large cut and cover rail trench, are likely to have changed the overland flow paths through the area and the flood modelling may not reflect these changes.

If buildings are likely to be located within any areas where flooding has been indicated on GIS or any critical infrastructure is likely to be located near these areas, it is recommended that additional flood investigations are undertaken to update the information currently available. This investigation should provide a minimum floor level for buildings and any recommendations for diverting overland flow paths (if any are now present) away from potential building sites.

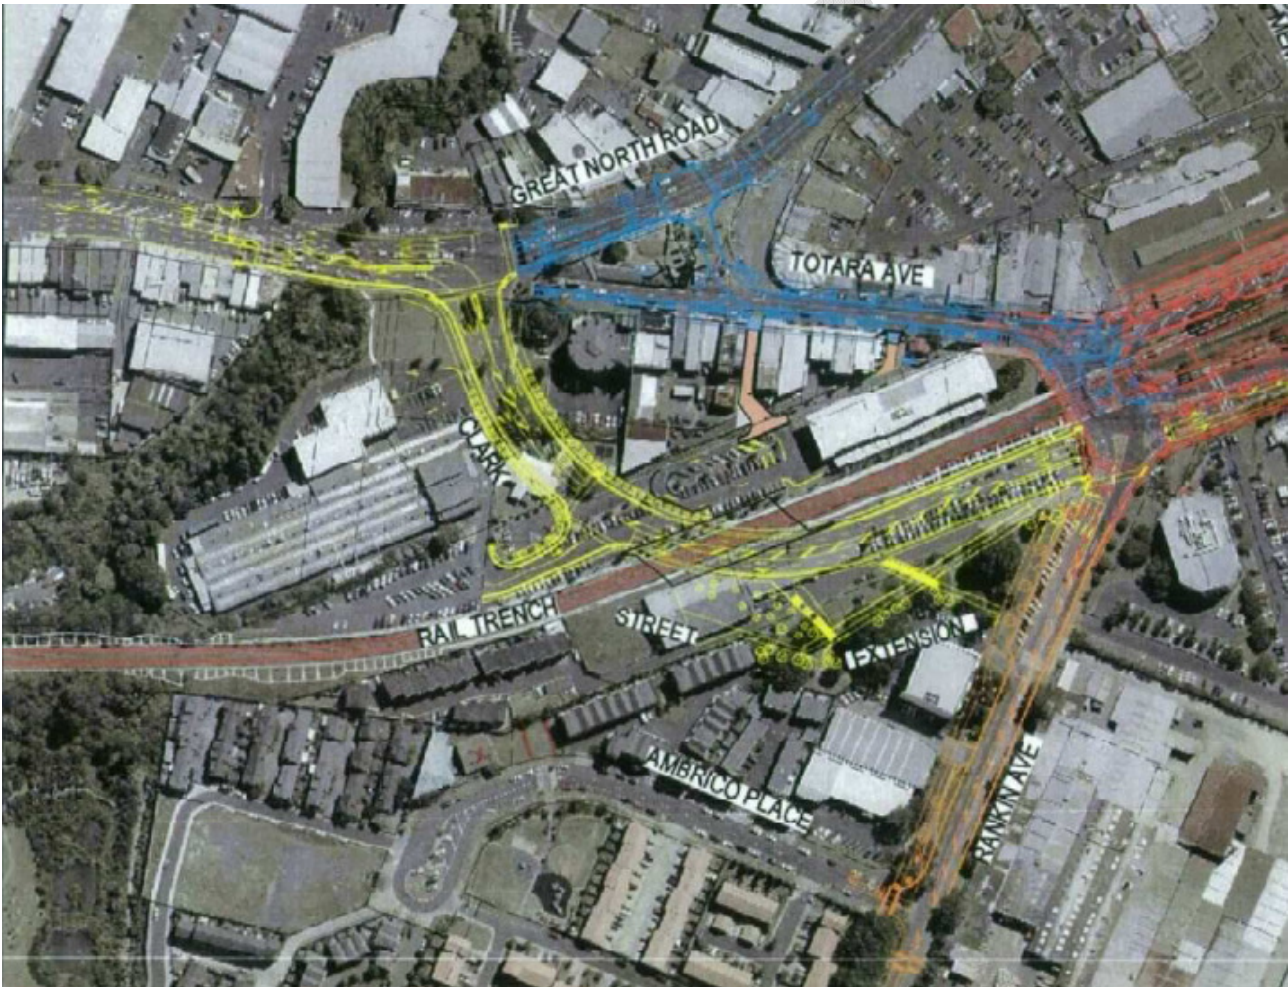
With the change on the road network as part of the Clark Street Extension, the site is now accessed off the Clark Street Extension / Cambridge Lane signalised intersection, refer to Figures 8 and 9.

FIGURE 8 – CLARK STREET EXTENSION

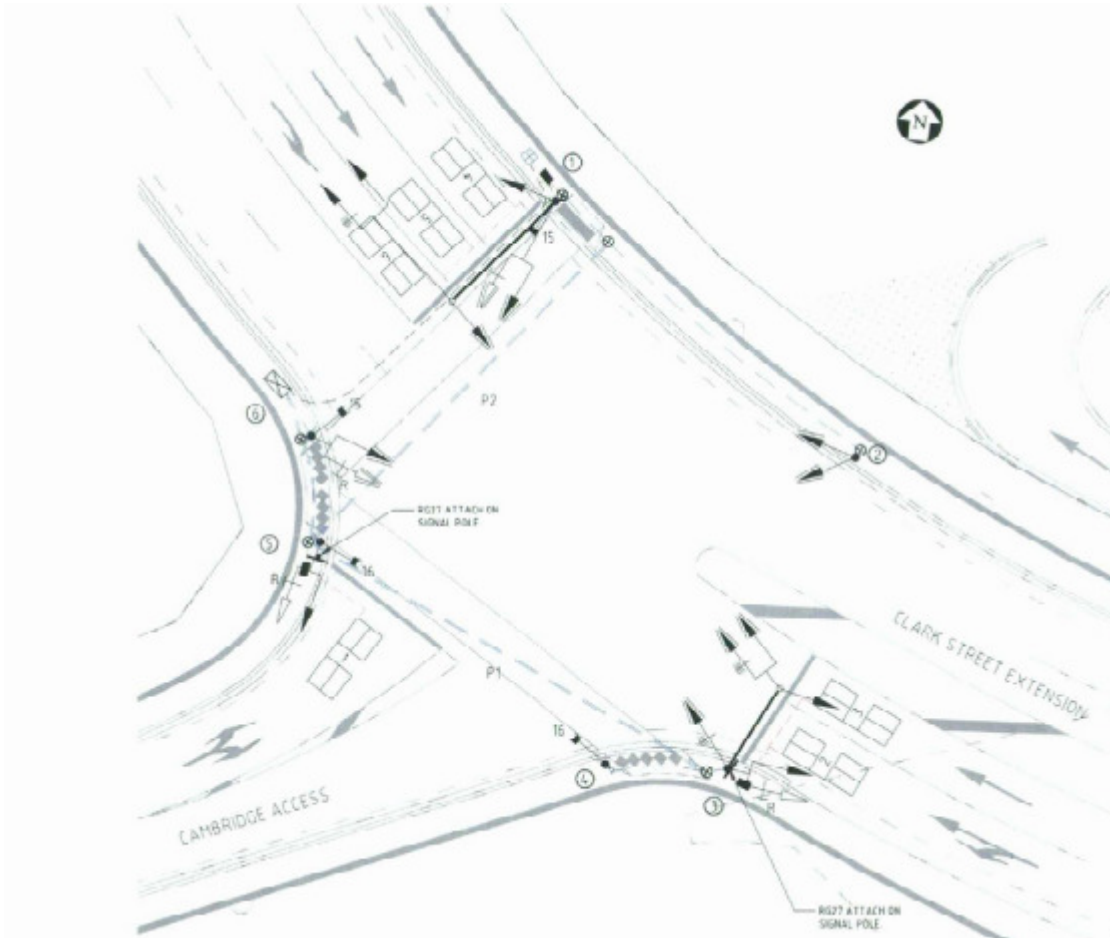
FIGURE 9 – CLARK STREET EXTENSION; TRAFFIC SIGNAL DETAIL
