Warkworth to Wellsford

Existing Water Quality Report

Technical Report

July 2019

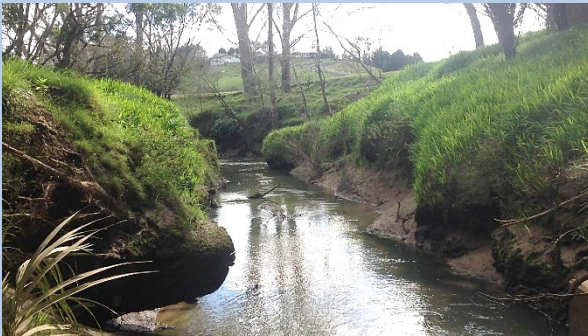
Hōteō catchment	Unnamed tributary (H2) of Hōteō River at Rustybrook Road	Site number	W2W-Hōteō10 -BL

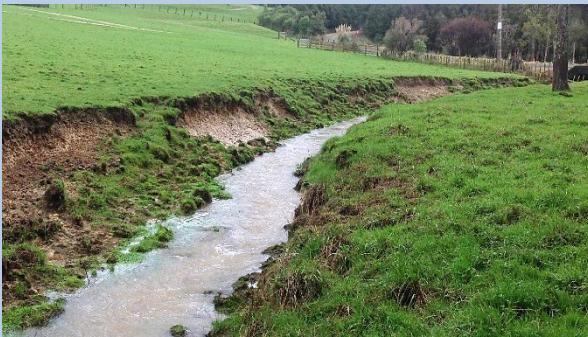
Location	173948X 598070Y	
		Description	<p>This monitoring point is located on an unnamed tributary of Hōteō River, downstream of Rustybrook Road.</p> <p>The tributary flows through pasture at this location in an incised channel with bank erosion. The upstream catchment is undulating pasture.</p> <p>The freshwater ecology survey site HN_F_Hōteō_3 is located approximately 260 m downstream from this site on the same tributary.</p>

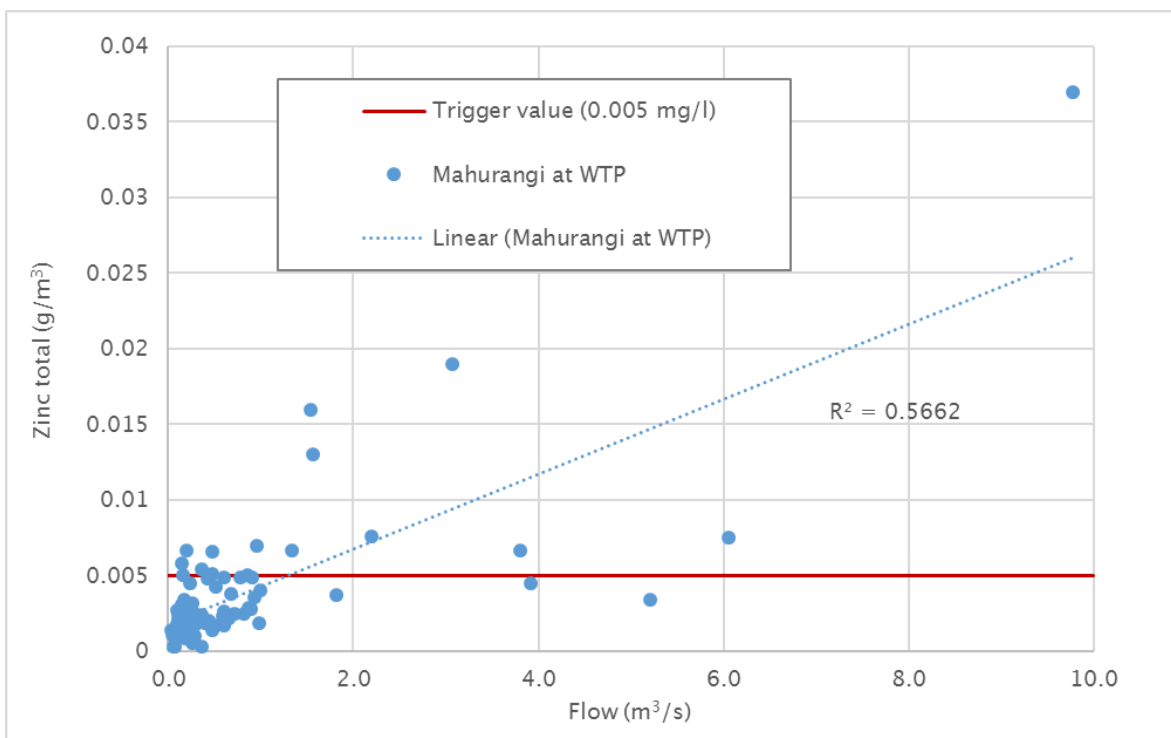
Figure 25 - Comparison of Total Zinc concentration (mg/L) and daily flow (m³/s) at Mahurangi at WTP

- For total copper (mg/L) the average data was below ANZECC/ARMCANZ (2000) guidelines, however there were occasional exceedances of the trigger values on some sample dates. Exceedances occurred more frequently for the downstream Mahurangi at WTP site. At this site the copper was plotted against the daily flow at Mahurangi at College and found that there is a linear correlation ($R^2=0.70$) between flow and copper concentration.
- For total zinc (mg/L) the average data was below ANZECC/ARMCANZ (2000) guidelines, however there were occasional exceedances of the trigger values on some sampling dates for Mahurangi at FHQ, with frequent exceedances for the downstream Mahurangi at WTP site. At this site the total zinc concentrations were plotted against the daily flow at Mahurangi at College, highlighting a linear correlation ($R^2=0.566$) between flow and zinc concentration.

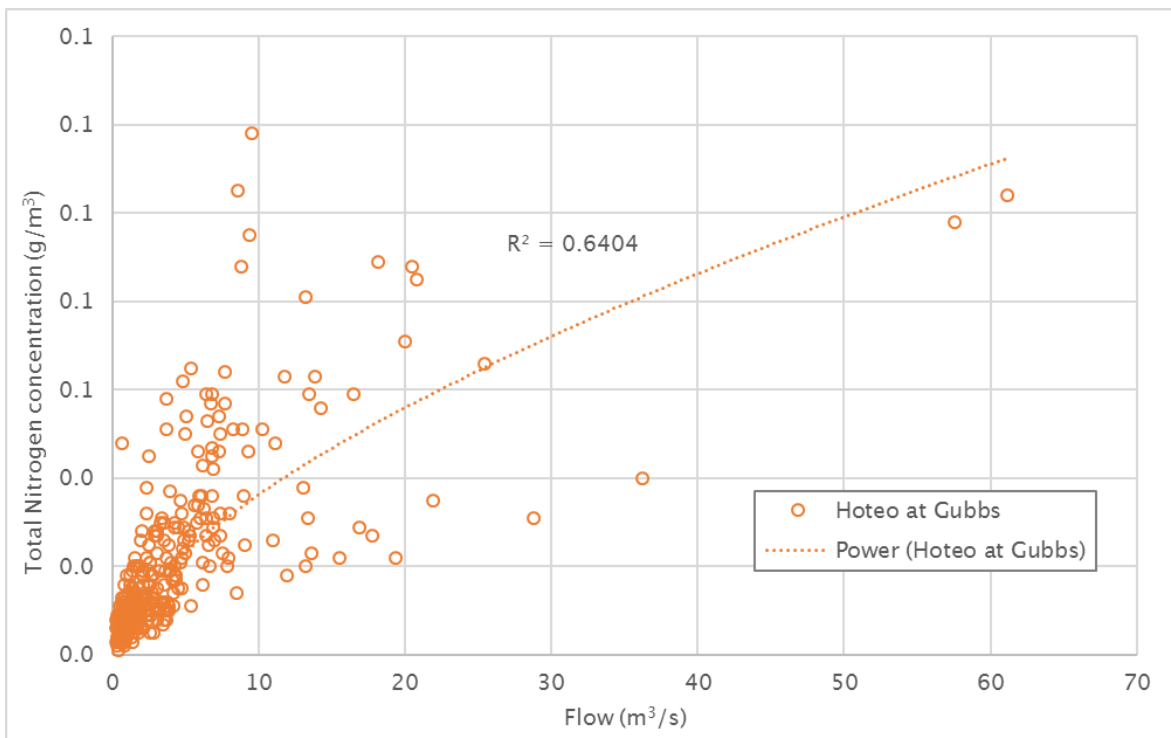
Figure 41 - Comparison of Ammoniacal Nitrogen concentration (mg/L) and daily flow (m³/s) at Hôteo at Gubbs

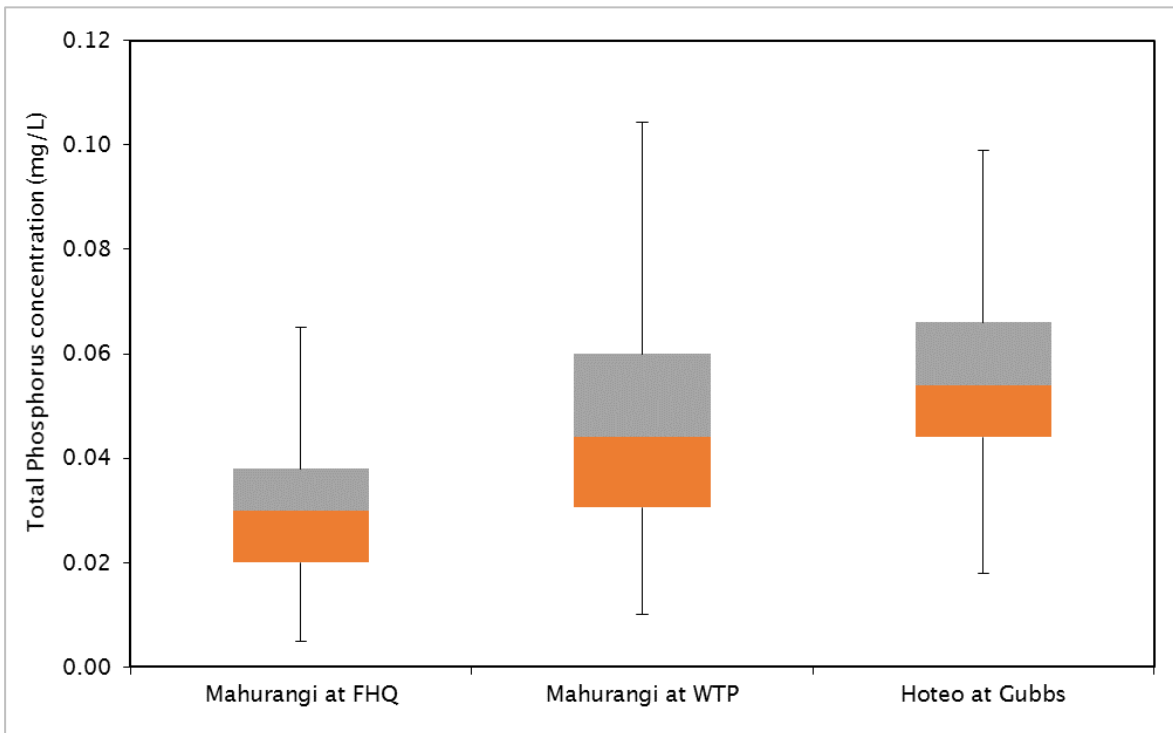
Figure 53 - Comparison of Total Phosphorus concentration (mg/L) at Mahurangi at FHQ, Mahurangi WTP and Hōteo at Gubbs
