# APPENDIX C: CONSTRUCTION SIMULATION RESULTS

# APPENDIX D: DIFFERENCE BETWEEN BASELINE AND CONSTRUCTION SIMULATIONS

# APPENDIX E: ORUAWHARO RIVER SITE VISIT NOTES

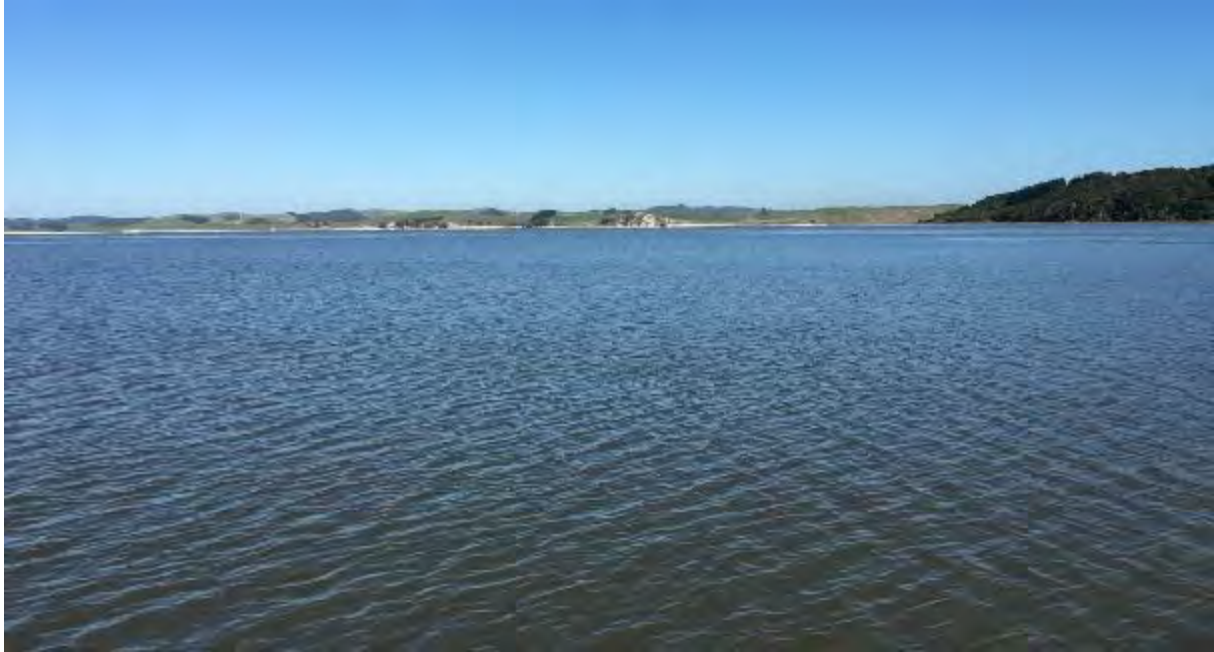
The maximum wave height in Hargreaves basin is likely to be around 0.6 m which may develop at high tide under strong winds from all wind directions. Sediment resuspended by wave action will be advected into sheltered areas such as the mangrove fringe or shallow inlets. The quantity of fine sediments swept downstream into the main body of the Kaipara Harbour will only be small based on previous CSSI sediment tracing (Gibbs et al. 2012) and sediment transport modelling (Green et al. 2017).

**Figure 123: Broad expanses of open water in Hargreaves Basin at mid-tide.** Photograph viewing north with the tree covered Gitto's Point at right. [Credit: M. Allis (NIWA), 16-2-2018 at 0914].

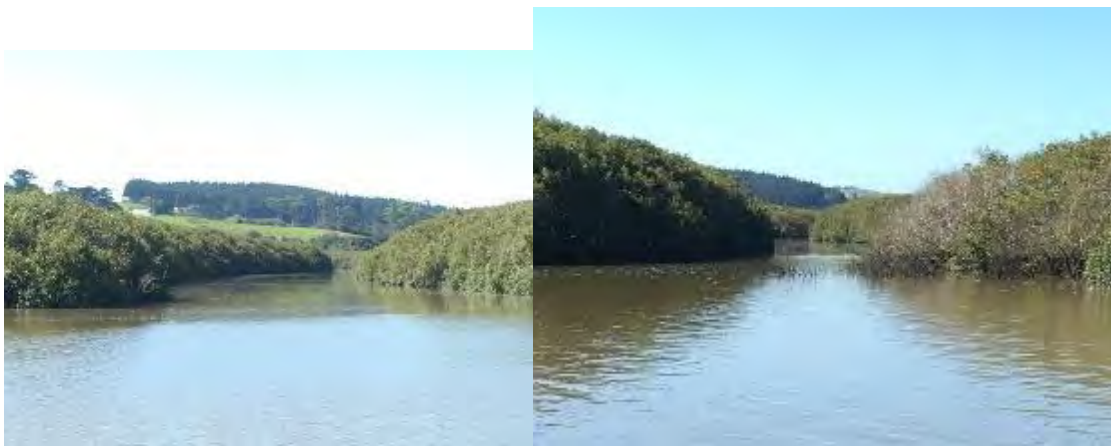
The smaller rivers and streams discharging into the Oruawharo River are generally deeply incised into the intertidal flat, with well-established mangroves (estimated to be at least 30 years old) flanking the outlet channels (Figure 124).

**Figure 124: Outflow channels of the Wharehine River (top) and Wharehau Creek (bottom) flanked by well-established mangroves stands.** [Credit: M. Allis (NIWA), 16-2-2018 at 1024].

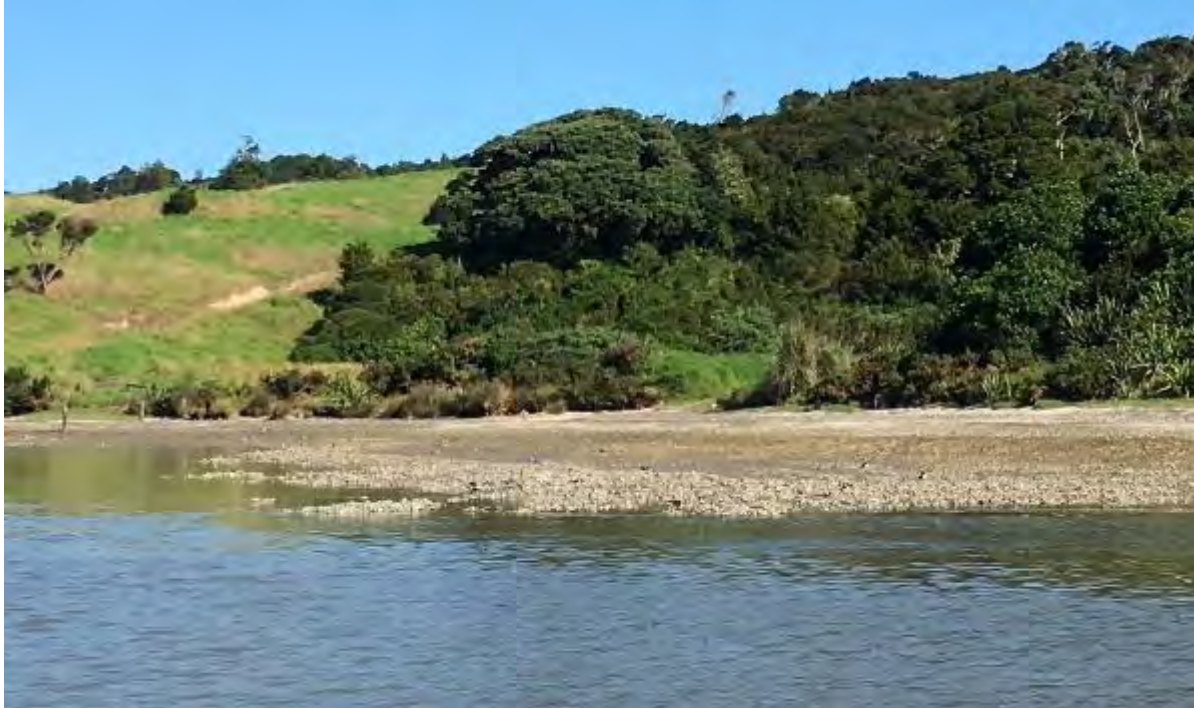
**Figure 125: Oyster reefs outcrops on the northern shoreline of Oruawharo River, near Hargreaves Basin.** [Credit: M. Allis (NIWA), 16-2-2018 at 0939].

Several oyster reefs were observed on the northern shores of the Oruawharo River between Port Albert and Hargreaves Basin (Figure 125). At the time of inspection, a 2 cm coating of fine-sediment was observed on one of the reefs. It is unclear whether the oysters bed contained live oysters. Near the oyster reefs, there is an exposed high-tide beach comprising gravel, shells and sand (Figure 126) indicating high-tide wave-processes. For this beach to form, the oyster beds must have produced and discarded shells in sufficient quantity for waves to mobilise and concentrate at the shoreline. A

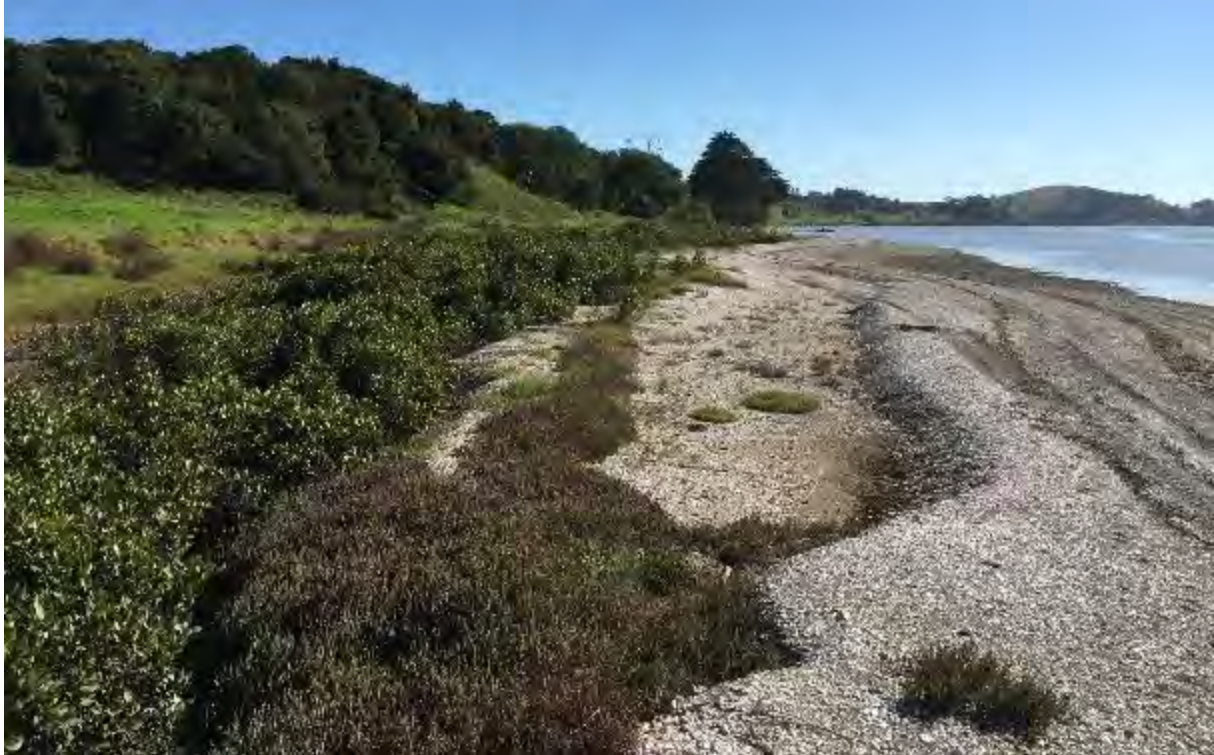
**Figure 126: Gravel and shell beach with small storm-berm fronting mangrove filled depression.**Oruawharo River, approx. 500m north of Hargreaves Basin [Credit: M. Allis (NIWA), 16-2-2018 at 0949].

small (0.3 m high) wave-created storm berm has formed above the high-water mark and is composed entirely of shell fragments. The berm has isolated a low-lying depression from the main tidal channel and has filled with mangroves (Figure 126). Several other white sandy beaches were observed at the high-tide mark along the northern shoreline (e.g., opposite Port Albert wharf), along with large *Macrocarpa* trees (approx. 100 years) close to the water.

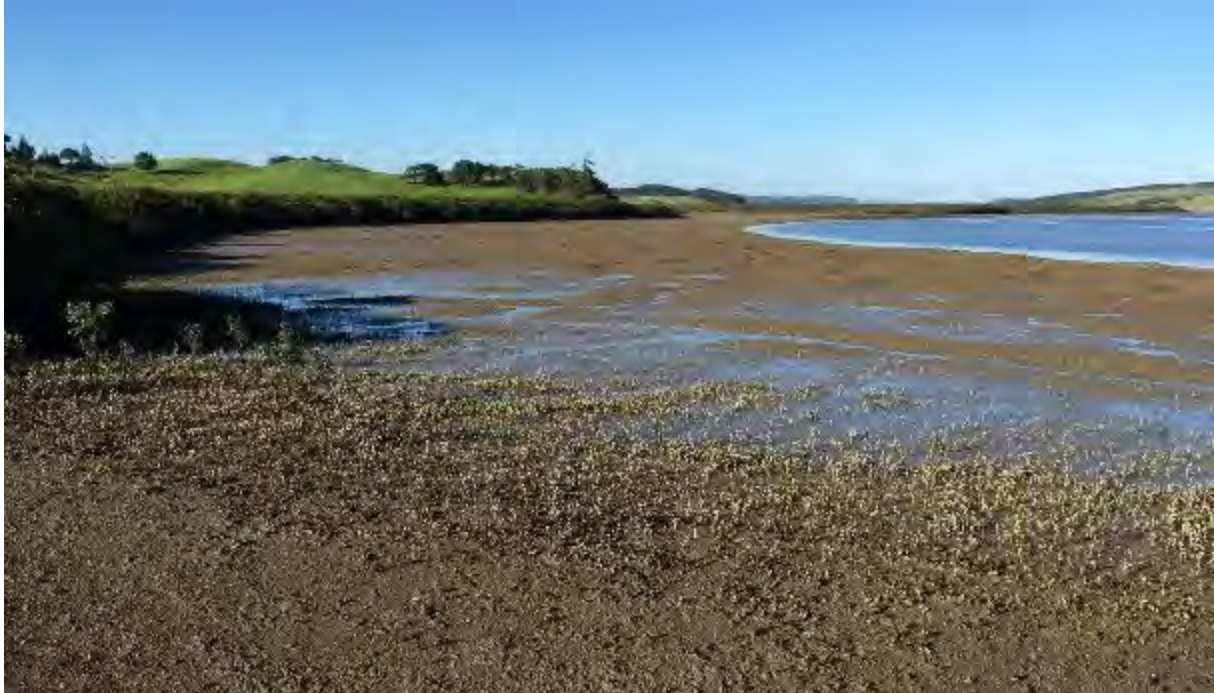
Continuing upstream, from Hargreaves Basin to the Topuni River confluence, the flanks of the Oruawharo River are dominated by intertidal flats which are either vegetated with mangroves or remain as unvegetated mudflats. Near Port Albert wharf the southern flats comprise 100 m wide exposed mudflats flanked by a vegetated fringe 10-100 m wide (Figure 127). These exposed flats are very soft mud with occasional oyster beds protruding and a large number of mangrove seedlings which are rapidly colonising the fringe of the mangrove forest and any sheltered intertidal flats. Several mud-thickness measurements were made using a steel rod, with thicknesses greater than 1.5 m observed in many locations throughout this area. Vegetated mud flats appear to fully occupy all inlets excluding small sub-tidal drainage channels which are typically shallow with low current speeds.

**Figure 127: Broad intertidal flats immediately west and south of Port Albert wharf.** Viewing west as photographed from wharf. [Credit: M. Allis (NIWA), 16-2-2018 at 0835].

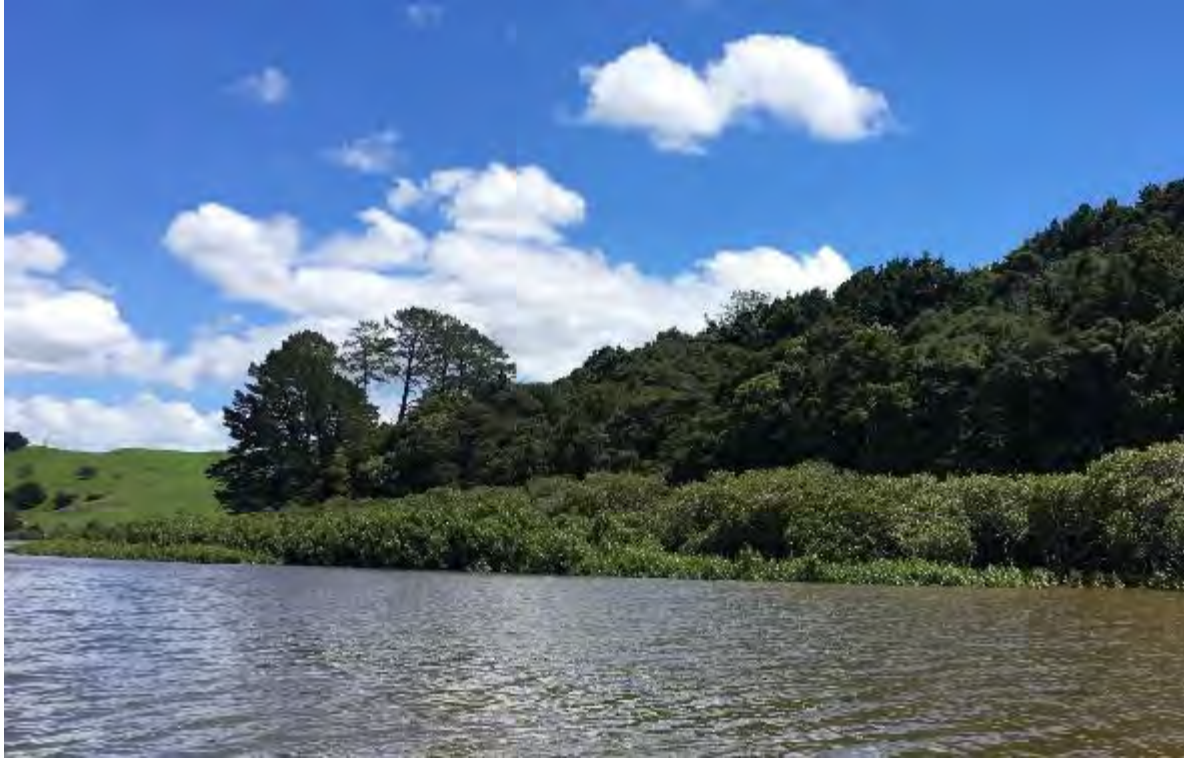
**Figure 128:** Slow expansion of intertidal flat shown by new mangrove growth seaward of mature mangroves. [Credit: M. Allis (NIWA), 16-2-2018 at 1305].

Near the confluence of the Topuni River with the Oruawharo River, the intertidal flats appear fully colonised by mangroves with few areas of exposed mudflats. The high-tide channel is flanked by mature mangroves although some dieback of mangroves was observed. No high-tide shelly/sandy beaches were observed through the dense mangrove forest. Several stretches of young mangroves were observed growing in a band 1-3 m wide on the flank of the main channel (Figure 128). This slow expansion and narrowing of the channel is inferred to be from infilling and migration of main channel allowing sediment to deposit and mangroves to colonise.

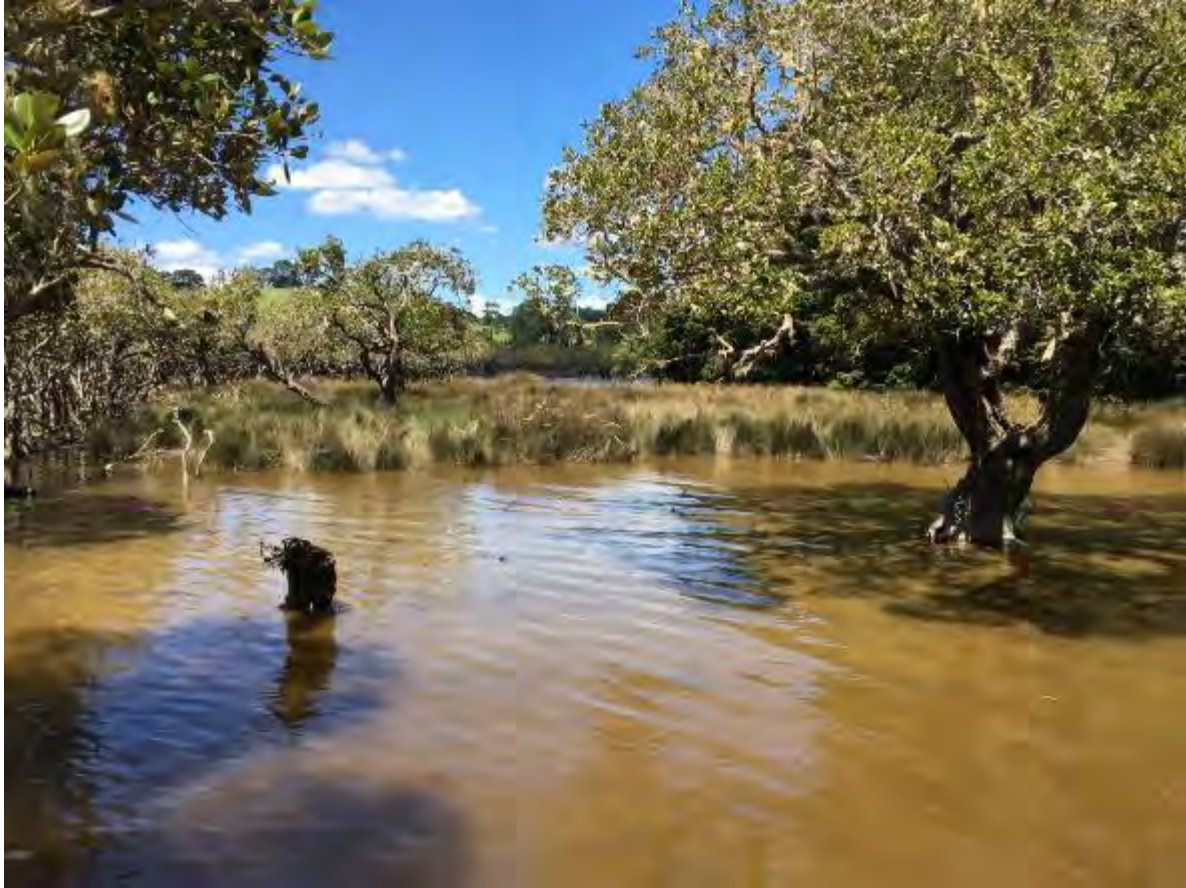
**Figure 129: Grasses and marsh within mangrove forest, lower Maeneene Creek.** Note the few mangrove stumps and dead branches [*Credit: M. Allis (NIWA), 16-2-2018 at 1321*].

Alongside Maeneene Creek, large areas with mangrove dieback were observed behind the outer perimeter of healthy and expanding trees. The dead mangrove areas are also occupied by grass/reed stands (Figure 129). Cattle were observed wading/grazing in multiple locations along northern vegetated intertidal flats alongside Maeneene Creek.

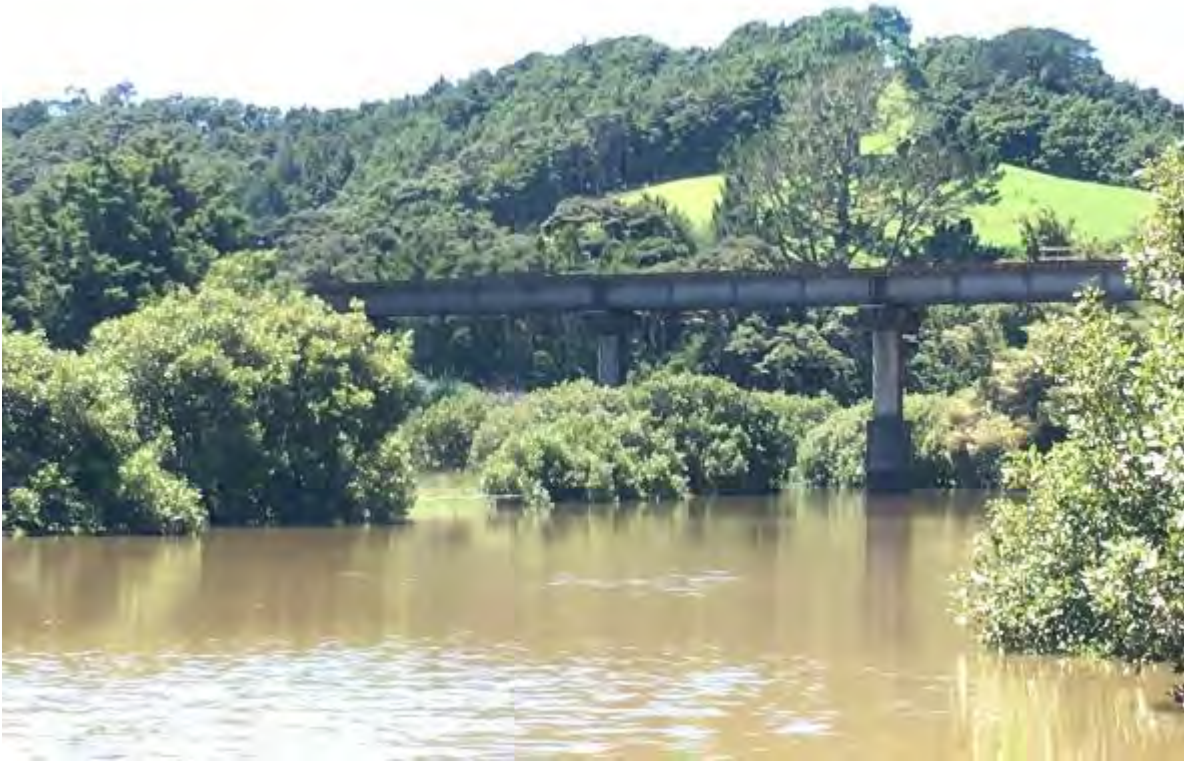
Continuing further upstream, the estuary creek continues to narrow between the flanking hillsides. At the rail bridge (4 km upstream, refer Figure 121) the shoreline is 40 m wide, with flanking intertidal flats that are 15 m wide (Figure 130). Mangrove presence is reduced with increased stretches of shoreline covered in pasture grasses.

**Figure 130: View upstream in Maeneene Creek at rail bridge, 4 km upstream.** [Credit: M. Allis (NIWA), 16-2-2018 at 1340].

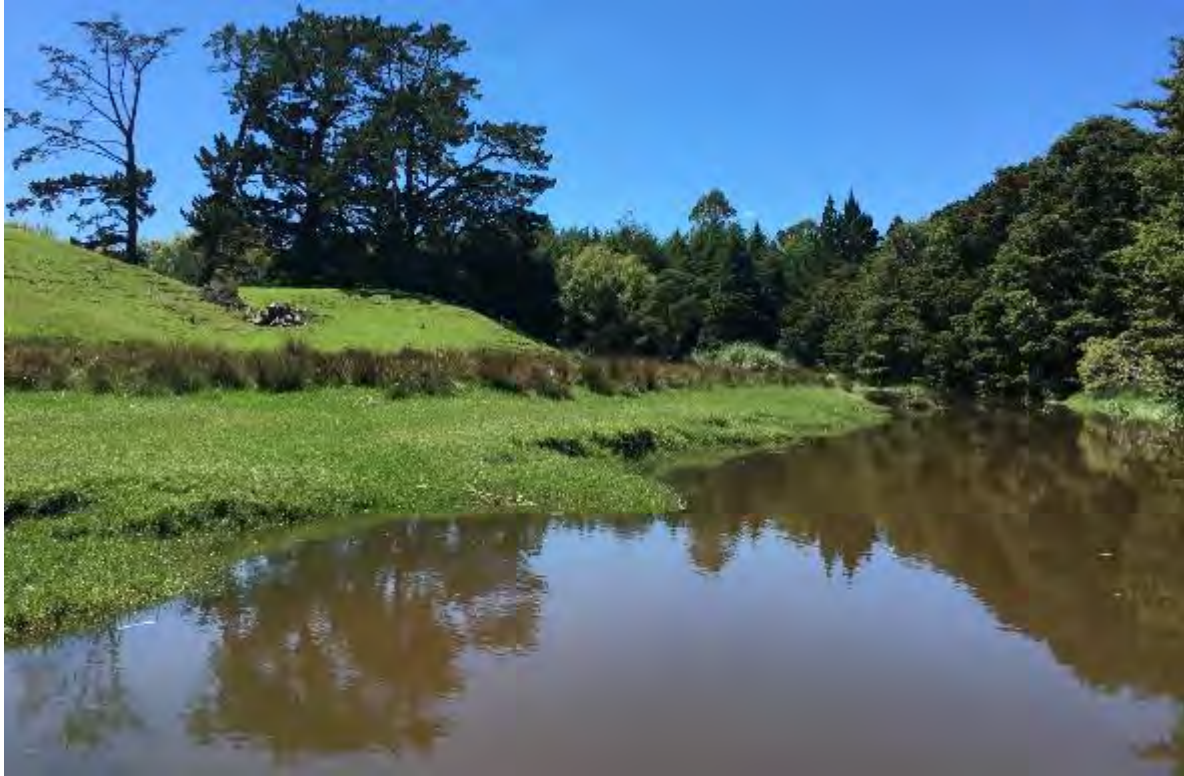
From 5 to 8 km upstream, Maeneene Creeks flows alongside Waimanu Road to where it meets SH1 (refer Figure 121). In this stretch, the estuary gradually become more riverine in nature. Reflecting this, the proportion of mangroves reduce rapidly with distance upstream and are replaced by pasture grass and trees (see Figure 131).

**Figure 131: Absence of mangroves and pasture extending to water level, Maeneene Creek, 7 km upstream.** [Credit: M. Allis (NIWA), 16-2-2018 at 1351].

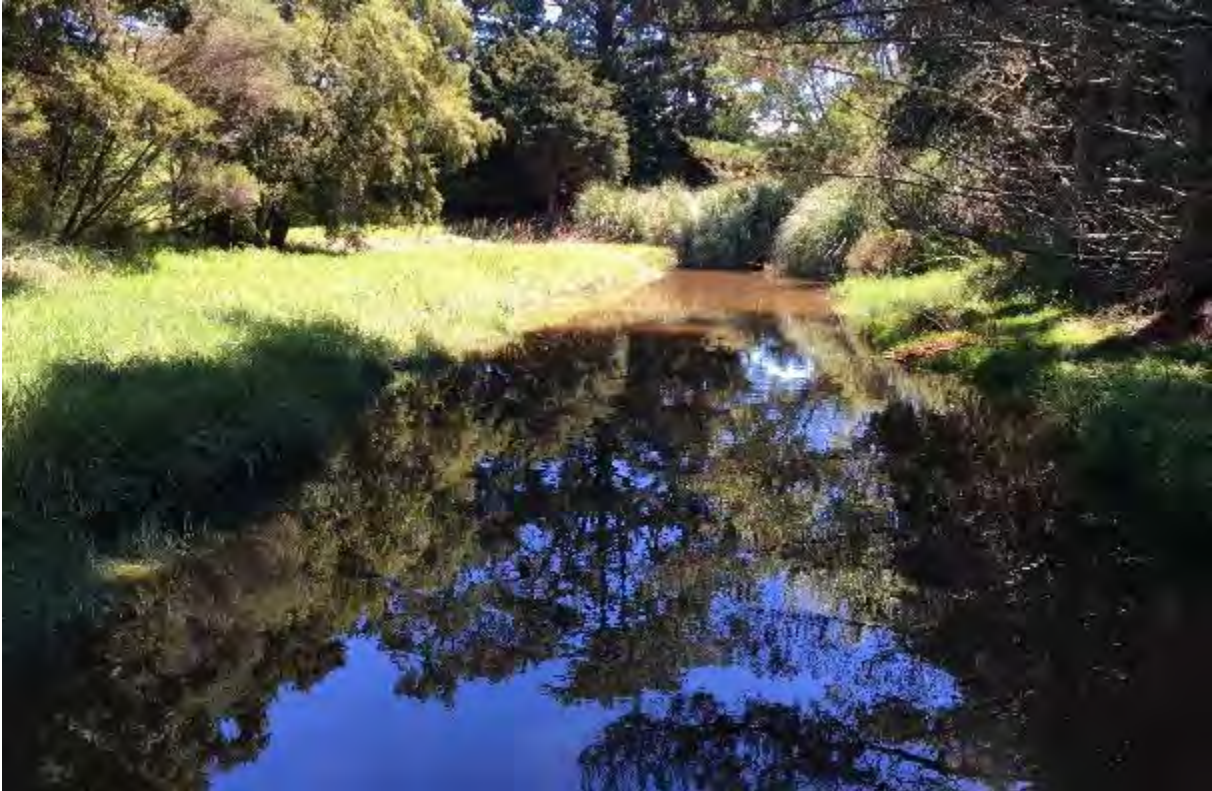
**Figure 132: View upstream at limit of site visit, Maeneene Creek** Photograph at approximately 200 m from existing SH1 and junction with Maeneene Road and Waimanu Road. Note absence of mangroves, streambank coverage by grass. [Credit: M. Allis (NIWA), 16-2-2018 at 1404].

At the uppermost limit of the inspection, Maeneene Creek is a narrow channel approximately 4-5 wide between stream banks, and less than 1.5 m deep at high tide (Figure 132). The environment is riverine in nature, and appears beyond the limit of saltwater intrusion.

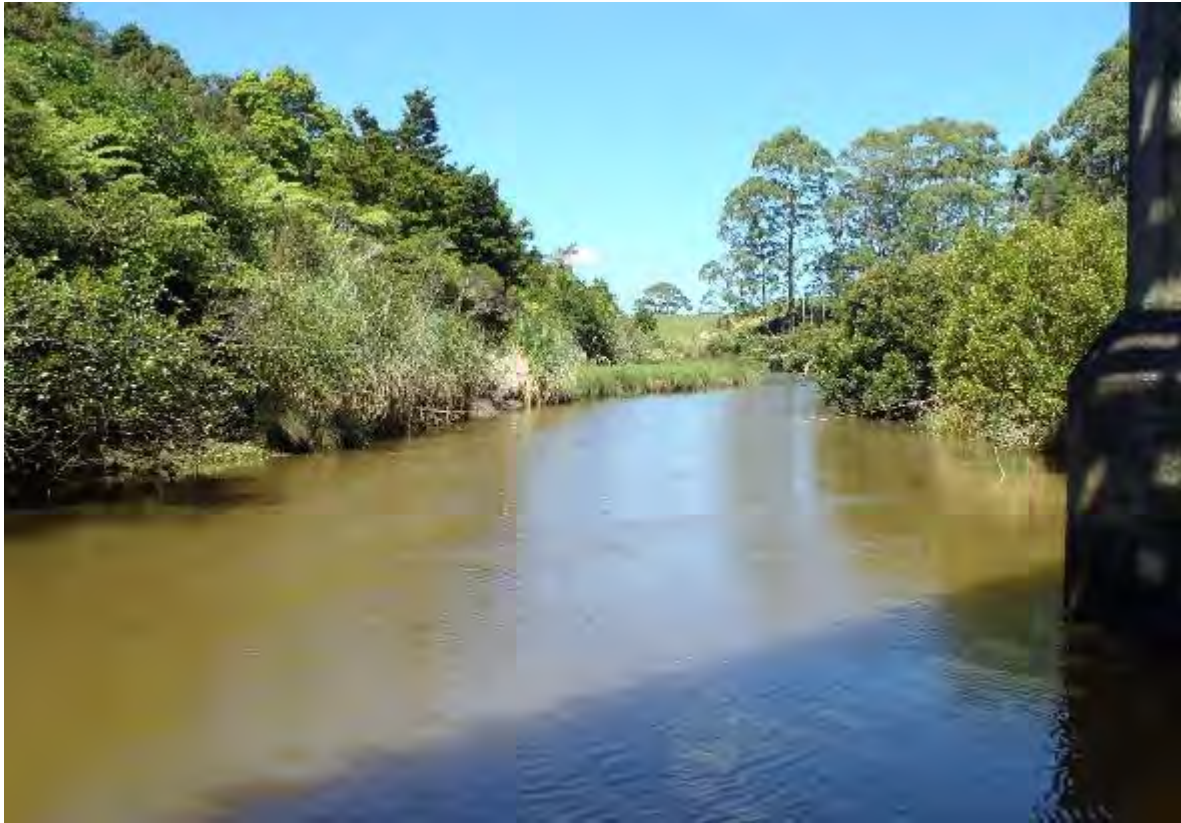
The inspection of Te Hana Creek was truncated at the existing state highway bridge due to time limits (Figure 133). At this location, 3 km upstream, the creek remains estuarine dominated, with mangroves stands occupying narrow intertidal flats between the flanking hillsides. Upstream, aerial photos indicate that there are increased stretches of shoreline covered in pasture grasses.

**Figure 133:** View upstream at limit of site inspection, Te Hana Creek. [Credit: M. Allis (NIWA), 16-2-2018 at 1440].
