Future Primary School, Hobsonville Point, Auckland

Ground Contamination, Flood Risk and Infrastructure Capacity Review

MINISTRY OF EDUCATION

WWLA0313 | Rev. 2

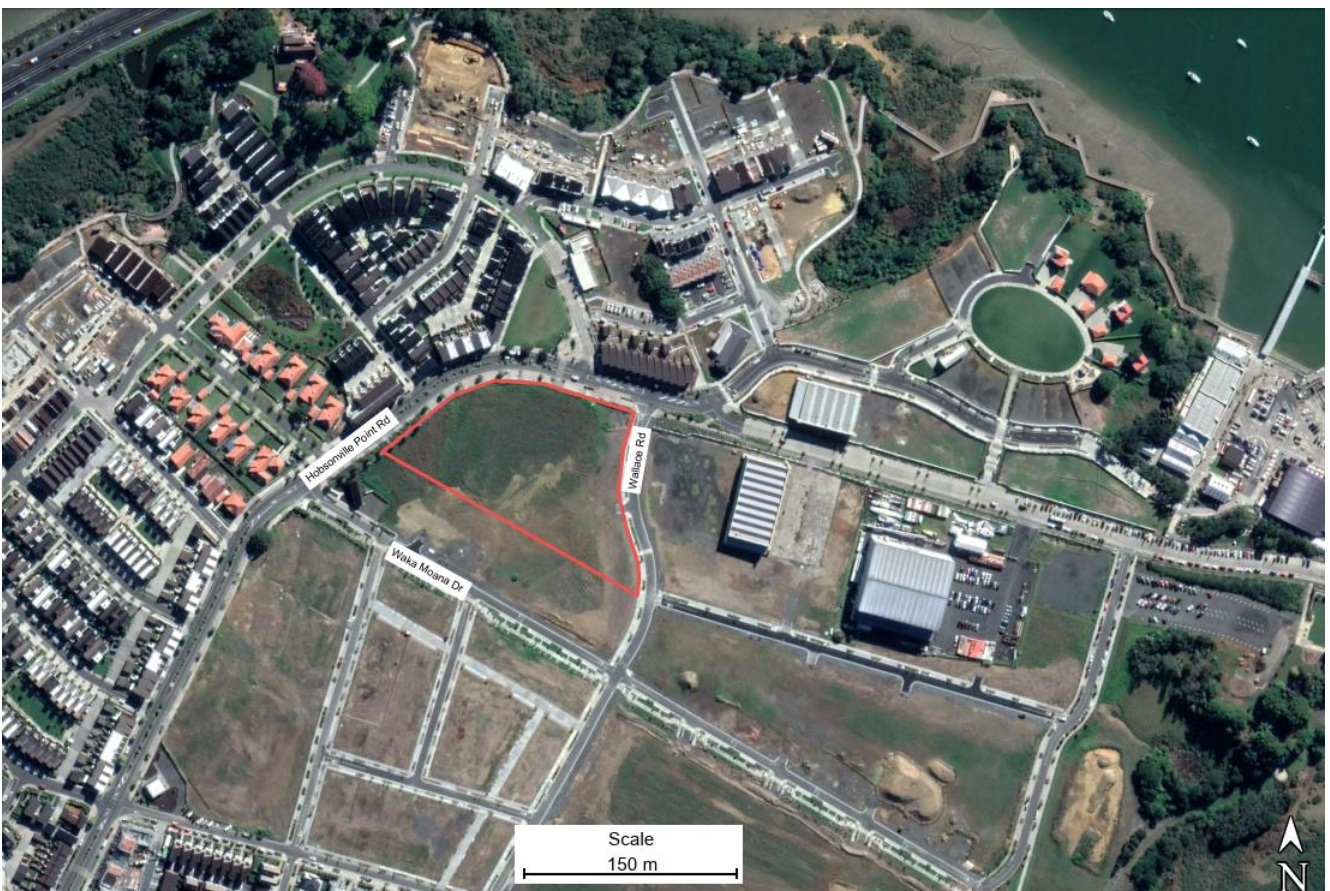
Figure 1. Location of the site, with current proposed site boundary outlined in red (Image source: Google Earth Pro).

Williamson Water & Land Advisory (WWLA) has been commissioned by the Ministry of Education (MoE) to provide a ground contamination, flood risk and infrastructure capacity review to assist the due diligence process for the possible acquisition of land at 279 Hobsonville Point Road (Site 5), for use as a primary school (refer **Figure 1**).

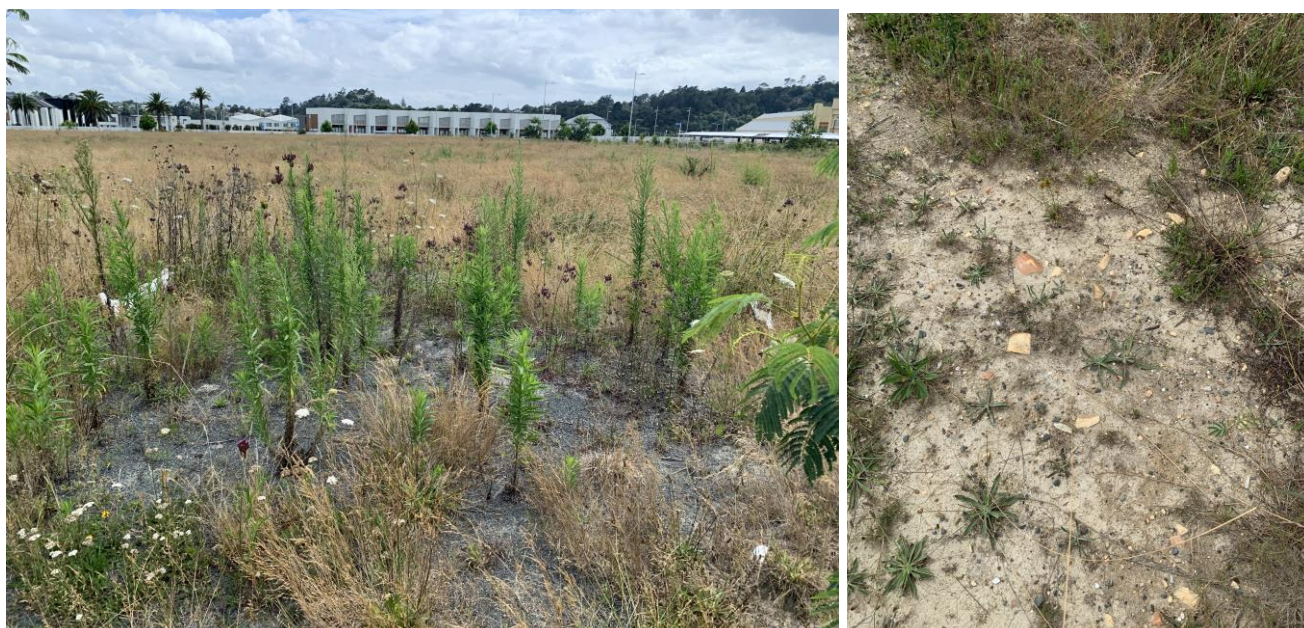
- The site is vacant (**Photograph 1**) and secured with chain link fencing.
- The site is in a fairly unkempt state. Ground cover is long grass with weeds. Minor amounts of demolition waste (gravel, concrete, ceramic pipe fragments) were visible across the surface (**Photograph 2**).
- The site slopes down gently to the northwest and the ground surface is uneven. There are deep ruts across the entire site where large vehicles or machinery have been driven through when ground conditions were wet. The site surface at the time (high summer) was dry.

Photograph 1 (left): Overall condition of the vacant site. Photograph 2 (right): Ceramic pipe fragments and gravel visible on the site surface.

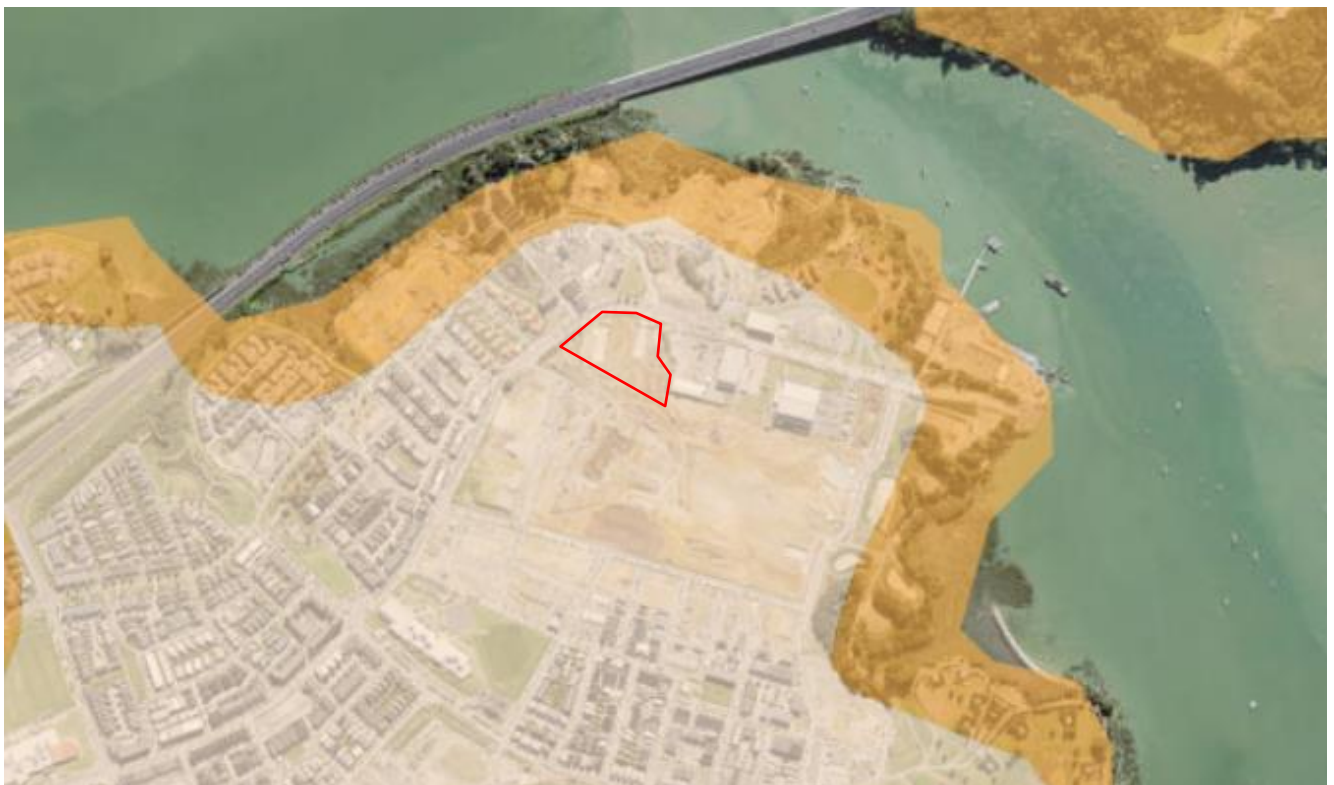
Figure 2. Geology of the site and surrounds: pale yellow indicates Puketoka Formation; orange indicates East Coast Bays Formation. (Source: GNS Webmap).

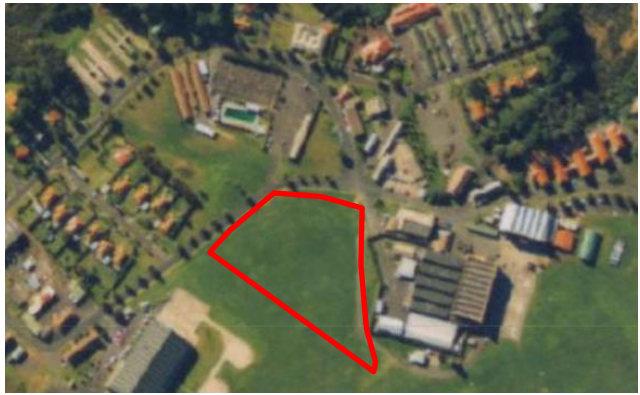
<p>2000, 2001, 2003/2004, 2006, and 2008 (shown)</p>	<p>No significant changes observed on the site or immediate surrounding area relative to the previous photographs.</p>

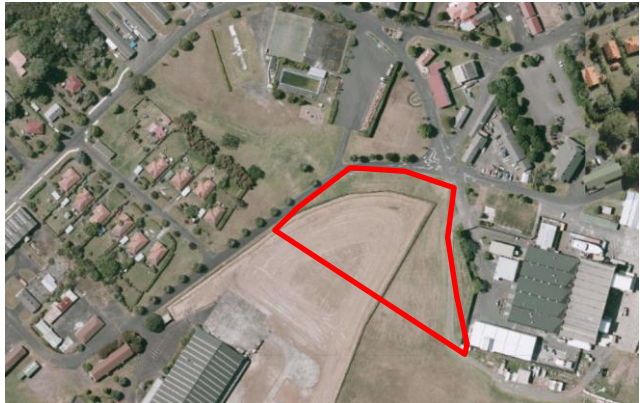
<p>2010/2011 (shown) and 2012</p>	<p>The majority of the site has been earthworked. Earthworks extend to the southwest of the site although the hangars remain intact. The 2012 photograph shows no changes to the site or surrounds but grass has re-established.</p>

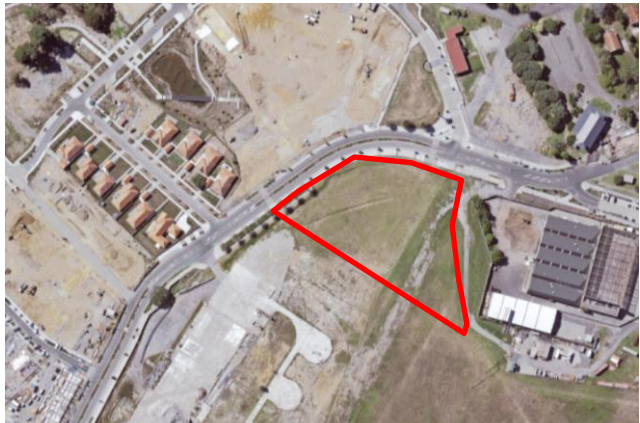
<p>2015</p>	<p>The site remains vacant but earthworks in the surrounding area are widespread. Hangar 3 has been demolished.</p>

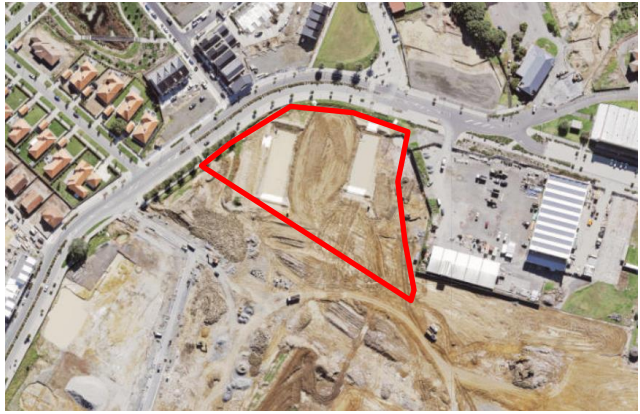
Photograph date	Activities	Aerial image
2017	The site and surrounds are undergoing earthworks. Two sediment retention ponds have been established and soil is being stockpiled on the site. Part of the Wasp hangar complex to the east has been removed.

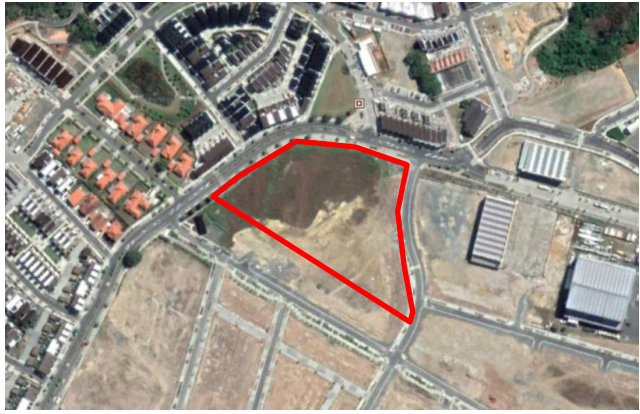
2019	Earthworks appear largely complete. Sediment ponds have been filled and grass has re-established in the north of the site. Additional roads have been constructed surrounding the site. The Wasp hangar remains but all other structures of the complex have been removed.

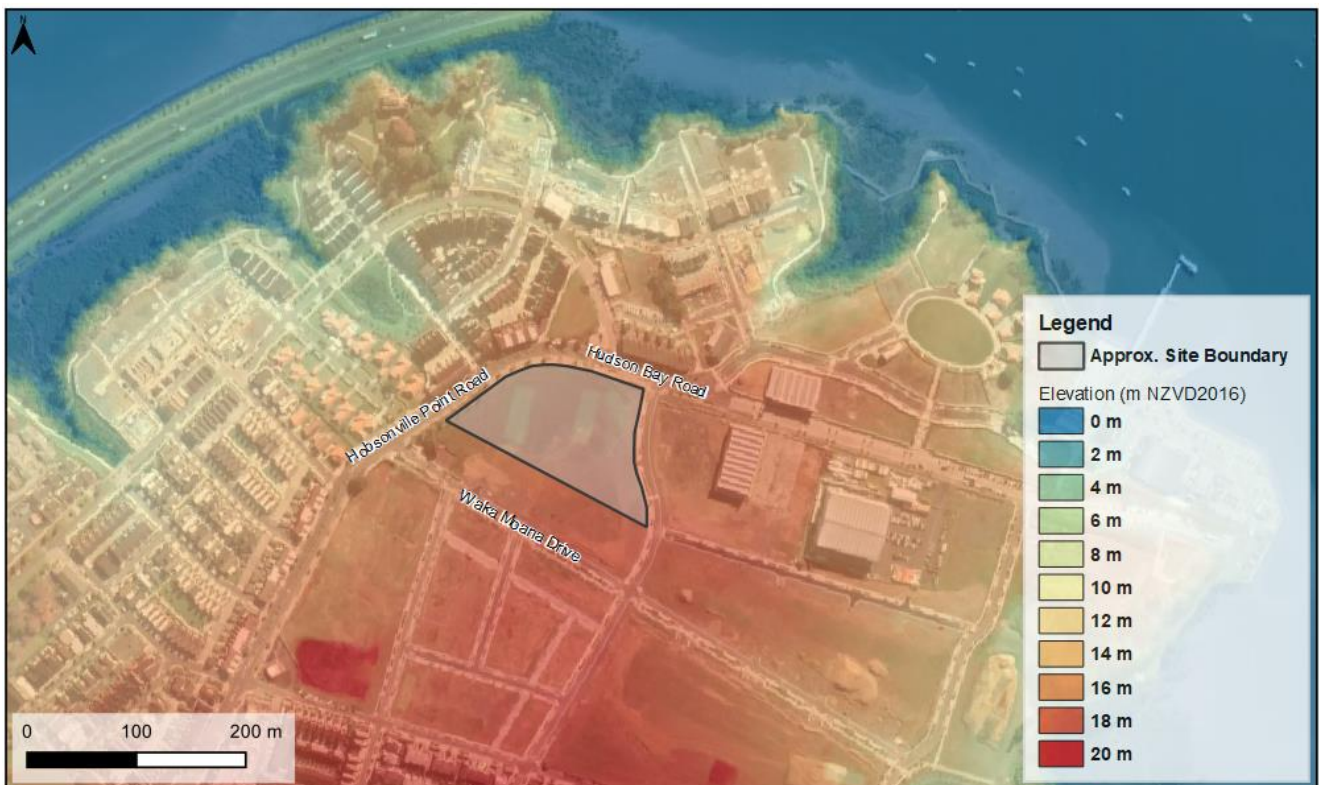
The currently proposed development plan (Jasmax: Site 5 Option F.pdf), shows developed land surface contours gently sloping from 17.5 m RL in the south-western corner of the site to 15.5 m RL along the north-western edge of the site.

Figure 4. Overview elevation map.

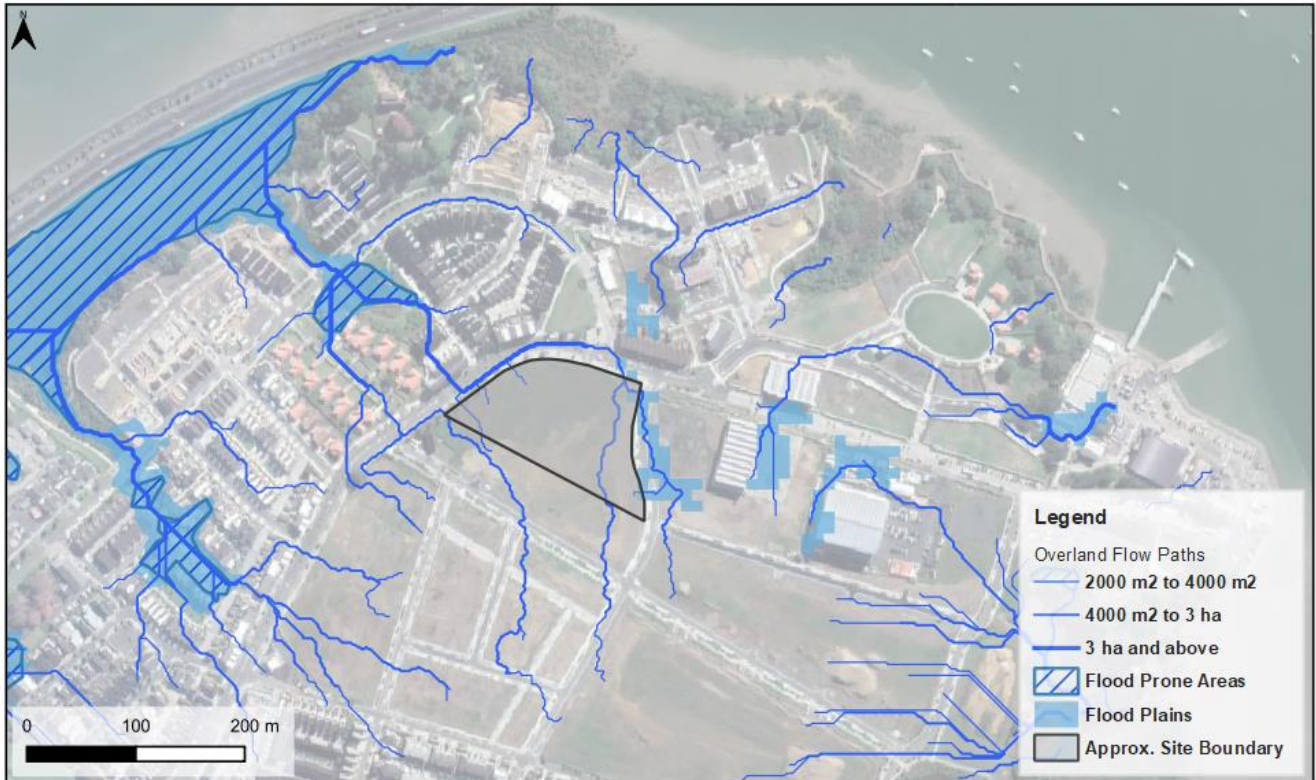
Figure 5. Auckland Council Catchments & Hydrology overlays.

An overland flow path cross from south to north, along the eastern side of the property. The flow path is generally consistent with contours shown on the developed site plan. The flow path will change to flow around buildings once the development is complete.

A flood plain area is shown adjacent to the eastern boundary of the site. This layer was developed based on a regional scale rapid flood hazard mapping assessment¹⁰, using a direct rain-on-grid modelling approach. The assessment utilised a 10 x 10 m DEM developed prior to the assessment (i.e., prior to 2010). The site itself and surrounding areas have undergone earthworks and slight recontouring in recent years, and therefore the outputs (i.e., presence of a flood plain at this location) of the rapid flood hazard assessment at this location are no longer expected to be accurate. Given the small size of the upgradient catchment, the risk of flooding from the overland flow path is considered low.
