GEOTECHNICAL INVESTIGATION REPORT FOR SITE EVALUATION AND MASTER PLANNING

Hobsonville Point Primary #2

279 Hobsonville Point Road

Project Number: 1422-01-20

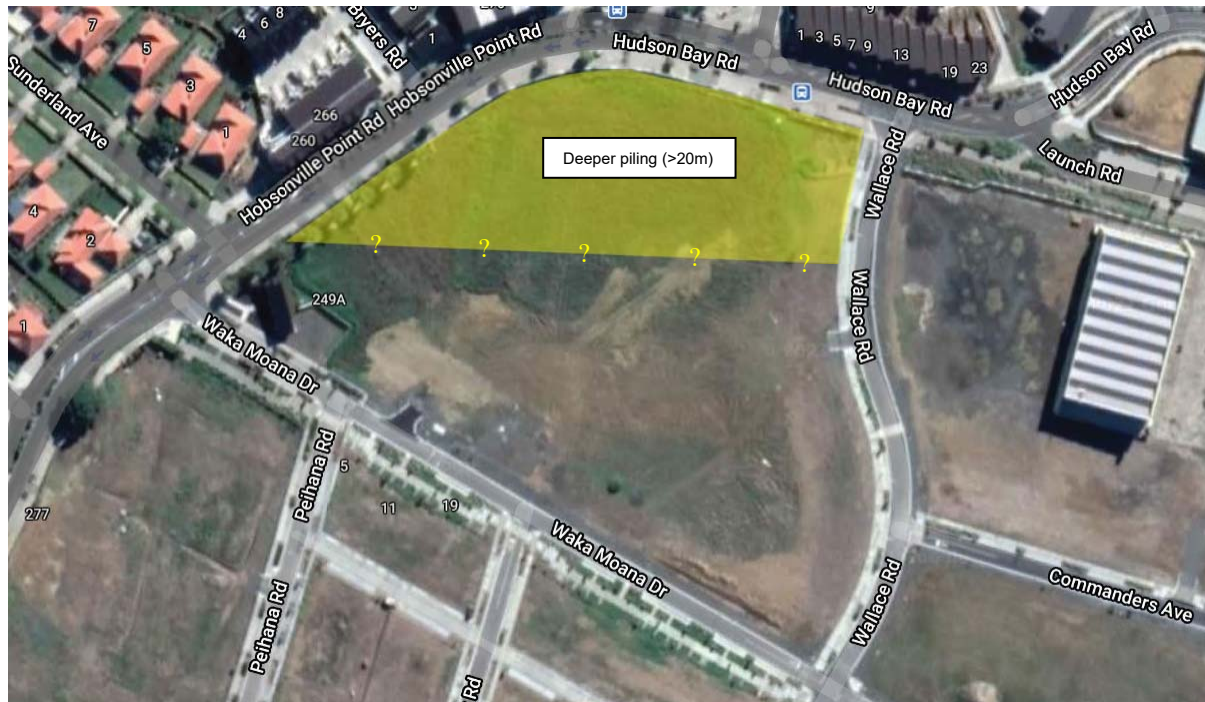
Figure 5-1 – Area of site likely to require pile depth of > 20m bgl – possibly up to 30m

Based on the results of the site investigations, the anticipated minimum depth to the top of the ECBF rock can be assumed to vary across the site from in the about 16 to 30m bgl, and the transition from the ‘shallower’ to ‘deeper’ pile depths may occur over a relatively short distance (refer to Plates A-3 and A-4 in Appendix A). The area of the site where piling depths are considered likely to be greater than 20m is shown in Figure 5-1 below.

If deep pile foundations are considered, it is recommended that deep investigation using machine-drilled boreholes be undertaken within the proposed building footprint(s) to confirm the required depth of piling. The information from the drilling program can also be used to assess the suitability of pile types other than bored piles (e.g., driven steel UC piles).

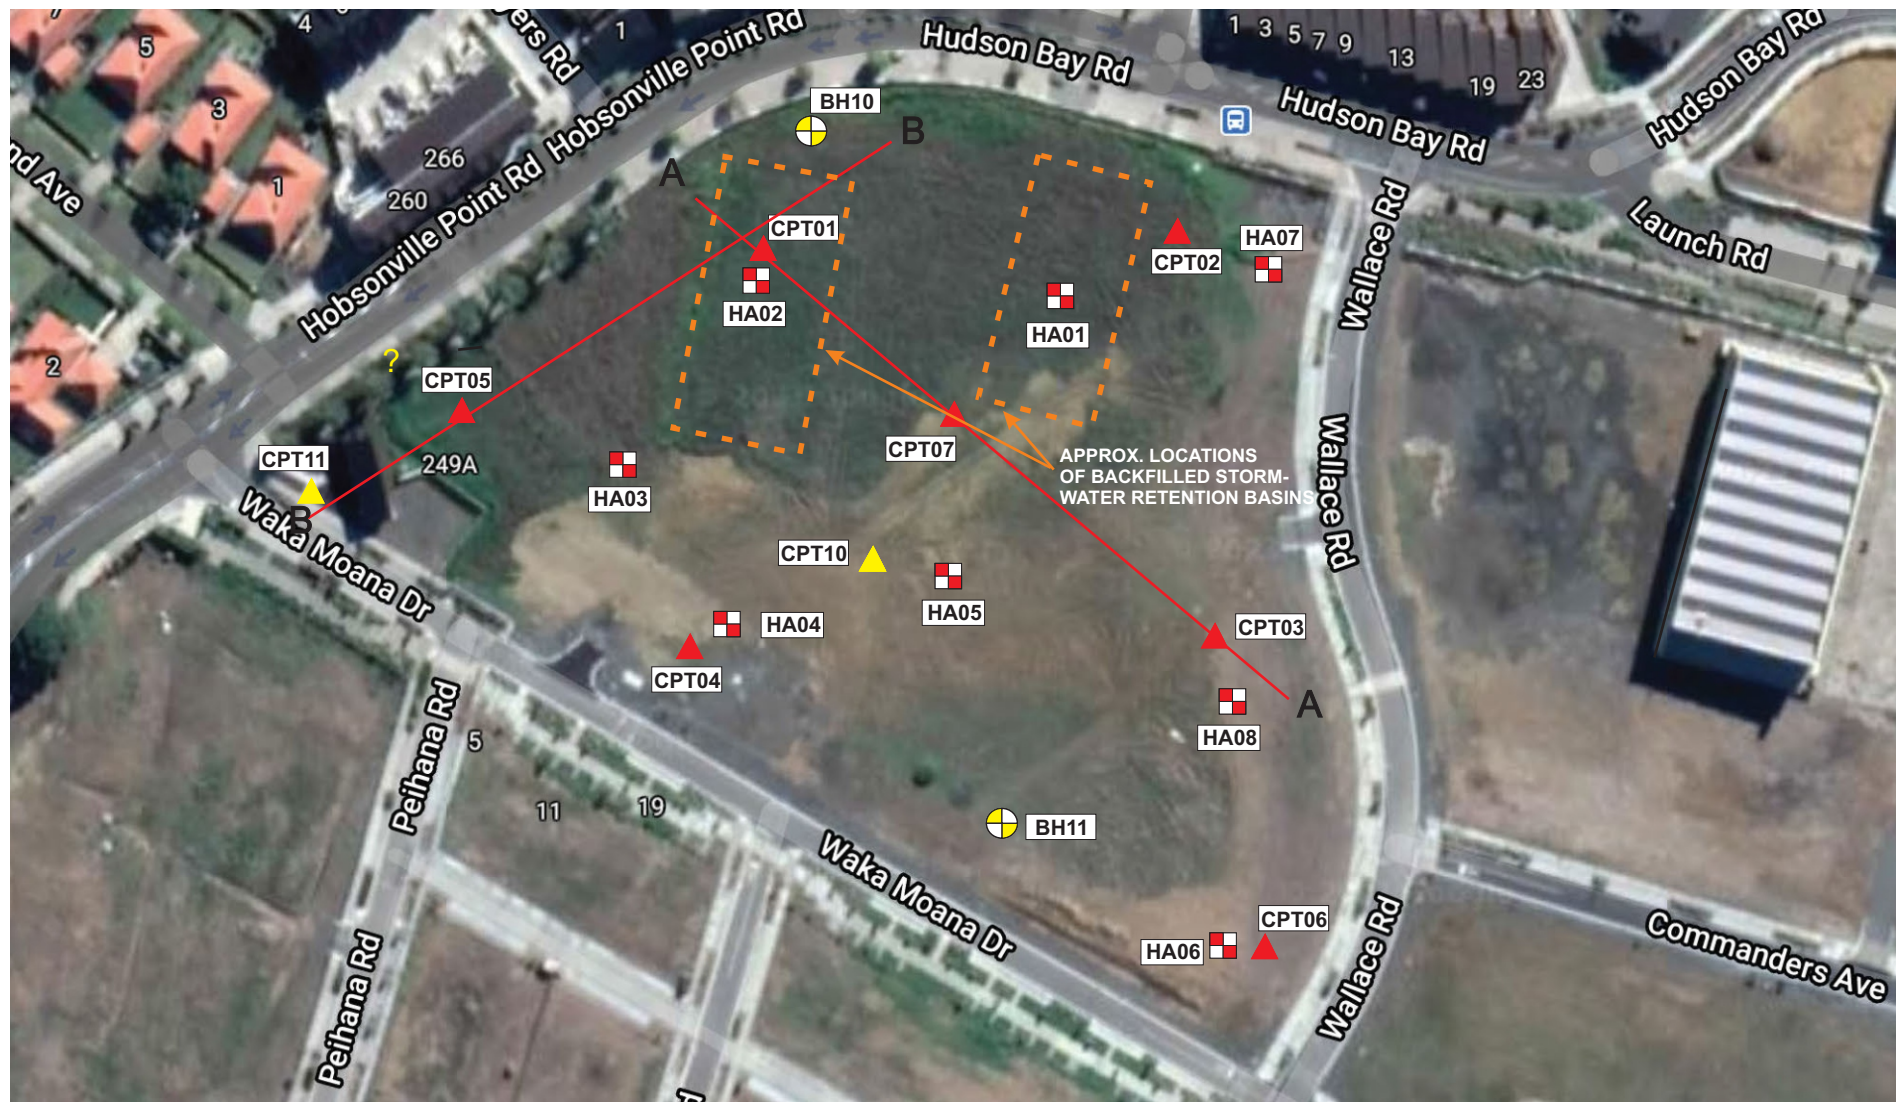
PLATE
A-2

▲ APPROXIMATE LOCATION
OF WENTZ-PACIFIC CPT

Seven cone penetrometer tests (CPTs) were performed at the site on 12 December 2020, at the approximate locations shown in Plate A-2 in Appendix A. The CPTs were advanced to depths of between about 13 and 28 m below existing ground (bgl). All CPTs encountered practical refusal of the cone penetrometer on inferred dense sandy soils. The CPT investigation results are presented in Appendix B.

The locations of the hand auger boreholes and DCP tests are shown in Plate A-2 in Appendix A and the borehole logs and the results of the DCP testing are contained in Appendix C.

The locations of the previous T&T site investigations are shown on Plate A-2 in Appendix A, and the logs of the CPTs and boreholes are contained in Appendix D.

An aerial photograph of the site taken in 2017 that clearly shows the bulk subdivision earthworks in progress is contained in Appendix A. Two relatively large stormwater detention basins are clearly visible in the northern portion of the site. The basins are presumed to have been backfilled with engineered fill as part of the completion of the bulk earthworks, but a record of this has not been sighted by WP. The approximate locations of the stormwater basins are also shown on the site investigation plan (Plate A-2, Appendix A).

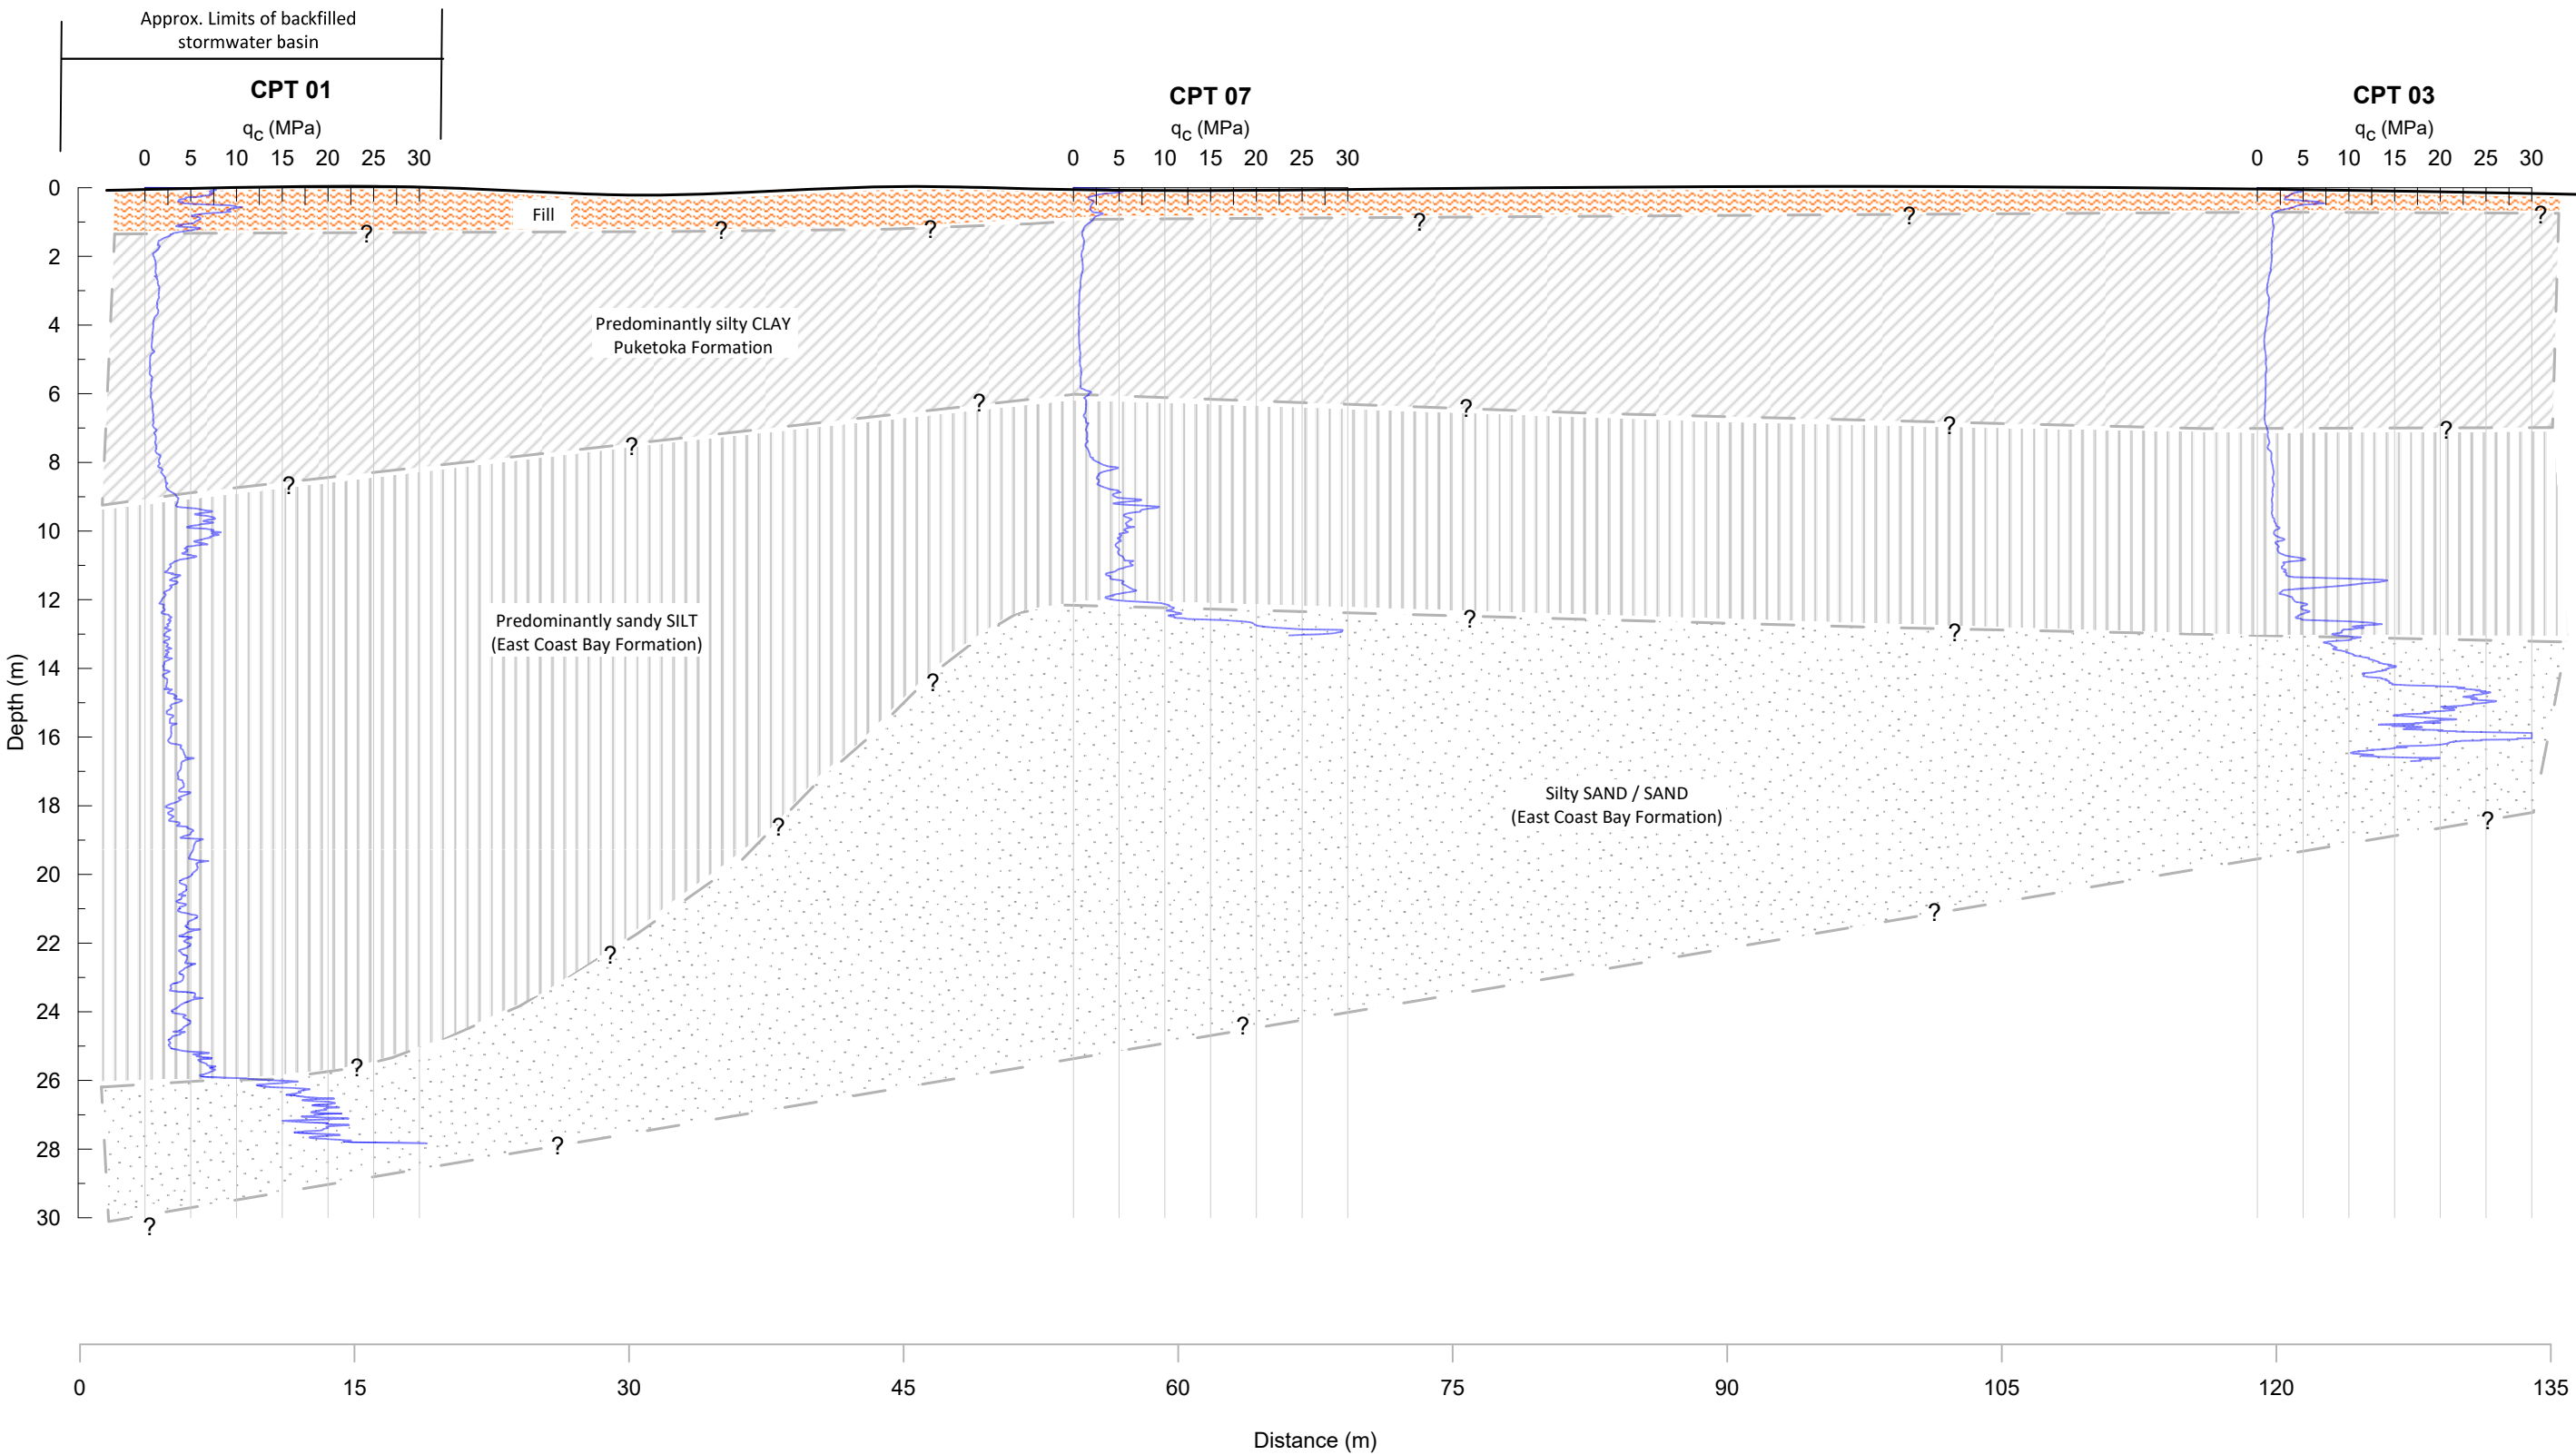
NOTE: The ground conditions shown are inferred only and not intended to be relied upon for design or construction.

SCALE: Vert. = 1:200, Horiz. = 1:400
