Drury East Plan Change, Drury, Auckland

Preliminary Site Investigation

By: EHS Support New Zealand Limited

Date: 9 August 2019

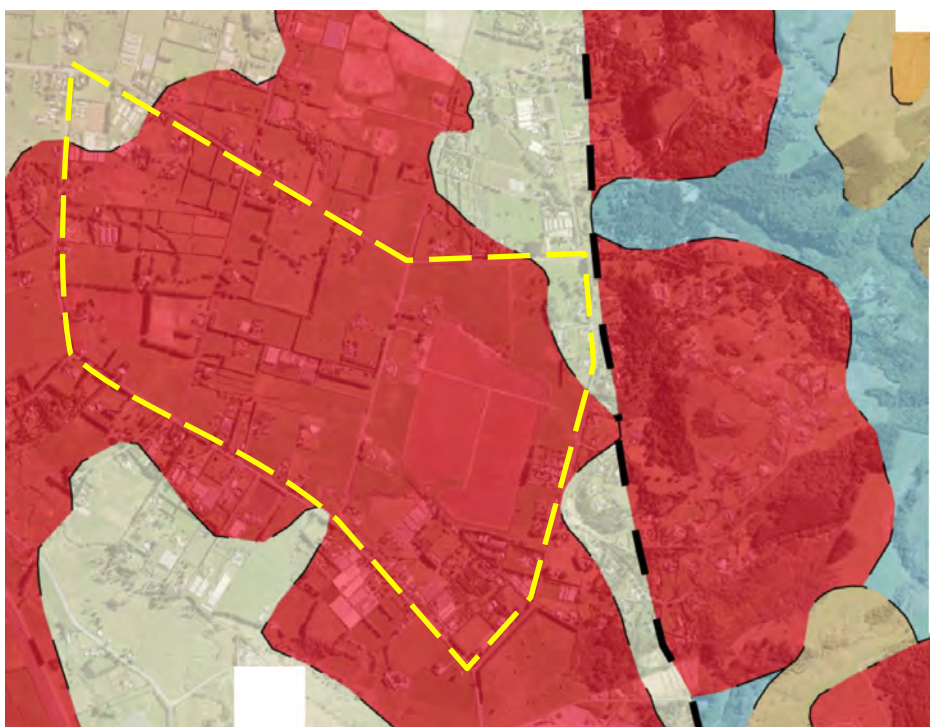
Plate 1: 1:250,000 Geological Map of Study Area

A review of the Scale 1:250,000 geological map on the GNS-Science website identified that the underlying geology of the majority of the study area comprises Undifferentiated Kerikeri Volcanic Group basalt lava of South Auckland Volcanic Field, Early Pleistocene - Late Pleistocene. This group of basalt lava consists of fine-grained and coarse-grained, porphyritic, olivine basalt, basanite and hawaiite lava flows.

The study area is underlain by two unconfined aquifers: the Drury Volcanic and Drury Sand Aquifers. A third, much deeper (>100 m below ground surface) confined aquifer known as the Drury Waitemata Aquifer is also present⁴. The Drury Sand Aquifer is identified as a sensitive rural aquifer within the AUP-OP under Section D2. 'Quality-sensitive Aquifer Management Areas Overlay'. Rules controlling the taking of groundwater and drilling of bores in this area are specified under Section E7. 'Taking, using, damming and diversion of water and drilling'. Section D2.1 of the AUP-OP states that aquifers within this overlay are shallow and unconfined and therefore susceptible to pollution from sources such as excess fertiliser application or discharges of contaminants from stormwater or sewage discharges.

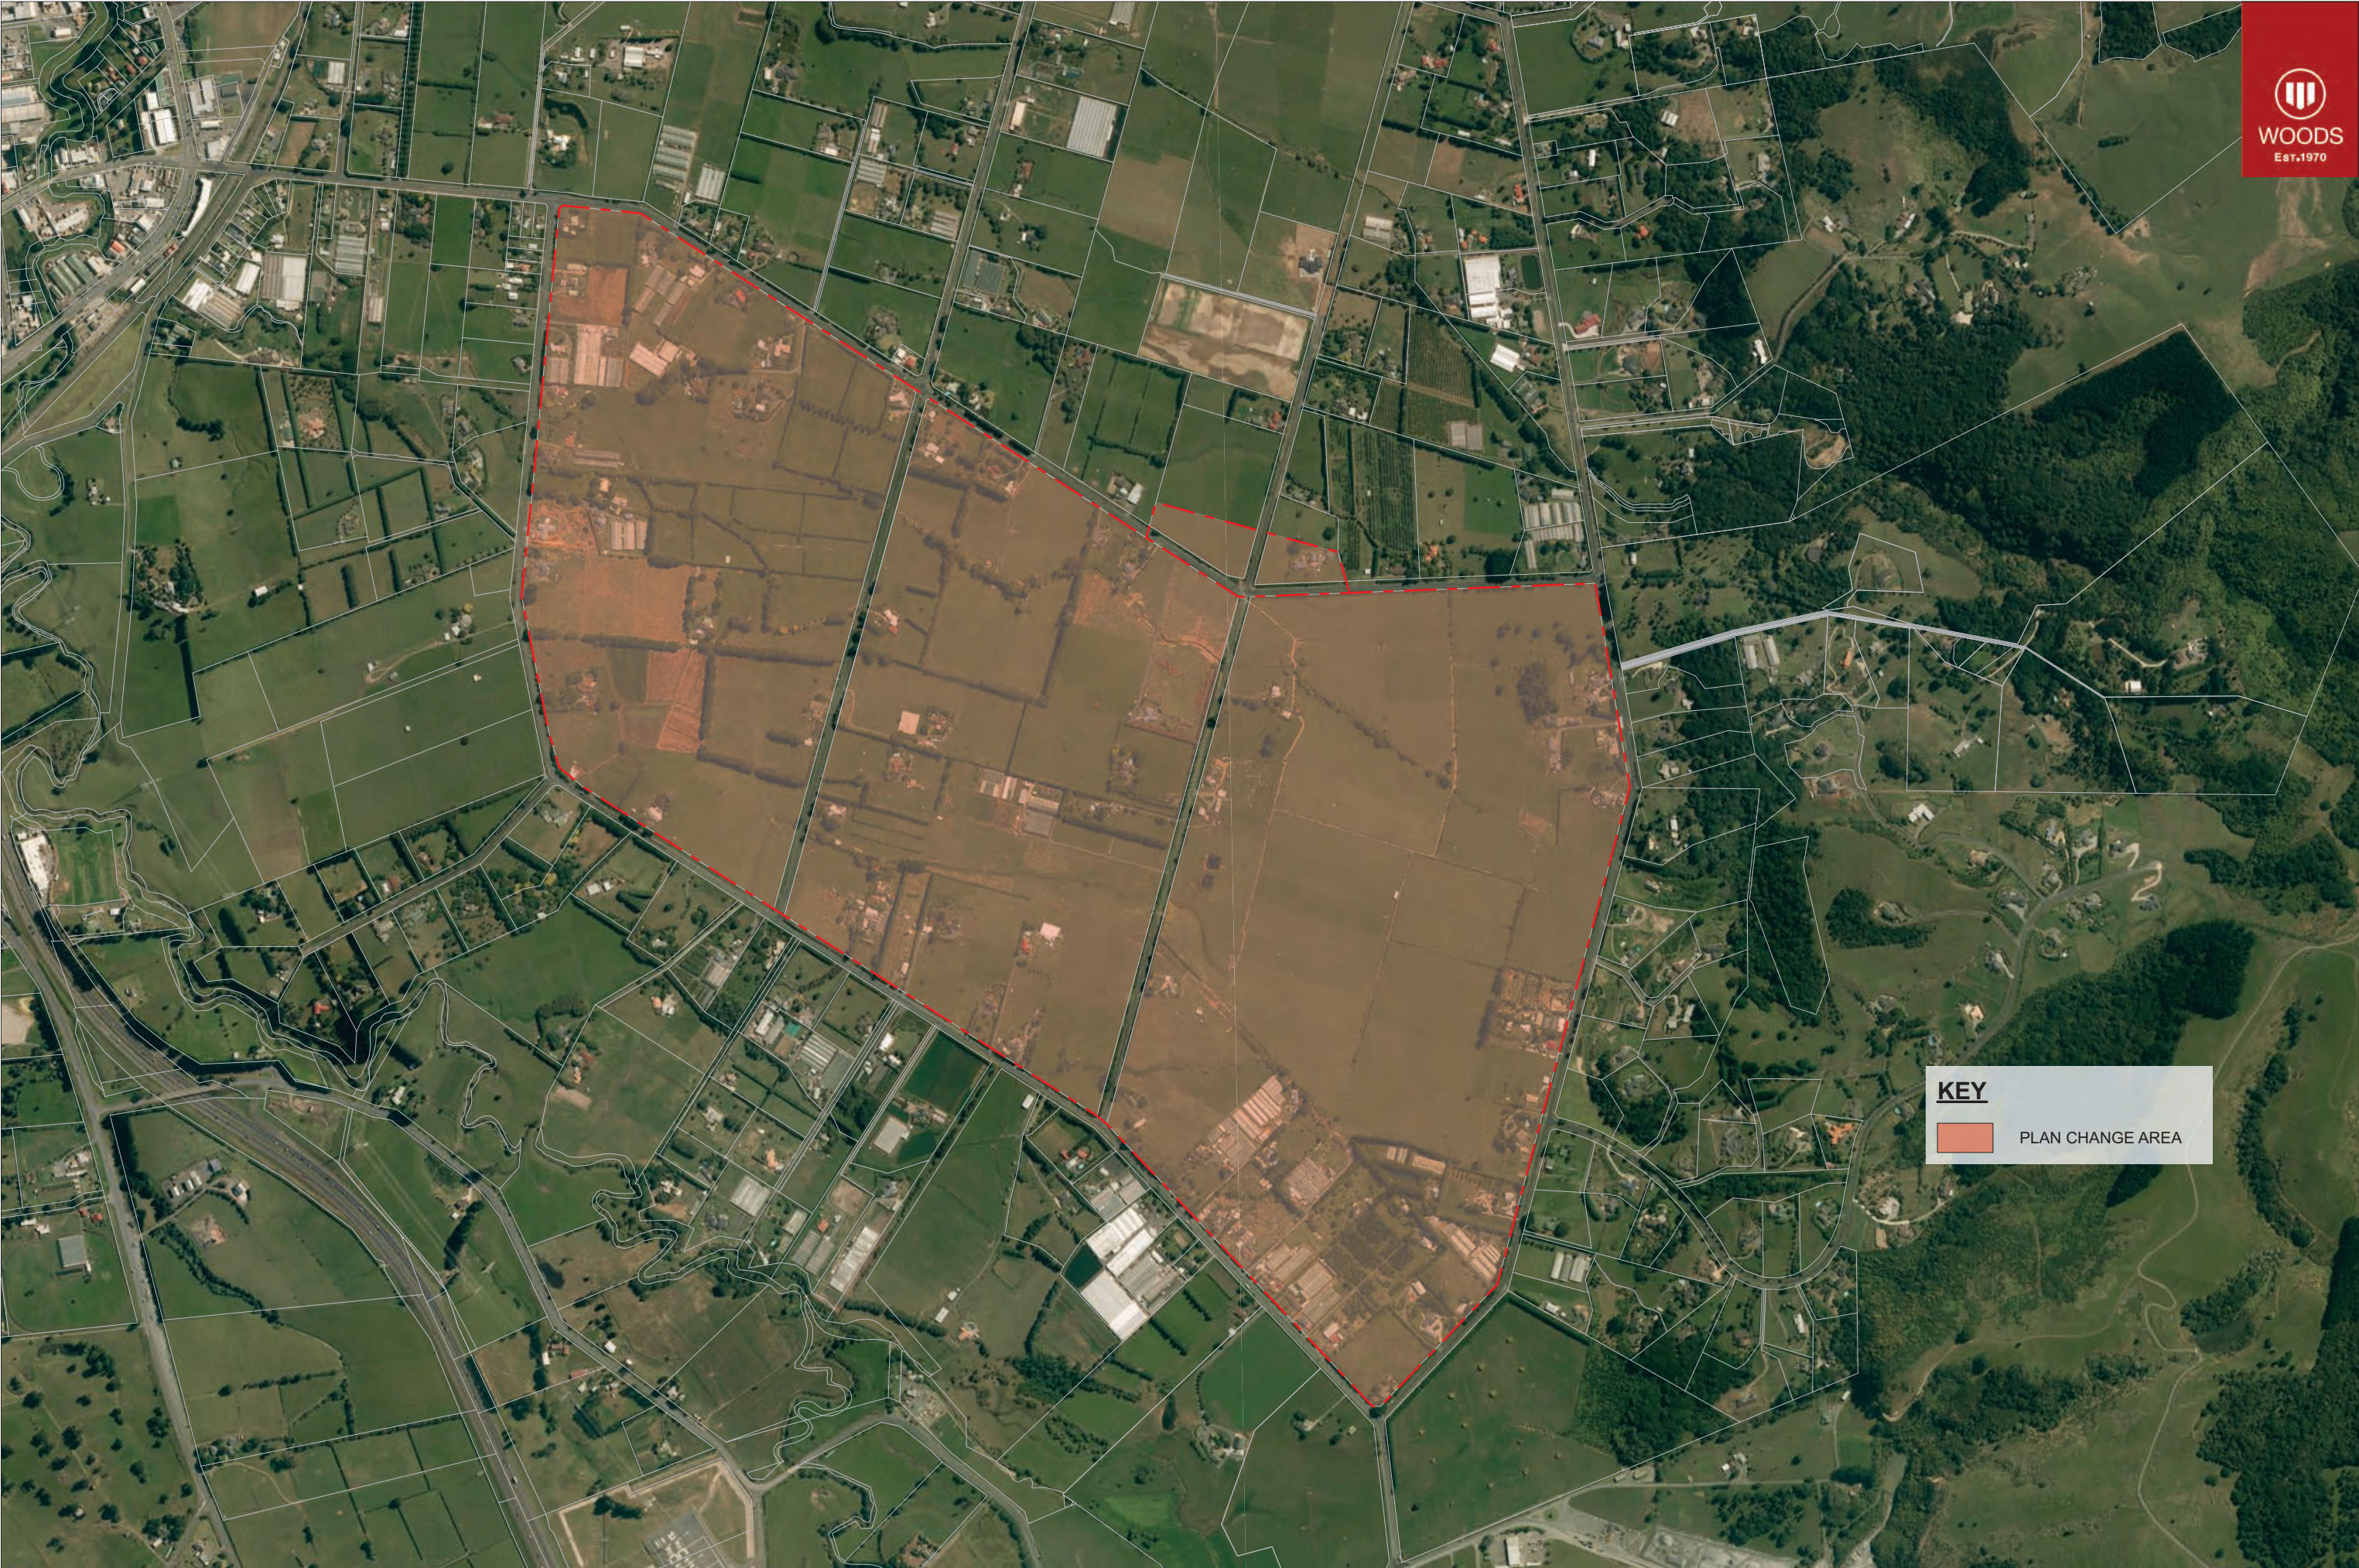
This PSI has been prepared to inform the Drury East Residential Plan Change on behalf of FHLd. The boundary of the Plan Change area is shown in Figure 1, Appendix A.

KEY

PLAN CHANGE AREA

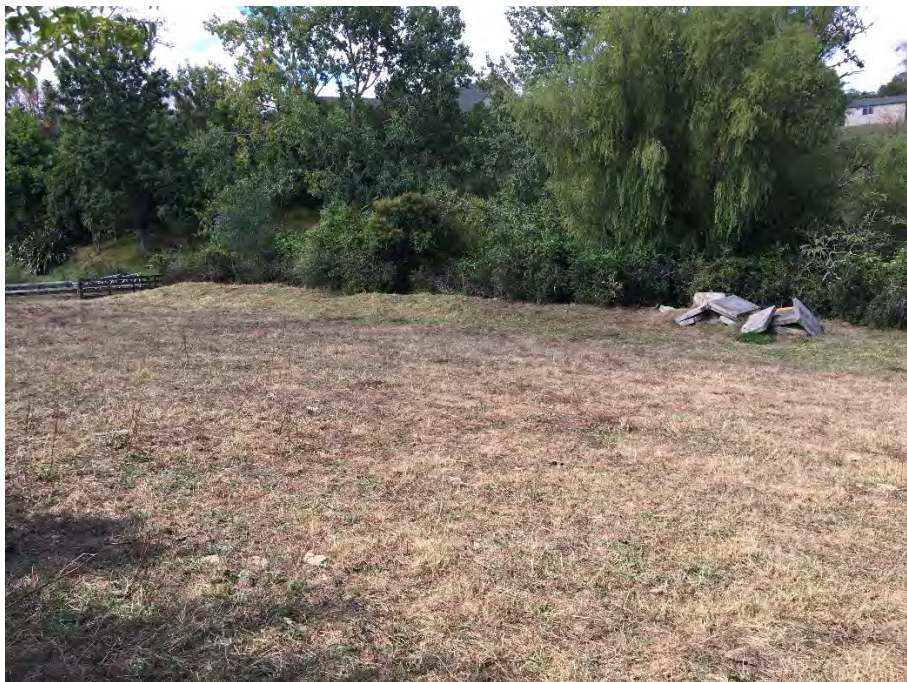
Client Name:		Site Location:	Project No.
Fulton Hogan Land Development Ltd		Drury East	NZ1902003
Photo No.	1.

Direction Photo Taken: Toward the southeast			
Description: 148 Fielding Road, Mounding from uncontrolled fill is evident in foreground in front of trees. Stockpile of concrete evident to the right.			
Photo No.	2.

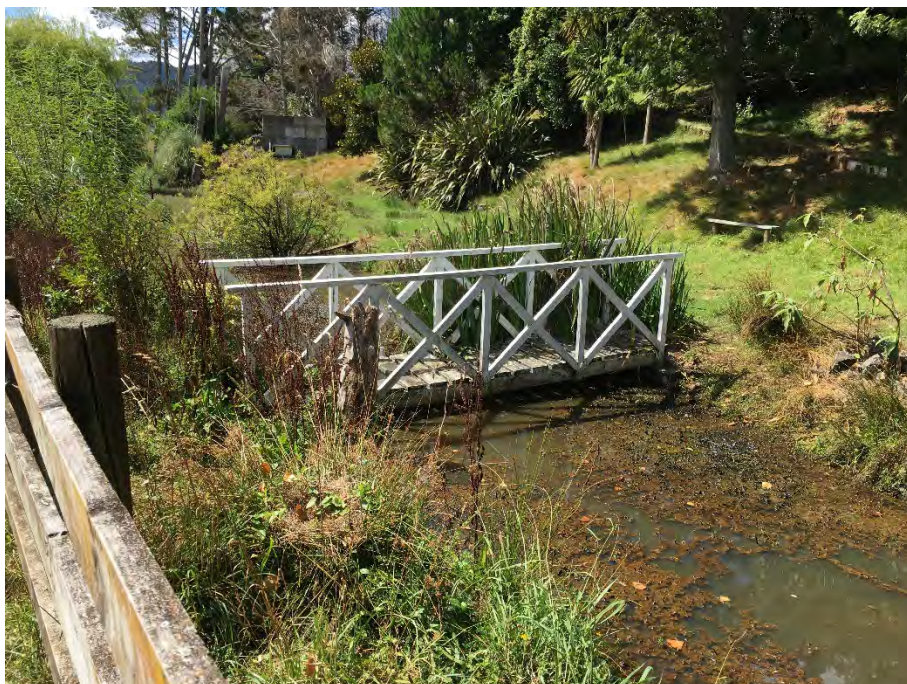
Direction Photo Taken: View to the east			
Description: Dammed stream on boundary of 148 Fielding and 330 Fitzgerald Roads.

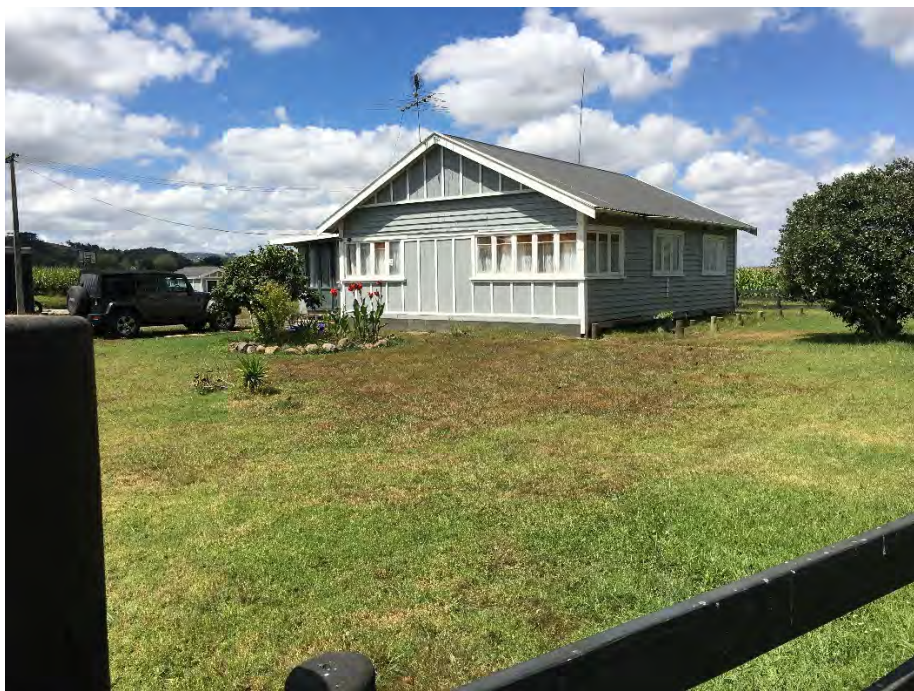
Photo No.	3.

Direction Photo Taken: View to the southeast		
Description: 35 Cossey Road – view of typical homestead.		
Photo No.	4.

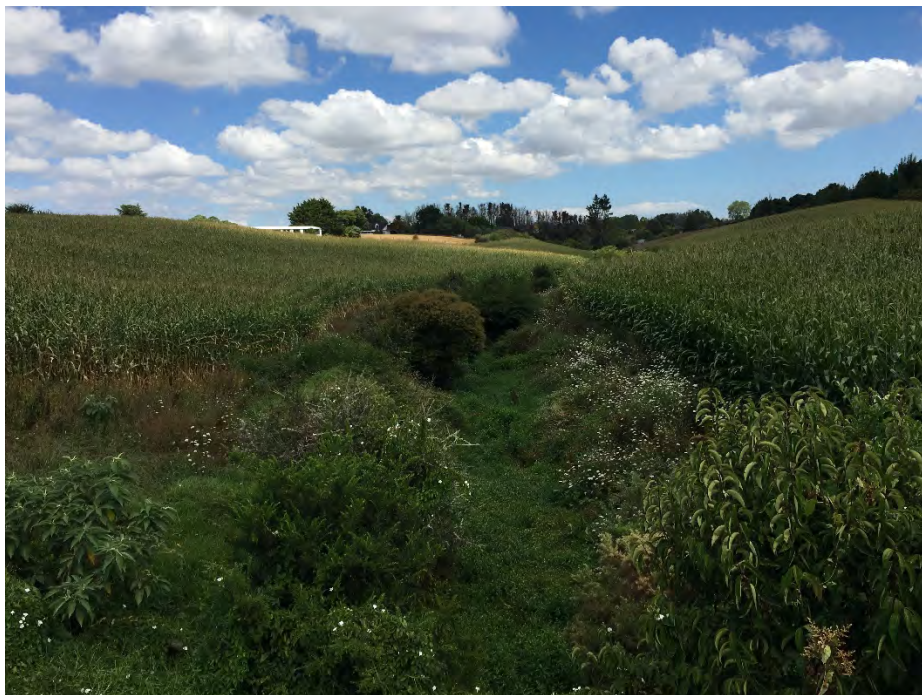
Direction Photo Taken: View to the west		
Description: 45 Cossey Road – view of stream surrounded by maize crop.

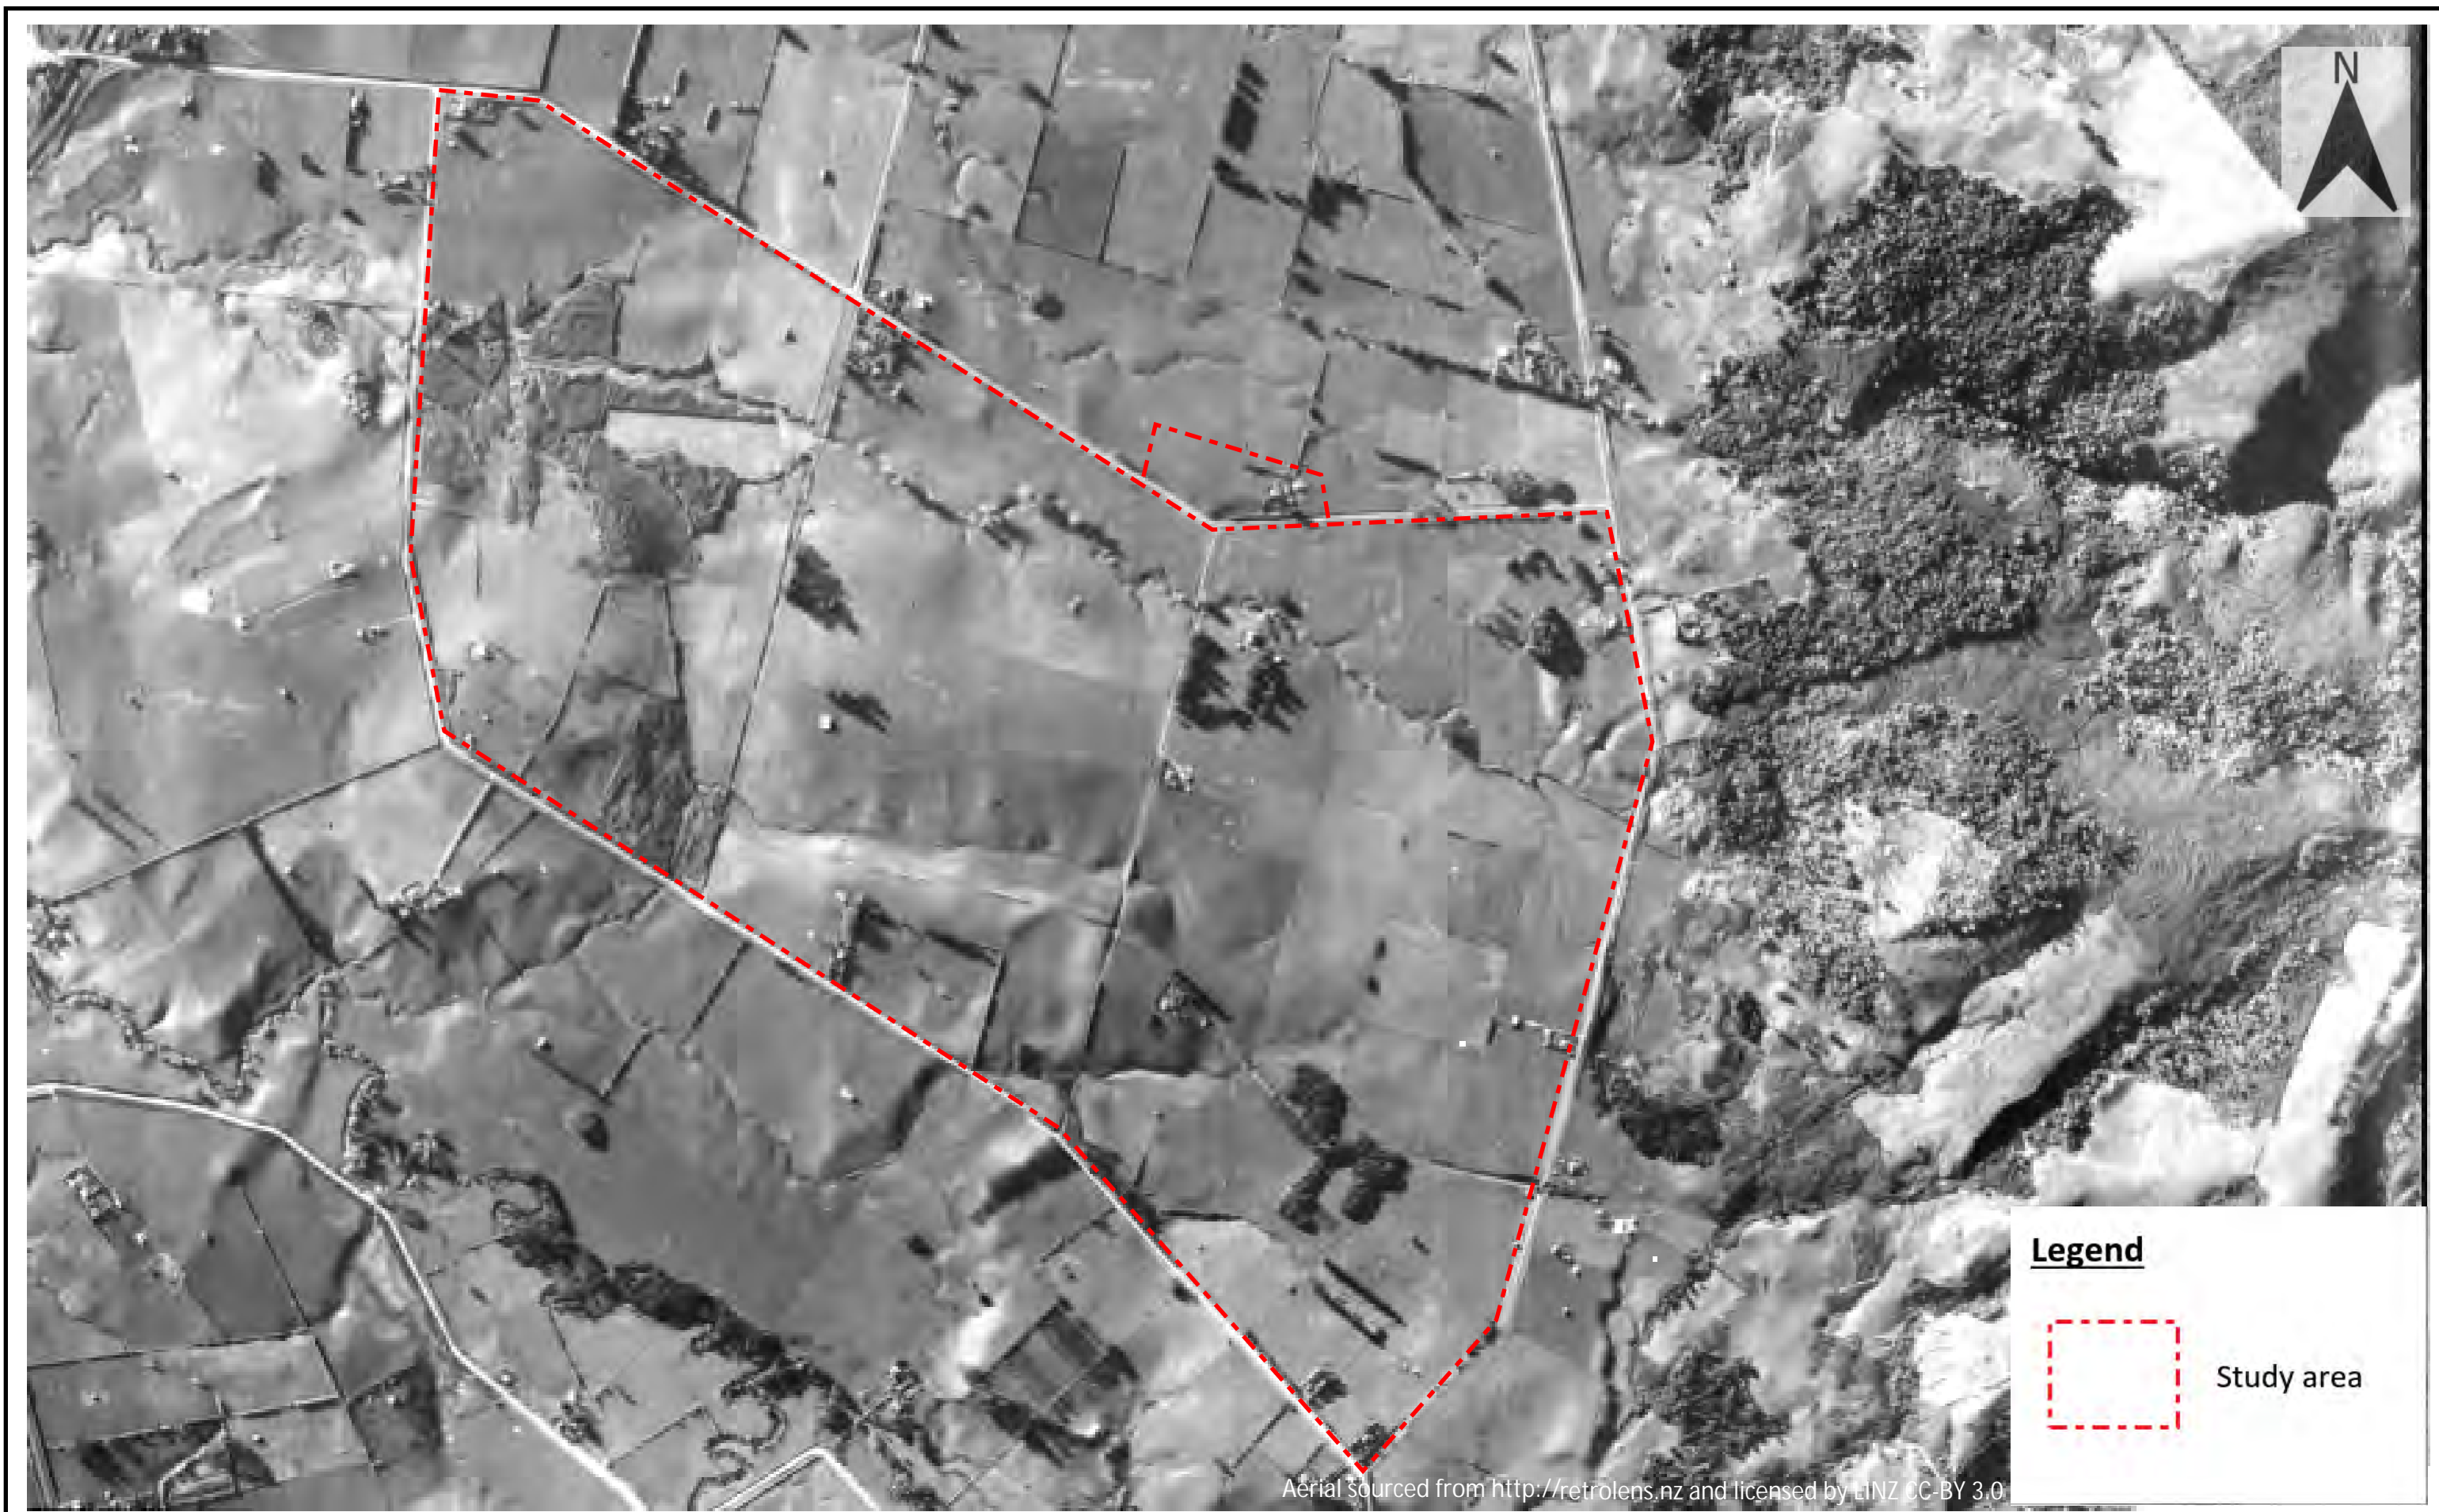
<div>EHS   Support</div>	Project PSI - Drury East		Client		Figure 1	
	Title Historical Aerial Photograph - 1940		Fulton Hogan Land Development Ltd		Drawn: JH	Checked: DD
					Date: 4 April 2019	For Information Only

- The study area has been dominated by open farmland since the earliest available image (1940), with some isolated pockets of bushland and some homesteads (approximately 10-15)/farm buildings visible. Large, open fields observed with very few windbreaks evident.
