Memo

To:	Rachel Morgan	Job No:	1003297.6000
From:	Justine Quinn	Date:	24 March 2020
cc:	Nick Carter, Gary Bramley		
Subject:	Drury East Plan Changes - Ecology Response

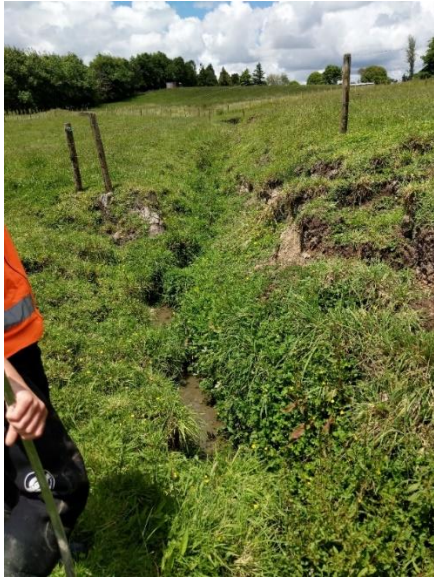
Photograph 1.1: Evidence of unrestricted stock access, lack of riparian margins, upper bank instability.

The collective area that the three plan changes apply to (the plan change area) is currently in predominantly agricultural and horticultural land use, including cropping, dairy farming and grazing. Many of the streams within the plan change area are intermittently flowing headwater systems that have unrestricted stock access to enable grazing when the streams are dry in summer. The Hingaia Stream which flows along the western boundary of the wider plan change area is the largest stream affected by the plan change. Photograph 1.1 below provides a representative image of the smaller streams within the plan change area.

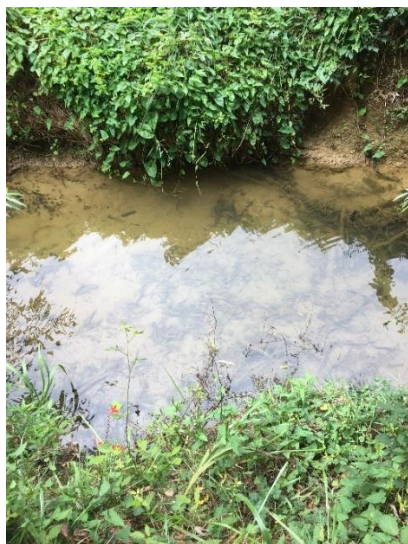
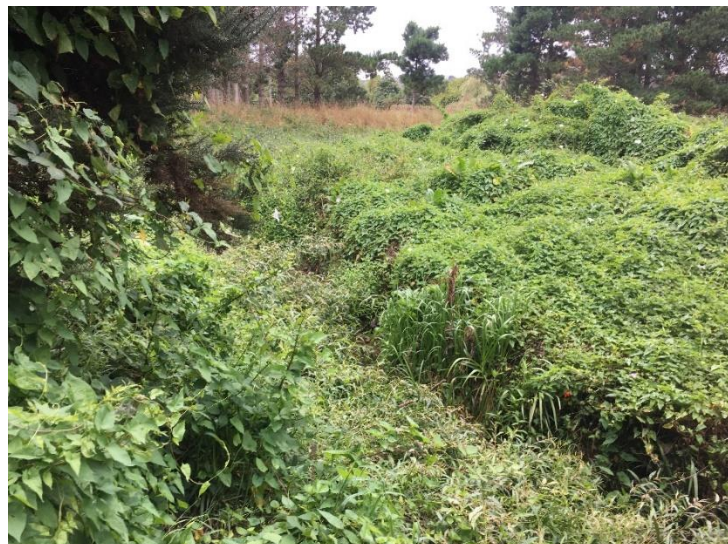
Photograph 1.2: Lack of riparian margins and bank instability along Waihoihoi Stream.

Auckland Council also surveyed streams within the Slippery Creek area², however most of the stream length present within the plan change area was not mapped. Therefore, we rely on the observations made during field assessments and reported in Freshwater Solutions (2019) where intermittent watercourses were found to be unfenced with severely damaged streambanks and channels. The section of the Waihoihoi Stream flowing adjacent to the plan change area was fenced but lined with low stature weed species and occasional mature trees so the streambanks were susceptible to streambank undercutting, slumping (i.e., due to poor root stability) and sedimentation (Photograph 1.2).

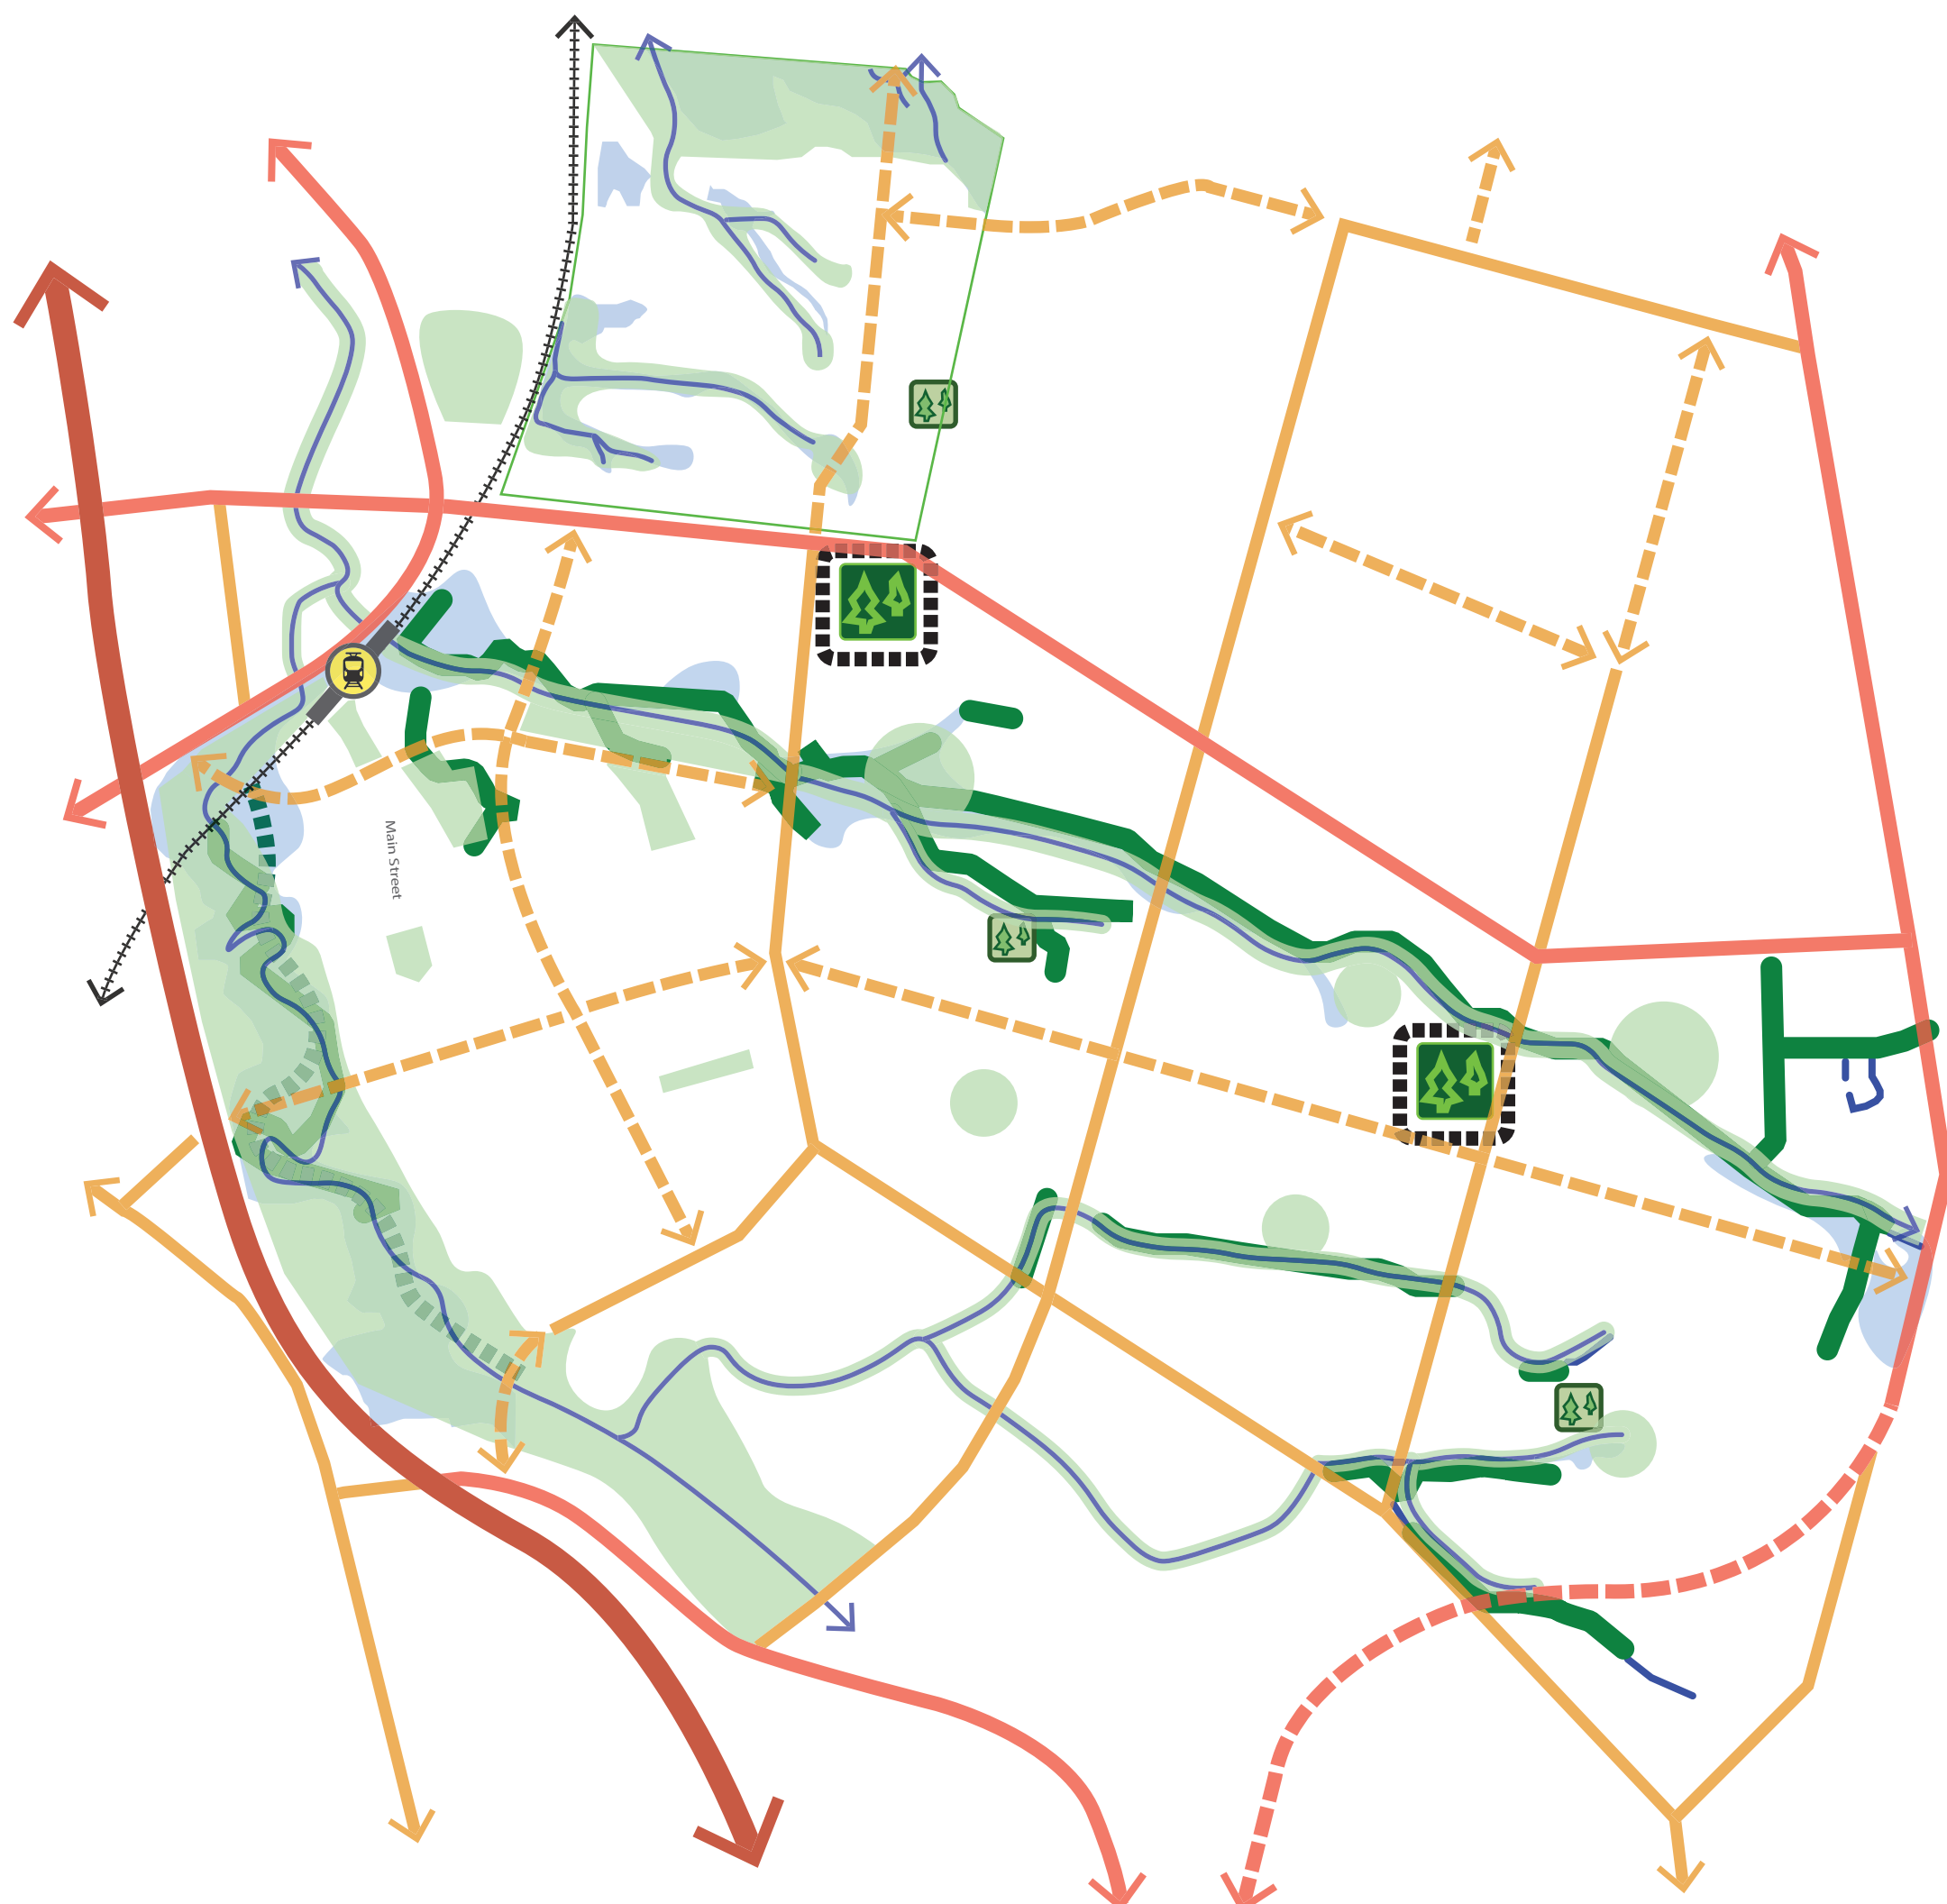
Appendix A: Blue Green Network Map

The following response has been prepared in relation to Stormwater 07 in relation to the blue-green network. Refer to Appendix A which shows the Blue-Green Network envisaged under the Structure Plan, overlain with the riparian corridors as proposed in the Plan Change. There are some parts of the site where stream alignment does not correspond between the two datasets. We consider that for the most part this relates to a lack of spatial resolution. The plan is conceptual and provides sufficient information at this time to identify that the Blue-Green Network, including the important connectivity with SEA to the west of Drury Hills Road, is integral to the Plan Change.
