Memo

To:	Mark Iszard and Carmel O'Sullivan (Auckland Council)	Job No:	1003297
From:	Charlotte Peyroux and Tim Fisher (T+T) and Pranil Wadan (Woods)	Date:	6 April 2020
cc:	David Schwartfeger (Kiwi Property), Greg Dewe (Fulton Hogan), Andrew McCarthy (Oyster), Nick Roberts (Barkers),		
Subject:	Response to Auckland Council Further Information Request on Stormwater Matters for Drury East - Stream Erosion Risk Assessment for Hingaia Catchment

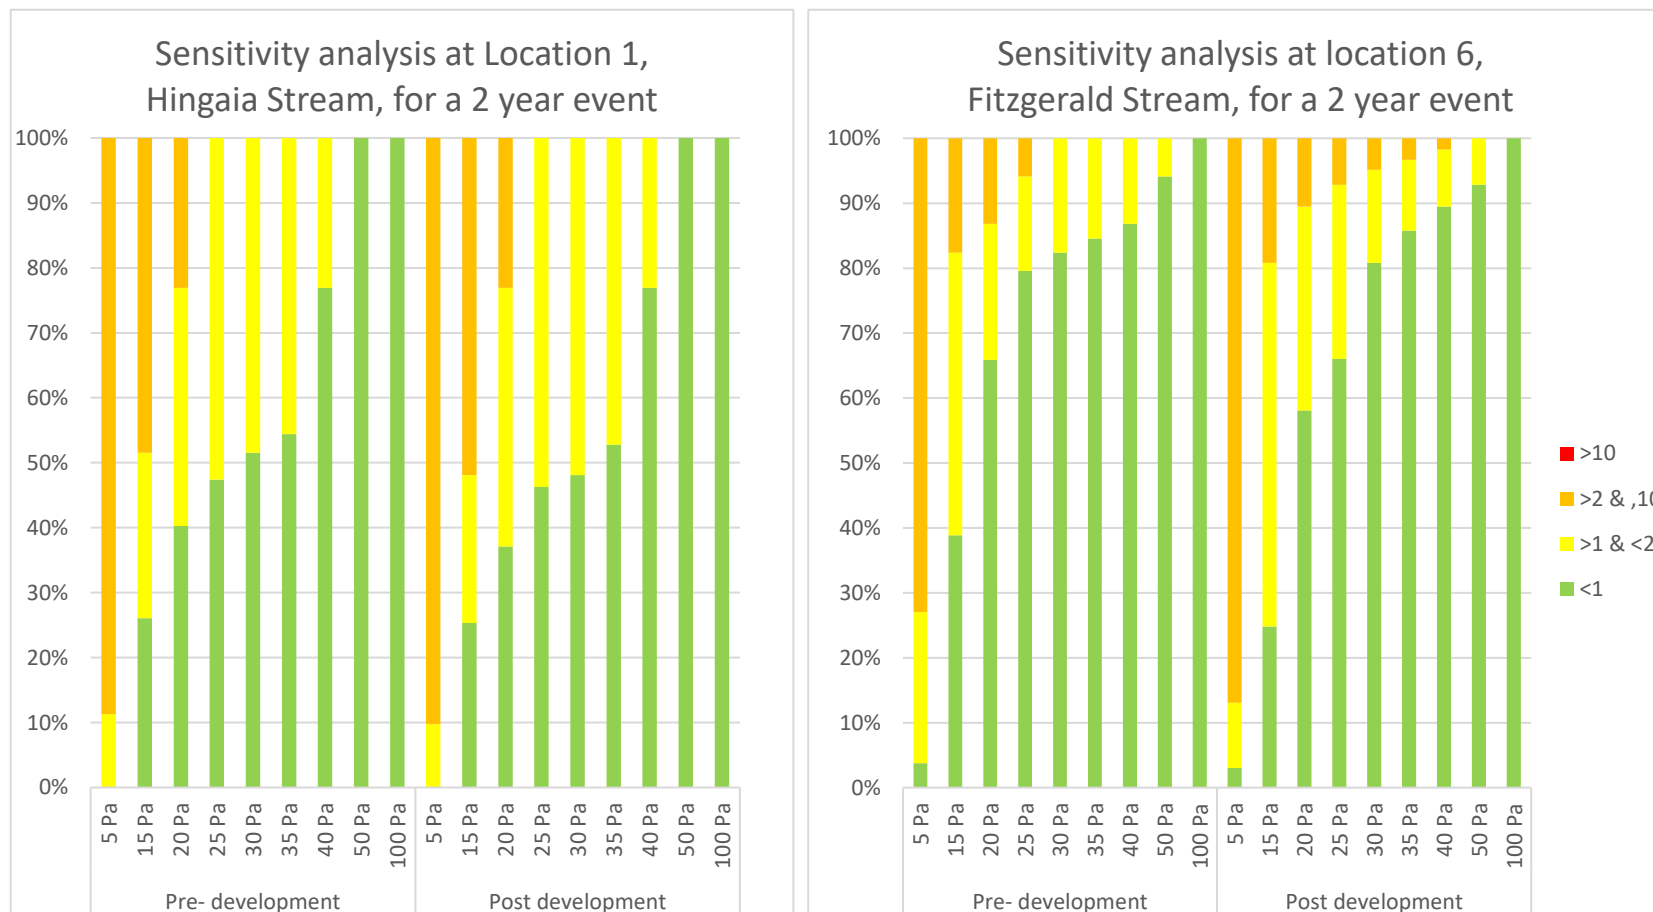
The critical shear stress of the stream is very site specific and dependent on factors including underlying geological features, substrate types, channel conditions such as the degree of weathering and the channel shape, and the conditions along the stream banks, such as vegetation. All of these variables change spatially along and across the stream channel. A sensitivity analysis was done at two locations to assess the suitability of estimating the critical shear stress from region wide testing due to the lack of site-specific testing. Figure 2 analyses the estimated erodibility potential at two locations (Location 1 at the mid-point along the Hingaia Stream of the Kiwi Property Plan Change Area and Location 6 along Fitzgerald Stream) for the 2 year event for a range of critical shear stresses between 5 Pa and 100 Pa. These both show a significant change in erosion potential depending on the critical shear stress.

Figure 2a and b - Sensitivity analysis for excess shear stress at Location 1, Hingaia stream and Location 6, Fitzgerald Stream for a 2 year event

This suggests that whilst there is a significant change in the predicted erosion for different critical shear stresses (shown by Figure 2), there are small percentage changes in erodibility potential between the pre-development and post development scenarios for each critical shear stress (Table 7) with Location 1 being more consistently low than Location 6. Therefore, the change in erosion potential (duration of excess shear >1) is reasonably insensitive of the critical shear stress.

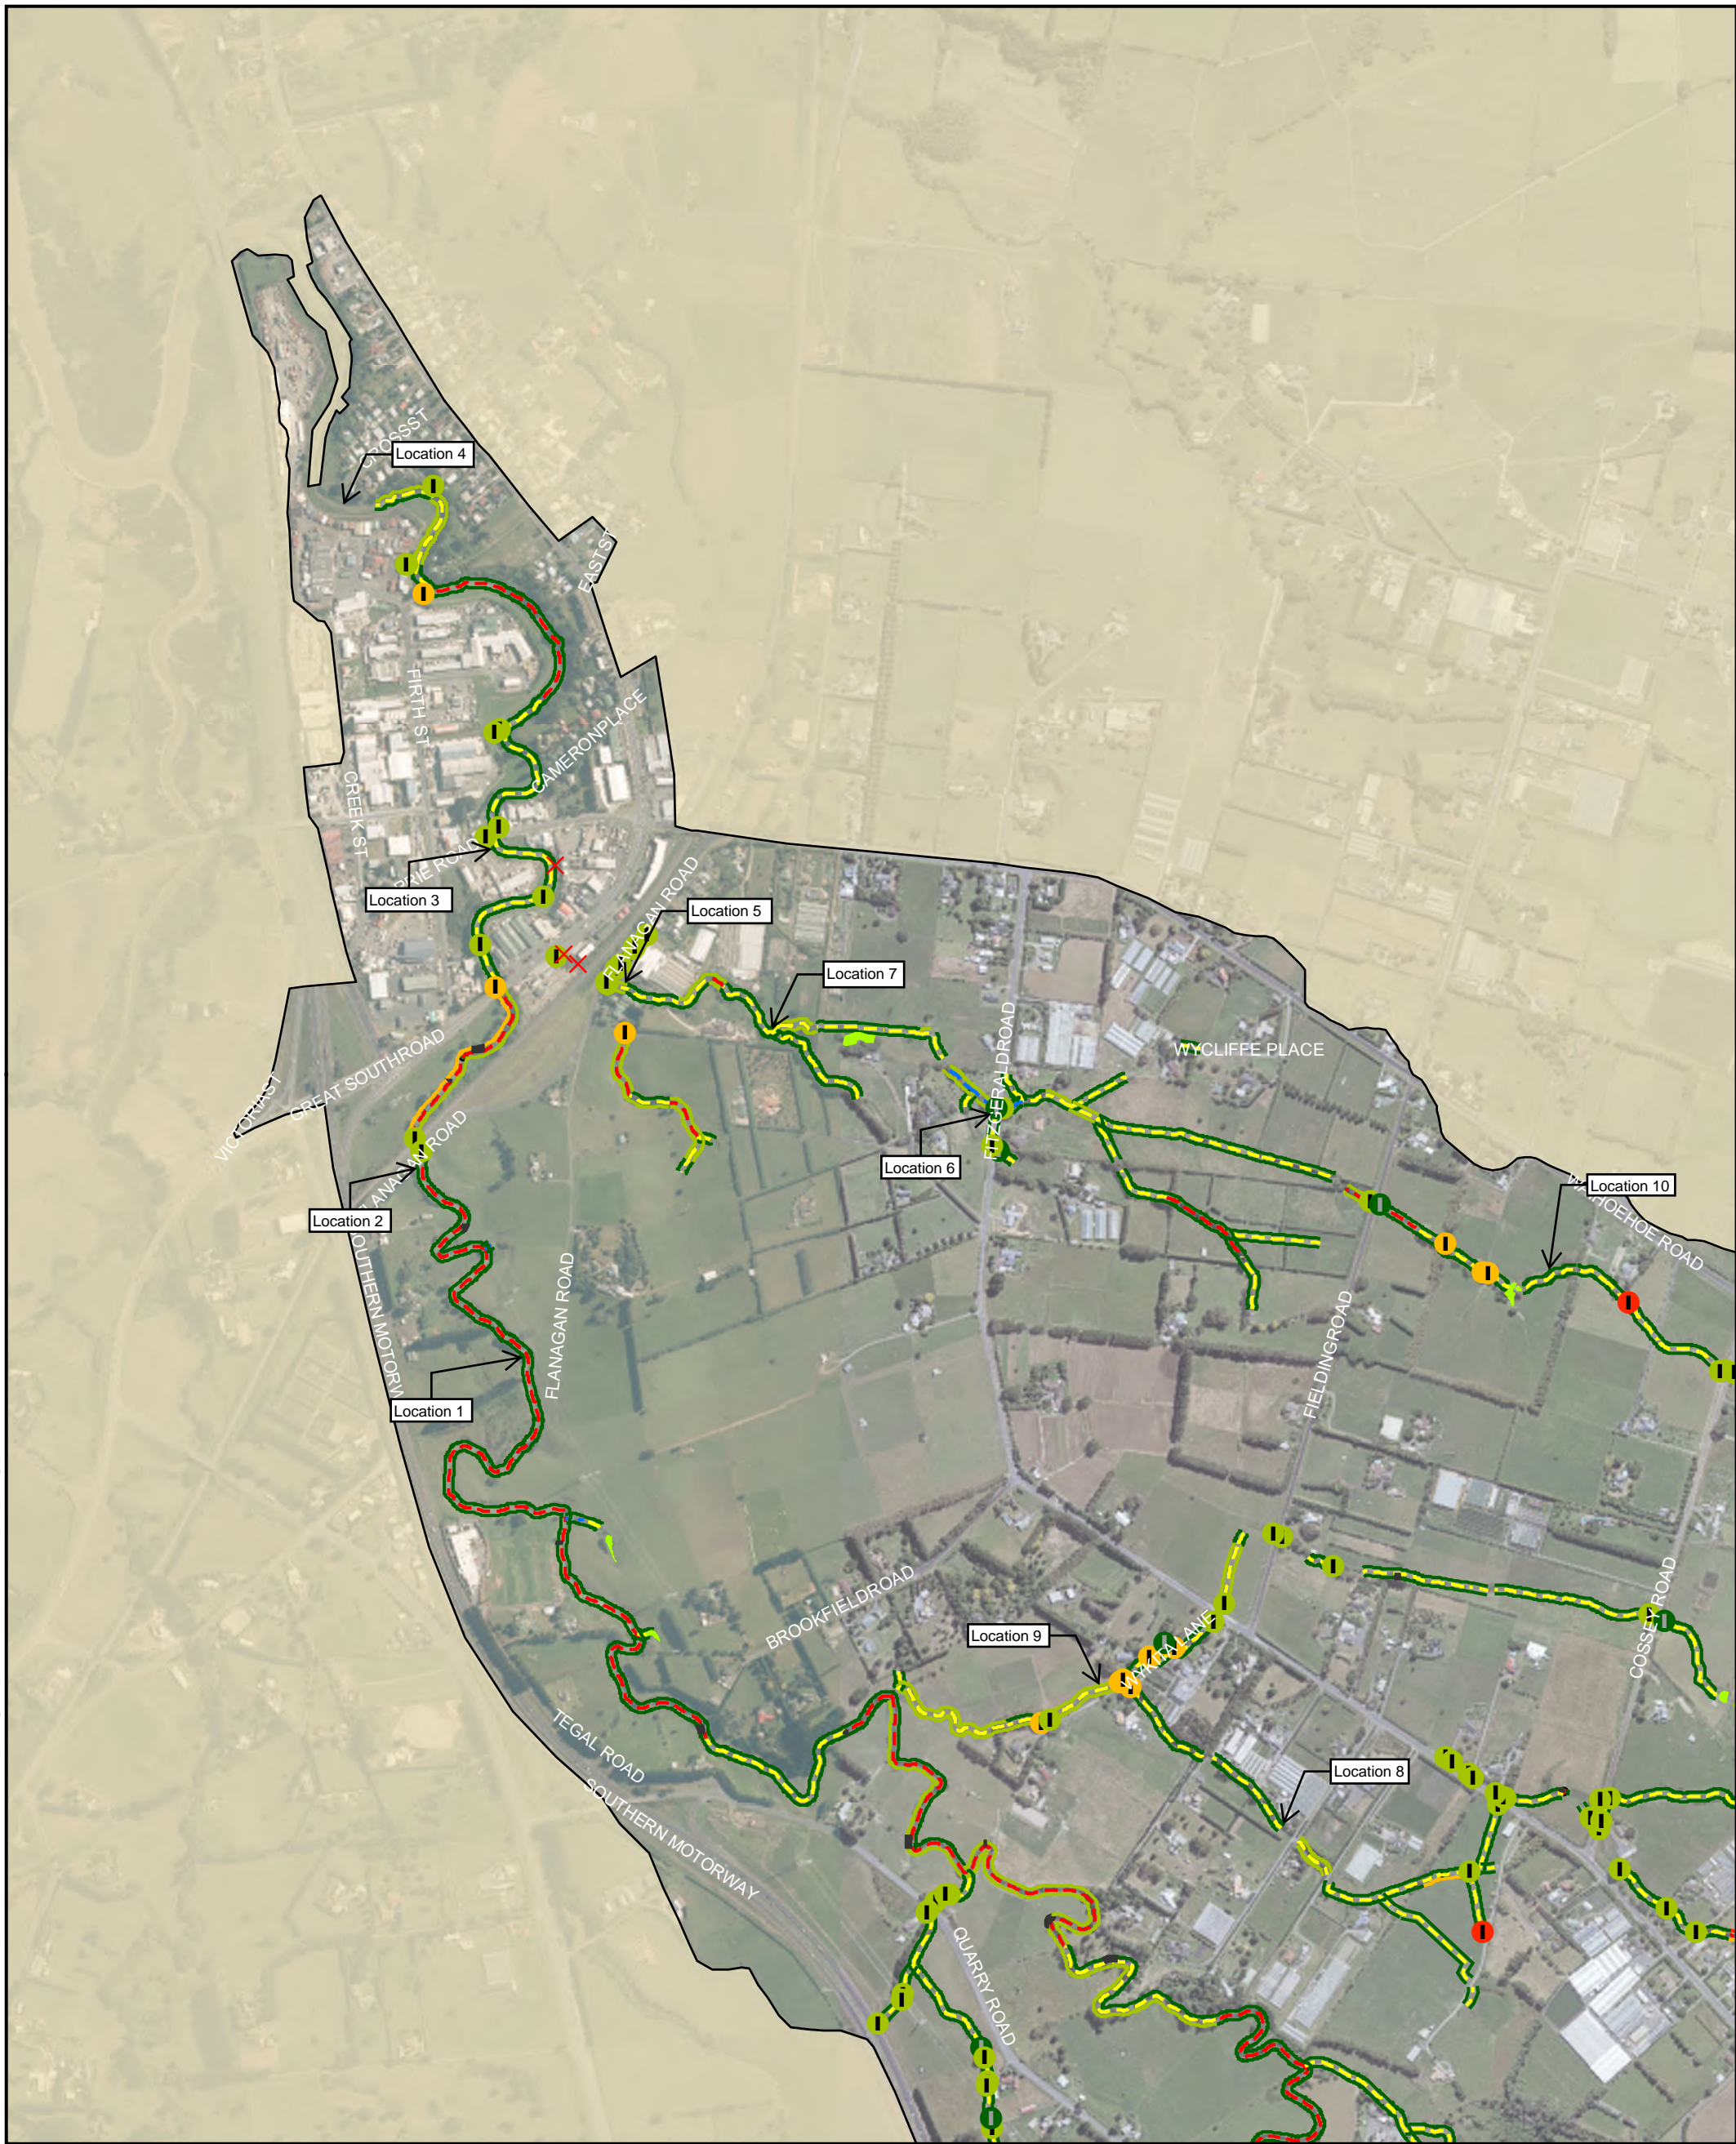
Map 4: Engineering Asset Locations, Stream Bank & Outfall Erosion

HINGAIA CATCHMENT STREAM SURVEY

These changes in erosion potential were compared against a survey of the erosion scars and bank stability within the Hingaia Stream Catchment Watercourse completed by Auckland Council in 2018. The results of both the watercourse survey and this erosion assessment are summarised in Table 6. The map from the Auckland Council survey showing the engineering asset locations, stream bank and outlet erosion has been marked up with the ten assessment locations and included in Appendix A. There is no clear correlation between the observed erosion and the predicted erosion.

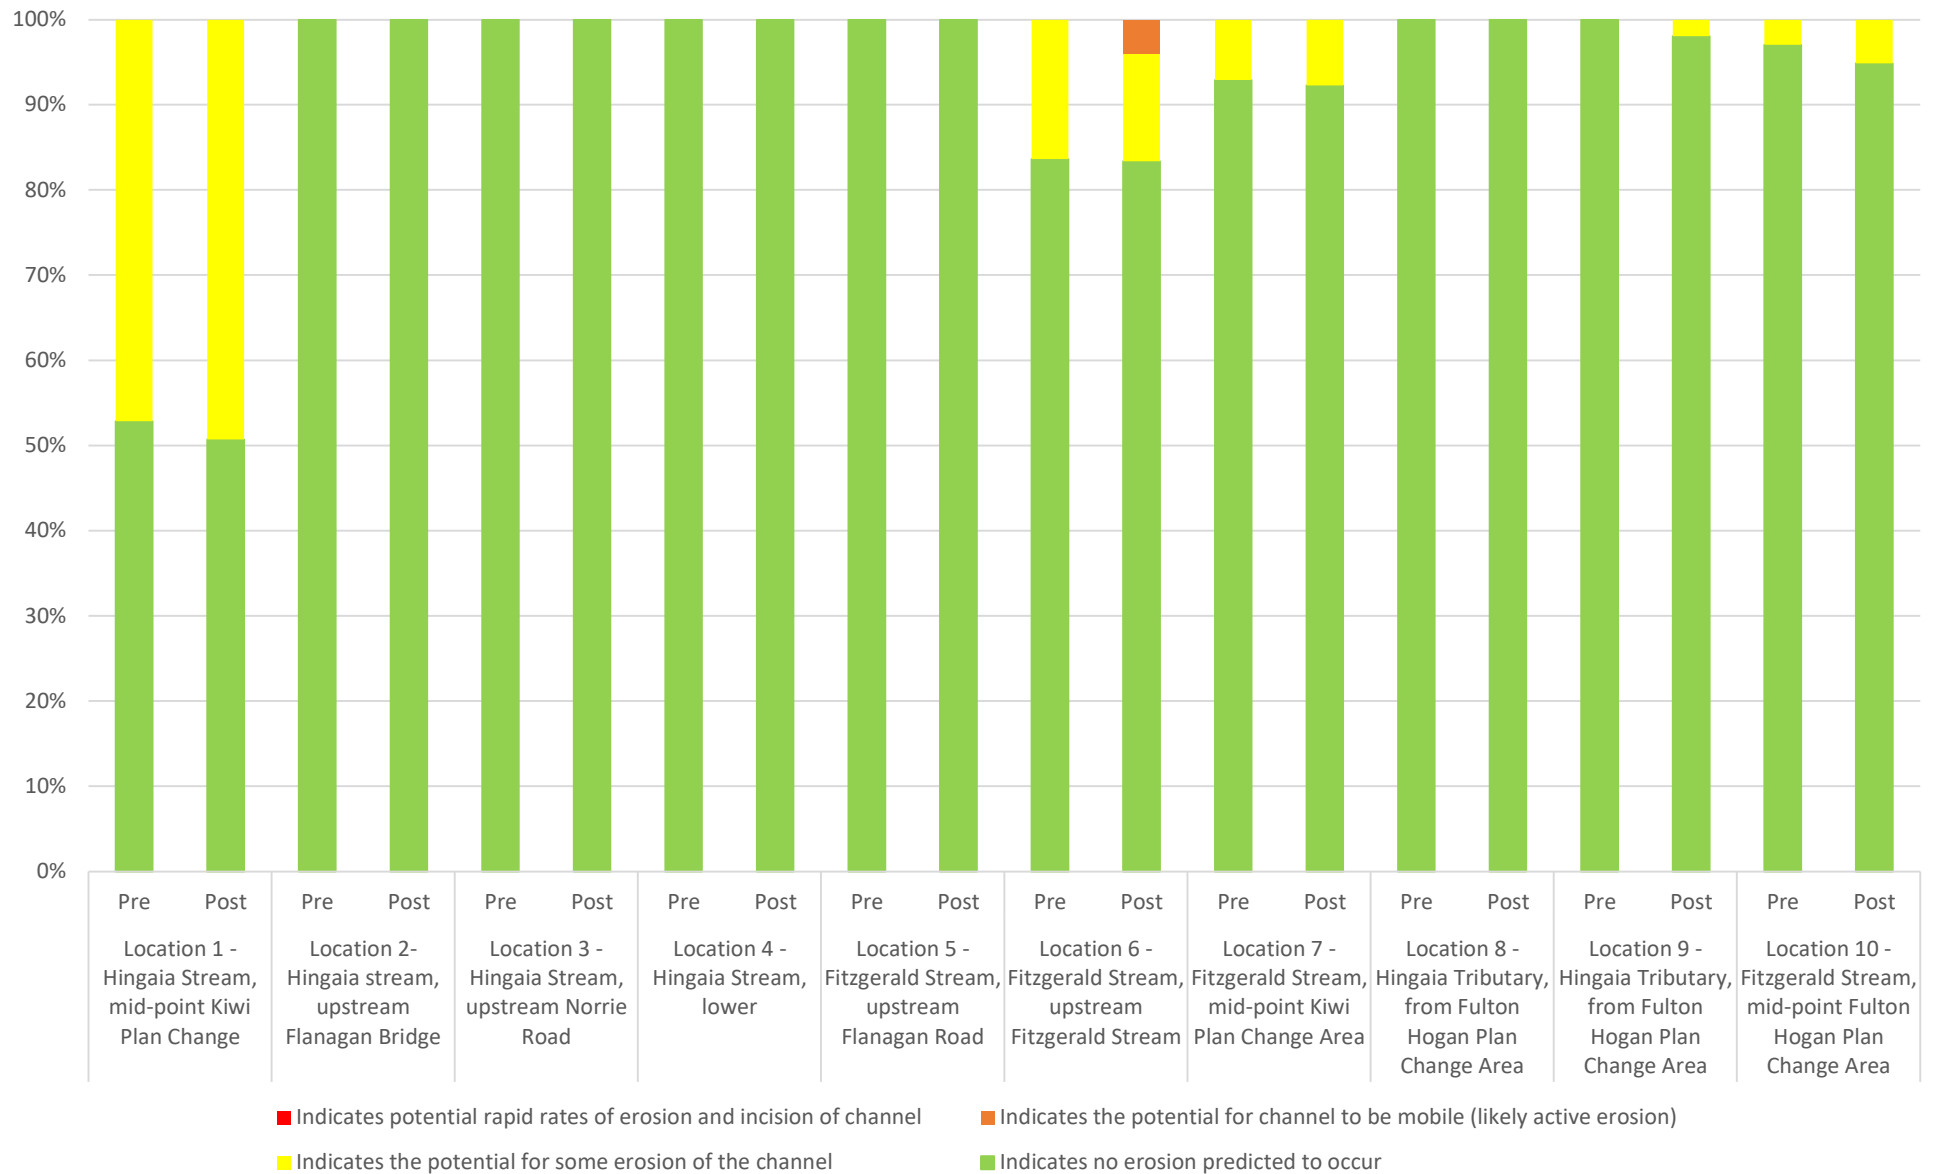
Excess shear stress in streams during 2 Year Pre and Post Development MPD CC

The excess shear for the 2 year ARI storm event is presented in normalised bar chart form in Figure 1. The 10 and 100 year ARI storm events are included in Appendix B. Time series of hydraulic shear stress at each location for all three storms are also included in Appendix B.

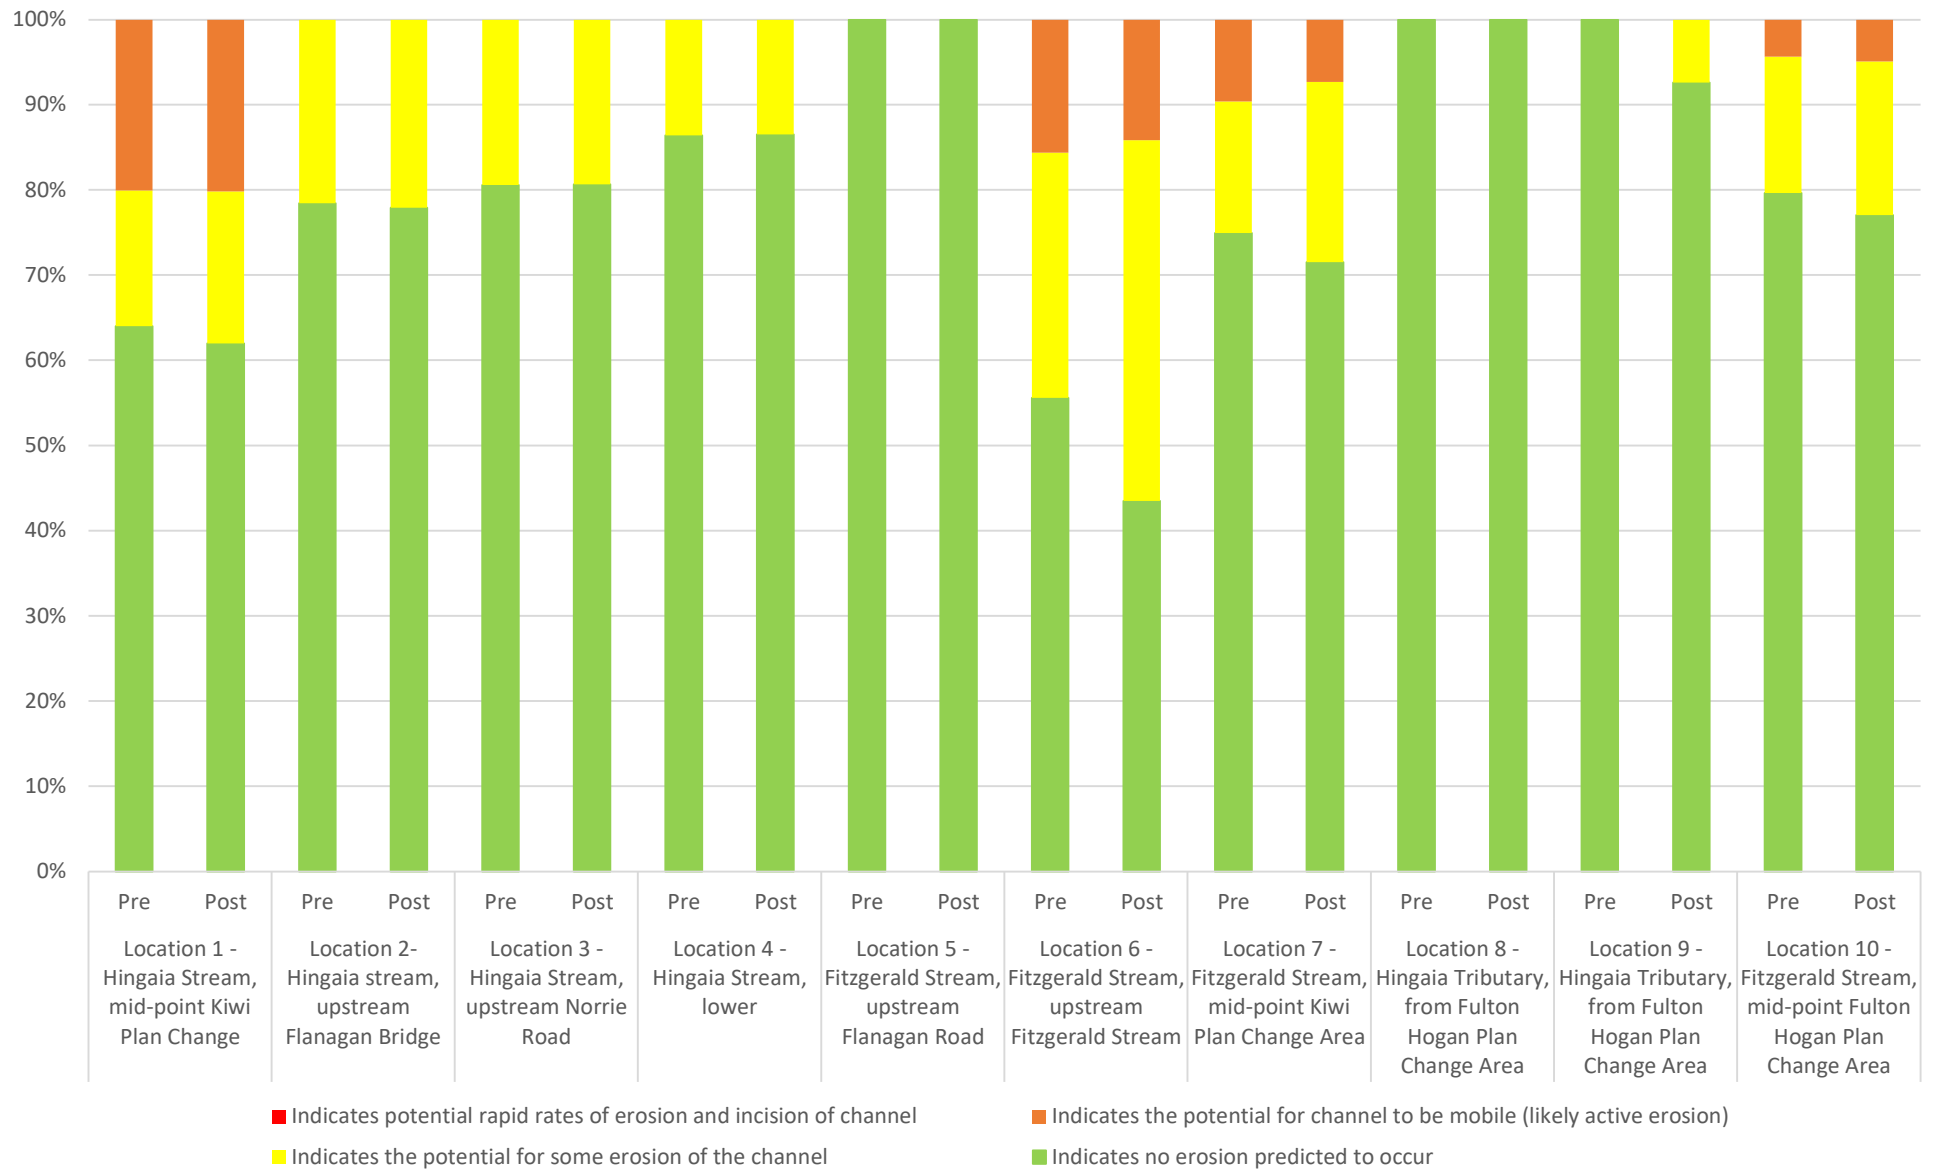
Excess shear stress in streams during 10 Year Pre and Post Development MPD CC

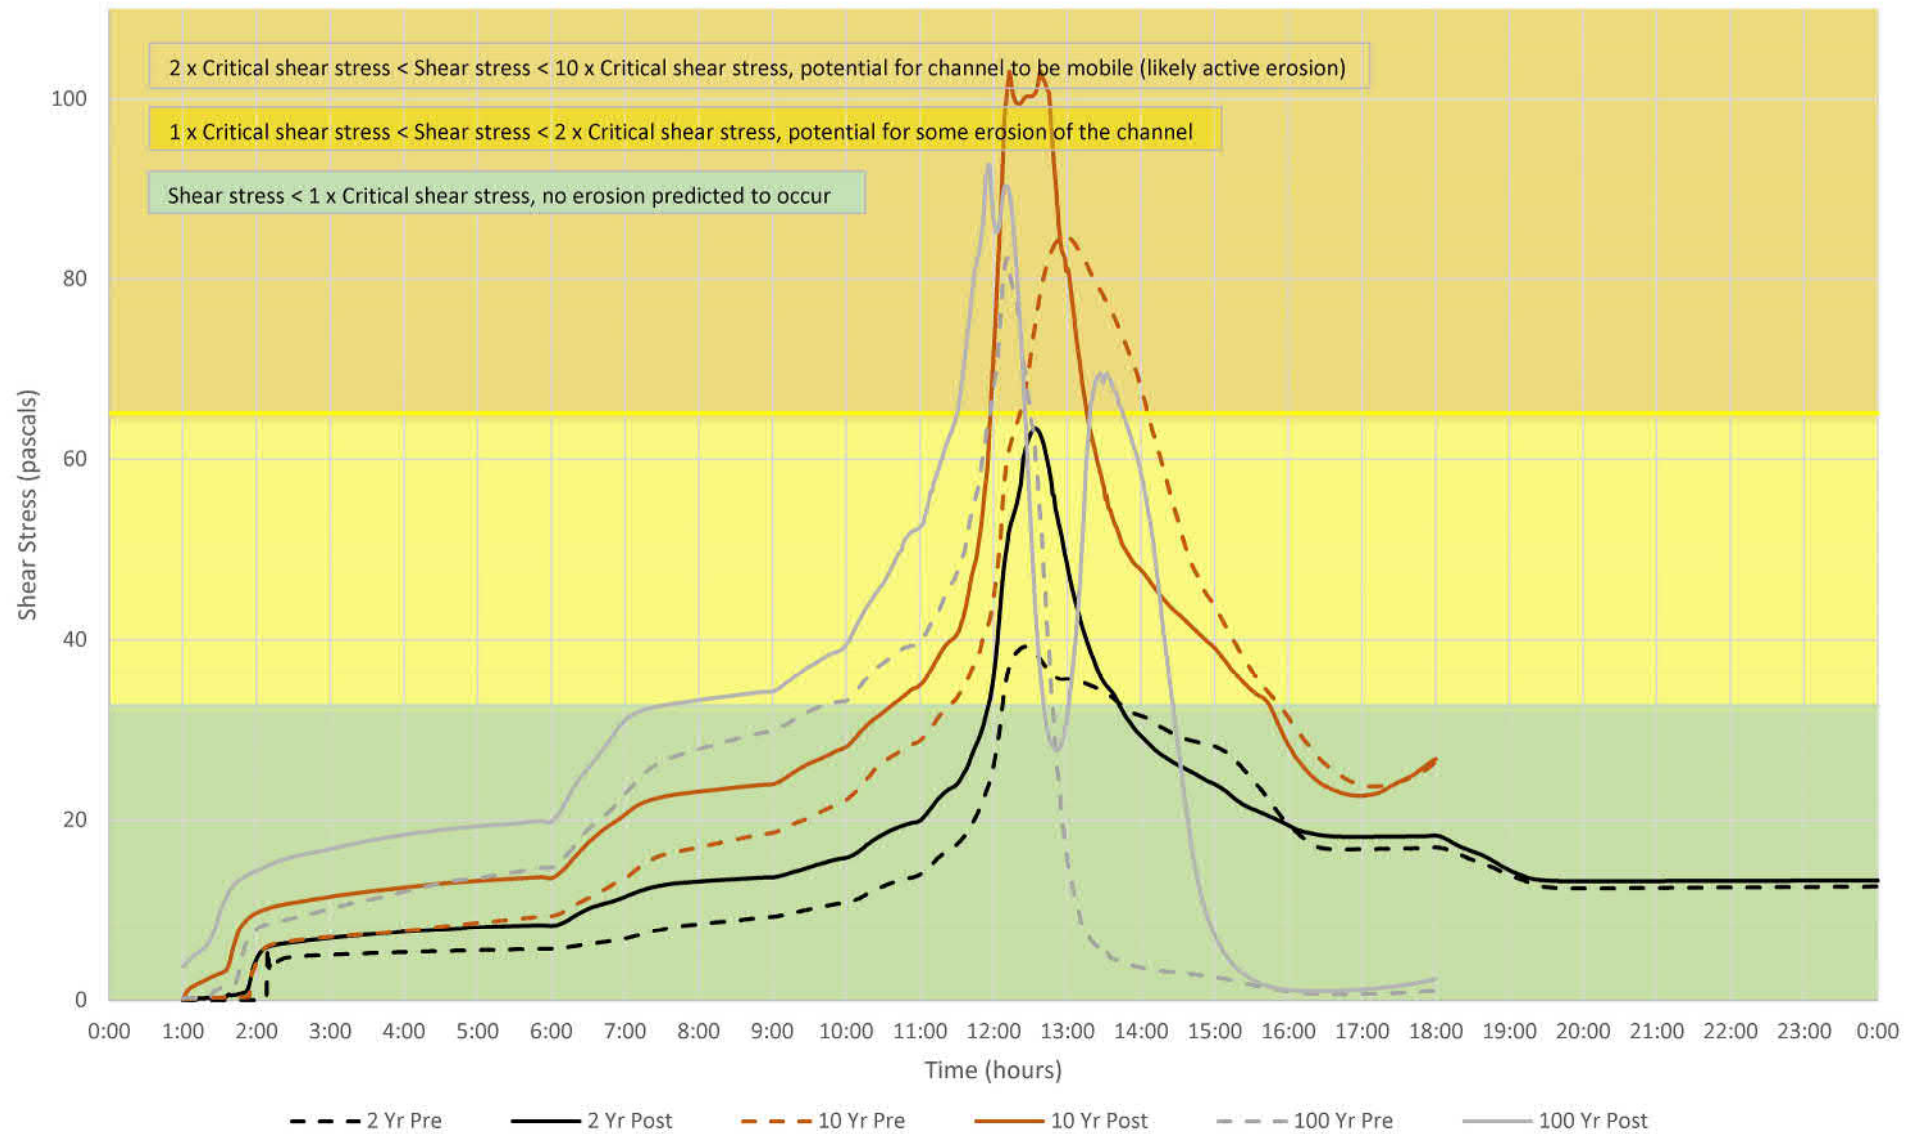
Shear Stress at Location 7 - Fitzgerald Stream, mid-point Kiwi Plan Change Area

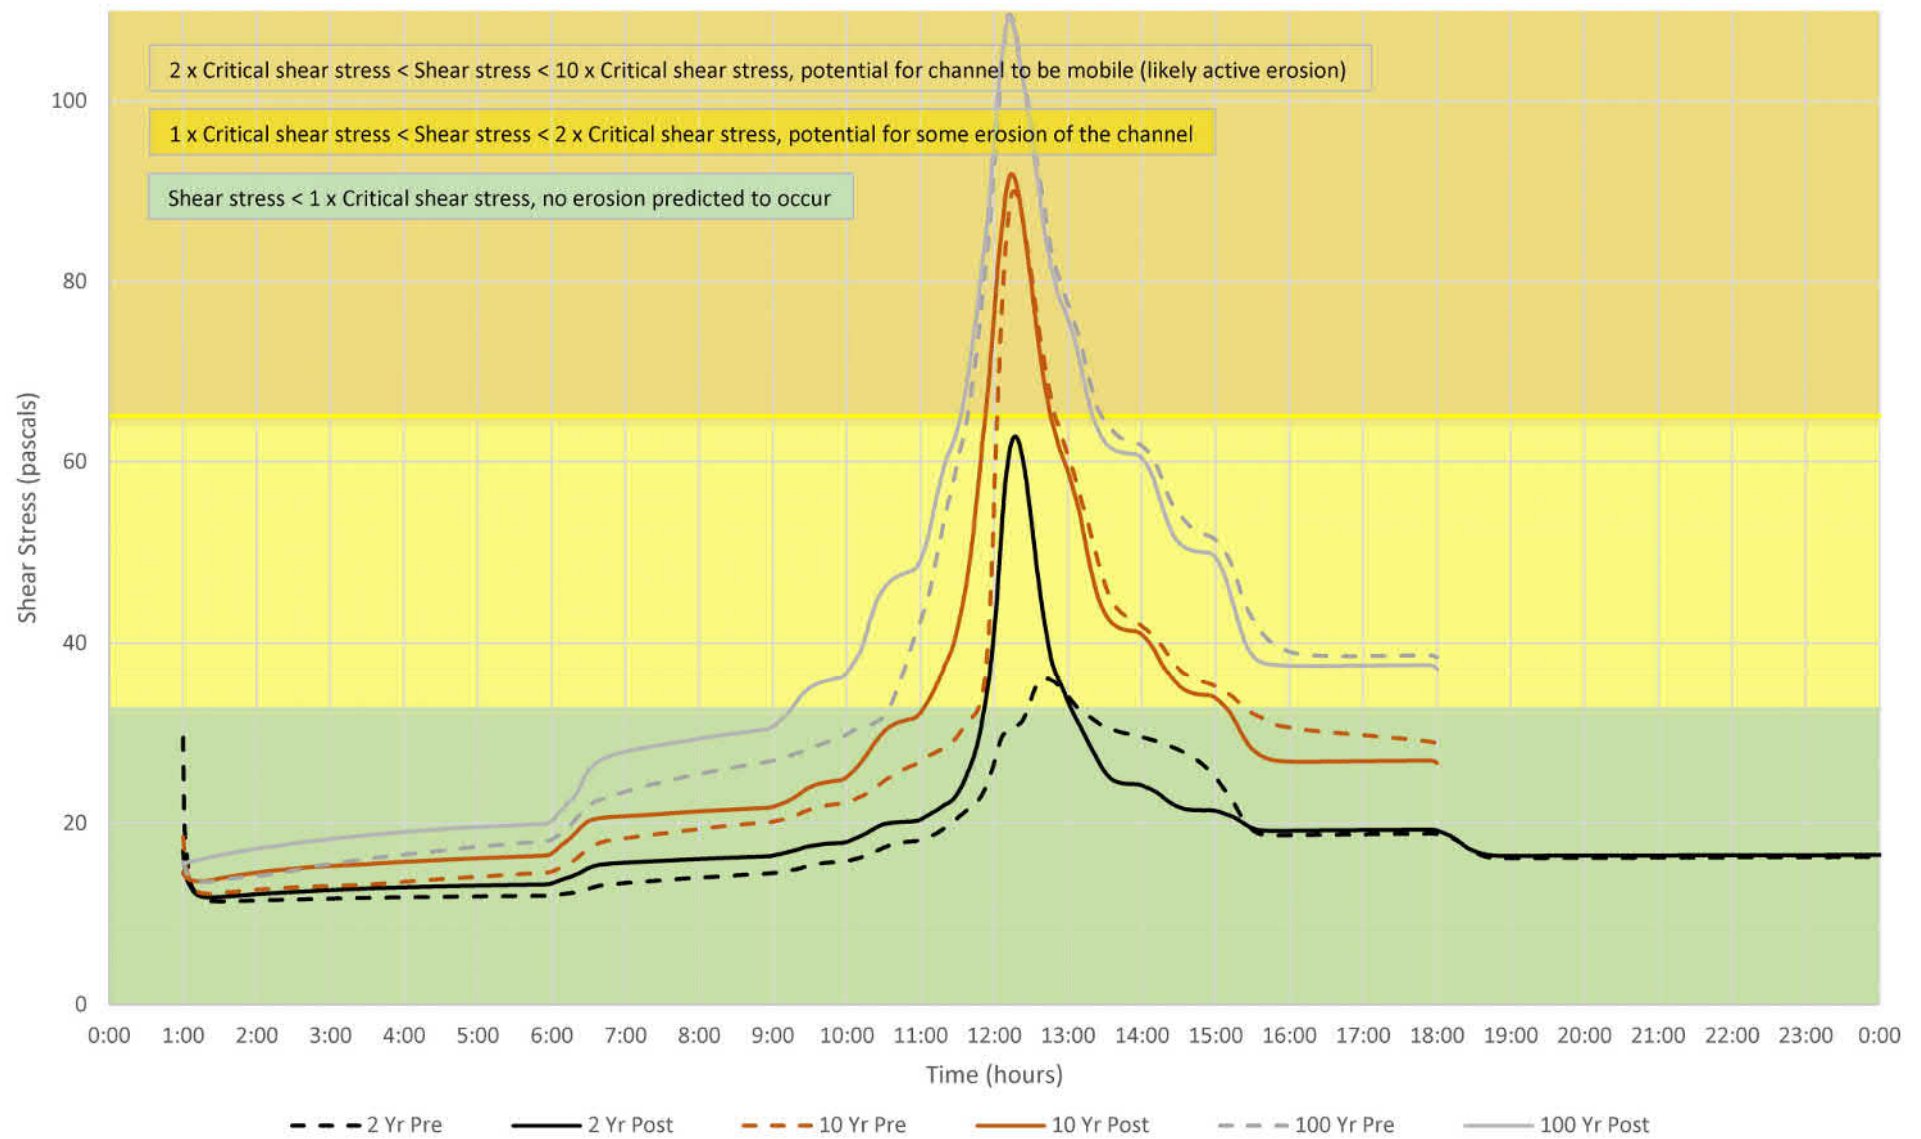
Shear Stress at Location 10 - Fitzgerald Stream, mid-point Fulton Hogan Plan Change Area
