Appendix A

Figures

Drury-Opāheke Draft Land Use Plan Map

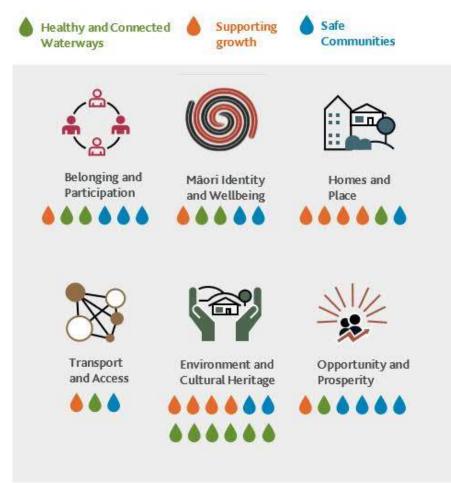
Figure 1 Auckland Plan Outcomes and Associated Alignment with Healthy and Connected Waterways

Six outcomes are identified in the Plan in which Auckland must make significant progress so that Auckland can continue to be a place where people want to live, work and visit. Stormwater management and protection of waterways are a component of each these outcomes. Refer Figure 1 below.

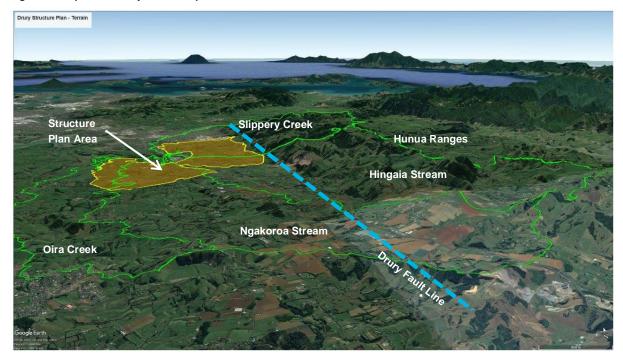
Figure 7 Opaheke-Drury structure plan area - Terrain

Although the catchments are largely within an area of low lying land, elevated landforms clearly separate each of the stream catchments. This is illustrated in Figure 7 Appendix A.

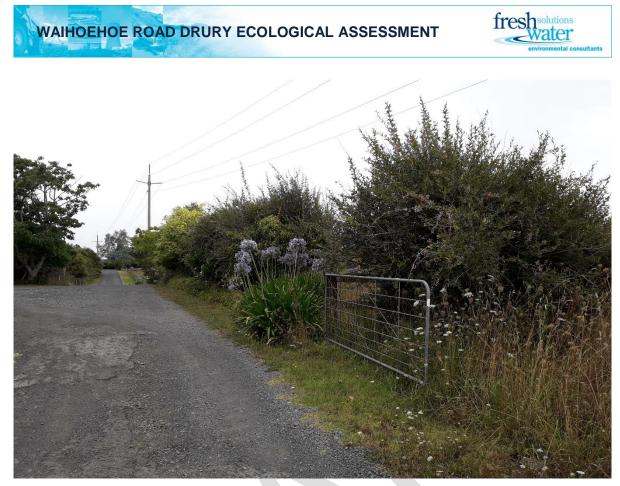
Figure 4: Typical vegetation within the site, showing hedge of barberry and tarata.

Common species observed within 116 Waihoehoe Road included exotic shelterbelts of pine (*Pinus* sp.) and bald cypress (*Taxodium distichum*), and occasionally hedges of gorse (*Ulex europaeus*), tarata (*Pittosporum eugenioides*) and barberry (*Berberis glaucocarpa*) (Figure 4). Singular specimen trees and ornamental plants included common oak (*Quercus robusta*), Norfolk pine (*Araucaria heterophylla*), macrocarpa (*Cupressus macrocarpa*), bead tree (*Melia azedarach*), Alder (*Alnus* sp.), *Magnolia* spp., fig (*Ficus carcia*), maple (*Acer sp.*), willow (*Salix* spp.), *Yucca* and fruit trees (i.e., *Malus*, *Citrus*, *Prunus* etc.) (Figure 5) Shrubs such as *Hydrangea*, *Alstroemeria*, flax (*Phormium* spp.), rose (*Rosa* spp.) and *Agapanthus* were common around dwellings and driveways. A similar collection of species are expected to be observed across the wider site.

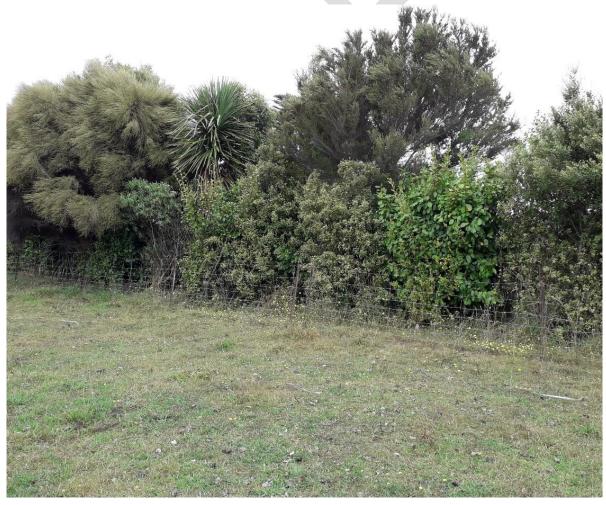
Figure 6: Native vegetation nearing pond P1.

Native planting along fence lines adjacent to Pond P1 included kāpuka (*Griselinia littoralis*), kōhūhū (*Pittosporum tenuifolium*), koromiko (*Veronica stricta* var. *stricta*), manuka (*Leptospermum scoparium*), kanuka (*Kunzea robusta*), cabbage tree (*Cordyline australis*), tarata, karo (*Pittosporum crassifolium*), flax and kowhai (*Sophora microphylla*) (Figure 6).

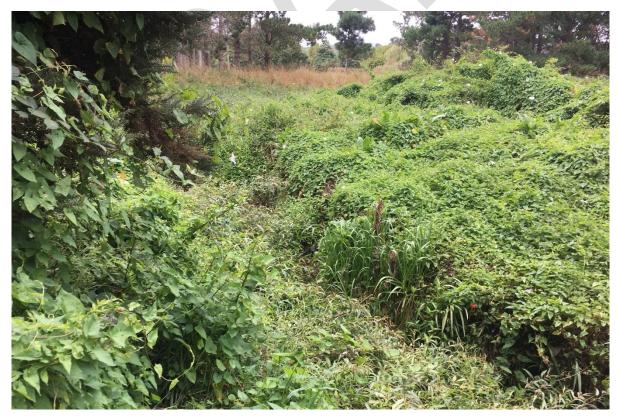
Figure 8: Riparian vegetation along the Waihoihoi Stream (February 2019).

The Waihoihoi Stream was overgrown with blackberry (*Rubus fruticosus* .agg) and great bind weed (*Calystegia silvatica* subsp. *disjuncta*) with occasional willow and arum lily (*Zantedeschia aethiopica*) (Figure 8). A hedgerow of pine was set back approximately 10 m on the true right bank.

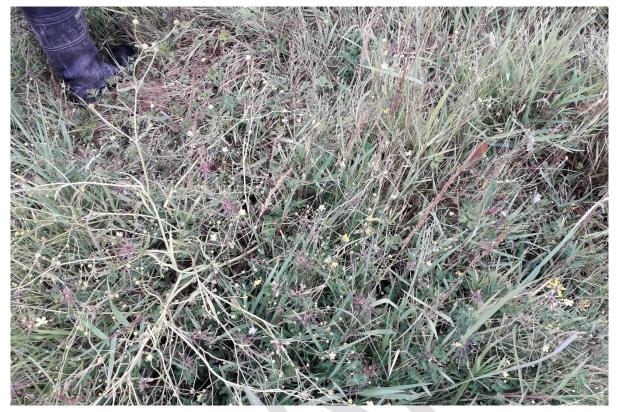
Figure 9: Typical wetland vegetation (February 2019).

Wetland areas were heavily degraded, open to stock grazing and contained minimal native values (Figure 9). Typical vegetation included exotic rushes such as sharp fruited rush (*Juncus acuminatus*), soft rush (*J. effusus var. effusus*), toad rush (*Juncus bufonius*) and numerous other flat leaved and leafless rushes. Other species included marsh bedstraw (*Galium palustre* subsp. *palustre*), mercer grass, creeping bent (*Agrostis stolonifera*), spearwort (*Ranunculus flammula*), *Isolepis* spp. water pepper (*Persicaria hydropiper* and starwort (*Callitriche stagnalis*).

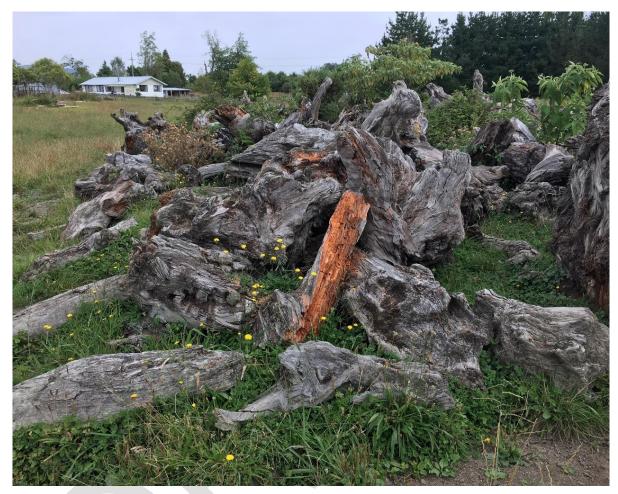
Figure 10: Large piles of woody debris suitable as lizard habitat within 116 Waihoehoe Road.

Both the native copper skink and ornate skink are adaptable ground dwelling skinks that prefer habitat such as wood and debris piles (common around dwellings), vegetated bush/shrub areas, gardens with vegetative cover and adjacent rank grass. There is a considerable amount of habitat within the site suitable for both the native copper skink and ornate skink, especially within the 116 Waihoehoe Road site, under large piles of woody debris (Figure 10). Copper skink and ornate skink can occupy areas of rank pasture when adjacent to other more suitable habitats but are unlikely to be disbursed throughout grazed pasture areas or mown lawn areas. Ornate skink are regarded as 'At Risk' (Declining) by Hitchmough et al. (2015).

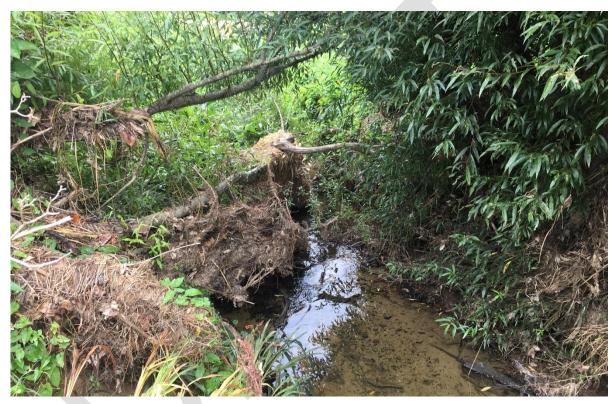
Figure 15: The Waihoihoi Stream within the site.

There is a short section of the mainstem of the Waihoihoi Stream that drains along the north-eastern boundary of the site (Figure 15). The Waihoihoi Stream is one of four main watercourses within the Slippery Creek catchment. Slippery Creek joins Hingaia Stream to form the tidal Drury Creek at the northern end of Drury Township. The Waihoihoi Stream has a naturally meandering channel with a wetted width of 1–3 m and an average depth of 0.26 m at the time of the survey (Figure 15). The channel was incised with some connection with the floodplain during baseflow conditions. The streambed substrate was dominated by silt/sand and small gravels. Woody debris was common within the channel and increased stable aquatic habitat for invertebrates and shelter for fish. Aquatic habitat comprised mainly slow flowing run and pool habitat with occasional riffles. Riparian vegetation was dominated by exotic trees and shrubs and provided some channel shade.

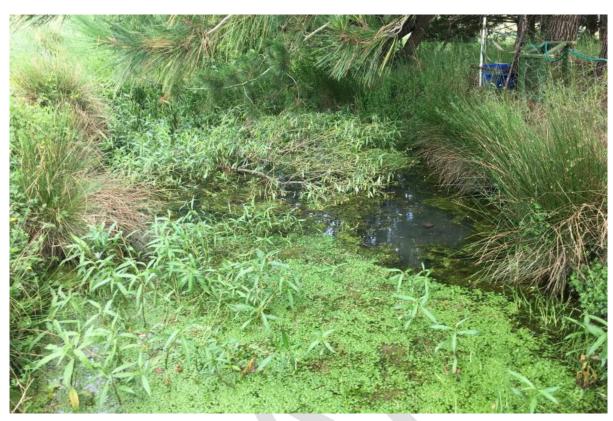
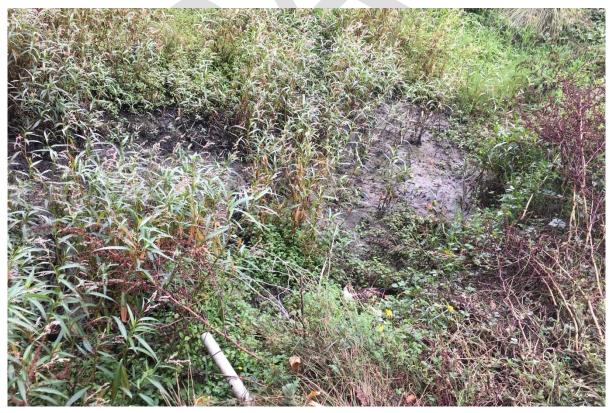
Watercourse A originates as an ephemeral flow path on 116 Waihoehoe Road and becomes an open intermittent channel surrounded by pine trees below a pipe outlet at the driveway (Figure 16 and Figure 17). The intermittent channel has been artificially widened (2–4 m) near its origin and is choked with emergent aquatic macrophytes (e.g., water pepper, starwort). The upper intermittent section held surface water (but not flowing) at the time of the 30 November 2018 survey and was dry during the 7 February 2019 survey. Watercourse A flows in a north-westerly direction onto 112 Waihoehoe Road over open grazed pasture and feeds into Watercourse I at Pond P2. Below pond P2, Watercourse A exits the site in its north western corner where it continues downstream until it drains into the mainstem of Waihoehoe Stream near Drury (~150 m upstream of Slipper Creek confluence). Watercourse A within the site provides marginal aquatic habitat of poor quality for invertebrates and fish.

Figure 16: Watercourse A within the site (November 2018).

Figure 17: Watercourse A within the site (February 2019).

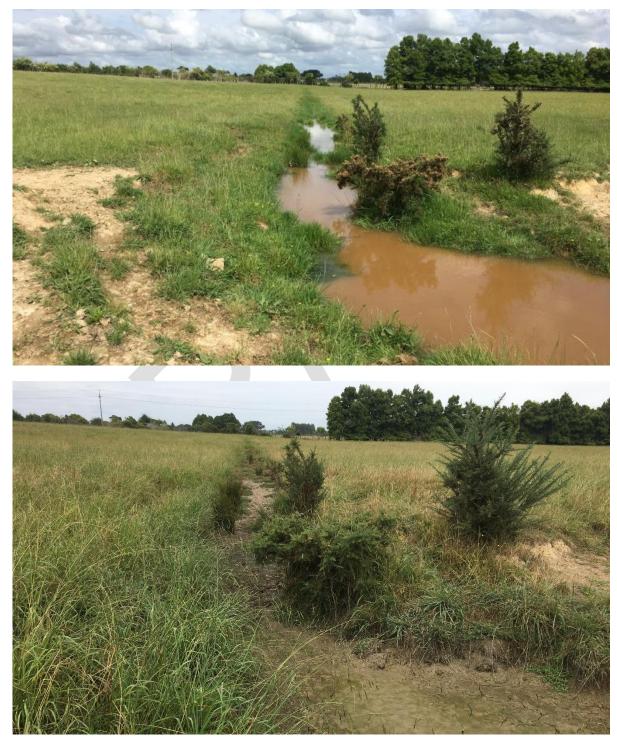
Figure 18: Watercourse D in November 2018 (top) and February 2019 (below).

Watercourses B, C, L, M and N were classified as artificial as they did not appear to be replacing natural drainage systems or appear as channels on the 1942 aerial photographs. Watercourse L in particular appears to have been dug recently (between 2015/16 and 2017 based on aerial imagery; Auckland Council Geomaps). Watercourse D was a straight aligned artificial channel and held water in November but was dry in February (Figure 18).

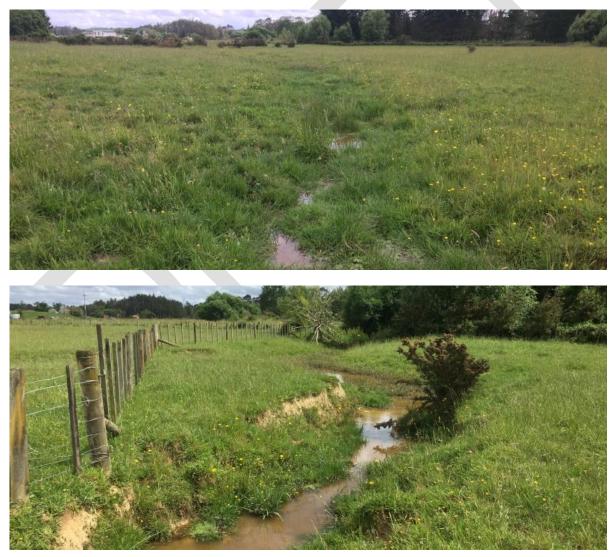
Figure 19: Intermittent sections of Watercourse E (upper and lower sections).

Watercourse E originates in a shallow but natural depression in a grazed paddock as an ephemeral flow path. The ephemeral section transitions into an intermittent section that held a small amount of surface water in November 2018 but was dry in February 2019. The upper intermittent section has a wide and poorly defined channel affected by grazing pressure. The channel was choked with grasses (including mercer grass and creeping bent) and supported emergent macrophytes including water pepper and starwort in November 2018. This natural upper section discharges to a highly channelised mid-lower section that flows along a fence-line and a narrow strip of gorse before discharging into the mainstem of the Waihoihoi Stream (Figure 19). Watercourse E represents a highly modified environment and provides marginal aquatic habitat of poor quality.

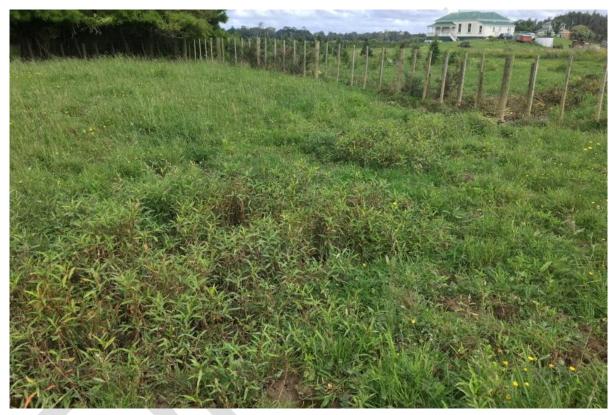
Figure 20: Lower Watercourse F within the site (February 2019).

Watercourse F (Figure 20) is an intermittent stream that drains a natural shallow depression in a flat grazed paddock. The upper reach is fed by ephemeral flow paths including one that appeared t be joined with Watercourse D. The channel is grazing damaged, poorly defined, choked with pasture grasses and lacks riparian vegetation. The channel held a small amount of surface water during the November 2018 survey but was dry in February 2019. Aquatic macrophytes recorded during the November 2018 survey included water pepper and starwort. Watercourse F is highly modified intermittent stream that provides poor quality aquatic habitat in its current state.

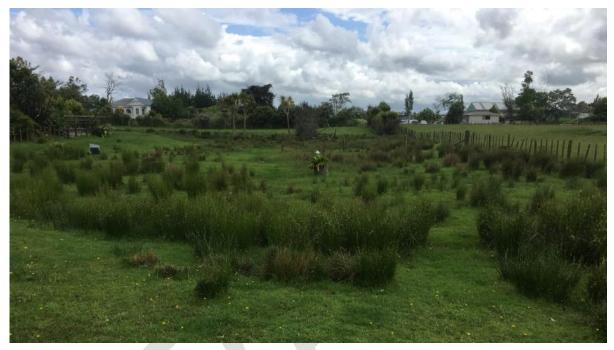
Figure 21: Wetland W1 during November 2018 survey.

Wetland W1 and W2 are severely damaged through unrestricted grazing pressure and are typically lined with exotic grasses (mercer grass, *Paspalum distichum*), rushes and sedges (i.e., *Juncus* and *Isolepis*) and macrophytes such as water pepper and starwort in wetter seasons. These wetland habitats are wide, waterlogged (in winter) and lack natural defined stream channels. These wetland habitats are unlikely to support native fish due to inadequate surface water depths but may support invertebrates tolerant of degraded conditions during periods when they hold surface water.

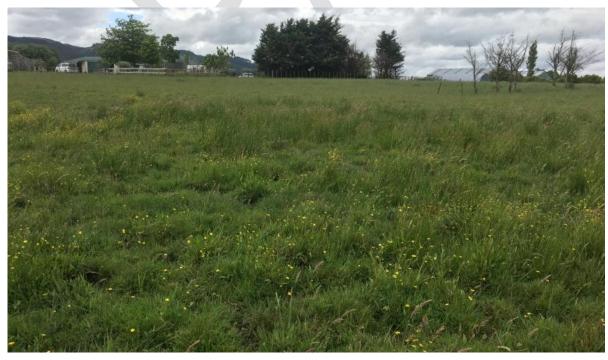
Figure 22: Wetland W2 during November 2018 survey.

The site contains two wetlands (W1 and W2). Wetland W1 is associated with the online Pond P1 (Figure 21). The boundary of wetland W2 was difficult to determine and was based on the presence of facultative and obligate wetland plant species (Figure 22). Rainfall in the week prior to the November 2018 survey may have resulted in wetland W2 holding more water than what would be expected. Wetland W2 did not hold surface water during the February 2019 survey and indicates it dries out after prolonged dry periods.

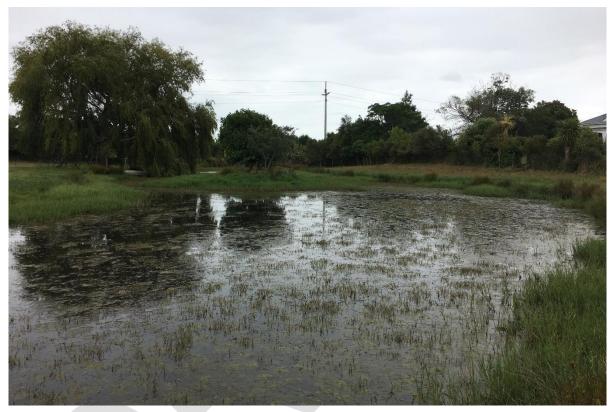
Figure 23: Online Pond P1.

Three artificial ponds were identified through a combination of reviewing aerial photography and site surveys. All ponds were online ponds and most were in the mid-upper reaches of intermittent tributaries. The largest pond occurs in the upper section of Watercourse H (Figure 23). Ponds are likely to be drained via perched culverts or structures that may be barriers to upstream fish passage. Artificial ponds within the site provided poor quality still water habitat and are likely to be adversely affecting downstream water physicochemistry.

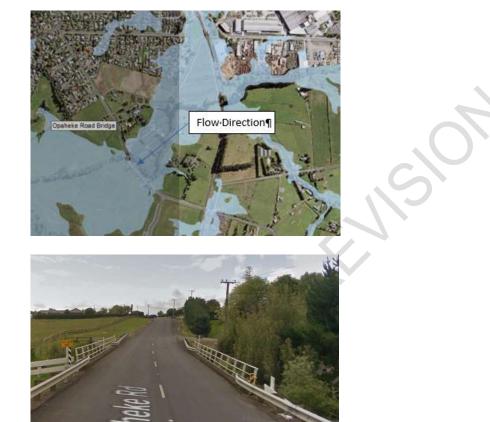
2.4 Opaheke Road Bridge

Drawing of bridge				
	P	20.7m	-	
	Inside face of		Inside face of	Centreline of road
	bridge abutment	Bridge soffit	bridge abutment	
	La			
		Water level 6.26m	5.9m	
	1			
Issue	The lack for flow	capacity through the undersized	1 hridae waterway c	ontributes to overtanning of
13500		1 3 0		11 0
10000	Opaheke Road s	south of the bridge, contributes to		11 0
Bau	Opaheke Road s development yie	south of the bridge, contributes to	o upstream floodpla	in extents potentially limiting
	Opaheke Road s development yie Bridge deck leve	south of the bridge, contributes to eld. el is 11.8mRL. Adjacent road ove	o upstream floodpla	in extents potentially limiting
	Opaheke Road s development yie Bridge deck leve 100 year ARI MF	south of the bridge, contributes to eld. el is 11.8mRL. Adjacent road ove PD CC level is 11.77mRL.	o upstream floodpla	in extents potentially limiting
	Opaheke Road s development yie Bridge deck leve 100 year ARI MF 100 year ARI MF	south of the bridge, contributes to eld. el is 11.8mRL. Adjacent road ove PD CC level is 11.77mRL. PD level is 11.6mRL	o upstream floodpla	in extents potentially limiting

Opaheke Road s development yie Bridge deck leve 100 year ARI MF 100 year ARI MF 100 year ARI MPI	south of the bridge, contributes to eld. PI is 11.8mRL. Adjacent road ove PD CC level is 11.77mRL. PD level is 11.6mRL D level is 11.06mRL	o upstream floodpla ertopping level is 11	in extents potentially limiting .3mRL
Overtopping	Opaheke Road s development yie Bridge deck leve 100 year ARI MF 100 year ARI MF 100 year ARI MPI Modelling indica	south of the bridge, contributes to eld. PI is 11.8mRL. Adjacent road ove PD CC level is 11.77mRL. PD level is 11.6mRL D level is 11.06mRL	o upstream floodpla ertopping level is 11 e bridge will overtop	in extents potentially limiting .3mRL by 0.43m during a 100 year ARI
	Opaheke Road s development yie Bridge deck leve 100 year ARI MF 100 year ARI MF 10 year ARI MPI Modelling indica MPD CC event.	south of the bridge, contributes to eld. PD CC level is 11.77mRL. PD CC level is 11.77mRL. PD level is 11.6mRL D level is 11.06mRL ites that the approach road to the	o upstream floodpla ertopping level is 11 e bridge will overtop f climate change ar	in extents potentially limiting .3mRL by 0.43m during a 100 year ARI

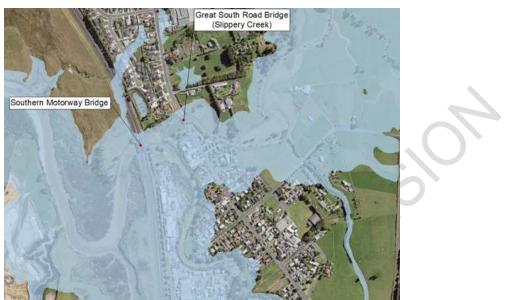
Drawing of bridge	-		27.0m	_
	Inside face of	Bridge soffit -	Water level (high tide) 1.95m Water level (low tide) 1.26m	- Inside face of bridge abutment
	48m 38m	Bridge pier	Bridge pier	
Issue	 The lack for and approact 		he undersized bridge wate	rway contributes to overtopping of the bridge
	of Miro Stree Slippery Cre commercial Bridge deck 100 year AR 100 year AR	et as there is a low poin ek channel in the vicini properties on the other	at there. A significant storm ty of Miro Street, overtoppi side of Great South Road. cent road overtopping level mRL. L	channel upstream of the bridge in the vicinity event in 1989 resulted in flow leaving the ing Great South Road and going through two This is borne out in the modelling results. is 5.8mRL
Overtopping	includes the level rise of • The approac	effects of climate chan 1m.	ge and a Mean High Wate nan the bridge deck, thus th	100 year ARI MPD CC event. This event r Springs (MHWS) tidal boundary with sea ne depth of flow over the road is predicted to

Flood Hazard Assessment	Significant (as	defined in AC Flood Mo	odelling Spec) with flood de	epth over road equal to 0.3m
100 year ARI MPD CC flow to bridge (with FUZ)	allowable impe		urban area allowed under t	one (FUZ), climate change, maximum the Unitary Plan and 10% imperviousness of
100 year ARI MPD CC flow to bridge (without FUZ)		erviousness for the rem		existing urban area allowed under the Unitary g the FUZ) draining to the structure and

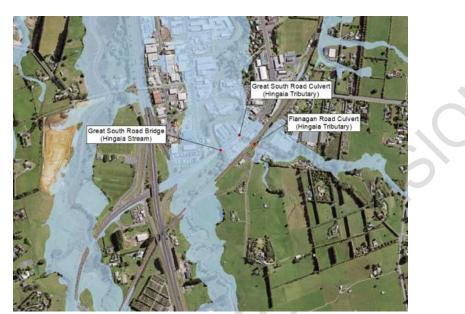
2.8 2100mm Arch culvert spanning Flanagan Road and the downstream railway line (52.2m long culvert)

Drawing of culvert	2.2m high 1.0m 2.4m wide
Issue	 The lack of flow capacity through the undersized culvert contributes to overtopping of Flanagan Road plus potentially limiting development yield due to flooding. Drury Creek (with a huge contributing catchment area of over 200sq km) is a flow constraint which contributes to floodplain extents (upstream of Flanagan Rd) potentially limiting development yield
	 Flanagan Road level is 7mRL 100 year ARI MPD CC level is 8.71mRL 100 year ARI MPD level is 8.021mRL
Overtopping	• Flanagan Road is predicted to overtop by 1.7m in the future 100 year ARI MPD CC event. This event includes the effects of climate change and a Mean High Water Springs (MHWS) tidal boundary with sea level rise of 1m.
	 Depth of flow over Flanagan Road in a 100-year ARI MPD event without climate change and sea level rise is predicted to be 1m.
	 Flanagan Road is overtopped but the railway is not overtopped as it is at a higher elevation (9.876mRL versus 7mRL).

Flood Hazard	 Significant (as defined in AC Flood Modelling Spec) with flood depth over road > 0.3m
Assessment	 Maximum Flow velocity (in the stream) in 100-year ARI MPD CC event is 3.6 m/s

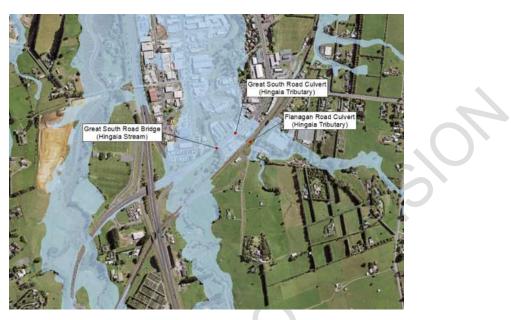
2.9 Great South Road 2100mm dia Culvert

Drawing of culvert	
Issue	• The lack of flow capacity through the undersized culvert contributes to overtopping of Great South Road during a 100-year ARI MPD CC event.
	 Drury Creek (with a huge contributing catchment area of over 200sq km) is a flow constraint which contributes to floodplain extents (upstream of Flanagan Rd) potentially limiting development yield
	 Level of Great South Road – 7mRL (approx.)
	 100 year ARI MPD CC level is 8.263mRL
	 100 year ARI MPD level is 7.729mRL
Overtopping	 Great South Road is predicted to overtop by 1.2m in the future 100 year ARI MPD CC event. This event includes the effects of climate change and a Mean High Water Springs (MHWS) tidal boundary with sea leve rise of 1m.
	 Depth of flow over Great South Road in the 100 year ARI MPD event without climate change and sea level rise is predicted to be 0.7m
	 Yes – levels currently being re-assessed
Flood Hazard Assessment	 Significant (as defined in AC Flood Modelling Spec) with flood depth over road > 0.3m

100 year ARI MPD CC flow to culvert (with FUZ)	16.5m³/s (flow based on 70% imperviousness of FUZ, full development of Drury South Precinct (with associated proposed mitigation measures and Mill Road) and 10% imperviousness of upstream rural zoned land.
100 year ARI MPD CC flow to culvert (without FUZ)	16.5m ³ /s flow based on full development Drury South Precinct (with associated proposed mitigation measures and Mill Road), climate change and 10% imperviousness for the catchment draining to the culvert.
100 year ARI MPD flow to culvert (without FUZ)	16m³/s (flow based on full development of Drury South Precinct (with associated proposed mitigation measures and Mill Road), no climate change and 10% imperviousness for the catchment draining to the culvert.
Conveyance capacity of culvert	12m ³ /s (is the free full capacity if there was no downstream constriction)
Conveyance capacity of channel

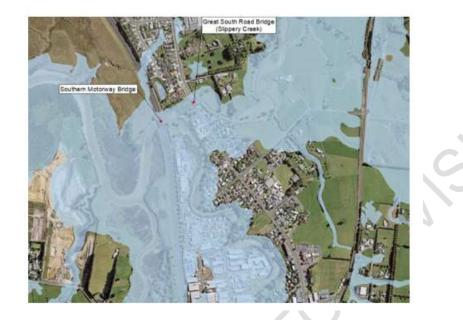
2.11 Motorway South of Motorway Bridge

Modelling indicates that the motorway south of the motorway bridge will be overtopped (by water from Ngakoroa and Hingaia Streams) during a 100-year ARI MPD with CC event. The flooding will extend for approximately 900m in length between the Motorway bridge and Great South Road intersection and last for approximately 100min. The maximum depth of water will be approximately 1.2m.

• Bund motorway to prevent flow from Hingaia and Ngakoroa overtopping the alignment
Options modelled,	 Flanagan Road bridge was widened/removed from the model. This had minimal effect on water levels in the vicinity of the SH1 bridge
results and	Both Flanagan Road bridge and Great South Road bridge were widened/removed from the model. This had

comment	 minimal effect on water levels in the vicinity of the SH1 bridge. Flanagan Road bridge, Great South Road bridge and Norrie Road bridge were widened/removed from the model. This had minimal effect on water levels in the vicinity of the SH1 bridge.
Constraints	Works on a motorway have significant health and safety and cost implications.
	Works required in a watercourse adding diversion, erosion and consenting complexity. Safety in Design issues – construction within a watercourse and floodplain
Comments	Provide signage indicating that road is flood prone during extreme storm events. SMP to recommend that Emergency Management Plan be prepared for Structure Plan Area. The purpose of the Plan is to identify flood prone structures
Adopted option

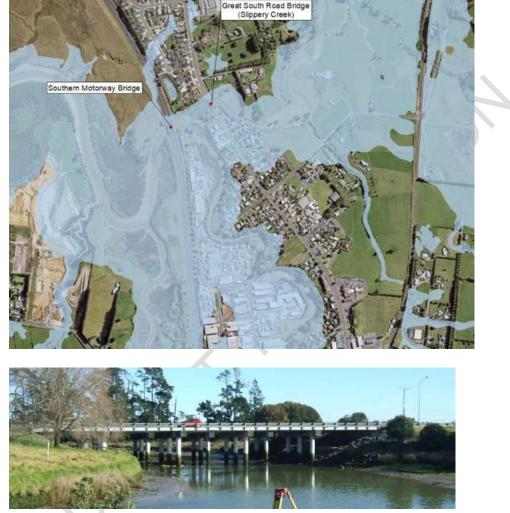
2.12 Southern Motorway Bridge

100 year ARI MPD CC level is 5.86mRL 100 year ARI MPD level is 5.5mRL
Overtopping	Currently being assessed.
Flood Hazard Assessment	
100-year ARI MPD CC flow to bridge (with FUZ)	527m ³ /s - flow based on 70% imperviousness of the FUZ, full development of Drury South Precinct (with associated proposed mitigation measures and Mill Road), climate change, full development allowed under the Unitary Plan and 10% imperviousness of rural zoned land.
100-year ARI MPD CC flow to bridge (without FUZ)	527m ³ /s - flow based on 10% imperviousness of the FUZ, full development of Drury South Precinct (with associated proposed mitigation measures and Mill Road), climate change, full development allowed under the Unitary Plan and 10% imperviousness of rural zoned land.
100-year ARI MPD flow to bridge (without FUZ)	467m ³ /s flow based on 10% imperviousness of the FUZ, full development of Drury South Precinct (with associated proposed mitigation measures and Mill Road), no climate change, full development as allowed under the Unitary Plan and 10% imperviousness for rural zoned land.

Conveyance capacity of bridge	650m ³ /s (is the free full capacity if there was no downstream constriction. However, the high water levels in the downstream Drury Creek are a significant flow constraint))
Conveyance capacity of channel	
Headloss across structure	
Criticality	Critical
Meeting Level of Service	
Freeboard	 NZTA Bridge manual specifies a freeboard of 0.6m between the 100 year ARI event and the underside of the superstructure. Where the possibility exists that large trees may be carried down the waterway then the freeboard requirement increases to 1.2m.

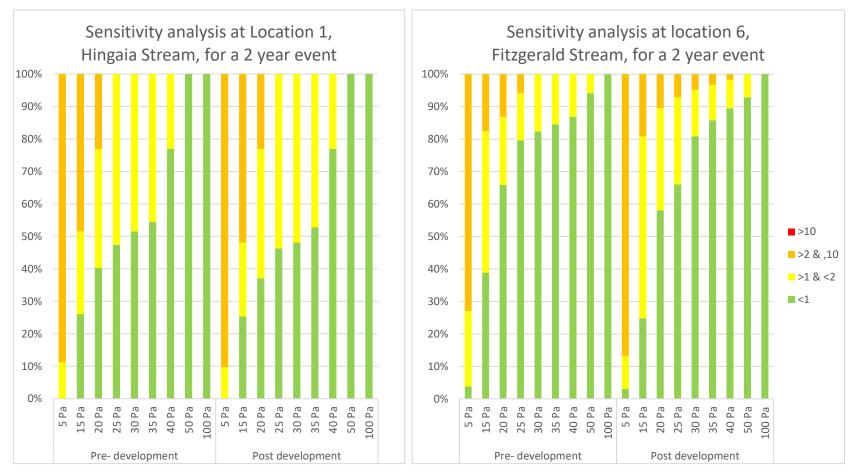
Figure 2a and b - Sensitivity analysis for excess shear stress at Location 1, Hingaia stream and Location 6, Fitzgerald Stream for a 2 year event

The critical shear stress of the stream is very site specific and dependent on factors including underlying geological features, substrate types, channel conditions such as the degree of weathering and the channel shape, and the conditions along the stream banks, such as vegetation. All of these variables change spatially along and across the stream channel. A sensitivity analysis was done at two locations to assess the suitability of estimating the critical shear stress from region wide testing due to the lack of site-specific testing. Figure 2 analyses the estimated erodibility potential at two locations (Location 1 at the mid-point along the Hingaia Stream of the Kiwi Property Plan Change Area and Location 6 along Fitzgerald Stream) for the 2 year event for a range of critical shear stresses between 5 Pa and 100 Pa. These both show a significant change in erosion potential depending on the critical shear stress.

However, Table 7 summarises the percentage increase in duration with an excess shear of more than 1 (which indicates that no erosion is expected to occur during that timestep).

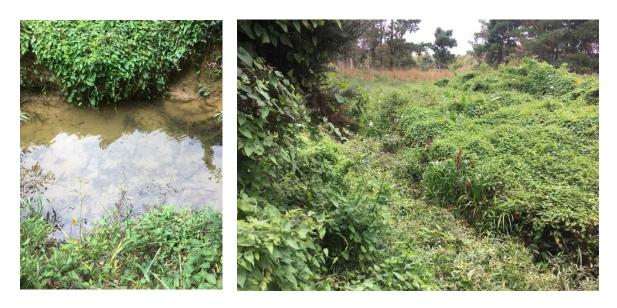
Photograph 1.2: Lack of riparian margins and bank instability along Waihoihoi Stream.
