Ref No: J01132 (Rev. 1)

Karaka & Drury Limited

RE: Preliminary Geotechnical Appraisal Report for Auranga B2 Re-zoning Concept, Drury

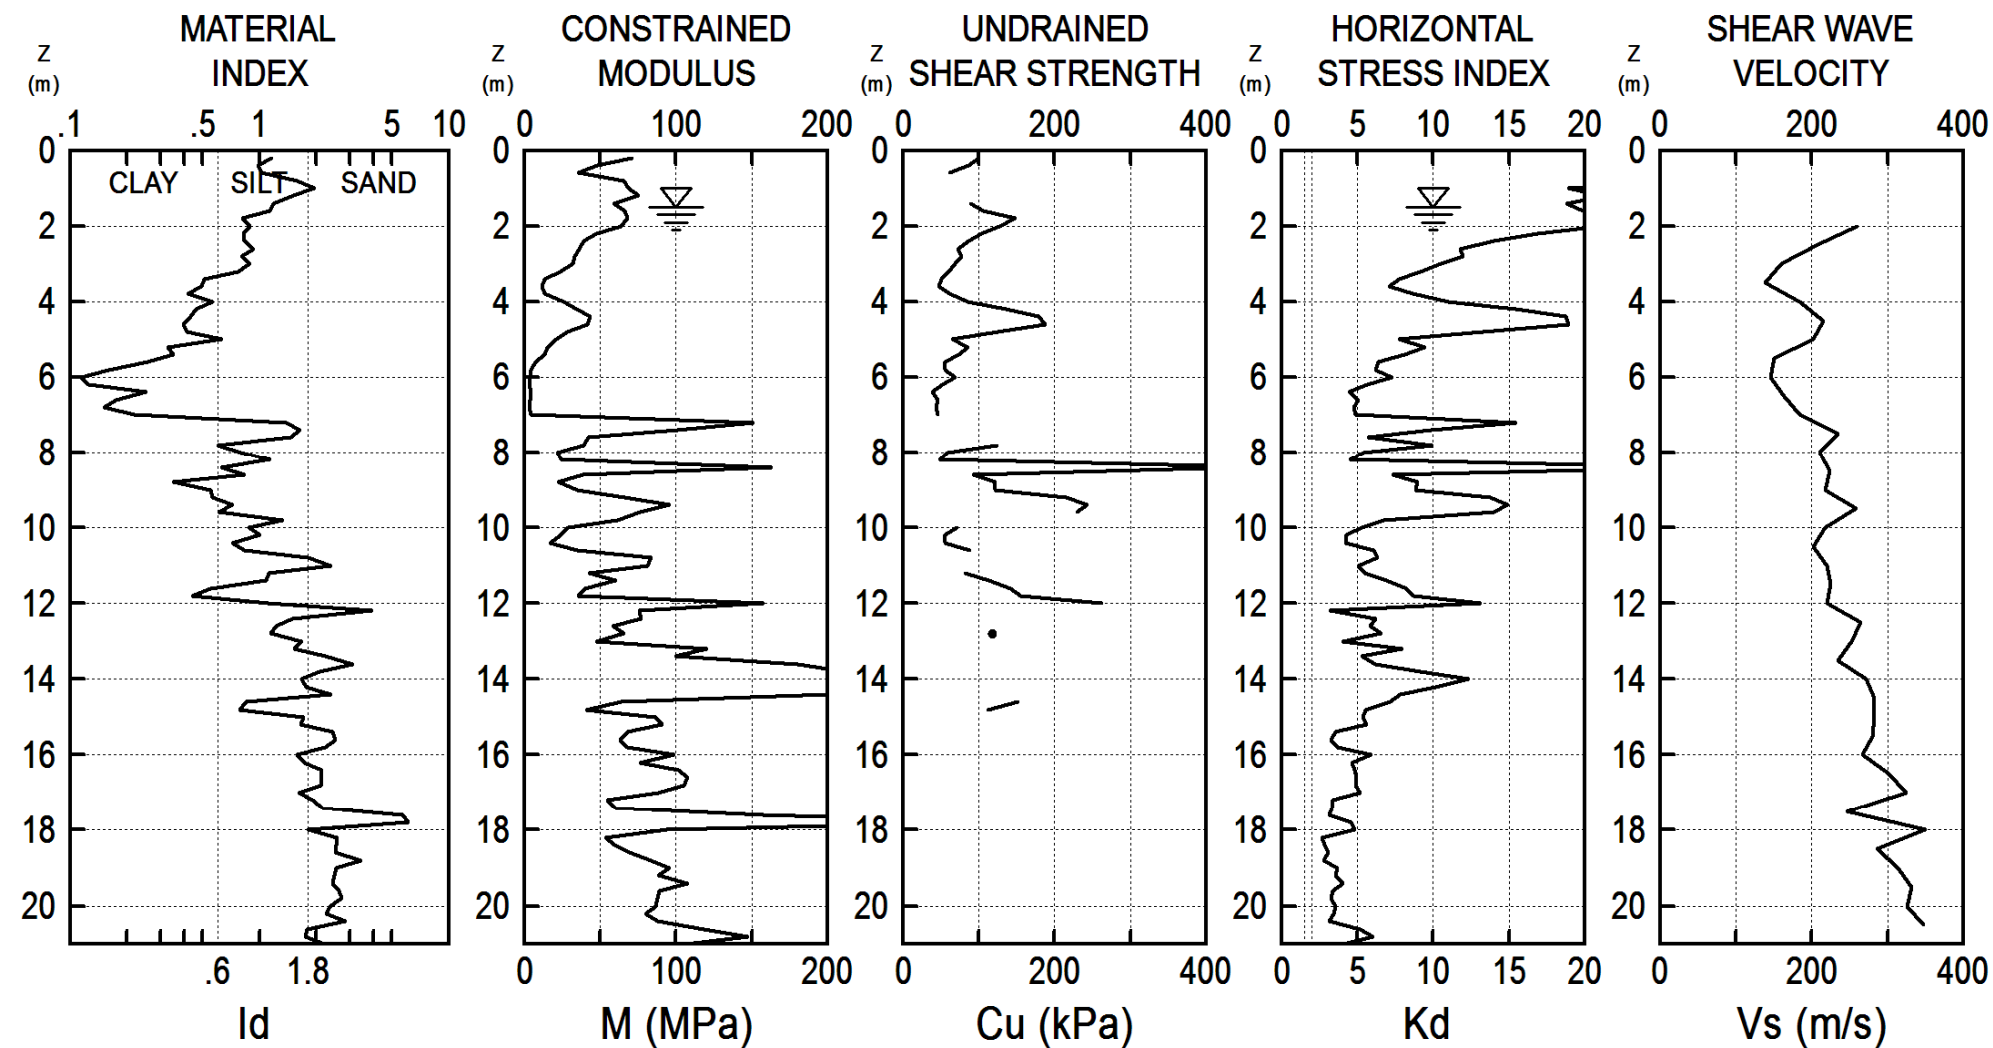
TEST
SDMT-01
28 JAN 2016

Lander Geotechnical
31 Burberry Rd

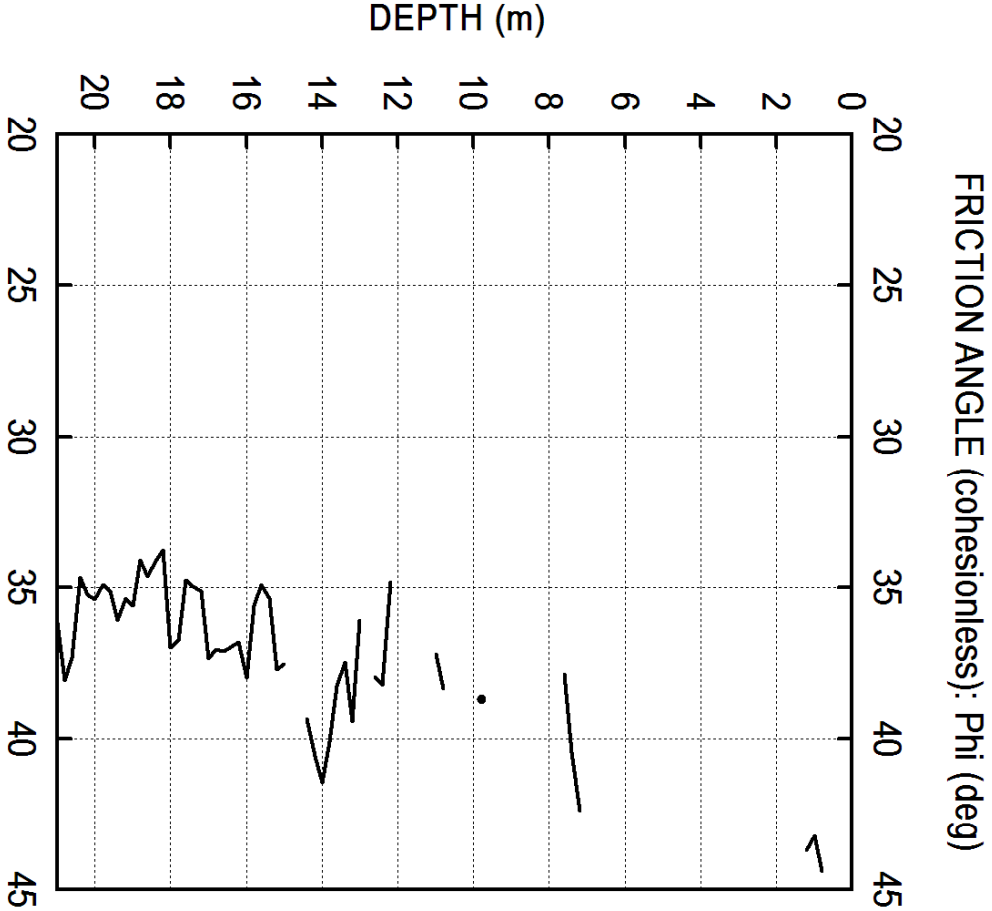
DILATOMETER TEST (D M T)

| INTERPRETED GEOTECHNICAL PARAMETERS | | 28 JAN 2016 |

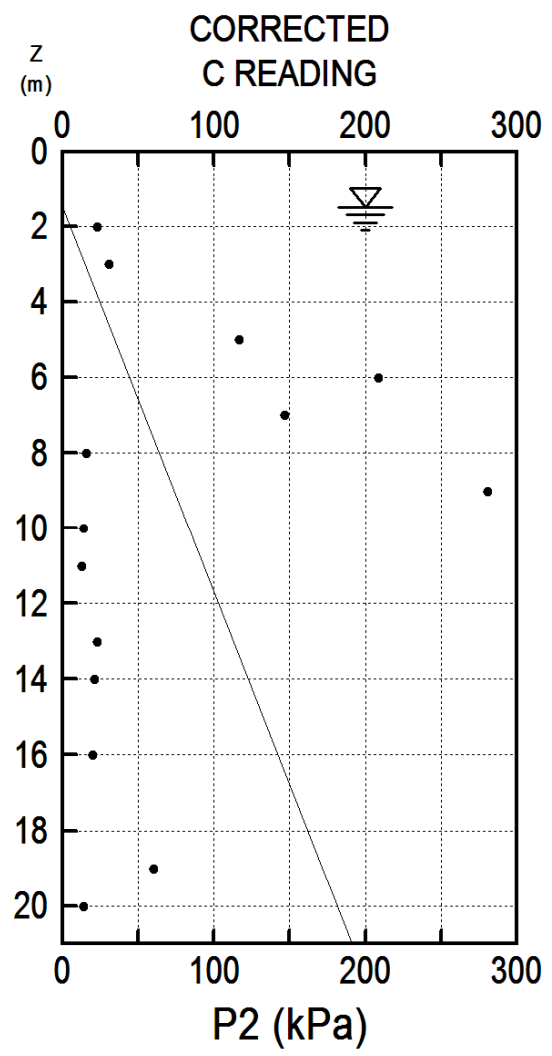
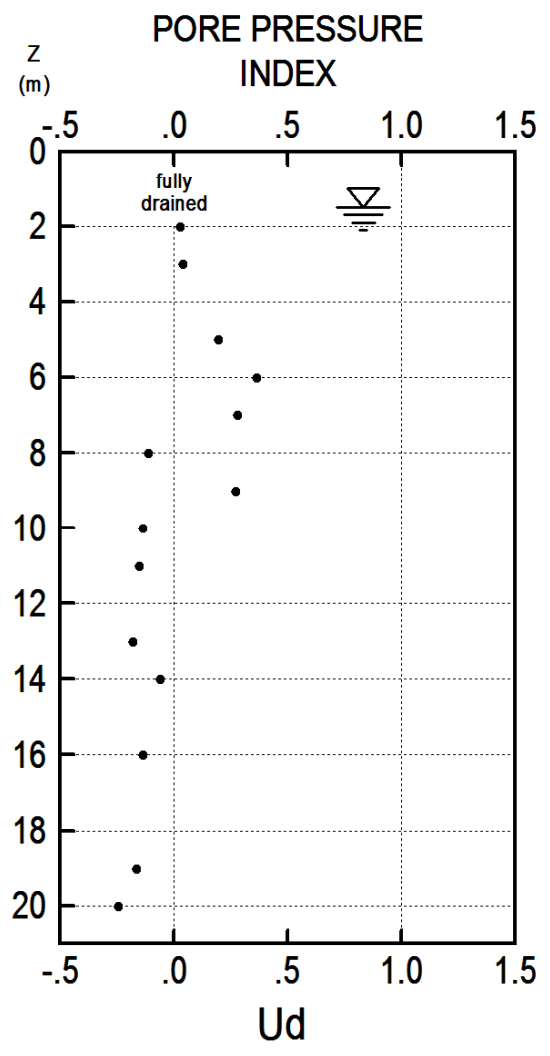
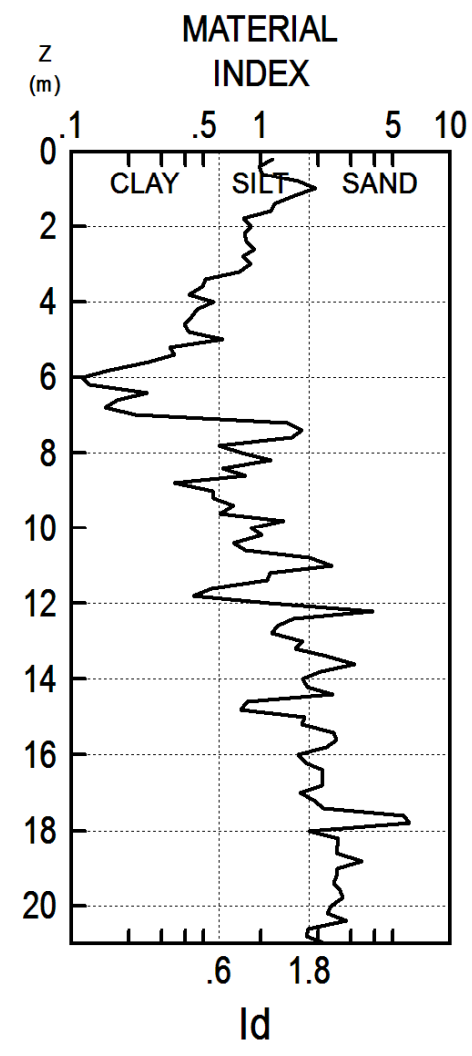
| TEST SDMT-01 28 JAN 2016 | |

| INTERPRETED GEOTECHNICAL PARAMETERS | |

| SDMT-01 | | LEGEND | INTERPRETED PARAMETERS | GENERAL PARAMETERS |

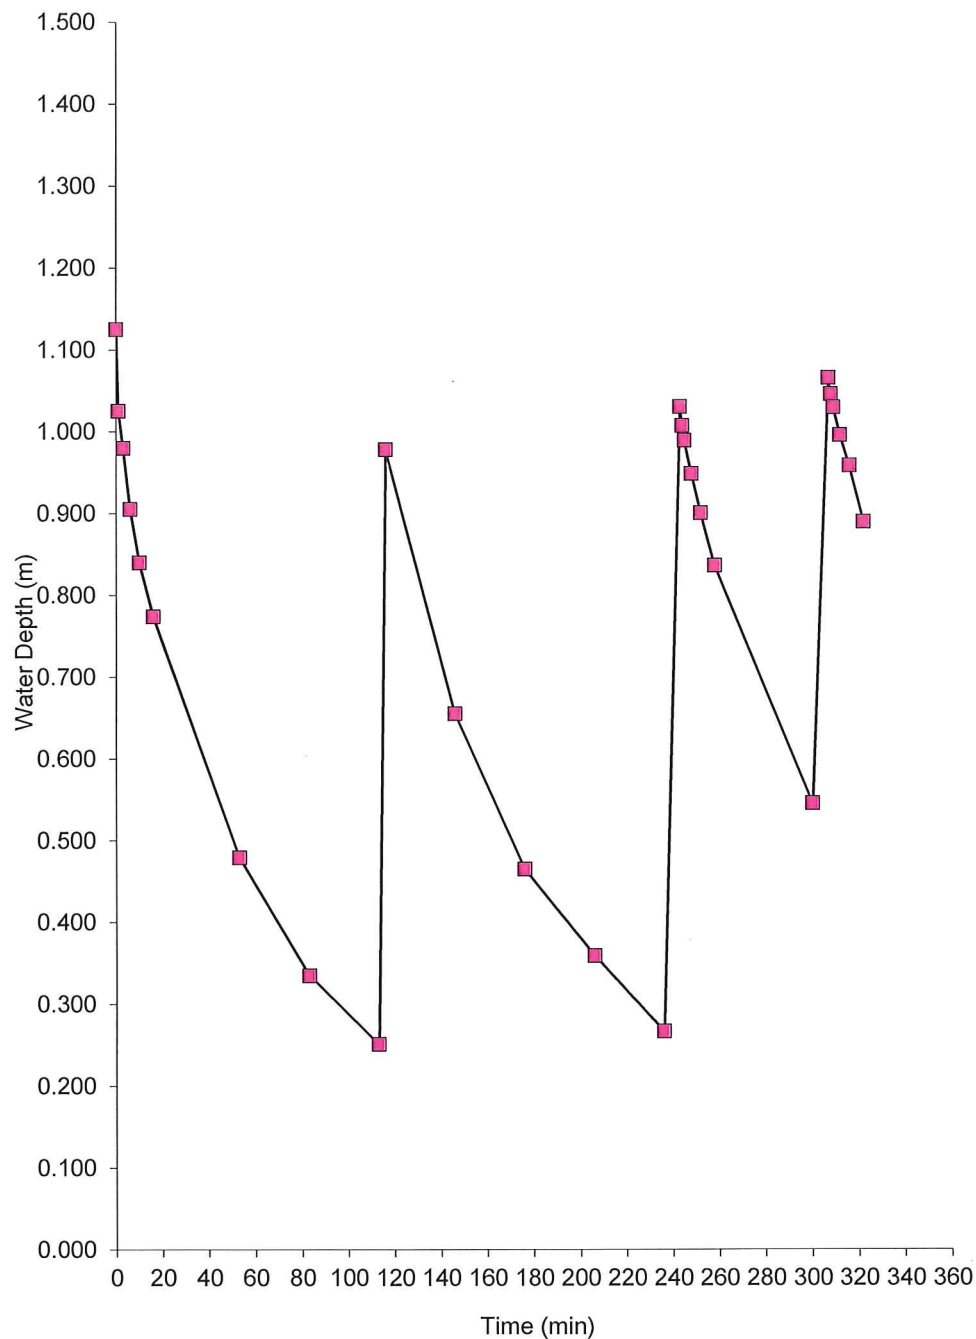
Water Depth vs Time

| Location: | Refer to Site Plan | Depth: | 1.19 (m) |

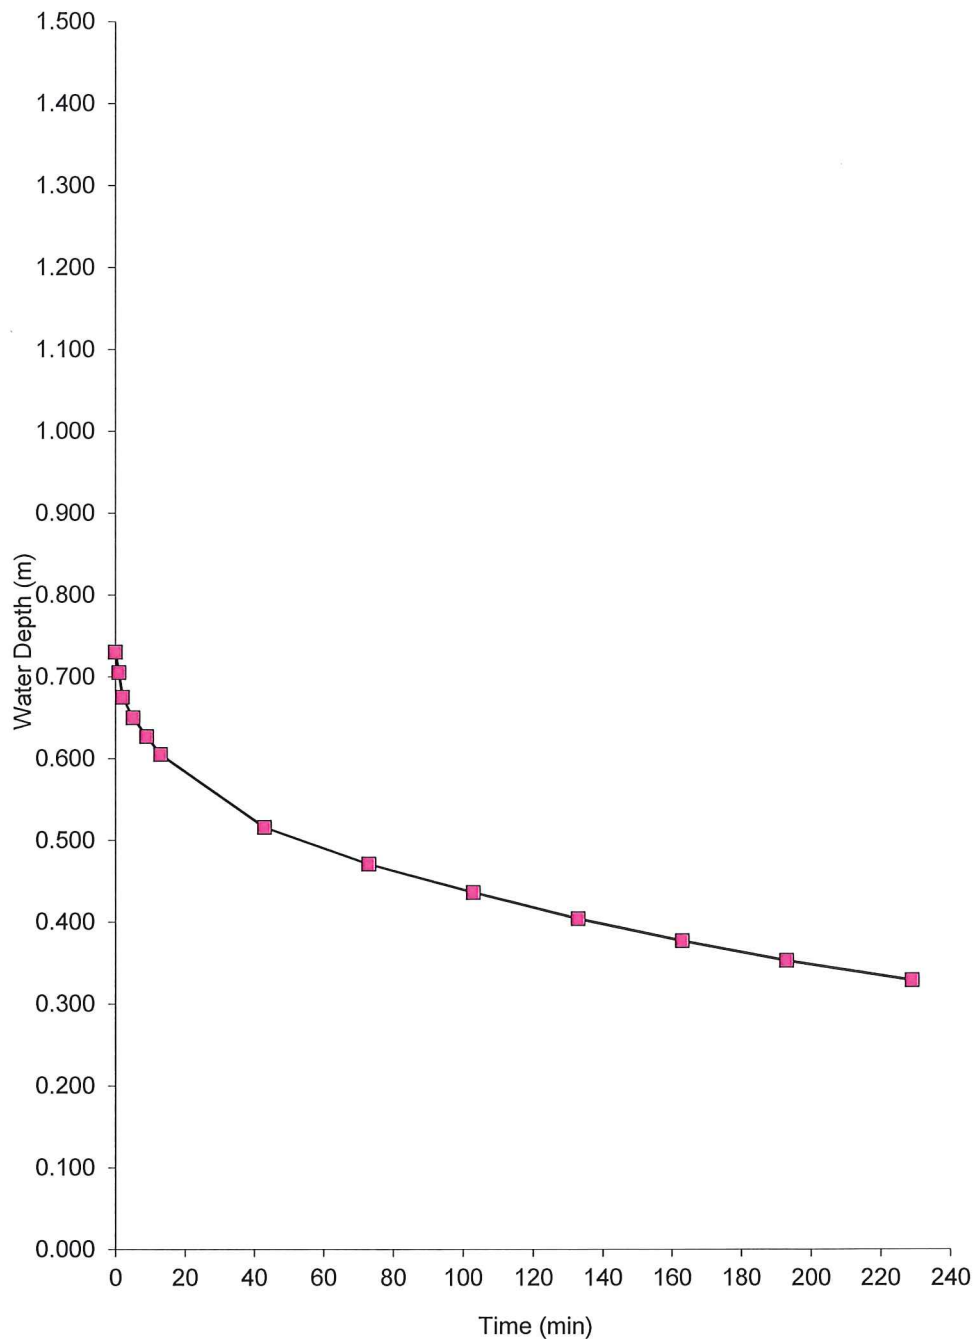
Water Depth vs Time

| Location: | Refer to Site Plan | Depth: | 0.75 (m) |

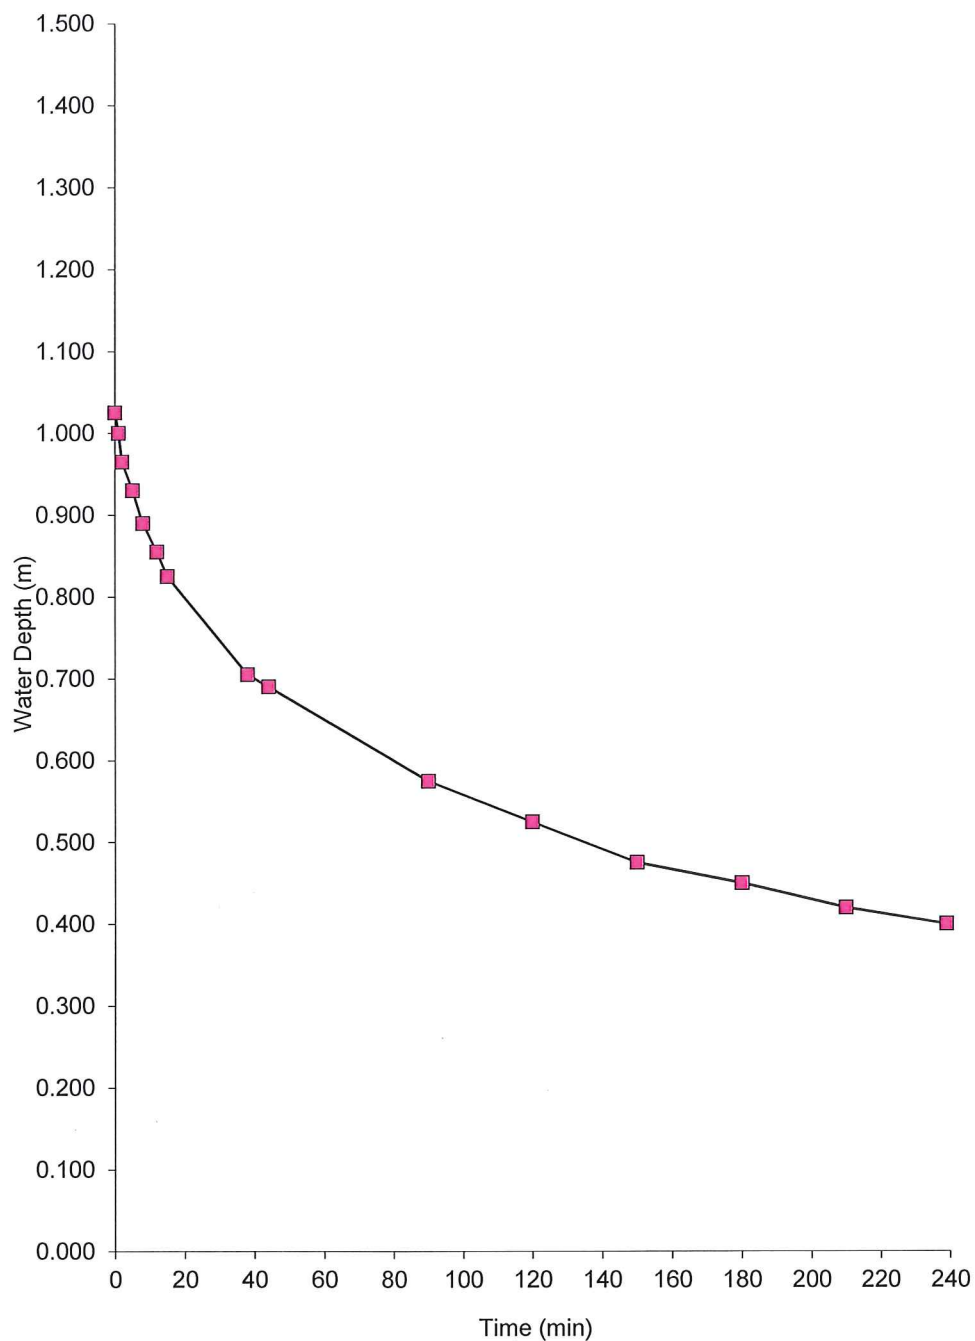
Water Depth vs Time

| Location: Refer to Site Plan | Depth: | 1.05 | (m) |
