473 ALBANY HIGHWAY, ALBANY: ARCHAEOLOGICAL ASSESSMENT

Prepared for Albany Estates Limited

March 2020

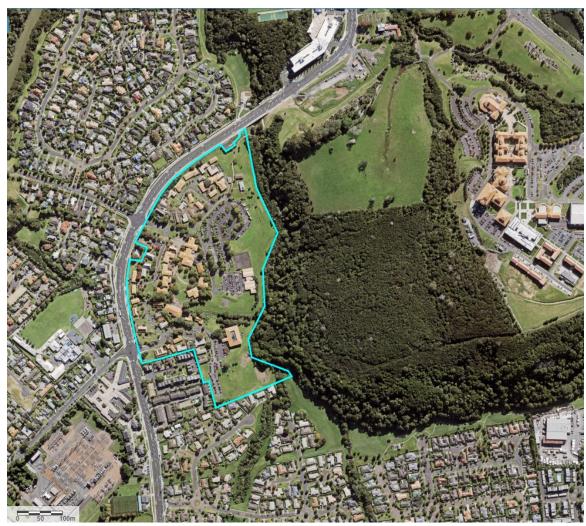
Figure 3. Aerial view of property, 2017 (source: Auckland Council Geomaps)

There are numerous recorded archaeological sites along Lucas Creek, the majority on the eastern side of the creek. However, there is only one recorded archaeological site (R10/1307) in close proximity to the project area (Figure 3). This is a midden site on the west bank of the Oteha Stream, north of Albany Highway, described on the site record as a scattered and disturbed deposit of fragmented shell, located at E1751332 N5933588.

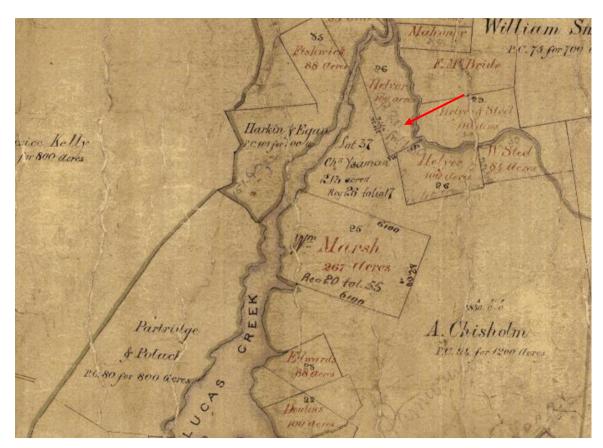
Figure 5. Detail from Roll 41/1 (undated) showing early land ownership in the Lucas Creek area, with the project area (arrow) owned by Helyer (source: Quickmap)

Early survey plans were reviewed but provided little information on the property that might indicate the presence of archaeological sites. However, one early but undated plan showing the ownership of land blocks in the upper harbour area identifies the owner of the property as 'Helyer' (Figure 5). This is likely to have been the Helyer after whom Hellyer's Creek was named, or a member of the same family. Hellyer's Creek is named Hilyer's Creek on the plan, and the spelling of names on early plans and title deeds was often variable.

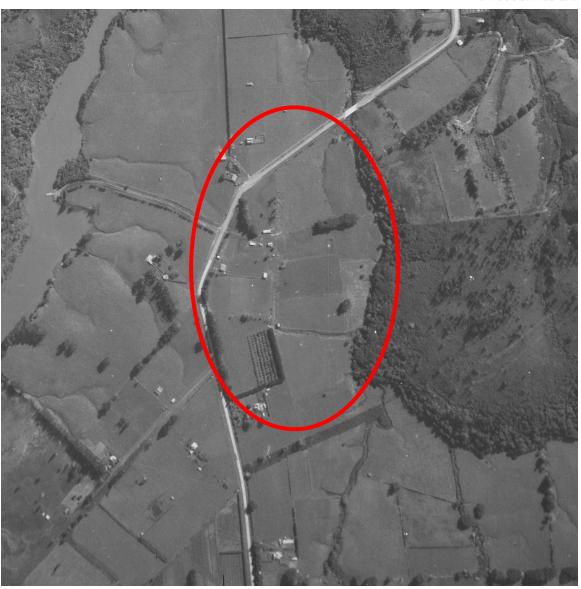
Figure 6. 1940 aerial photograph of the project area (circled in red). Source: RetroLens

Inspection of early aerial photographs shows that the project area was used as farmland and for orchards during the 1940s (Figure 6). Some small farm buildings can also be observed. Mixed use of the area for farming and orchard activities continued through to 1988, at which time all orchards had been removed and the area appears to have returned to pasture. (Figure 7–Figure 8). By the late 1990s a number of Massey University campus buildings had been constructed (Figure 9), with additional buildings added subsequently (compare Figure 3).

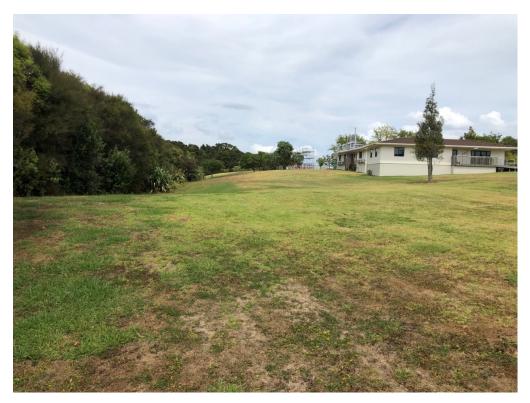
Figure 10. View south along Oteha Stream/esplanade reserve (at extreme left of image), with one of the campus buildings at right. Note extensive landscape modification

In general, the property displayed substantial landscape modification. In addition to the campus facilities, all ground surfaces in the eastern area were smooth and appeared designed to enhance the outlook towards the Oteha Stream (Figure 10–Figure 12). Additionally, a number of modifications had been made in order to facilitate drainage of water, and these were clearly visible during the course of the survey (Figure 13–Figure 14).

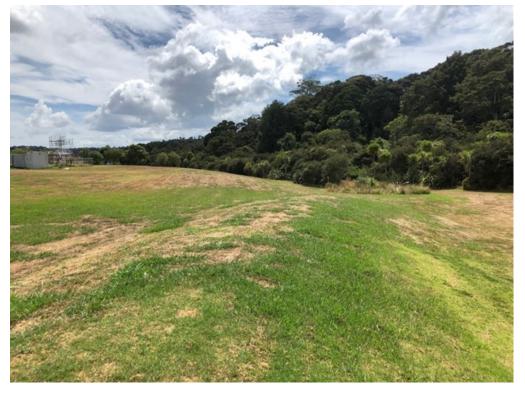
Figure 11. View north along Oteha Stream/esplanade reserve (at extreme right of image) with campus buildings at far left. Note extensive landscape modification

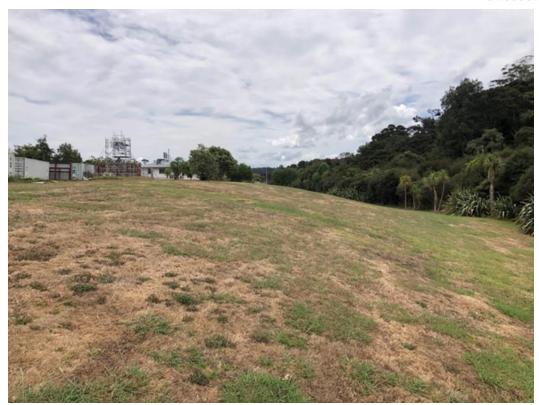
Figure 12. View north along the Oteha Stream/esplanade reserve (to extreme right of image), with campus buildings at far left. Note extensive landscape modification

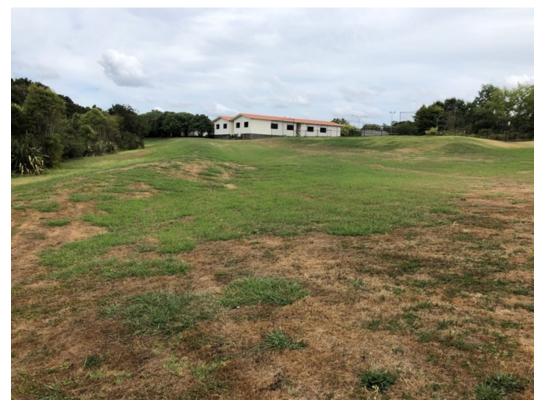
Figure 13. View south with campus buildings in the distance and evidence of landscape modifications to assist with drainage in foreground

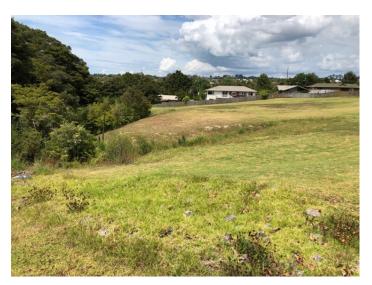
Figure 14. Another example of landscape modifications to assist with drainage, looking south

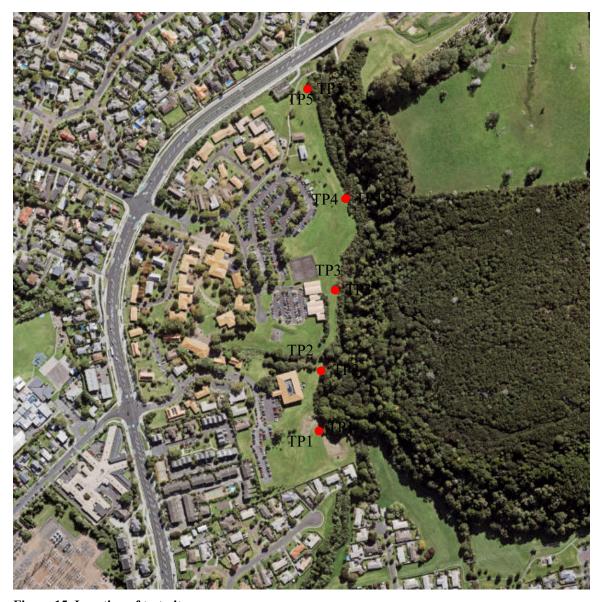
Figure 15. Location of test pits

Five test pits were opened along the contour of the Oteha Stream (Figure 15). The first, TP1, was located on a gradual slope at the southern end of the project area at coordinates E1751317 N5932977 +-1m. TP1 was opened to a depth of 12cm (Figure 16). A thin 3cm topsoil was encountered, overlaying 9cm of light brown silt with black PVC inclusions. The base of TP1 consisted of a compact yellow and brown mottled clay with no inclusions.

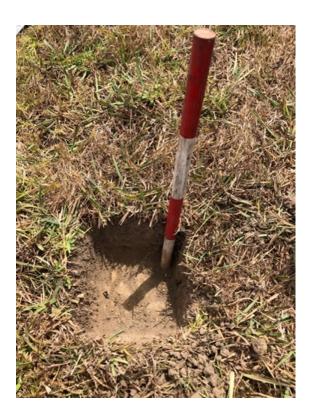
Figure 16. Close up of TP1

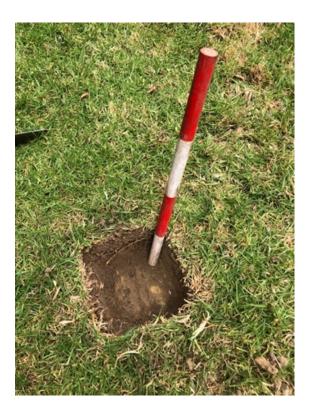
TP2 was located slightly north from TP1 at coordinates E1751321 N5933064 +-1m and opened to a depth of 9cm (Figure 17). TP2 displayed the same characteristics as TP1, a thin topsoil layer capping a layer of brown silt, and a base of mottled clay. Black PVC inclusions were also present in TP2.

Figure 17. Close up of TP2

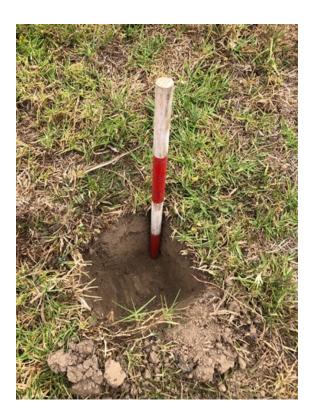
TP3 was located halfway along the eastern project boundary at coordinates E1751342 N5933180 +-1m and was opened to a depth of 16cm (Figure 18). As with previous test pits, TP3 displayed a thin topsoil layer overlaying brown silt and a base of mottled clay. Black PVC inclusions were also present.

Figure 18. Close up of TP3

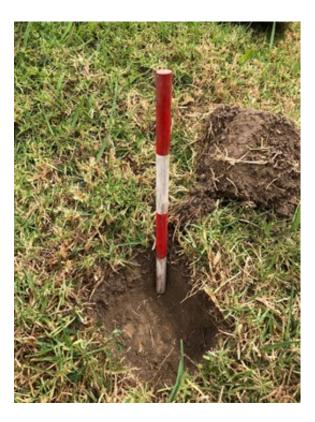
TP4 was located north of TP3 adjacent to the contours of Oteha Stream. TP4 was located at coordinates E17513 N5933312 +-1m and was opened to a depth of 10cm (Figure 19). The characteristics of TP4 were consistent with all previous test pits.

Figure 19. Close up of TP4

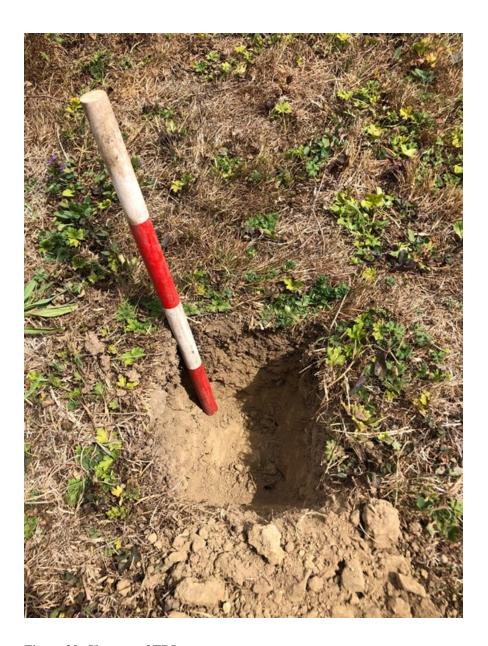
TP5 was located at the extreme northern end of the project area at coordinates E1751305 N5933465 +-1m. TP5 was opened to a depth of 15cm (Figure 20). In contrast to all previous test pits, TP5 displayed a thicker topsoil layer (5cm) and a light brown silt with clumpy clay and rock inclusions. A compact clay was observed at the base of TP5.

Figure 20. Close up of TP5
