301 & 303 BUCKLAND RD

GEOTECHNICAL REPORT – FOR LAND USE
CHANGE

INITIA REF P-000925-1 REV 0

SEPTEMBER 2021

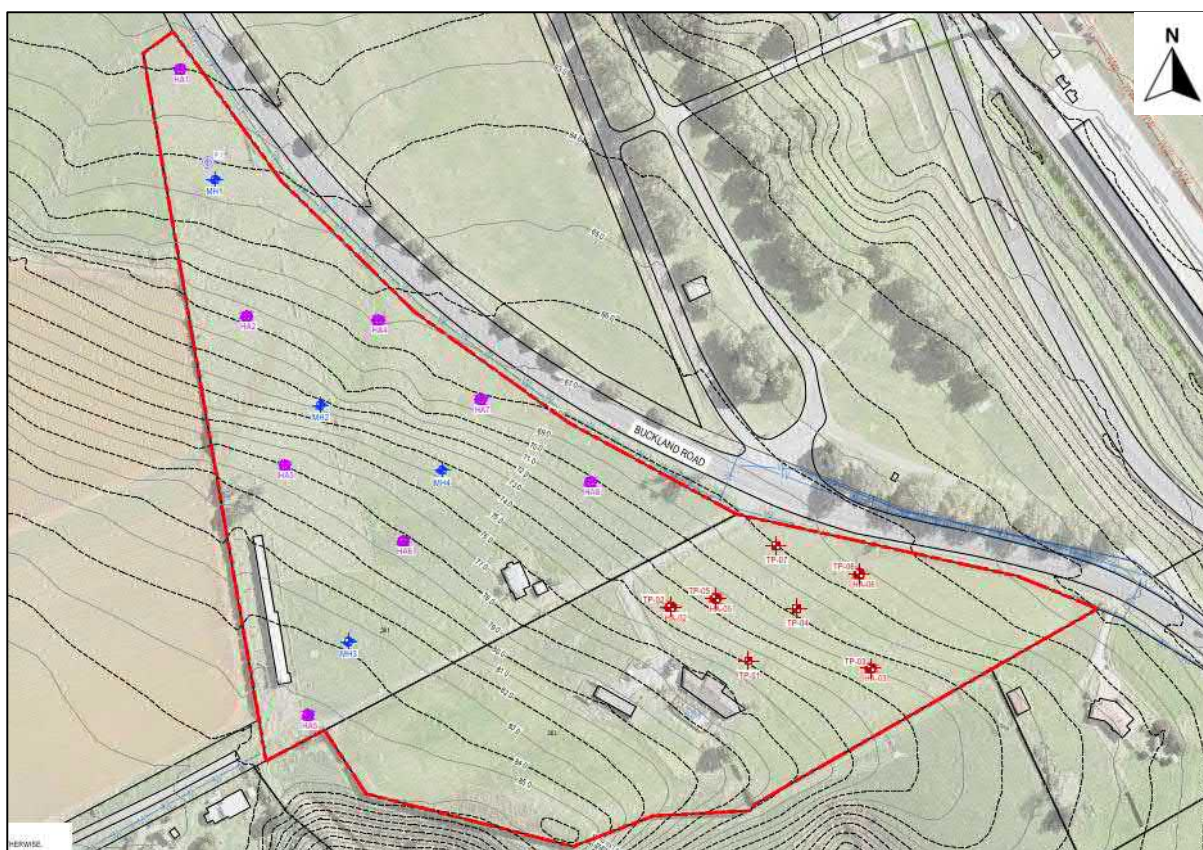
The proposed PPR is for two neighbouring properties, located at No. 301 and 303 Buckland Rd, Buckland. The site is presented in Figure 1-1 below and on Figure 925-1-001 in Appendix A. Both sites are currently used as pastoral land and have an approximate combined area of 7.86 HA. Each property has single storey dwellings with associated sheds and garages. Topography at the site slopes gently to moderately ($\sim 5\text{-}10^\circ$) toward the northeast from up to RL 86m at the western and southern boundaries down to RL 62m along Buckland Road in the east. There is a small gully situated near the centre of 301 Buckland Road. At the back of 303 Buckland Road, to the south, the topography drops away steeply.

Figure 1-1: 301 – 303 Buckland Road, Pukekohe.

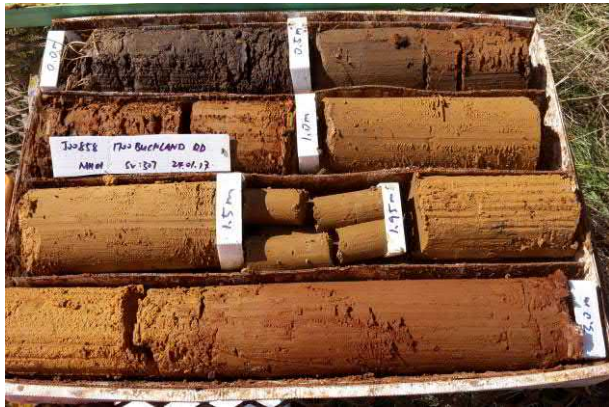
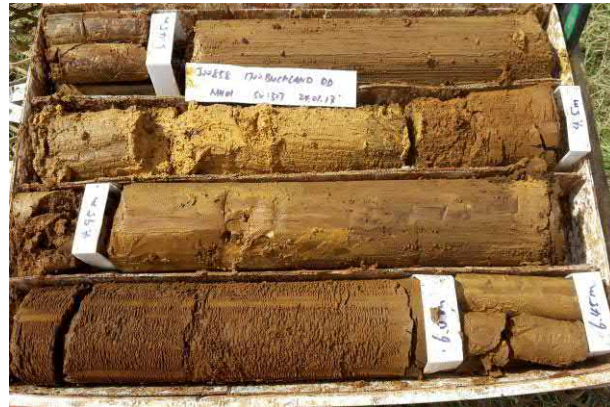
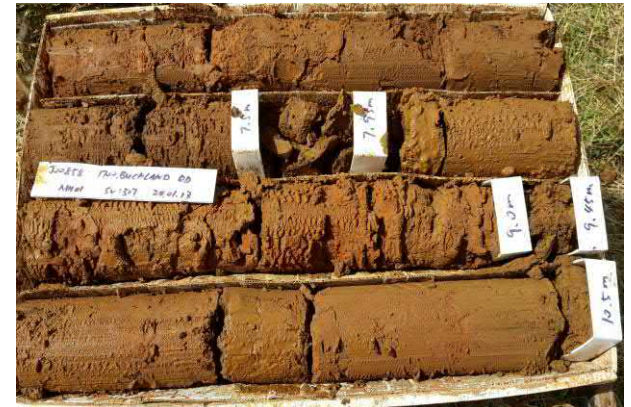
client:	PETEREX LIMITED		project no:	figure no:
	project:	1700 BUCKLAND ROAD		
			PUKEKOHE	compiled:
	title:	MH01 CORE PHOTOS		AB

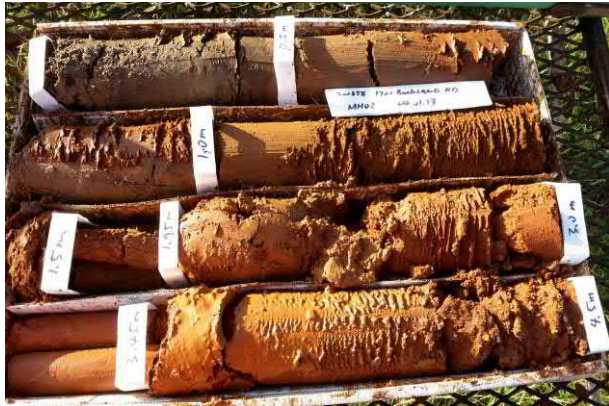
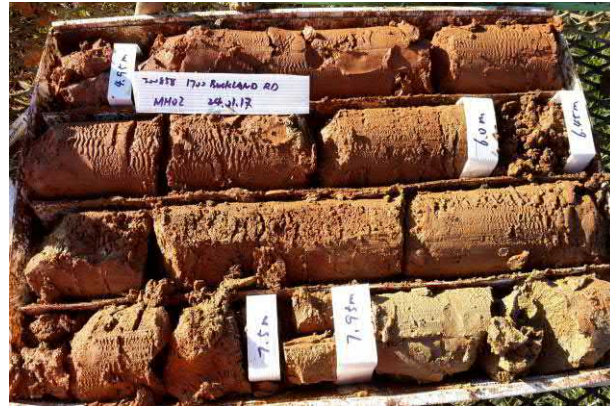
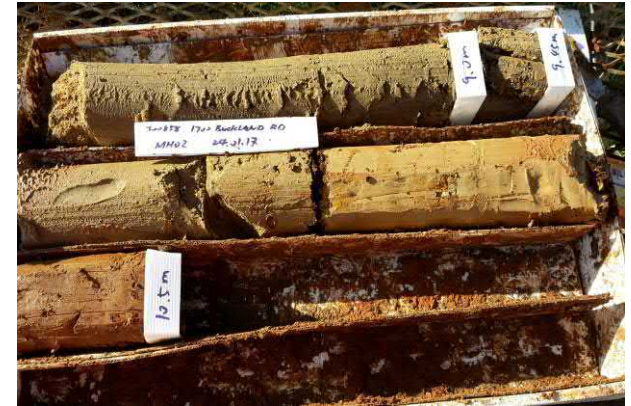
client:	PETEREX LIMITED		project no:	figure no:
	project:	1700 BUCKLAND ROAD		
			PUKEKOHE	compiled:
	title:	MH02 CORE PHOTOS		AB

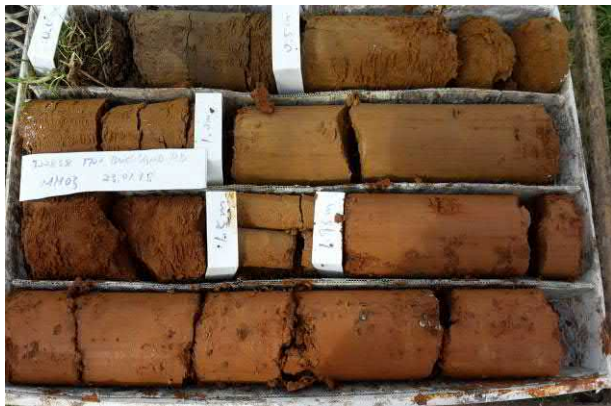
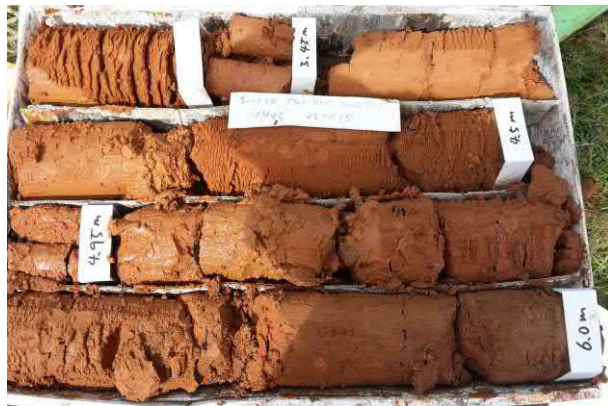
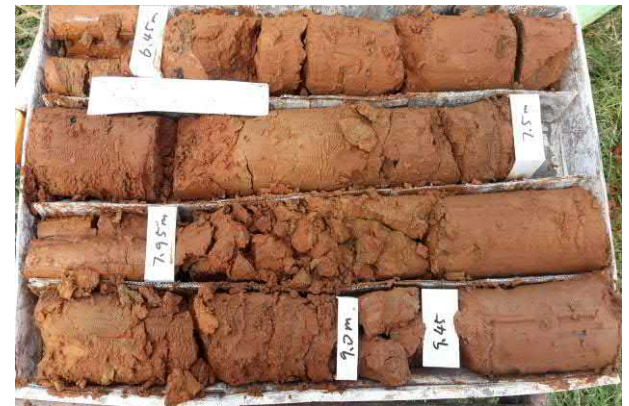
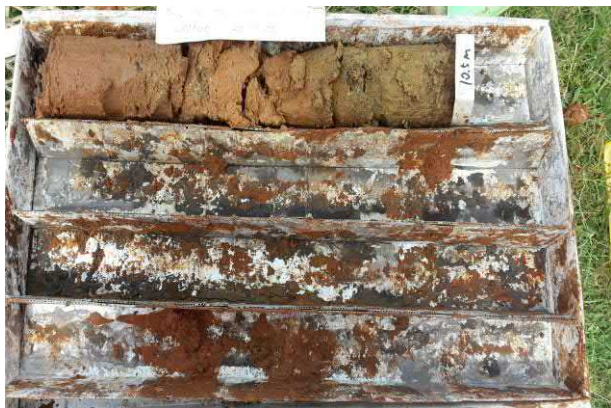
client:	PETEREX LIMITED		project no:		figure no:
project:	1700 BUCKLAND ROAD		J 00858		Figure MH03
	PUKEKOHE		compiled:		date:
title:	MH03 CORE PHOTOS		AB		25.01.18

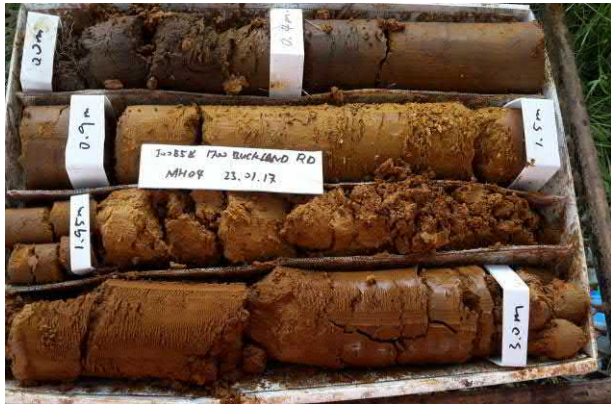
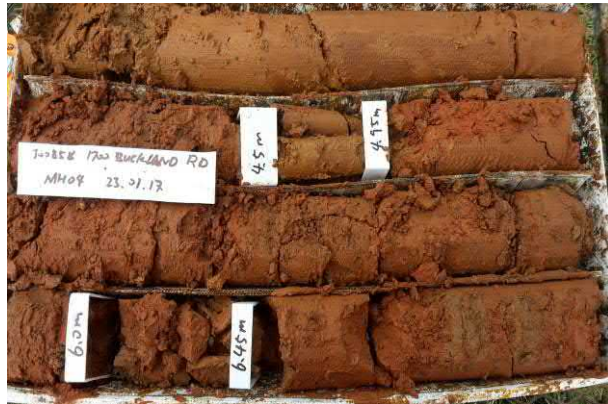
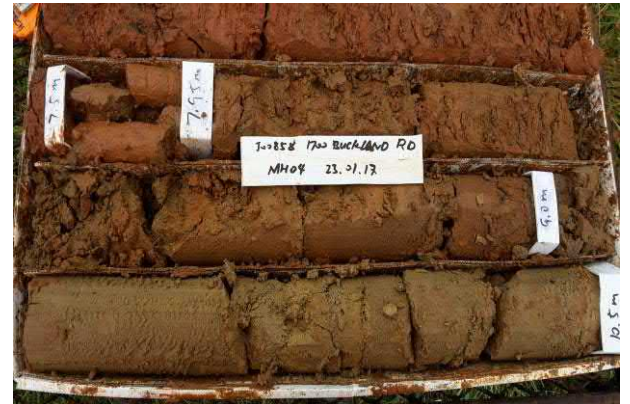
client:	PETEREX LIMITED		project no:	figure no:
	project:	1700 BUCKLAND ROAD		
			PUKEKOHE	compiled:
	title:	MH04 CORE PHOTOS		AB

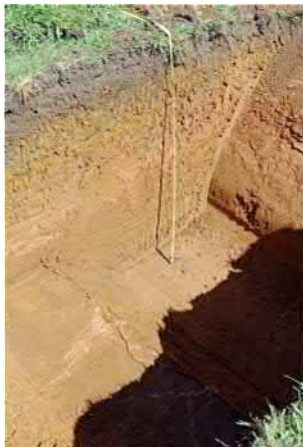
MATERIAL DESCRIPTION (See Classification & Symbology sheet for details)	SAMPLES	DEPTH (m)	LEGEND	SCALA PENETROMETER (Blows / 0mm)		VANE SHEAR STRENGTH (kPa) Vane: 2503		WATER
				2	4	50	100	
Topsoil SILT; dark brown. Firm; non-plastic; dry.		0.2	TS					
South Auckland Volcanic Field Clayey SILT; orange brown. Very stiff; high plasticity; moist.		0.4	TS					
		0.6	TS					131 61
Clayey SILT; brown with light brown mottles. Very stiff; high plasticity; moist.		1.0	TS					
		1.4	TS					161 99
EOH: 2.60m		2.0	TS					175 91
		2.6	TS					
		2.8						
		3.0						
		3.2						
		3.4						
		3.6						
		3.8						
		4.0						
		4.2						
		4.4						
		4.6						
		4.8						
		5.0						
		5.2						
		5.4						
		5.6						
		5.8

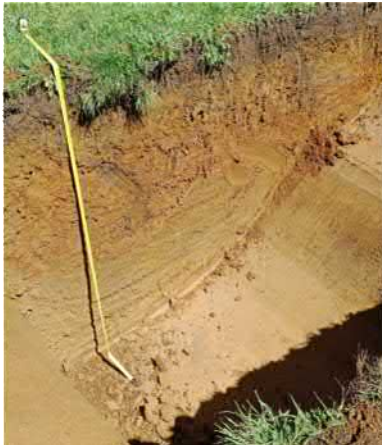
MATERIAL DESCRIPTION (See Classification & Symbology sheet for details)		SAMPLES	DEPTH (m)	LEGEND	SCALA PENETROMETER (Blows / 0mm)	VANE SHEAR STRENGTH (kPa) Vane: 2503	VALUES	WATER
Top soil	SILT; dark brown. Firm; non-plastic; dry.		0.2					
South Auckland Volcanic Field	Clayey SILT; orange brown. Very stiff; high plasticity; moist.		0.4				124 66	Groundwater Not Encountered
	Clayey SILT; yellowish brown. Hard; high plasticity; moist.		1.0				204.54+	
	EOH: 2.00m		1.8				190 61	
	1.8m: Grading to very stiff		2.0					
			2.2					
			2.4					
			2.6					
			2.8					
			3.0					
			3.2					
			3.4					
			3.6					
			3.8					
			4.0					
			4.2					
			4.4					
			4.6					
			4.8					
			5.0					
			5.2					
			5.4					
			5.6					
			5.8

Continued as hand auger. Refer to HA-02

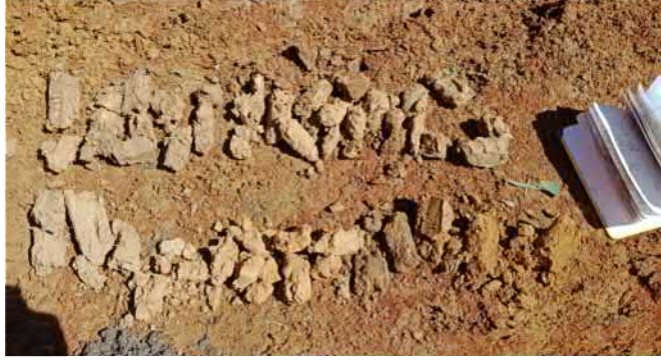
UNIT	MATERIAL DESCRIPTION (See Classification & Symbology sheet for details)	SAMPLES	DEPTH (m)	LEGEND	SCALA PENETROMETER (Blows / 0mm)	VANE SHEAR STRENGTH (kPa) Vane: 2503	WATER
					2 4 6 8 10 12 14 16 18	50 100 150 200 Values	
	Test Pit 0.0 to 2.0 m (refer to TP-06)		0.2 0.4 0.6 0.8 1.0 1.2 1.4 1.6 1.8 2.0				
South Auckland Volcanic Field	Clayey SILT; light brown. Very stiff; high plasticity; moist.		2.0 2.2 2.4 2.6 2.8 3.0 3.2 3.4	[Cross-hatched pattern]		161 47 124 69 161 82	Groundwater Not Encountered
	SILT, with some clay; brown. Hard; low plasticity; moist.		3.4 3.6 3.8 4.0	[Cross-hatched pattern]		205+ -	
	EOH: 4.00m		4.0 4.2 4.4 4.6 4.8 5.0 5.2 5.4 5.6 5.8

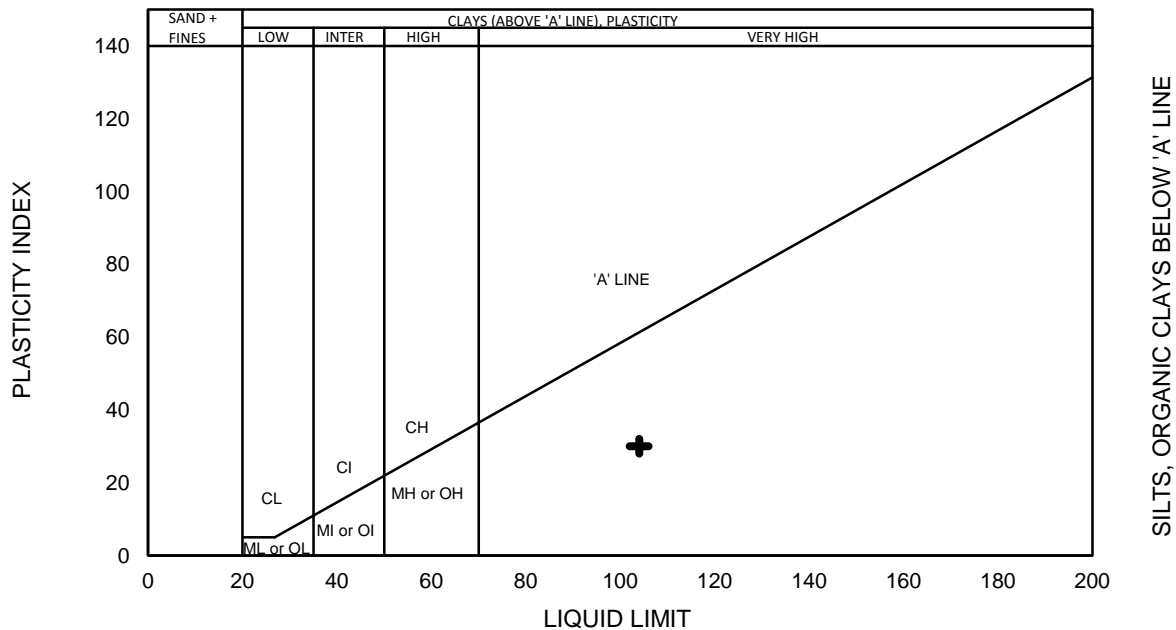
Liquid Limit	104	Sample History:	Natural state
Plastic Limit:	74	Fraction Tested:	Passing 425µm sieve
Plasticity Index:	30	Material Description:	Disturbed Soil
Linear Shrinkage:	21		
#Liquidity Index (w-PL)/PI	0.2	Moisture Content (%)	79.1

CASAGRANDE PLASTICITY CHART

The site is underlain by fine grained cohesive South Auckland Volcanic Field ash. Two samples of ash tested by Lander at 301 Buckland Road² resulted in linear shrinkages of 21 to 24, and liquid limits between 104 and 114, indicating a high shrink/swell potential. The shrinking and swelling of surficial soils can result in foundation movement, which can distort the superstructure. If this movement occurs it typically manifests as cracking damage to foundations, rigid cladding systems and to the internal linings (ceilings and walls). Due to the nature of the damage mechanism, i.e. wetting and drying of the soils, this tends to occur seasonally and effect only near surface soils which are subject to moisture change.

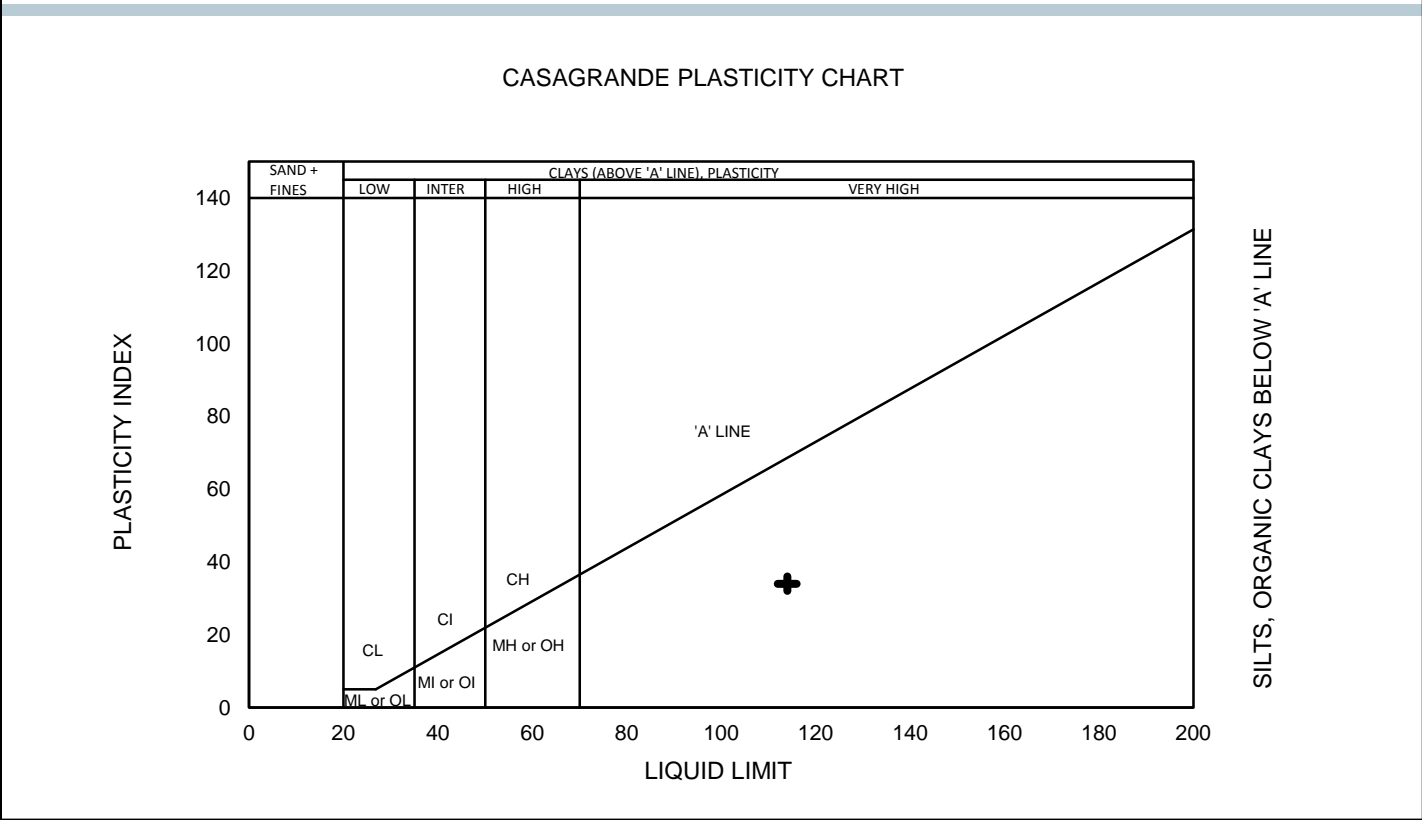
Liquid Limit	114	Sample History:	Natural state
Plastic Limit:	80	Fraction Tested:	Passing 425µm sieve
Plasticity Index:	34	Material Description:	Disturbed Soil
Linear Shrinkage:	24	Moisture Content (%)	72.2
#Liquidity Index (w-PL)/PI	-0.2
