DETAILED SITE INVESTIGATION (DSI)

301 BUCKLAND ROAD, PUKEKOHE

Reference Number: REP-1258A/DSI/JAN19

15 JANUARY 2019

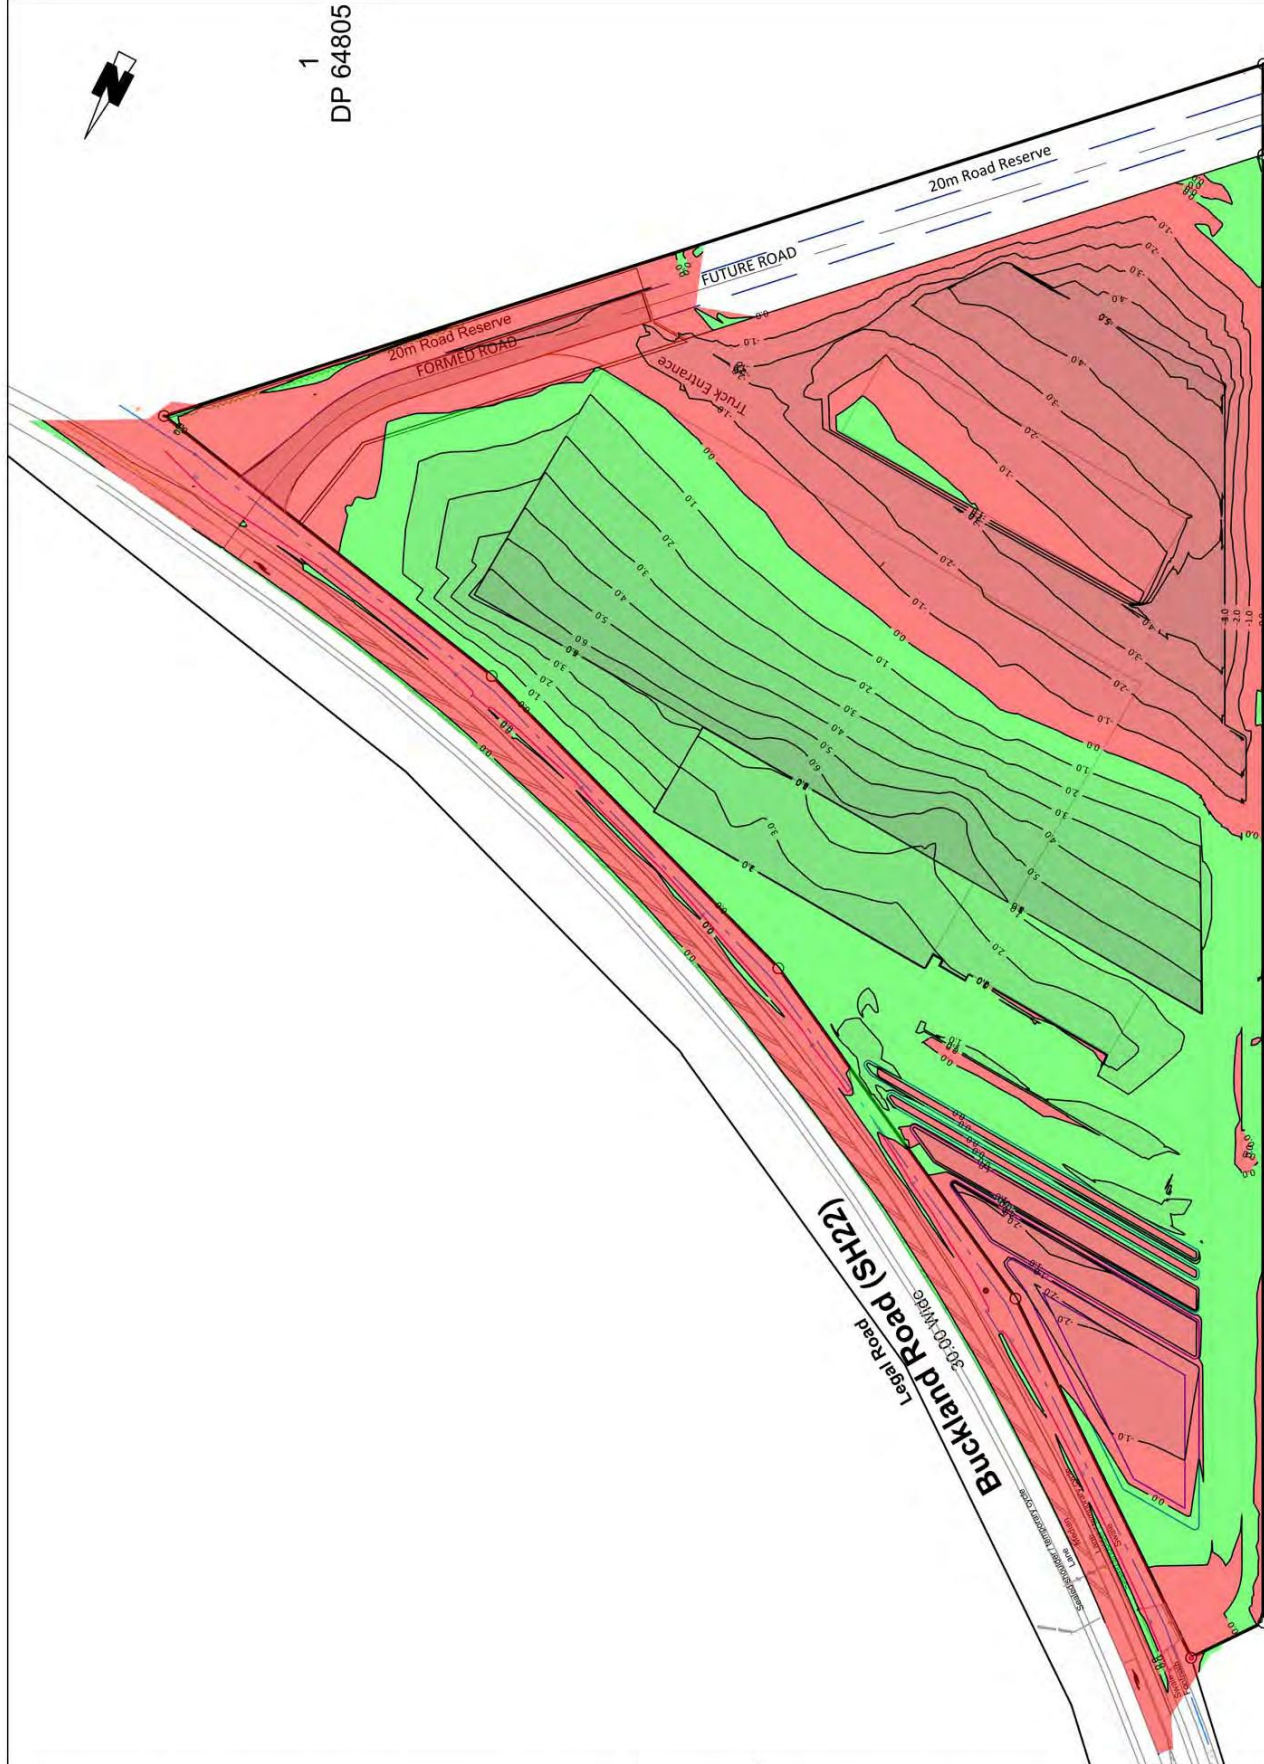
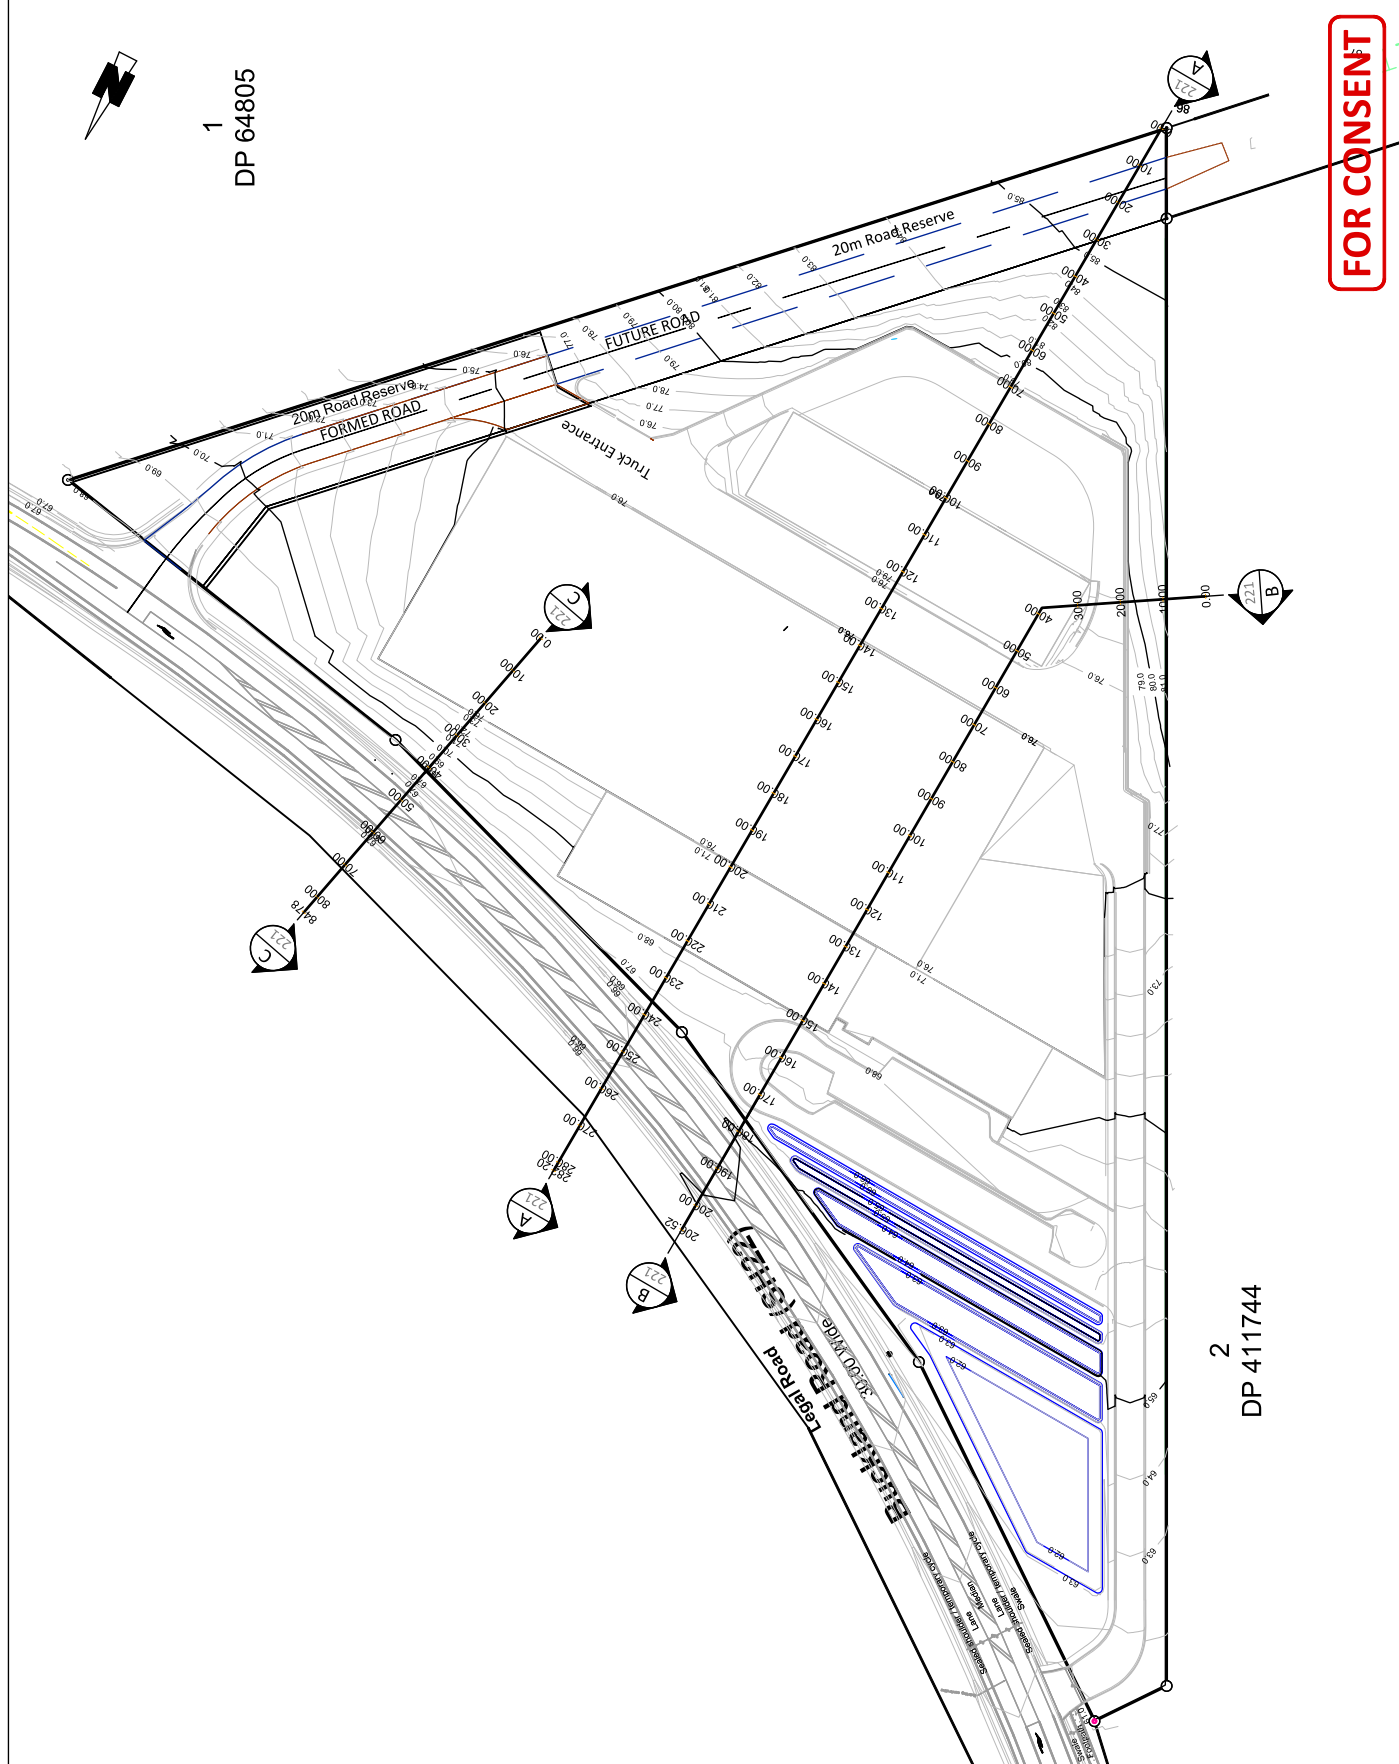
EARTHWORKS CUT-FILL TABLE				
FROM	TO	UNIT	CLOUR	RANGE VOLUME (m³)
0	1	m	Green	42086
0	-1	m	Red	-31785

To achieve this, approximately 31,785 m³ of cut, and 42,086 m³ of fill work is proposed, with approximately 10,300 m³ of engineered cleanfill material required to be imported to create the platform below the main warehouse and pipe storage building. Where cut material is deemed unsuitable for use in construction, it will be removed from site for disposal at an appropriate facility. A copy of the proposed earthworks plan is attached in Appendix A.

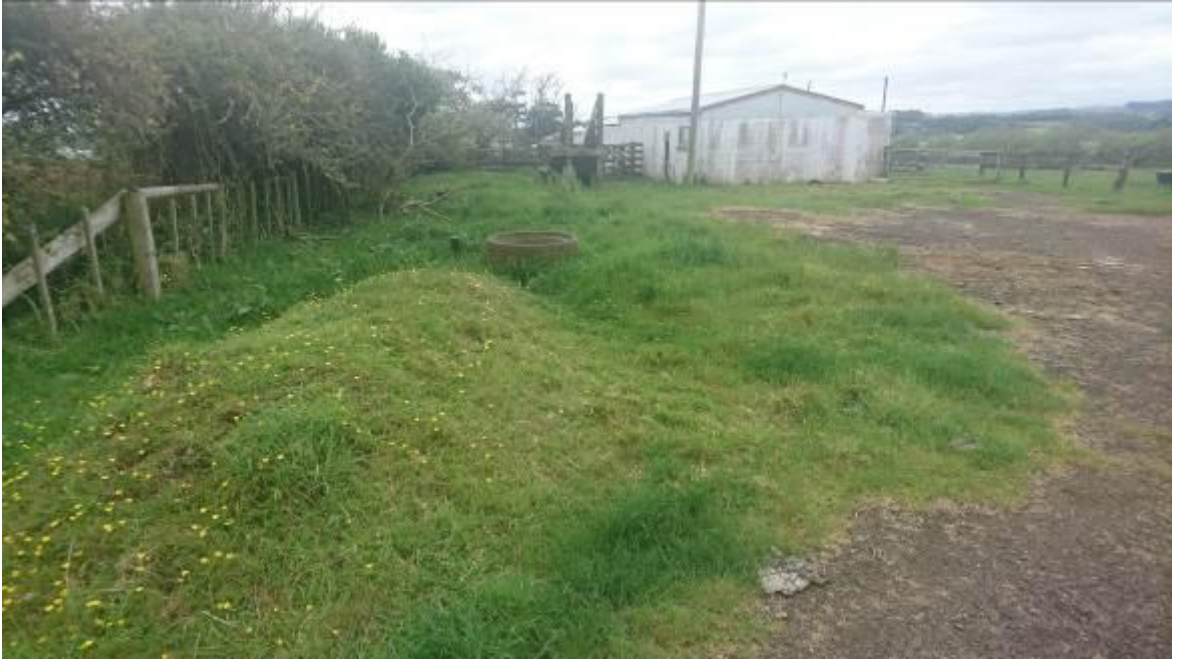
PLATE 1: Arsenic impacted stockpile

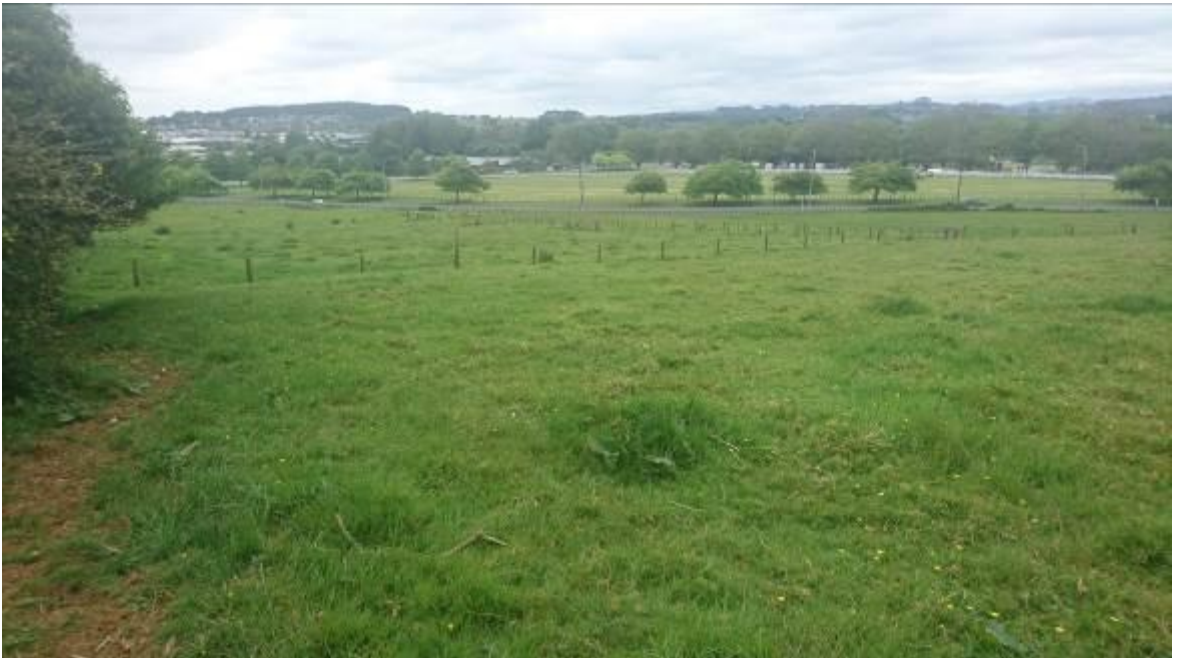
PLATE 2: Area of sediment plume from adjacent property

With regards to the sediment plume noted in the PSI, the migration of soil from the adjacent property has the potential to impact the surface soil in a discrete area of the site, identified in Figure 2. The migration of soil would be expected to result in a reasonably uniform distribution of contaminants in the uppermost soil horizon. Potential horticultural activity was identified in one portion of the site during the 1960s. The primary source of potential contamination as a result of horticultural activity is through the direct sprayed application of persistent pesticides to crops, there are no structures noted which could have been the location of the bulk storage of persistent pesticides of agrichemicals. Such an application of persistent pesticides is likely to produce a uniform distribution of contaminants through the uppermost soil horizon and is unlikely to produce hotspots of contamination.

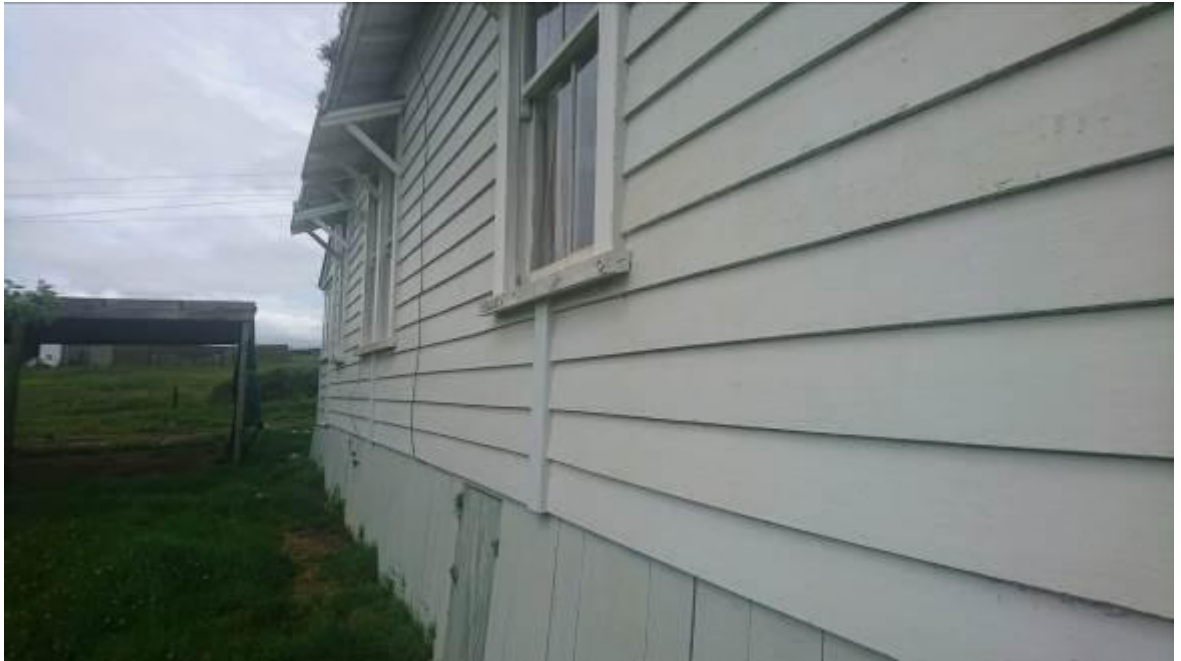
PLATE 3: Dwelling curtilage

Due to the age of the dwelling on site the potential exists for lead based paints to have been used on the buildings exterior. Lead based paints have the potential to impact soil surrounding the building at times when the paint is in deteriorated condition, or at times where routine maintenance is undertaken through scraping or sanding painted surfaces with insufficient ground protection. The soil can be impacted when paint flakes or dust infiltrate the uppermost soil around the structure, and can result in a well constrained hotspot surrounding the structure. Concentrations of lead can be high in close proximity to the structure and generally attenuate rapidly with distance from the source, generally reducing to background concentrations within 3 m from the structure.

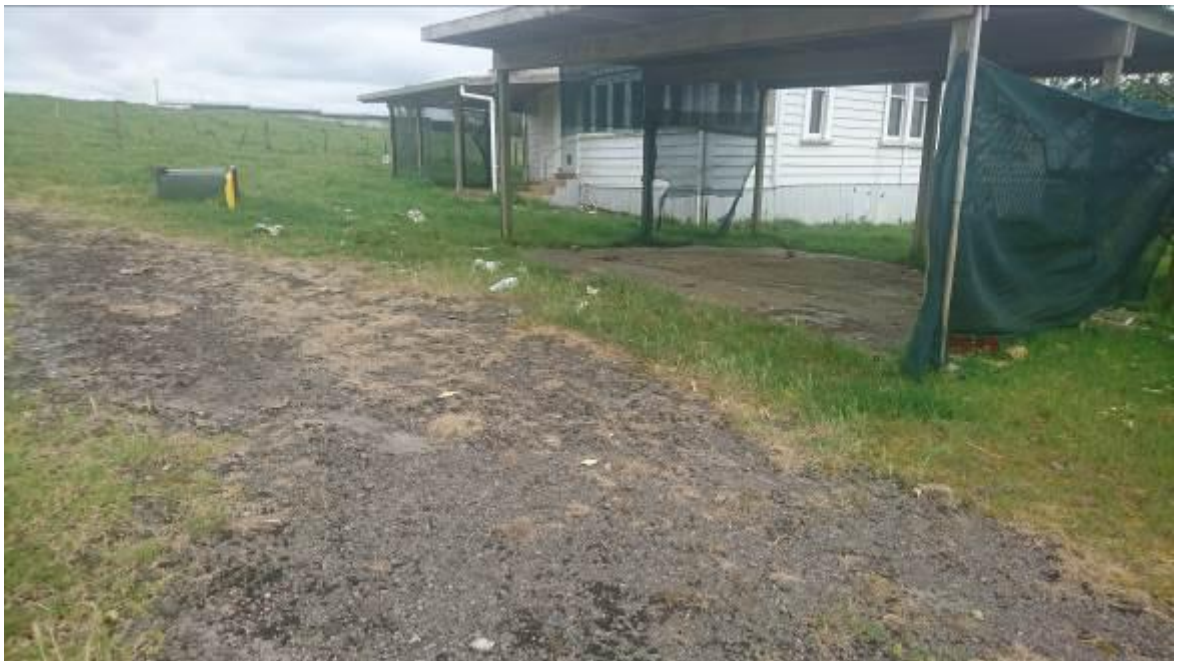
PLATE 4: Dwelling curtilage
