Preliminary Geotechnical Assessment Report

80 MCLARIN ROAD, GLENBROOK

Ref No: J01798

RE: Preliminary Geotechnical Assessment Report for Private Plan Change for 80 McLarin Road, Glenbrook

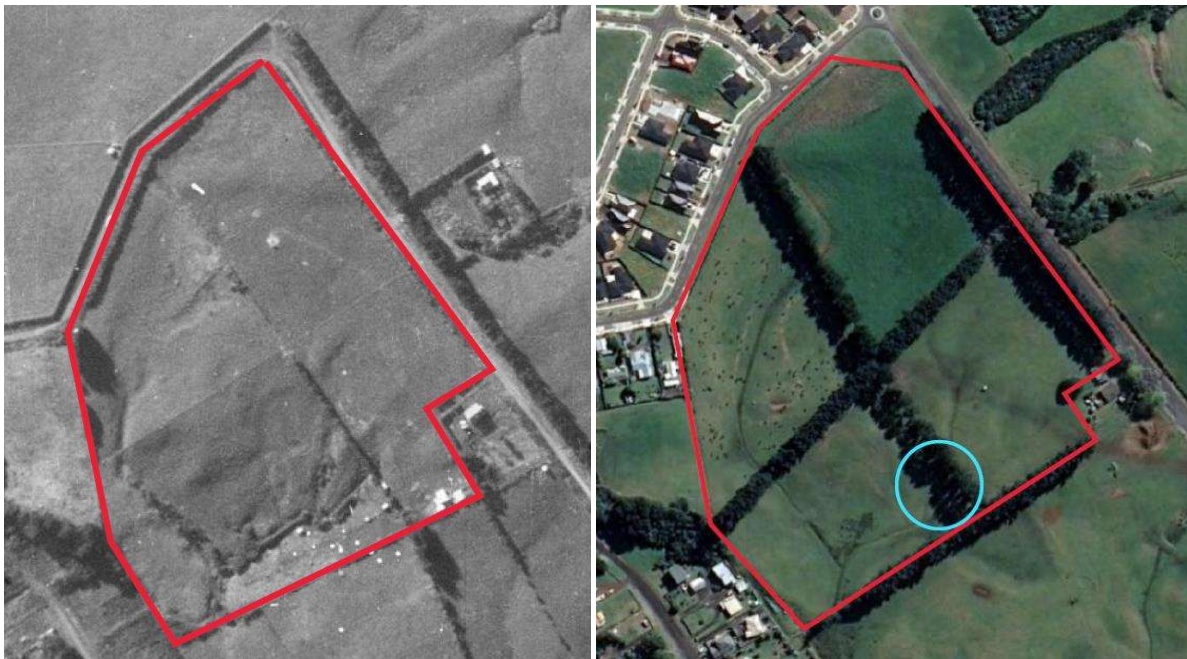
Inset A: Left: Photograph dated 1942, retrieved from Retrolens.nz, Right: Photograph dated 2021, retrieved from Google Earth.

A review of available historic photographs on Auckland Council's online GIS database, Google Earth images and historic images from Retrolens.nz found no obvious or significant land modification on the majority of the study area over the period 1942 to 2021. However, some minor earthworks may have occurred with the infill of a pre-existing overland flow path to ease land gradients (circled blue on inset A), and a manmade drainage ditch is quite well defined in 2021 from the north to the south. Historic aerial photographs dated 1940 and 2021 are inset below.

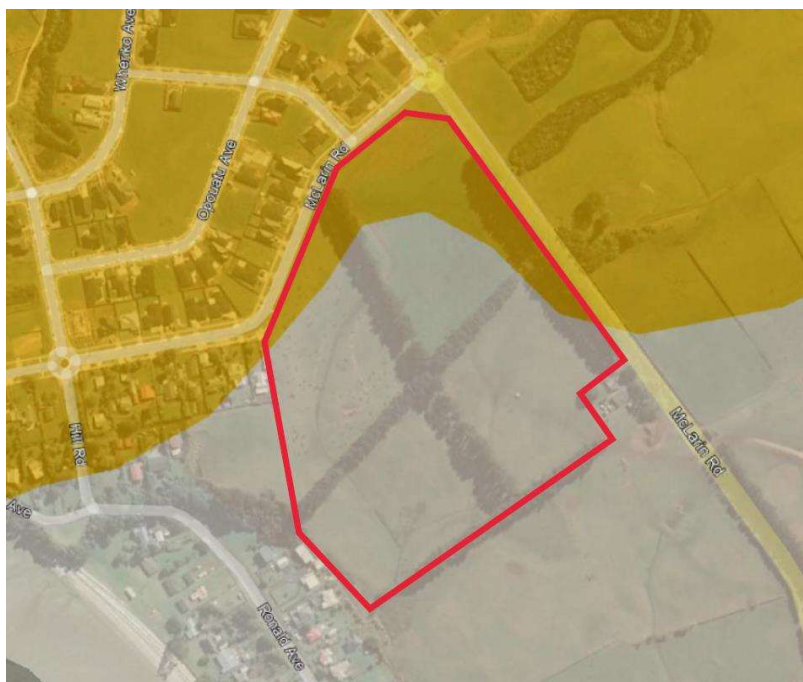
Inset B: Published Geology (Institute of Geological and Nuclear Sciences. QMap geology. KMZ file. Available from <https://services.arcgisonline.co.nz>)

Approximately 3km beyond the site to the south are deposits (Basalt and Ash / Tuff soils) of the South Auckland Volcanic Field. It is possible that thin, surficial ash deposits from the South Auckland Volcanic Field may be present overlying Puketoka Formation deposits, particularly in the elevated portions of the site.

The site is approximately 24km west from the Drury Fault and approximately 34km west from the Wairoa North Fault.

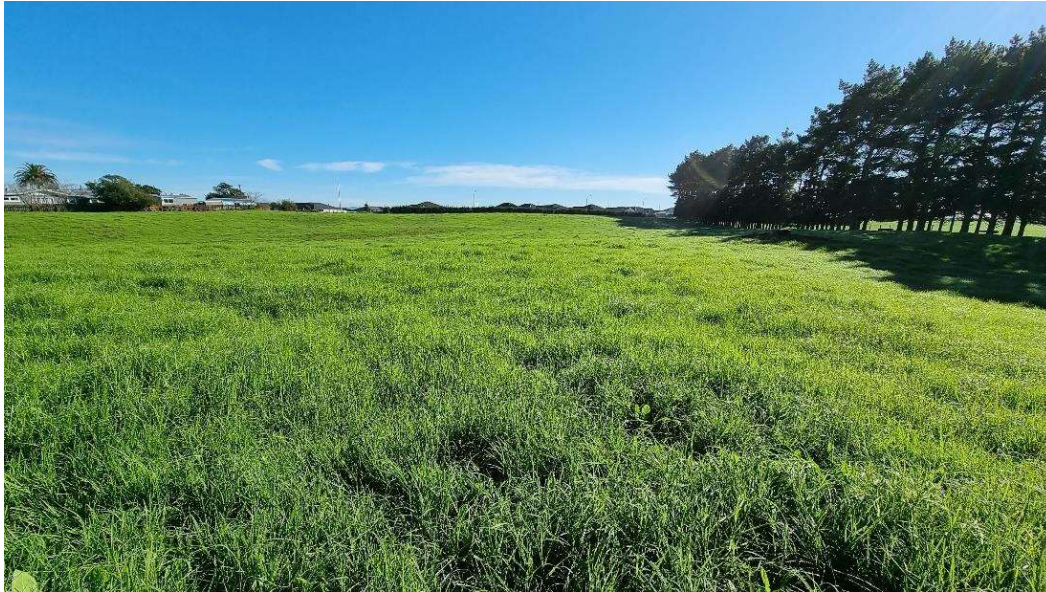
Inset D: The steeper slopes and low lying land in the southern half of the site.

Site geomorphology at 80 McLaren Road includes rolling and undulating terrain in the northern half of the site, sloping away from around RL 20m to RL 5m in the southern half of the site. Slopes of up to 1(v) in 4(h) are present in this part of the site which slope toward a lower lying area; see insets C & D below. Several overland flow paths bisect the site however are not deeply incised. There were no obvious visual signs of large scale and/ or recent land / slope instability observed.

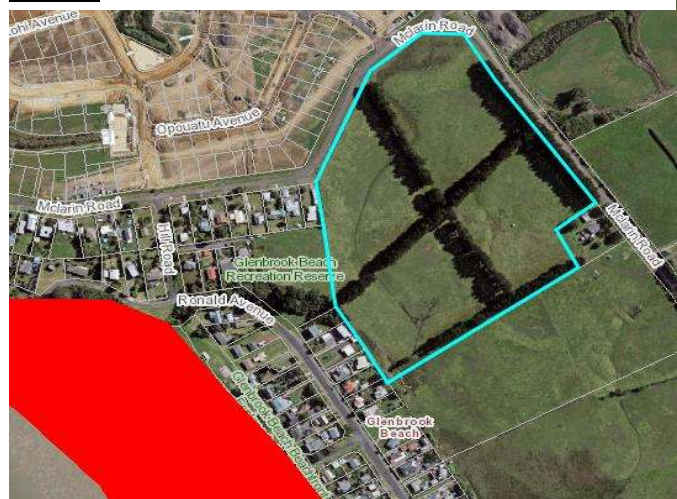
Inset E – Tsunami Shore Exclusion Zone

The site is located approximately 150m from the nearest Tsunami shore exclusion zone as per Auckland Councils Geomaps database (indicated red on Inset E). The site ranges in elevation between 5mRL and 20mRL and therefore, inundation from tsunami should be dismissed as a likely hazard to 80 McLaren Road.

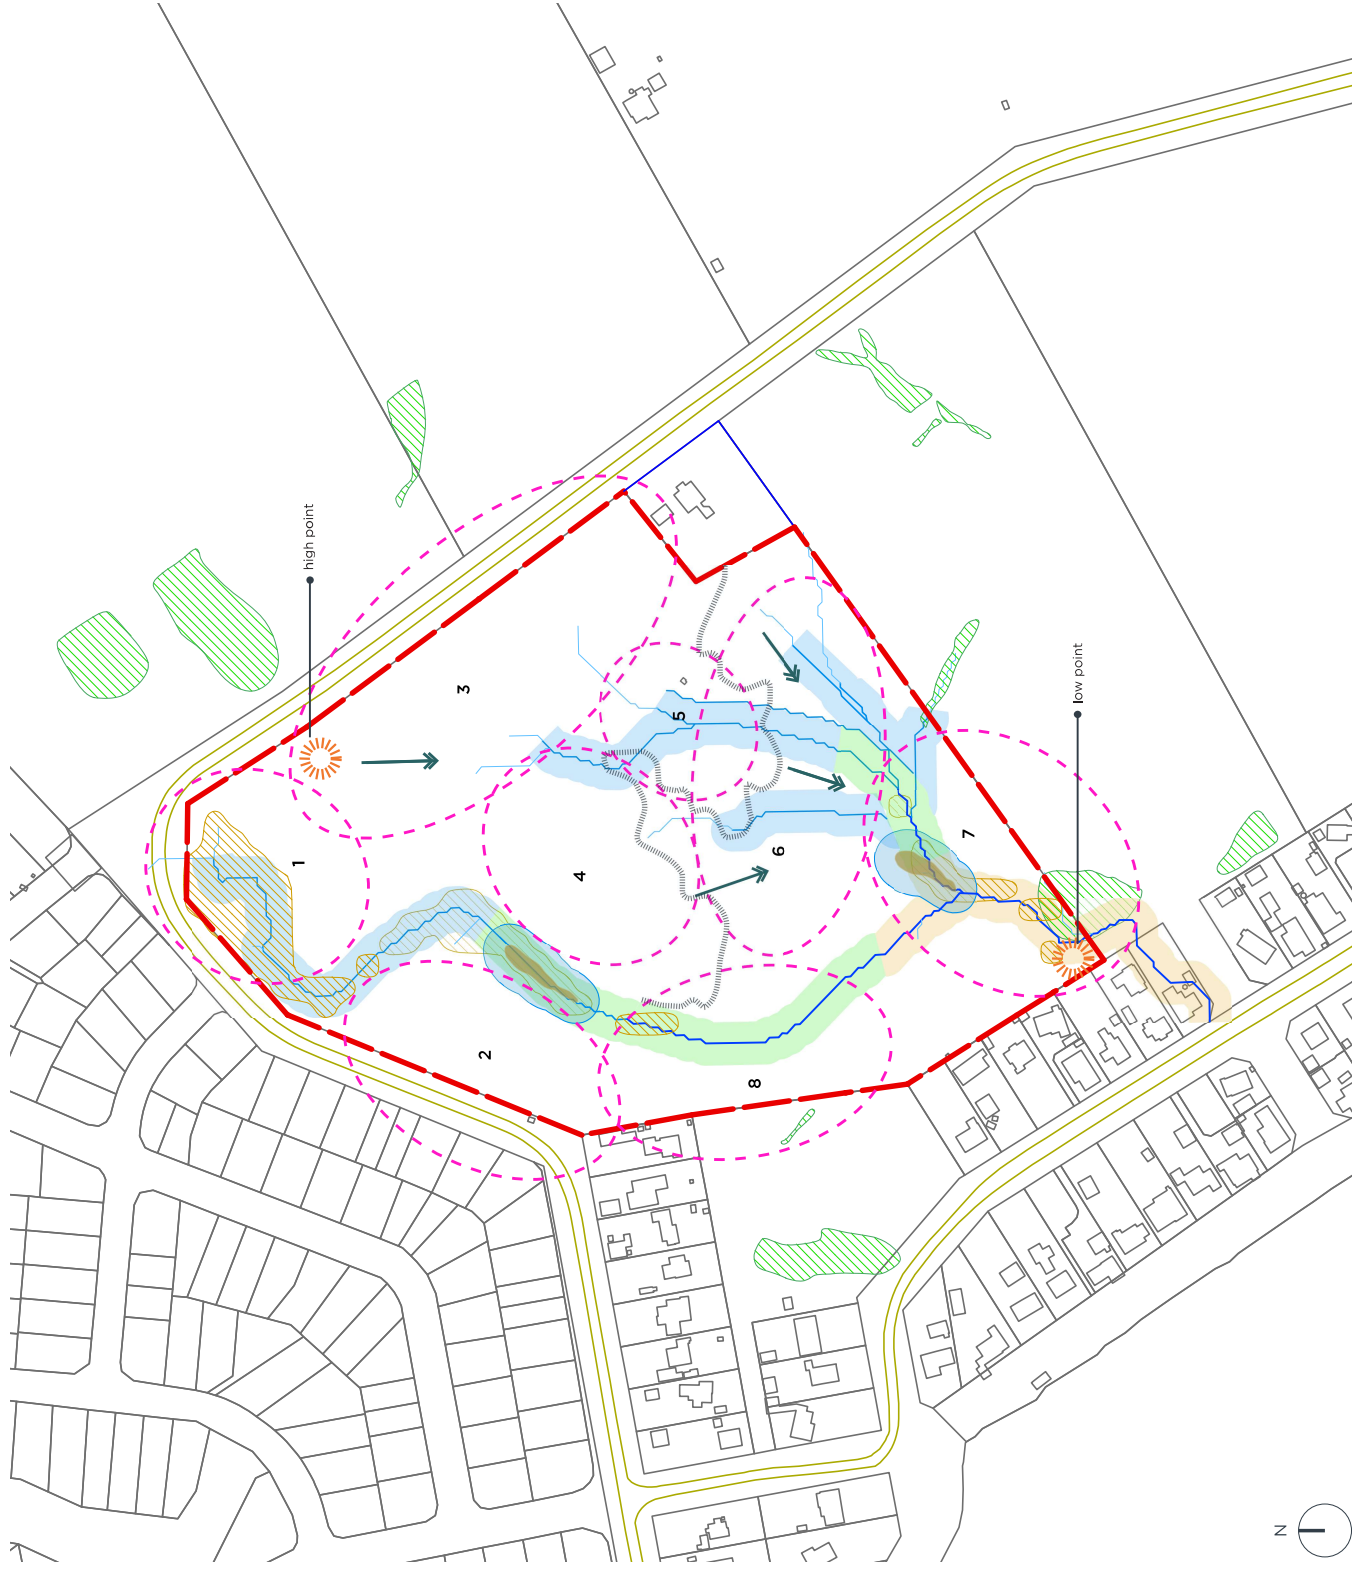
OPTION 1

KEY MOVES

1. Possible connection to Rere Awa Road.
2. Reserve edge crescent with pedestrian/cycle path.
3. Assume 50 km/h McLaren Road.
4. Lot access from McLaren Road.
5. Connection to the existing reserve.
6. Stormwater in existing wetland W2.
7. Align with existing lot boundaries.
8. Street avoid steep slopes follow easiest gradient less than 1:10.
9. Stormwater wetland or recreational reserve when dry.
10. Average lot size ~800m².
11. Higher density closer to the future commercial zone - 400m² lots.
12. Larger lots where steeper.
13. Possible pedestrian/cycle connection.

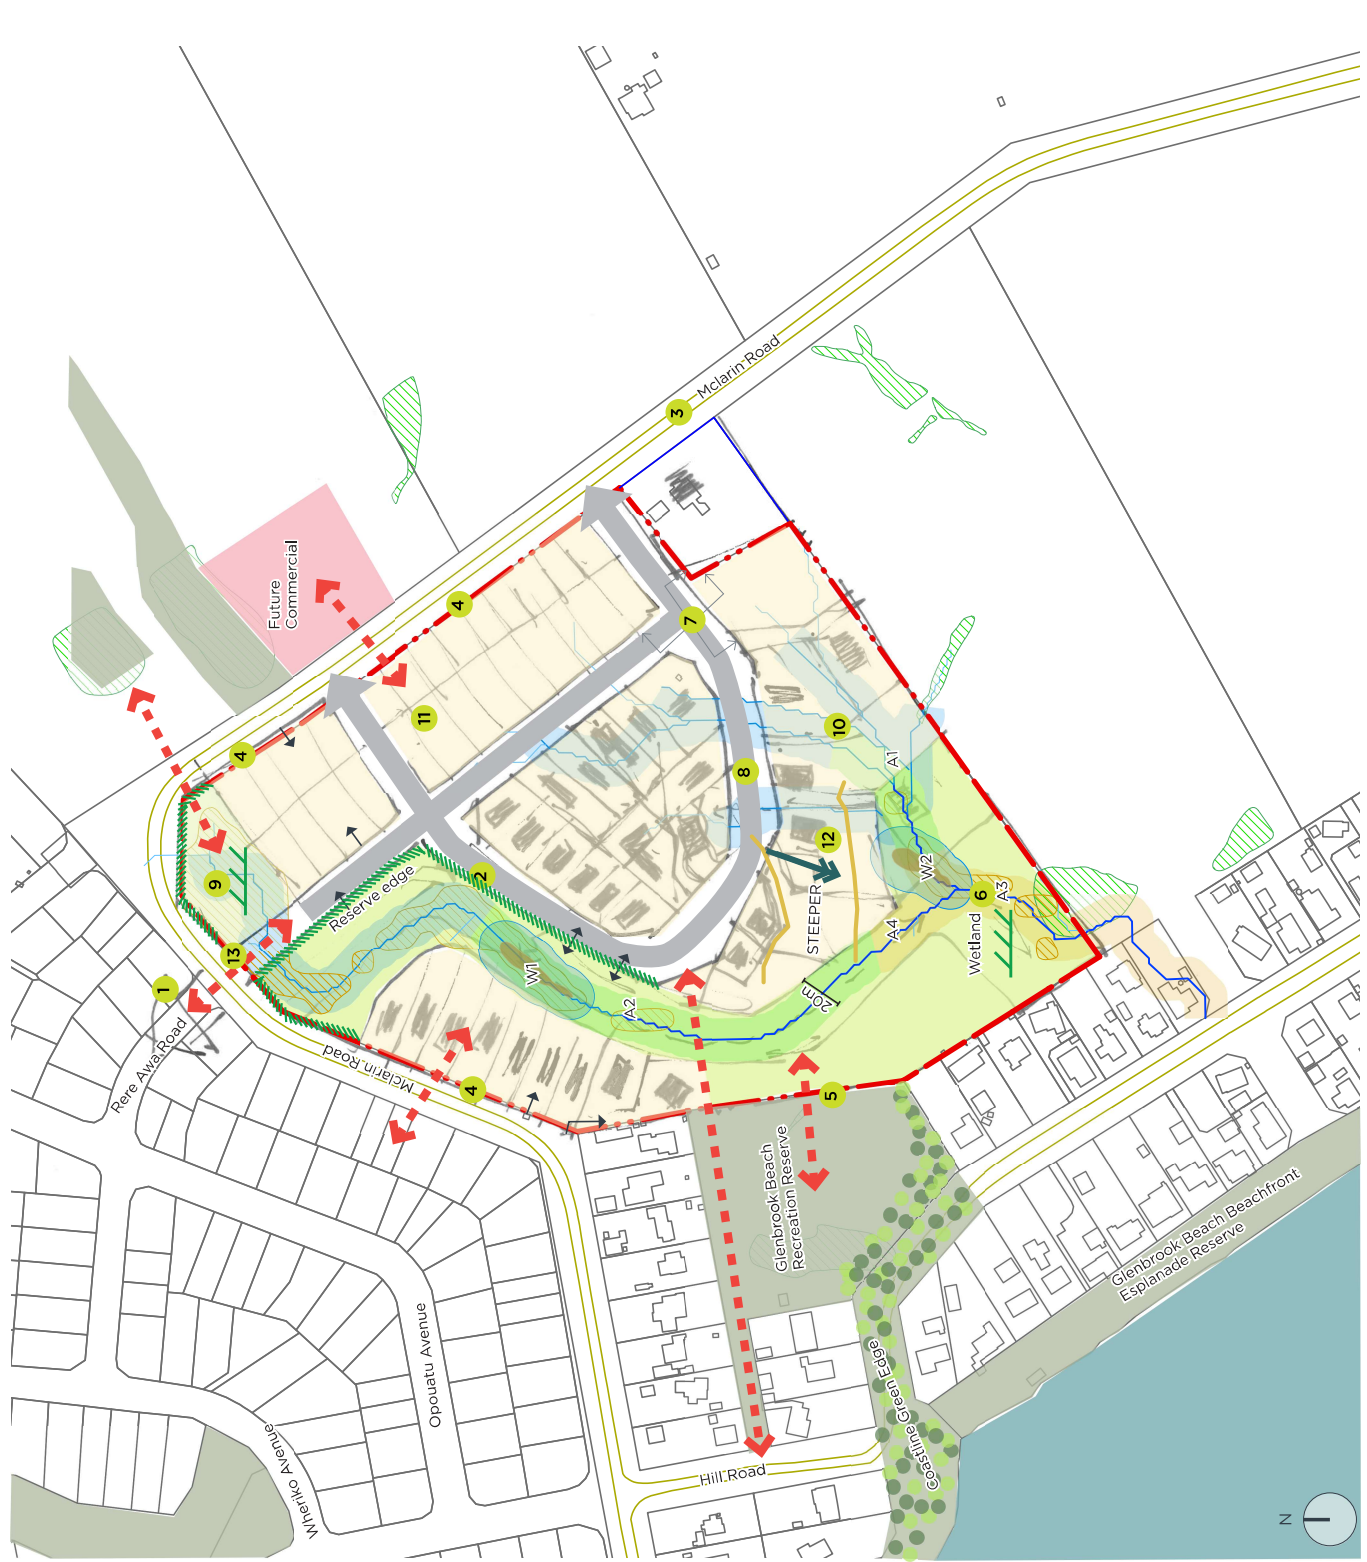
OPTION 1B

KEY MOVES

1. Possible connection to Rere Awa Road.
2. Reserve edge crescent with pedestrian/cycle path.
3. Assume 50 km/h McLaren Road.
4. Lot access from McLaren Road.
5. Connection to the existing reserve.
6. Stormwater in existing wetland W2.
7. Align with existing lot boundaries.
8. Street on steeper areas.
9. Stormwater wetland or recreational reserve when dry.
10. Average lot size - 650m².
11. Higher density closer to the future commercial zone - 400m² lots.
12. Larger lots where steeper.
13. Possible pedestrian/cycle connection.

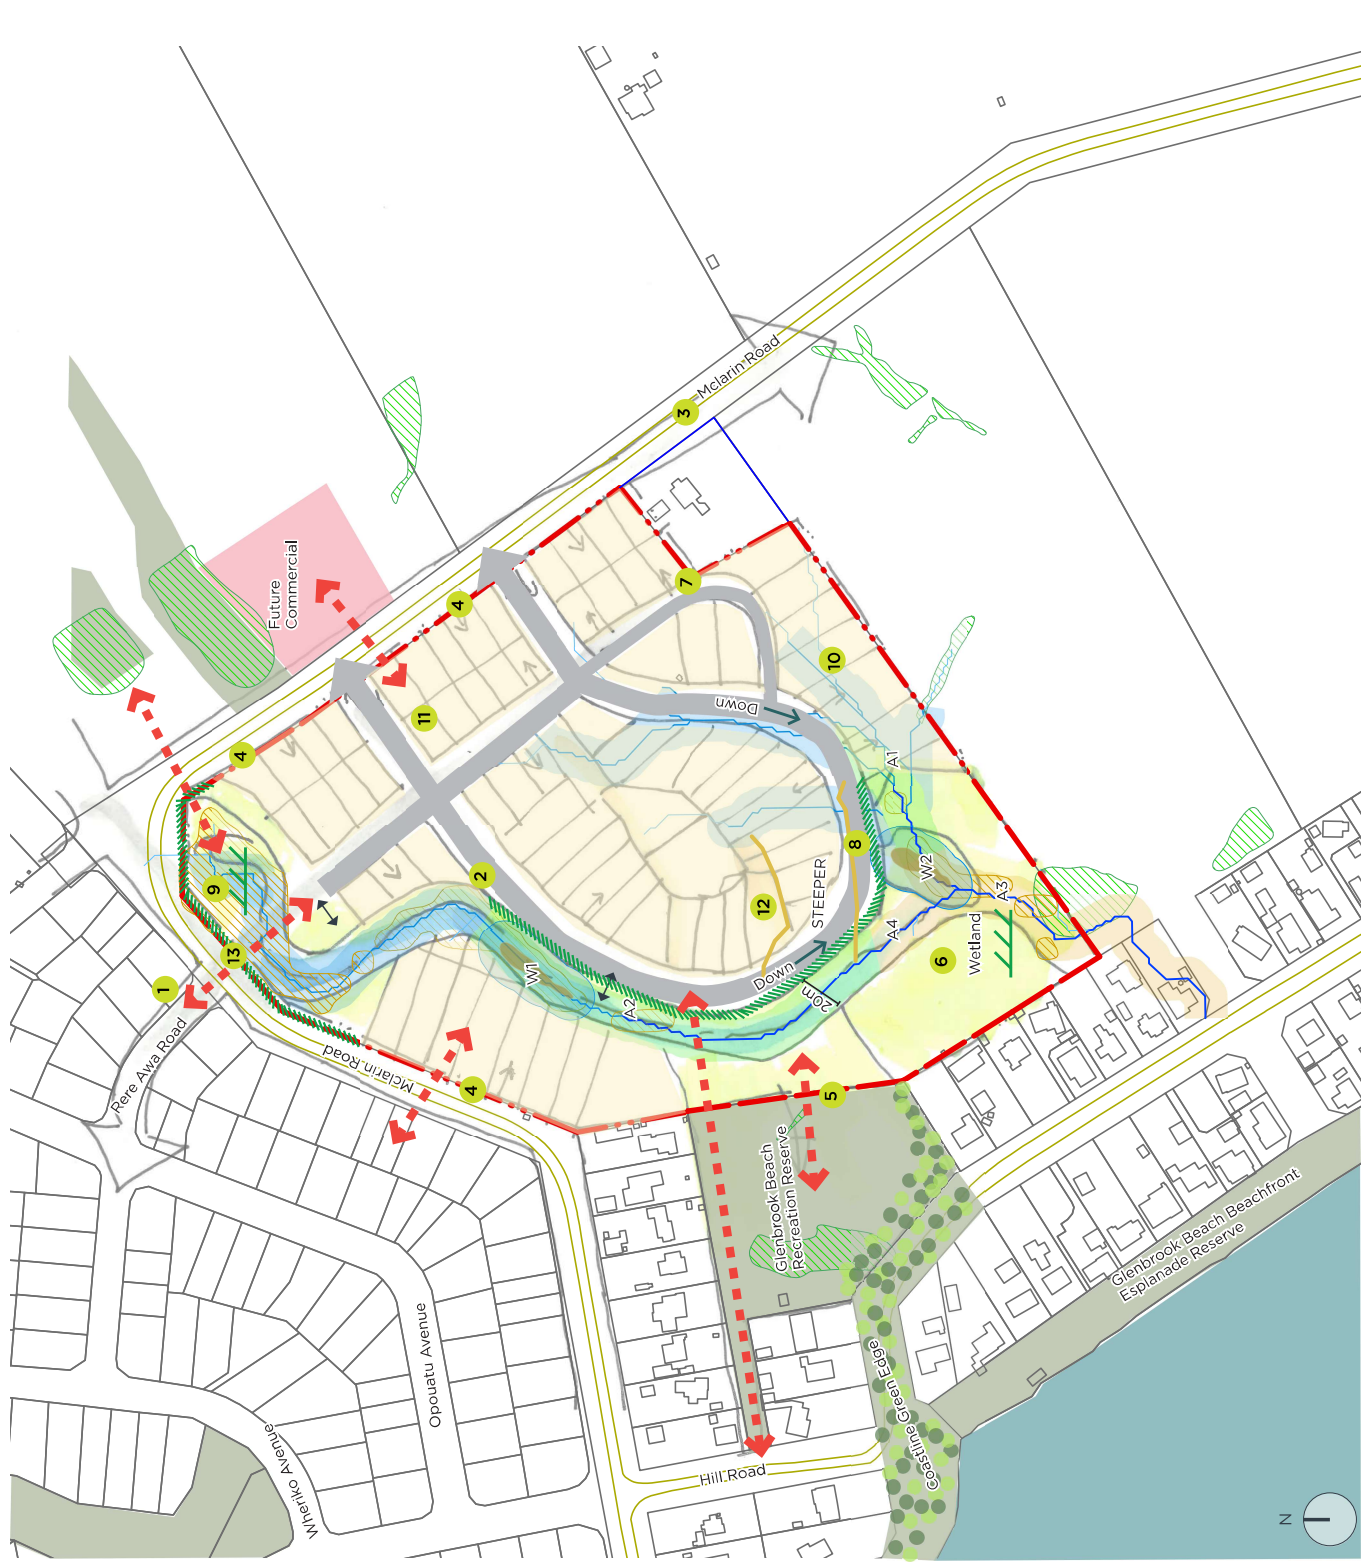
OPTION 2

KEY MOVES

1. Possible connection to Rere Awa Road.
2. Reserve edge street with pedestrian/cycle path.
3. Assume 50 km/h McLaren Road.
4. Lot access from McLaren Road.
5. Connection to the existing reserve.
6. Stormwater in existing wetland W2.
7. Lot backing on to the reserve.
8. Street on steeper areas.
9. Stormwater wetland or recreational reserve when dry.
10. Average lot size - 600m².
11. Higher density closer to the future commercial zone 250-450m² zero lots and two storeys.
12. Larger lots where steeper.
13. Possible pedestrian/cycle connection.

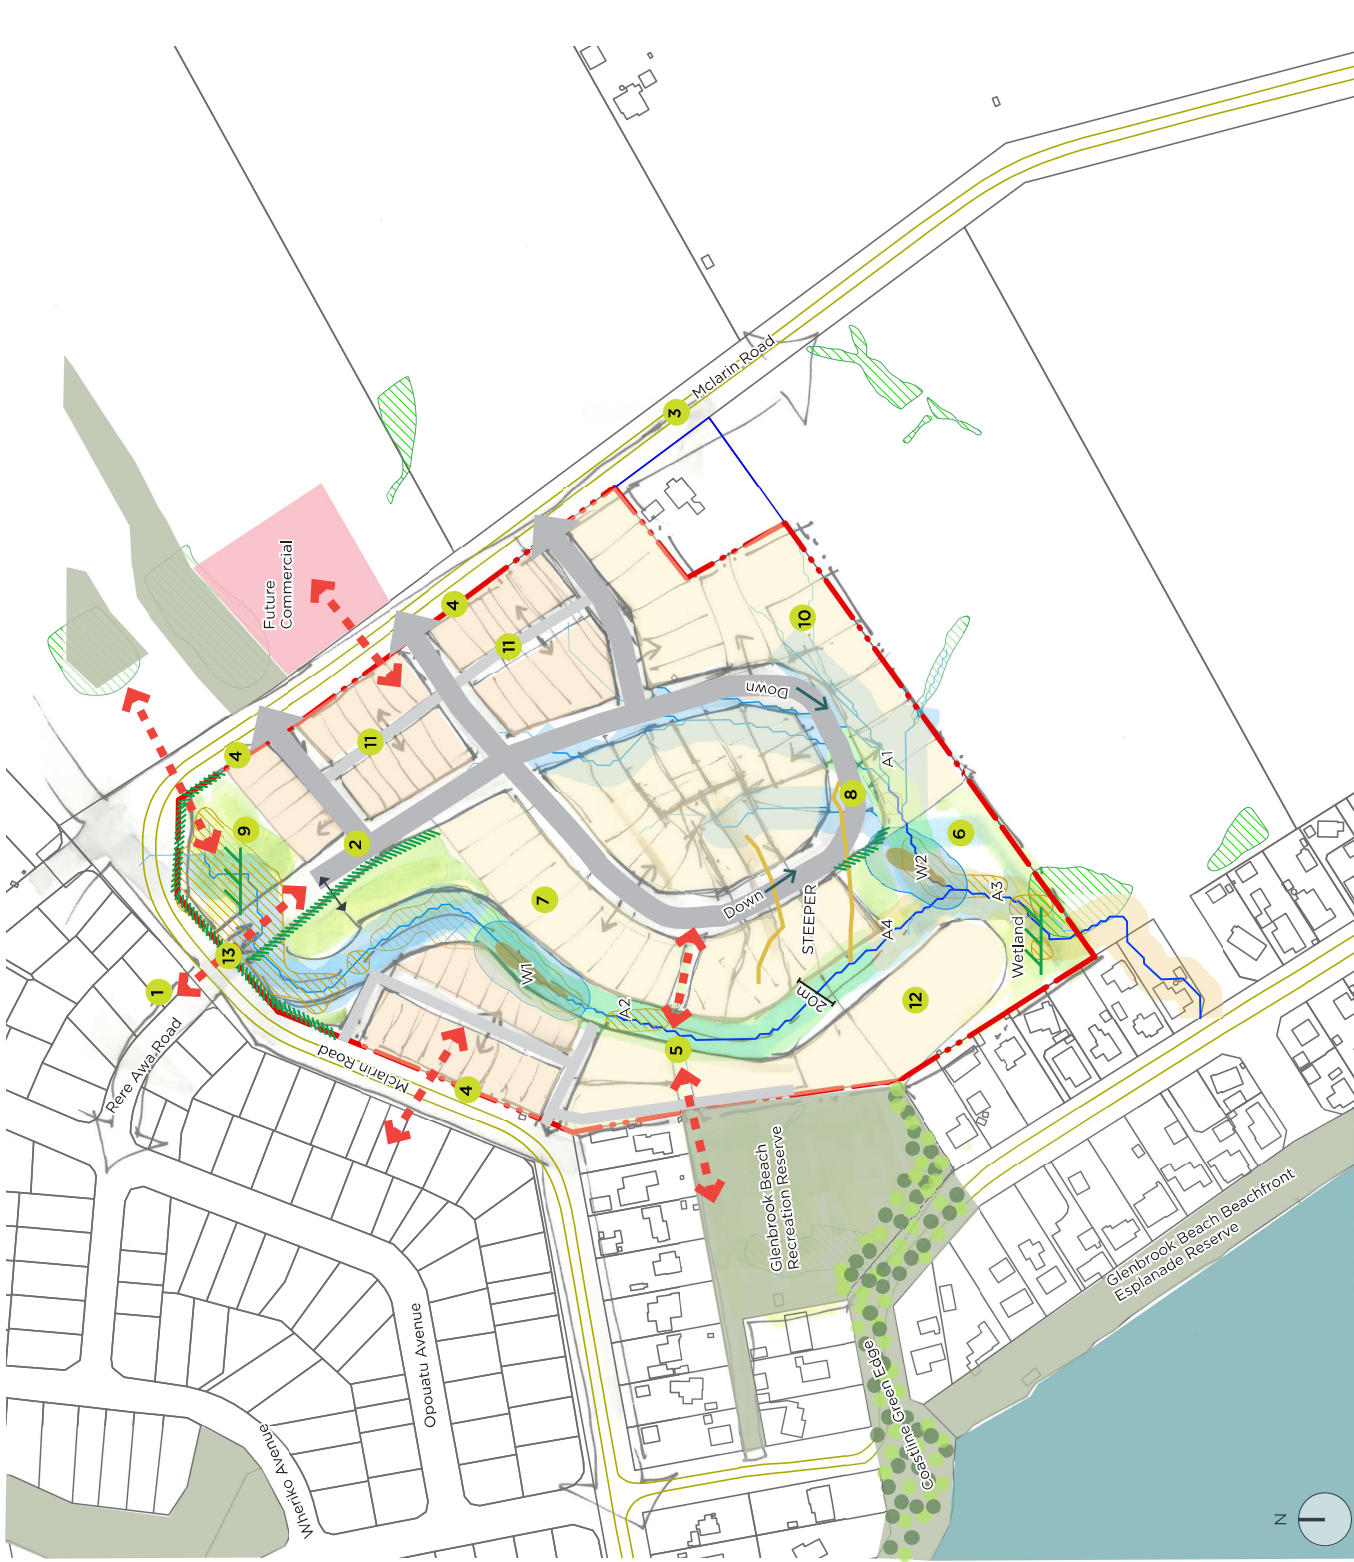
OPTION 2B

KEY MOVES

1. Align access with Rere Awa Road.
2. Reserve edge to W2 and W1 with pedestrian/cycle path.
3. Assume 50 km/h McLaren Road.
4. Lot access from McLaren Road.
5. Connection to the existing reserve.
6. Stormwater in existing wetland W2.
7. Lot backing on to the reserve.
8. Street on steeper areas.
9. Stormwater wetland or recreational reserve when dry.
10. Average lot size - 450m².
11. Higher density closer to the future commercial zone 250- 450m² zero lots with rear access lanes and potential for two storeys.
12. Larger lots where steeper.
13. Stream incorporated into lots.
14. Possible Future Commercial/Mixed Use.
15. Flexible lot layout based on typology.

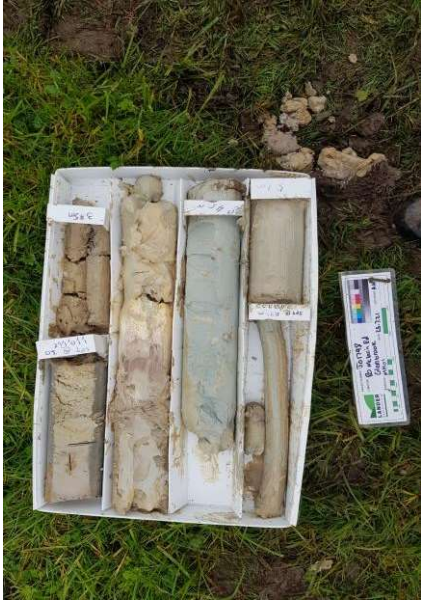
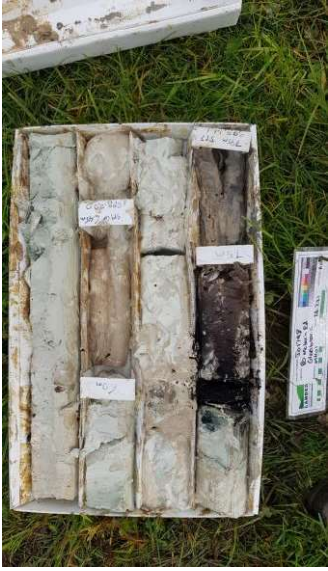
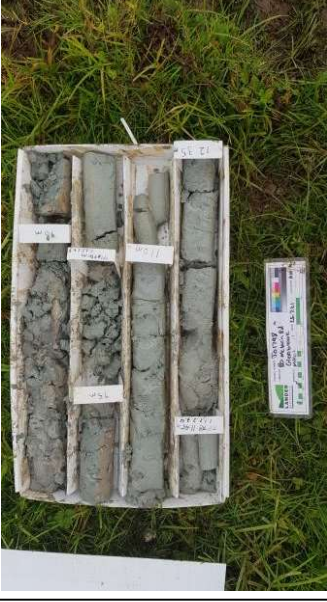
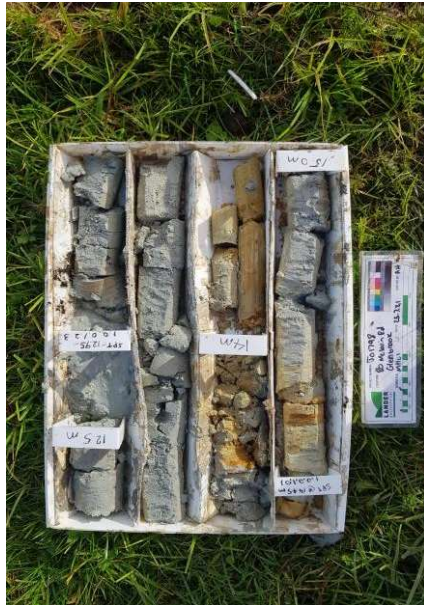
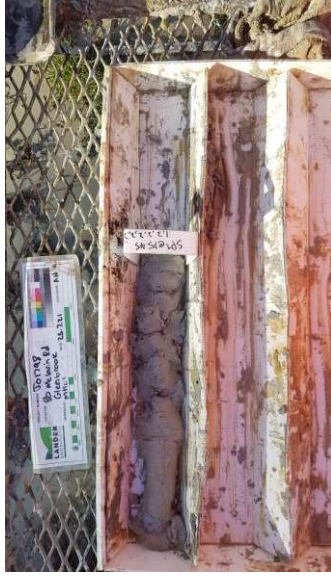
client:	HD Project 2 Limited		figure no:	
	project:	80 McLaren Road Glenbrook		project no:	J01798
	title:	MH01		compiled:	RZ
				date:	23.07.21
				figure 1

Driller: Pro-Drill Rig: Digger

Drilling Fluid:	water	Topsoil	Sand	Sandstone	Plutonic
	Fill	Gravel	Siltstone	No Core	
Checked:	RZ	Clay	Organic	Limestone	
		Silt	Pumice	Volcanic

Silty sands were found in MH01 from 8.7m depth to the end of the borehole at 15m depth. SPT N values within these soils were typically between 6 and 22 blows of the hammer indicating these soils are sometimes loose (e.g. an isolated N value at 14m being very loose), but mostly medium dense to dense.
