PROPOSED WHENUAPAI BUSINESS PARK PLAN CHANGE

TRIG ROAD AND BRIGHAM CREEK ROAD, WHENUAPAI

GEOTECHNICAL ASSESSMENT REPORT

AKL2023-0230AB Rev 0

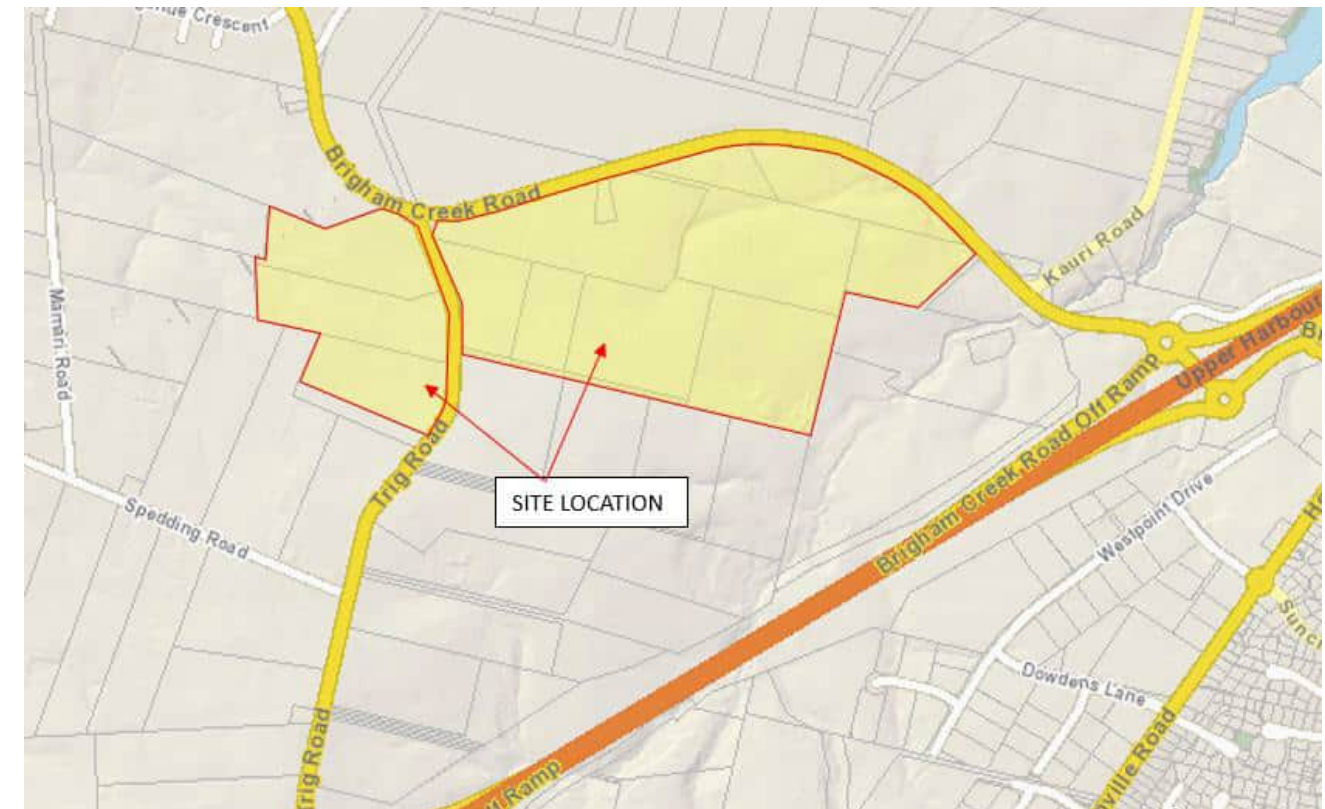
Figure 1: Site Location Plan (Reference Auckland Council Geomaps)

The site comprises an area of approximately 47.5 hectares and comprises the 13 following land parcels, as shown on **Figure 1**:

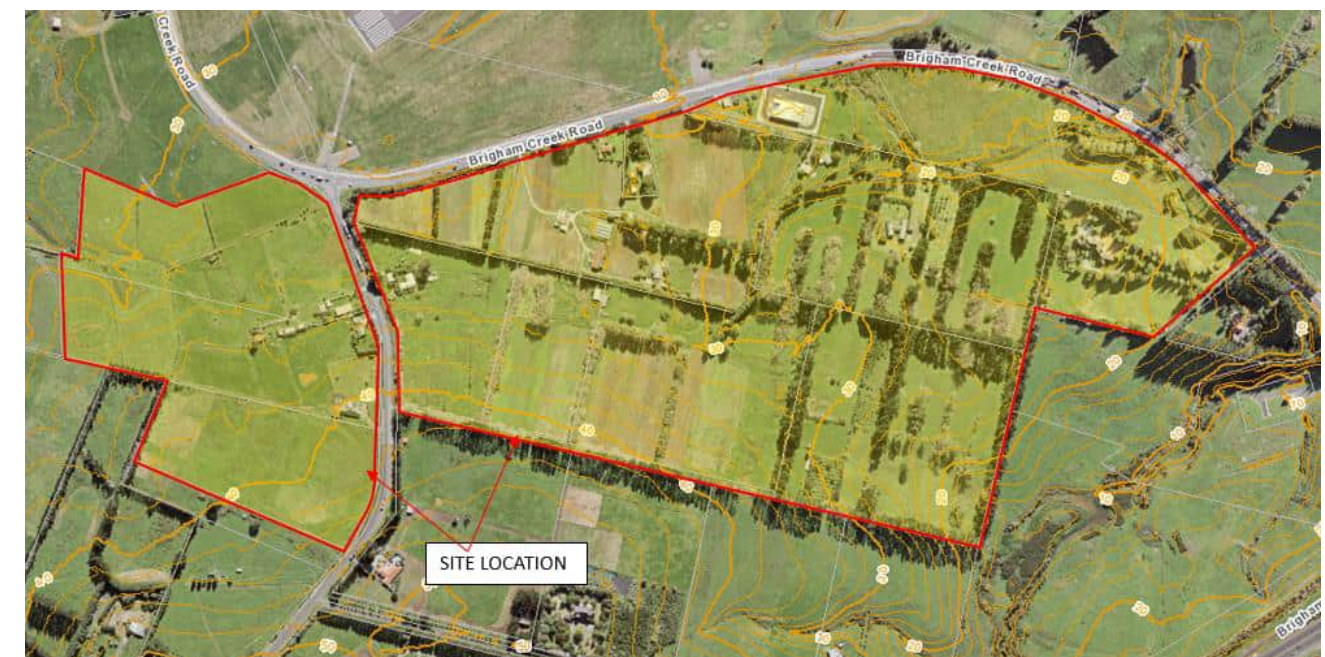
Figure 2: Site Contour Plan (Reference Auckland Council Geomaps)

The current general landform is presented on **Figure 2**.

The area is characterised by an alluvial terrace that grades from Trig Road in the southwest gently towards the northwest and gently to moderately to the east/northeast. A minor stream runs from west to northeast through the centre of the main site, with a larger southwest to northeast trending stream located to the south-east of the overall block. The overall topography falls from a high point on Trig Road of RL45m, to a low on the south-eastern flank of RL14m and in the eastern corner of RL12m.

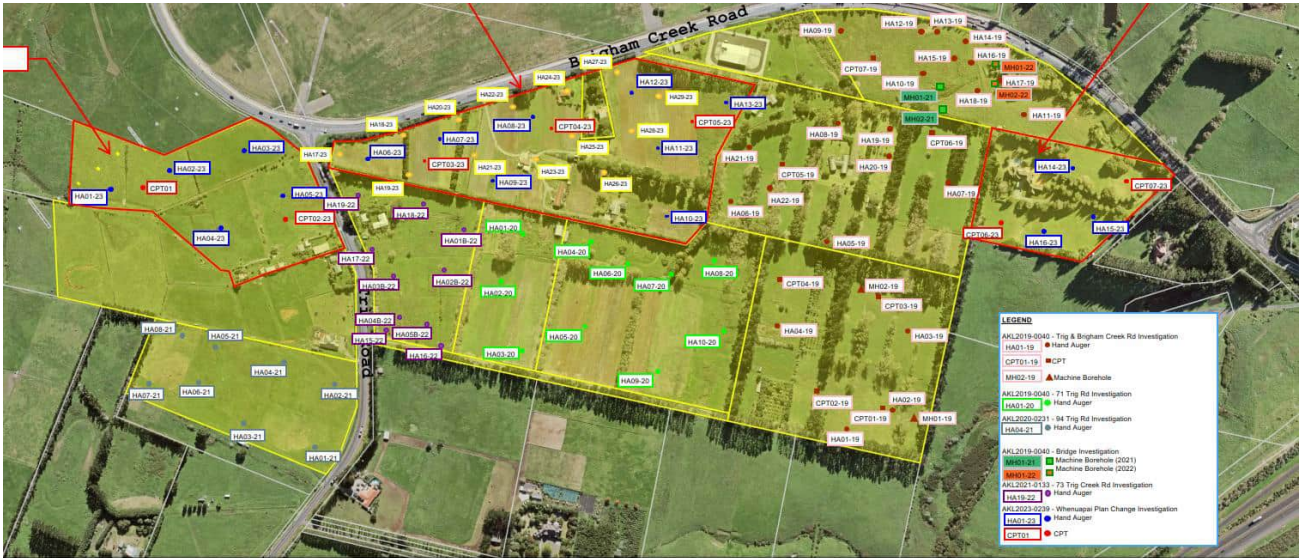
Figure 8: CMW Site Investigation Plan

Site investigations have been previously undertaken by CMW across some of the properties comprised within the proposed Plan Change area. Investigations have also been recently completed across the properties at 96 Trig Road and 141 & 159 Bringham Creek Road, to supplement the previous investigations. The scope of recent fieldwork completed comprised a suite of hand auger boreholes (HA01-23 to HA16-23) and Cone Penetration Tests (CPT). The appended Site Investigation Plan, and **Figure 8** below show all CMW investigations that have been completed within the subject area.
