9885-3G

18 January 2019

**GEOTECHNICAL ENGINEERING FEASIBILITY ASSESSMENT
PROPOSED PLAN CHANGE
NORTH WARKWORTH AREA
WARKWORTH**

KGA Geotechnical Group Limited

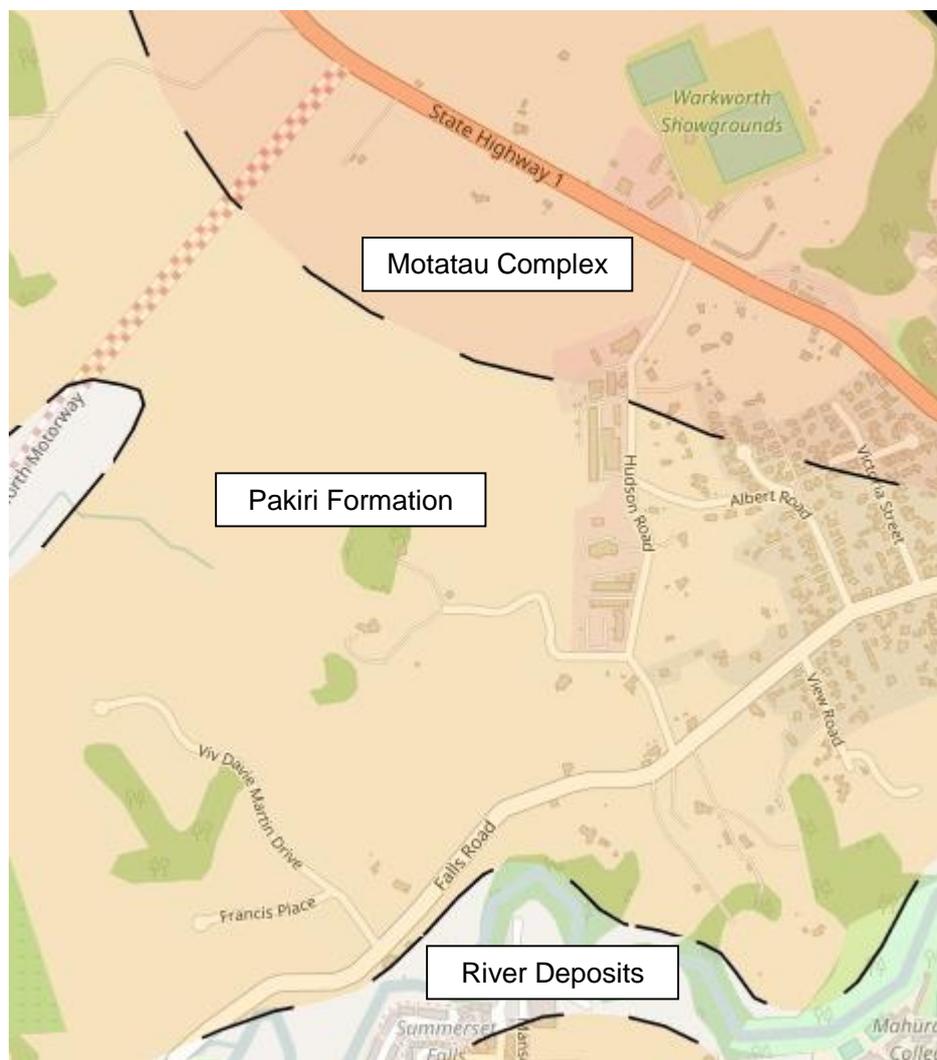
Figure 1. Annotated general geology of subject area, not to scale (GNS Science, 2013).

The general geology of the area, as described above, is shown in Figure 1 below.

Motatau Complex rocks, mainly consisting of the Mahurangi Limestone, tend to be closely fractured and intensely crushed, and their strength apparently varies from moderately soft to moderately hard when fresh. When weathered they form soft to very soft yellow-white, low shear strength clay to depths of about 5m. Where the rocks of the Motatau Complex are undifferentiated on the map, they should again be approached as though they are the least stable rocks of the complex.

The portion of the subject area adjacent to the Mahurangi River is shown to be underlain by Holocene river deposits described as sand, silt mud and clay with local gravel and peat beds.

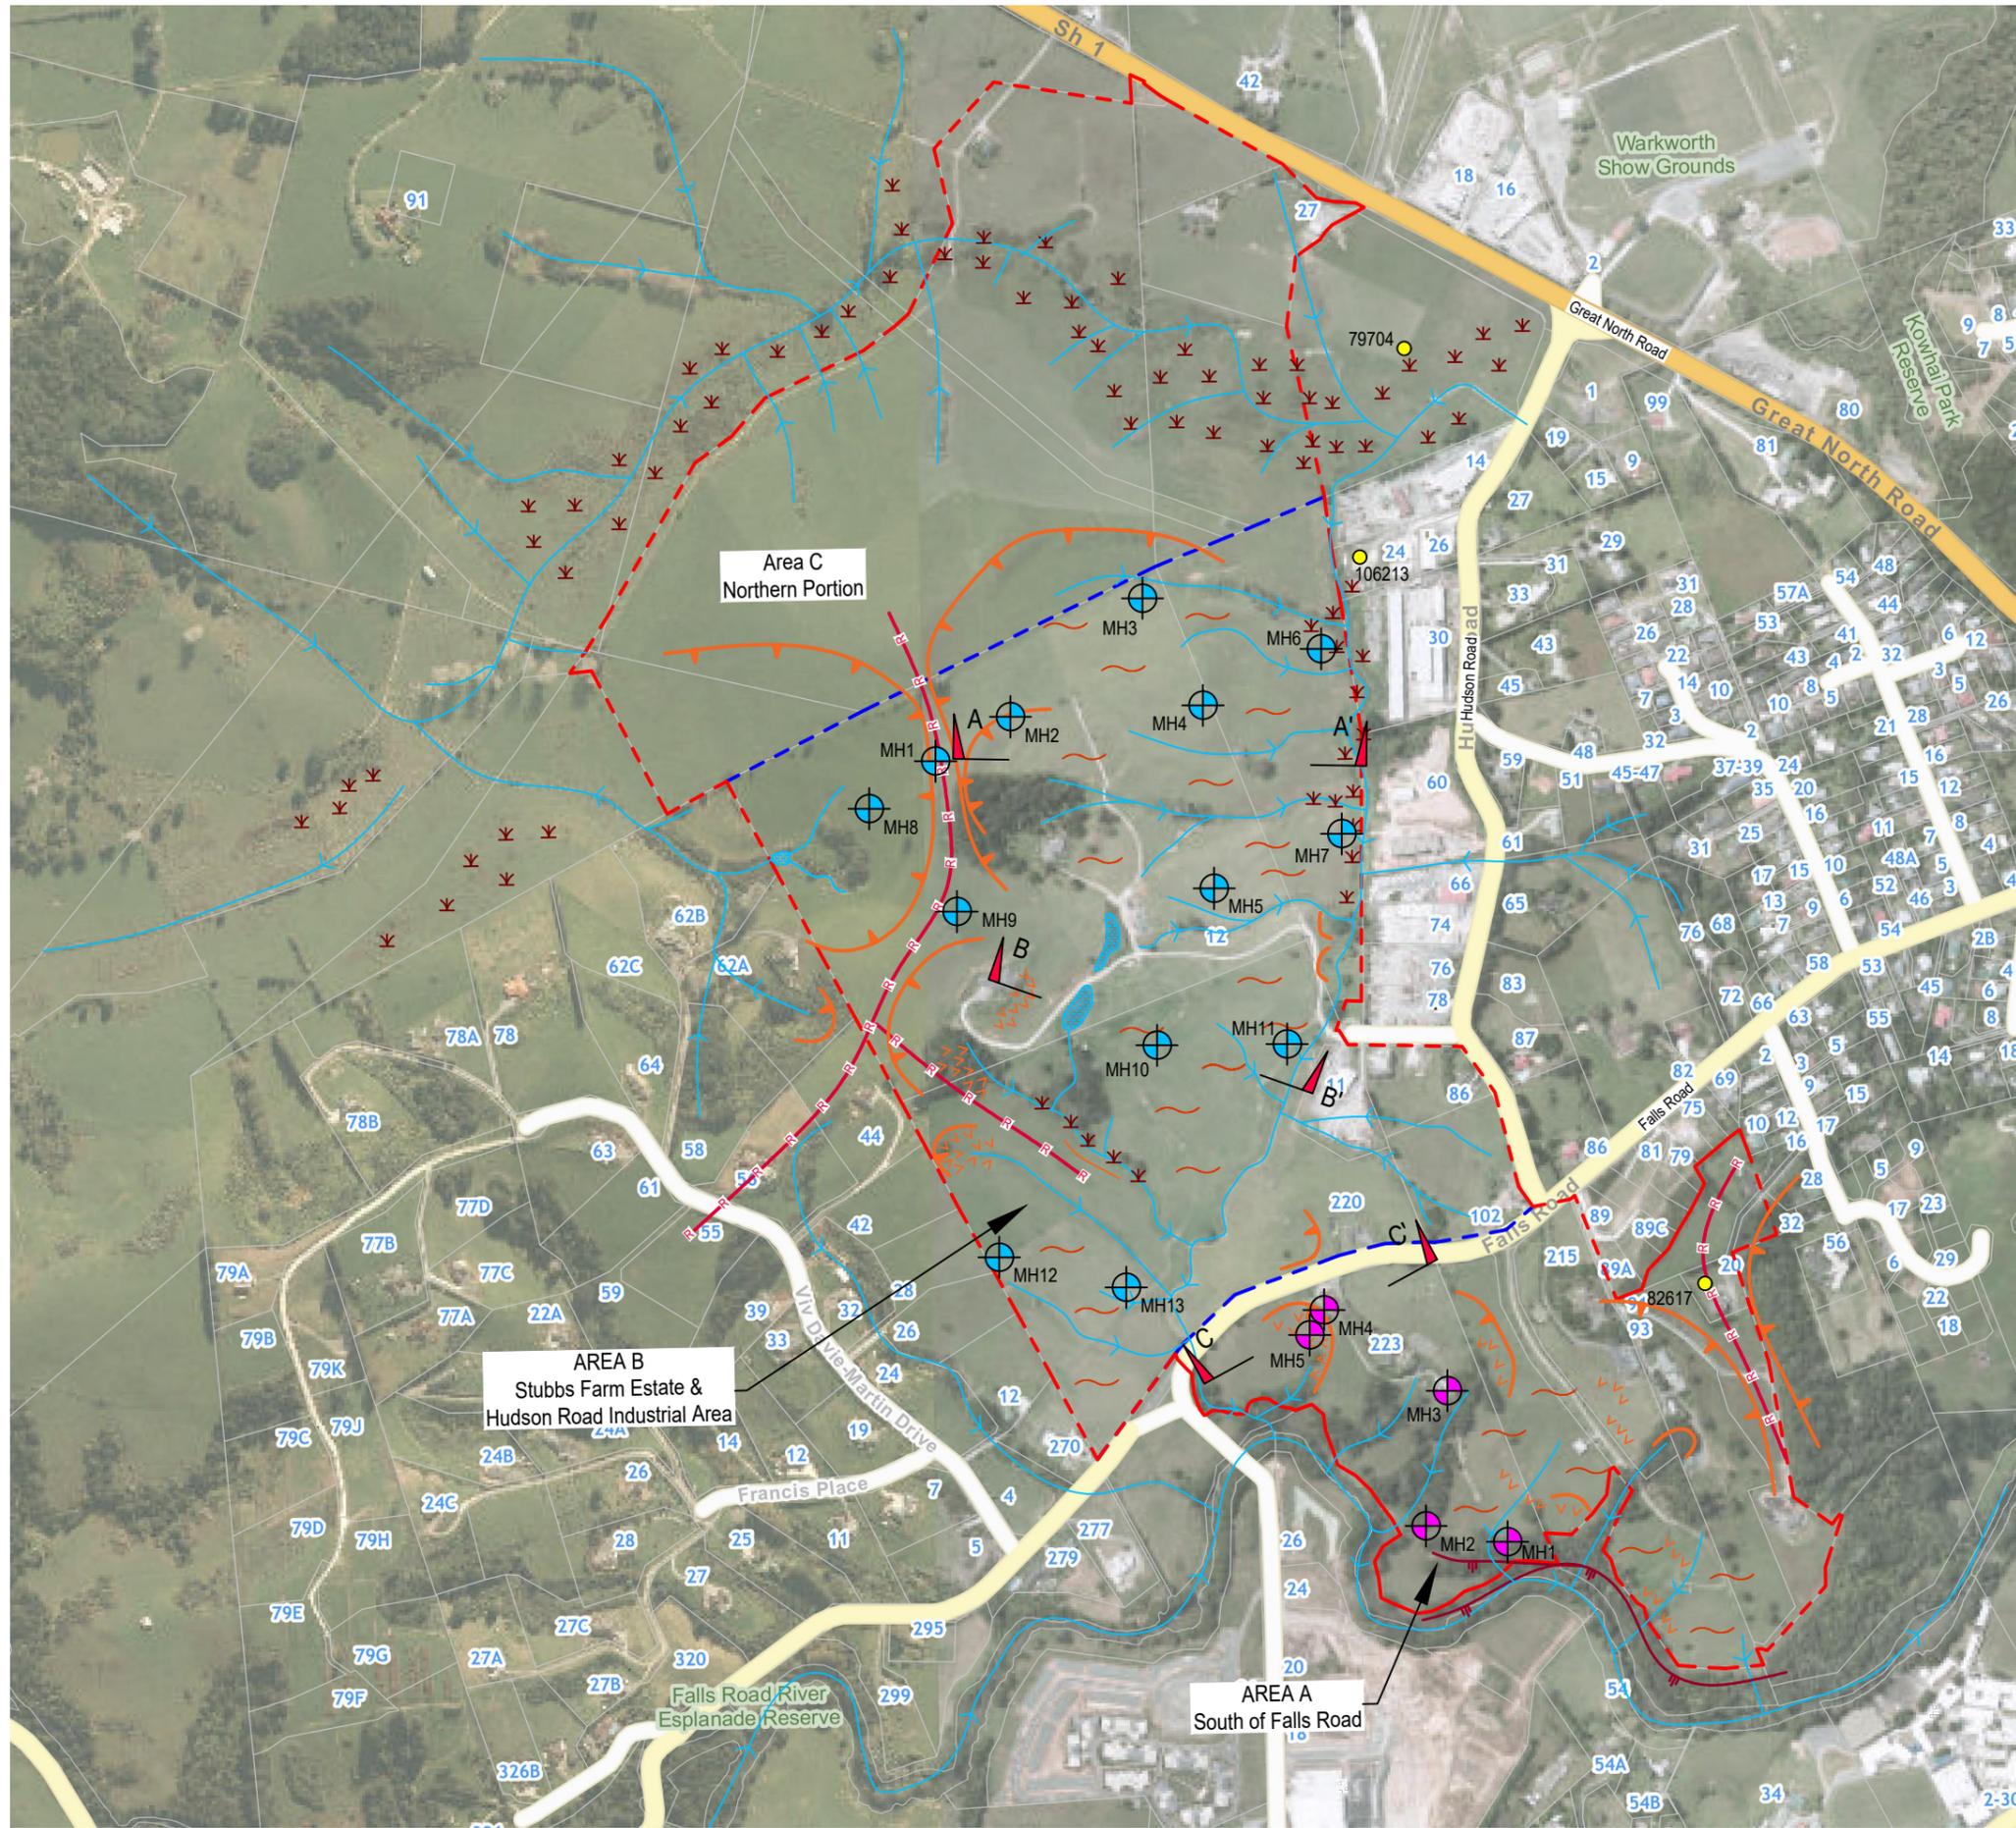
- Key:
- Approximate location of ridge lines
 - Approximate location of backscarp
 - Approximate location of minor scarps
 - Approximate location of shallow surface creep
 - Approximate location of watercourses and overland flow paths
 - Approximate location of wetland areas
 - Approximate location of hummocky Ground
 - Plan Change Boundary
 - Area Boundaries
 - Approximate location of machine boreholes, Mar-Apr 2017 (MH1)
 - Approximate location of machine boreholes, Dec 2016 (MH1)
 - Subsurface information from New Zealand Geotechnical Database (106213)
 - Approximate cross section locations

The investigation identified that the subsurface conditions generally comprised residually weathered Waitemata Group deposits overlying Waitemata Group rock at depth. Colluvial materials were identified on the steeply sloping gully sides and alluvial deposits were identified within the gully areas and low lying portions of the site adjacent to the Mahurangi River. Copies of the machine borehole logs from the investigation are presented in Appendix 2, and the approximate locations of the boreholes are shown on Sheet 2.

As part of the investigation, subsurface conditions at the site were explored by drilling thirty-four hand auger boreholes, thirteen rotary machined drilled boreholes, thirteen CPT probes and four seismic dilatometer probes. Data from our site investigation at Stubbs Farm Estate has indicated that the site is generally underlain by residual Waitemata Group deposits, colluvium and alluvium, and that groundwater levels are relatively high across the site. Copies of the machine borehole logs from the investigation are presented in Appendix 2, and the approximate locations of the boreholes are shown on Sheet 2.

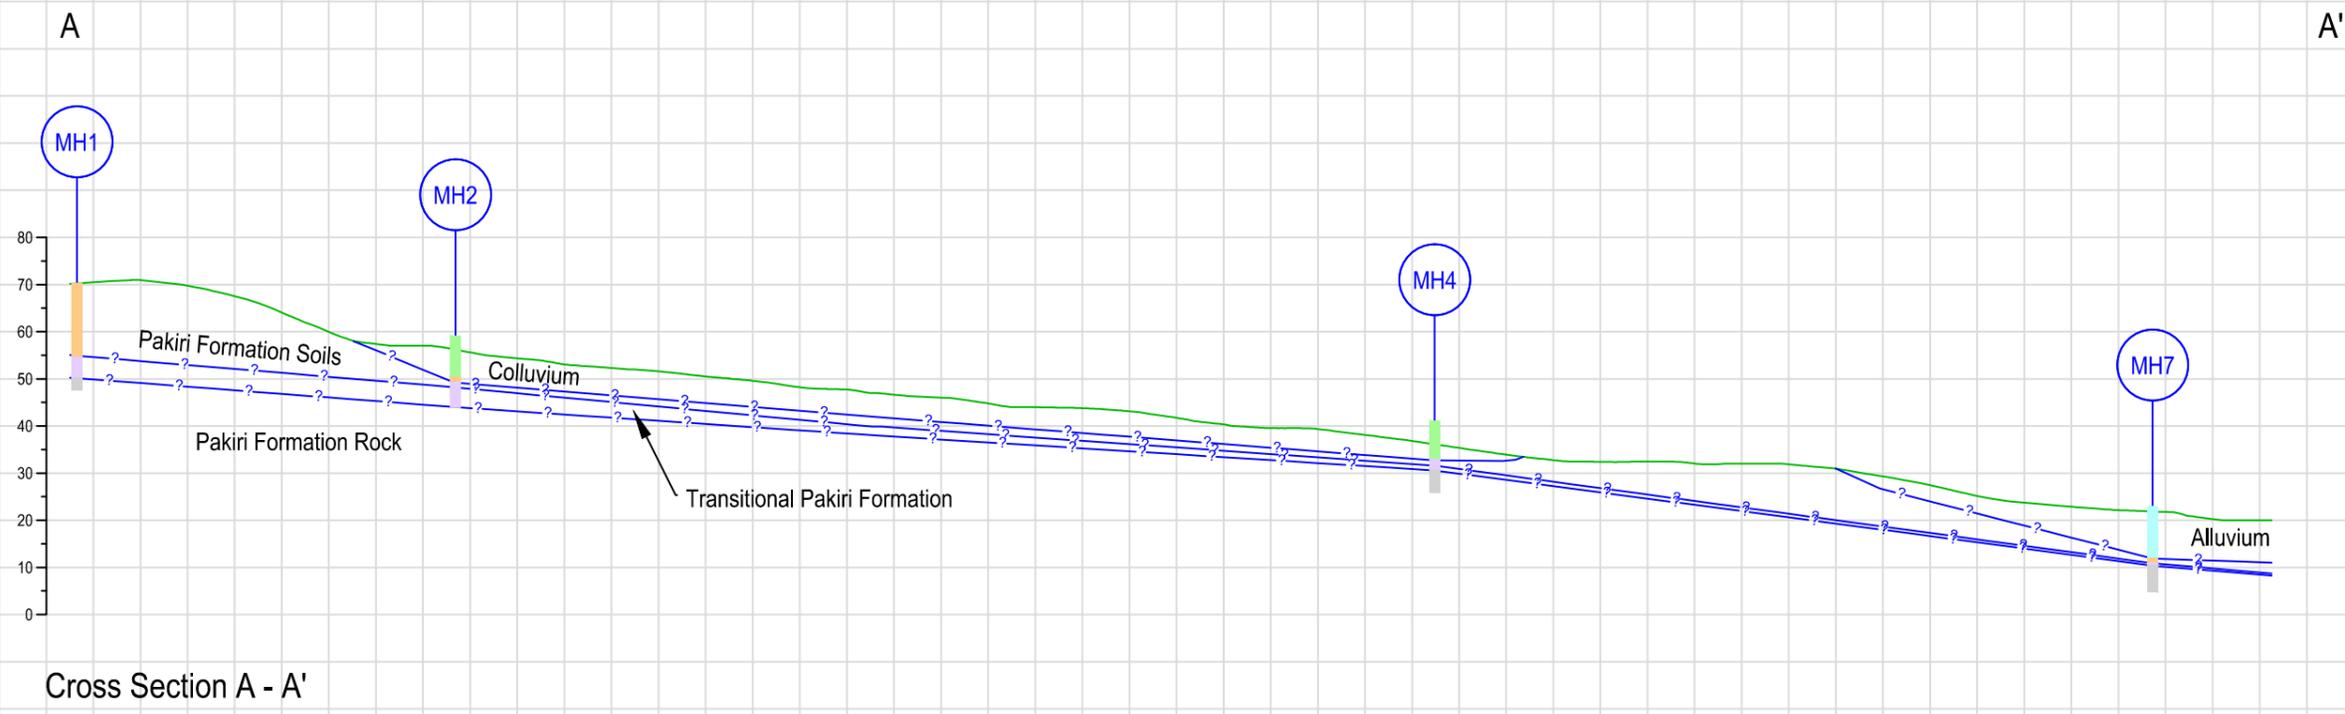
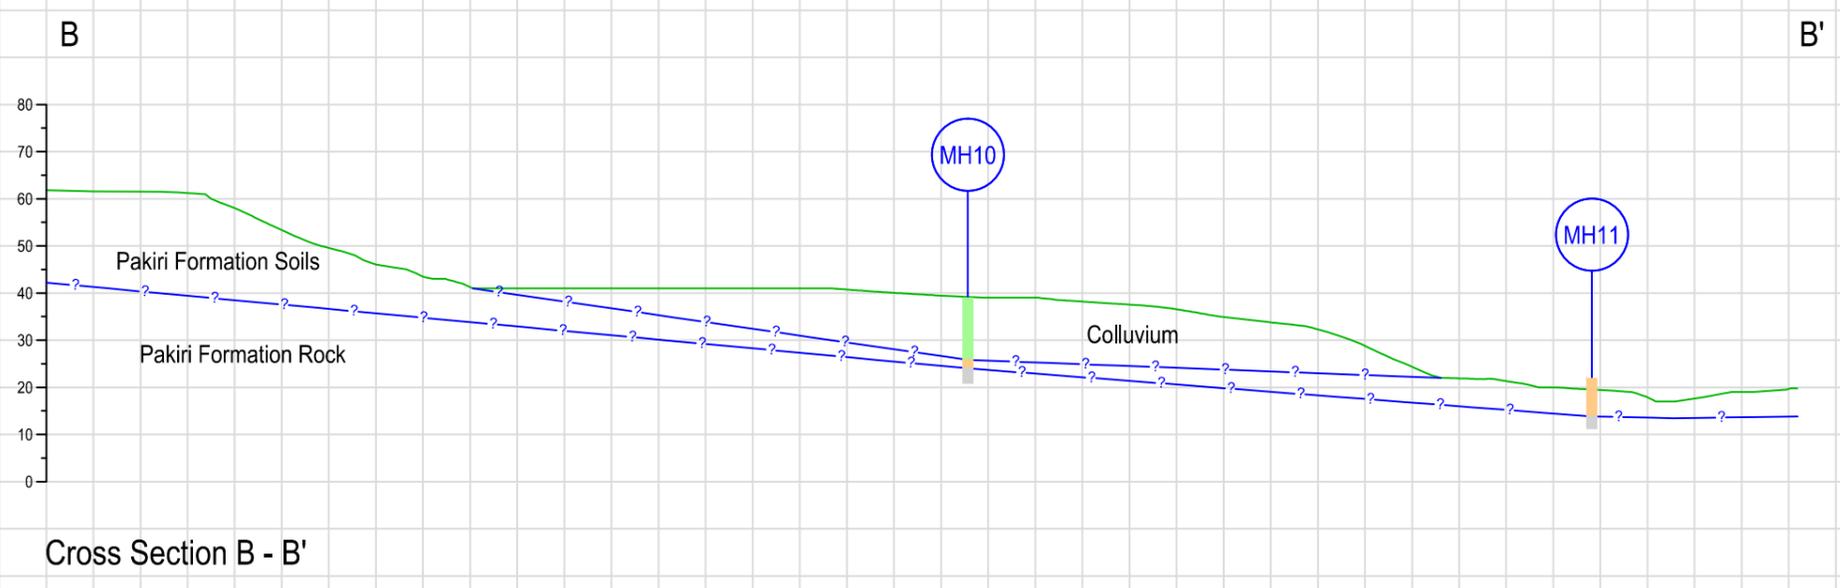
- Alluvium
- Colluvium
- Pakiri Formation Soils
- Transitional Pakiri Formation
- Pakiri Formation Rock

- Notes:**
- Locations of features approximate only.
 - Ground profile based on topographical information provided to us by Chester Consultants Ltd.
 - For detailed subsurface conditions and groundwater levels, refer to borehole logs.

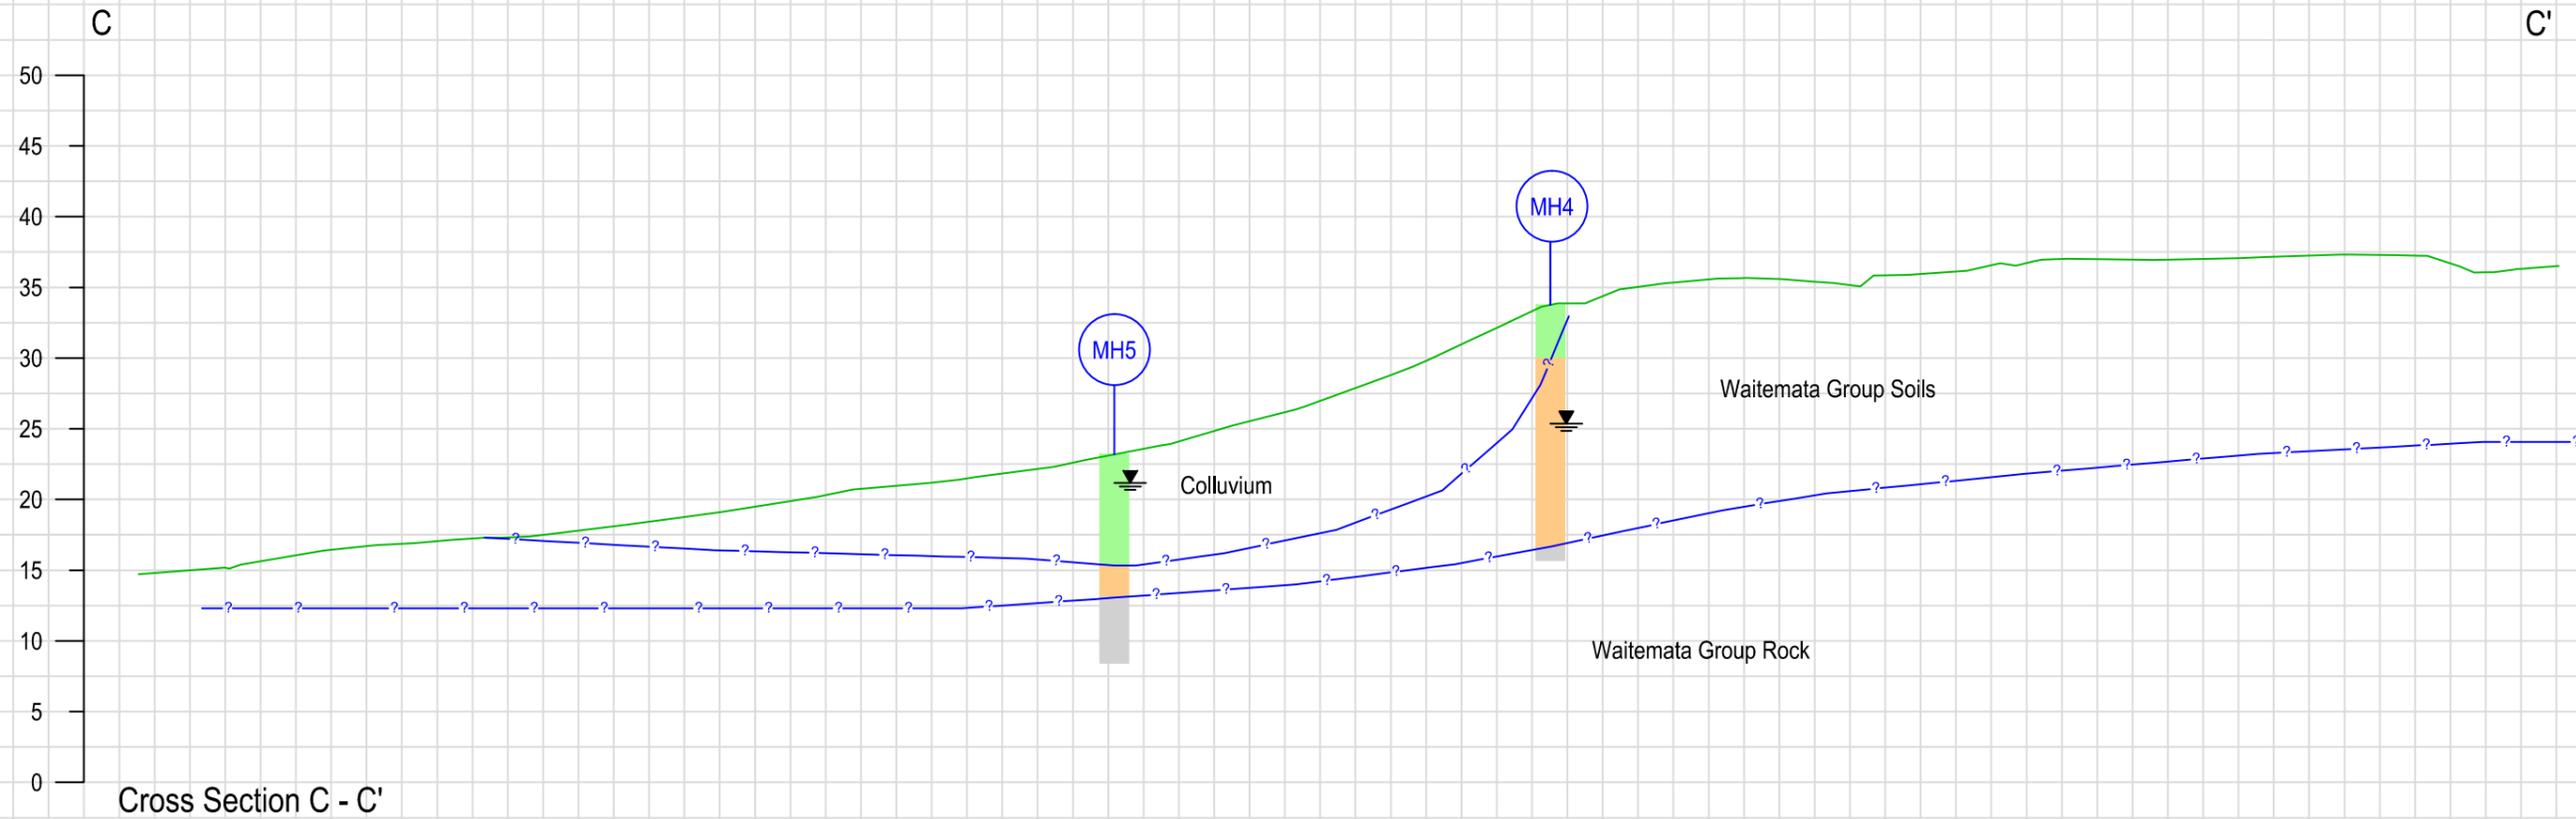
- Notes:
1. Locations of features approximate only
 2. Cross section profiles provided by Chester Consultants Ltd, titled, 'Earthwork Section Views', Ref 11504, dated 15-Sept-2016.
 3. For full details on ground conditions, refer to individual borehole logs.

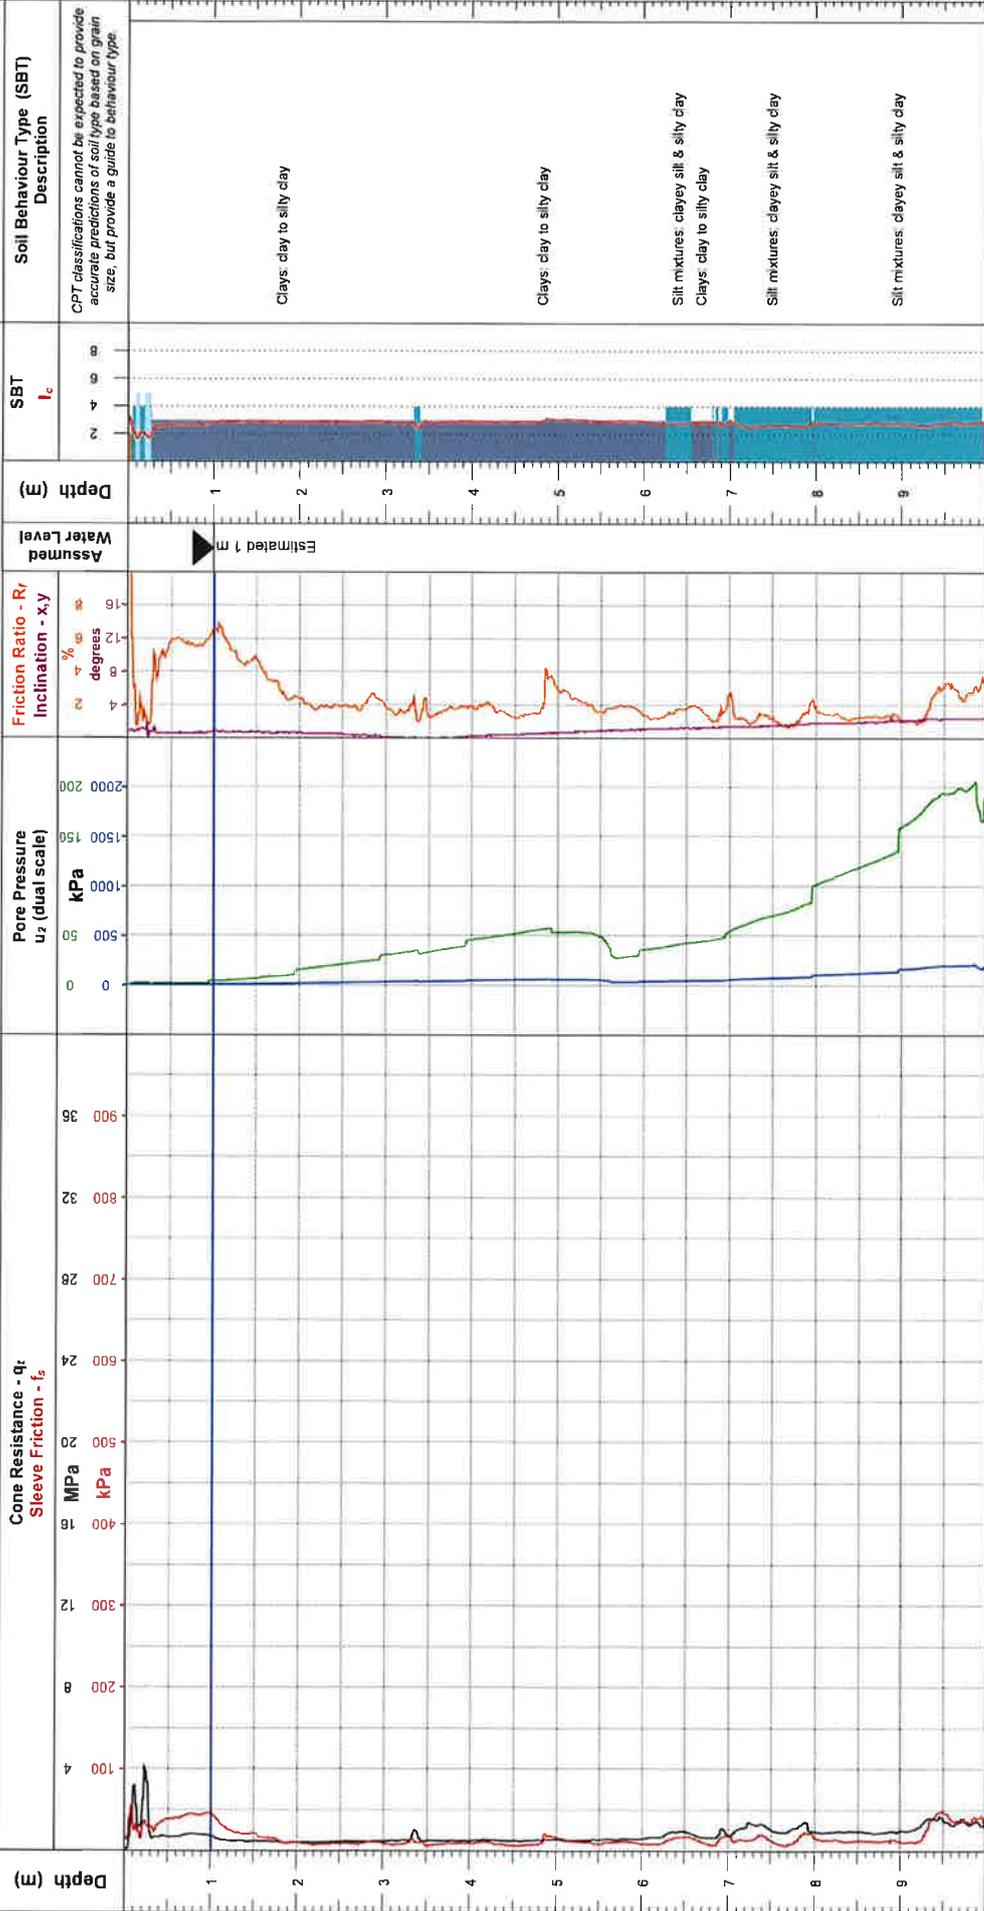
NZGDREF 106213
1/2

CONE PENETRATION TEST (CPT) LOG

<p>Client: Tonkin + Taylor Project: 24 Hudson Road Location: Warkworth, Auckland Engineer: Luke Storie Contractor: Ground Investigation Ltd. www.g-i.co.nz</p>	<p>Operator: Tony Whiteleaw Cone Ref: MKJ335 Cone Type: 10 cm² Compression Piezocene Area Ratio: 0.8 Filter Type: u2</p>	<p>NZTM2000 N,E (m): 5971082.14, 1747849.68 WGS84, (deg): 174.648621, -36.394048 Location Method: Handheld GPS Surveyor: N/A</p>
<p>Client Job Ref: - Date of Test: 8/08/2017 Elevation (m): - Depth (m): 17.54 Pre-Drill (m): N/A</p>		
<p>CPT Number: CPT-01</p>		
<p>G.I. Job Ref: 17-430</p>		
<p>Termination Reason: Limit of reaction force</p>		
<p>Remarks: Mixed fill at surface</p>

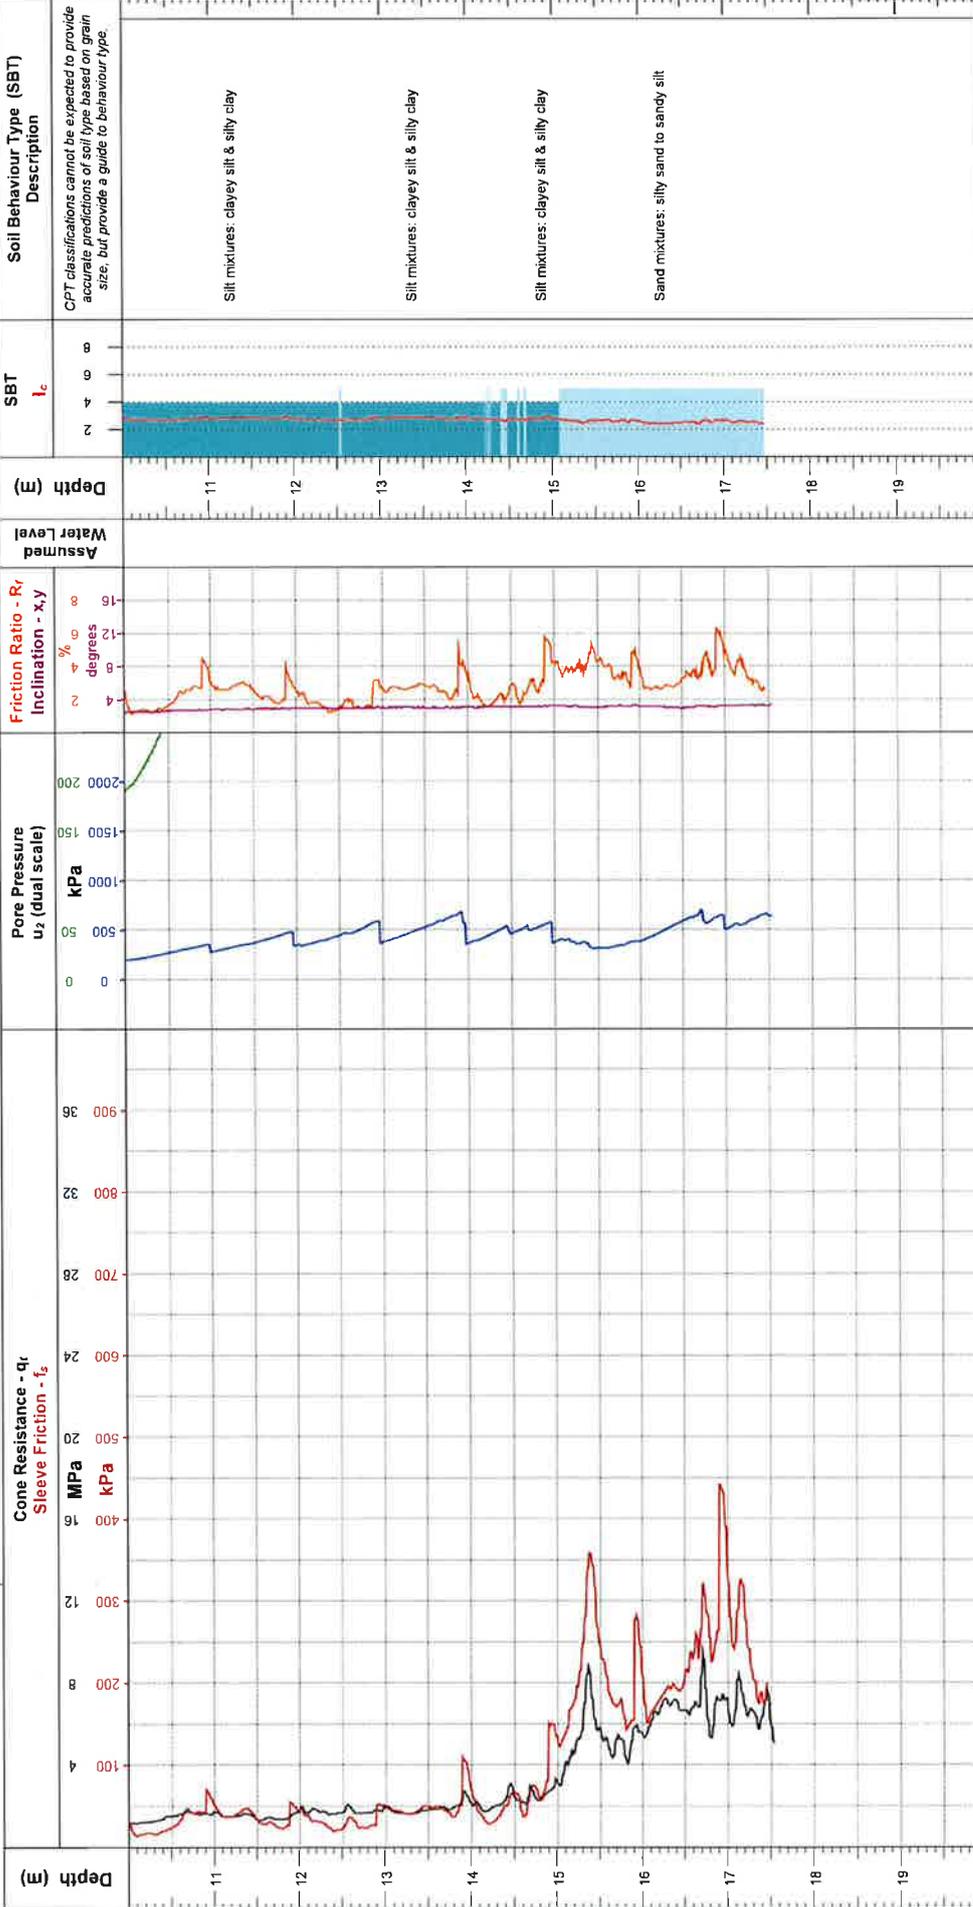
NZGDRAF 109213
2/2

CONE PENETRATION TEST (CPT) LOG

<p>Client: Tonkin + Taylor Project: 24 Hudson Road Location: Warkworth, Auckland Engineer: Luke Storey Contractor: Ground Investigation Ltd. www.g-i.co.nz</p>	<p>Operator: Tony Whitelaw Cone Ref: MKJ335 Cone Type: 10 cm² Compression Piezocene Area Ratio: 0.8 Filter Type: u2</p>	<p>NZTM2000 N,E (m): 5971082, 14, 1747849, 68 WGS84, (deg): 174.648621, -36.394048 Location Method: Handheld GPS Surveyor: N/A</p>	<p>Elevation (m): - Date of Test: 8/08/2017 Depth (m): 17.54 Pre-Drill (m): N/A</p>	<p>Client Job Ref: CPT Number: CPT-01 G.I. Job Ref: 17-430</p>
<p>Remarks: Mixed fill at surface</p>
