Title: Central Park, 666 Great South Road, Greenlane					
Date	Version	Description	Prepared by:	Reviewed by:	Authorised by:
5 July 19	1	Ground contamination assessment for private plan change and rezoning	E. LaFace	L. Phuah	Y. Thorp
25 July 19	2	Updated following review and comment by Tattico	C. Di Vitto	L. Phuah	L. Phuah

# 1 Introduction

Tonkin & Taylor Ltd (T+T) has been engaged by Oyster Management Ltd (Oyster) to prepare an updated ground contamination assessment for 666 Great South Road, Greenlane, Auckland. The location of the site is shown as the hatched area presented in Map 1.1 below.

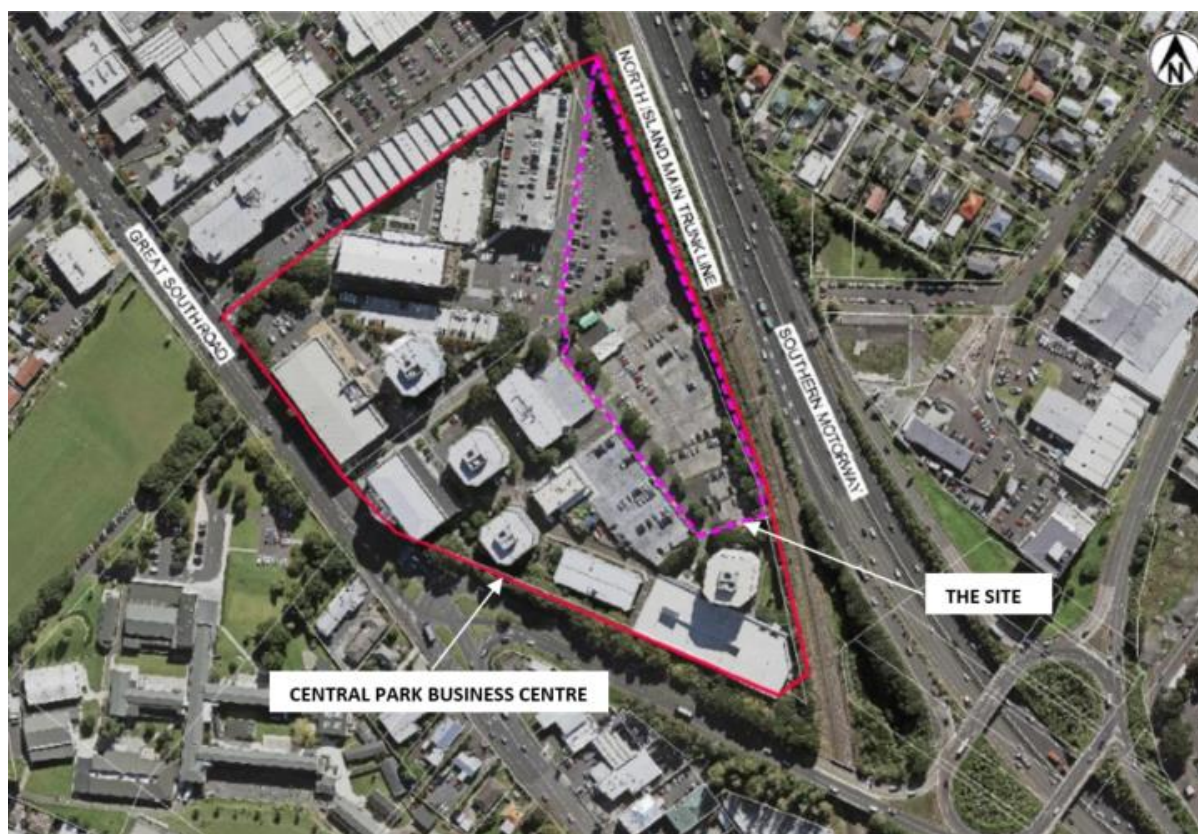
Map 2.1: Site setting. The pink dashed line indicates the site with respect to the greater Central Park Business Centre outlined in red (aerial source: Auckland Council GeoMaps).

The site is a portion of the wider developed business centre known as Central Park. The site is located along the eastern boundary of Central Park adjacent to the North Island Main Trunk railway line that abuts the eastern boundary of the site along with State Highway 1 (southern motorway) which runs parallel to the railway line. The wider area is comprised of commercial land to the north and south while directly across Great South Road to the west of site is One Tree Hill College School. An aerial photograph of the site and surrounds is presented in Map 2.1 below

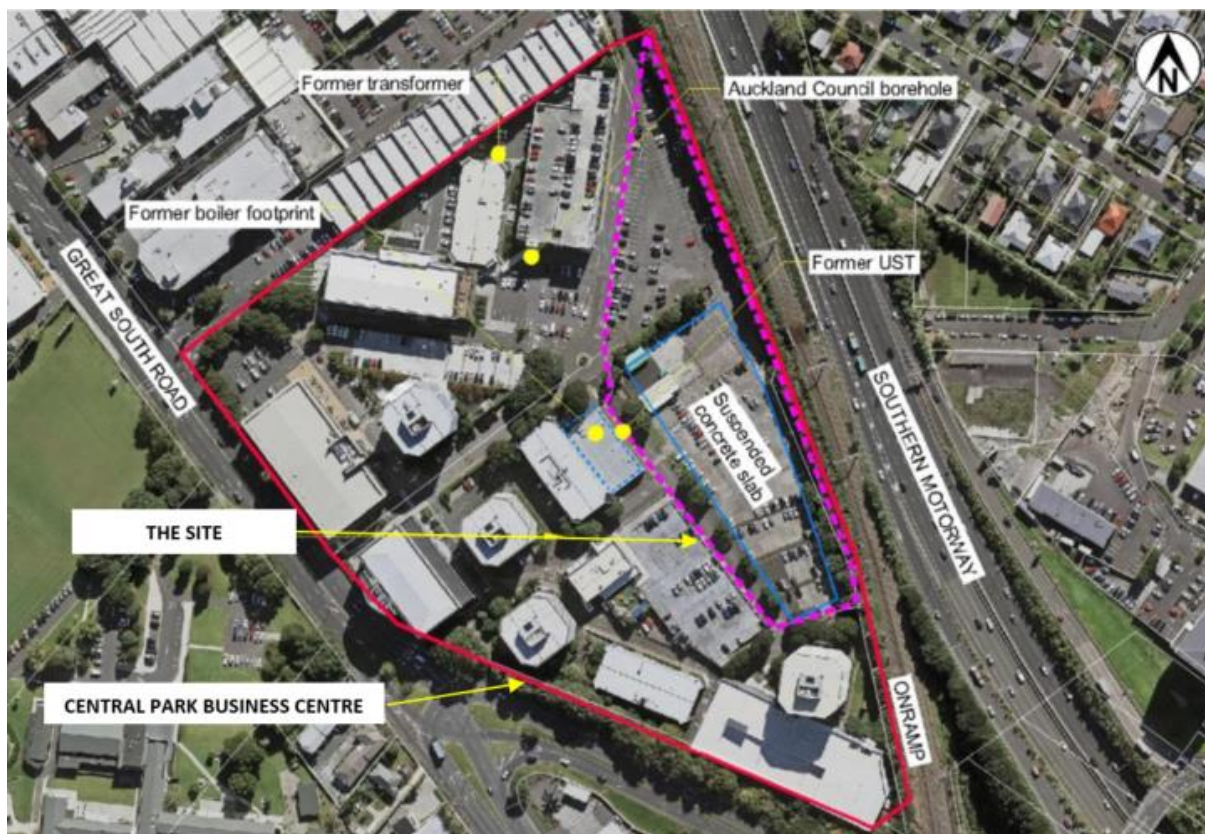
Map 2.2: Site features. The pink dashed line indicates the site with respect to the greater Central Park Business Centre outlined in red (aerial source: Auckland Council GeoMaps).

Key features of the site are shown on Map 2.2 below and in Photograph 2.1 and Photograph 2.2 overleaf, as summarised below:

- The northern portion of the site is an asphalt sealed carpark. The asphalt is in a fair condition;
- The southern portion of the site is also used for vehicle parking over a suspended concrete slab. The southern carpark contains two levels, asphalted on-grade and raised areas for the suspended slab;
- The void beneath the suspended slab is between 0.5 and 2.5 m to ground. Several cored holes were evident in the suspended slab, capped with steel lids;
- Beneath the concrete slab is a stormwater detention area that was relatively dry at the time of the inspection, with the surface covered by dry silt. The silt is underlain with gravelly soil;
- Steep vegetated batters are present along the eastern boundary of the site abutting the main-trunk railway line.
