report

July 2015

Park Estate SHA Ecological Assessment

Submitted to:
Harrison Grierson Ltd
PO Box 5760
Auckland

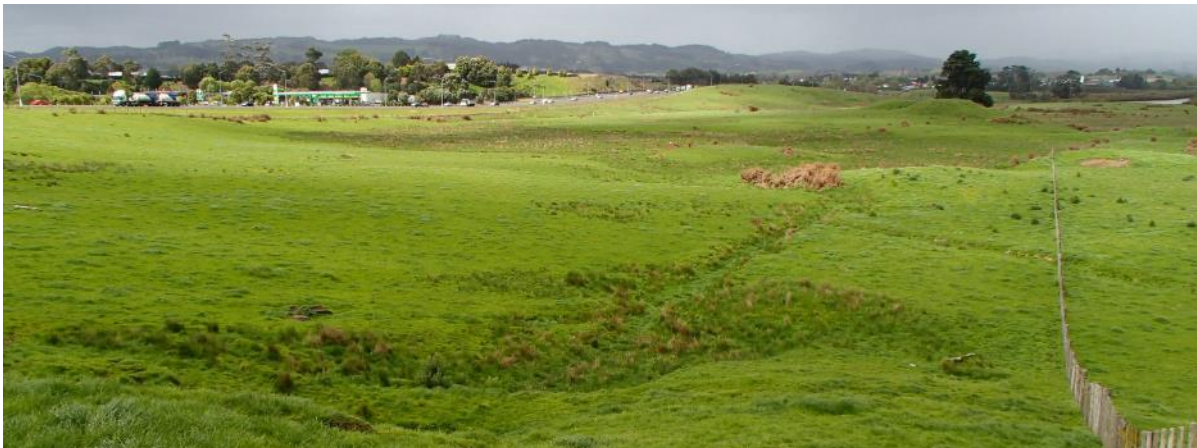
The vegetation comprises mostly exotic pasture used for cattle farming but sheep and horses are also grazed. There is also an area of messmate (*Eucalyptus obliqua*) plantation. Very little native vegetation or habitat for native fauna remains since the majority of the land has been subject to grazing as shown in Figure 2. A list of plant species recorded at the site is provided in Appendix A.

Figure 2: Pasture at the Park Estate Road site.

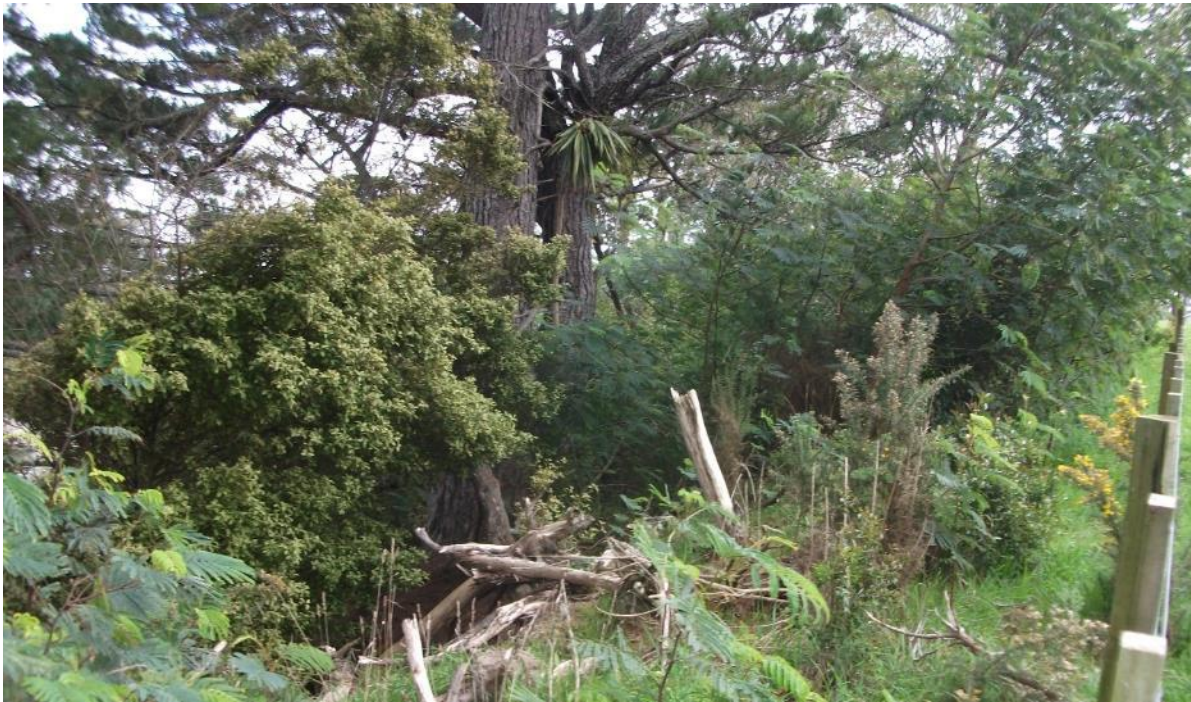
The coastal fringe is fenced to exclude livestock in the northern part of the site. This coastal buffer varies in width, but is generally narrow and the vegetation comprises mostly exotic weeds including maritime pine (*Pinus pinaster*), tree privet (*Ligustrum lucidum*), gorse (*Ulex europaeus*), pampas (*Cortaderia selloana*), Japanese honeysuckle (*Lonicera japonica*) and black wattle (*Acacia mearnsii*) with common exotic grasses. Native species within this

Figure 3: Coastal fringe vegetation at the Park Estate Road site.

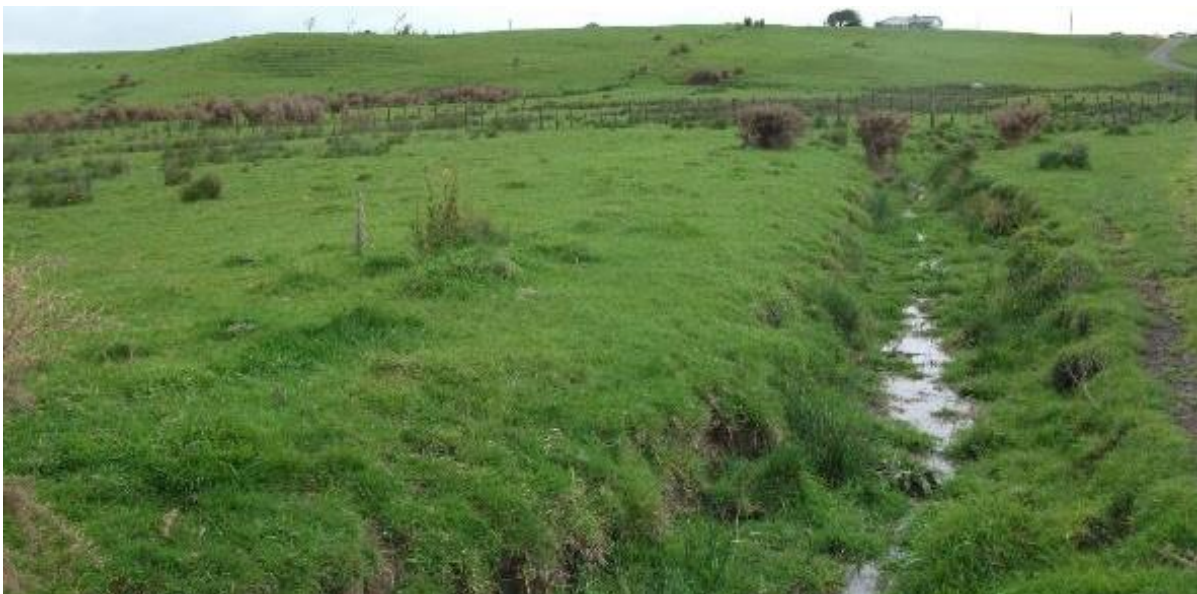
Figure 4: Riparian vegetation within the site has mostly been removed.

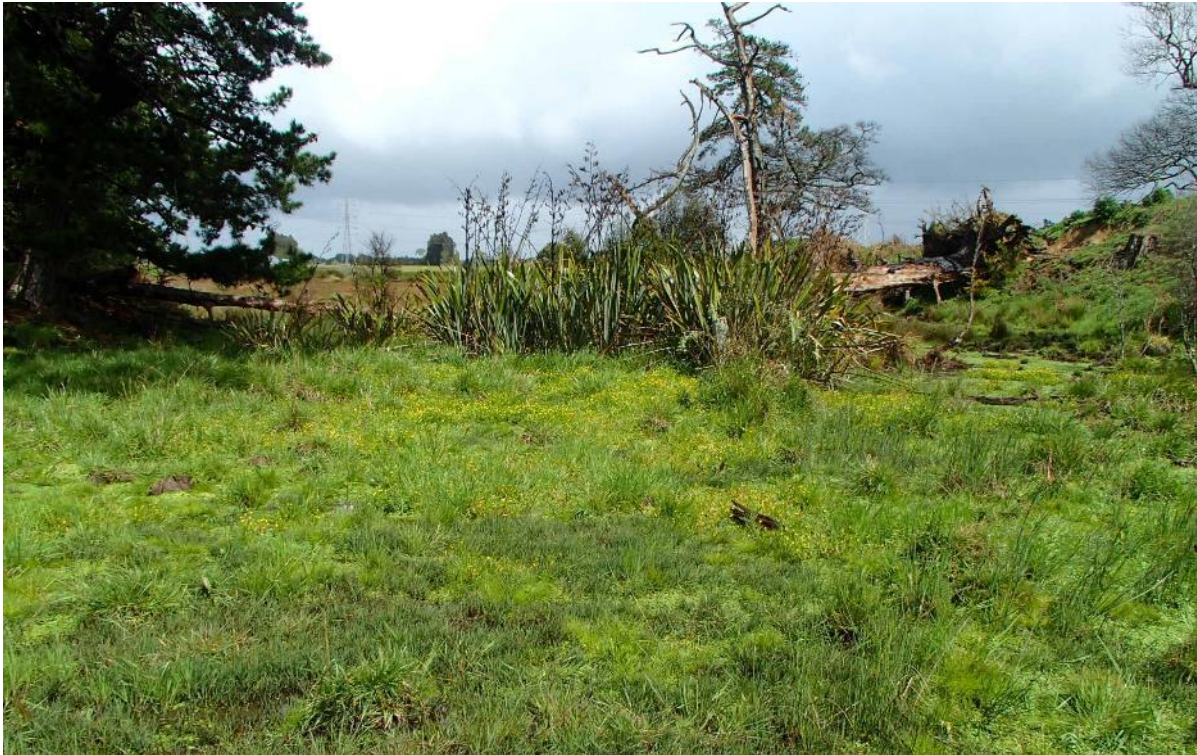
coastal fringe are sparse, but include tī kōuka (*Cordyline australis*), māpou (*Myrsine australis*), whekī (*Dicksonia squarrosa*) and bracken (*Pteridium esculentum*). An example of this coastal fringe vegetation is shown in Figure 3. Watercourses crossing the site drain directly to the sea, but these are not fenced to exclude livestock and include no native riparian vegetation. A representative example is shown in Figure 4. Remnant or modified vegetation persists at some locations including oioi (*Apodasmia similis*), bachelor's button (*Cotula coronopifolia*) and flax (*Phormium tenax*) (Figure 5).

Figure 5: Remnant flax (*Phormium tenax*) affected by grazing livestock.

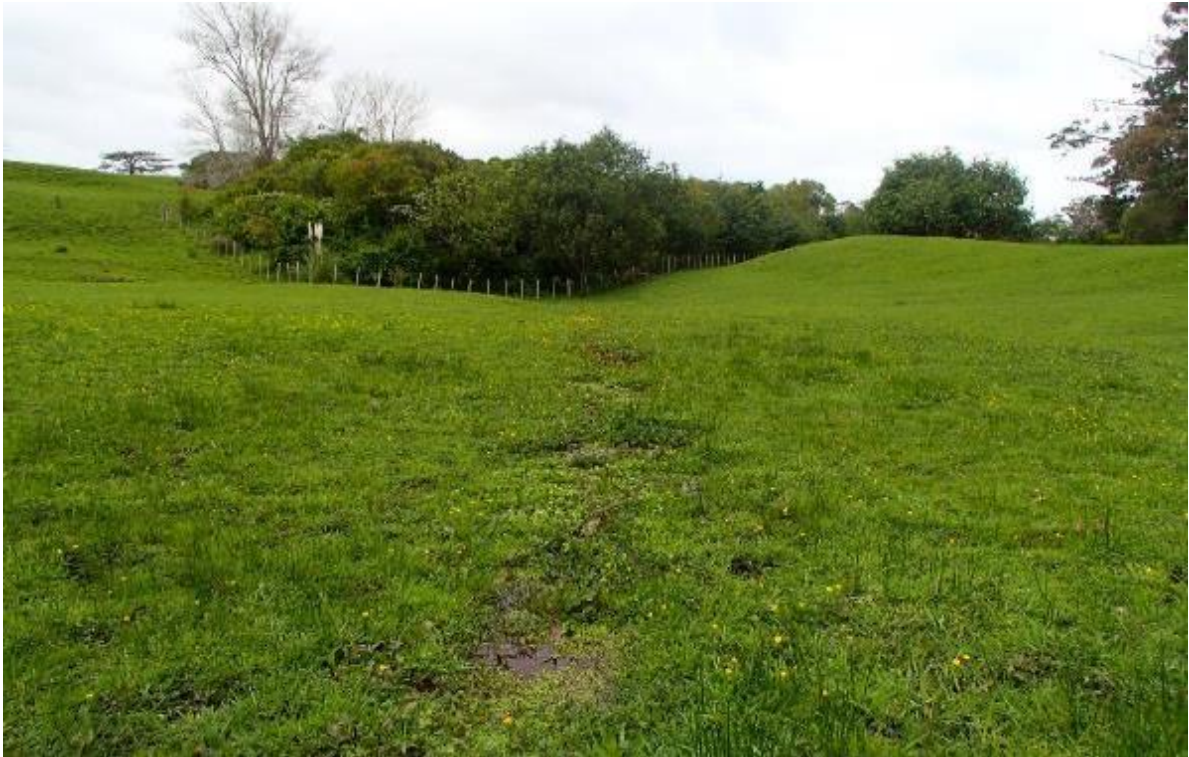
Watercourse W1 comprises three ephemeral branches totalling 172 m in length (Table 1) and located in the north-western corner of the site (refer Figure 6 for location). All three branches lacked defined channels and exotic pasture grasses grew within the overland flow paths. The channels held no surface water except during or immediately after heavy rainfall events. Three branches associated with Watercourse W1 provided no intermittent or permanent aquatic habitat capable of supporting aquatic life and had no aquatic ecological values (Figure 9 and Figure 10).

Figure 9: View of lower Watercourse W1 in October 2014.

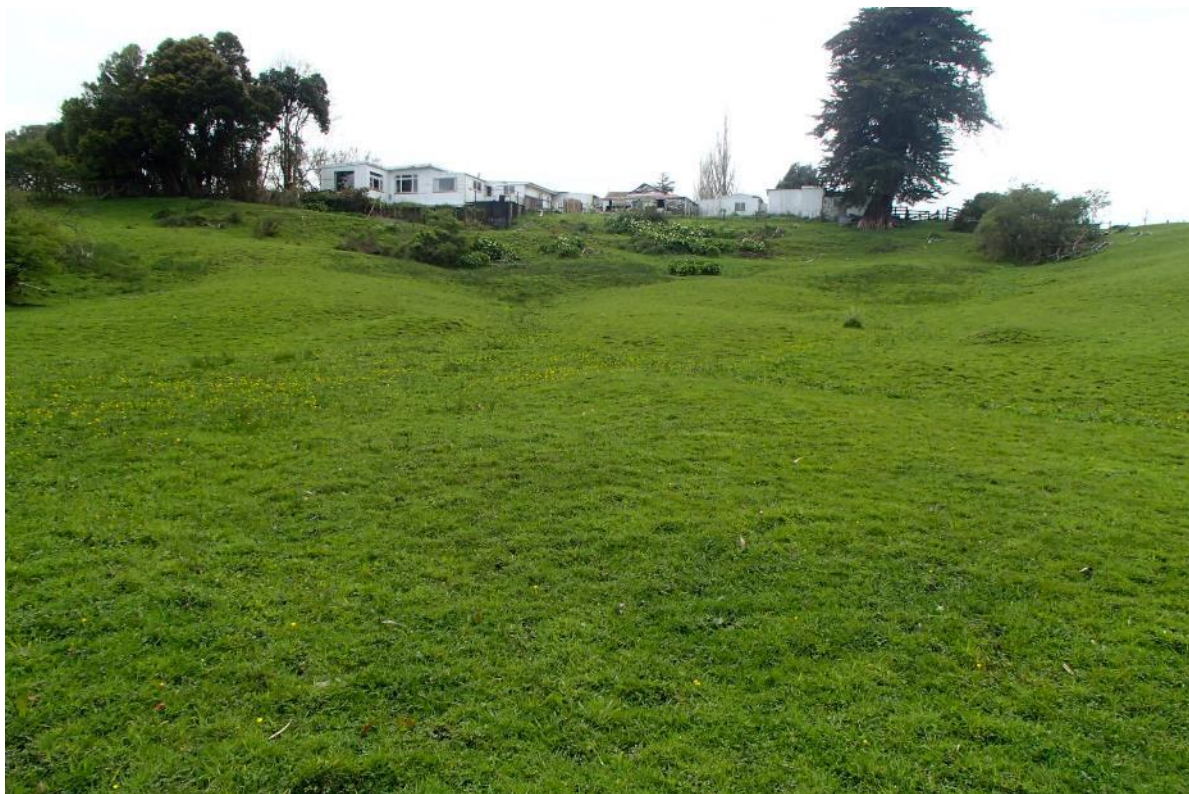
Figure 10: View of mid-upper Watercourse W1 in October 2014.

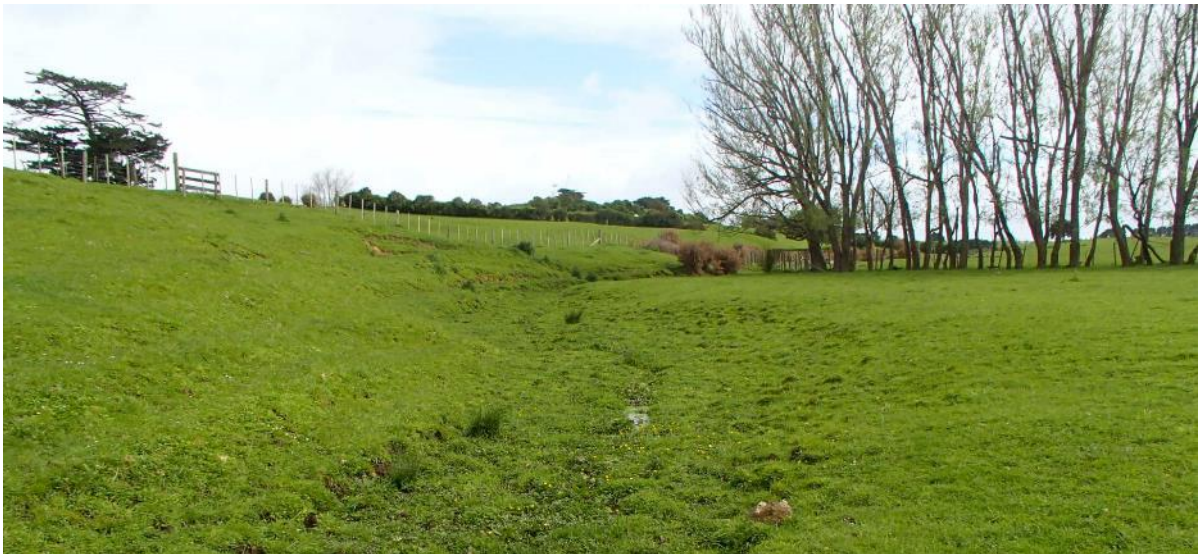
Watercourse W2 is a 372 m long predominantly ephemeral watercourse located in the north western portion of the site (Table 1 and Figure 6). The ephemeral section of Watercourse W2 extending from the lower reaches upstream holds no water except during or immediately following heavy rainfall events and were dry in January 2015. The ephemeral reach lacked a well-defined channel and had exotic pasture grass growing throughout (Figure 11). The lowermost intermittent reach extends for 31 m upstream from an area of mangroves provided some aquatic habitat of low quality and has low ecological value (Figure 12). There are two culverts along Watercourse W2 totalling 5 m in length.

Figure 11: View of ephemeral habitat along Watercourse W2 in October 2014.

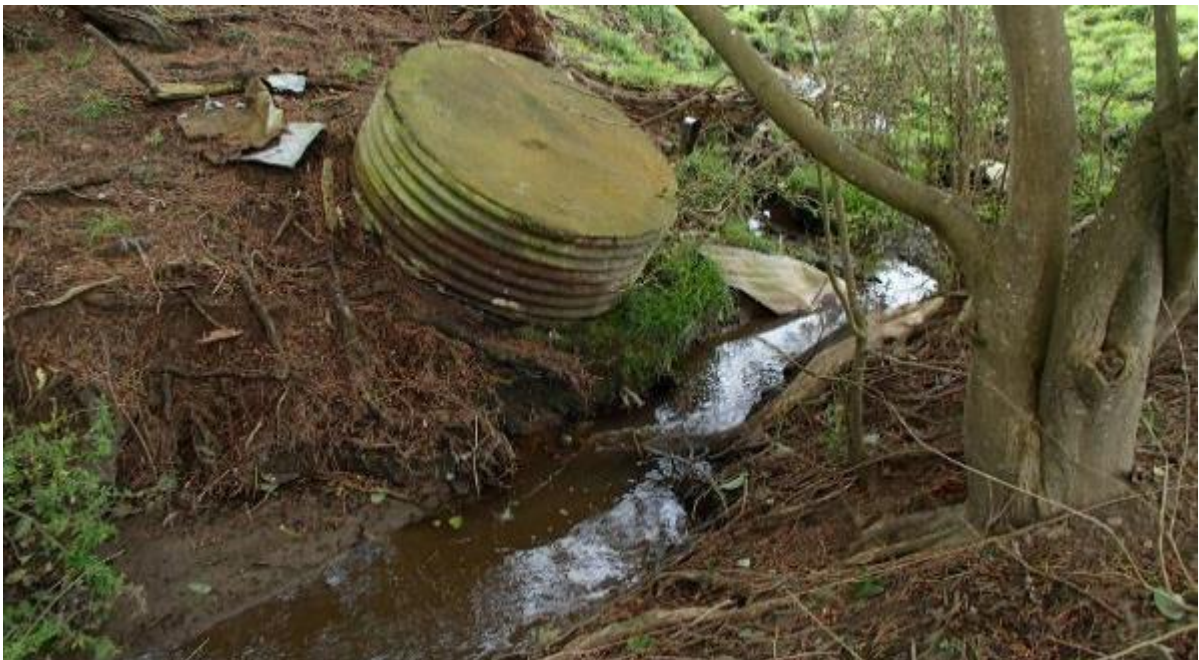
Figure 12: View of intermittent habitat in lower Watercourse W2 in October 2014.

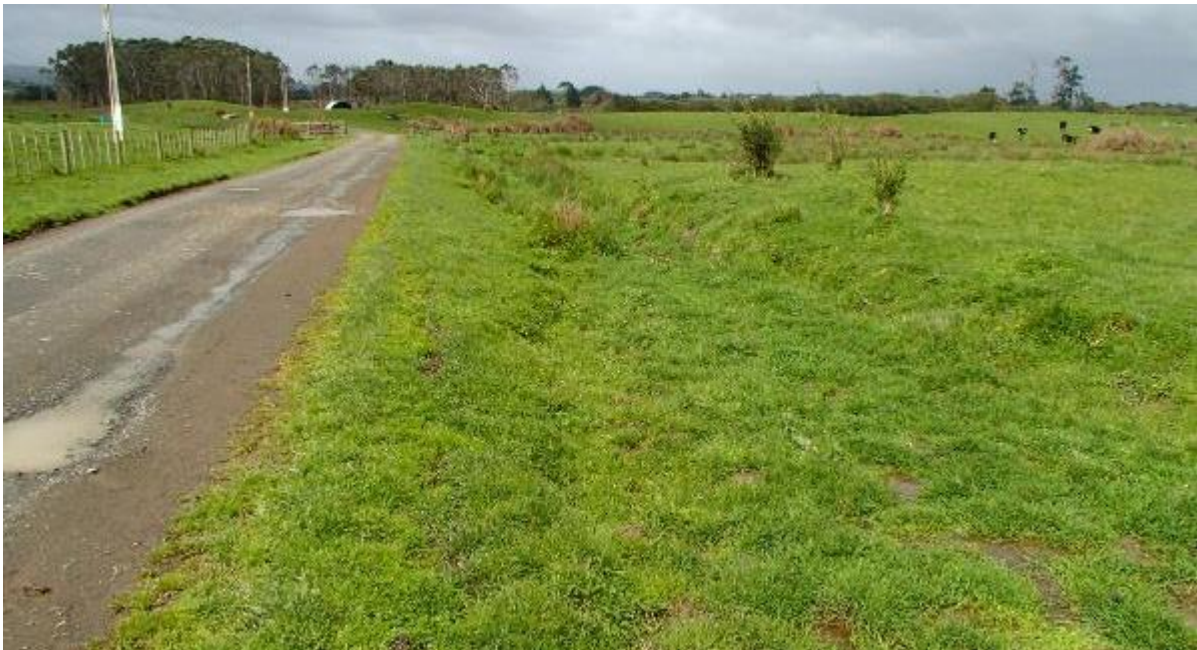
Watercourse W3 is a 568 m long artificial watercourse aligned with the access road running through the centre of the site (Table 1 and Figure 6). Watercourse W3 has ephemeral characteristics in its mid-upper section and intermittent characteristics in its lowermost reaches and is grazed throughout (Figure 13). The mid-upper section is poorly defined and has pasture grasses growing throughout. There is a small area of grazed wetland at the head of Watercourse W3 and may represent a potential spring area. There are two culverts totalling 13 m in length along Watercourse W3. There was very little or no surface water within Watercourse W3 during the October 2014 survey and was dry in January 2015 so aquatic habitat was limited and ecological values are very poor within Watercourse W3.

Figure 13: View of ephemeral artificial channel in Watercourse W3 in October 2014.

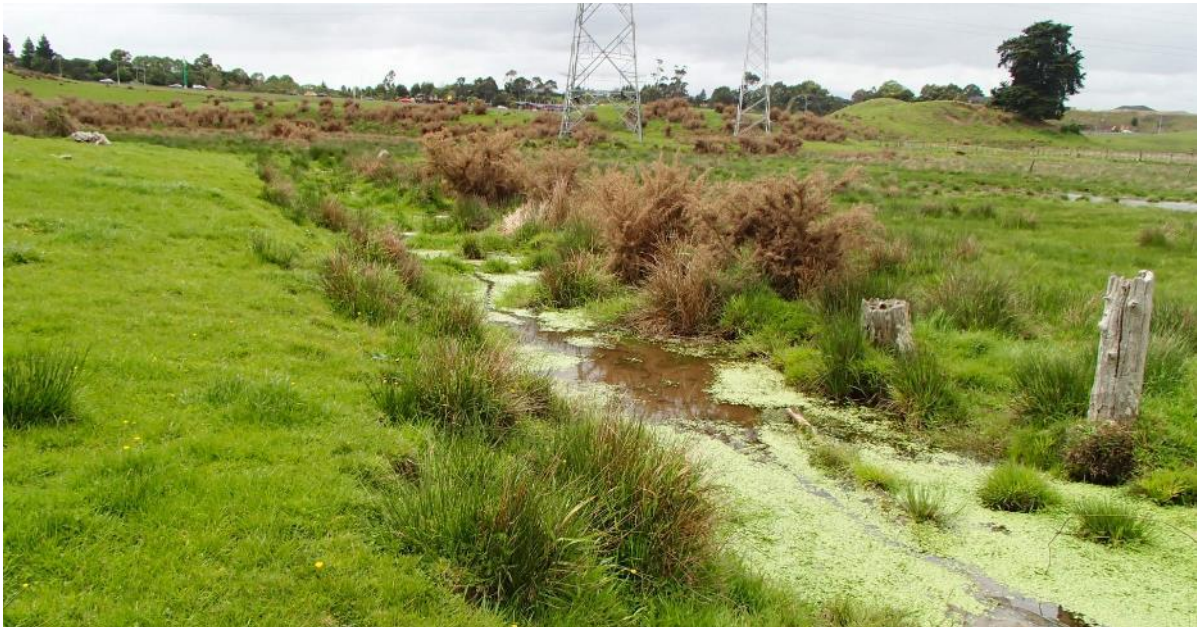
Ephemeral habitat within Watercourse W4 was heavily pugged, had pasture grass/weeds growing in channels, held very small amounts of surface water and lacked defined channels. As a result, ephemeral reaches provide very limited habitat (if any) for invertebrates and no habitat for fish due to a lack of connected surface water of sufficient depth. Intermittent reaches held surface water in shallow (<0.1 m deep) non-flowing pools in October 2014 after heavy rainfall (Figure 14) but were dry in January 2015 (Figure 15).

Figure 14: View of intermittent habitat on Watercourse W4 in October 2014.

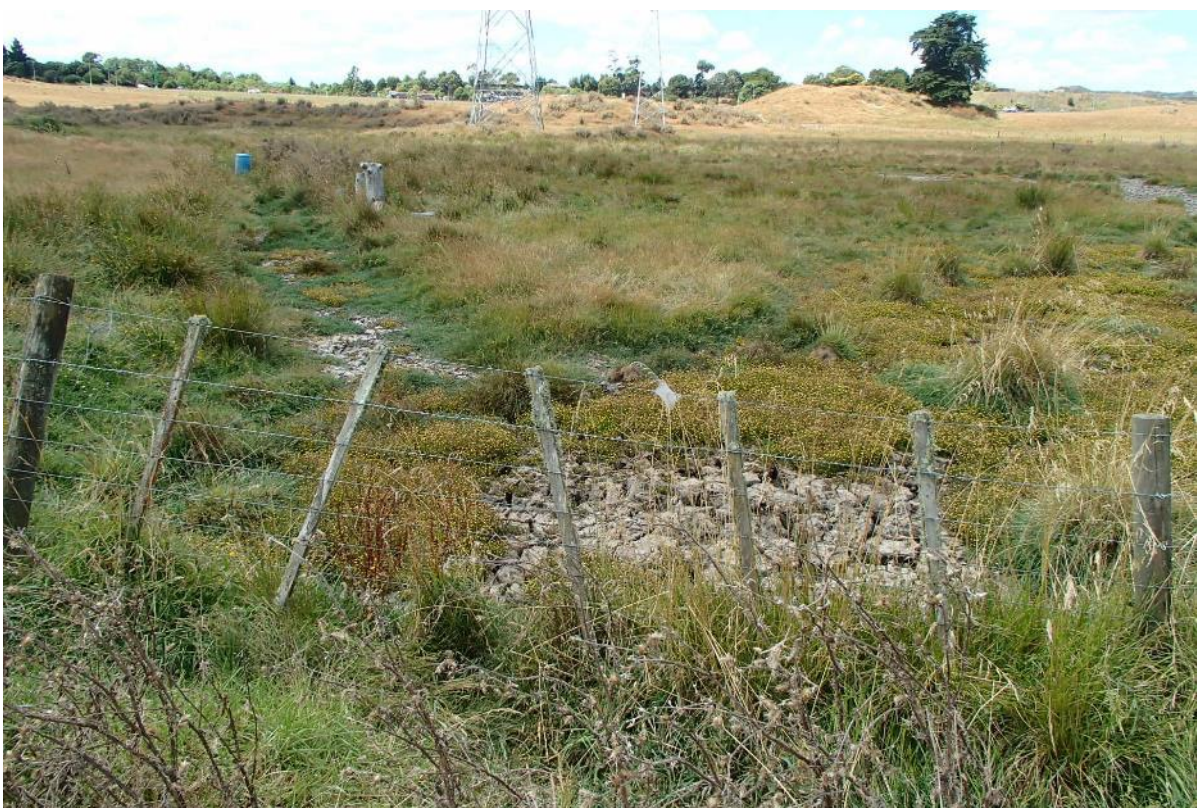
Figure 15: View of intermittent habitat on Watercourse W4 in January 2015.

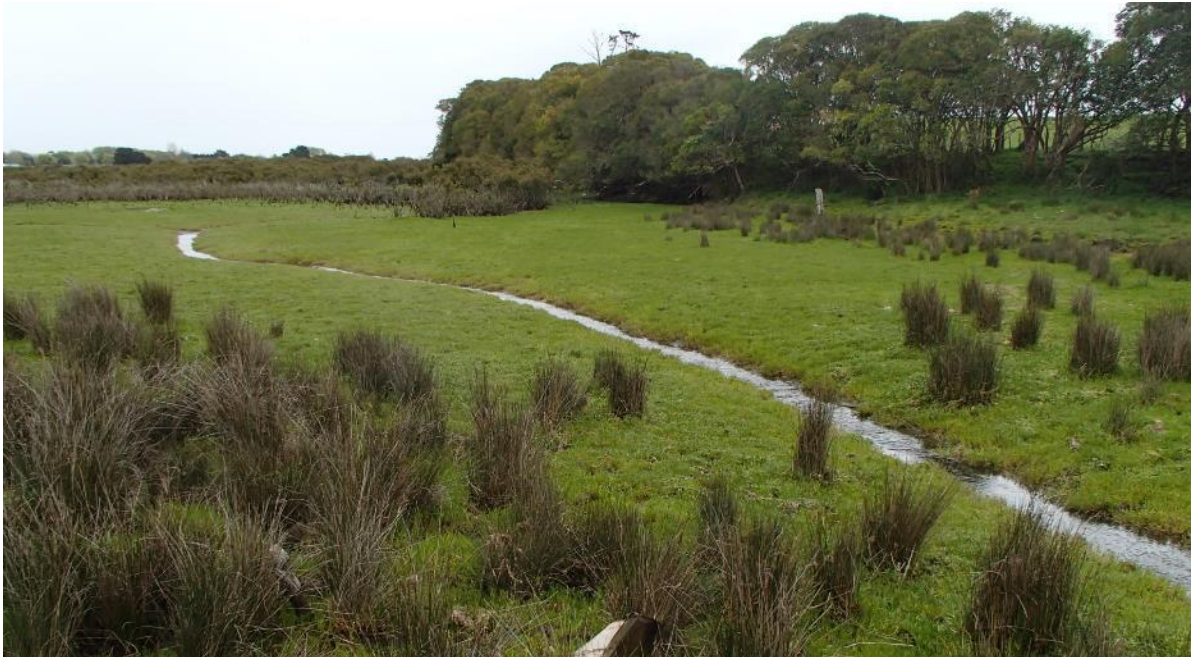
The intermittent and permanent sections in Watercourse W4 provide poor quality aquatic habitat that are likely to support water and habitat tolerant species. This lowermost permanent section is likely to be influenced by the tidal movement of saltwater up the channel as it flows through coastal saltmarsh (e.g., bachelor's button meadow) (Figure 16).

Figure 16: View of permanent habitat on Watercourse W4 in October 2015.

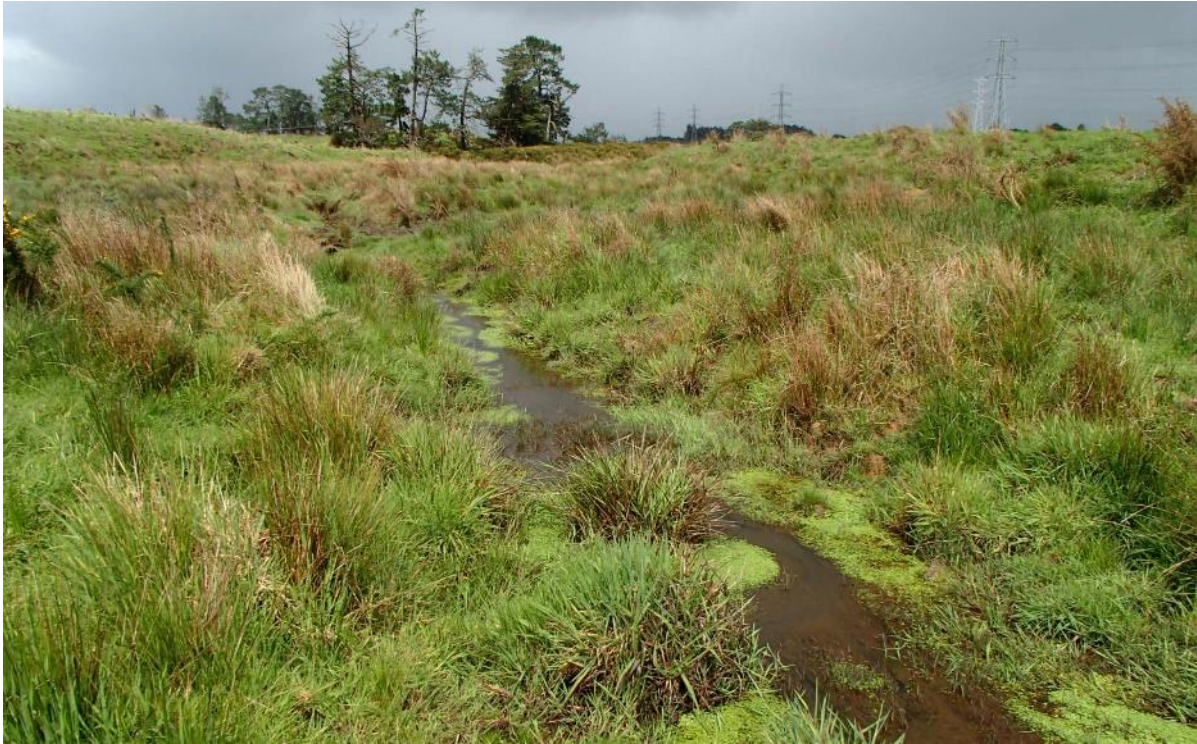
intermittent section may provide temporary aquatic habitat during wet periods of the year but not in summer as these sections dry up (e.g., in January 2015). The permanent habitat downstream from the culvert held surface water in October 2014 and January 2015 and is influenced by tidal movements of water up the channel and is more likely to support fish. All aquatic habitats within Watercourse W6 were poorly shaded, damaged by stock grazing, provide poor overall quality aquatic habitat.

Figure 17: View of permanent habitat on Watercourse W6 in October 2014.

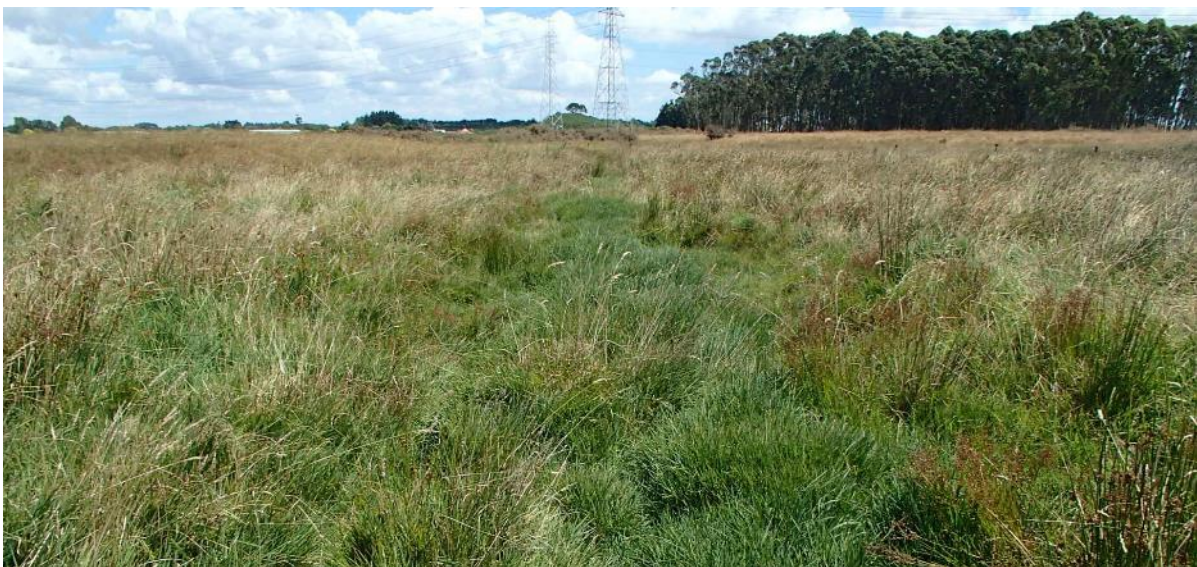
Ephemeral habitat in the mid-upper reaches of Watercourse W6 lacked defined channels, was heavily pugged, had pasture grass/weeds growing in channels, held very small amounts of surface water in pugs after heavy rainfall in October 2014 but were dry in January 2015 (Figure 18). As a result, ephemeral habitat in Watercourse W6 provides very limited (if any) aquatic habitat for invertebrates and no habitat for fish due to a lack of connected surface water of sufficient depth and no surface water in dry periods. The

Figure 18: View of ephemeral habitat on Watercourse W6 in January 2015.

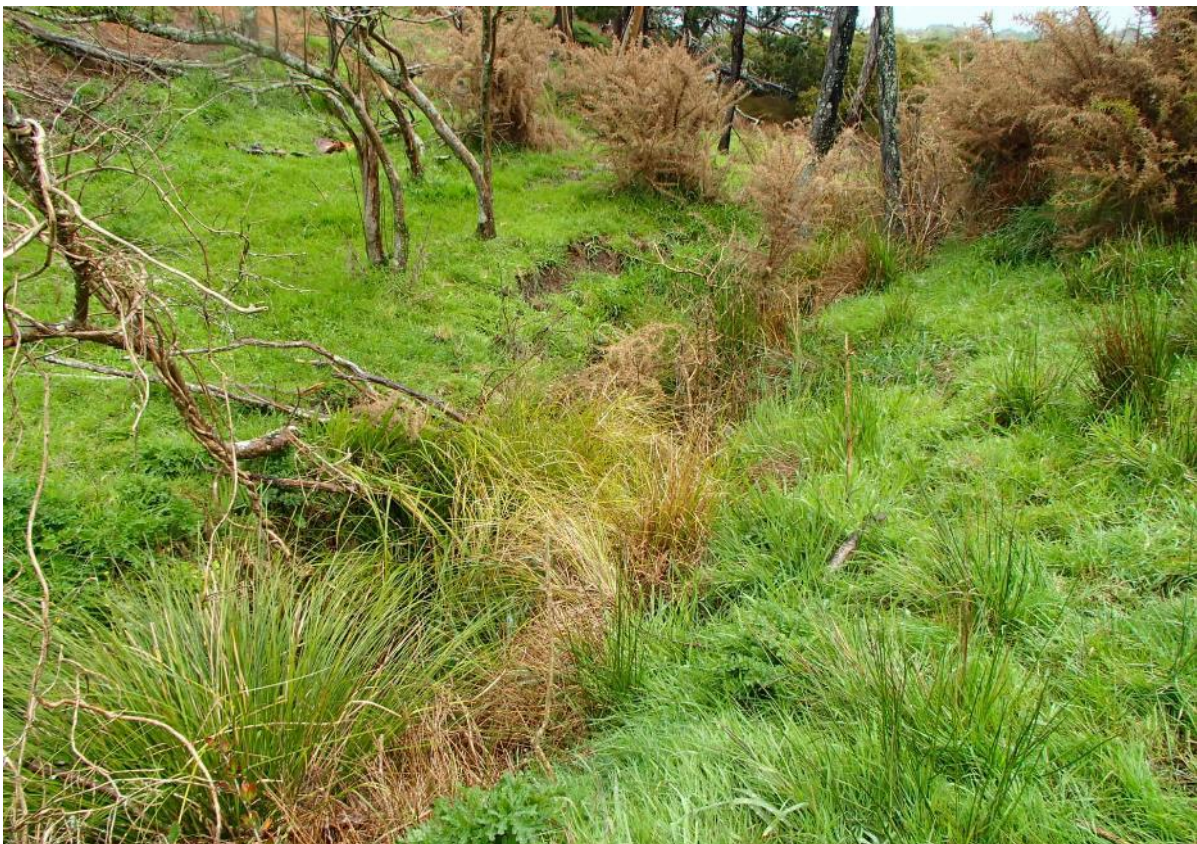
Watercourse W7 is located in the southern portion of the site and comprises 168 m of highly modified intermittent stream habitat (Table 1 and Figure 6). The stream appears to receive runoff from the Southern Motorway but there is no catchment east of the motorway. It appears from historical aerial photographs (e.g., 1942) that drains dug upstream from the site boundary are artificial. The shallow gully depression that the lower reaches of Watercourse W7 flows in (within the site) suggests this section is at least a probable natural flow path. Watercourse W7 has been highly modified and displays evidence of channelisation as it is deeply incised in the lower reaches just before it discharges to the coastal margin (Figure 19). Watercourse W7 has been dammed in its mid-reaches and an online pond has formed. This pond and the small length of channel upstream have been classified as artificial.

Figure 19: View of intermittent habitat on Watercourse W7 in October 2014.

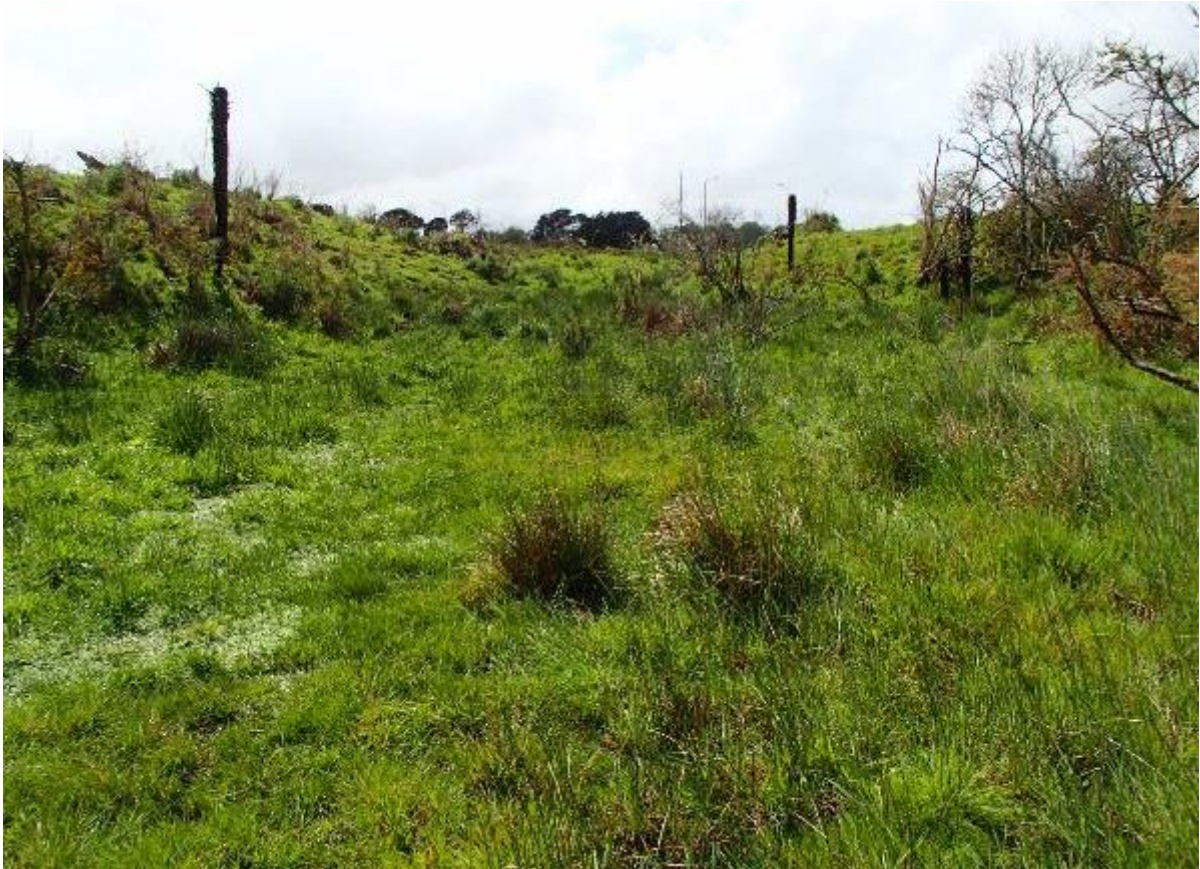
Watercourse W8 is located in the southern corner of the site and comprises 50 m of highly modified ephemeral stream habitat (Table 1 and Figure 6). It is unclear from historical aerial photographs if Watercourse W8 is an artificial channel or a highly modified watercourse. The stream has been channelised since at least 1942 and drains to the estuary via a small wetland (Figure 20). Watercourse W8 lacks a defined channel and the follow path is lined with pasture grass. The stream appears to receive runoff from the Southern Motorway into two ponds (P4 and P5) but there is no catchment east of the motorway feeding into Watercourse W8. There does not appear to be obvious outlets from

Figure 20: View of ephemeral habitat on Watercourse W8 in October 2014.

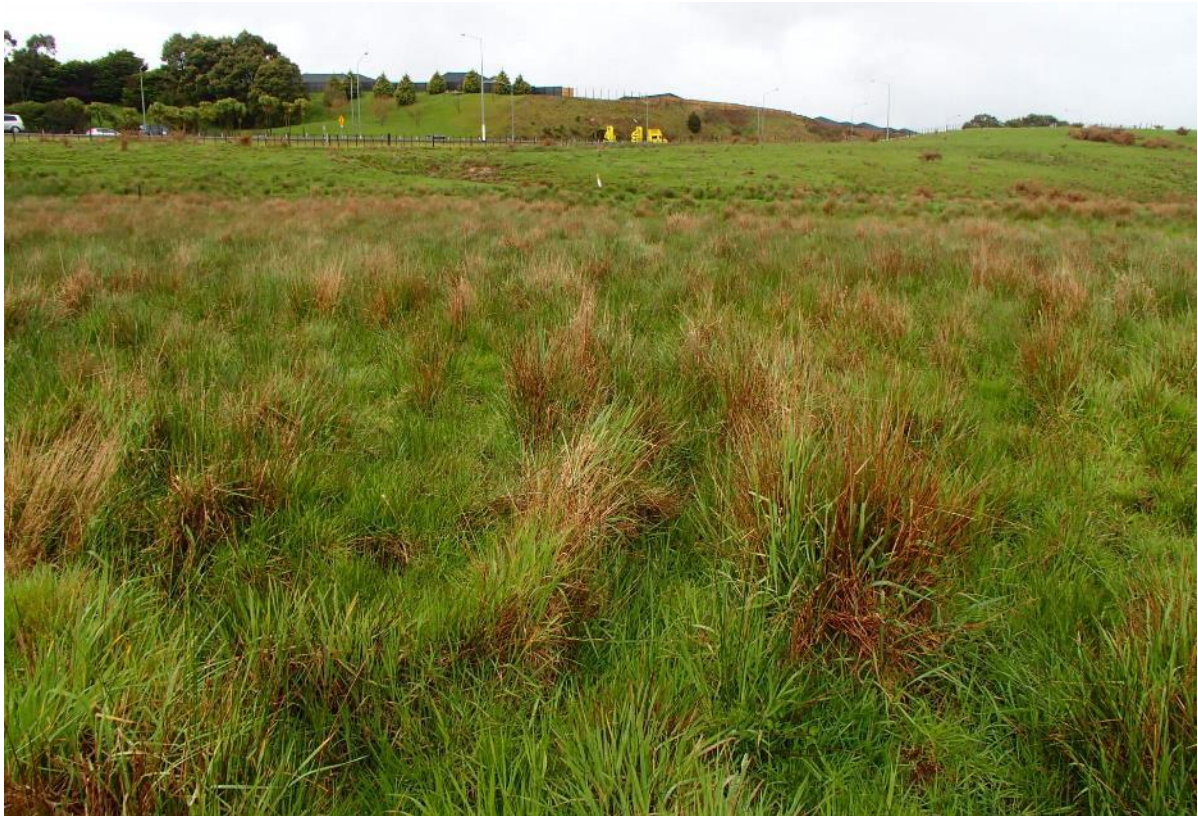
Figure 21: Upper area of northern wetland with no surface water.

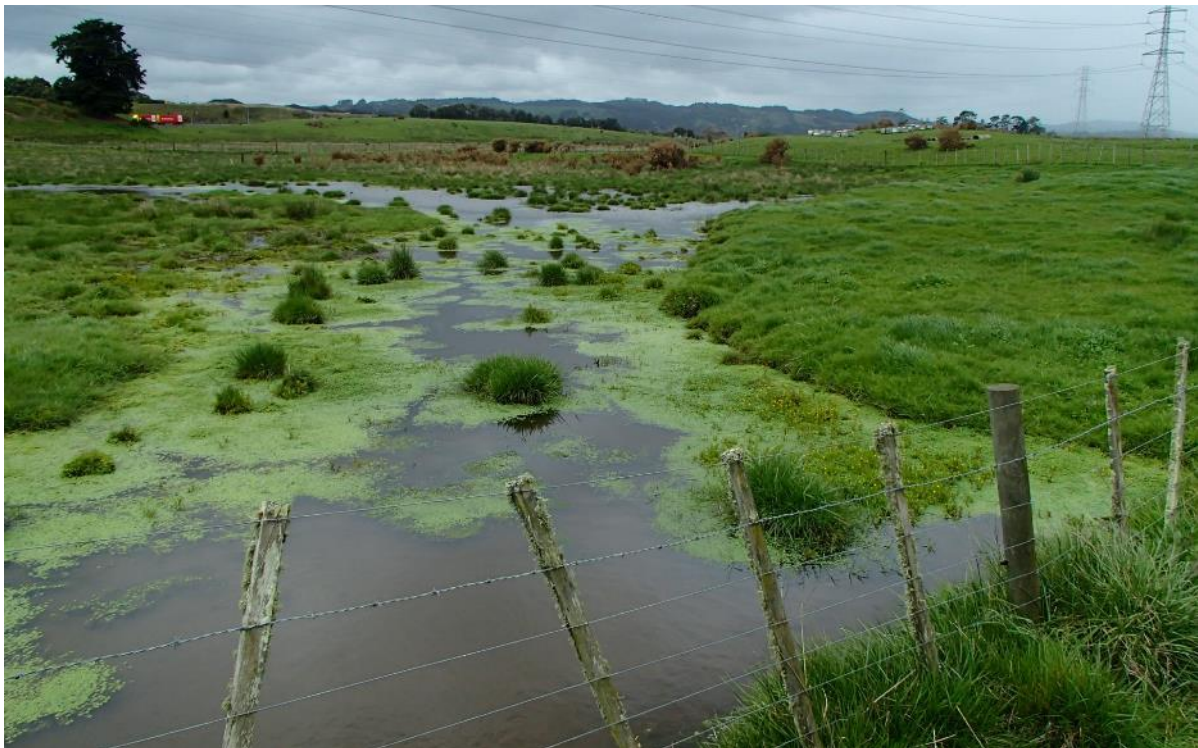
Figure 22: Surface water in the lower northern wetland in October 2014.

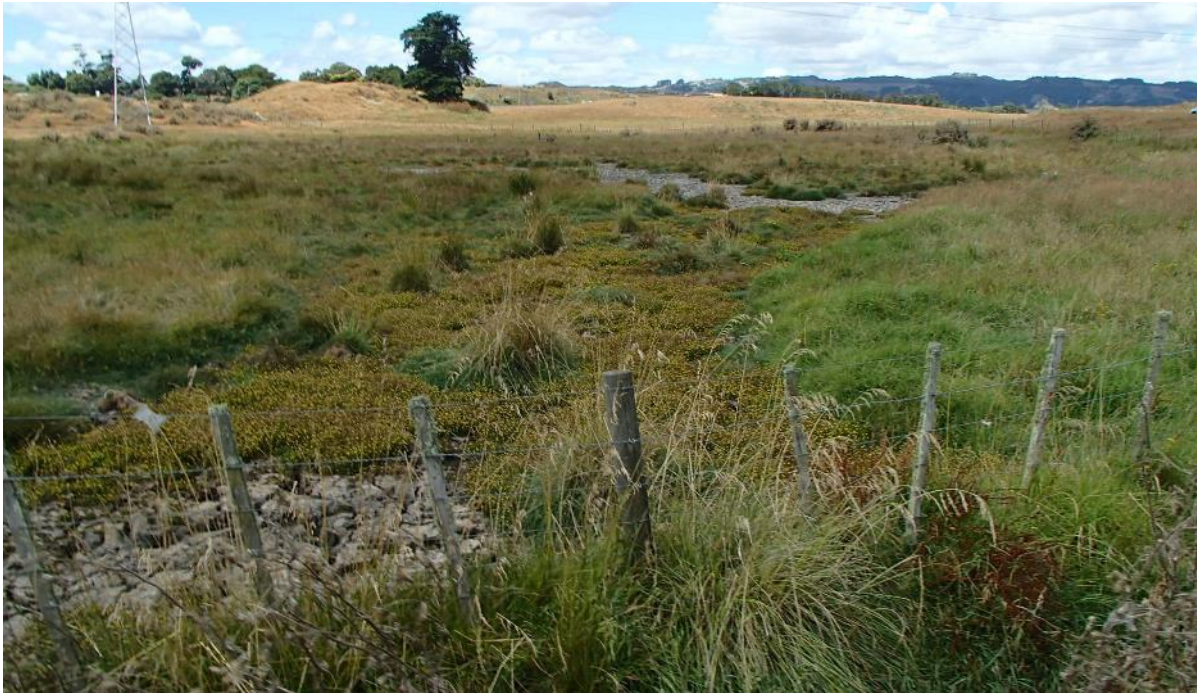
Figure 23: Absence of water in the northern wetland in January 2015.

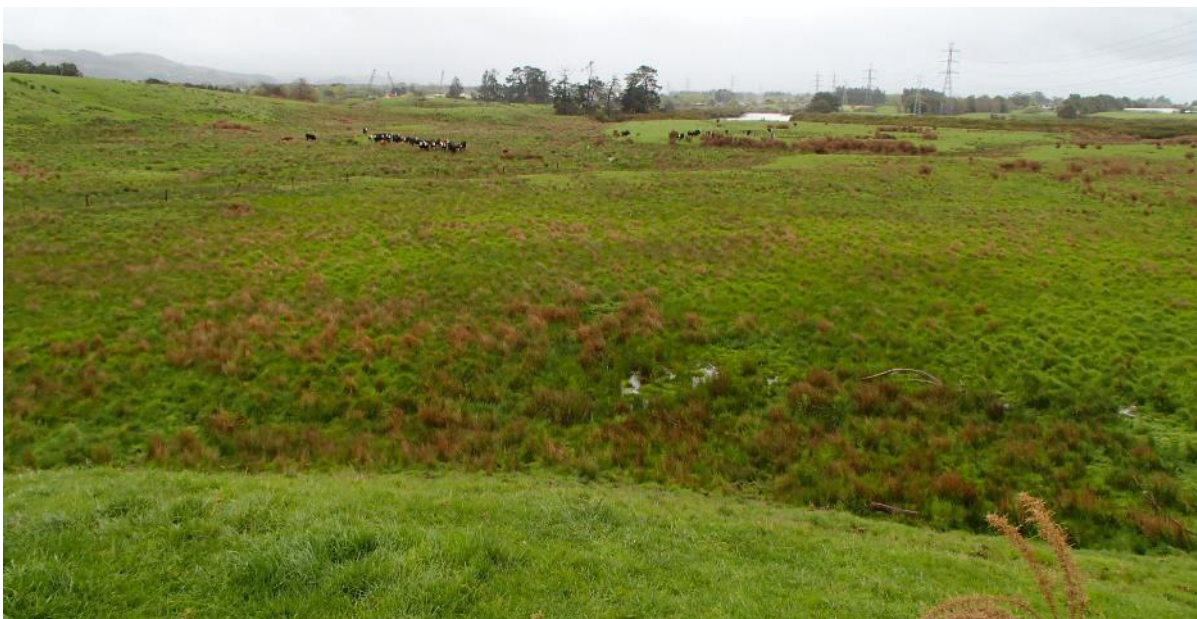
The southern wetland is shown in Figure 24 and Figure 25. Vegetation within this wetland is predominantly soft rush (*Juncus effusus*), exotic grasses/herbs and *Carex maorica*. The southern wetland held smaller amounts of standing surface water than the northern wetland in October 2014 and was similarly dry in January 2015. The southern wetland drains into a small but diverse salt marsh upstream of the larger salt marsh. Golder (2009) defined wetland areas as being smaller than in the present study and was most likely a reflection of the very dry summer low flow conditions at the time.

Figure 24: Mid-upper area of the southern wetland in October 2014.

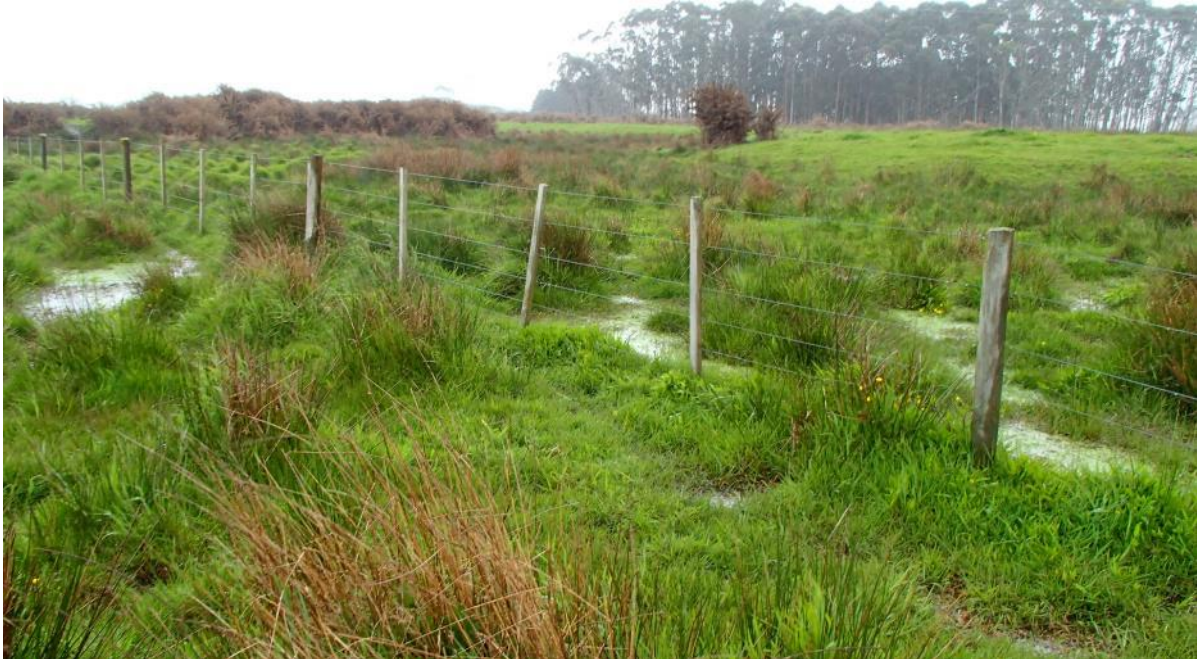
Figure 25: Lower area of southern wetland in October 2014.

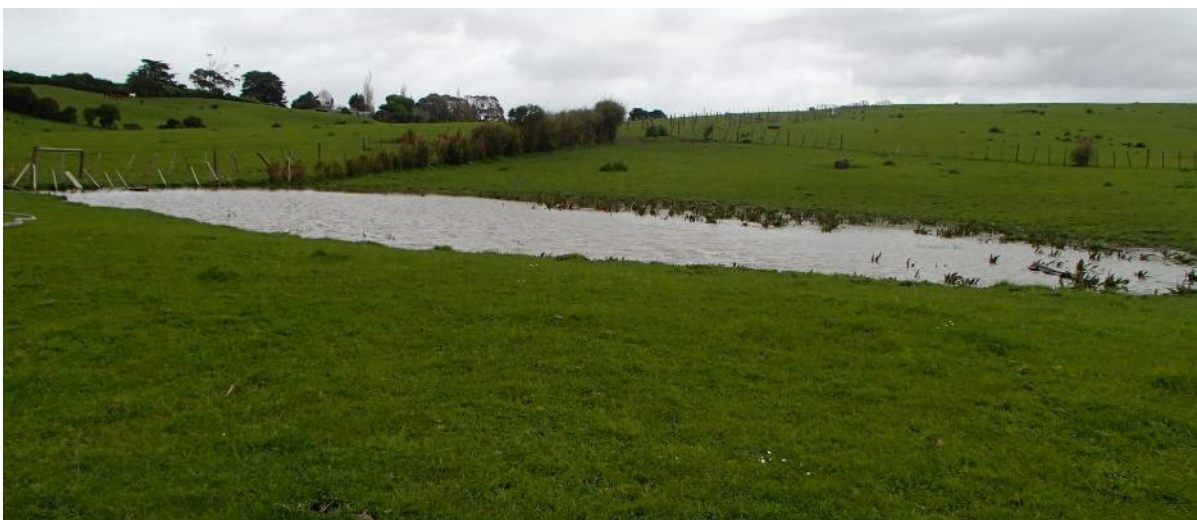
Figure 26: Pond P1 in October 2014.

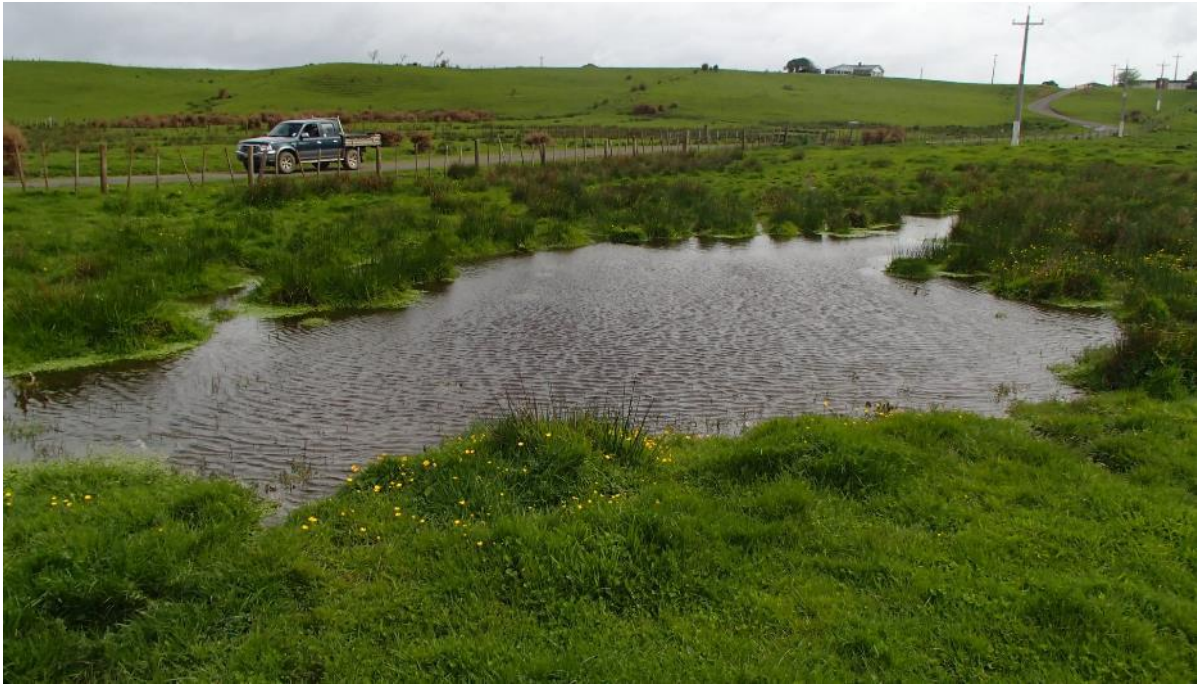
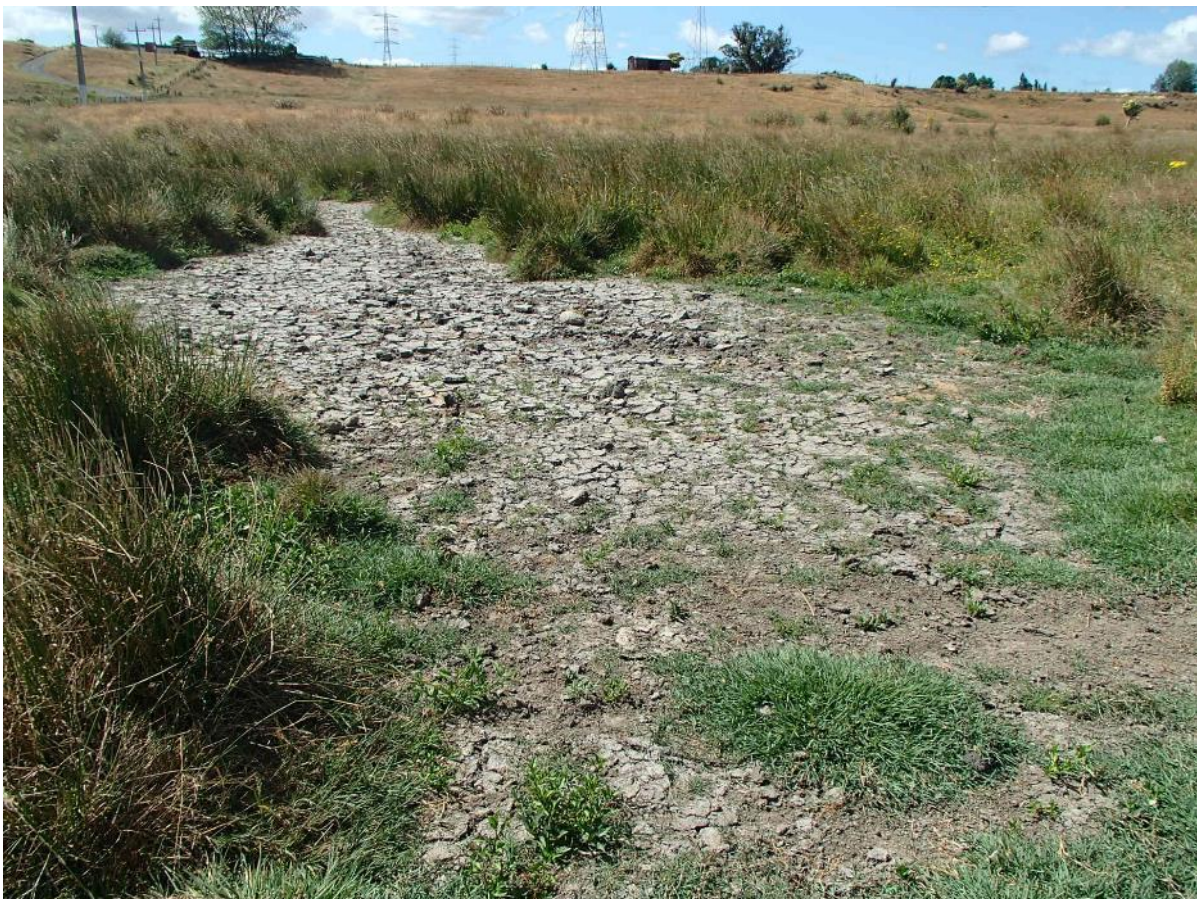
Figure 27: Pond P2 in October 2014 (above) and January 2015 (below).
