report

July 2015

Park Estate SHA Ecological Assessment

Submitted to:
Harrison Grierson Ltd
PO Box 5760
Auckland

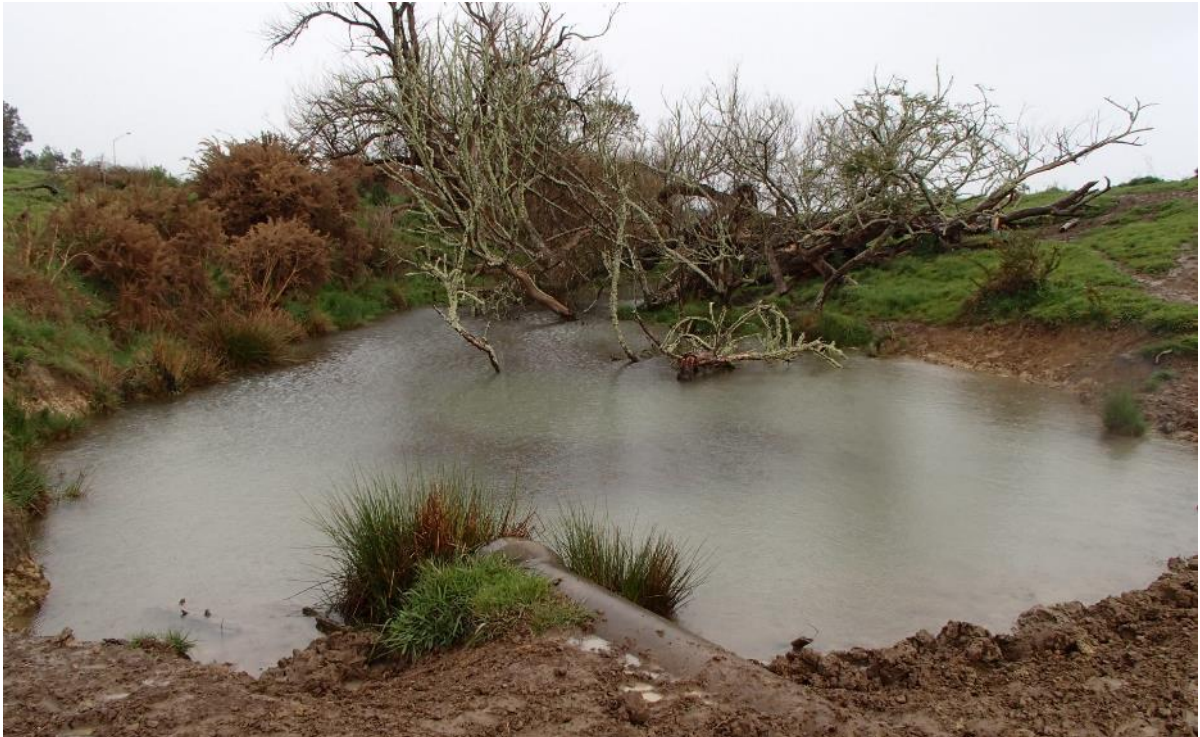
Figure 28: Pond P3 on Watercourse W7 site in October 2014.

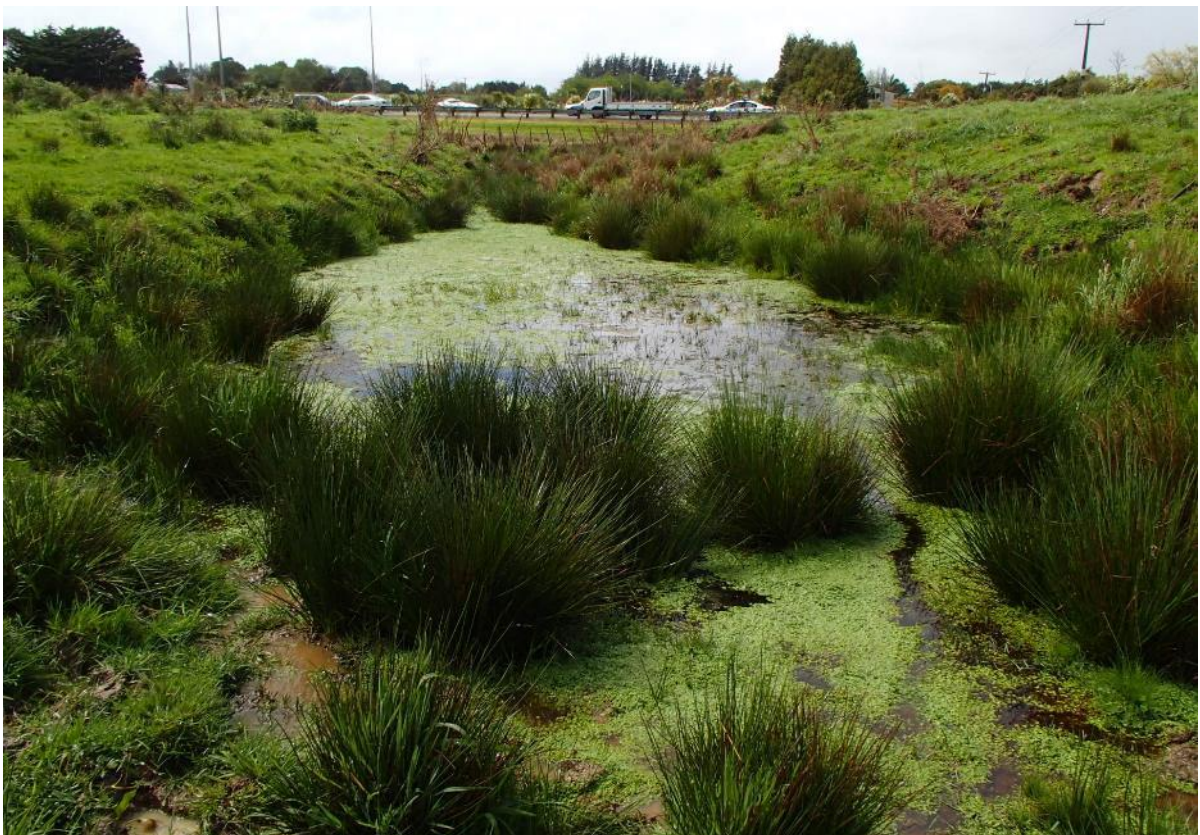
Figure 29: Pond P4 in October 2014.

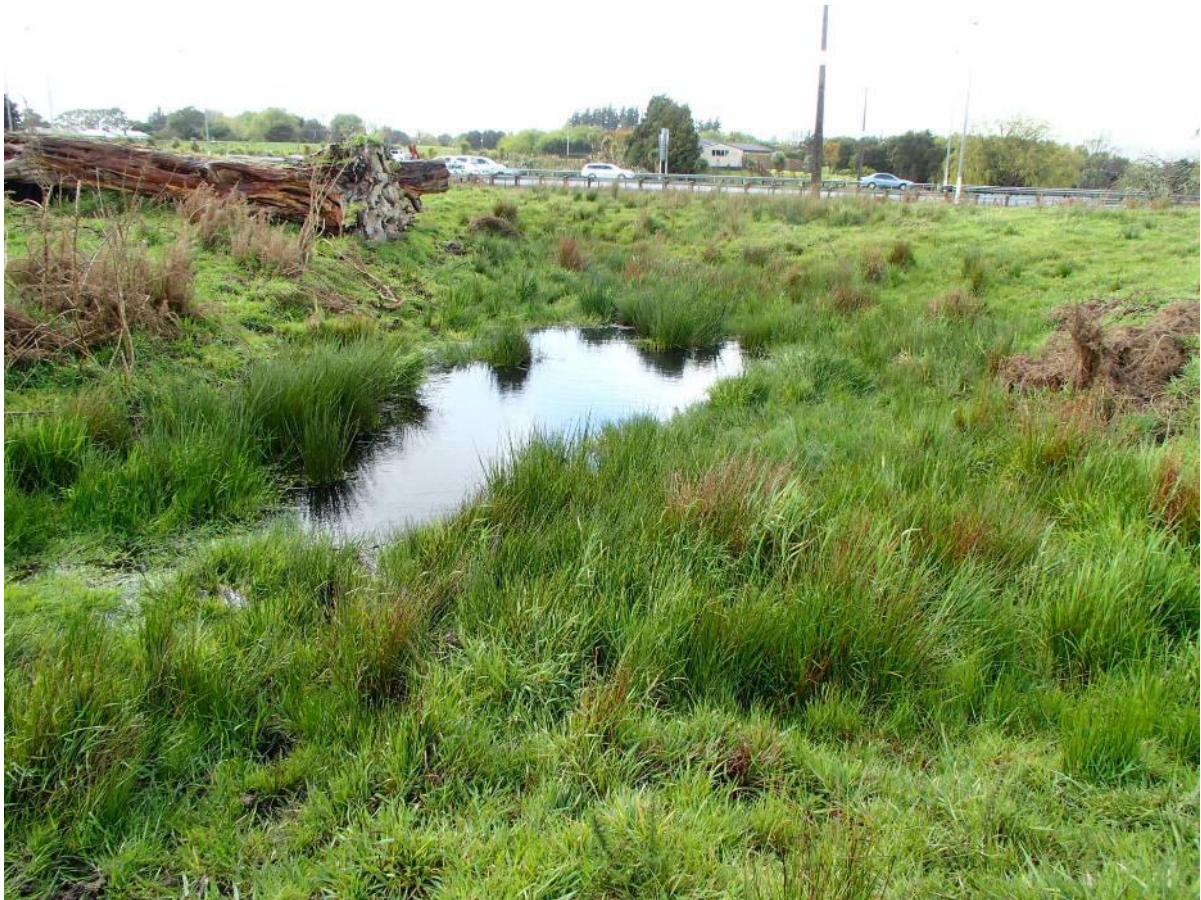
Figure 30: Pond P5 in October 2014.

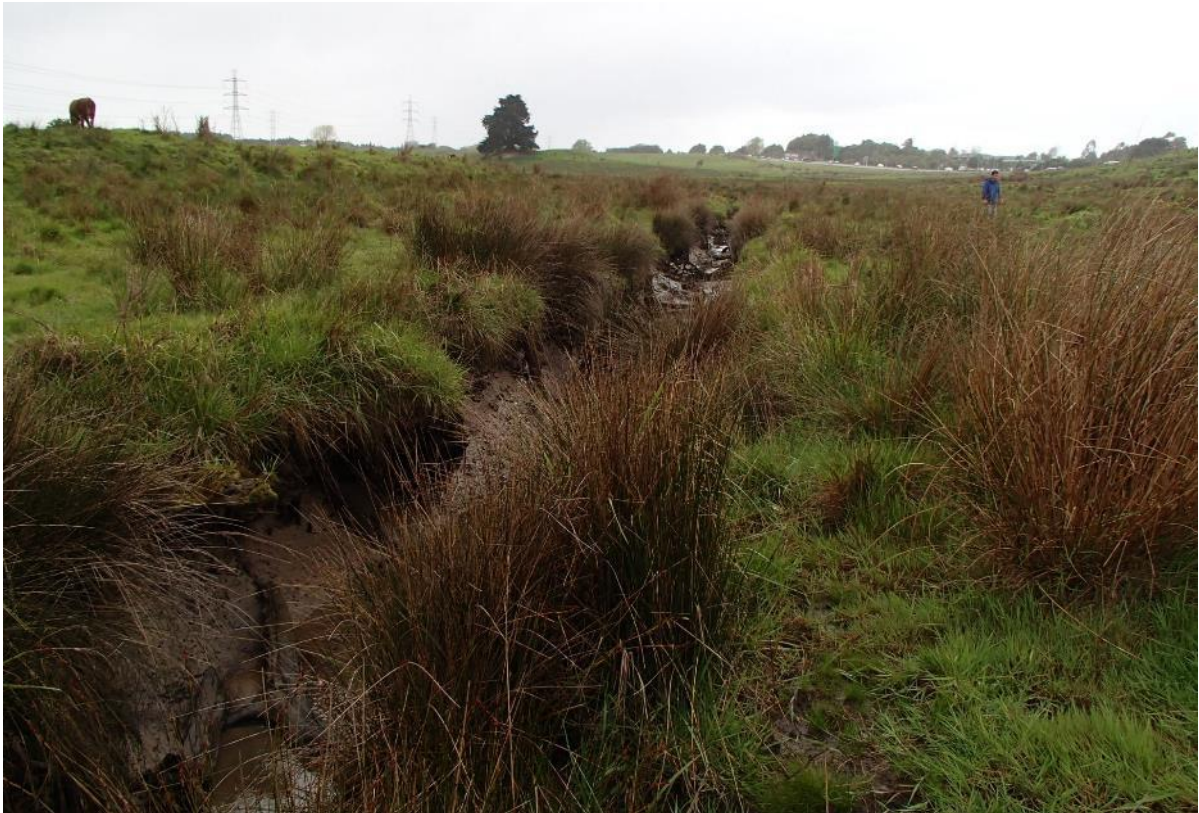
Six fish species have been recorded from watercourses within the site (NZFFD and Golder 2009). The locations where fish have been recorded are shown in Figure 6. Species recorded include *Anguilla australis* (shortfin eel), *Galaxias fasciatus* (banded kōkōpu), *Galaxias maculatus* (īnanga), *Gobiomorphus cotidianus* (common bully), *Gobiomorphus gobioides* (giant bully) and the pest fish *Gambusia affinis* (gambusia). Īnanga have an 'At Risk' (Declining) conservation status (Goodman et al. 2014). Īnanga were observed in the lower reaches of watercourse W6 during the site visit. The lower reaches of watercourses W4 and W6 that extend into the northern and southern wetlands have tidally influenced lower sections and are potential īnanga spawning habitats (Figure 31).

Figure 31: Potential Īnanga spawning habitat in lower reaches of Watercourse W6.

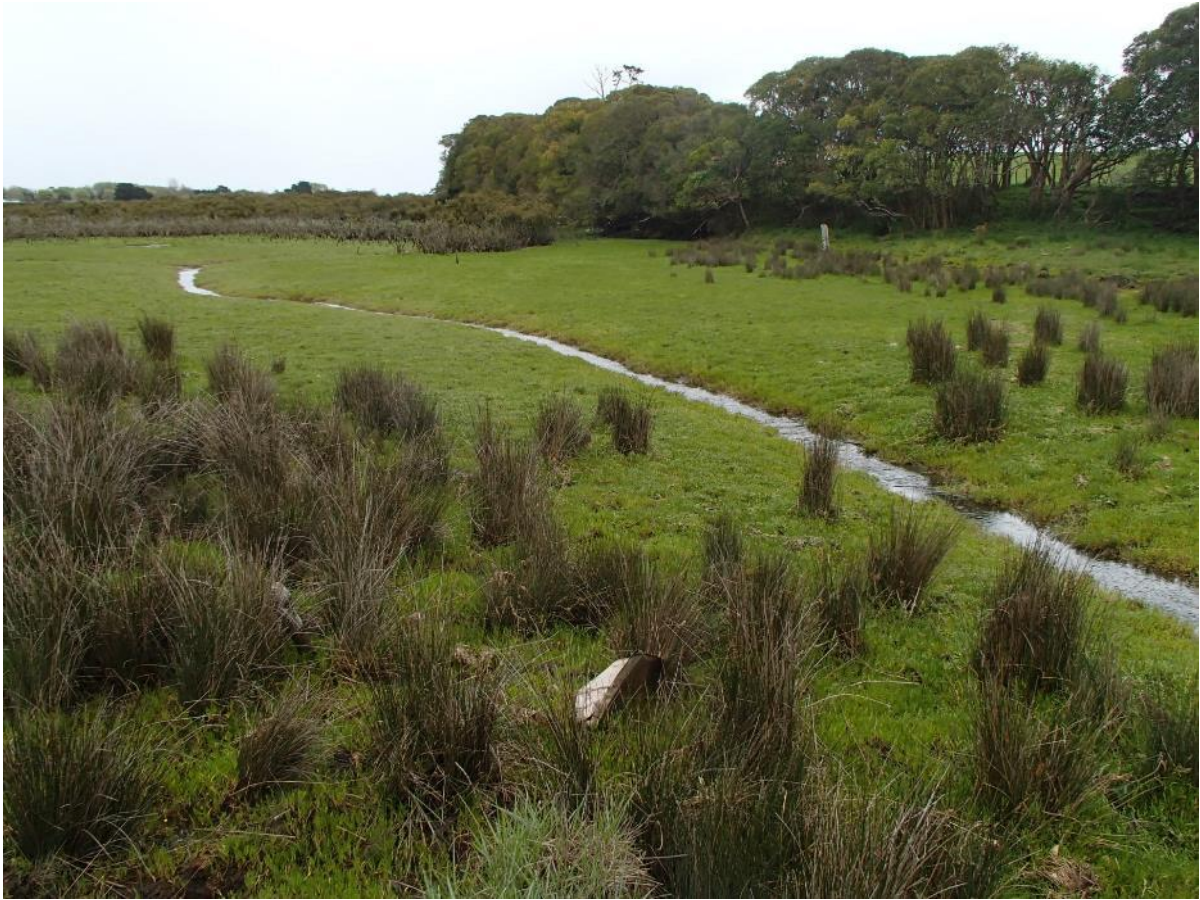
Estuarine vegetation along the northern part of the site and wider Hingaia Peninsula coastline comprises predominantly mangroves (*Avicennia marina* subsp. *australasica*) (Larcombe 2000). Further south along the site boundary, not all of the coastal margin is fenced, and the natural transitional habitats from mangroves to salt marsh or salt meadows in the estuarine wetlands have been influenced or mostly removed by grazing livestock. Maritime marsh was found to be a common habitat type around the Hingaia Peninsula by Larcombe (2000). Maritime marshes include rush marsh and salt marsh and occur in sheltered, low sloping areas around high tide level. Remnant or modified vegetation persists at some locations including bachelor's button (*Cotula coronopifolia*) meadows as shown in Figure 32 and oioi (*Apodasmia similis*) in Figure 33.

Figure 32: Bachelor's button meadow downstream of northern wetland.

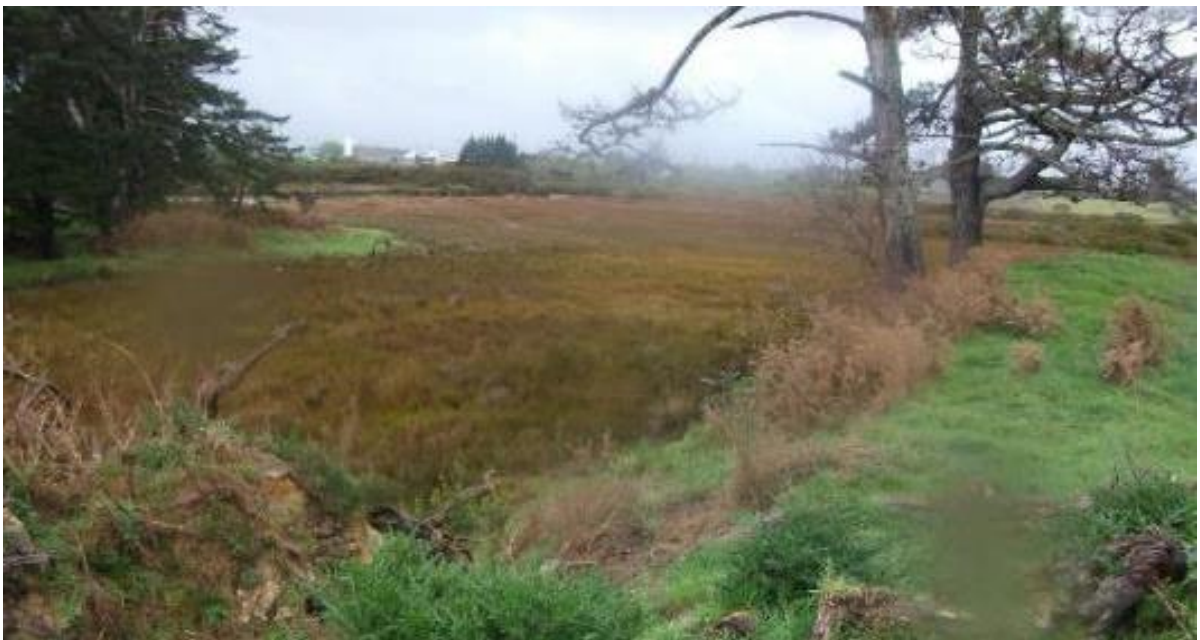
Figure 33: Oioi (*Apodasmia similis*) at the southern end of the site.
