## **Park Estate Road Development**

For Hugh Green Group Limited

Site Specific Coastal Erosion Assessment

July 2018

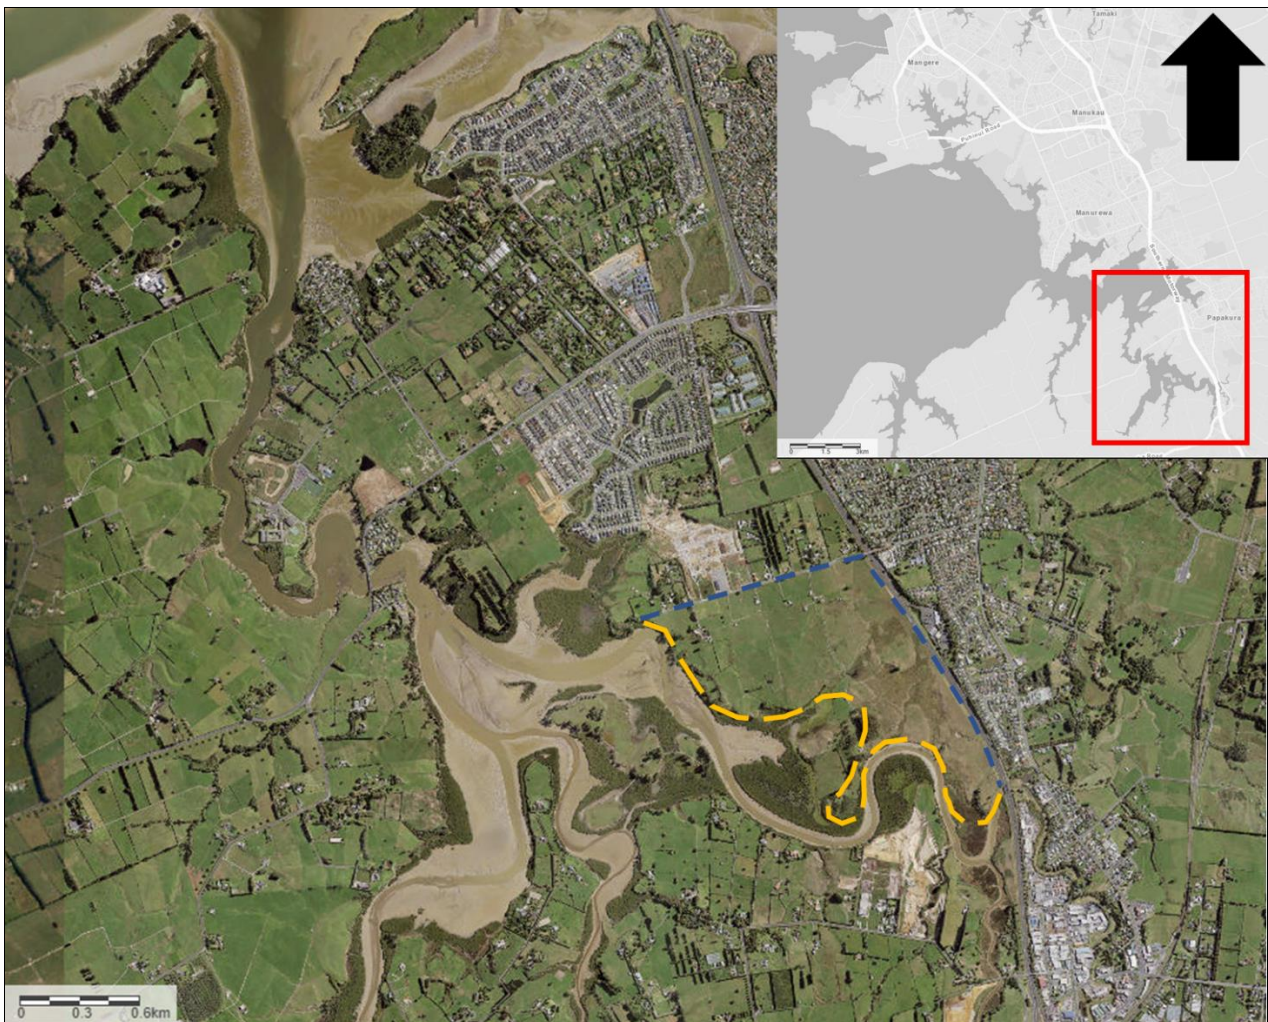
Figure 1: Location of the subject site. The yellow line shows the extent of the subject coastline, the blue line is the approximate landward extent of proposed development and the red box illustrates the location (Source: Auckland Council Geomaps)

Geomorphology of the site varies from estuarine coastal cliffs and coastal embankments to low lying sub-inlets. The northern portion of the subject coastline (refer **Figure 1**) is dominated by coastal cliffs transitioning to the landward topography above situated at about RL10m. The cliff height reduces toward the south as the coast moves toward a sub-inlet of approximately 20Ha, which is characterised by mangrove and mudflat habitats on the outer limits and migrating toward salt marsh and meadow habitats further inward. The southern portion site is characterised by tidal banks on the outer bend of the main channel. These banks are at approximately RL4m and in places have mature mangrove trees along their seaward margin. The banks themselves are vegetated with a mix of salt marsh species and exotic grasses.

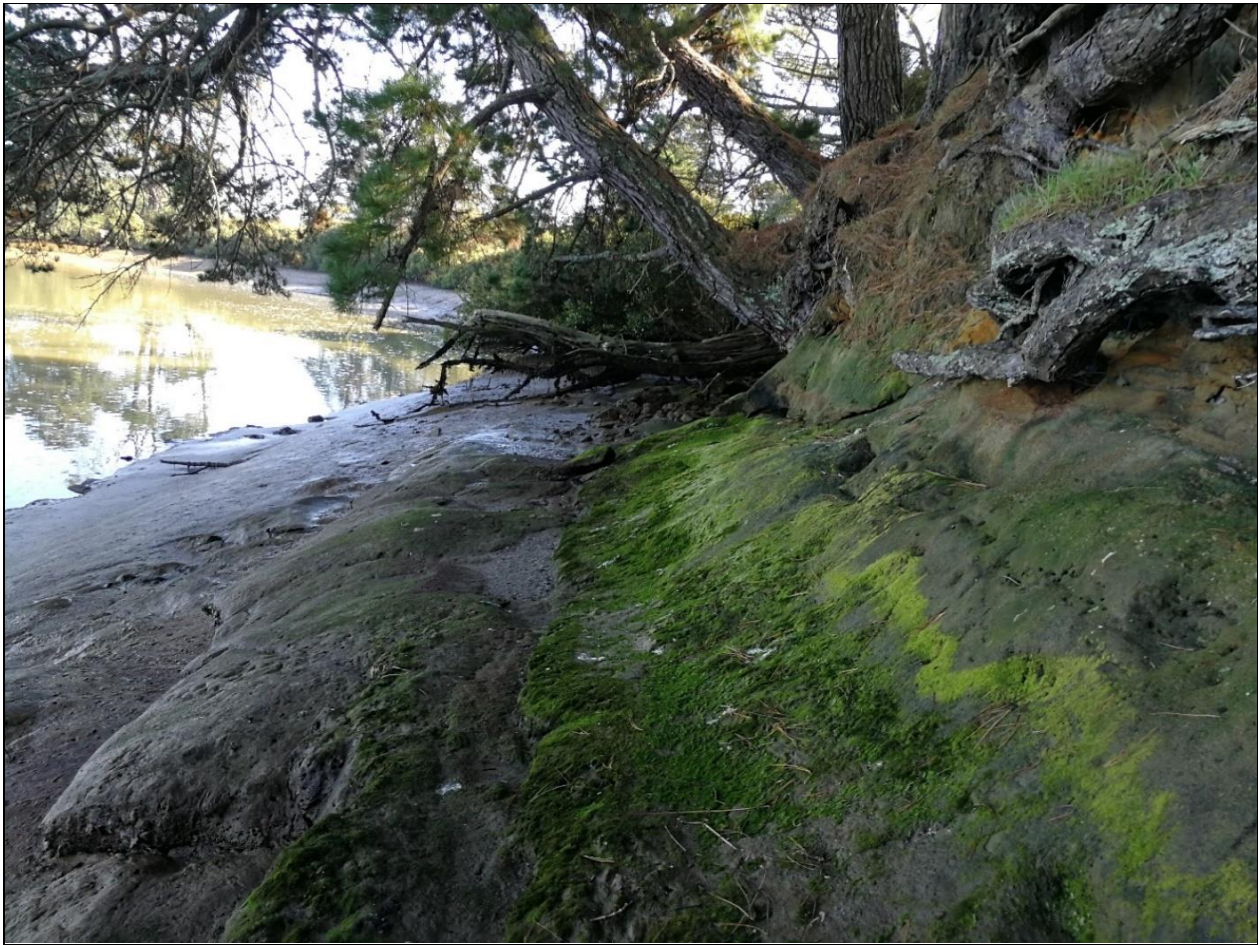
Figure 3: Waitemata Series toe material from the norther section of cliff at the subject site. (Source: Site visit)

Information from the geological maps available on Auckland Council Geomaps indicates the area is dominated by Puketoka formation material, with some minor outcropping of East Coast Bays Formation sandstones (**Figure 2**). Coffey Ltd. undertook geotechnical investigations of the site in 2015 as a part of the feasibility investigations for development of the site. Hand auger samples from sites close to the coastal margin indicate relatively shallow (2-3m below the surface) occurrence of East Coast Bays Formation material in the northern section of the site. This is supported by observations from the site visit which indicates the cliff material along the northern section is comprised of East Coast Bays Formation material (**Figure 3**).

The areas afforded protection from either mangrove or saltmarsh habitat are mapped in **Figure 8** below. This illustrates that only one small area in the north western part of the subject coastline is not afforded protection by coastal vegetation. During the site visit this was attributed to the exposure of East Coast Bays Formation rock material and the proximity to the main tidal channel not allowing for the settlement of soft sediment and mangrove seedlings required to establish the habitat (refer **Figure 3**).

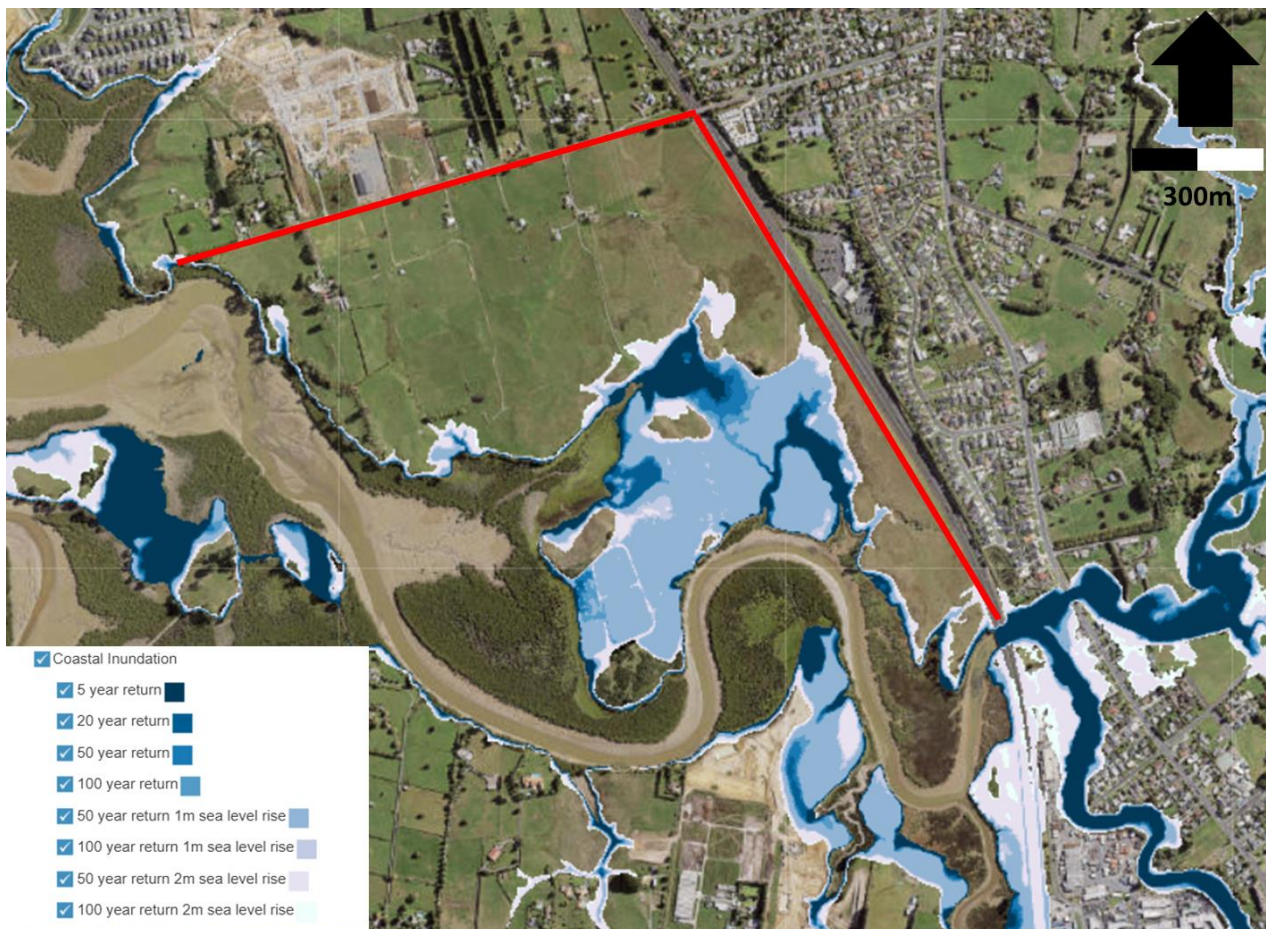
Figure 6: Areas susceptible to coastal inundation with the solid red line demarcating the approximate landward boundary of the subject site (Source: Auckland Council Geomaps)

Parts of the site are subject to current and potential future coastal inundation during storm events as highlighted in **Figure 6** below. **Table 1** above provides a summary of current inundation levels from a nearby modelled location.

Low lying areas of the site are expected to be currently susceptible to inundation events and the frequency of inundation is expected to increase with predicted sea-level rise. As an analogy of future frequency of inundation, the event of 4 January 2018 was considered to be between a 10 and 20yr event in terms of inundation on the Manukau Harbour. An event of this magnitude can be expected to be closer to a MHWS tidal event, based upon an allowance of 1m sea-level rise prescribed by the Auckland Unitary Plan.

- There is a recognised coastal inundation and tsunami risk in low lying southern portion of the site (refer **Figure 6 and 7**).
- The majority of the coastal margin along the site is considered to be depositional with sediment and vegetation accreting, which makes erosion of the coastal cliff toes from wave action to be considered unlikely. Natural slope settlement is still expected in these areas.
- A ~180m section at the northern portion of the site has the potential for coastal erosion now, and in the future increased erosion. This retreat has been estimated to be between 18-20m over 100 years based upon the guidance provided from Auckland Council.

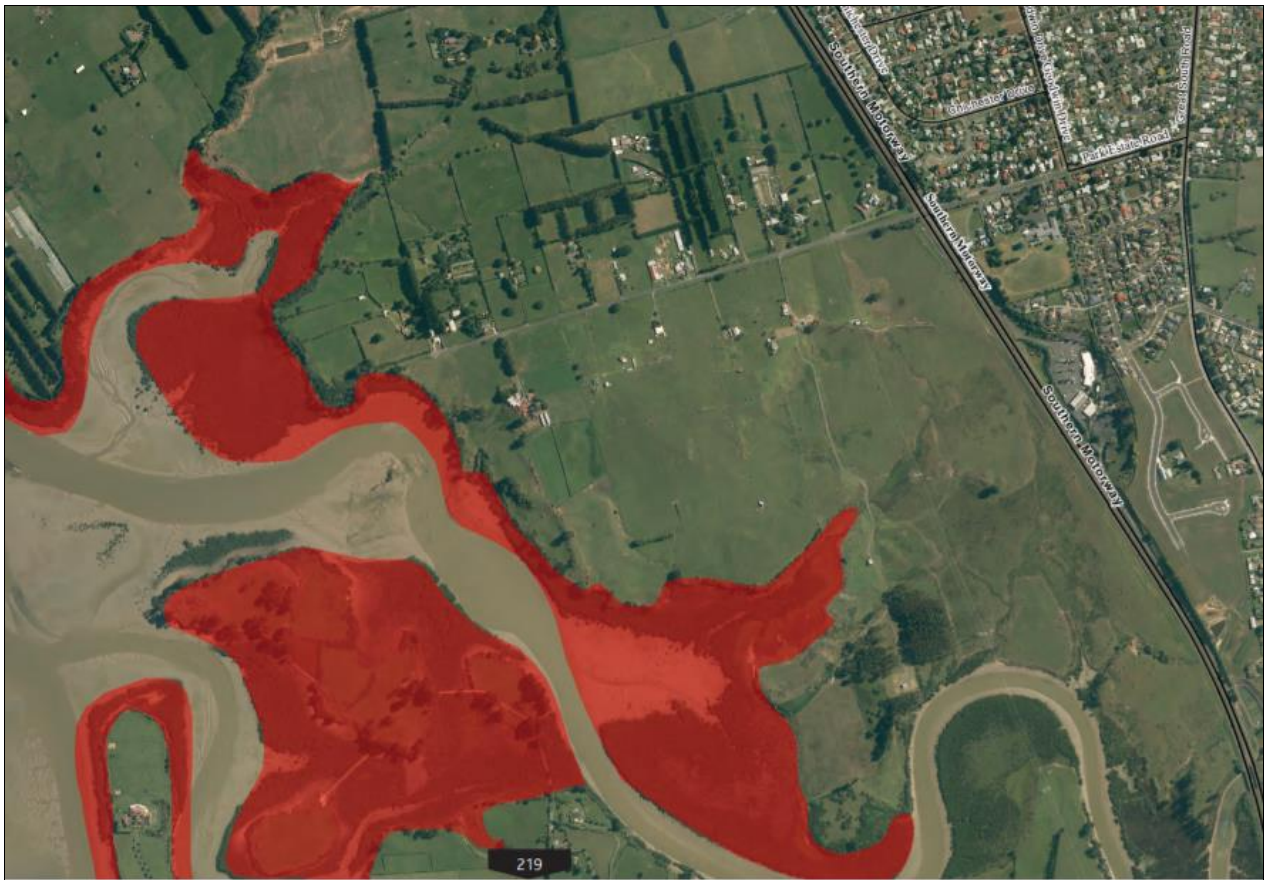
Figure 7: Tsunami risk for the subject coastline with the red area representing an exclusion zone.

Auckland Civil Defence have produced maps highlighting tsunami risk across the Auckland region. For the subject coast the areas below MHWS are highlighted as exclusion zones (**Figure 7**). Above this point, the risk to the site from tsunami is assumed to be similar to that presented by storm inundation plus predicted sea-level rise.

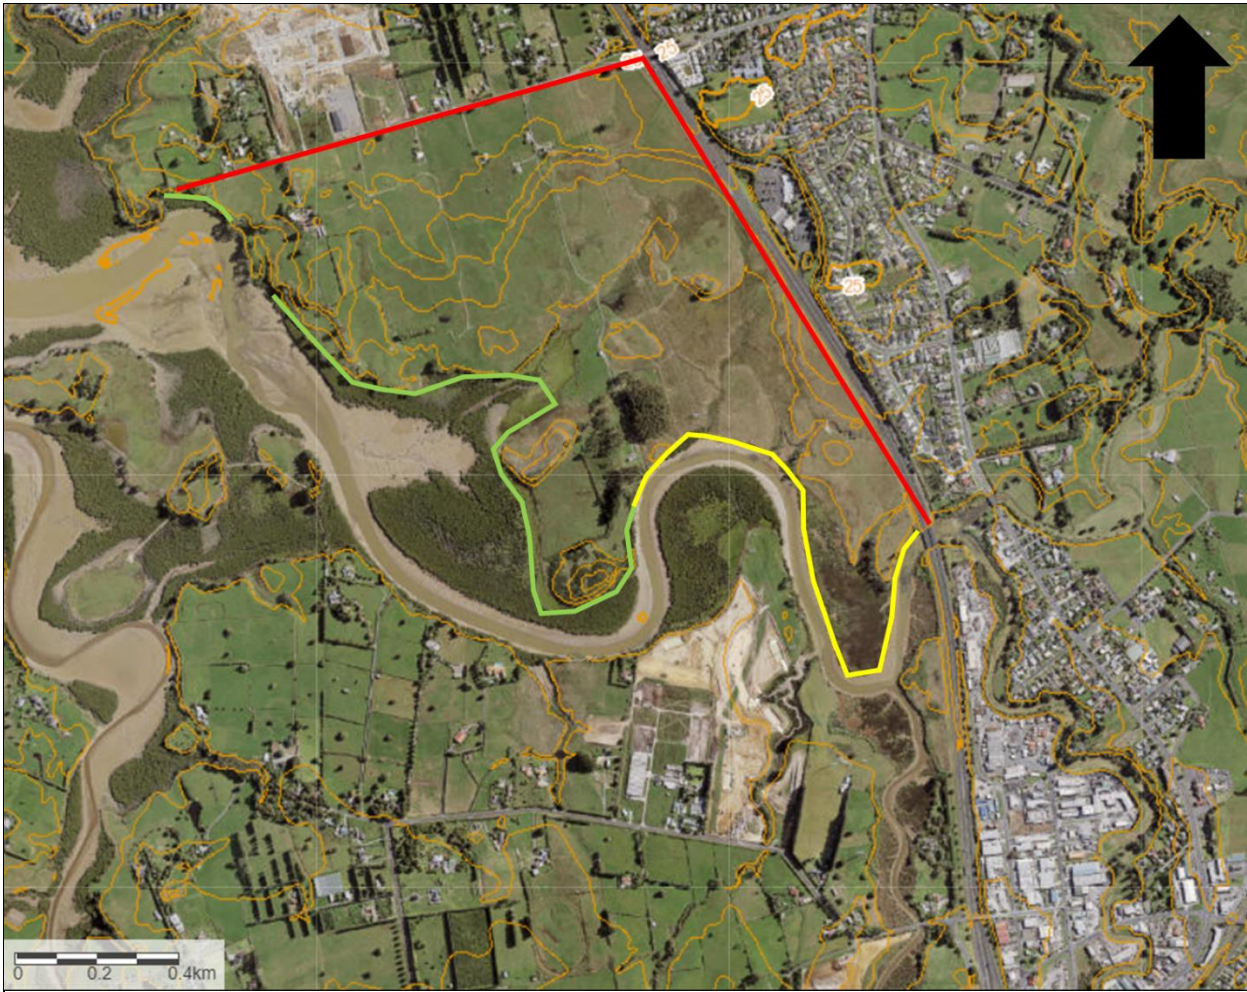
Figure 8: Areas of the subject coastline afforded protection by either mangrove or saltmarsh habitat. The green line represents mangrove habitat, the yellow line is a mix of mangrove and saltmarsh habitat.

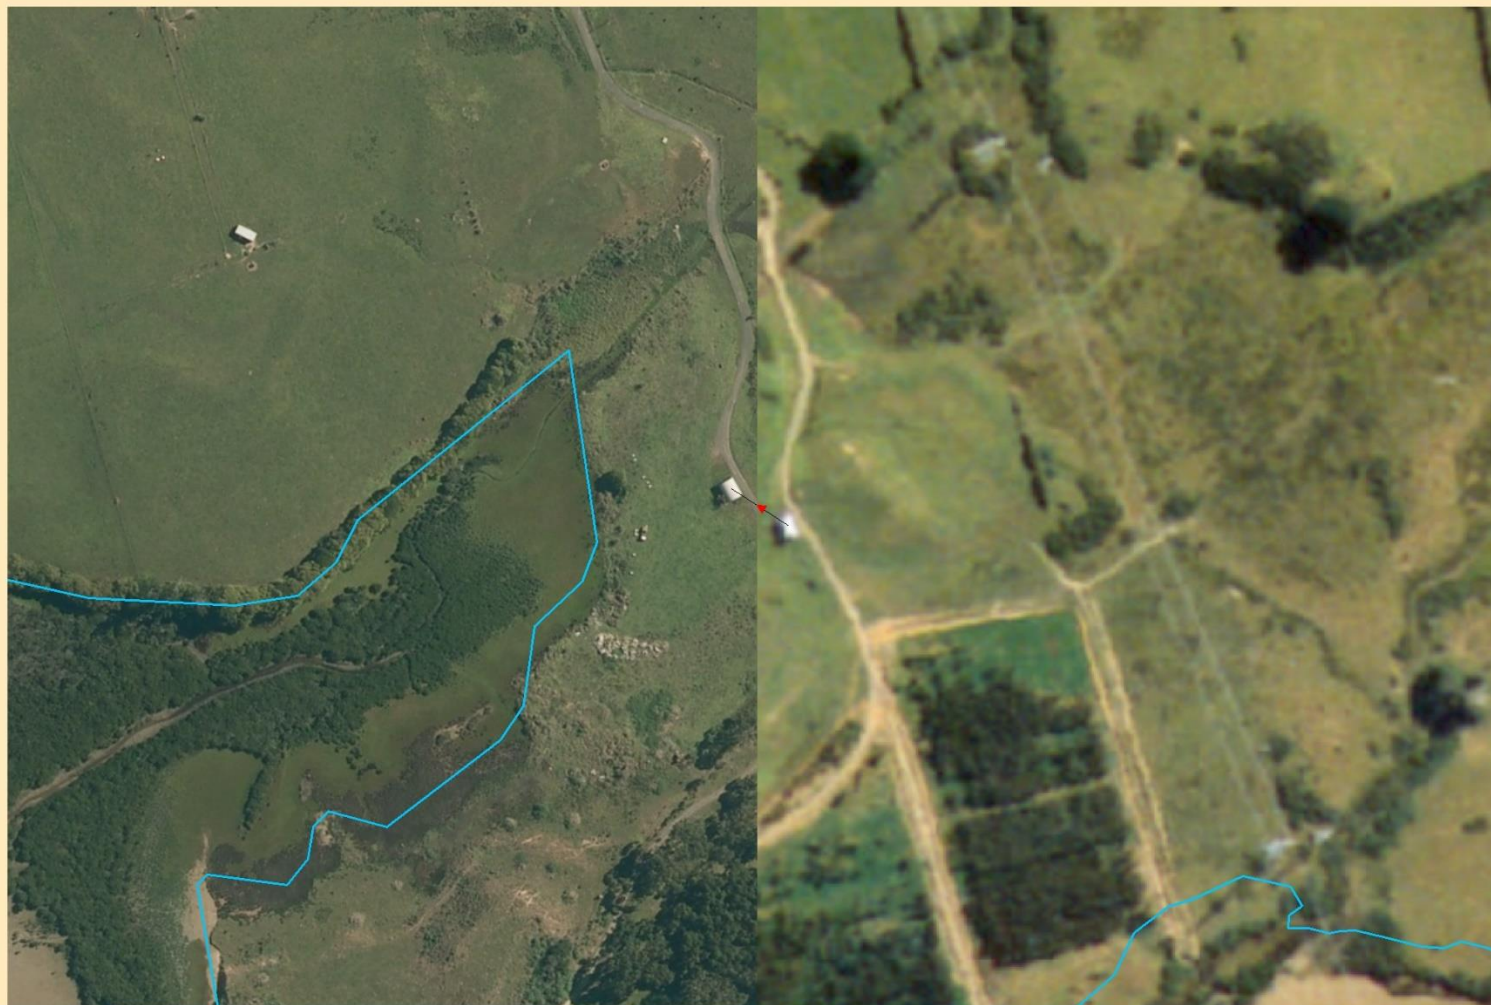
PROJECT  
TITLE Shift applied to 1996 aerial image

Legend  
— Current Coastline  
— Shift Applied to 1996 imagery

Detailed GIS analysis of the available historic aerial photos from the Auckland Council Geomaps website was undertaken as a part of this investigation. This involved manipulation of the aerial images to correct and align the imagery, noting there were some minor discrepancies due to the large-scale rectification process undertaken for Geomaps. Images from the northern section dated back to 1959, while examination of the southern section were limited to 1996. To provide greater context the comparison to the 1959 air photo was extended approximately 3km downstream of the site to improve the extent of longer term analysis.

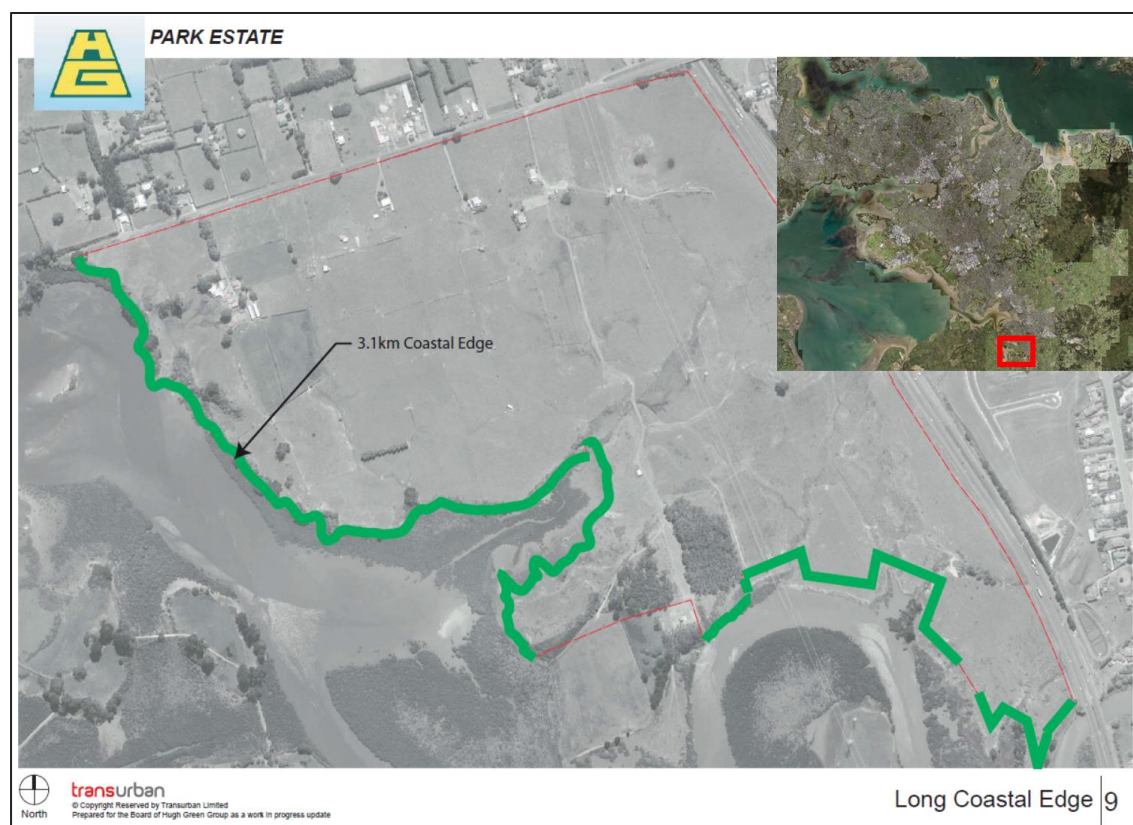
Figure 1 - Location of the subject site. The green line shows the extent of the subject coastline and the red box illustrates the approximate location (Source: Auckland Council Geomaps)

Hugh Green Group are investigating the development potential of approximately 88Ha of coastal land along the eastern shore of Drury Creek, situated in the south-eastern corner of the Manukau Harbour (**Figure 1**). Parts of the site have been highlighted within a coastal erosion hazard zone as per the Auckland Unitary Plan definitions section.

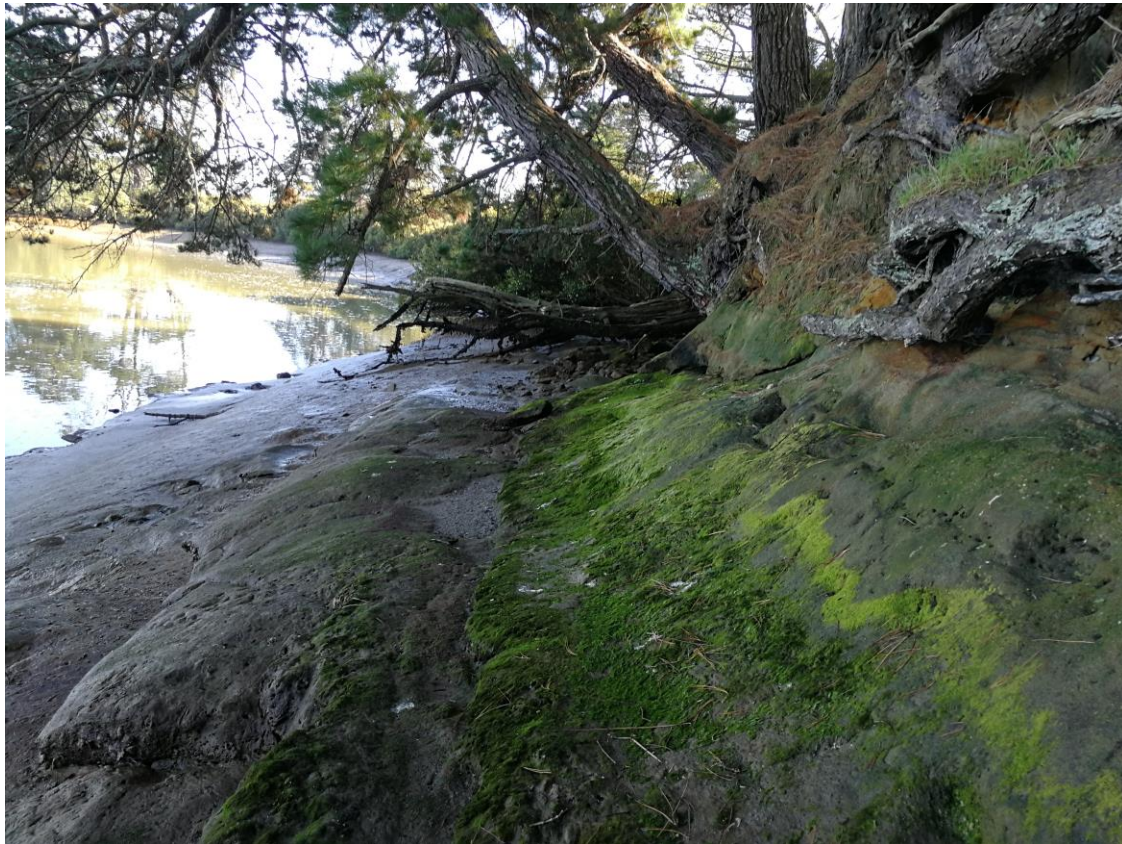
*Figure 3 - Waitemata Series material forming a narrow shore platform along the northern shoreline of the subject area (Source: Site Visit)*

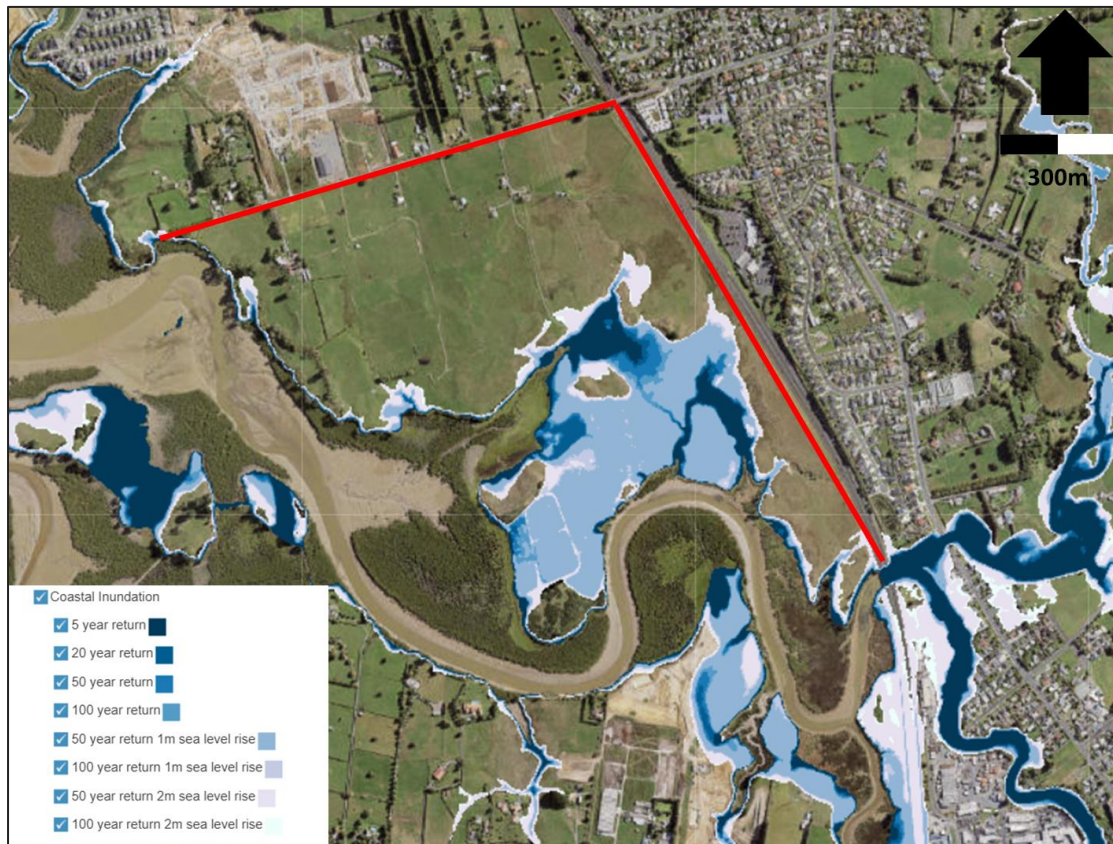
Figure 4 -Areas susceptible to coastal inundation with the solid red line demarcating the approximate landward boundary of the subject area (Source: Auckland Council Geomaps)

**Figure 4** illustrates those areas of the proposed development site subject to present coastal inundation and, that with projected sea-level rise, will potentially be subject to additional inundation in the future. Typically, these areas are associated with low lying sub arms of the Drury Creek. It is expected that inundation of these areas would have occurred during the storm in early January 2018, which could be used as a proxy for future conditions at the site. It is noted that increased inundation (expected with predicted sea-level rise) can be managed via elevation of the proposed development area, due to the sheltered nature of the site.
