Heritage Evaluation

The Royal New Zealand Air Force Institute Building (former)

[Currently known as The Sunderland Lounge]

Hudson Bay Road, Hobsonville Point

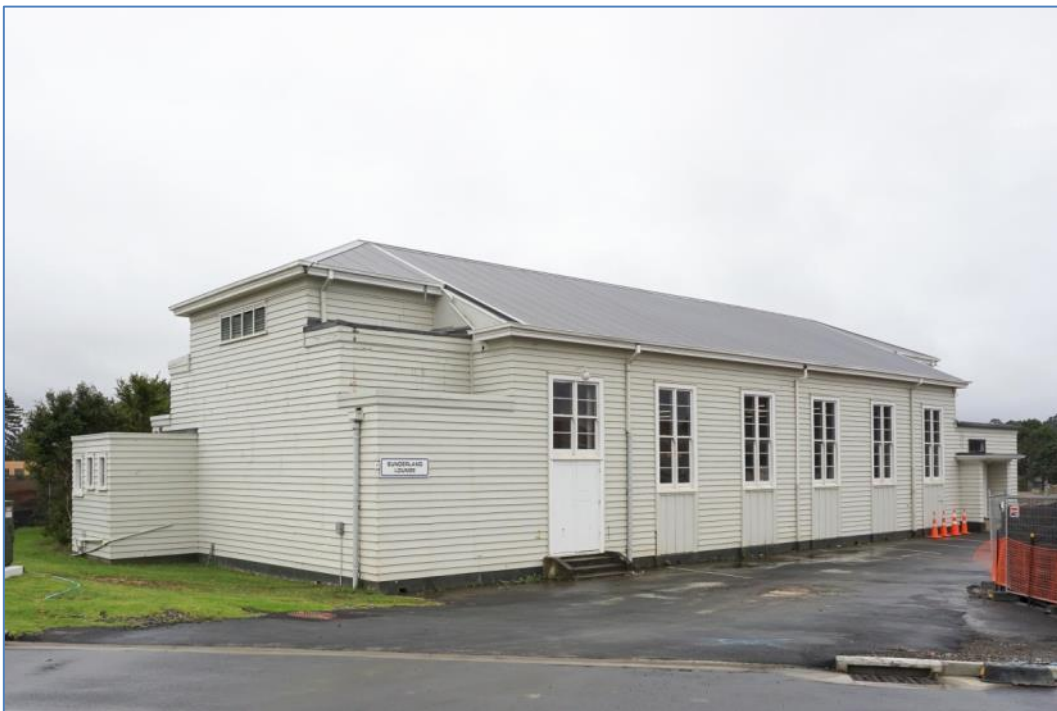
The South and East elevations of the former Royal New Zealand Air Force Institute Building.

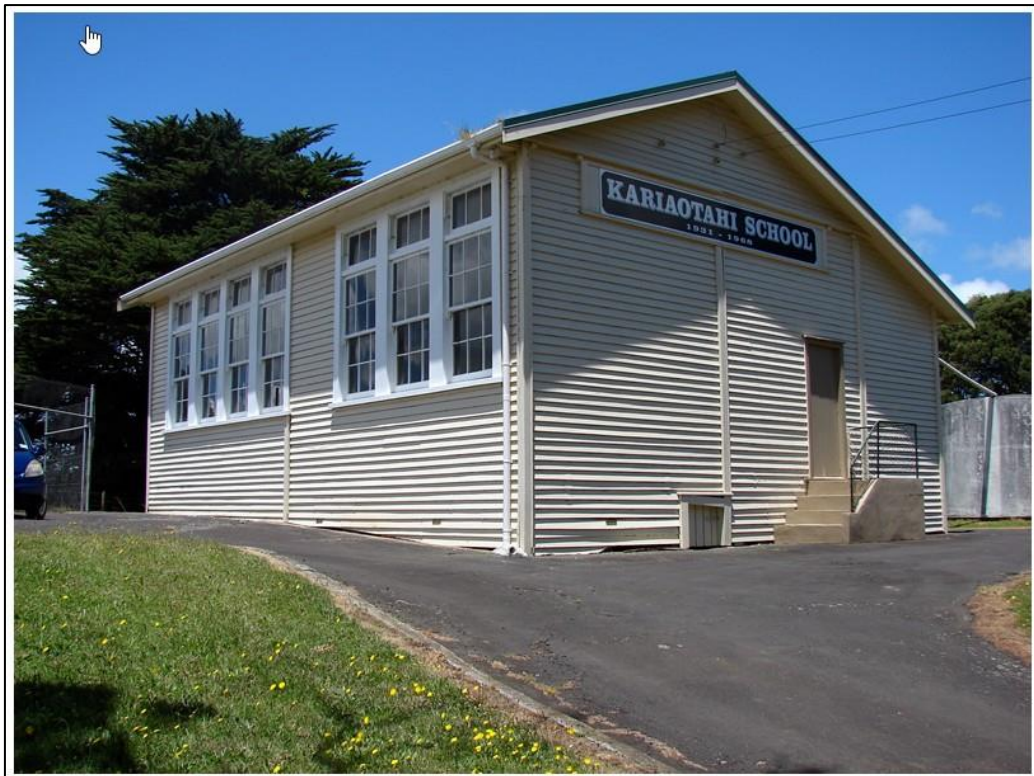
Figure 8: The Kariaotahi School Hall - built **1931** in a generic rectangular gable ended style. Timber framed, timber weatherboards, hung windows and an iron roof. The building exhibits a robust simplicity to the form – much of which is similar to the Institute building.
<https://www.waikatodistrict.govt.nz/recreation/community-halls>.

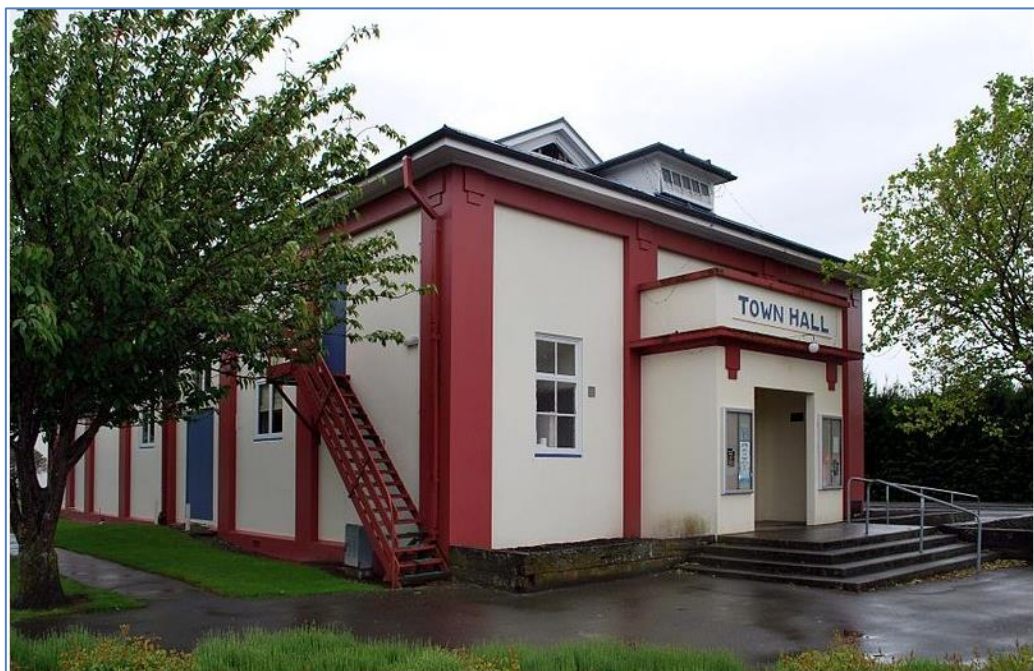
Figure 9: The Oxford Town Hall - built 1931. Built with more decorative flair, and with different materials than the Kariaotahi School Hall and the Institute building, the Oxford Town Hall still exhibits a similar shape, form and function to the Institute Building.
[https://commons.wikimedia.org/wiki/Category:Oxford_Town_Hall_\(New_Zealand\)#/media/File:Oxford_NZ_Town_Hall.JPG](https://commons.wikimedia.org/wiki/Category:Oxford_Town_Hall_(New_Zealand)#/media/File:Oxford_NZ_Town_Hall.JPG).

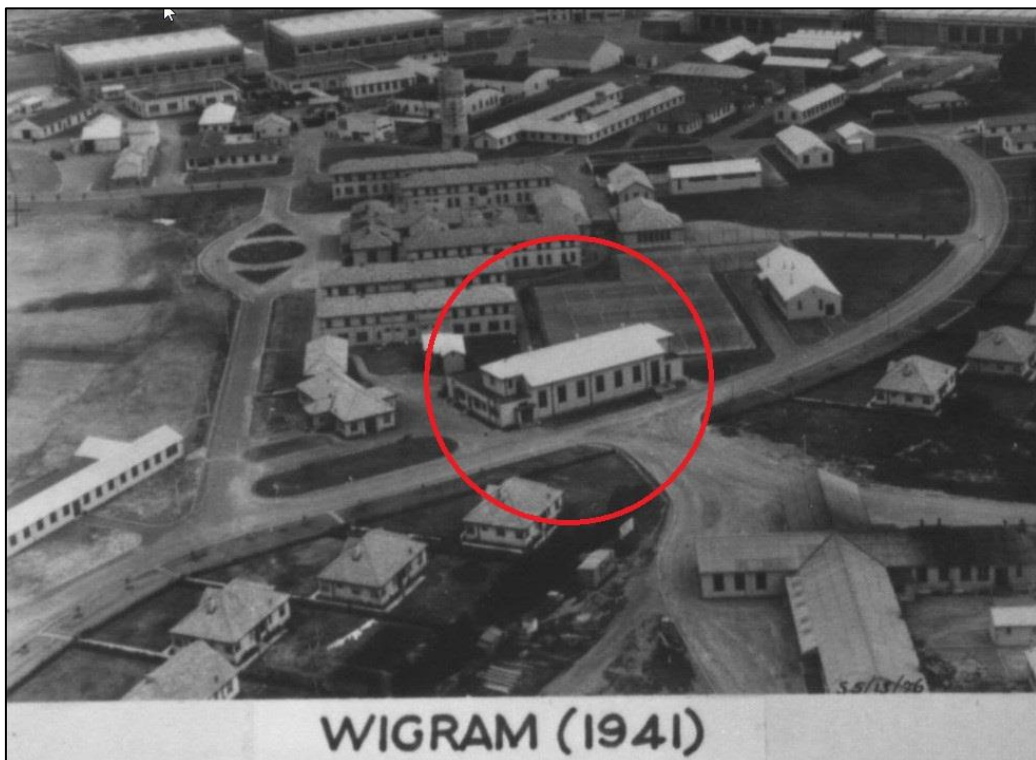
Figure 12: [Assumed to be] **1941**. View of Wigram Aerodrome RNZAF base, Christchurch – shows the very similar (but slightly larger, longer by 1 bay) version of the Institute Building at Hobsonville. The Hobsonville Building is reversed about both the x and y axes – refer drawings, figs. 103-109. <http://rnzaf.proboards.com/thread/14286/early-wigram-pics>.

Referring to figs. 103–109 below, the plans for Hobsonville were based on the plans for Wigram. It is worth noting that while the internal structural and/or room layout of the Wigram plans is very similar to Hobsonville, the uses are in some cases quite different. For example, the main entrance in Wigram appears to be through a vestibule adjacent/within the lavatory block, whereas at Hobsonville, the entrance is through what is the canteen at Wigram. With such scant detail available to us, we cannot know whether the changes made were a) because the layout at Wigram had proved at fault, or b) because the way the building was deemed to be used at Hobsonville was to be different. Regardless, the buildings are so similar they were clearly a grouping, and if the Hobsonville Institute building is the last remaining of a grouping, then it is all the more important in terms of both our military and community hall architecture.

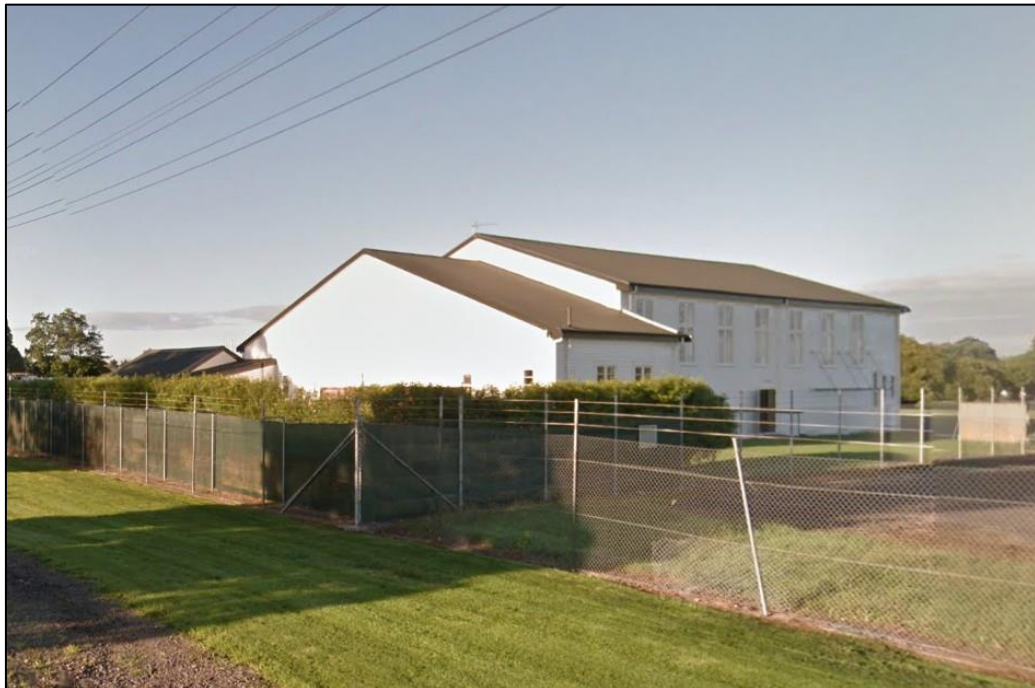
Figure 15: The Papakura Military Camp building, shows a similar scale and form to the Institute building at Hobsonville.

Papakura Military Camp is located in the Auckland suburb of Papakura North. It is today the National Headquarters for the New Zealand Special Air Service. Established in 1939, it includes within its curtilage a timber framed, iron-roofed hall building, similar in size and form, and perhaps age²³, to the Institute building (refer fig. 15 below). It did, at least in 1962 (see fig. 14 below), operate in a similar capacity too, called up in the photo as the camp cinema.

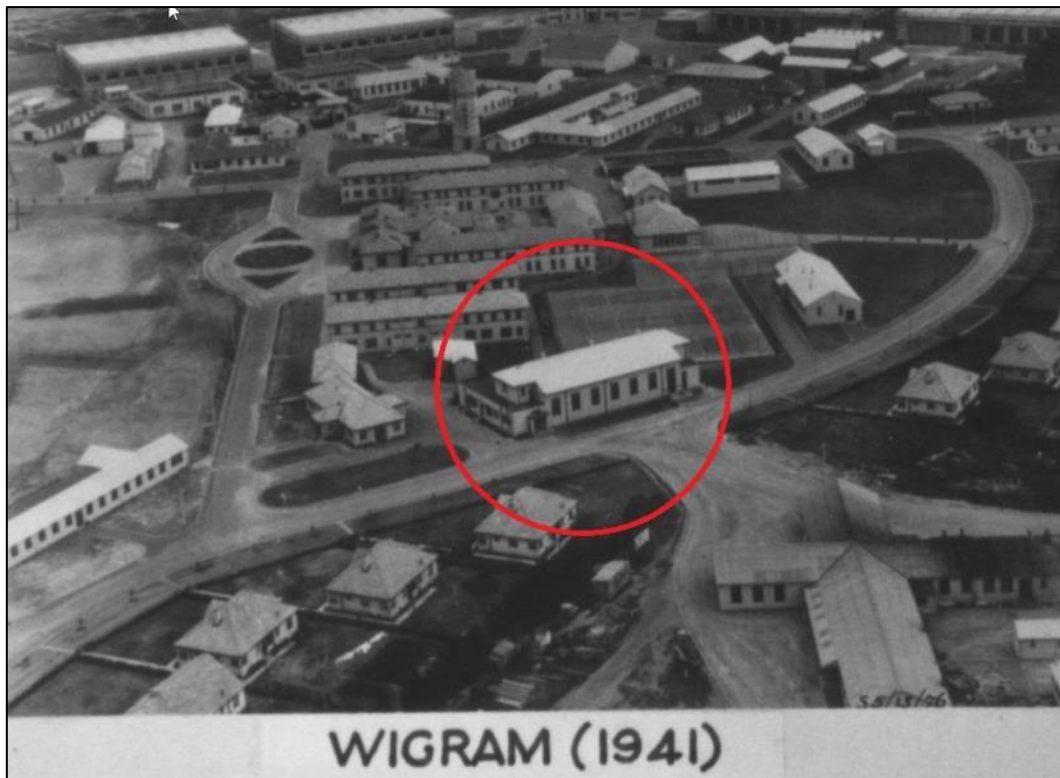
Figure 25: [Assumed to be] **1941**. View of **Wigram** Aerodrome RNZAF base, Christchurch – shows a very similar (but slightly larger, longer by 1 bay) version of the Institute Building at Hobsonville. The Hobsonville Building is reversed about both the x and y axes – refer drawings, figs. 103-109.
<http://rnzaf.proboards.com/thread/14286/early-wigram-pics>.

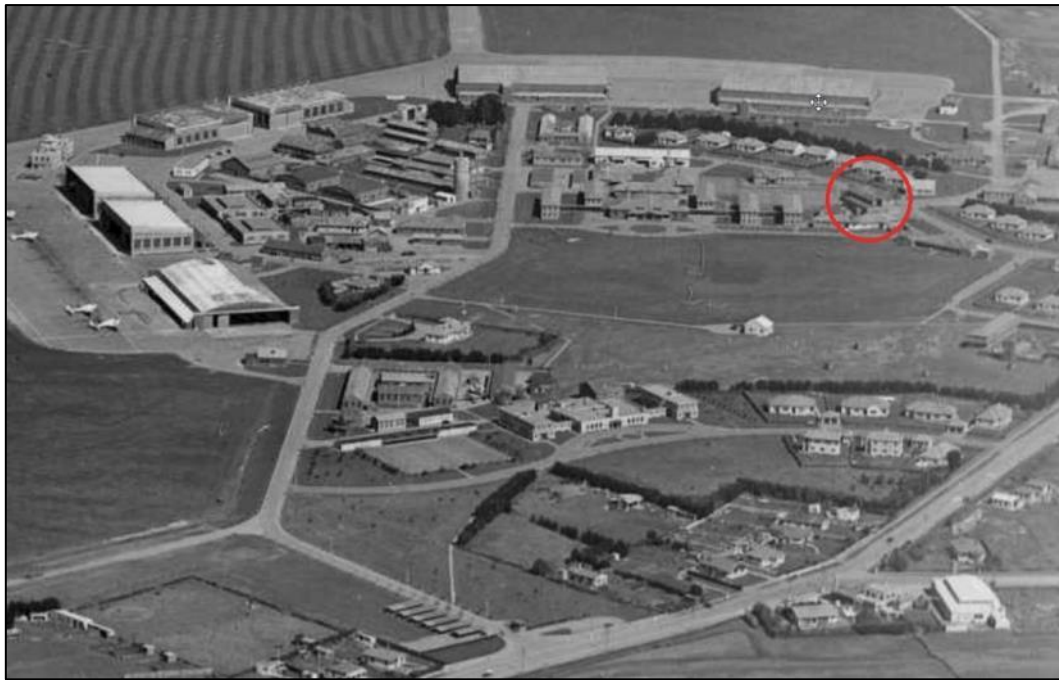
Figure 28: September **1946**. View of **Wigram** Aerodrome RNZAF base with planes, hangars and buildings, Christchurch, Canterbury. Shows the institute building (circled in red, now gone) to the same or similar design to the subject building at Hobsonville. Whites Aviation Ltd :Photographs. Ref: WA-03934-G. Alexander Turnbull Library, Wellington, New Zealand. /records/30650934.

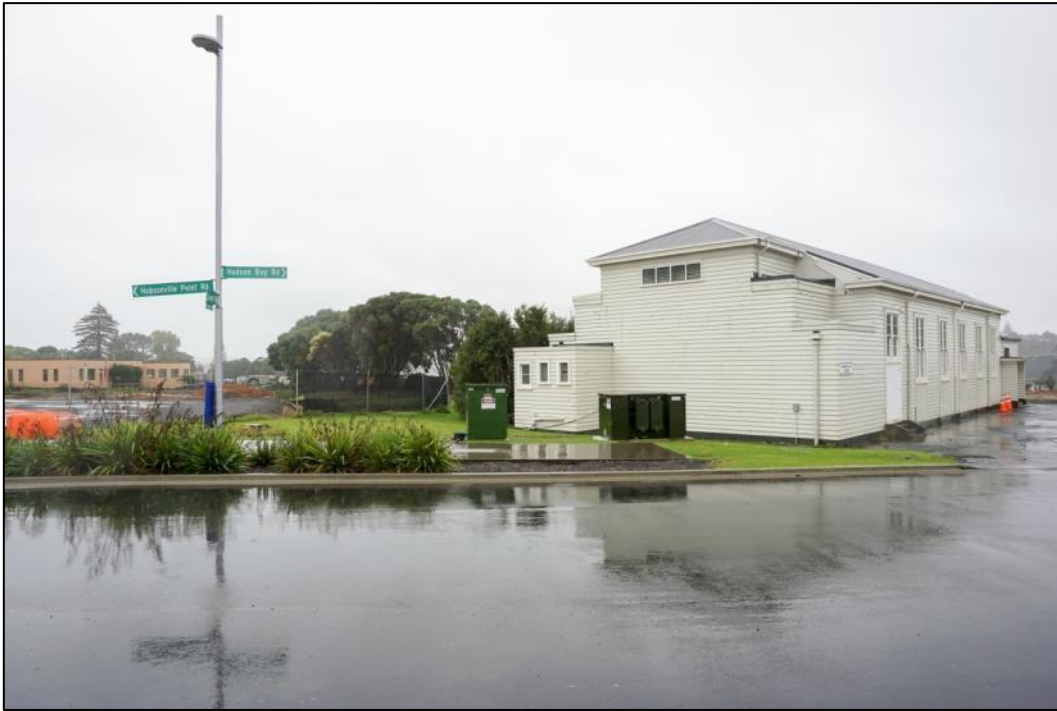
Figure 61: Site context – Looking north towards the subject site and building. The Royal New Zealand Air Force Headquarters building is to the left of the photograph, or to the northwest of the subject building. Photo: Blair Hastings – March 2017.

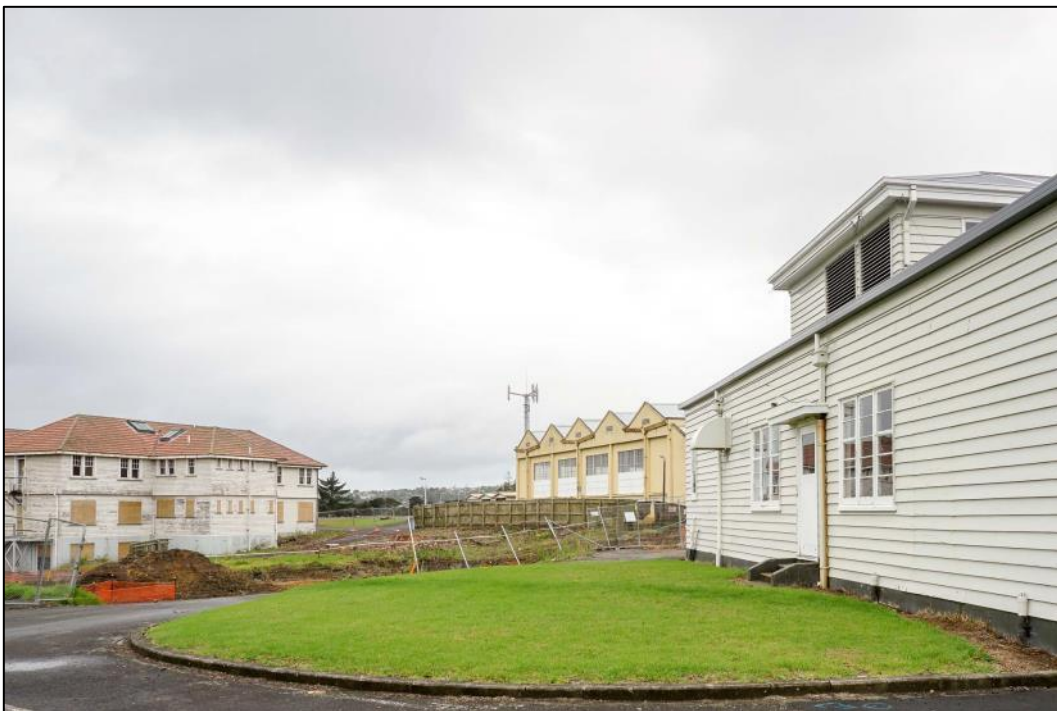
Figure 62: Site context – Looking southeast with the north elevation of the subject building to the immediate right of the photograph. The Catalina Barracks are to the distant left and the Catalina (No.2) Hangar is in the distant middle. Photo: Blair Hastings – March 2017.

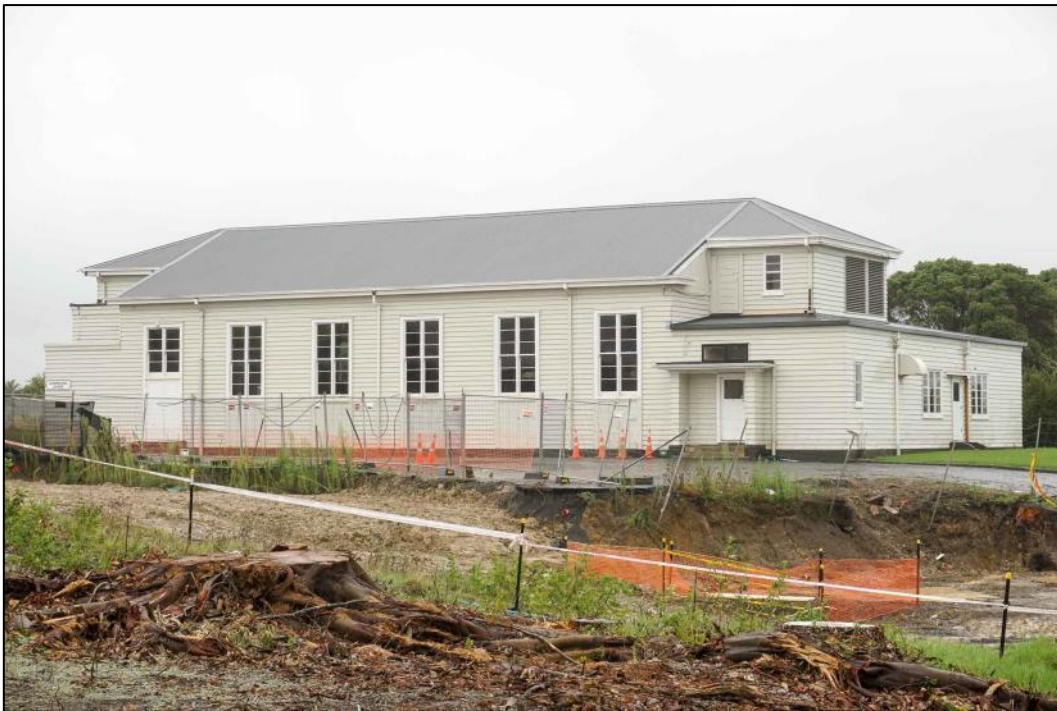
Figure 65: Site context – Looking west towards the east elevation of the subject building. The foreground site marks the approximate location from where the Canteen building has been removed.
Photo: Blair Hastings – March 2017.

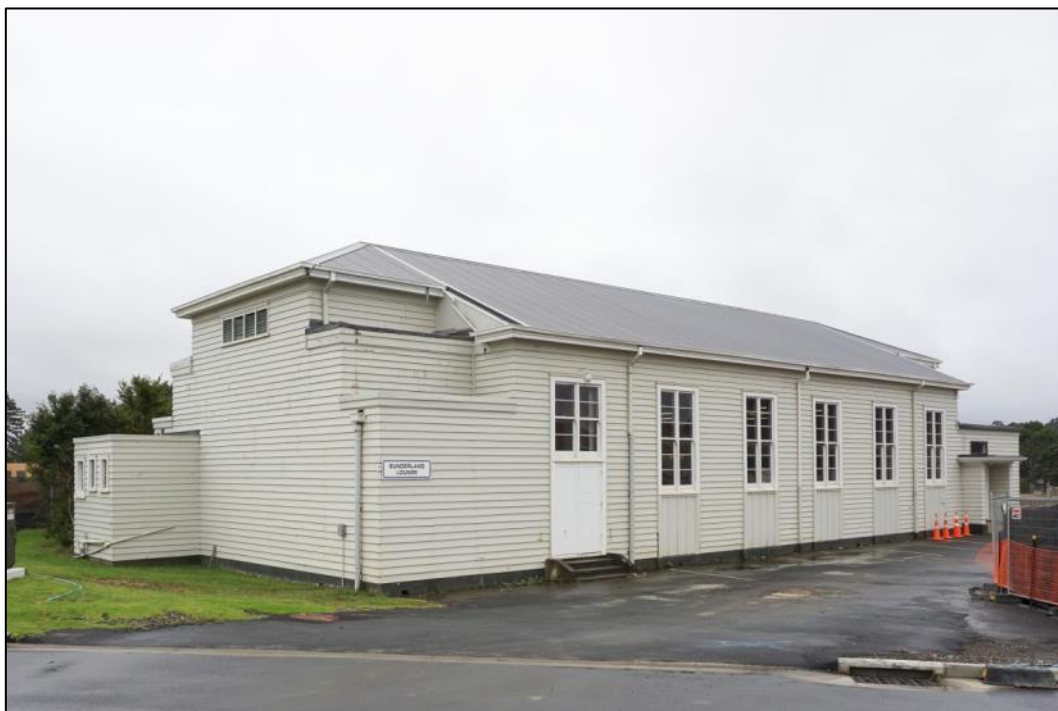
Figure 67: Looking northwest towards the south and east elevations of the subject building. The second 'tier' or flat roof in the south elevation is not thought to be original. There was also a further door in the southern end of the east elevation – into a Barber's Shop. Photo: Blair Hastings – March 2017.

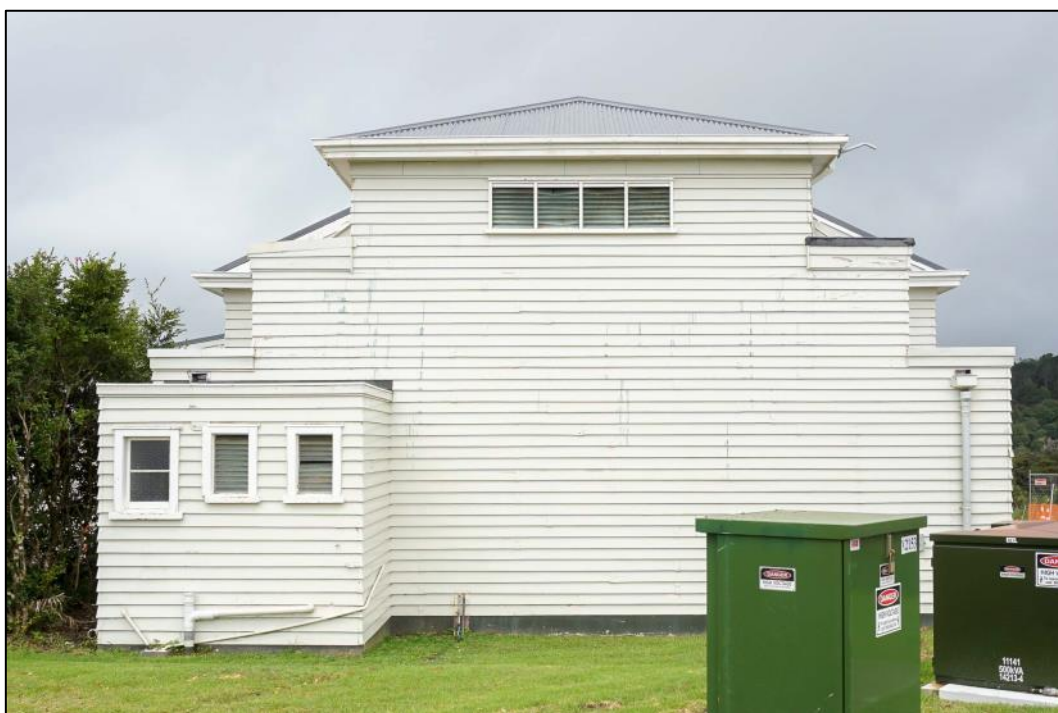
Figure 68: Looking North at the south elevation of the building. The toilet block to the lower left of the image was added circa 1940 (see figure 110 below). Photo: Blair Hastings – March 2017.

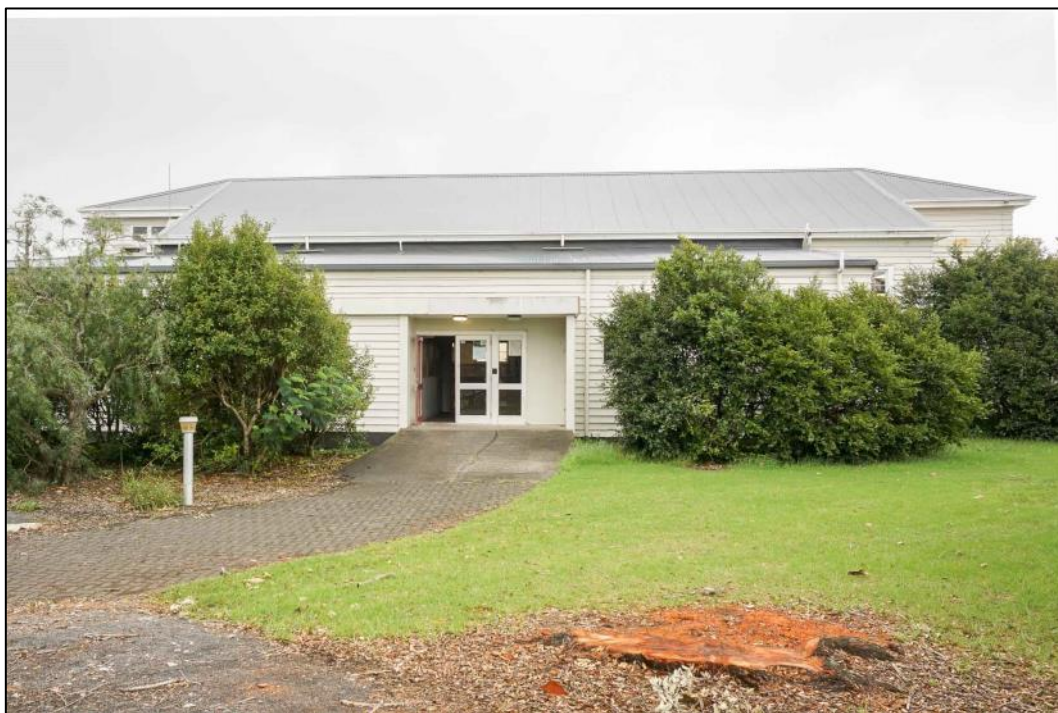
Figure 69: Looking east at the west elevation of the subject building. The porch that provides shelter external to the main door has been added. The roof above the entrance foyer has re-pitched and re-roofed. Photo: Blair Hastings – March 2017.

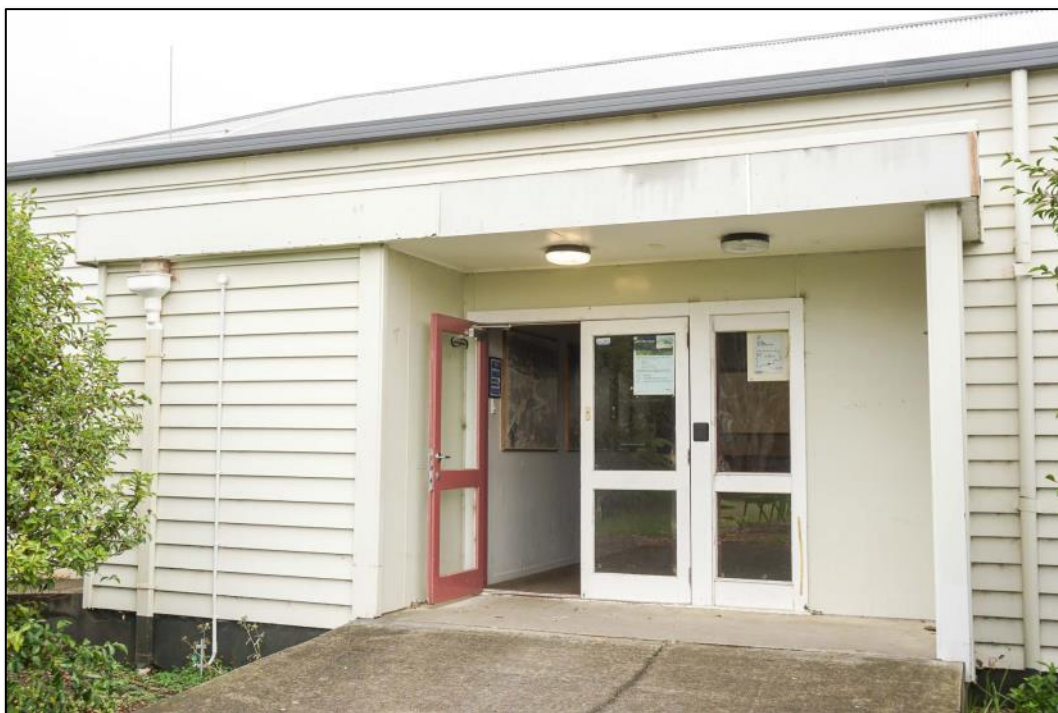
Figure 70: Close-up image of the entrance porch seen above. Not original to the building. Modified doors. Photo: Blair Hastings – March 2017.

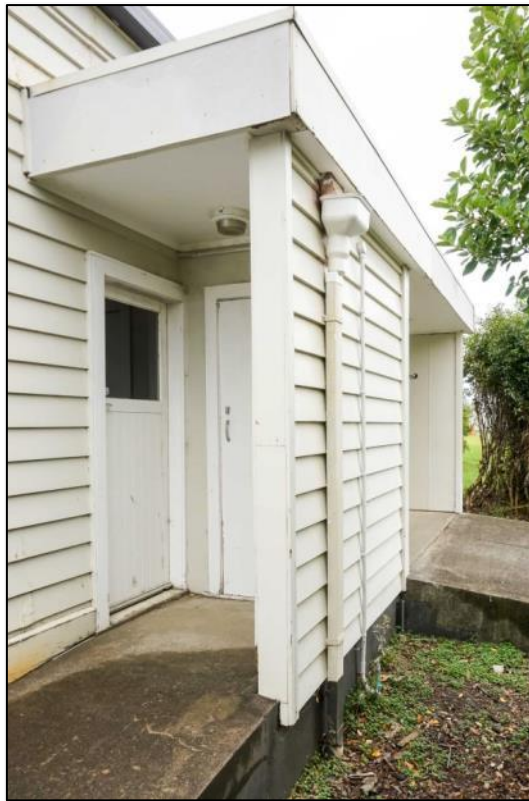
Figure 71: Non-original entrance porch to the west elevation. Both ramps have been added at some stage. Photo: Blair Hastings – March 2017.

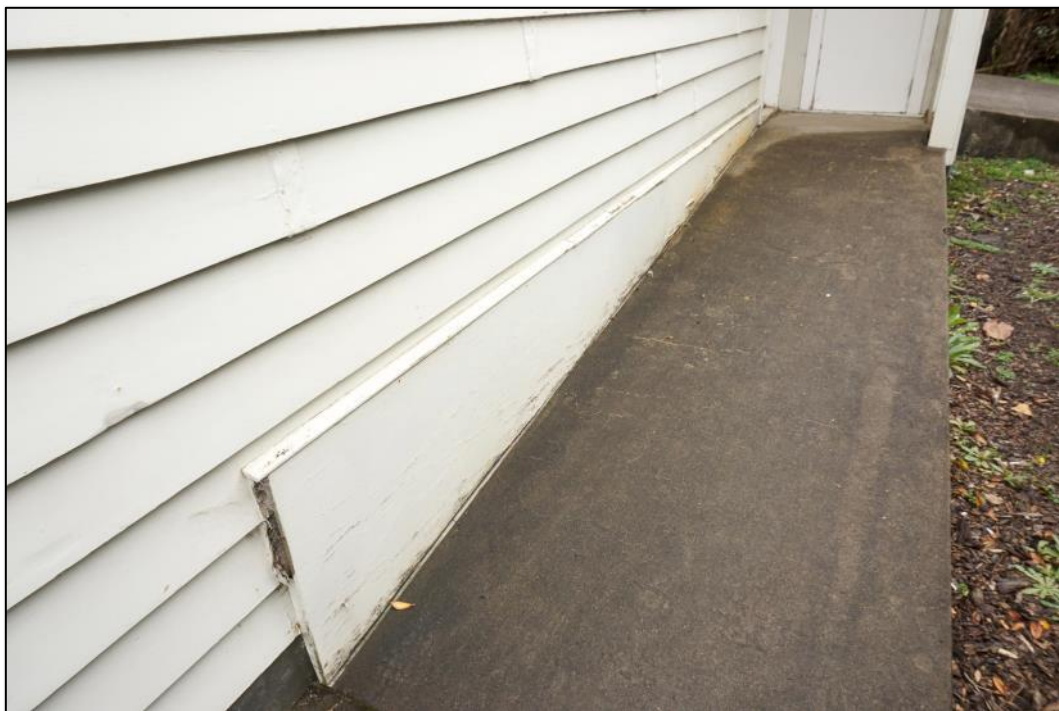
Figure 72: Ramp detail from above. Boarding has been applied to cover rotten weatherboards and floorboards internally. A temporary repair job that will need attention. Photo: Blair Hastings – March 2017.

It is recommended that a condition report be written for the building, in order for the owners to establish a program of repairs and maintenance.

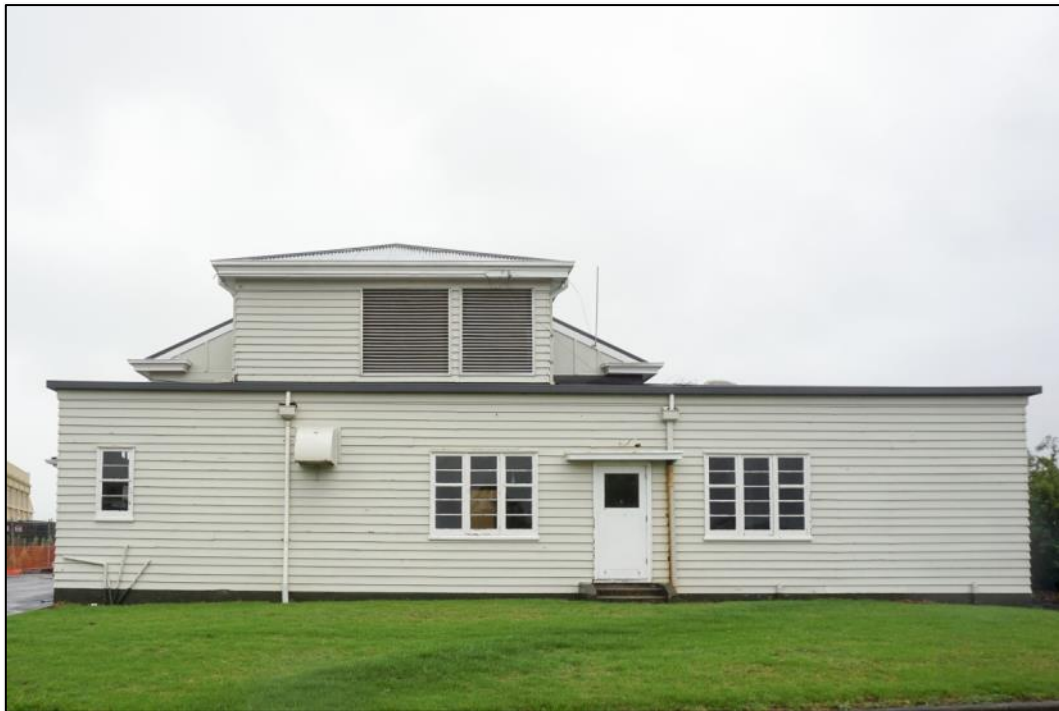
Figure 73: North elevation of the building. Windows appear to be original although when compared to the Wigram Institute Building, some windows may have been removed around the kitchen – perhaps to accommodate larger cooking facilities. Grille to projection room modified. Photo: Blair Hastings – March 2017.

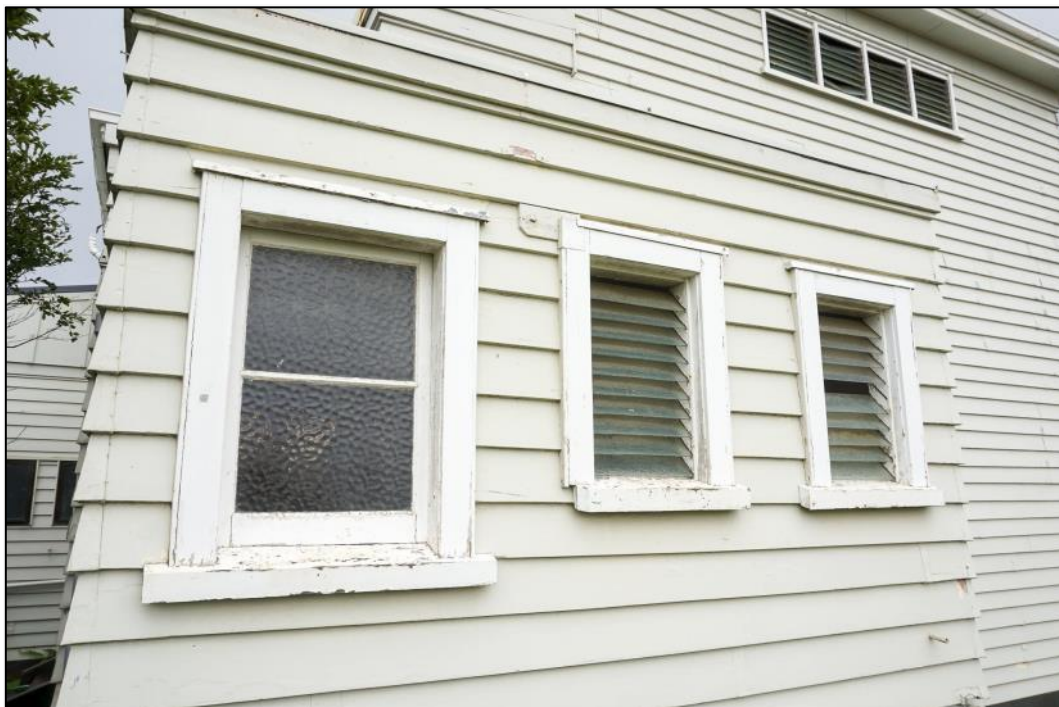
Figure 74: North elevation of the building. Toilet block added circa 1940 – windows appear to be original. See plan figure 110 below. Photo: Blair Hastings – March 2017.

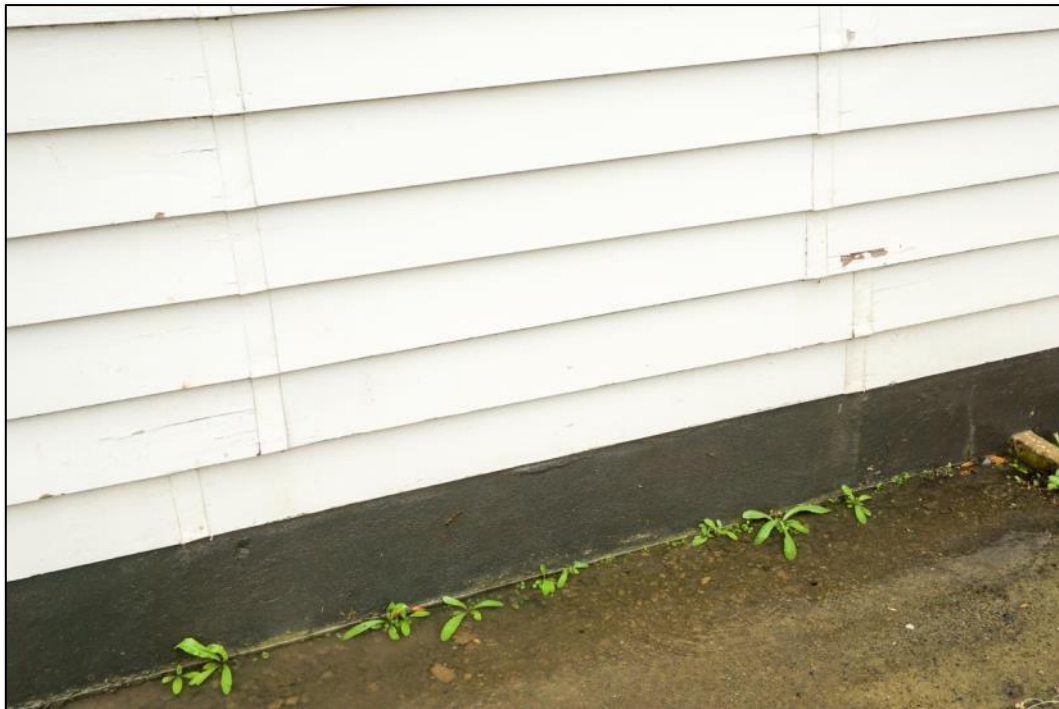
Figure 75: Southern section of the east elevation – the outline of the original door and steps into the Barber's Shop can be seen in the tin weatherboard jointers – refer also below. Photo: Blair Hastings – March 2017.

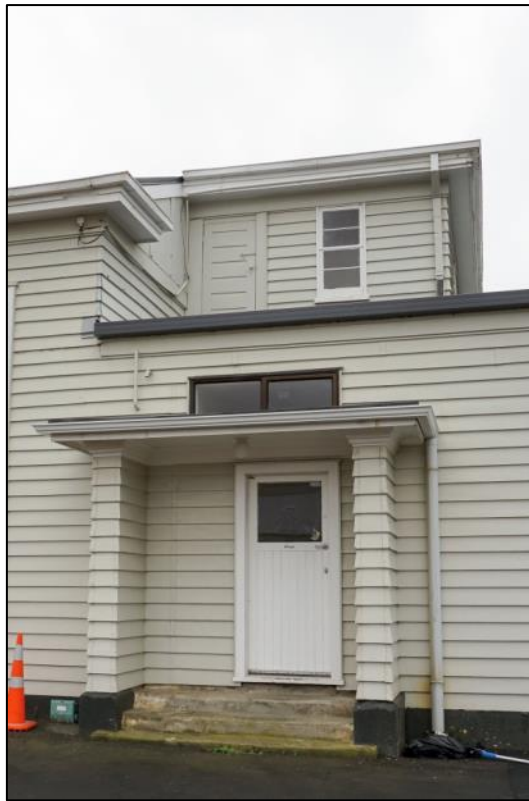
Figure 77: Northern end of east elevation. Porch detail original. Opening modified. Joints clearly show where the original door was. Modern aluminium windows above. projection room above that again. Photo: Blair Hastings – March 2017.

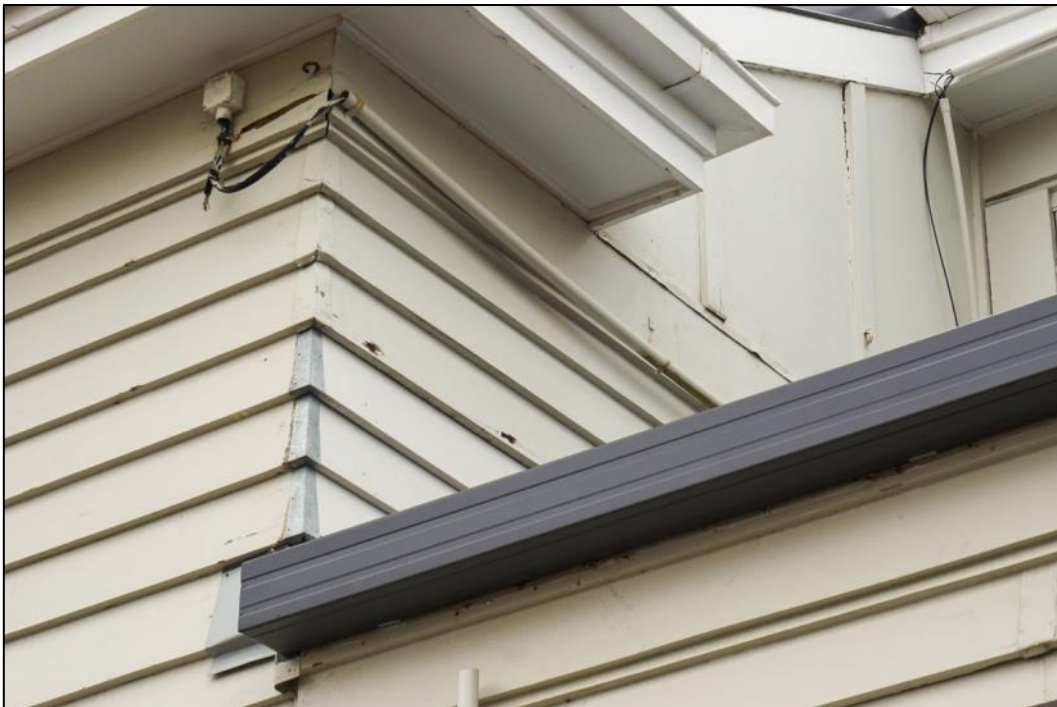
Figure 78: Detail of the wall junction above the porch (referring to the photo above in figure 77). Galvanised soakers have been fitted to address a problem. They remain unpainted. Further timber rot is still evident. Photo: Blair Hastings – March 2017.

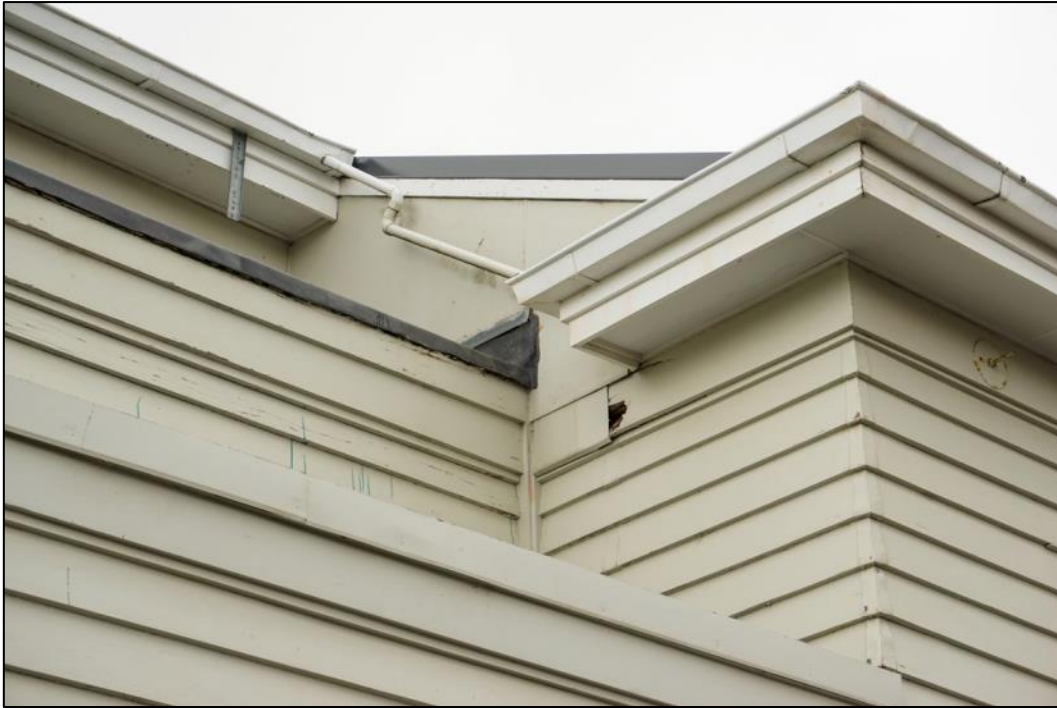
Figure 79: Detail of the wall junctions at the southeast corner of the building. The middle 'tier' (shown also below) was added at some stage. A combination of weatherproofing and roofing systems are evident. Photo: Blair Hastings – March 2017.

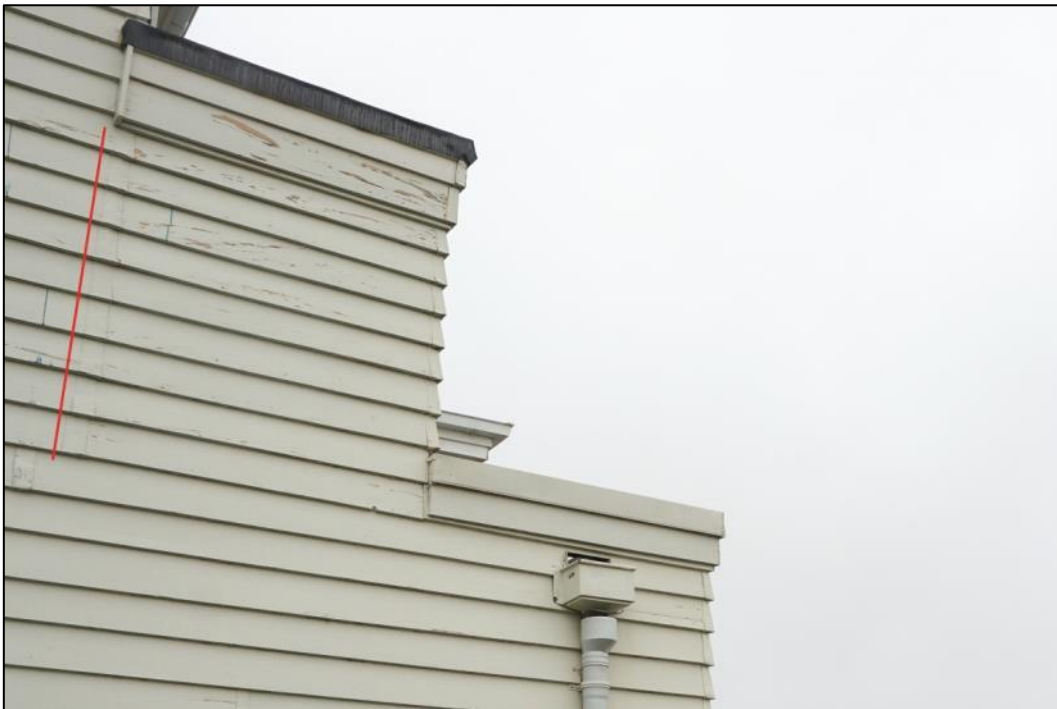
Figure 80: Detail of the southeast corner of the south elevation of the building. The red line shows tin jointers where the second 'tier' was added. Photo: Blair Hastings – March 2017.

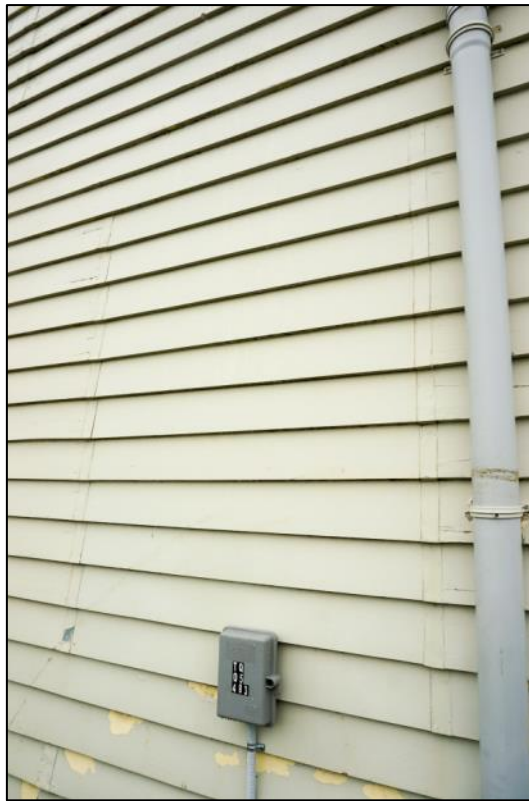
Figure 81: Southern section of the west elevation – the outline of the original door and steps into the dressing room can be seen in the tin weatherboard jointers – refer also below. Photo: Blair Hastings – March 2017.

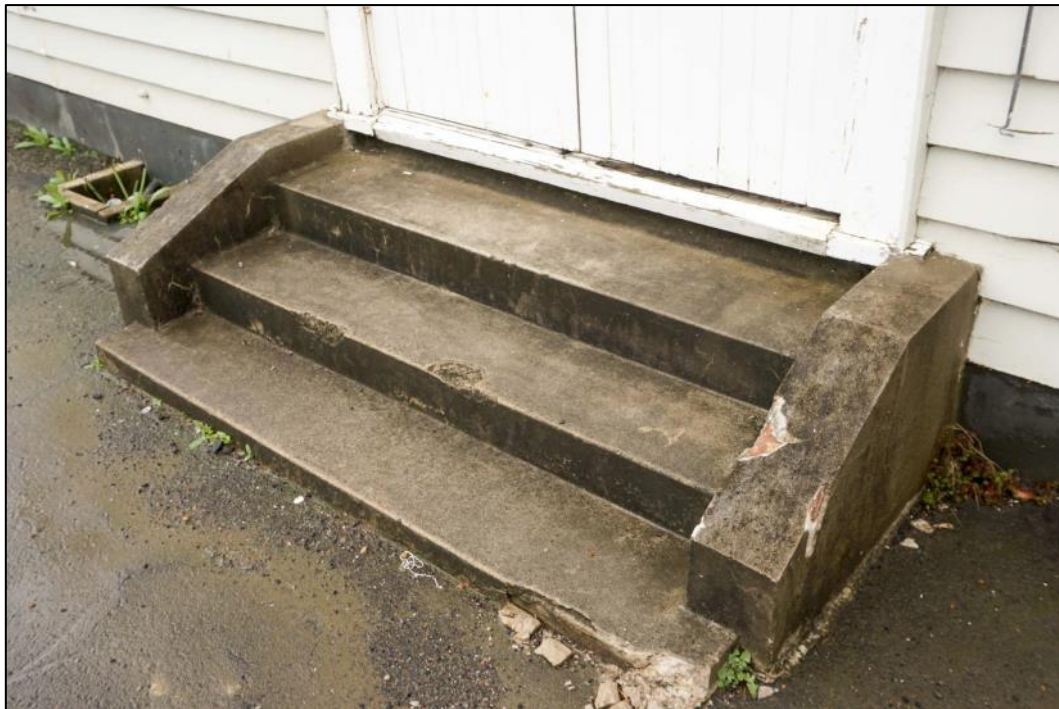
Figure 83: Southern section of the east elevation – original steps into the main hall space show concrete render over brick. The disrepair is common across material and fabric across the exterior shell of the building. Photo: Blair Hastings – March 2017.

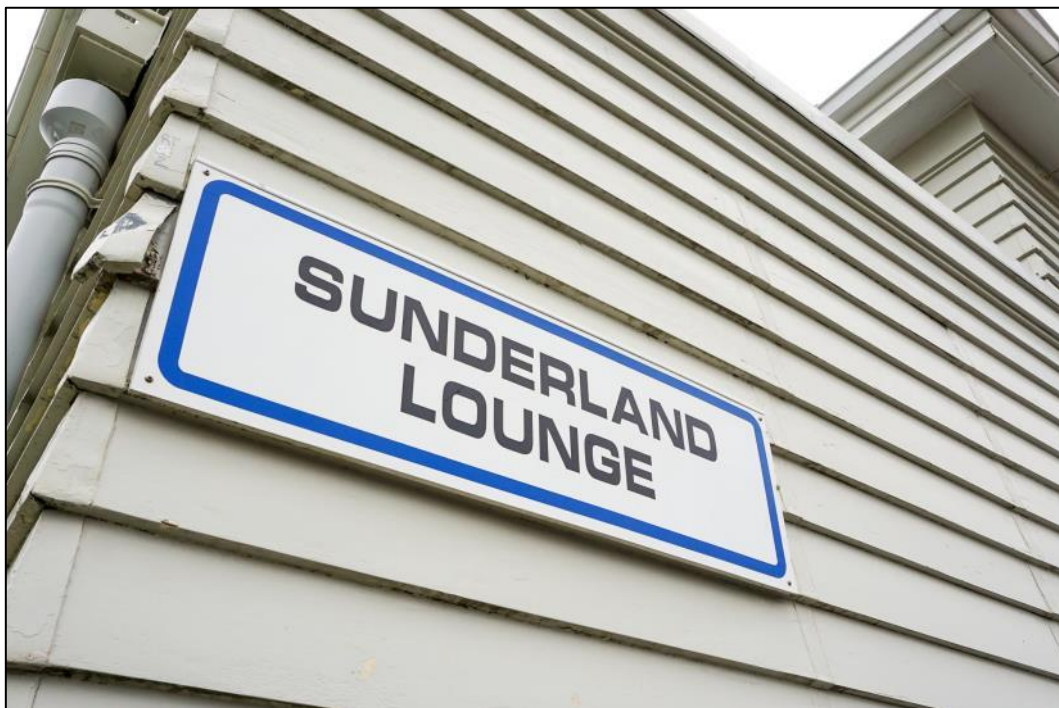
Figure 84: Signage applied to the Southern section of the east elevation, renaming the Institute Building as the Sunderland Lounge – presumably, to give it more of a community feel – within the Sunderland Precinct of Hobsonville Point. Photo: Blair Hastings – March 2017.

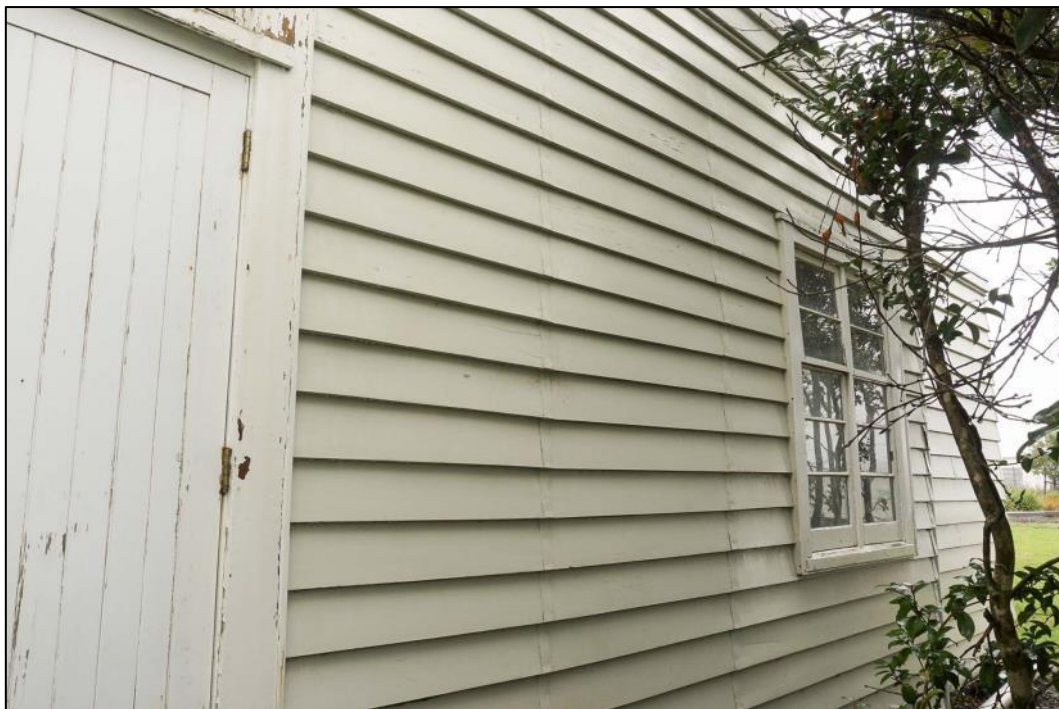
Figure 85: Southern section of the west elevation and to the right of the window the toilet block, built circa 1940. The filled in door into the former dressing room is evident (to the left of the window). The photograph shows the general disrepair of the building fabric. Photo: Blair Hastings – March 2017.

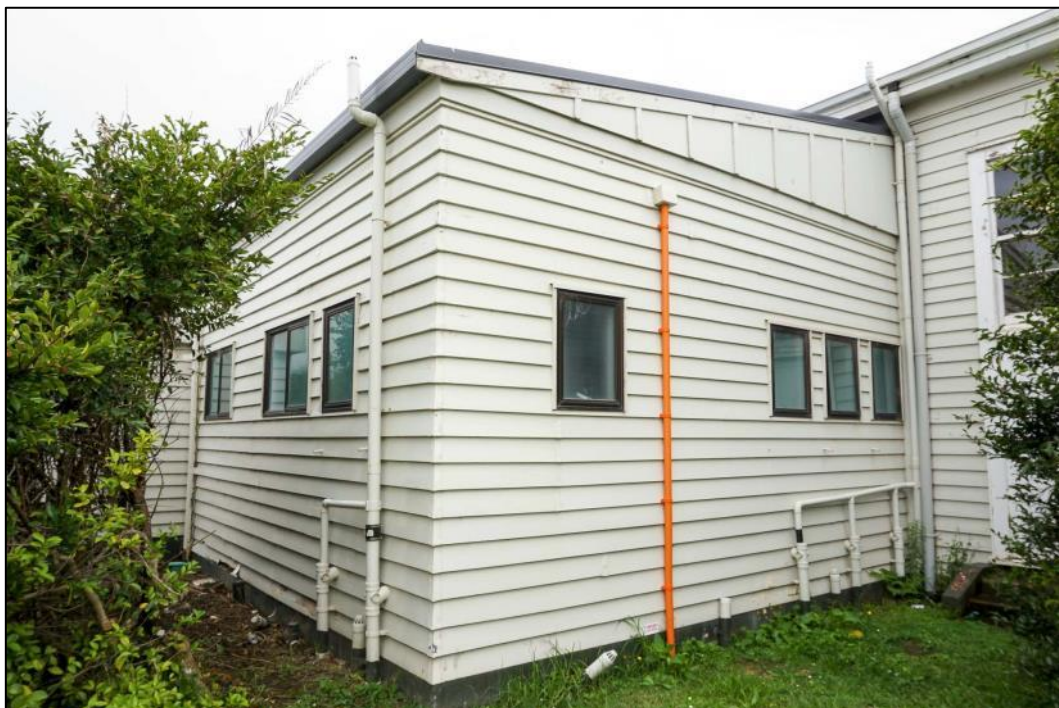
Figure 86: The southwest corner of the originally flat-roofed 'apron' that extends the building to the west and the north. The newly pitched roof is evident, as is also aluminium windows and a mix of modern plumbing fixtures. Photo: Blair Hastings – March 2017.

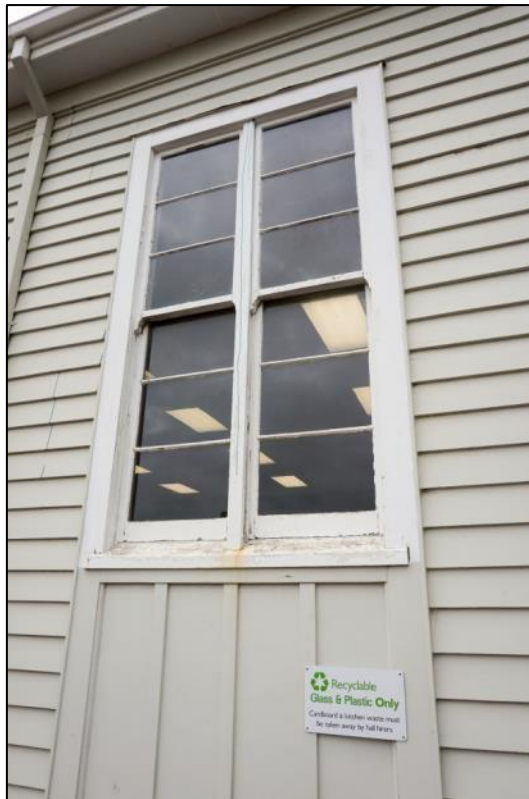
Figure 87: Hung windows with horned sashes. Transoms match the style of the both the era, and of the casement windows used within the apron annex of the building – as seen in figure 88 below. Photo: Blair Hastings – March 2017.
