Heritage Evaluation

The Royal New Zealand Air Force Institute Building (former)

[Currently known as The Sunderland Lounge]

Hudson Bay Road, Hobsonville Point

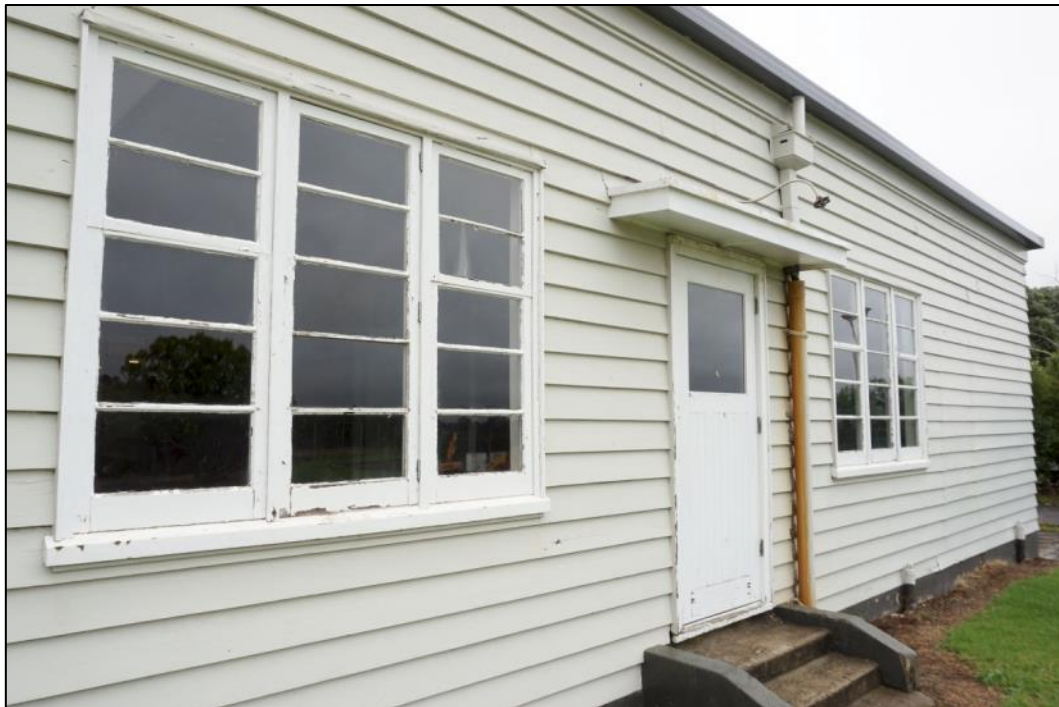
Figure 88: Casement windows similar to those used in state houses at the time. Modern internal fixings. Transoms match the proportioning used in the hung windows seen along the main or east elevation. The porch is quite likely original. A mixture of plumbing fixtures evident. Photo: Blair Hastings – March 2017.

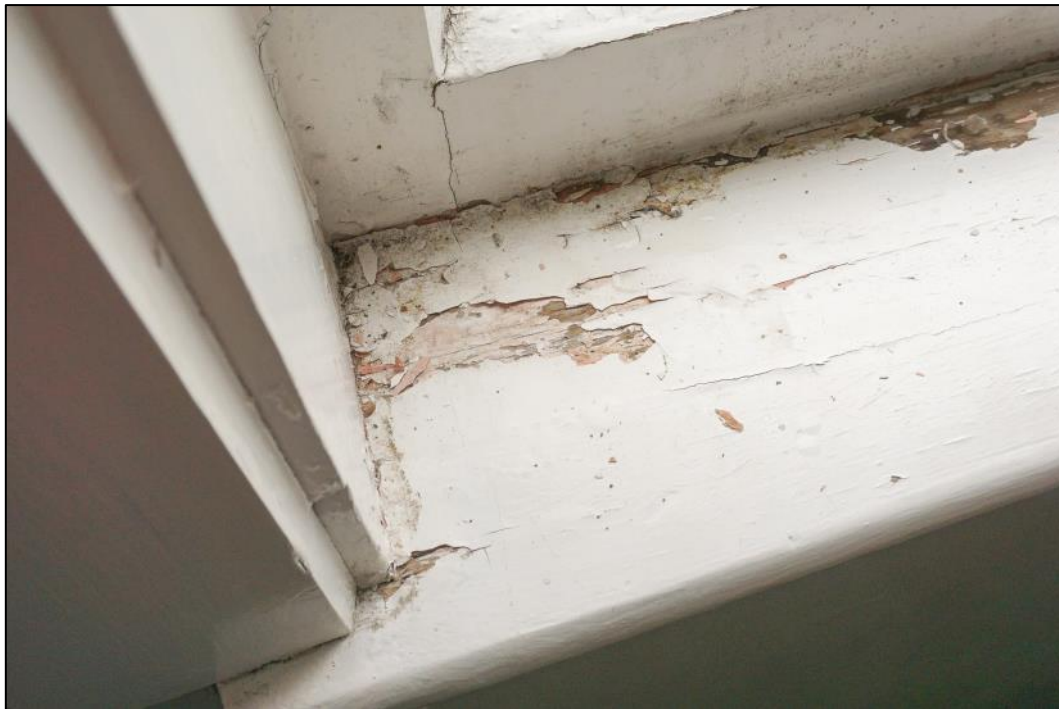
Figure 89: Internal window sill detail – showing signs of wear and possible water ingress. Photo: Blair Hastings – March 2017.

It is recommended that a condition report be written for the building, in order for the owners to establish a program of repairs and maintenance.

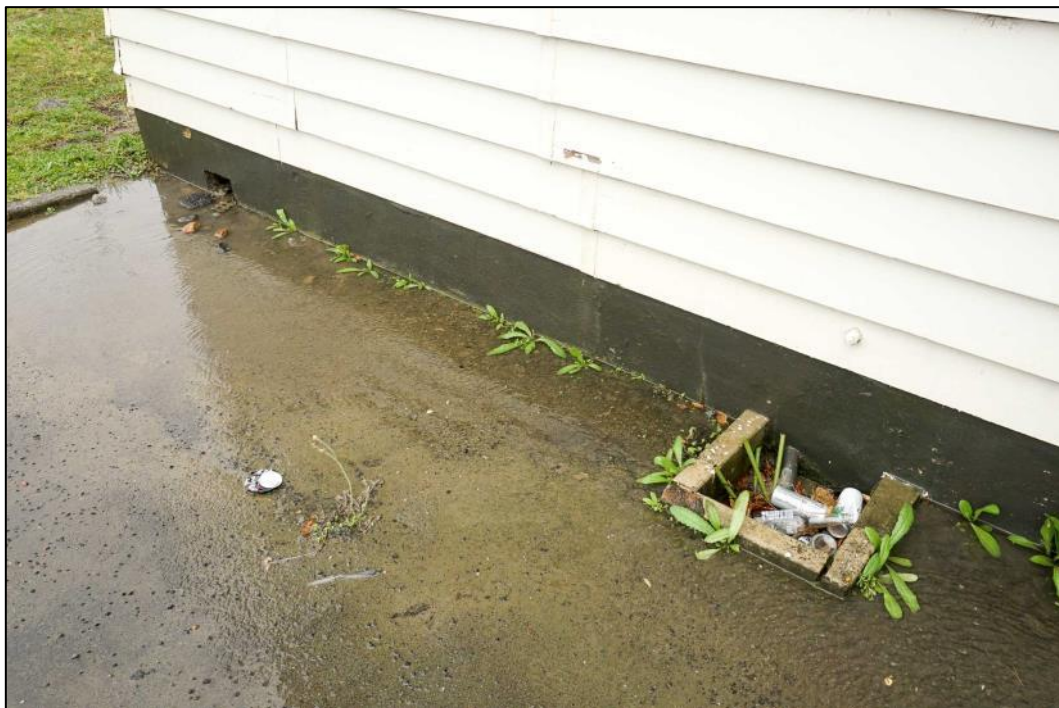
Figure 90: Southern end of the east elevation – rain water ponding against the building. Photo: Blair Hastings – March 2017.

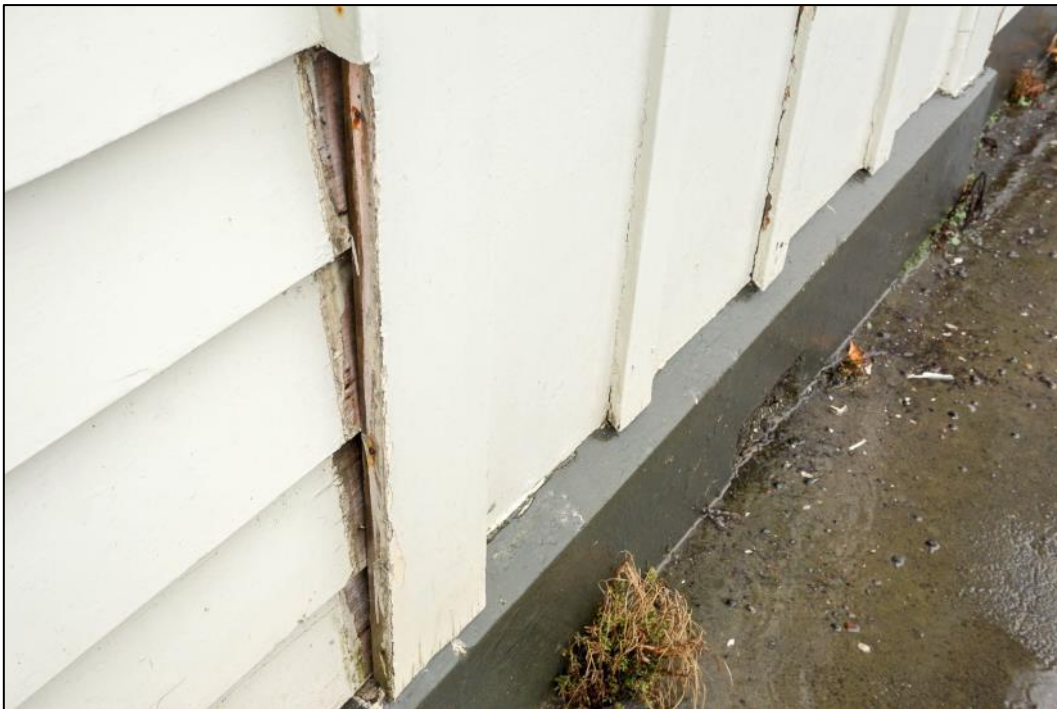
Figure 91: External trim detail – scribe missing – common of other ingress defects across the exterior shell. Photo: Blair Hastings – March 2017.

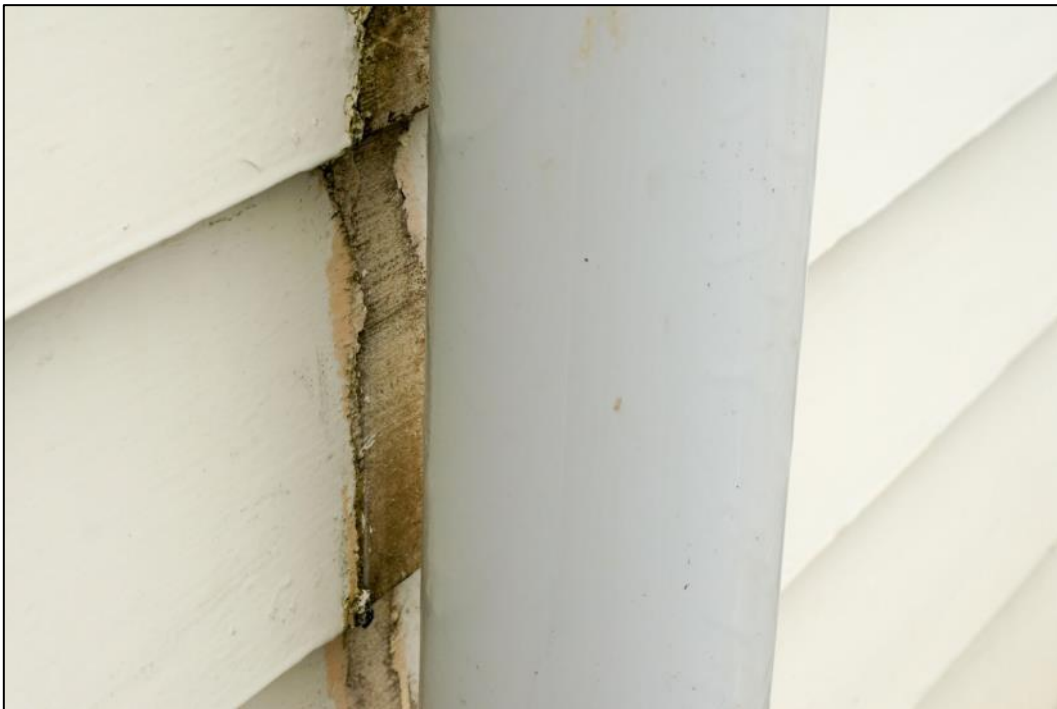
Figure 92: External paint detail – no paint behind downpipe - common across the exterior shell – will cause material and fabric failure. Photo: Blair Hastings – March 2017.

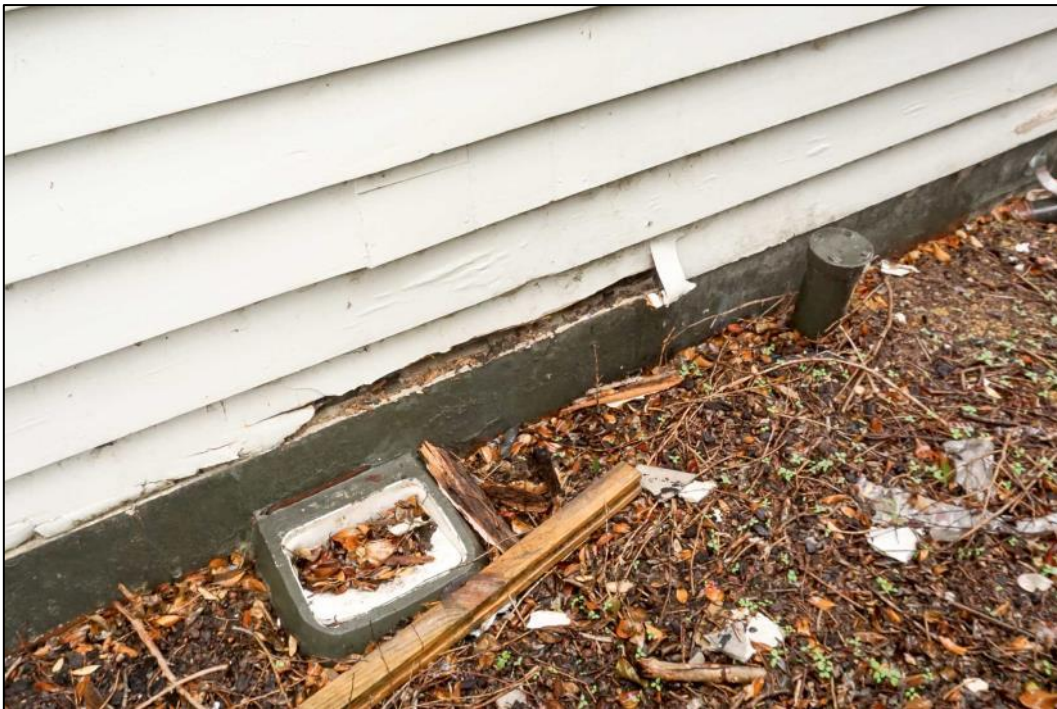
Figure 93: External weatherboard and drainage detail – weatherboards rotten and hard landscaping not calibrated correctly – water falling to the building. Photo: Blair Hastings – March 2017.

It is recommended that a condition report be written for the building, in order for the owners to establish a program of repairs and maintenance.

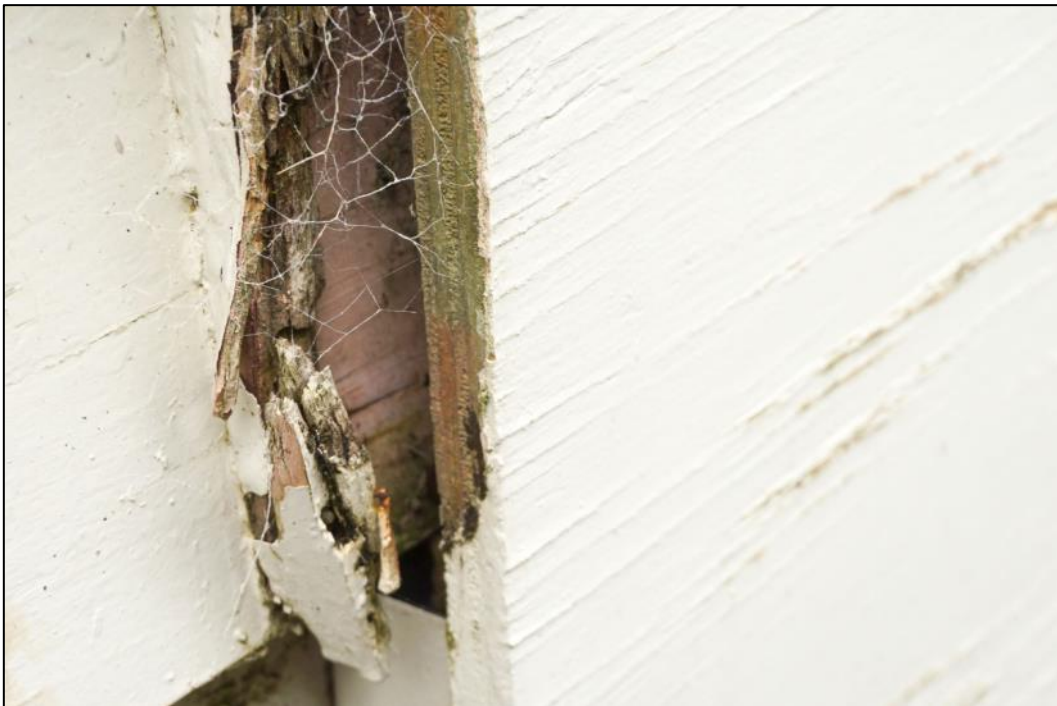
Figure 94: External weatherboard detail – rotten boards have been covered rather than replaced. Ingress is continuing – further fabric failure likely. Some evidence of previous paint colours (possibly undercoat) evident. Photo: Blair Hastings – March 2017.

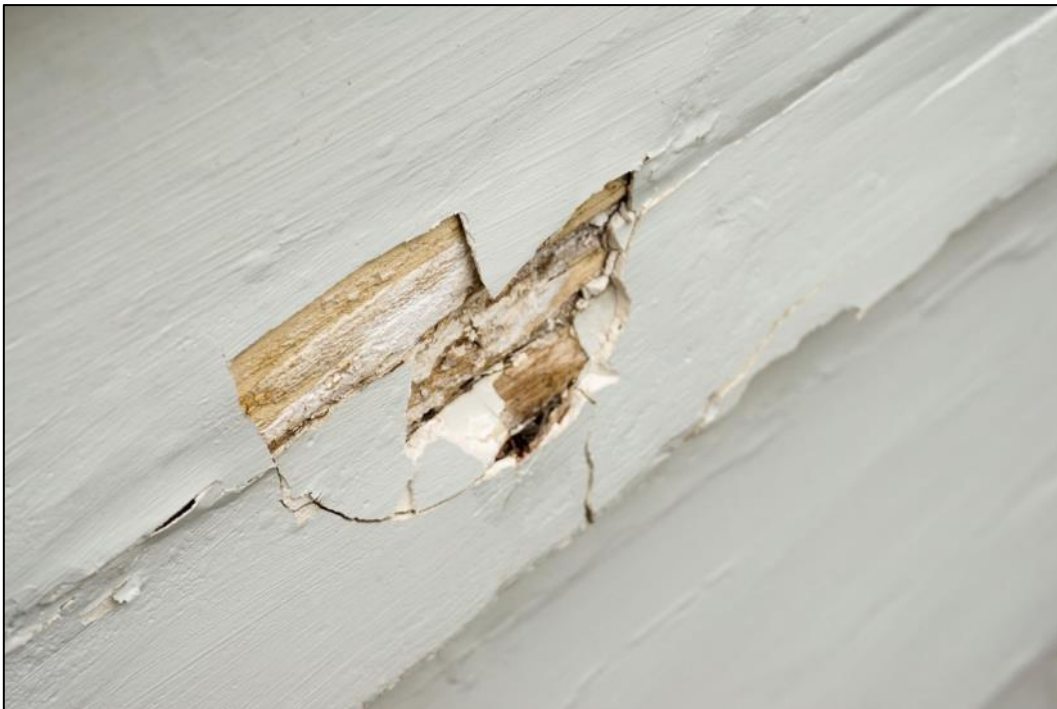
Figure 95: Paint failure – perhaps due to water ingress – indicative of many similar problems across the exterior shell. Photo: Blair Hastings – March 2017.

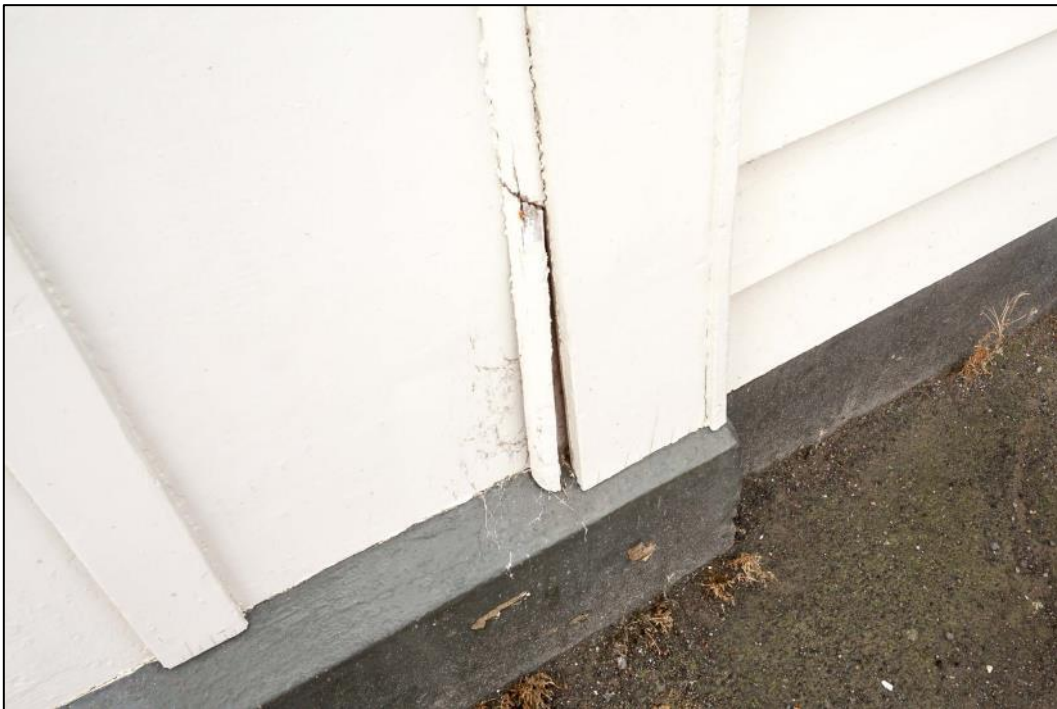
Figure 96: External beading failure - indicative of many similar problems across the exterior shell. Photo: Blair Hastings – March 2017.

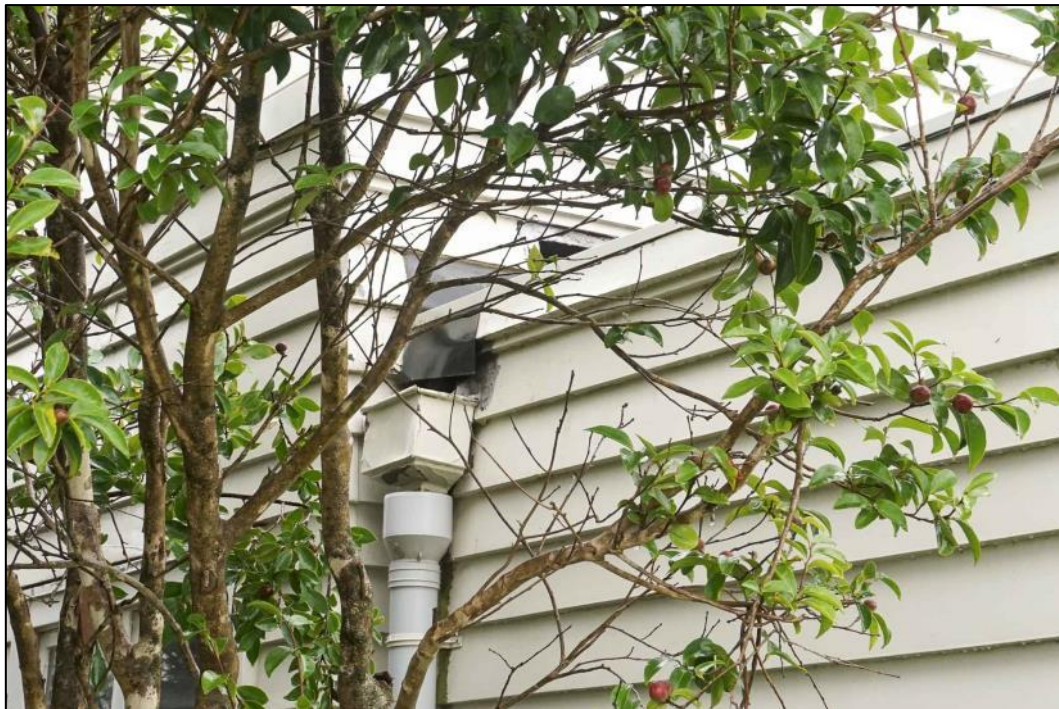
Figure 97: Rainwater head, downpipe and flashing system all incompatible with one another - at this and similar junctions across the building. Roofing does not appear to have been redone in conjunction with re-roofing the main hall and apron space 2014. Photo: Blair Hastings – March 2017.

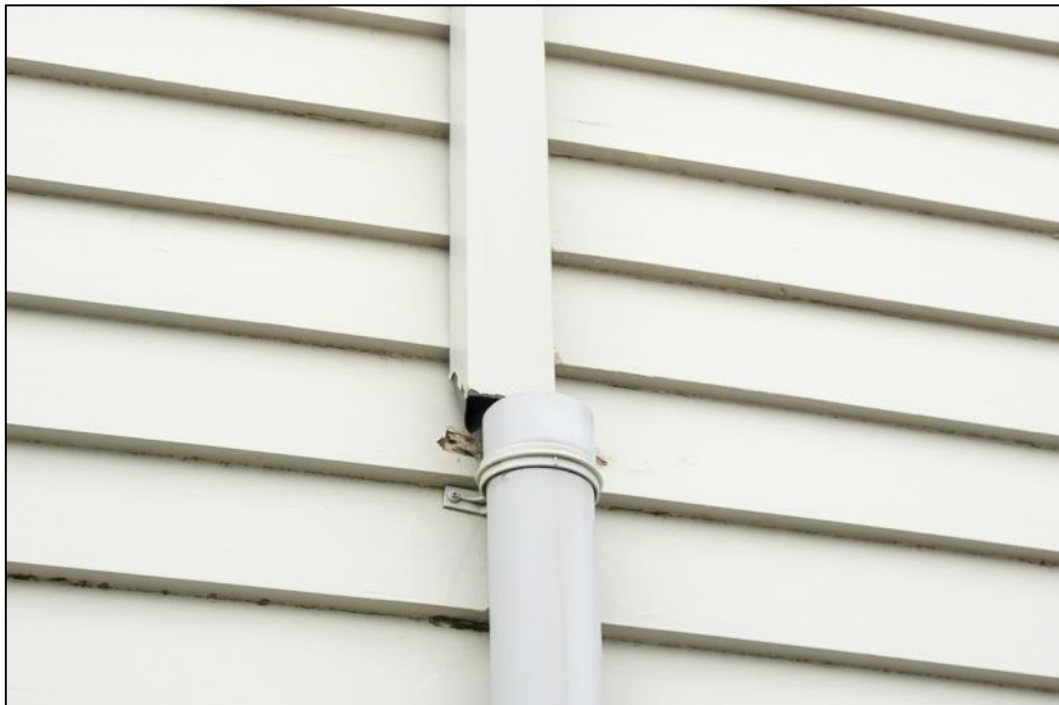
Figure 98: Downpipe detail – typical across the building. Photo: Blair Hastings – March 2017.

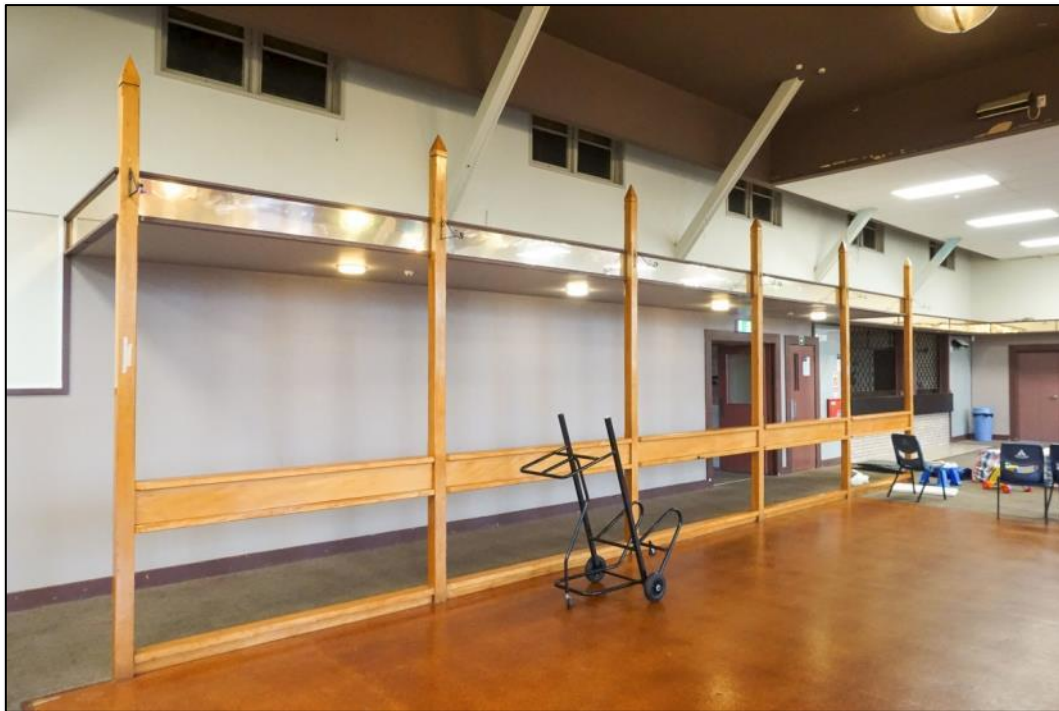
On inspection it was obvious that the interior of the building had been highly modified, and its original form and character, significantly compromised (refer to figures 99–102). Reference is, however, made throughout this evaluation to the interior spaces, as originally built, or as modified today, in order to support this initial assumption, and in effect in order to prove the recommendation that only the exterior of the building be proposed for scheduling.

Figure 99: Interior – highly modified and compromised. High level windows mirror hung windows on the opposite (east) elevation but are now wholly internal facing as the re-pitched apron roof springs from above the window heads. Photo: Blair Hastings – March 2017.

It is also recommended that any interior works proposed for the building should, in accordance with best practice architectural conservation principles, retain, conserve and reveal any original interior fabric and/or internal building features.

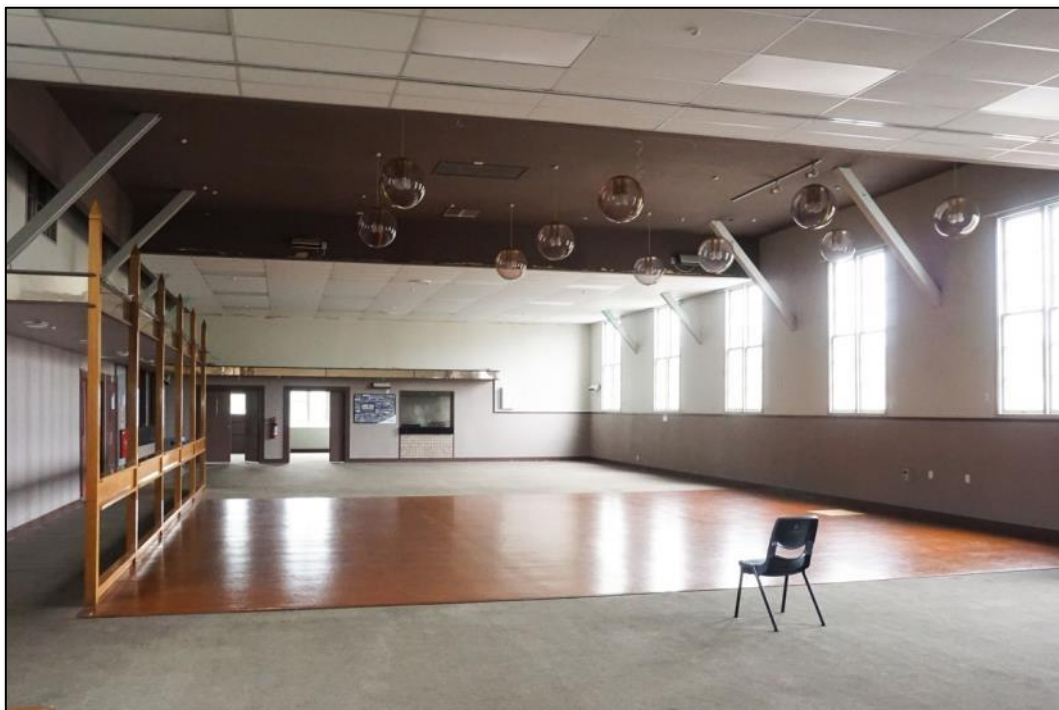
Figure 100: Interior – highly modified and compromised. Almost no original fabric evident other than most of the window and door joinery and the ceiling buttressing, encased in timber. Photo: Blair Hastings – March 2017.

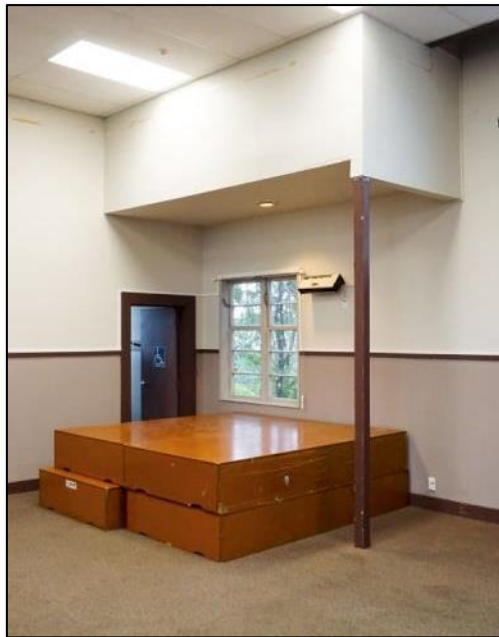
Figure 101: Interior – Southwest corner of the interior – originally part of the dressing room – walled off from the Hall (from where the photo is taken) and the stage, to the left. The column is modern – as is the ceiling. The dressing room was originally accessed from a door to the right of the window – now removed. Photo: Blair Hastings – March 2017.
