Carrington Backbone Works project: archaeological assessment

**report to
Beca Ltd
and
Marutūāhu and Waiohua-Tāmaki Rōpū**

Date: 12 August 2021

Reference: 21-1204

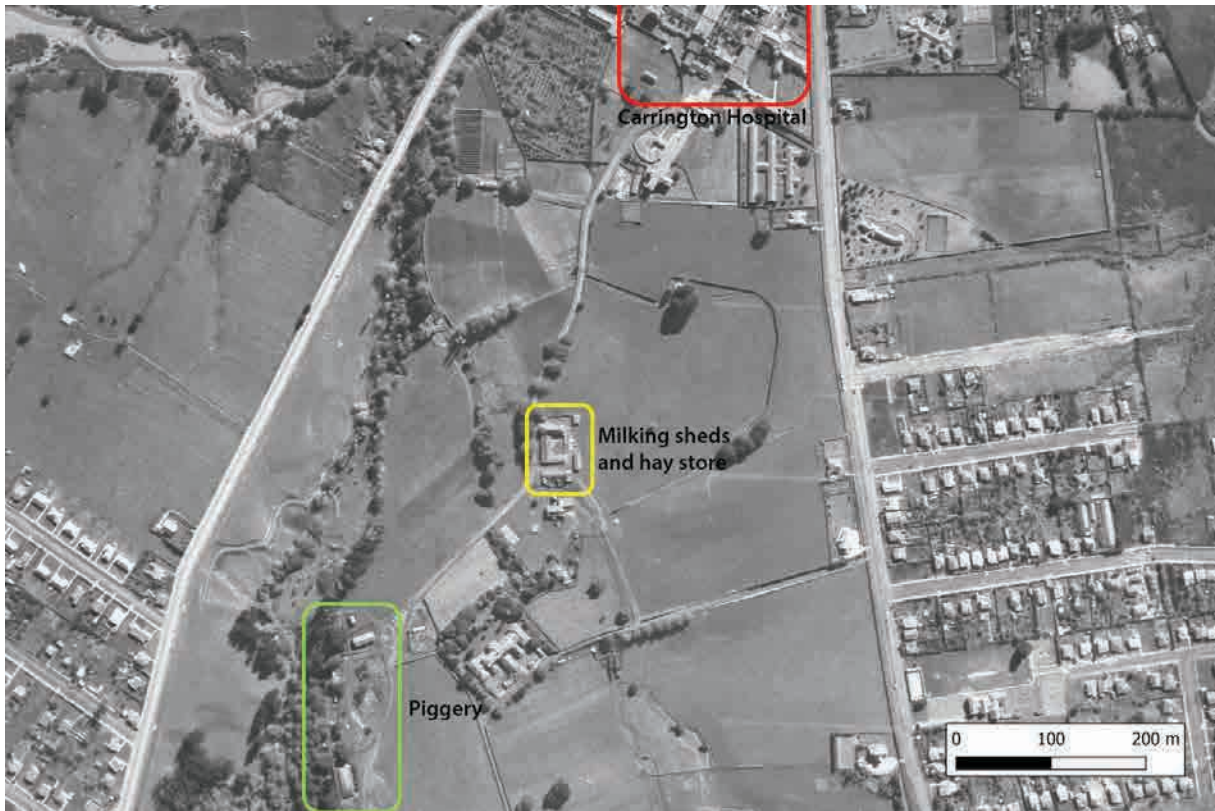
Figure 2. 1940 aerial photograph showing Carrington Hospital and the associated farm buildings.

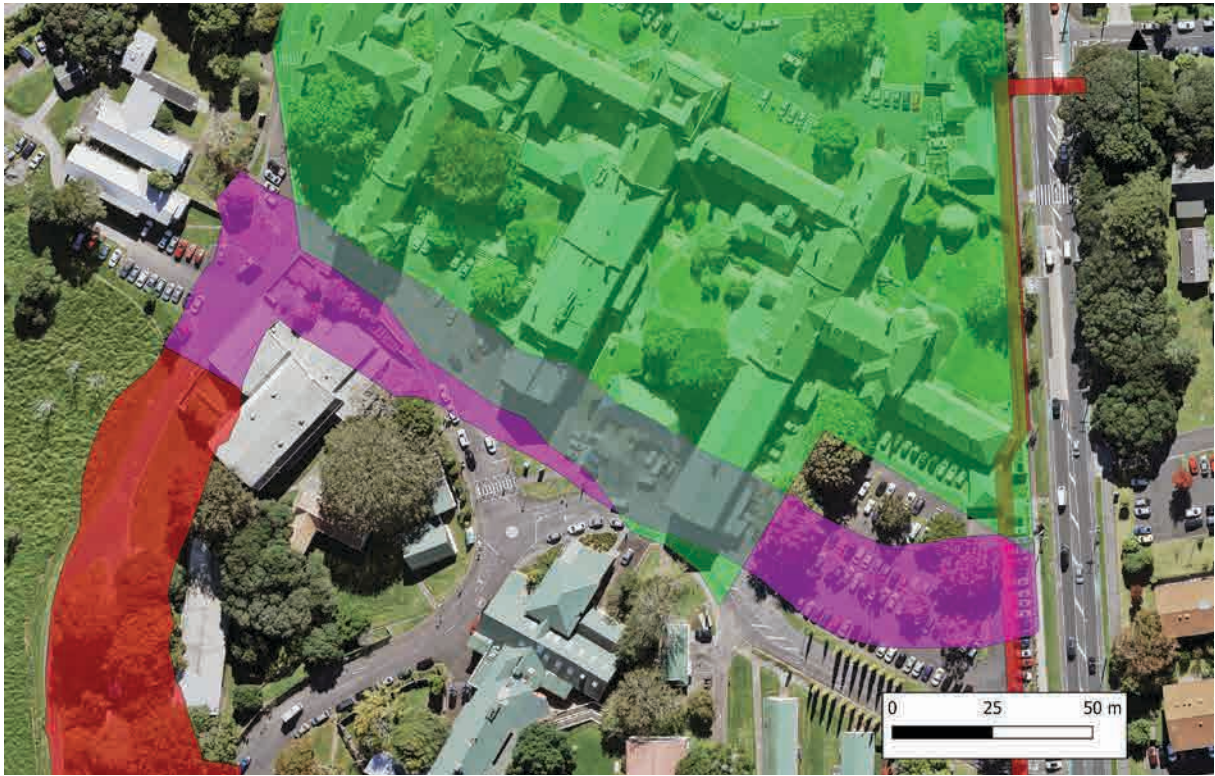
Figure 4. Northern (purple) and southern (red) Gate 1 Road options and Oakley/Carrington Hospital building Historic Heritage Extent of Place in the AUP (Item 1618) (green).

The proposed Gate 1 Road works follows the general existing alignment of the private Gate 1 Road, however while the current road skirts Building 001, the proposed works will involve some demolition of elements of the building. TP1 dug within one of the grassed berms in the existing carpark at the start of the alignment showed that services run through these areas at least 300 mm below the surface. The proposed alignment then runs through the south-eastern, central and south-western wings of Building 001, and the courtyards between these which are a mixture of landscaped lawn and carparks. This option will involve at least partial demolition of the southern wings of the building that are within the Scheduled Category A Historic Heritage Extent of Place for the Oakley / Carrington Hospital in the AUP (Item 1618). A 1940 aerial photograph also shows several buildings, now demolished, within the extent of the works (Figure 5). An 1890 plan of the hospital shows two of these to the south and southeast of the central wing of the building (Figure 6), and a 1903 plan of the alterations and additions to the main hospital building note that at this time these were a workshop and drying shed (Figure 7). Three test pits (TP2, TP9 and TP13) were dug in this location between the central and south-eastern wings of Building 001. Both TP2 and TP13 (Figure 8) contained a very compacted surface of crumbled scoria at 200 mm and 450 mm below the surface respectively. This layer was below a 200 mm thick charcoal-stained mixed clay subsoil with brick fragments in TP13, but in TP2 there was a mixed clay with gravel and roof slate fragments, above this same compacted surface. TP9 did not contain this compacted surface but appeared to have been recently modified due to the presence of a very mixed silty clay subsoil with yellow clay pockets to 300 mm, with no natural subsoil encountered. Similarly, between the central and south-western wings of Building 001, a building is visible in the 1940 aerial bordering this courtyard on its southern extent. TP14 dug in this location showed a possible small concrete foundation at 230 mm below the surface, surrounded by larger scoria gravel and cut into a layer of very compacted small scoria gravel and charcoal at 380 mm, similar to that seen in TP2 and TP13. It is clear that despite recent landscaping, there are both existing and subsurface features connected with the Oakley/Carrington Hospital building within the proposed footprint of works.

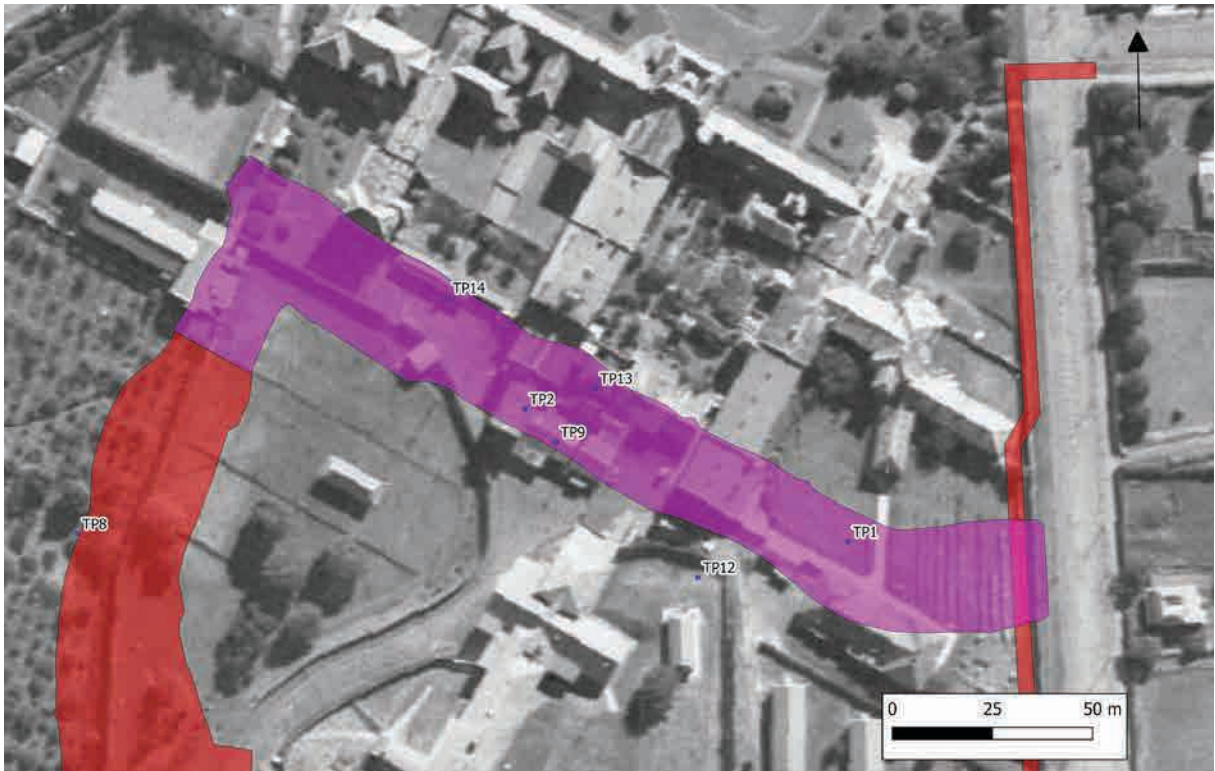
Figure 5. 1940 aerial image showing hospital and associated buildings within proposed northern (purple) and southern (red) Gate 1 Road works, and test pits dug during this assessment.

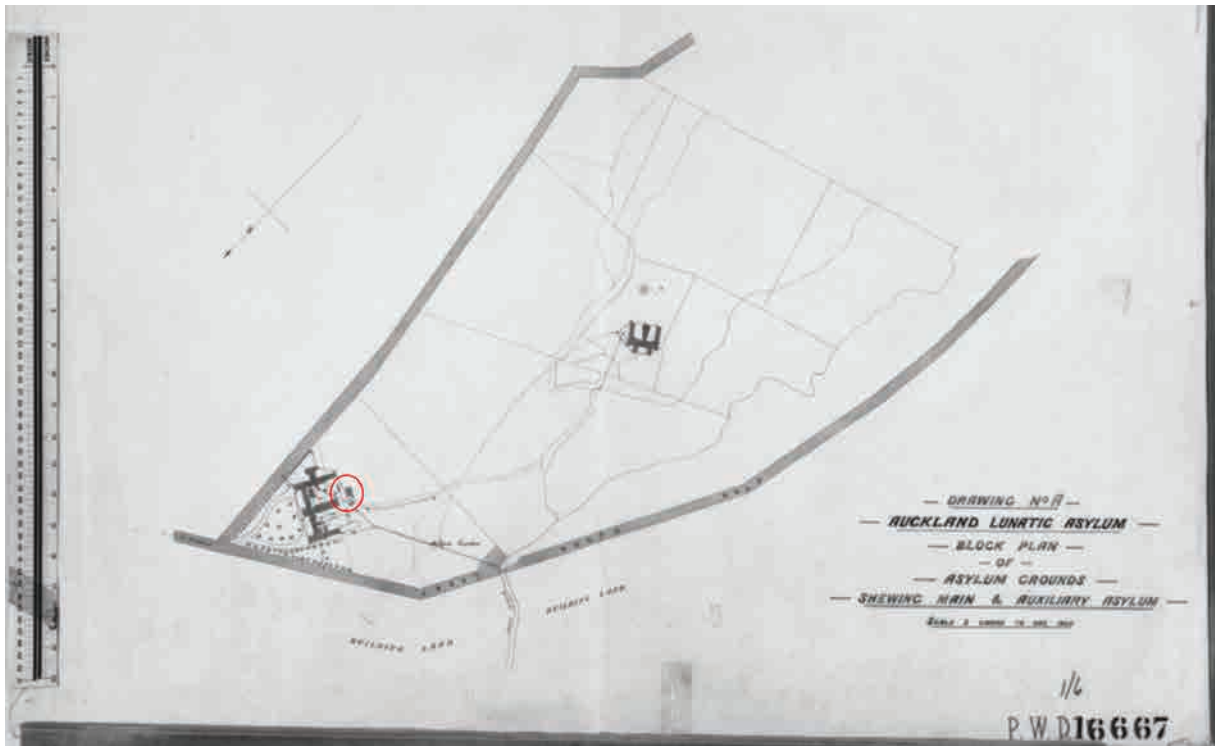
Figure 6. 1890 plan of the asylum grounds showing several buildings to the south of the main hospital building (circled in red) (Archives New Zealand ABZK 24411 W5433 PWD16667/1).

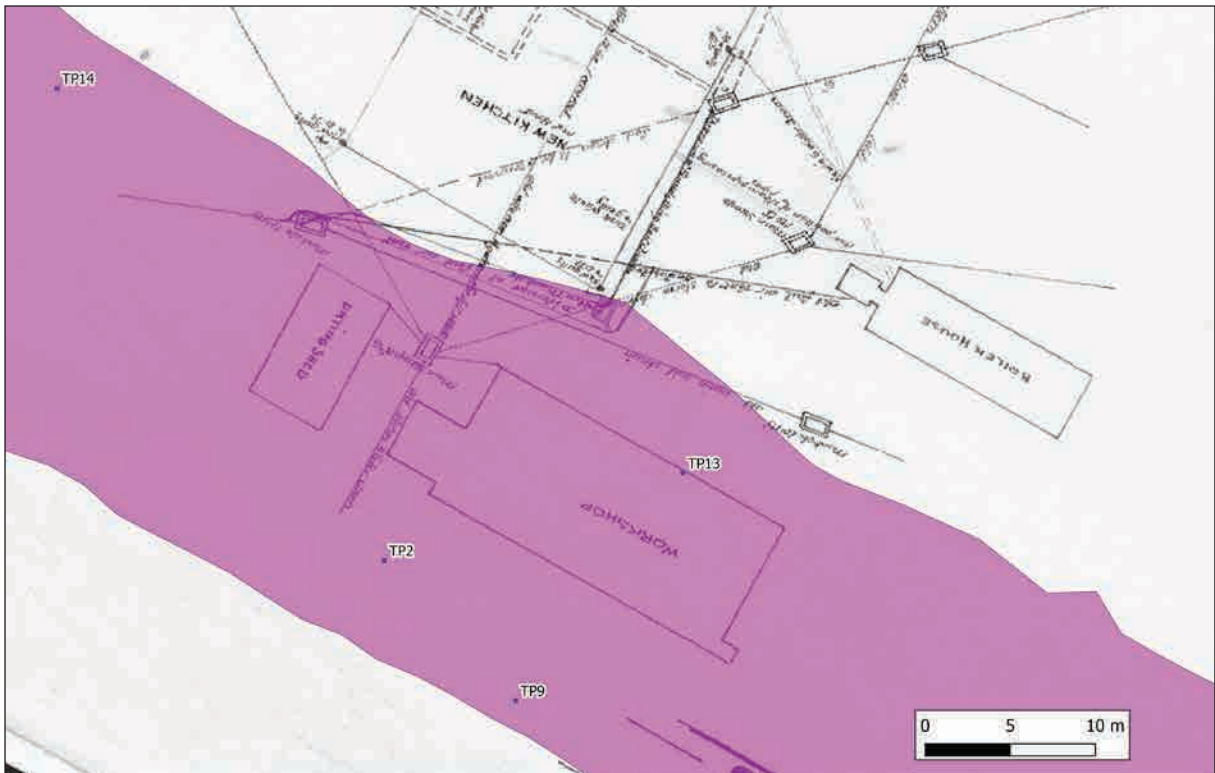
Figure 7. 1903 plan of the alterations and additions to the hospital building showing 'workshop' and 'drying shed' within the area of proposed northern Gate 1 Road works (purple), and test pits dug during this assessment (Archives New Zealand ABZK 24411 W5433 PWD20686/1).

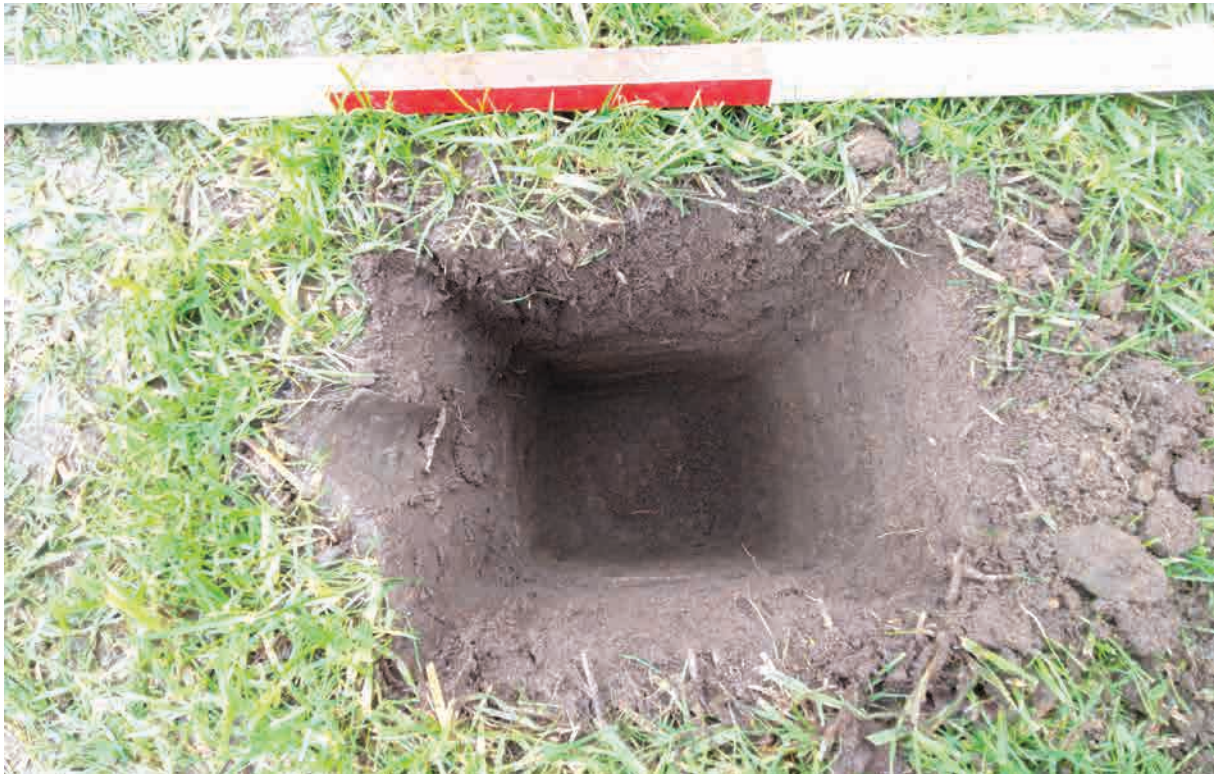
Figure 8. TP13 showing compacted fine scoria surface possibly connected with old workshop buildings.

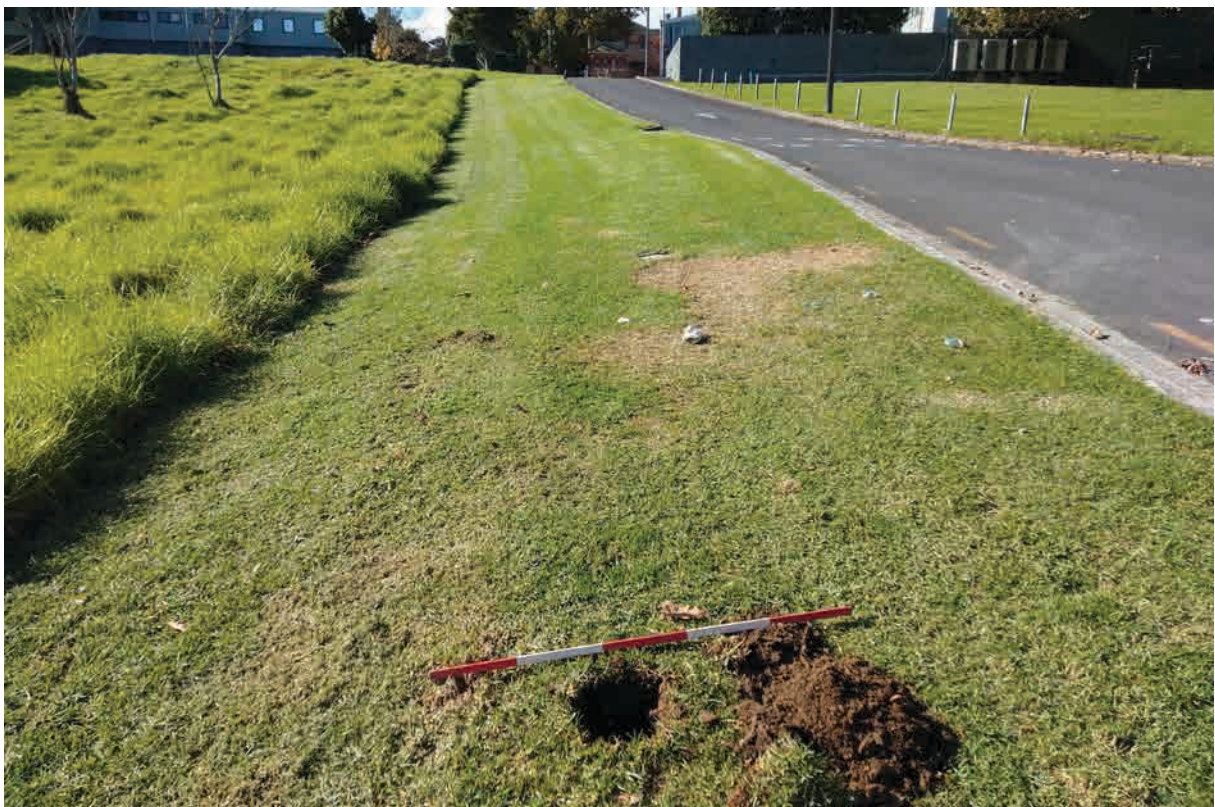
Figure 9. Location of TP8 in extent of proposed Spine Road within old Asylum Gardens.

The northern end of Spine Road begins at the southwest corner of the hospital and runs south through the location of the old Asylum Gardens, mostly following the route of the existing private road but having a significantly wider footprint (20 m). A test pit (TP8) dug to the west of the driveway showed a topsoil to 100 mm below the surface, above a mixed friable brown silty clay with pockets of yellow clay to 300 mm (Figure 9). No base of this layer was found, and this indicates that the area has been recently disturbed, which fits with aerial imagery that shows exposed soil in the location over the last 5 years. Gate 2 Road travels east from Spine Road widening the existing private road. The area is already heavily modified and so no test pits were dug in this location.

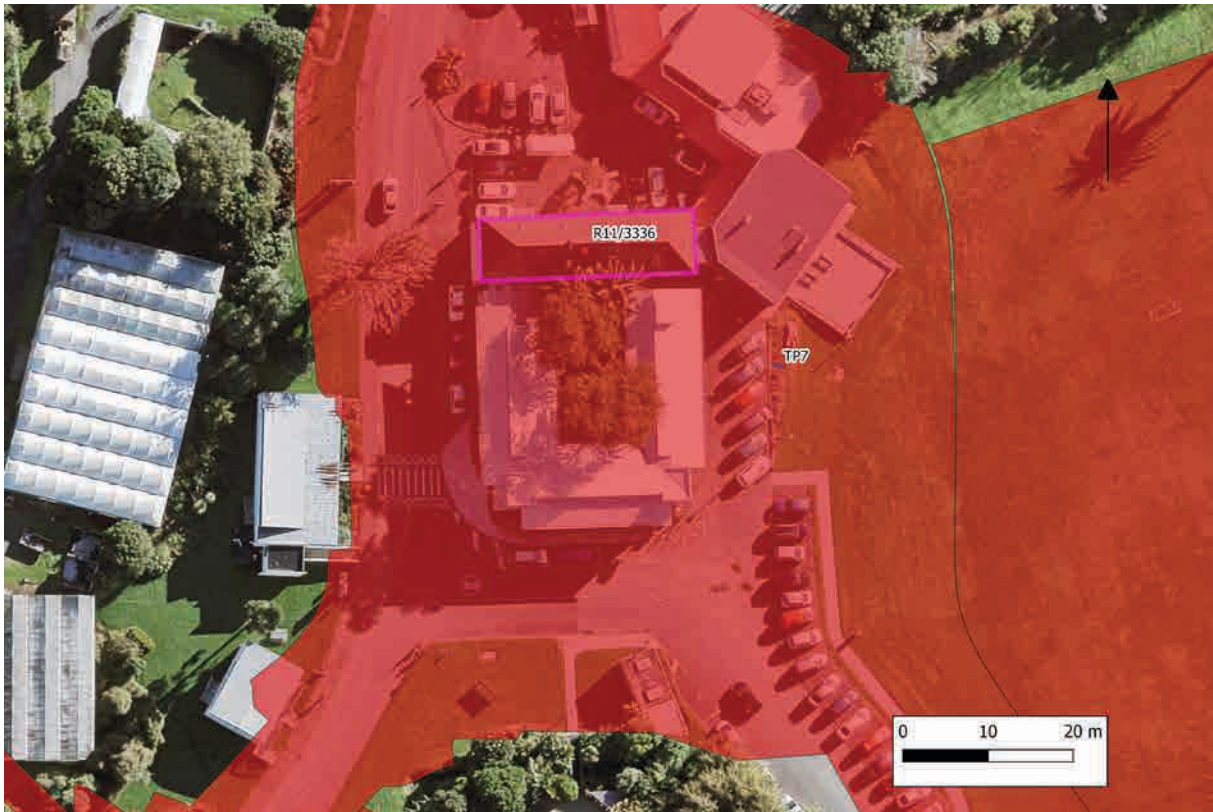
Figure 10. Northern wing of Building 028 recorded as the old milking shed/dairy site R11/3336, in relation to proposed extent of works (red).

Condition	The milking shed building is in very good condition, however the dairy buildings to the south have been replaced with new buildings in the same footprint. The piggery has been destroyed but some troughs and stone wall foundations remain. There is also reasonable cause to suspect that features relating to these farm buildings may exist subsurface. The most common form of site damage is likely to be from landscaping on the Unitec campus.
Rarity	Potential deposits will share rarity values with sites such R11/2373, R11/2205, R11/3331 and R11/2500 representing early Pākeha industry around Te Auaunga/ Oakley Creek, and the establishment and use of Carrington Hospital.
Context	Any deposits exposed will tie into the wider context of historic occupation of Ōwairaka/ Te Ahi-kā-a-Rakataura/ Mt Albert, specifically around the Te Auaunga/ Oakley Creek waterway and Carrington Hospital.
Information	There is the potential for scientific information to be recovered by archaeological means if archaeological material is uncovered during works.

- Demolition of the pre-1900 part of Building 28, recorded as site R11/3336, should be avoided;
- an authority to destroy, damage or modify pre-European Māori shell midden R11/3313 and R11/524; drystone retaining wall R11/2473; and possible occupation associated with asylum milking sheds R11/3336 and piggery R11/2983, within Lots 1, 5 and 6 DP 515012; Lot 3 DP 314949; and Lots 1 and 2 DP 531496; and Lot 5 DP 515012 be applied for from Heritage New Zealand Pouhere Taonga (HNZPT) under Section 45 of the Heritage New Zealand Pouhere Taonga Act 2014;

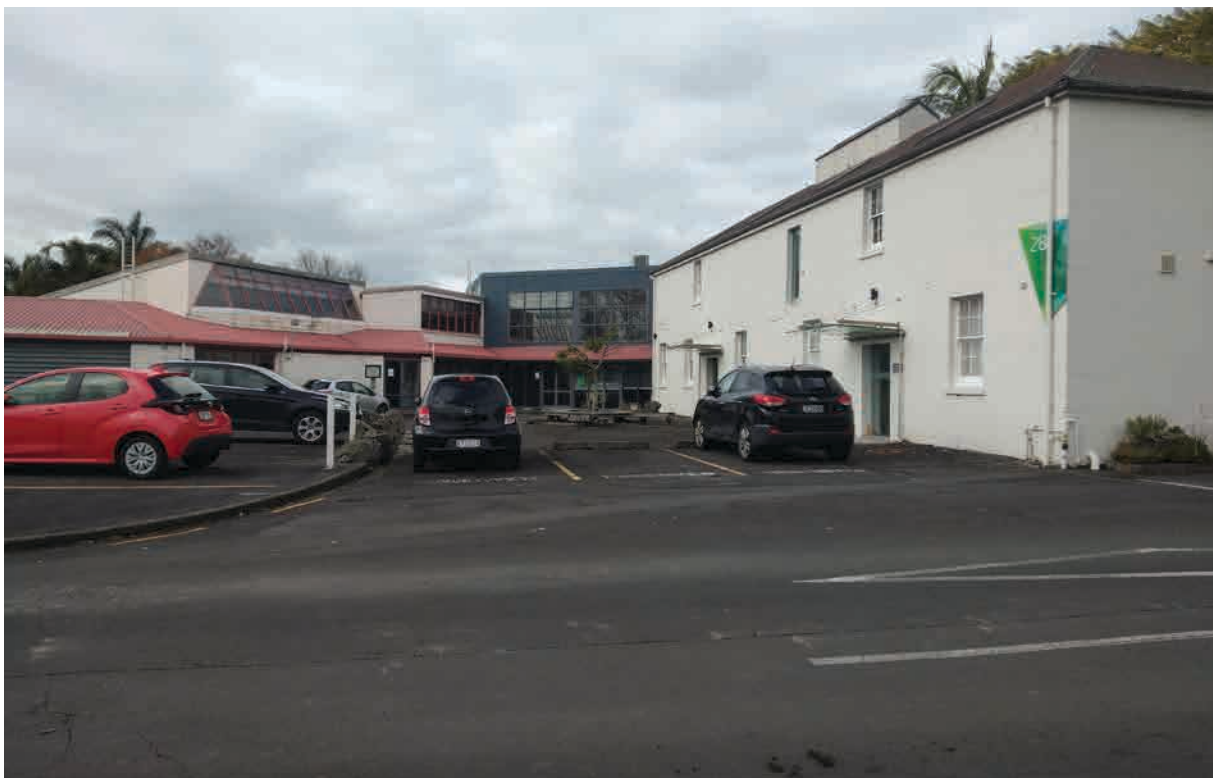
Figure 11. Old milking sheds/dairy to the right of the photograph, recorded as site R11/3336.

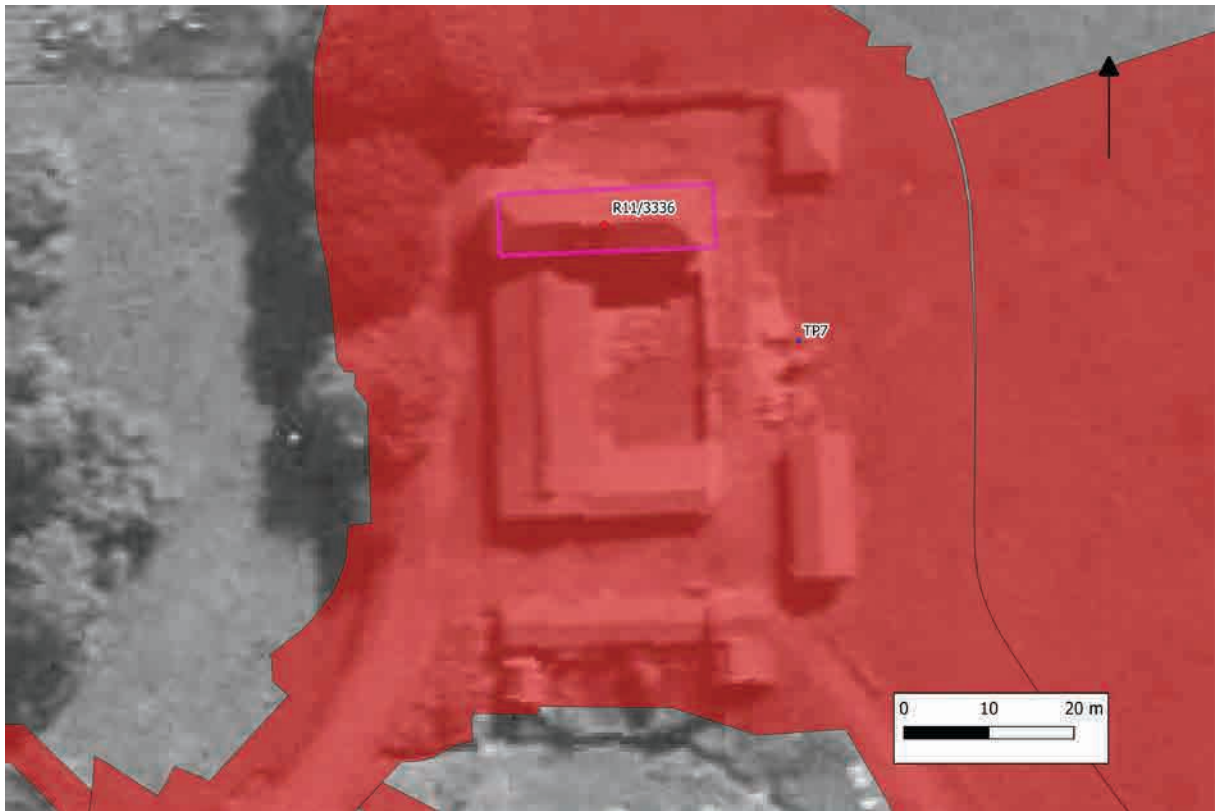
Figure 12. 1940 aerial photograph showing remaining dairy building (pink) and other associated buildings within the complex in relation to the proposed roading earthworks (red) and TP7.

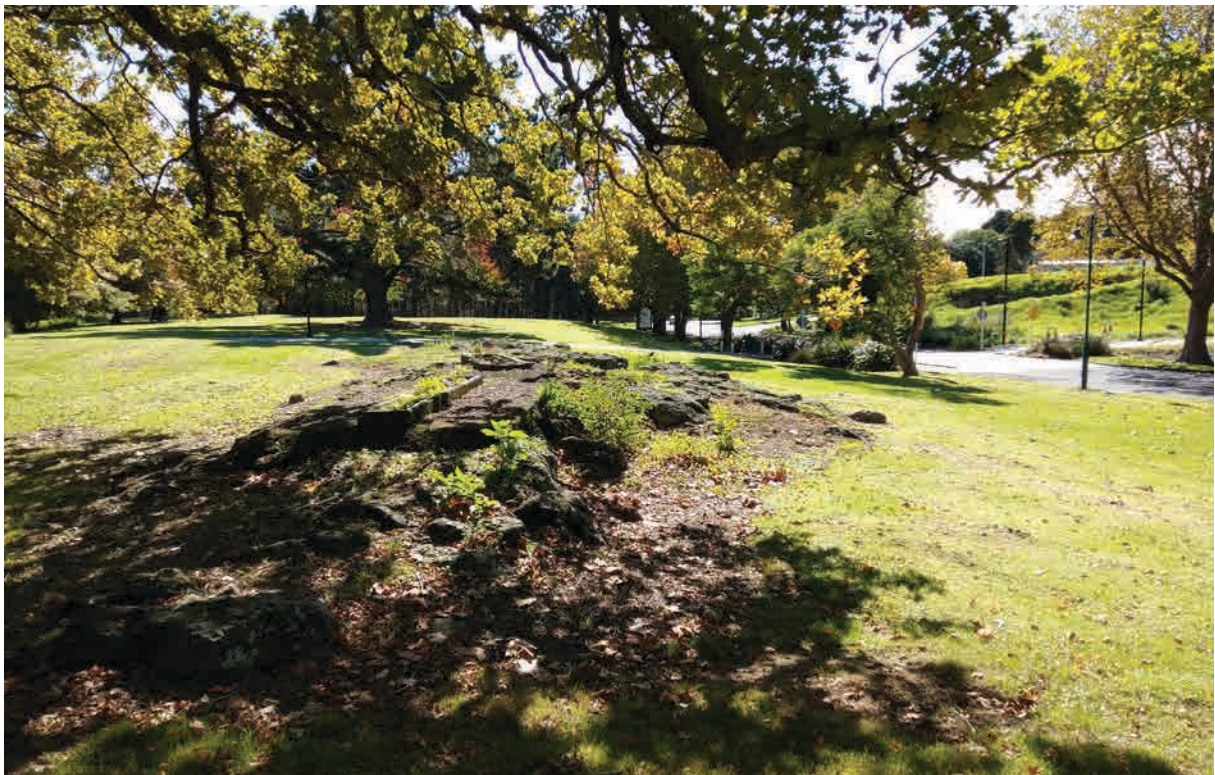
Figure 13. Location of recorded enclosure associated with piggery R11/2983 .

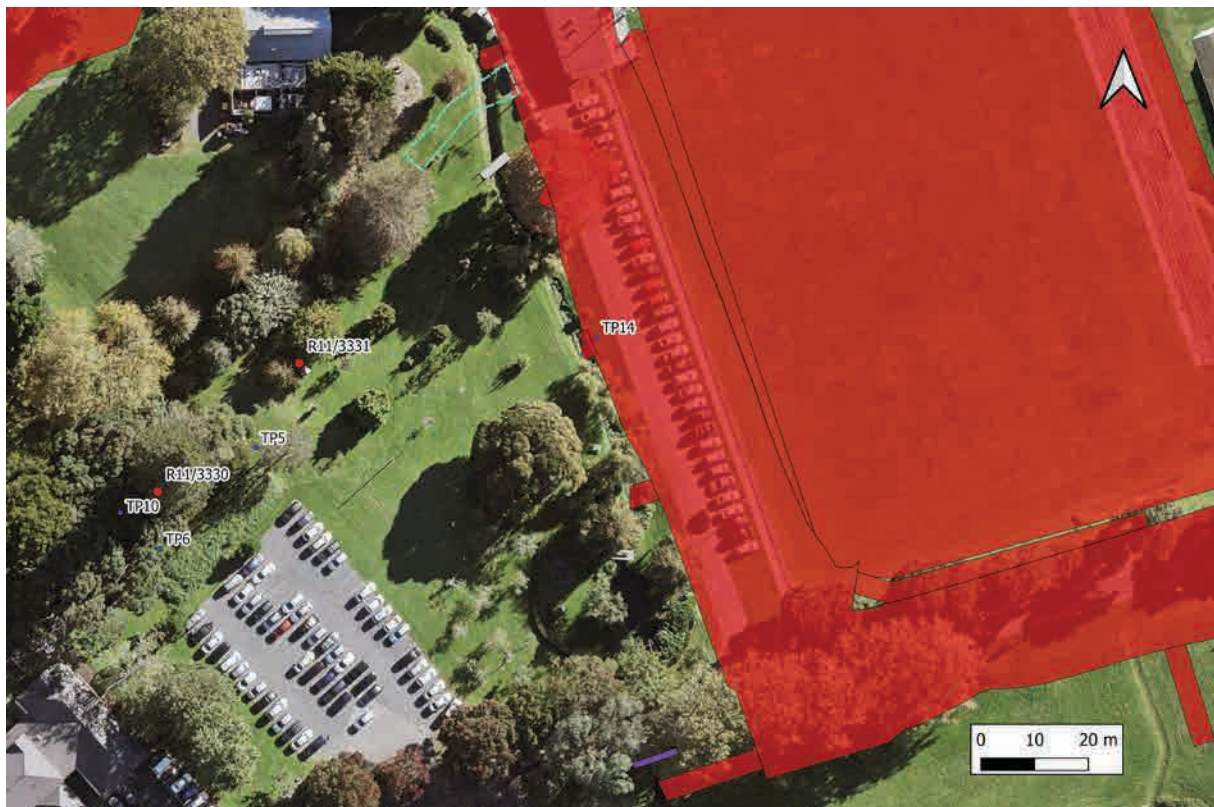
Figure 14. Location of stormwater trenching from proposed Farm Road into Wairaka Stream (red area) in relation to existing stone culvert (purple), original driveway to farm manager's house (light blue dashed).

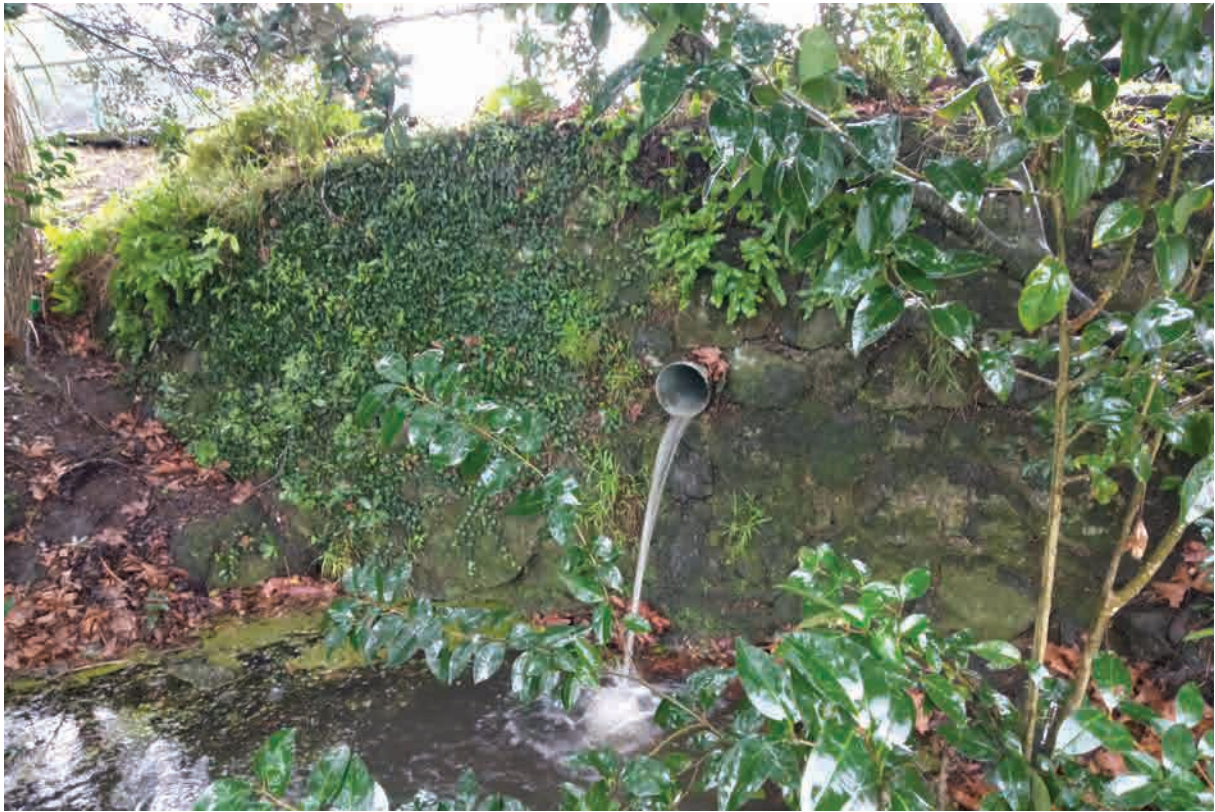
stream for Auckland's Auxiliary water supply. If this is the case, it has clearly been recently modified by the placement of a pvc pipe in the centre for stormwater flow from Farm Road (Figure 15)). The section of Wairaka Stream north of the culvert has been modified from the 1950s to create and then subsequently remove a driveway to the Farm Manager's House (site R11/3331), as well as for landscaping. TP14 dug within the proposed works near Wairaka Stream showed a modified clay subsoil with rusted nails, brick fragments, charcoal and yellow clay pockets above bedrock at 400 mm below the surface. There is also a visible layer of demolition material within the eastern side of the stream close to the old dairy location, probably from the demolition of the southern elements of that complex in the 1970s. The stream is stone-lined but again it is difficult to establish the antiquity of this feature, as these changes from the 1950s onwards would undoubtedly have disturbed any earlier work on the stream.

Figure 15. Dam and culvert on southern side of Farm Road in vicinity of new stormwater trenching.

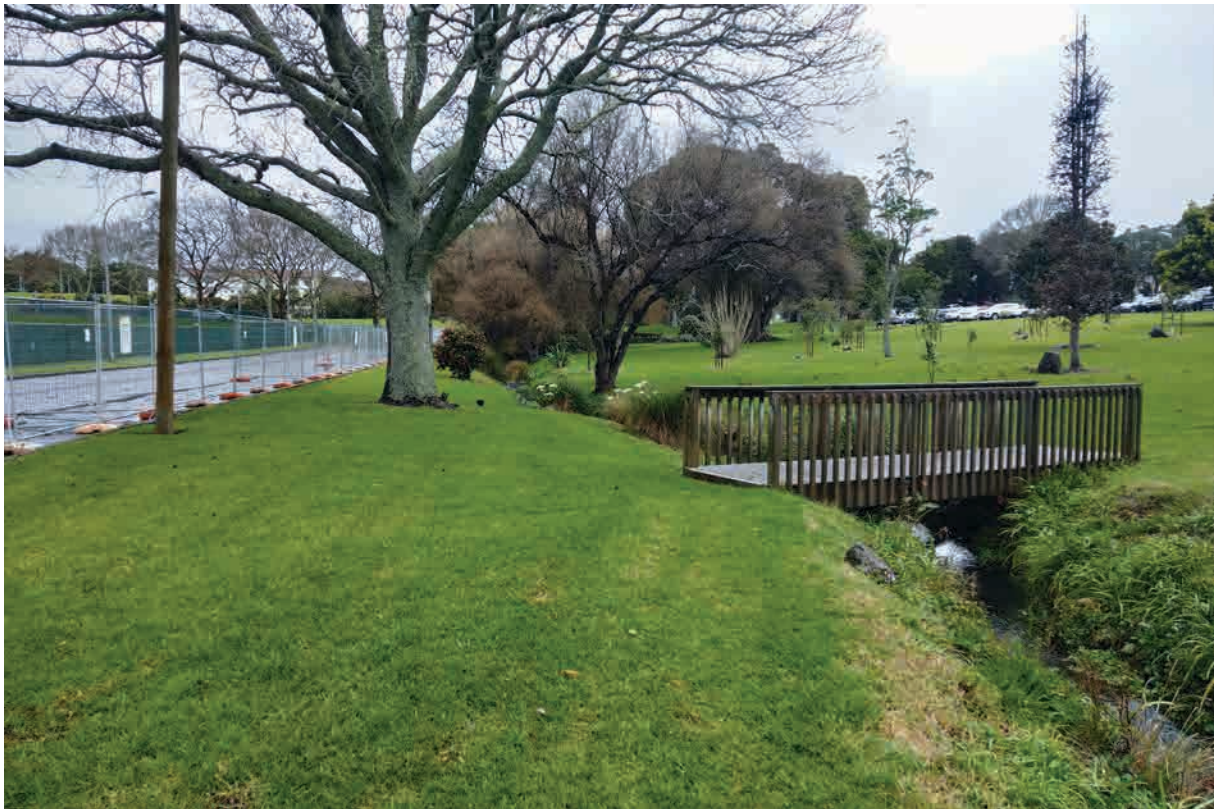
Figure 16. View southeast along Farm Road and stormwater trenching alignments to Wairaka Stream.

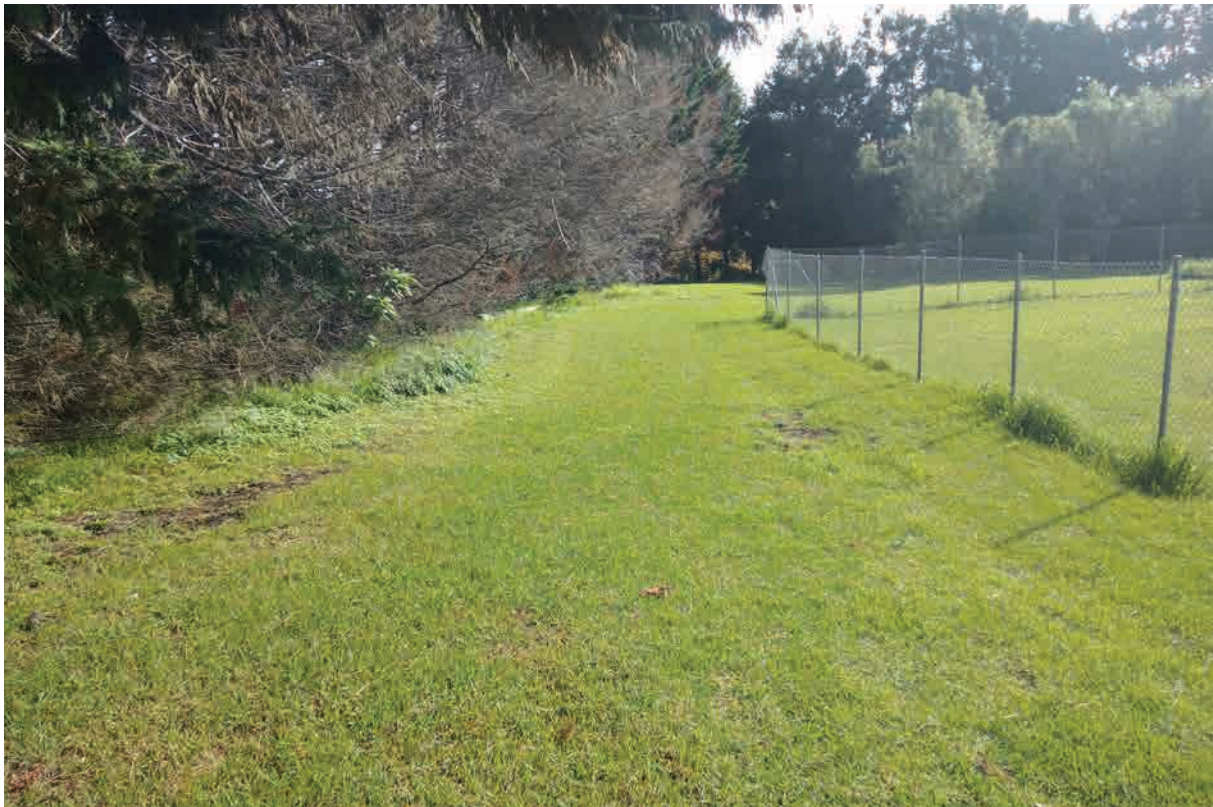
Figure 17. Start of proposed wastewater line near R11/3313.

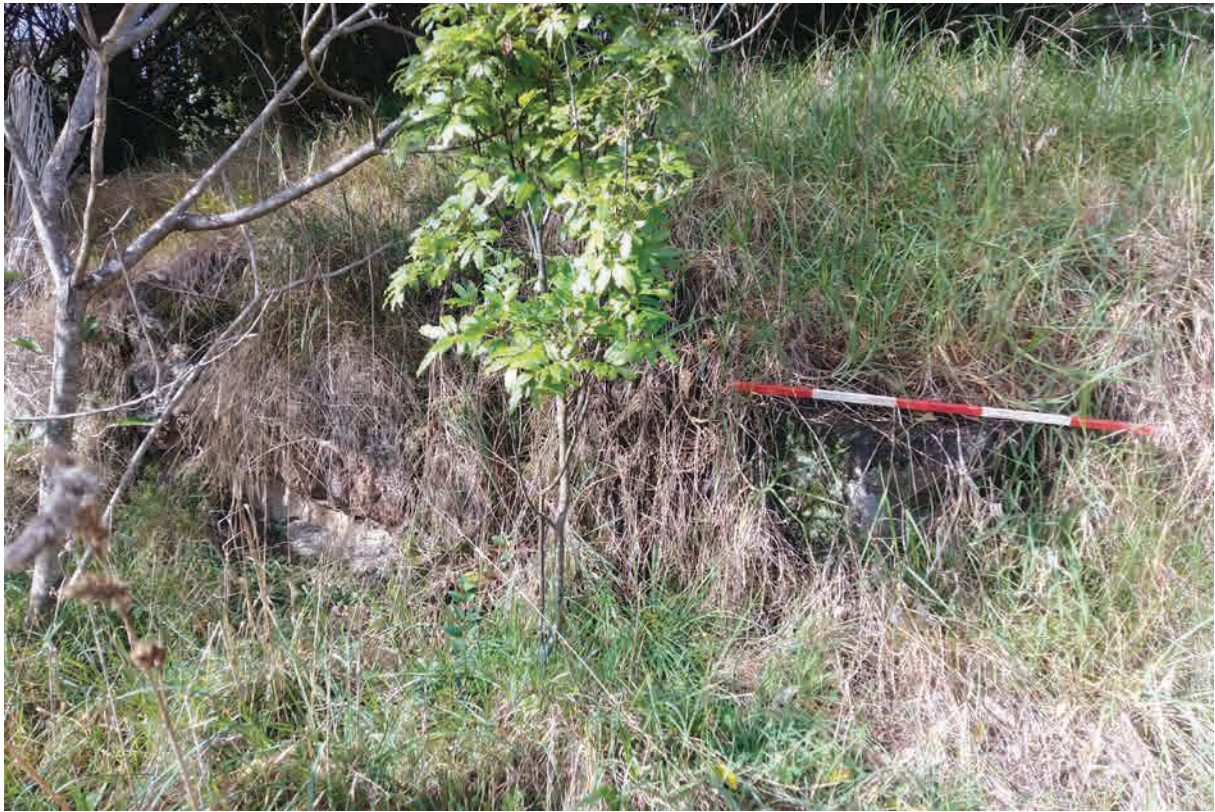
Figure 18. Stone wall R11/2473 in wastewater alignment above Te Auauanga / Oakley Creek (scale = 1 m).

Condition	The drystone wall was only visible in some places along its full extent due to being surrounded by long kikuyu grass and also an overburden from the gravel track above. Sections remain in fair condition but others appear to have stones removed. The most common form of site damage is likely to be from landscaping on the Unitec campus.
Rarity	Potential deposits will share rarity values with sites such R11/3336, R11/3331, R11/2373, R11/2205, R11/3331 and R11/2500 representing early Pākeha industry around Te Auauanga/ Oakley Creek, and the establishment and use of Carrington Hospital.
Context	Any deposits exposed will tie into the wider context of historic occupation of Ōwairaka, specifically around the Oakley Creek waterway and Carrington Hospital.
Information	There is the potential for scientific information to be recovered by archaeological means if archaeological material is uncovered during works.

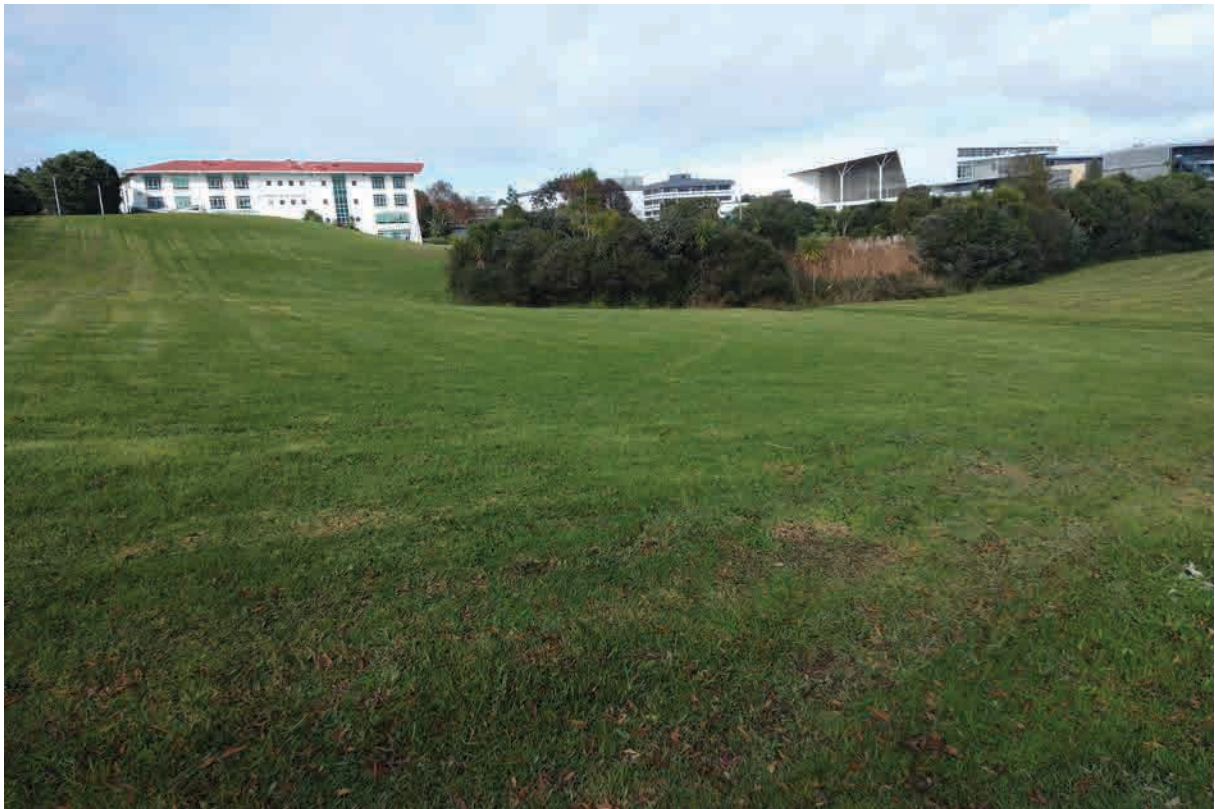
Figure 19. Location of proposed wastewater line running south from Farm Road to planted wetland.

the steeper slope above the creek to a new satellite manhole near the existing Orakei Main Sewer. One shell midden (R11/524) and a drystone wall (R11/2473) have been recorded within this area on the banks of Te Auaunga / Oakley Creek and would likely be impacted by this wastewater line. The nature of this impact is assessed in Section 5.5 and proposed mitigation in Section 5.6. The shell midden is subsurface and so could not be relocated, but the wall was photographed and a GPS point taken (Figure 18). A final wastewater will be trenched south from Farm Road to a manhole north of the planted wetland surrounding the spring at the head of the Wairaka Stream (Figure 19).

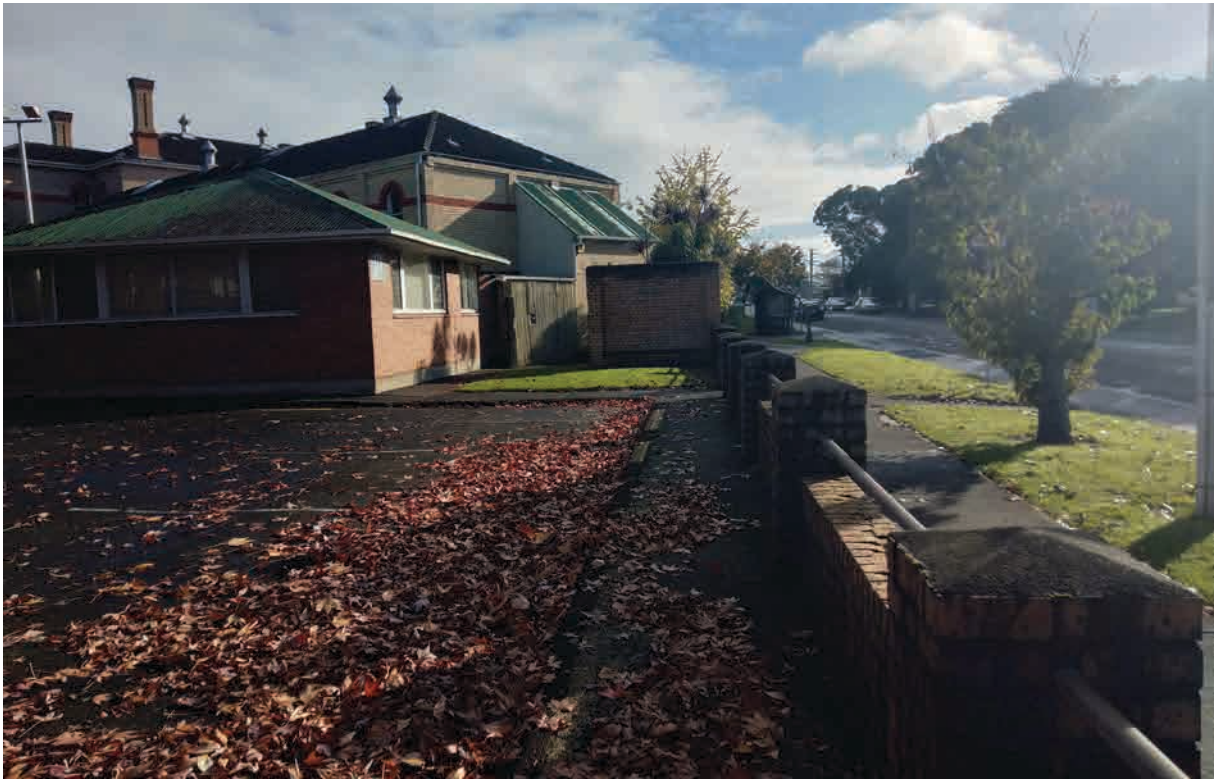
Figure 20. Route of water line between Carrington Hospital building and Carrington Road, in the Scheduled Historic Heritage Extent of Place for Oakley / Carrington Hospital in the AUP (ID 1618).

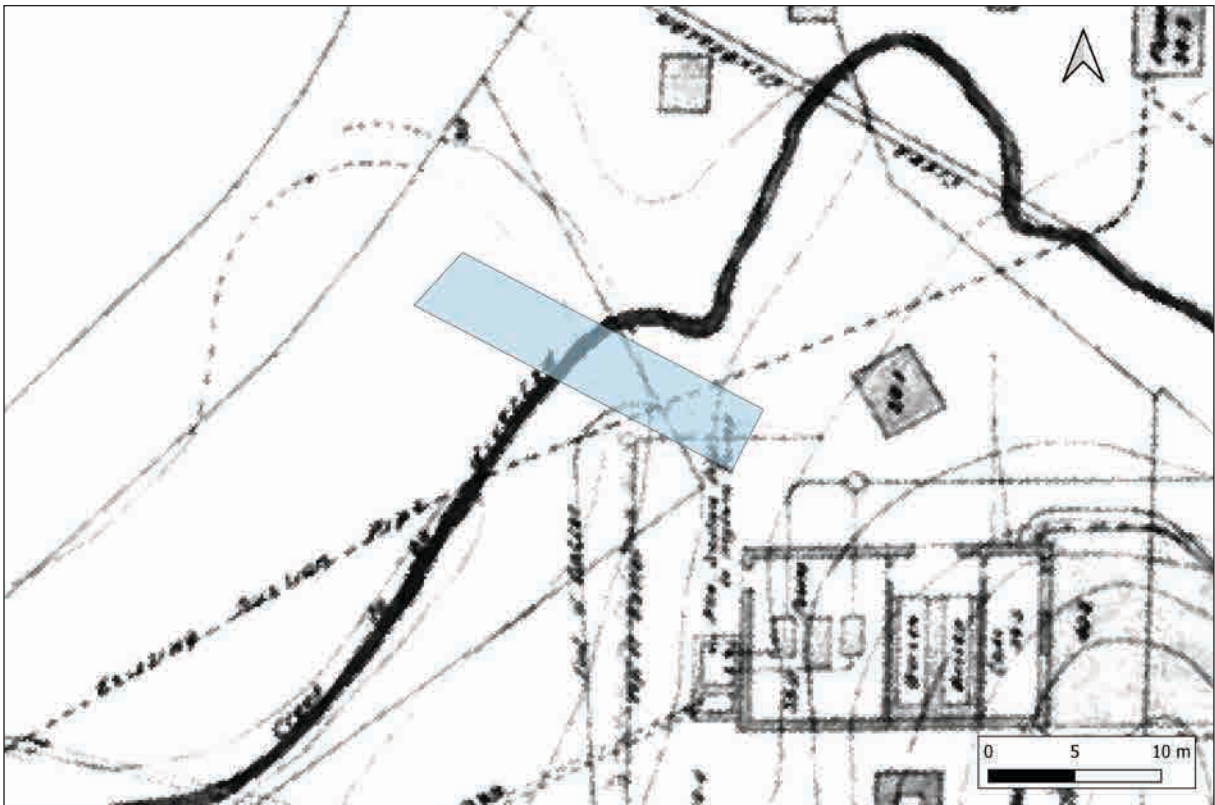
Figure 21. 1903 plan showing Wairaka Stream and pipework in relation to proposed water line (blue).

The Carrington Backbone works involve the construction of several new water reticulation lines. Most of these are within the extent of works for the roading and are covered in Section 4.1, but two lines were outside these. One line will run parallel to Carrington Road, being north and south from the Gate 1 Road intersection, and south from Gate 2 Road to Farm Road intersection. The only area within this line that has a likelihood of encountering intact subsurface archaeological deposits would be the section north of Gate 1 Road (Figure 20), as this passes the eastern wing of Oakley / Carrington Hospital and is within the Scheduled Heritage Extent of Place in the AUP for the building (ID 1618) but will not impact the primary features recorded within the AUP. Another line extends south from Gate 2 Road into Taylor's Laundry, an area which has already been heavily modified for that commercial premise. A third line will run from Spine Road towards the Old Pump House building (Building 033) through a currently grassed area and landscaped area. It is possible that there may be subsurface features of the original Wairaka Stream and pump supply for the hospital, as well as the later 1904 Pump House pipework, within this location (Figure 21).
