Geotechnical Assessment Report to Support a Private Plan Change at 50 Pukekohe East Road & 47 Golding Road, Pukekohe

Rev B

18 September 2023

Job No. 210968

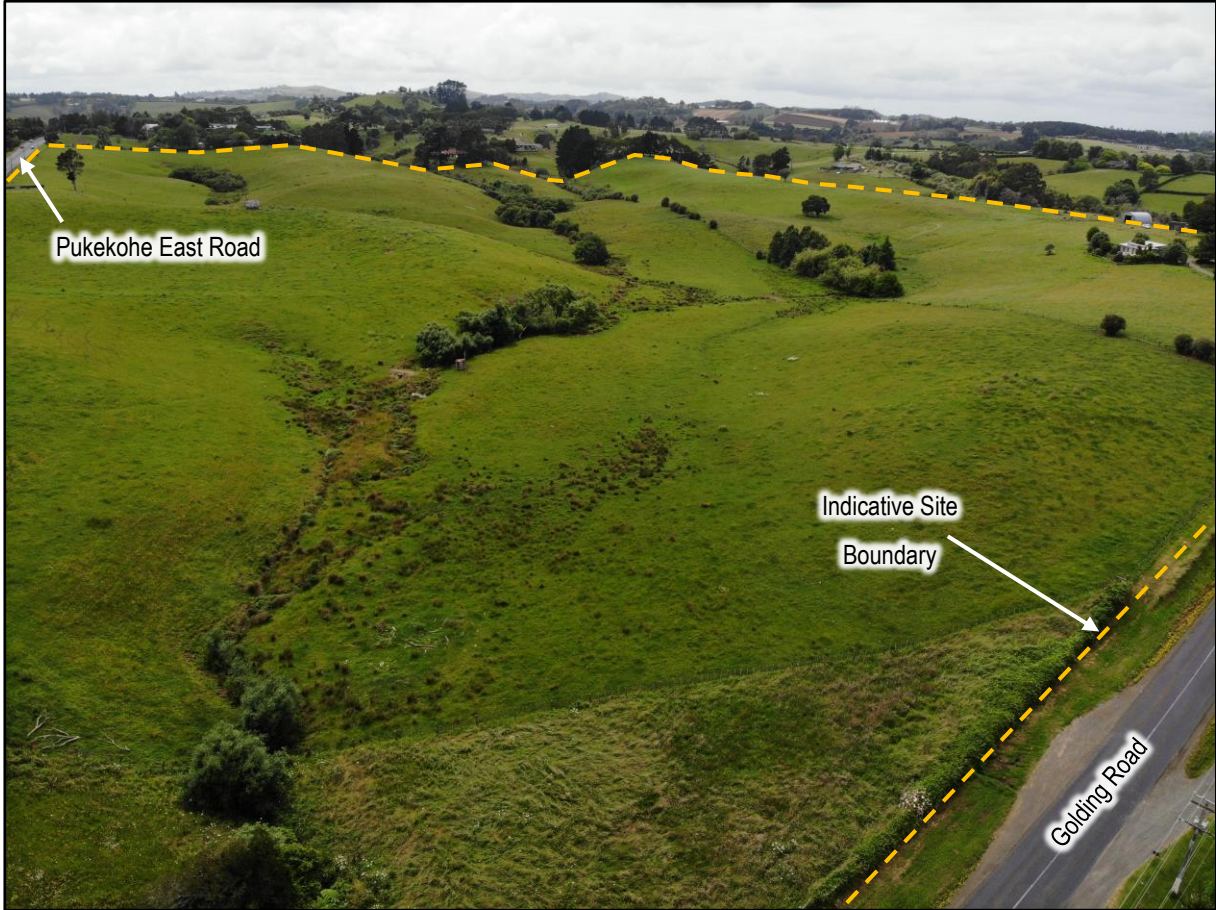
Figure 2: Drone Image of Site (Source: On-Site Photos)

The subject site comprises predominantly gently to moderately sloping farmland (see Figure 2), with one large shed located in the north-west corner and another near the south-western corner of the site.

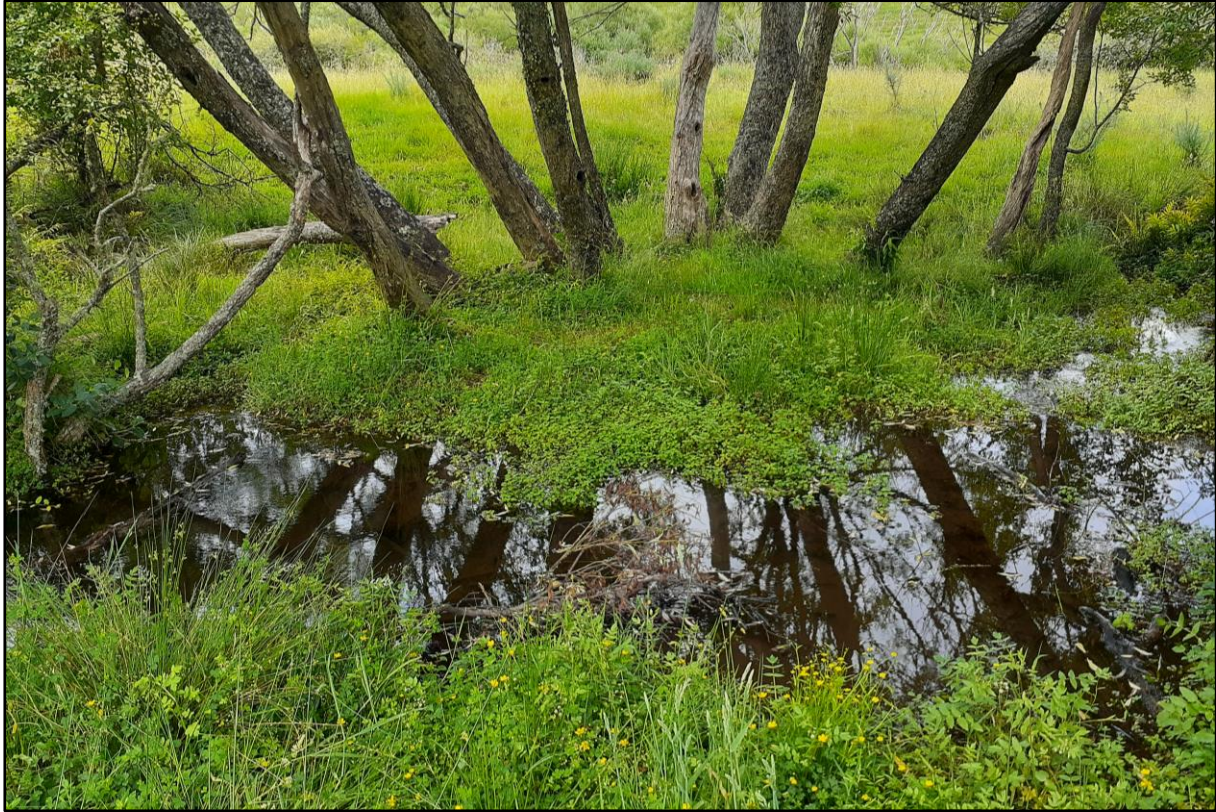
Figure 3: Example of 'Boggy' Area (Source: On-Site Photos)

Several gullies and overland flow paths (OLFPs) traverse the site, typically in an overall east-west orientation. The immediate banks of the gullies are moderately to steeply incised in places (up to 35°). The low-lying and flatter areas of the site (i.e. within the gully inverts) are significantly 'boggy' in certain areas, and a large pond is also present in the southwest portion of the site (see Figure 3).

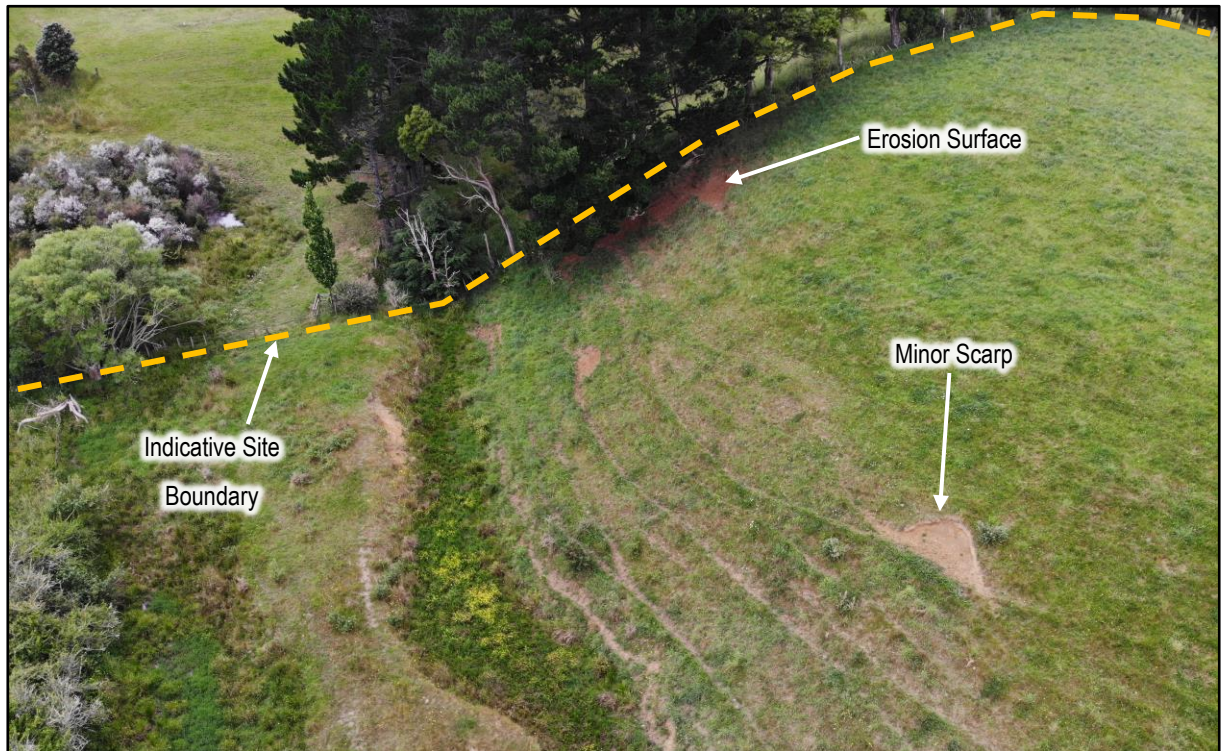
Figure 4: Example of Minor Scarps/Erosion (Source: On-Site Photos)

Slope inclinations within the site are generally in the order of approximately 5° to 25° with isolated areas at steeper inclinations (banks of some gullies). During our walkover several minor scarps/erosion surfaces were observed at various locations around the site, on the moderately to steeply inclined slopes (see Figure 4). The observed scarps are related to minor localised erosion/instability within the surficial soils (which has likely been exacerbated by stock movement) rather than deep-seated instability.

Evidence of relic slip scarps from small scale slope failures were noted on the slopes around the gully banks and on ground which is moderately to steeply sloping. Smaller scale slippage on the gully banks can be treated as synonymous with bank erosion. Slips within the moderately to steeply sloping ground were likely triggered by saturation of the soils following prolonged heavy rainfall, but may also be related areas of non-engineered fill.

Where this cannot be achieved, suitable erosion protection should be installed to mitigate small scale bank erosion and slippage. This may comprise measures such as rip-rap (also gabion rock), placement of geotextiles (e.g. Enkamat by Maccaferri or similar), or construction of gabion basket walls.

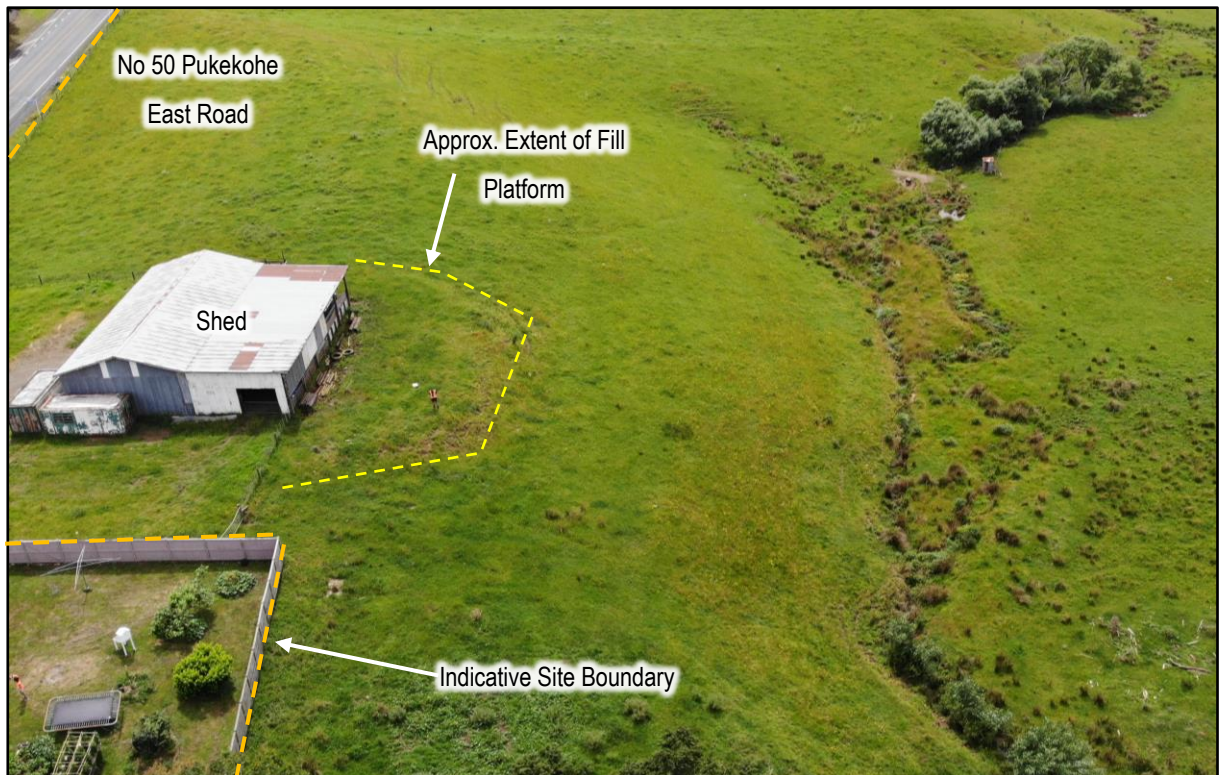
Figure 5: Apparent Fill Platform Below Shed (Source: On-Site Photos)

A large shed is present within the northwest corner of 50 Pukekohe East Road, and appears to be located on a filled building platform (see Figure 5). There is also evidence of a historical structures to northwest and the east of this shed which are likely areas for demolition debris and fill remnants.

Fill (likely non-engineered) can be expected in varying quantities across the site, generally around existing structures (such as that identified in Figure 5), historical structures and accessways. No large fill stockpiles were identified during the site walkover.

Unconsolidated alluvial deposits are generally restricted to gullies, overland flow paths and low-lying areas. As described above, such soils are subject to consolidation when additional loads are applied at the ground surface, resulting in subsidence (often referred to as settlement). Common practice to avoid this is to remove any weak, organic or compressible material during pre-development earthworks, install drainage, and replace with engineered fill.

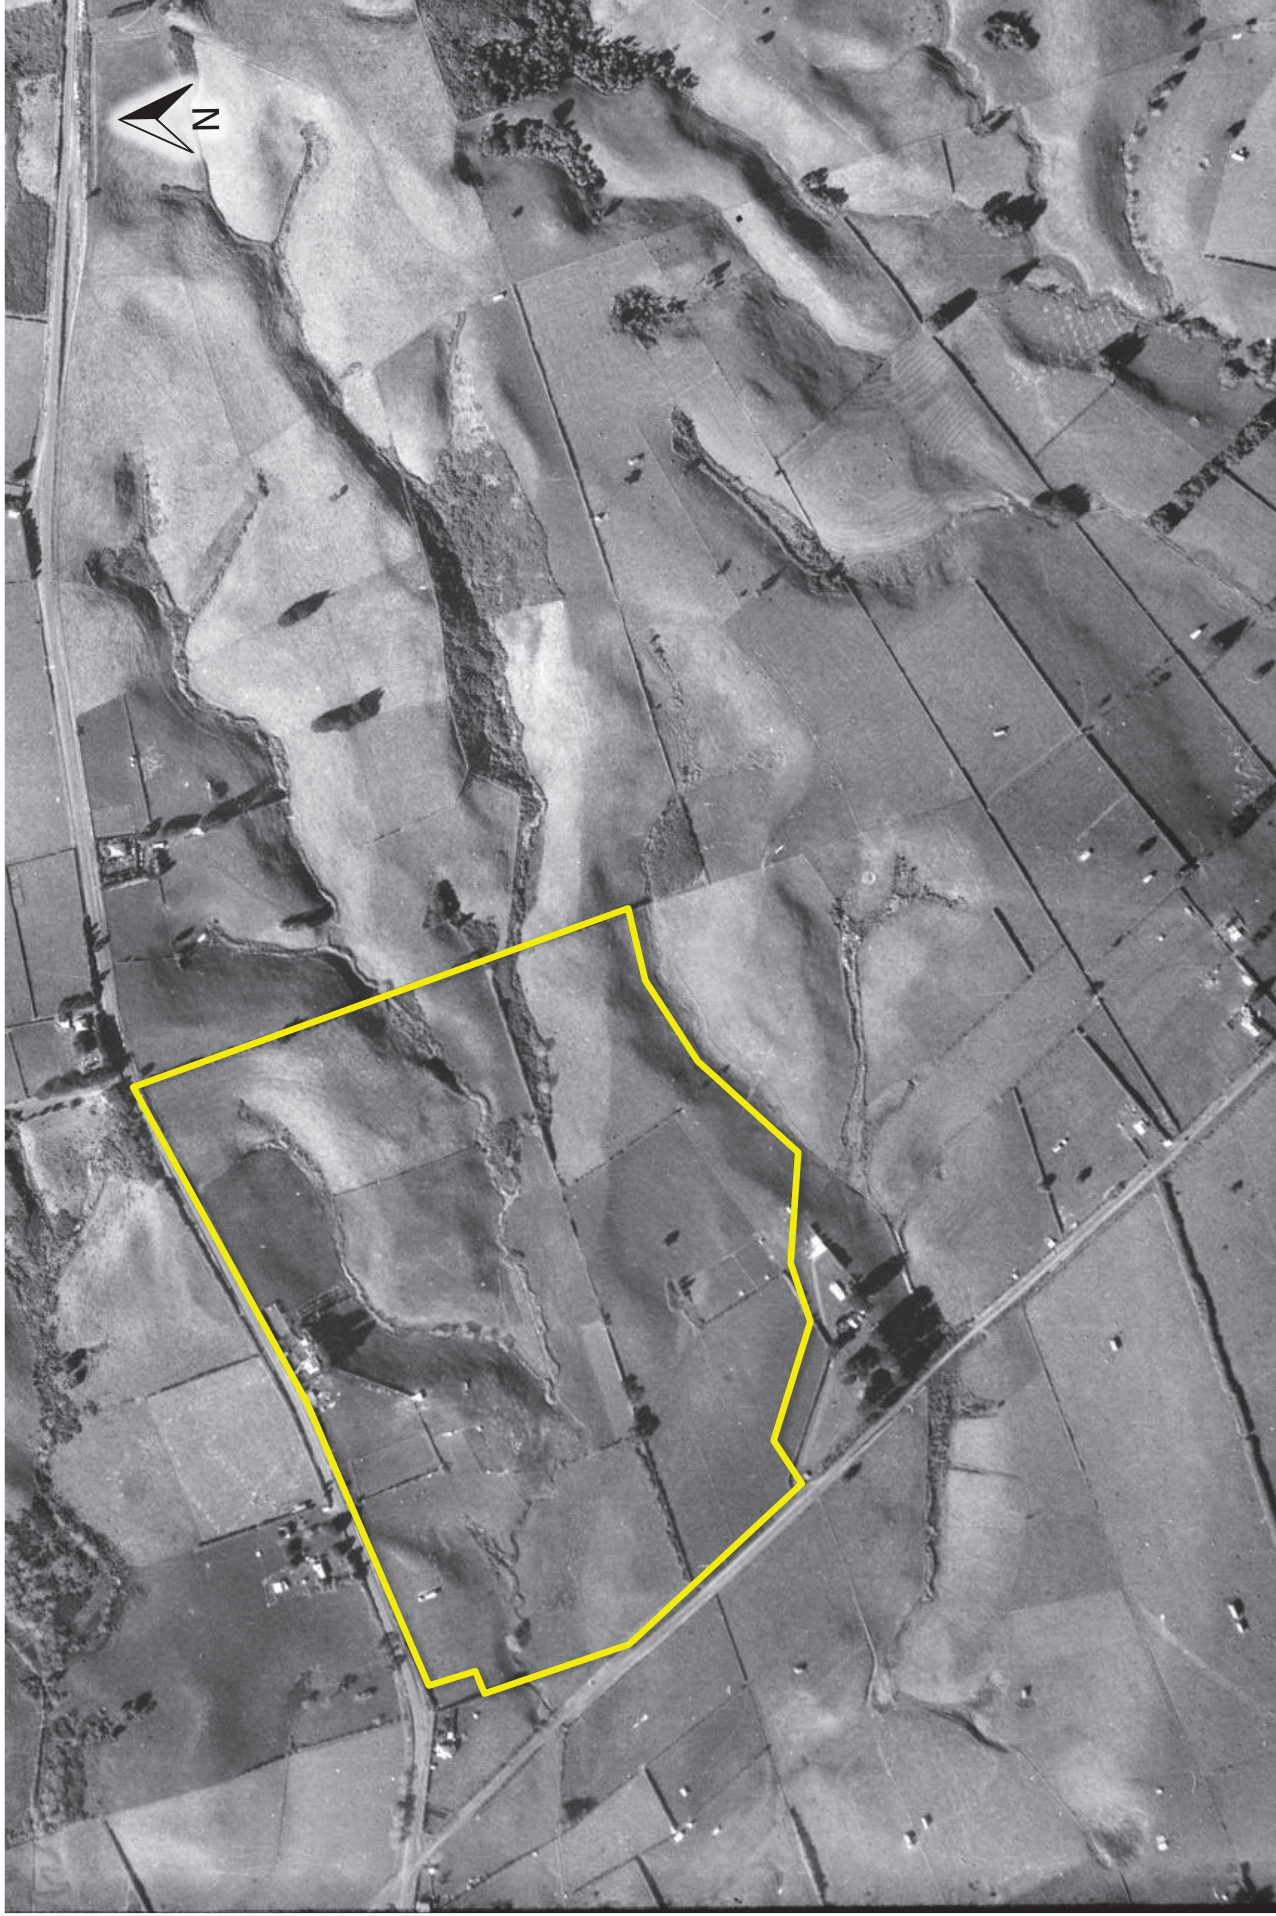
Retrolens
1942

Historical Aerial Photography
Sourced from <http://retrolens.nz> and licensed by LINZ CC-BY 3.0

Year	Source	Location and Geotechnical Features
1942	Retrolens	<p>The site and surrounding areas are predominantly being used for pastoral purpose. The current landform generally represents that observed during the November 2021 site walkover, with no major digressions of streams, overland flow paths and ponds (though some ponds are not present). Vegetation is sparse, with bush/shrubs generally confined to overland flow paths and ponds.</p> <p>A large building is located within northern boundary of 50 East Pukekohe Road. The remainder of the site contains several small sheds.</p>
1961	Retrolens	<p>No significant changes to the landform have been identified and the surrounding area remains predominantly as pasture.</p> <p>There appears to be a small horticultural operation in the northern section of 50 Pukekohe East Road.</p>
1975	Retrolens	<p>An access road has been constructed near the southern boundary, orientated east-west. No other significant changes to the landform have been identified.</p> <p>The large shed and another structure (inferred dwelling) have been constructed in the northwest corner of 50 Pukekohe East Road. The fill platform to the south of this shed is evident.</p>

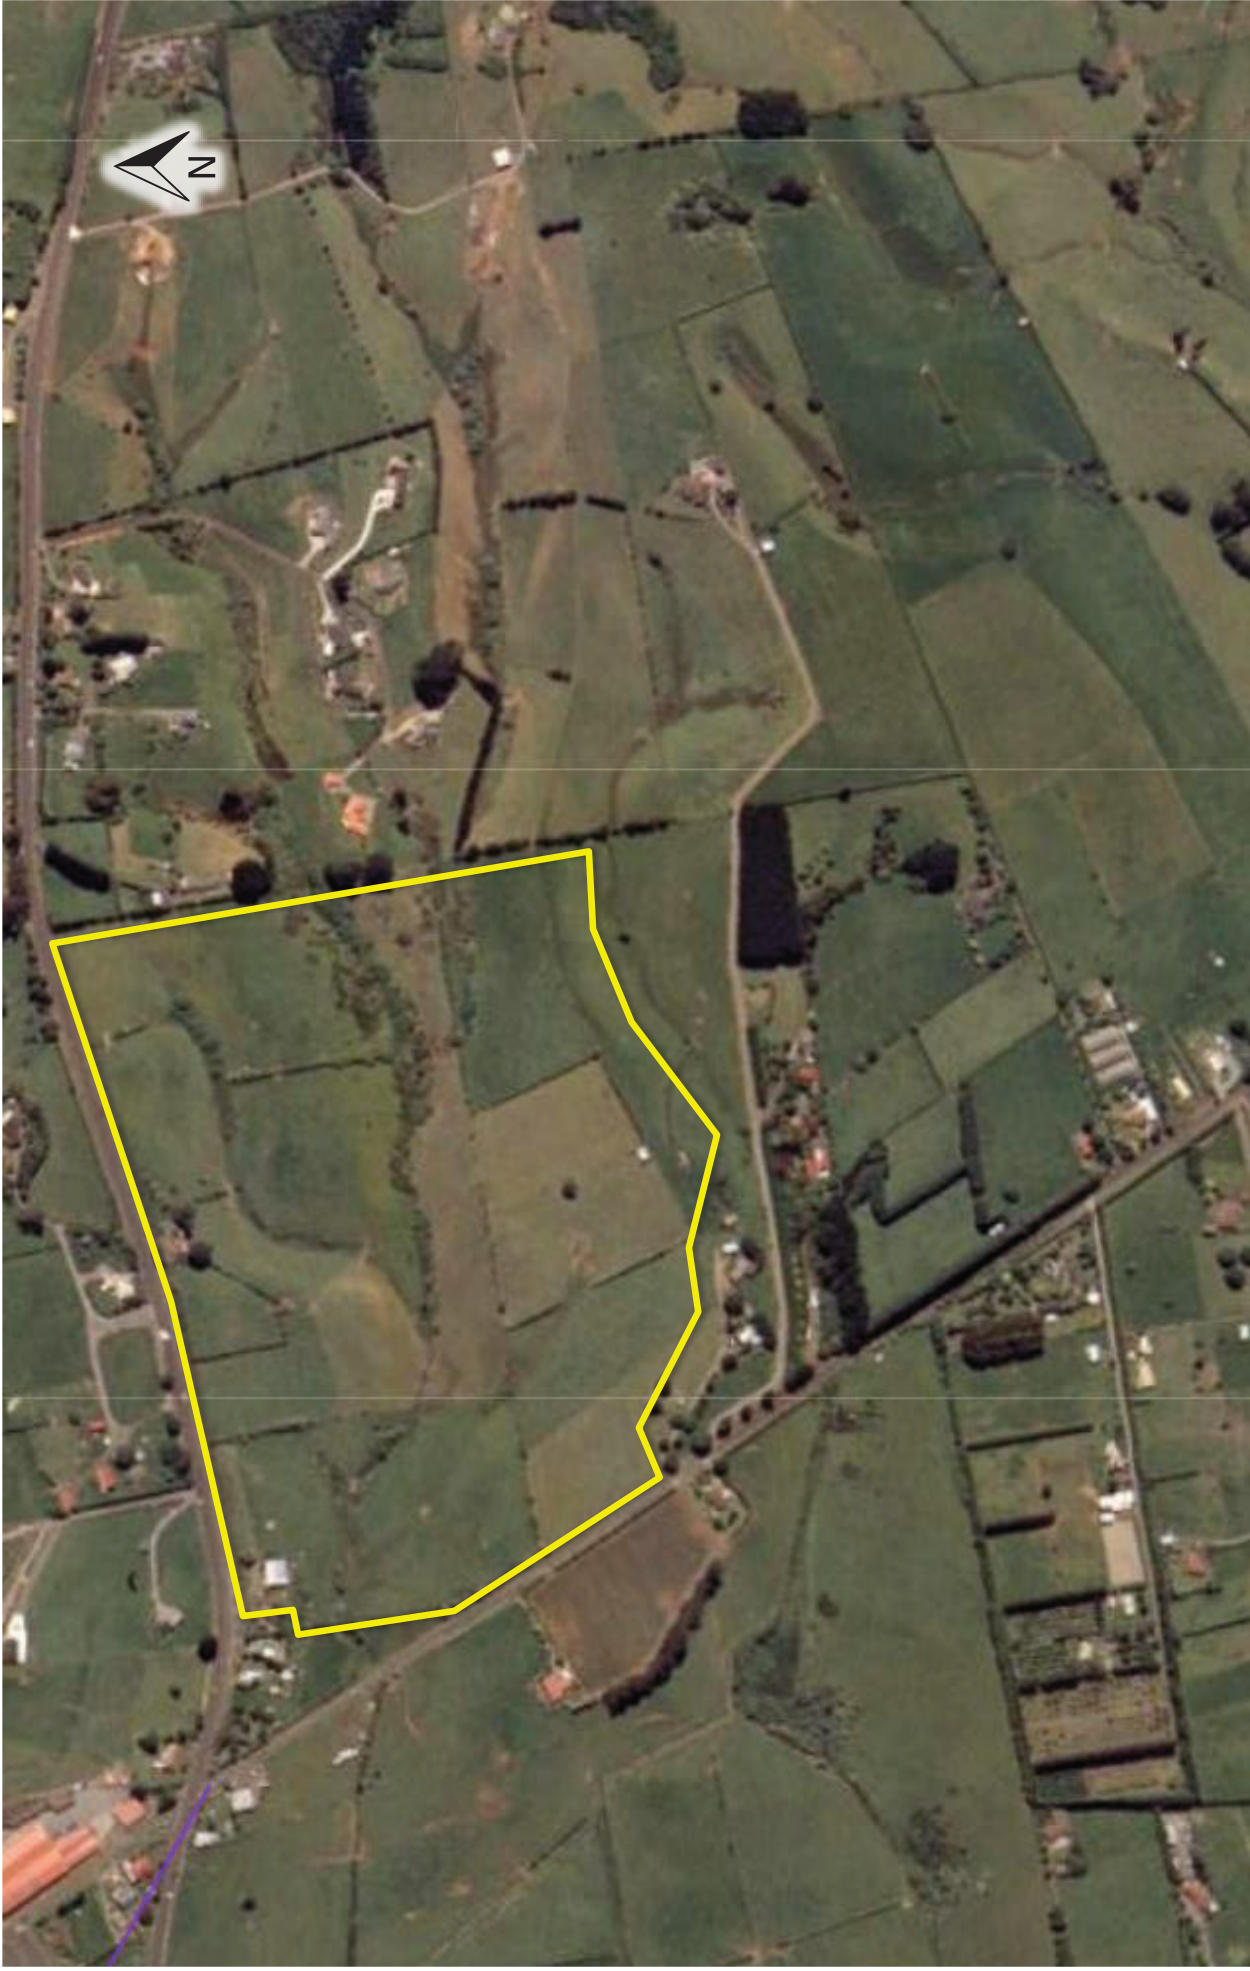
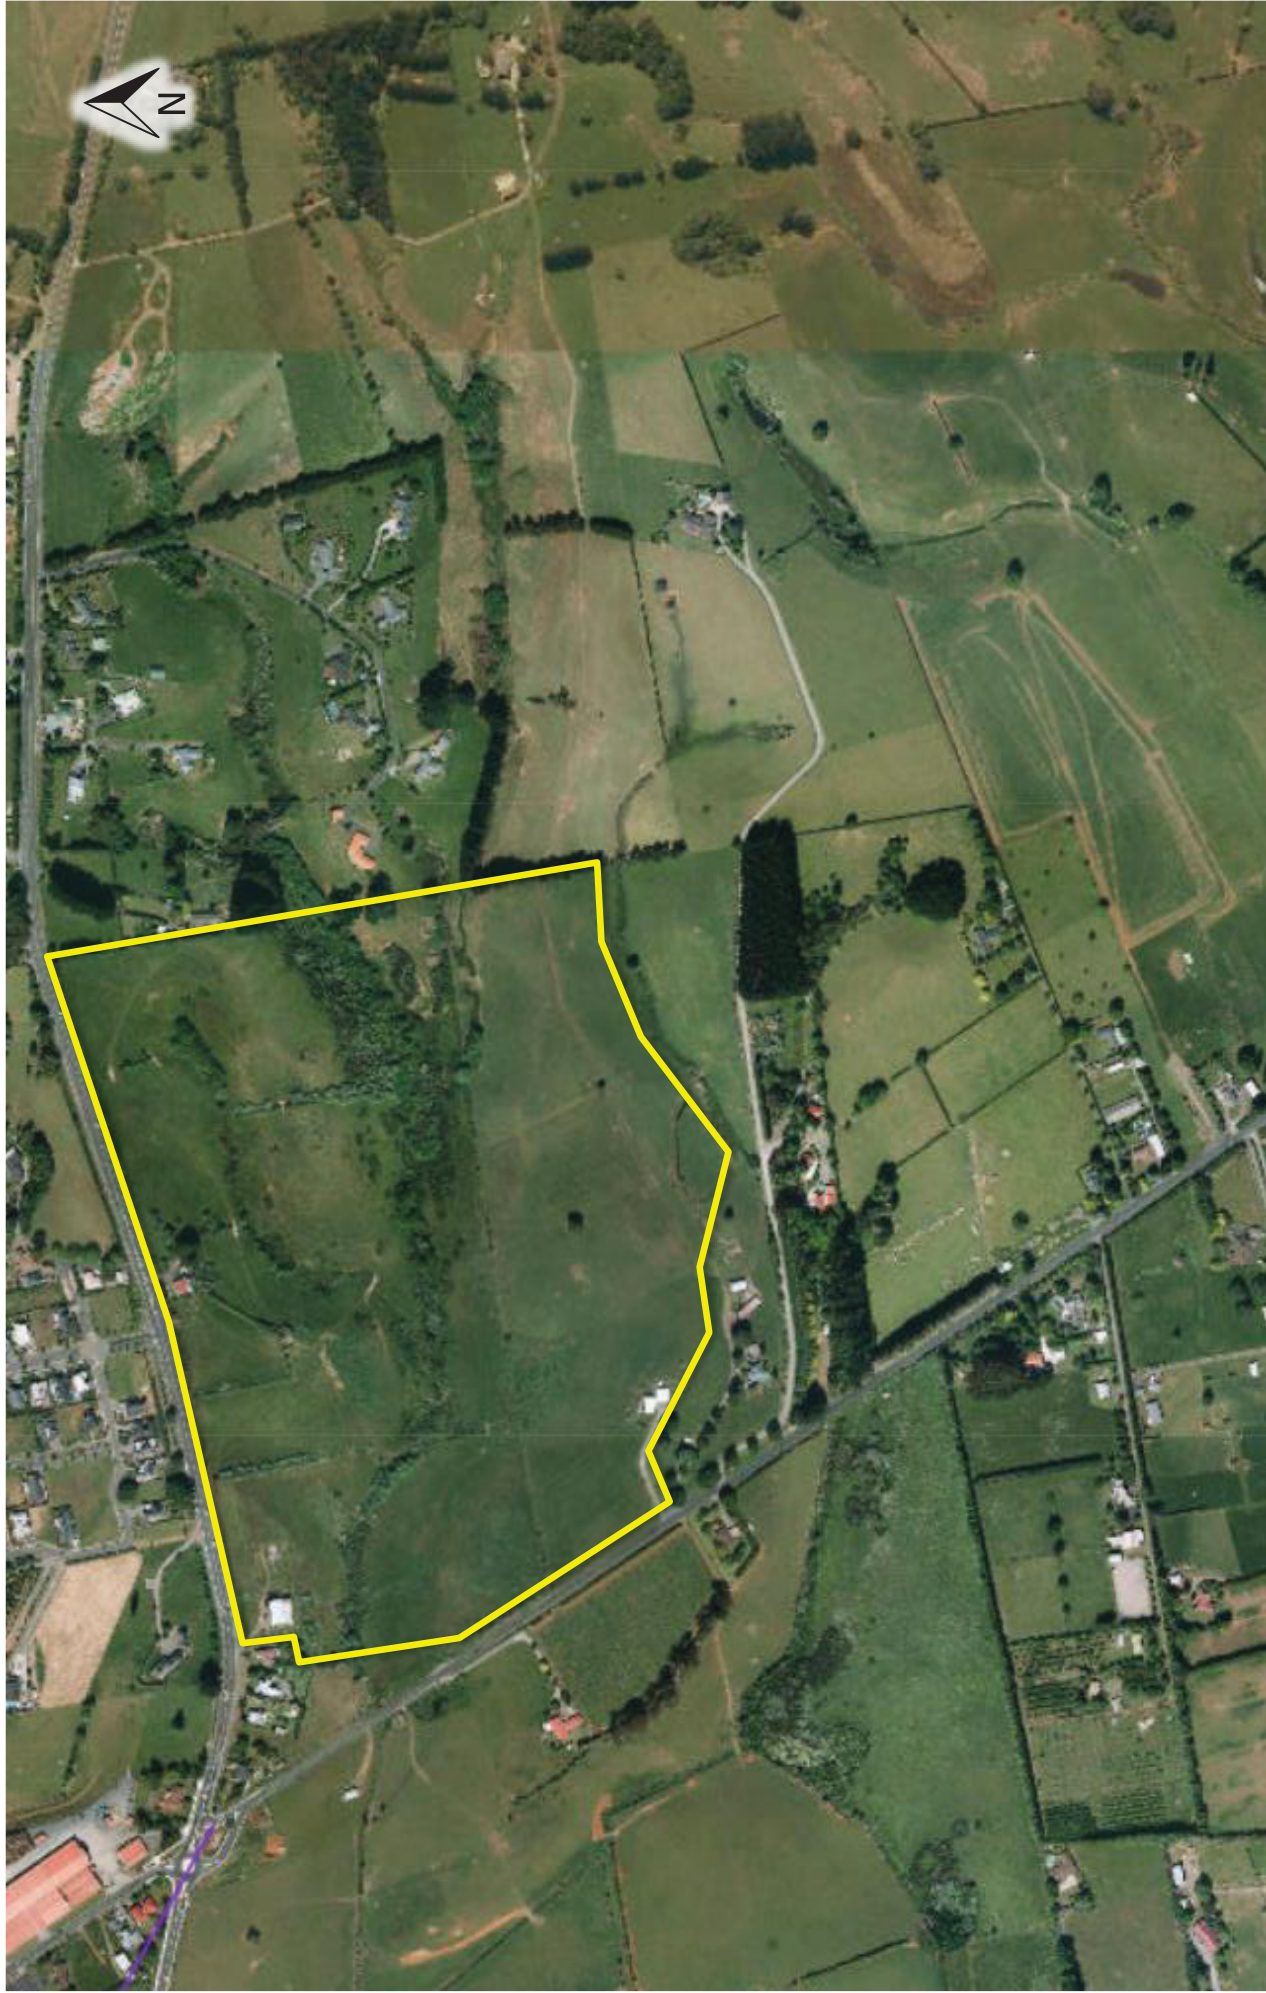
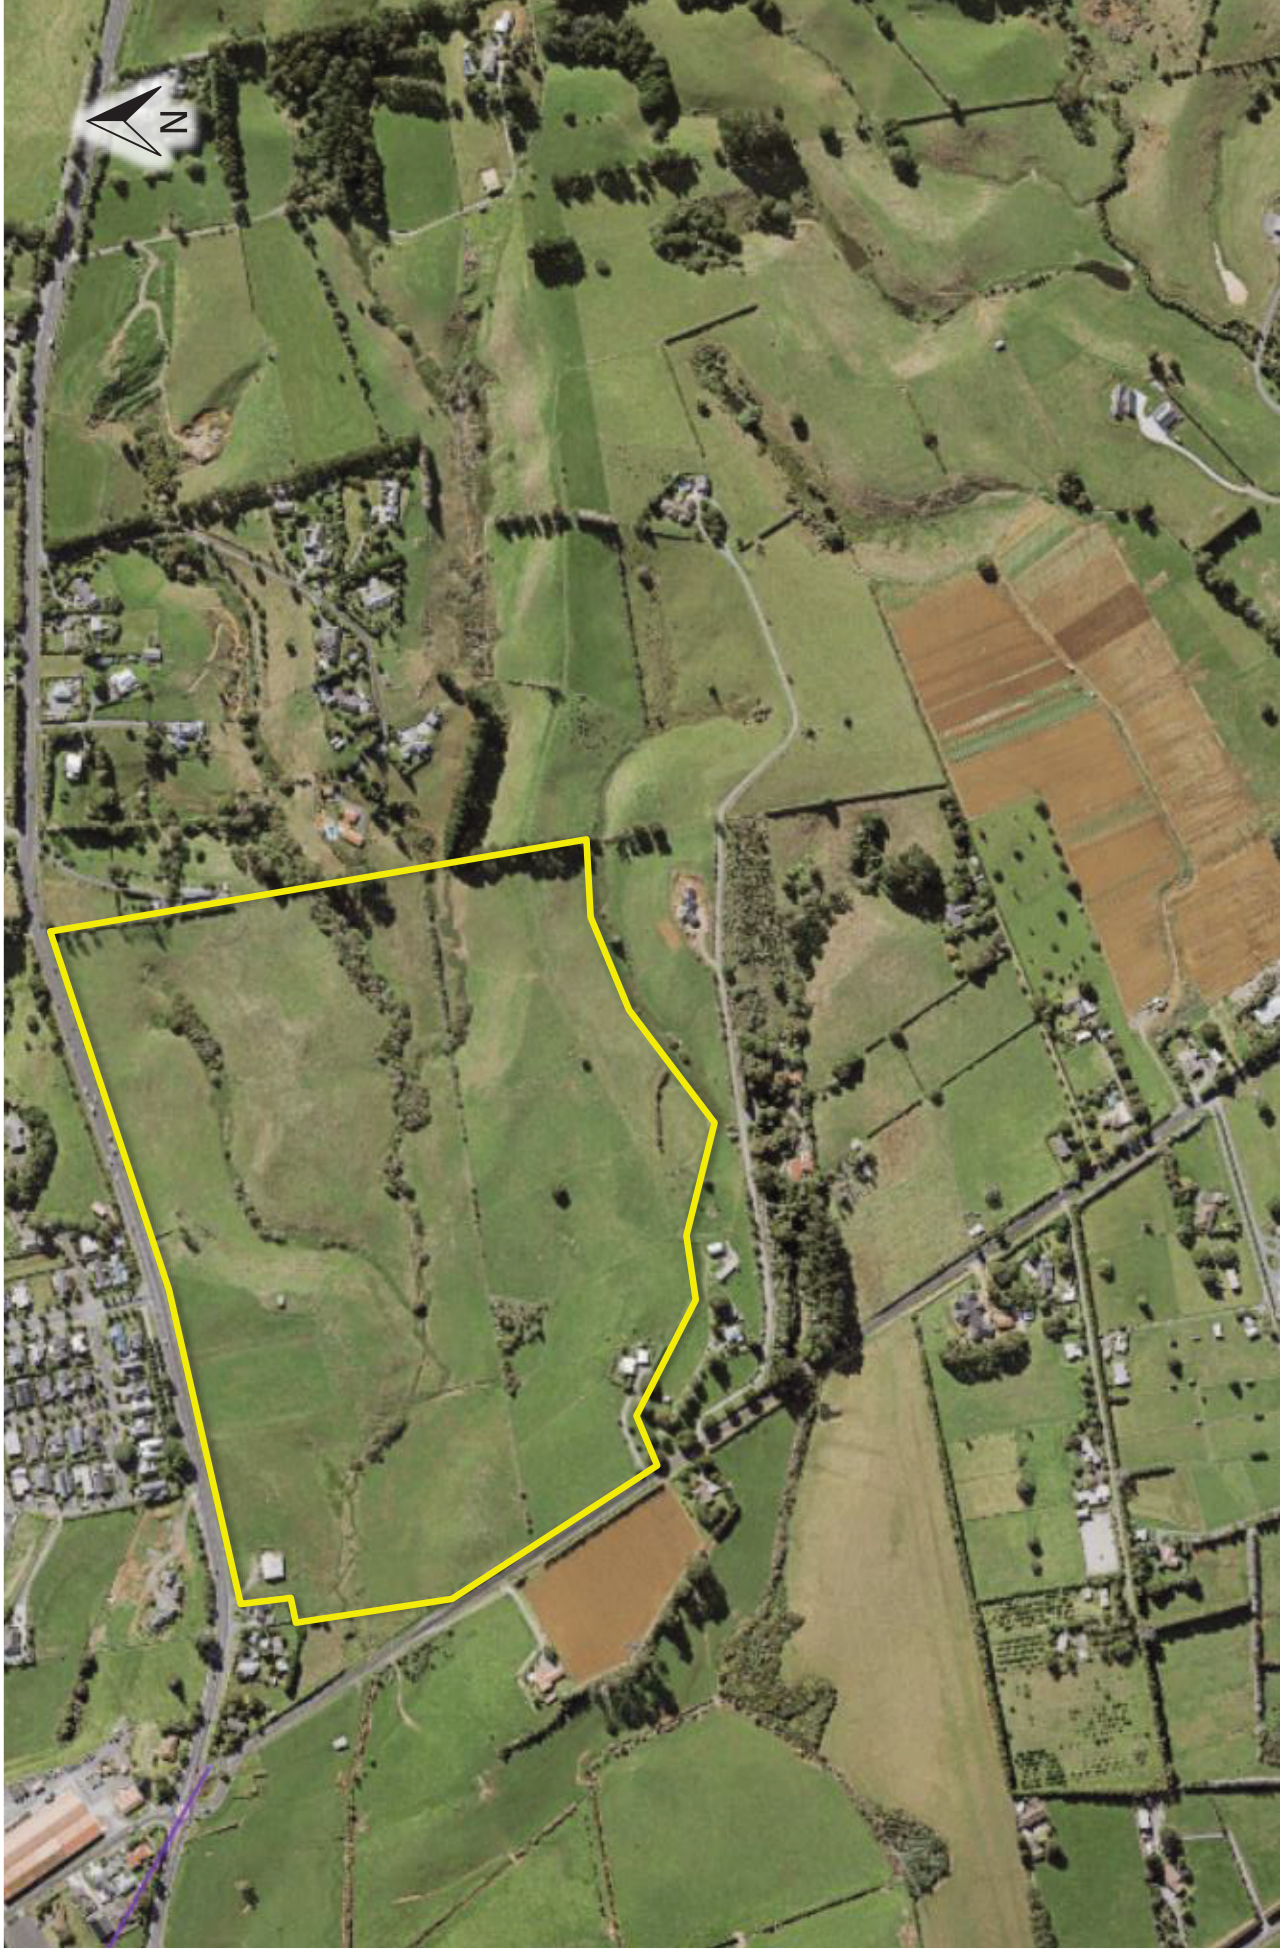
1988

Historical Aerial Photography
Auckland Council GeoMaps

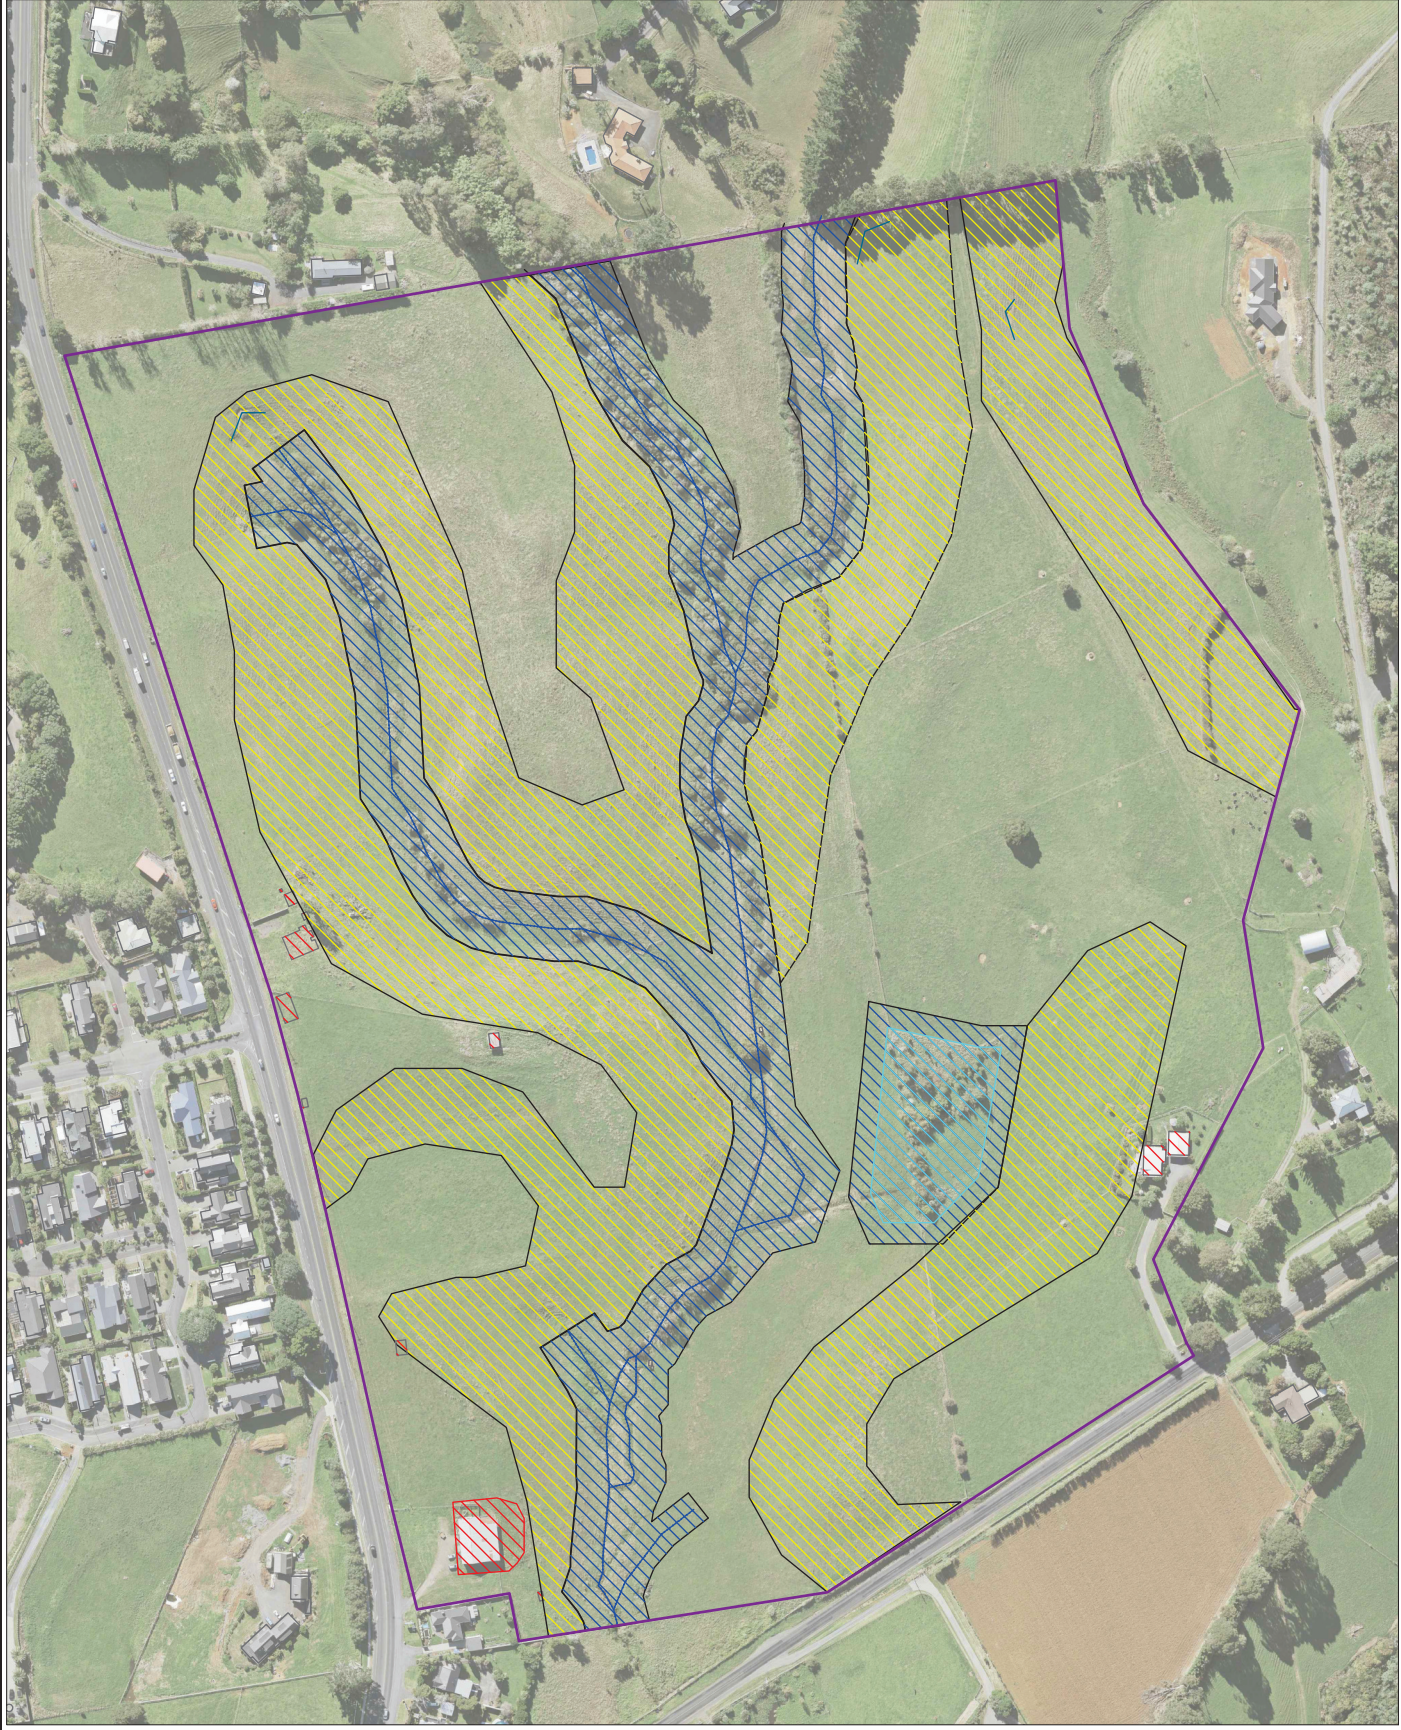
The areas considered to have the potential to be affected by these hazards are identified in the Site Identification Plan, Drawing No. 210968/1, attached in Appendix C. The hazards and risks to the site are described in more detail below.

The predominant landscape and landform character of the site, as described below, are identified on the Site Identification Plan, Drawing No. 210968/1, attached in Appendix C.

- Site Boundary
- Minor Scarp
- Gully / Overland Flow Path
- Areas of Shallow Instability
- Inferred Gully Alluvium
- Pond/Welland
- Inferred Non-Engineered Fill (Existing and Historical Structures)
