Faecal Source Investigation Tryphena, Great Barrier Island

Prepared for The Great Barrier Island Local Board and Auckland Council

July 2017

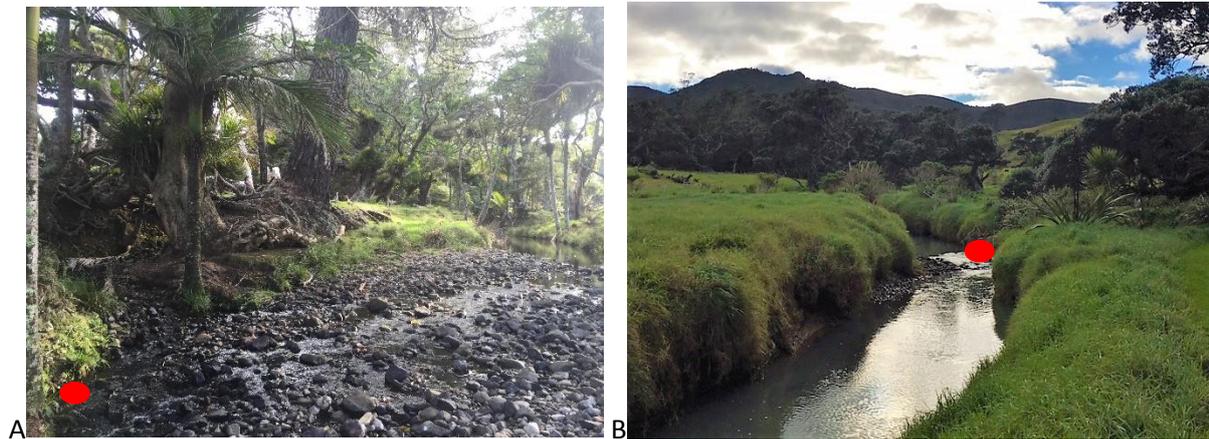
the main housing areas of Blackwell Drive, was selected to be representative of farming land where cattle have access to the stream and stream margins (Figure 2A). Lower down the stream catchment, BW7 is located in the main stem, just below the entrance of a cut out drain. This drain (and another further downstream above BW1) collects runoff from residential properties and stormwater infrastructure during high rainfall events along Blackwell Drive (Appendix A2). A small pond approximately 30 m from the stream edge also feeds into this cut out drain before entering the stream.

Figure 2. Blackwell Stream: A) Red dot indicates sampling location BW4. B) Red dot indicates sampling location BW1.

1. Visit property owners along Blackwell Stream without livestock exclusion to discuss mitigation options and riparian fencing. Riparian fencing alone would greatly reduce the bacterial contamination in Blackwell Stream, particularly during dry weather. It is recommended that funding (such as the Auckland Council Waterway Protection Fund) be allocated for livestock exclusion fencing along Blackwell Stream.

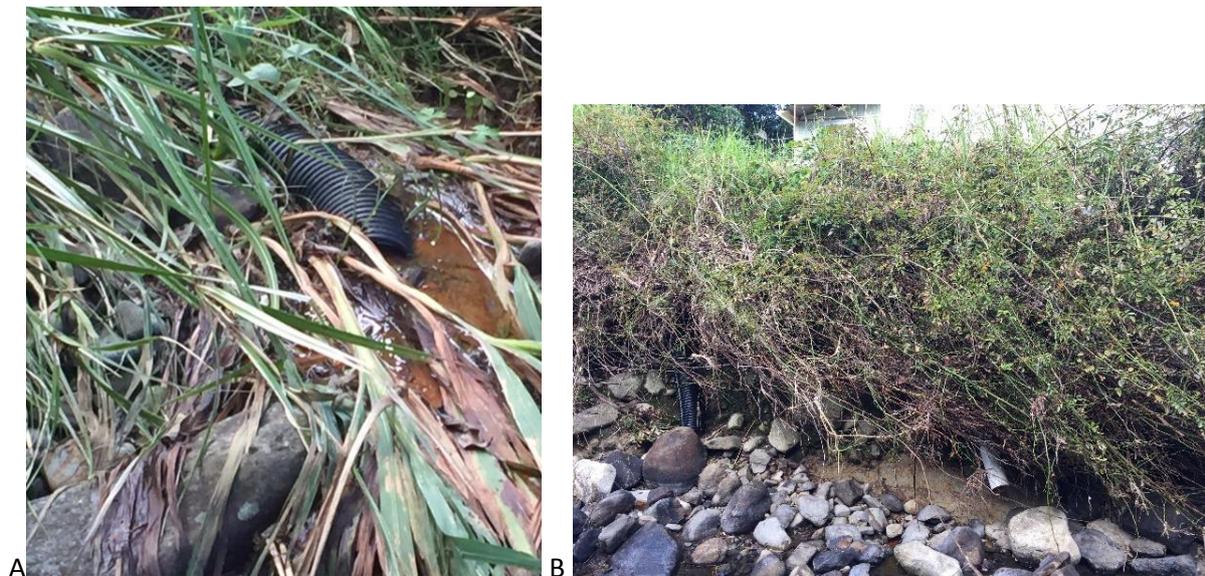
Figure 3. A) Large black ribbed pipe, with fine layer of orange algae above sampling location MG5. B) Two Large pipes on stream edge above sampling location MG4.

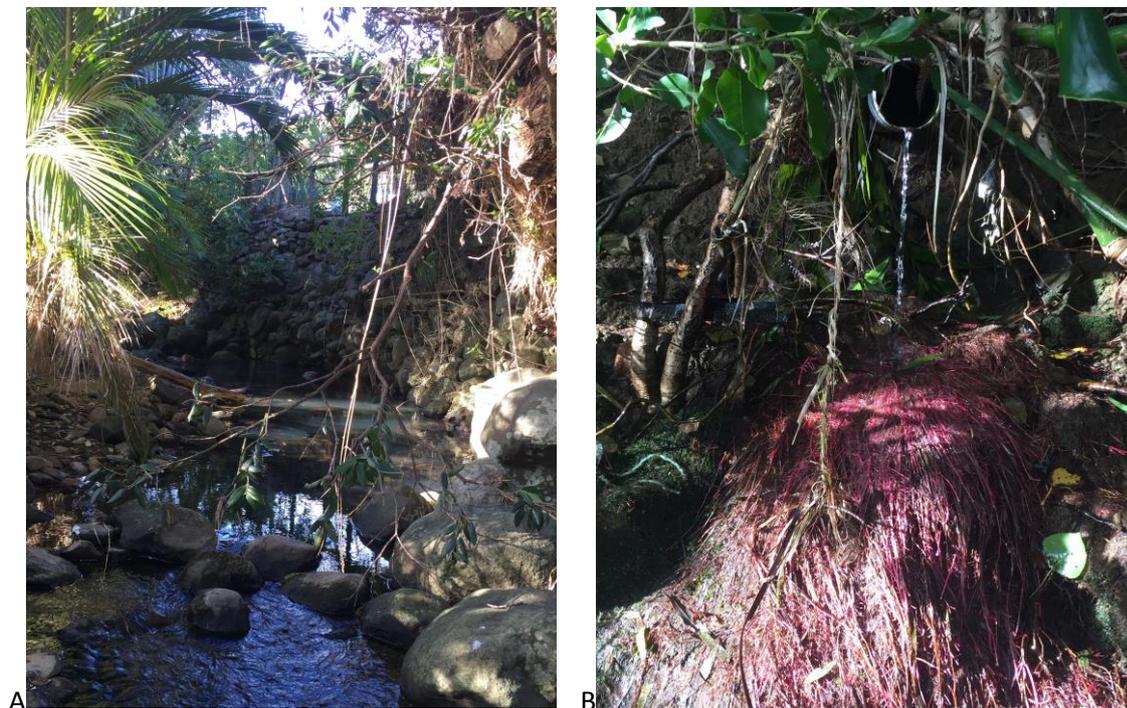
Figure 4. A) Sampling location GR4. B) Pipe entering the stream from a residential property, above sampling site GR2.

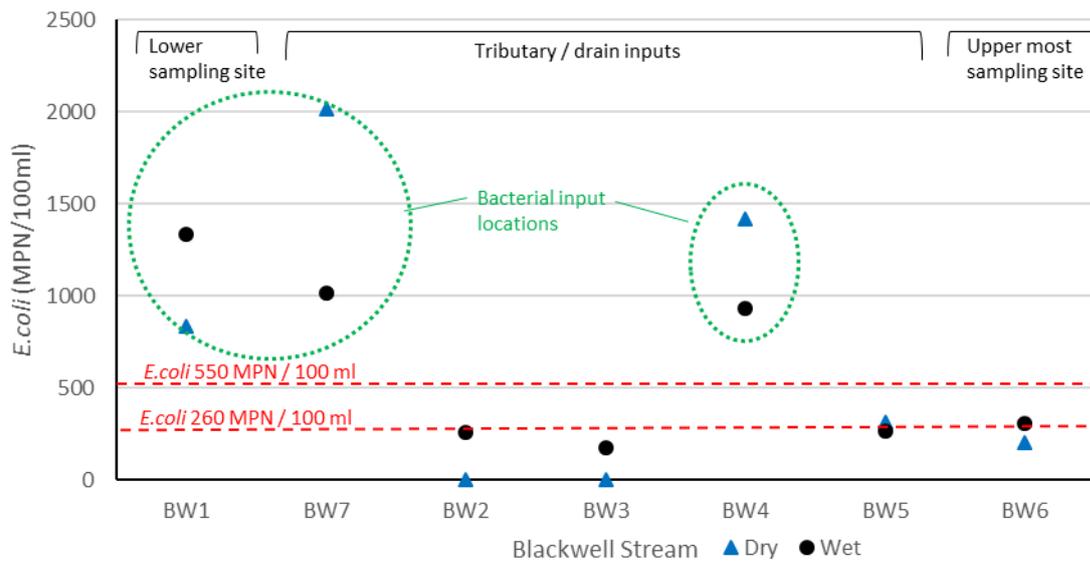
E.coli concentrations increased from the upper sampling location (BW6) down to the stream mouth (BW1; Figure 5, Appendix B). Nine of the eleven results (82 %) exceeded the alert level and six (54 %) exceeded the action level for contact recreation (MfE/MoH 2003).

Three key locations of faecal contamination were identified; BW1, BW7 and BW4. All three of those sites had high *E.coli* concentrations (> 800 MPN/100ml) during both dry and wet weather sampling (Figure 5, Appendix B). The increase in *E.coli* from BW7 to BW1 which are approximately 60 m apart during the wet weather sampling, suggests that there is a source of contamination coming in between the two sampling points (Figure 5). This is most likely from a cut out drain immediately above BW1 which collects runoff from residential and commercial properties (Appendix A2). There was no distinct pattern in *E.coli* concentrations between dry weather and wet weather sampling events. *E.coli* concentrations were higher during dry weather at BW7 and BW4 than during wet weather sampling and higher at BW1 during wet weather than dry weather sampling (Figure 5).

Figure 5. *E. coli* concentrations at Blackwell Stream, taken during March “Dry” and May “Wet” weather conditions 2017. Red dashed lines indicate guideline for recreational water quality (alert 260 and action 550 MPN/100ml; MoH/MfE 2003).

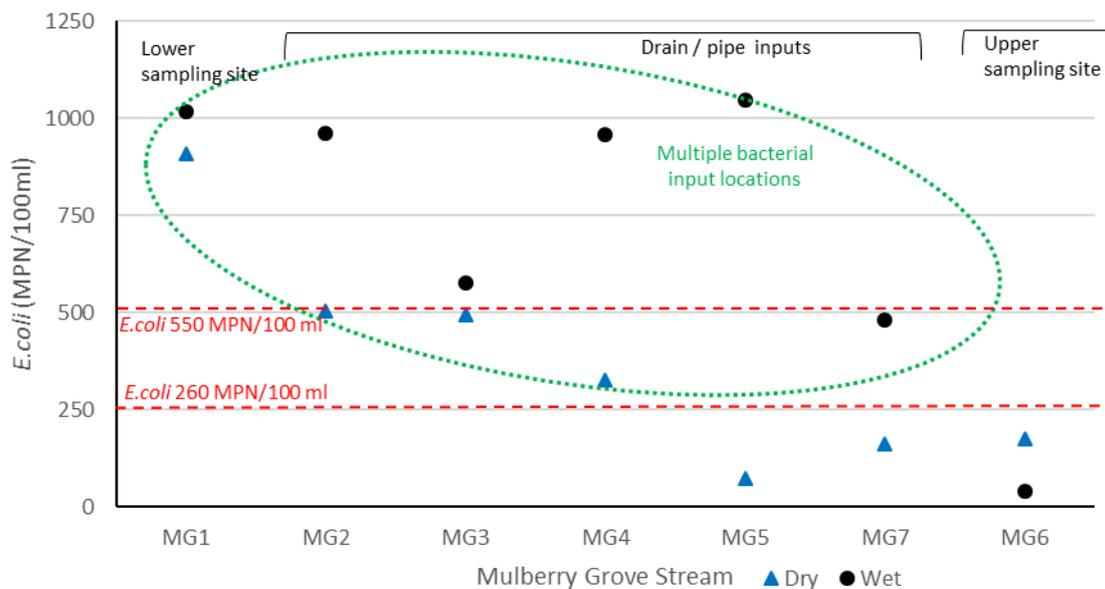
The concentrations of *E.coli* varied substantially between sites, increasing exponentially from the upper most sampling location MG6 to the lowest sampling location MG1 during both dry and wet weather sampling events (Figure 6). Results suggest multiple bacterial input locations (Figure 6). Ten of the fourteen sample results (71 %) exceeded the alert level and six (43 %) exceeded the action level for contact recreation (Figure 6; MfE/MoH 2003). The lowest *E. coli* level recorded was 41 MPN/100ml at site MG6 (the upper most sampling location) and the highest *E. coli* level recorded was 1046 MPN/100ml at site MG5 and 1017 MPN/100ml at the lowest sampling site MG1 (Figure 6; Appendix B).

There was a notable difference in results between the dry and wet sampling events, with *E.coli* concentrations almost doubling during the wet sampling event (Figure 6; Appendix B). Dry weather sampling results suggest there were four main areas of faecal contamination, increasing between sampling locations MG4, MG3, MG2 to MG1 and wet weather sampling results suggest there were multiple faecal contamination locations downstream of MG6 (Figure 6). During the wet weather sampling, concentrations increased from MG3 (576 MPN/100ml) to MG2 (960 MPN/100ml). These sites are 30 m apart and are located within the same property. Both dry and wet weather results for MG1 were high (MG1: dry 836 MPN/100ml and wet 1334 MPN/100ml) and higher than the upstream site MG2 (Figure 6, Appendix B).

Figure 6. *E.coli* concentrations at Mulberry Grove Stream, taken during March “Dry” and May “Wet” weather conditions 2017. Red dashed lines indicate guideline for recreational water quality (alert 260 and action 550 MPN/100ml; MoH/MfE 2003).

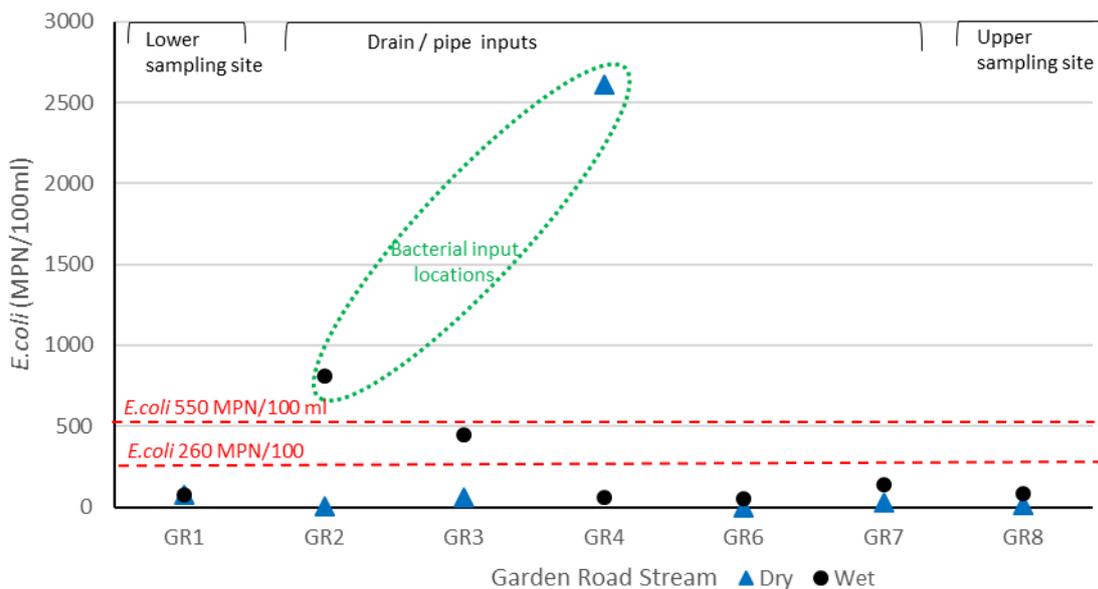
E.coli concentrations were generally low in Garden Road Stream (Figure 7, Appendix B) with the exception of three samples. *E.coli* concentrations increased at two sites during the wet weather sampling, GR3 (450 MPN/100ml) and GR2 (809 MPN/100ml) (Figure 6, Appendix B). The highest *E.coli* concentration (and of the whole study) was obtained at GR4 during the dry weather sampling (2613 MPN/100ml; Figure 6, Appendix B).

The upper most sampling location and lowest sampling location returned similar low values (Figure 7) on both dry and wet sampling events. This suggests that there was a reasonable level of dilution occurring within the stream on those occasions when high *E.coli* concentrations at GR2 and GR4 occurred.

Figure 7. *E.coli* concentrations at Garden Road Stream, taken during March “Dry” and May “Wet” weather conditions 2017. Red dashed lines indicate guideline for recreational water quality (alert 260 and action 550 MPN/100ml; MoH/MfE 2003).

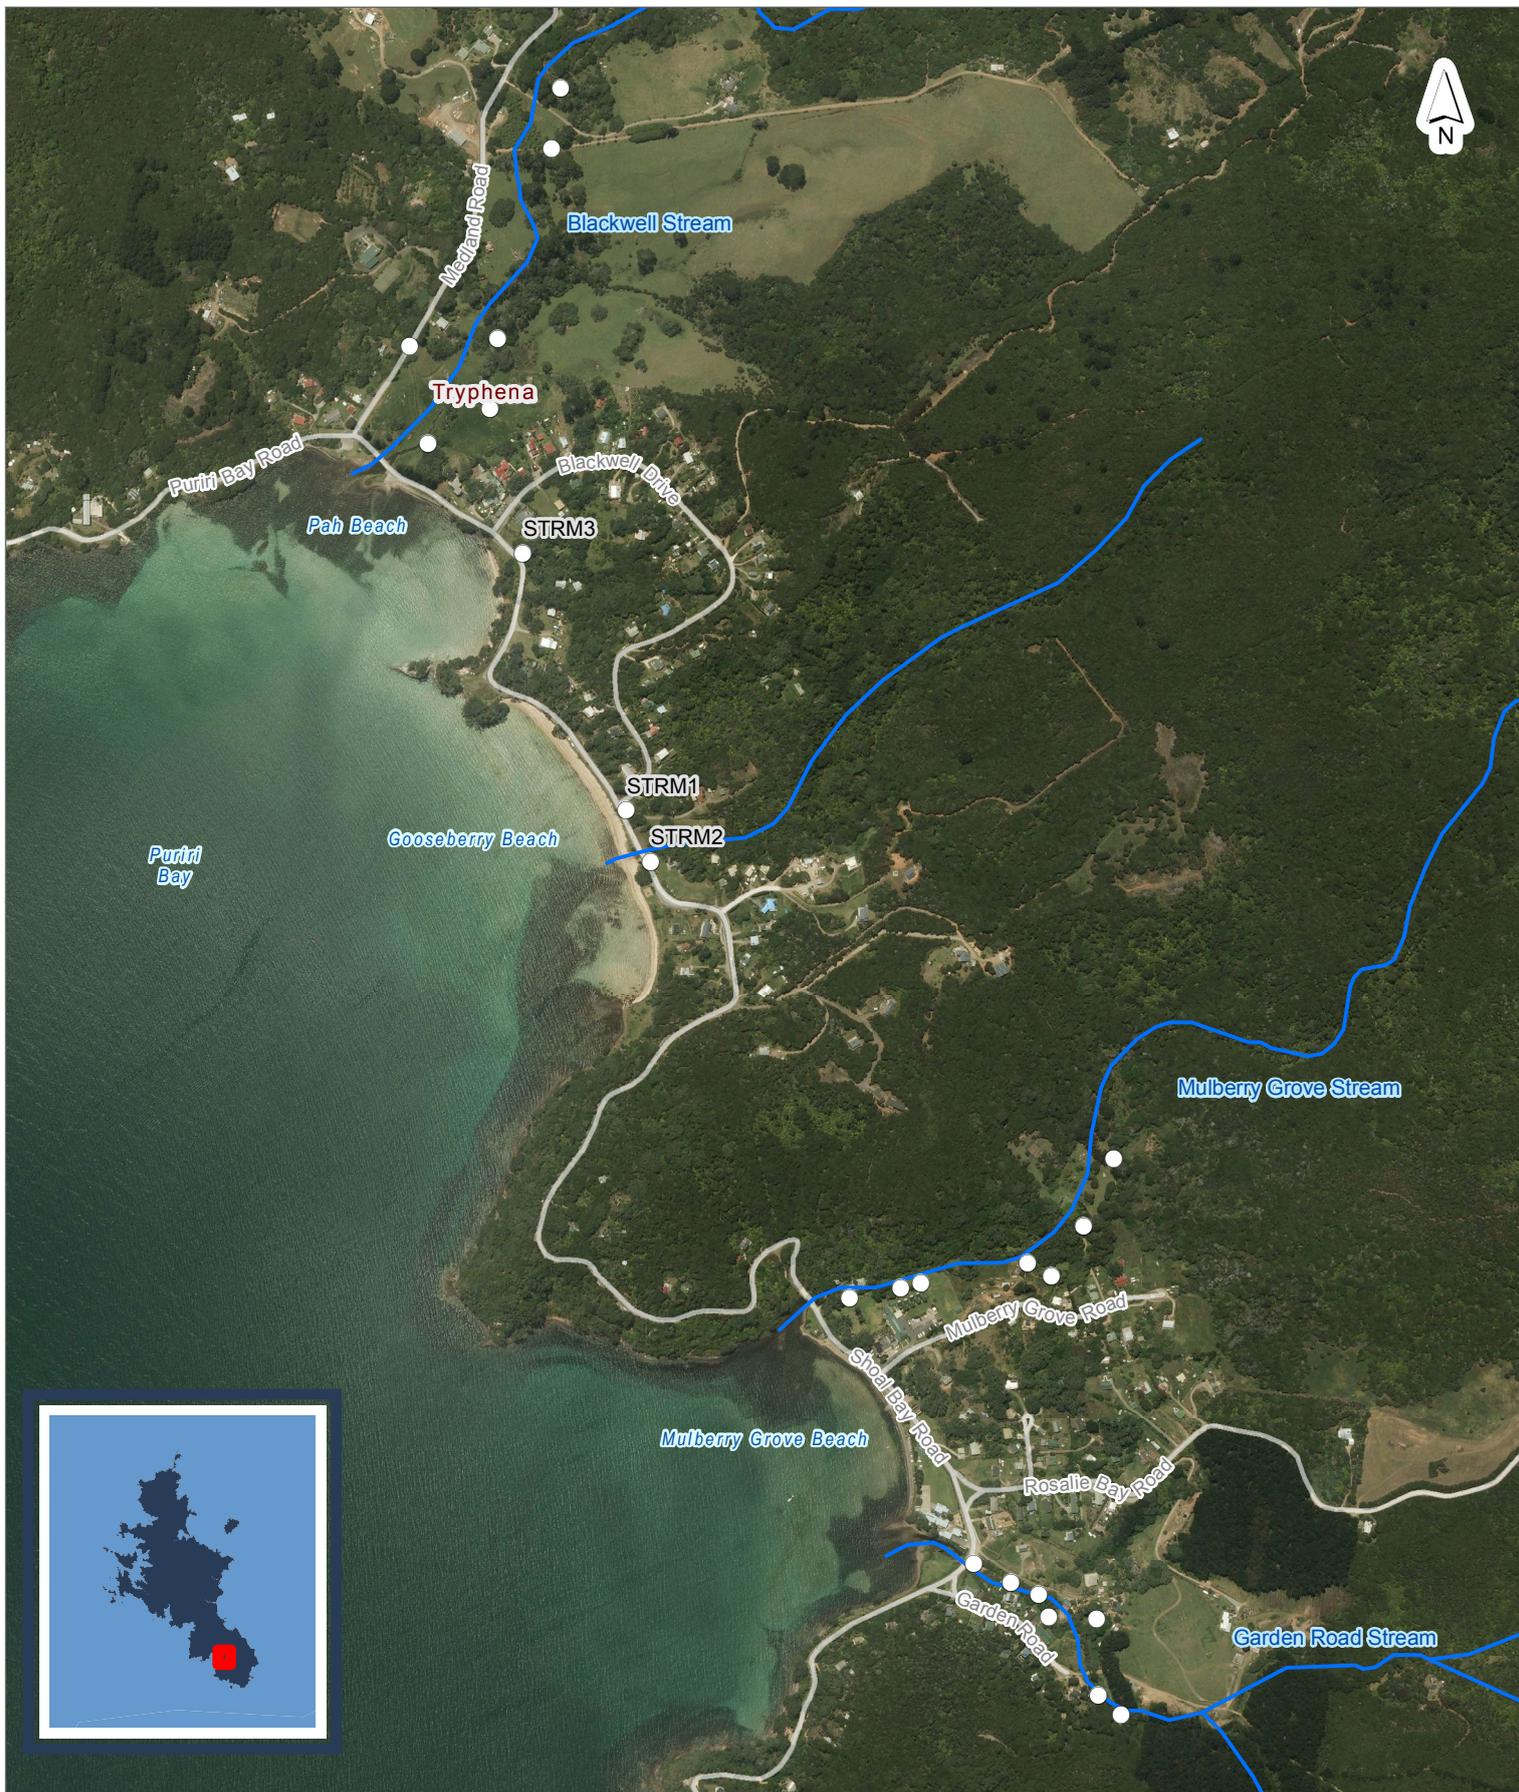
APPENDIX A1: Overview Map, Tryphena

Sample Locations Great Barrier Island

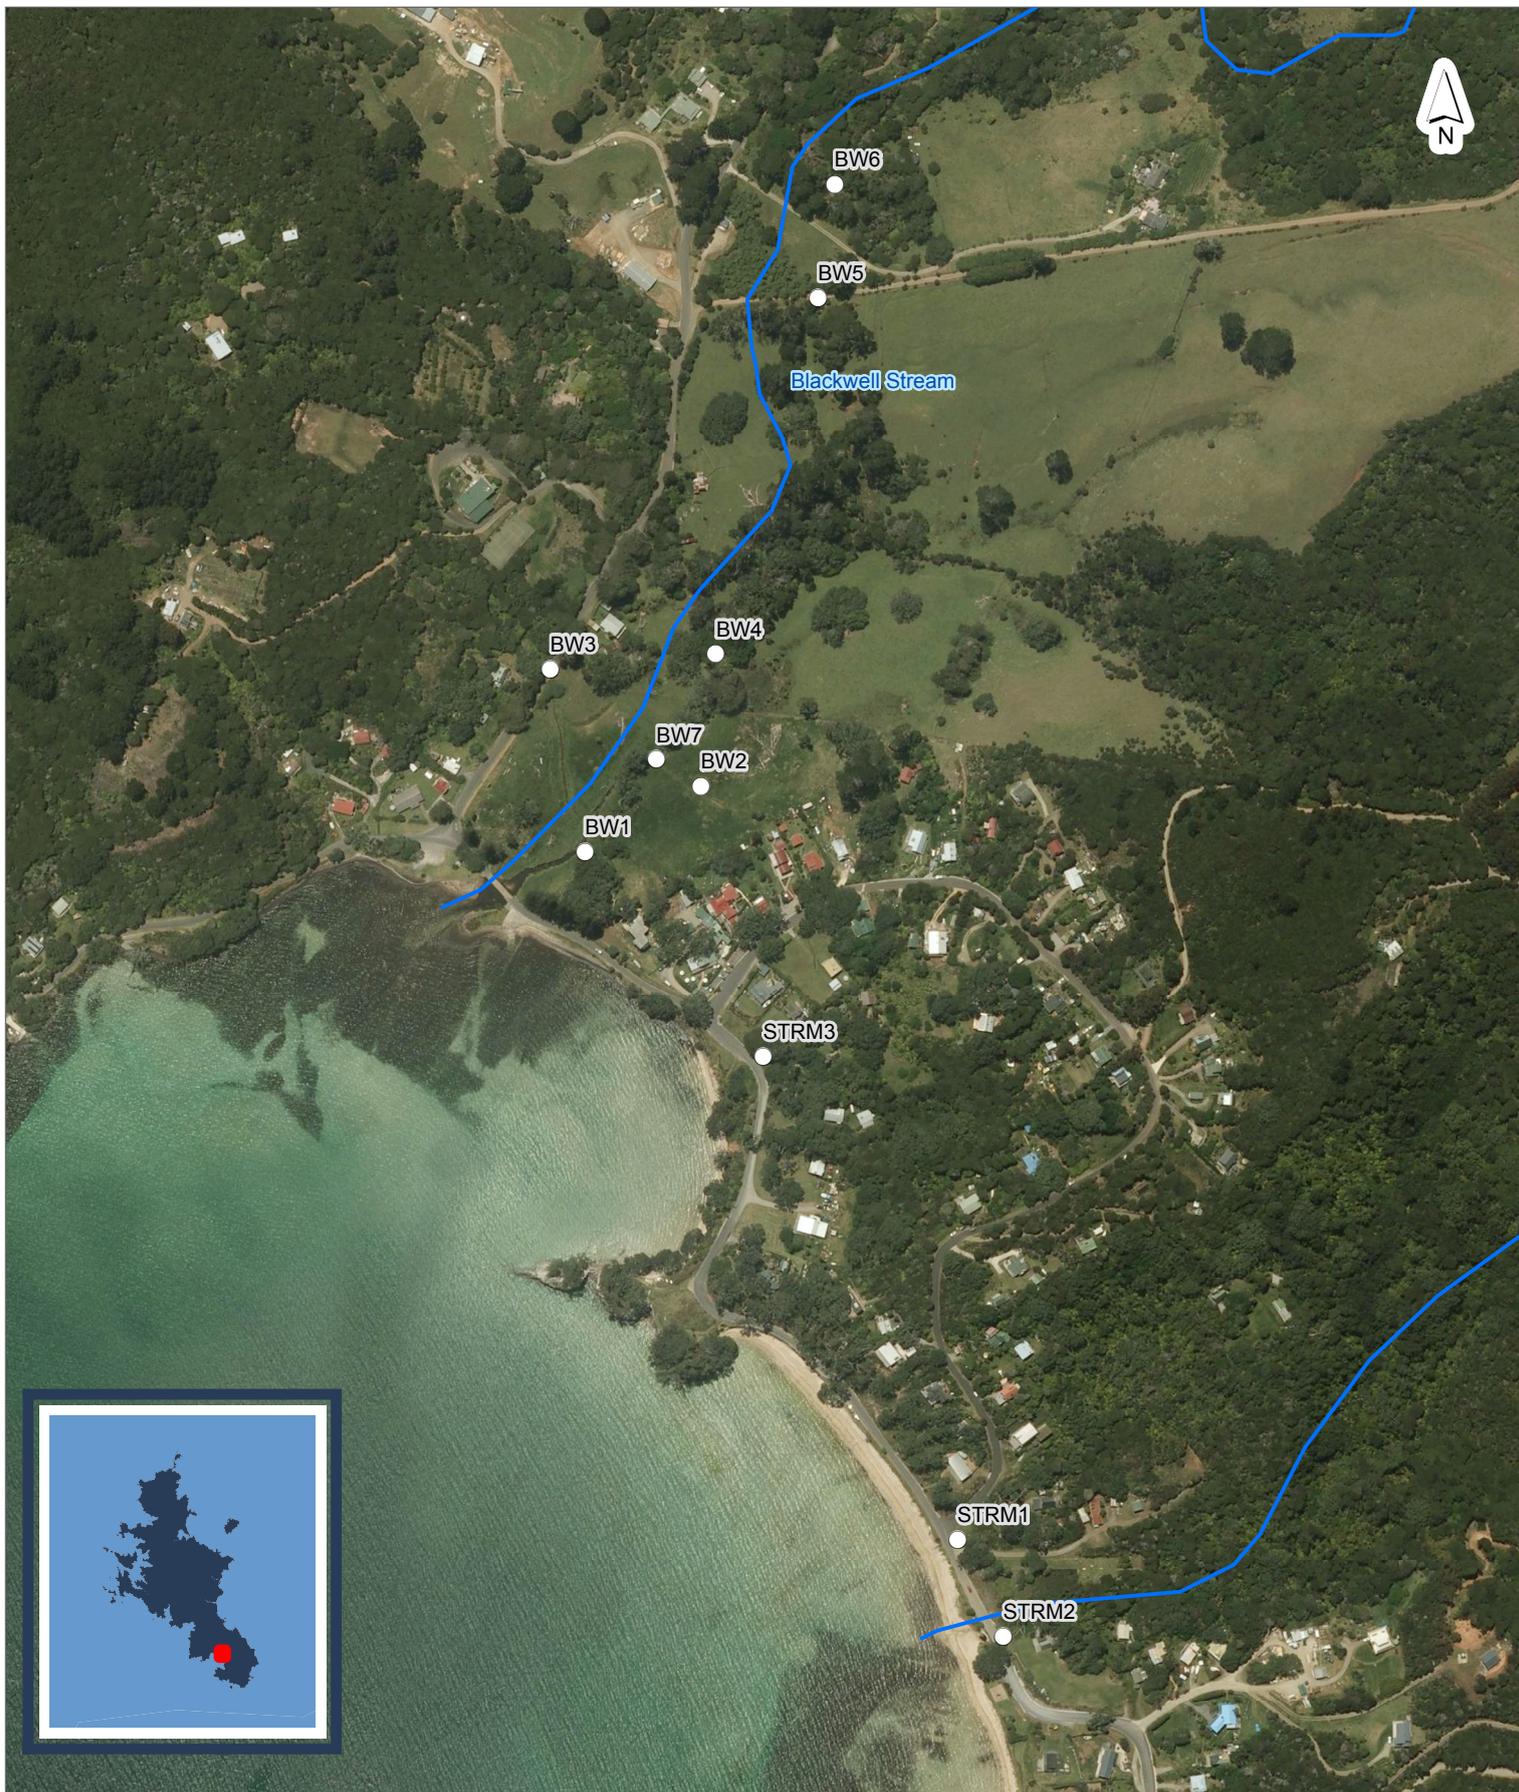
APPENDIX A2: Blackwell Stream Site Location Map

Sample Locations Blackwell Stream & Stormwater outlet pipes Great Barrier Island

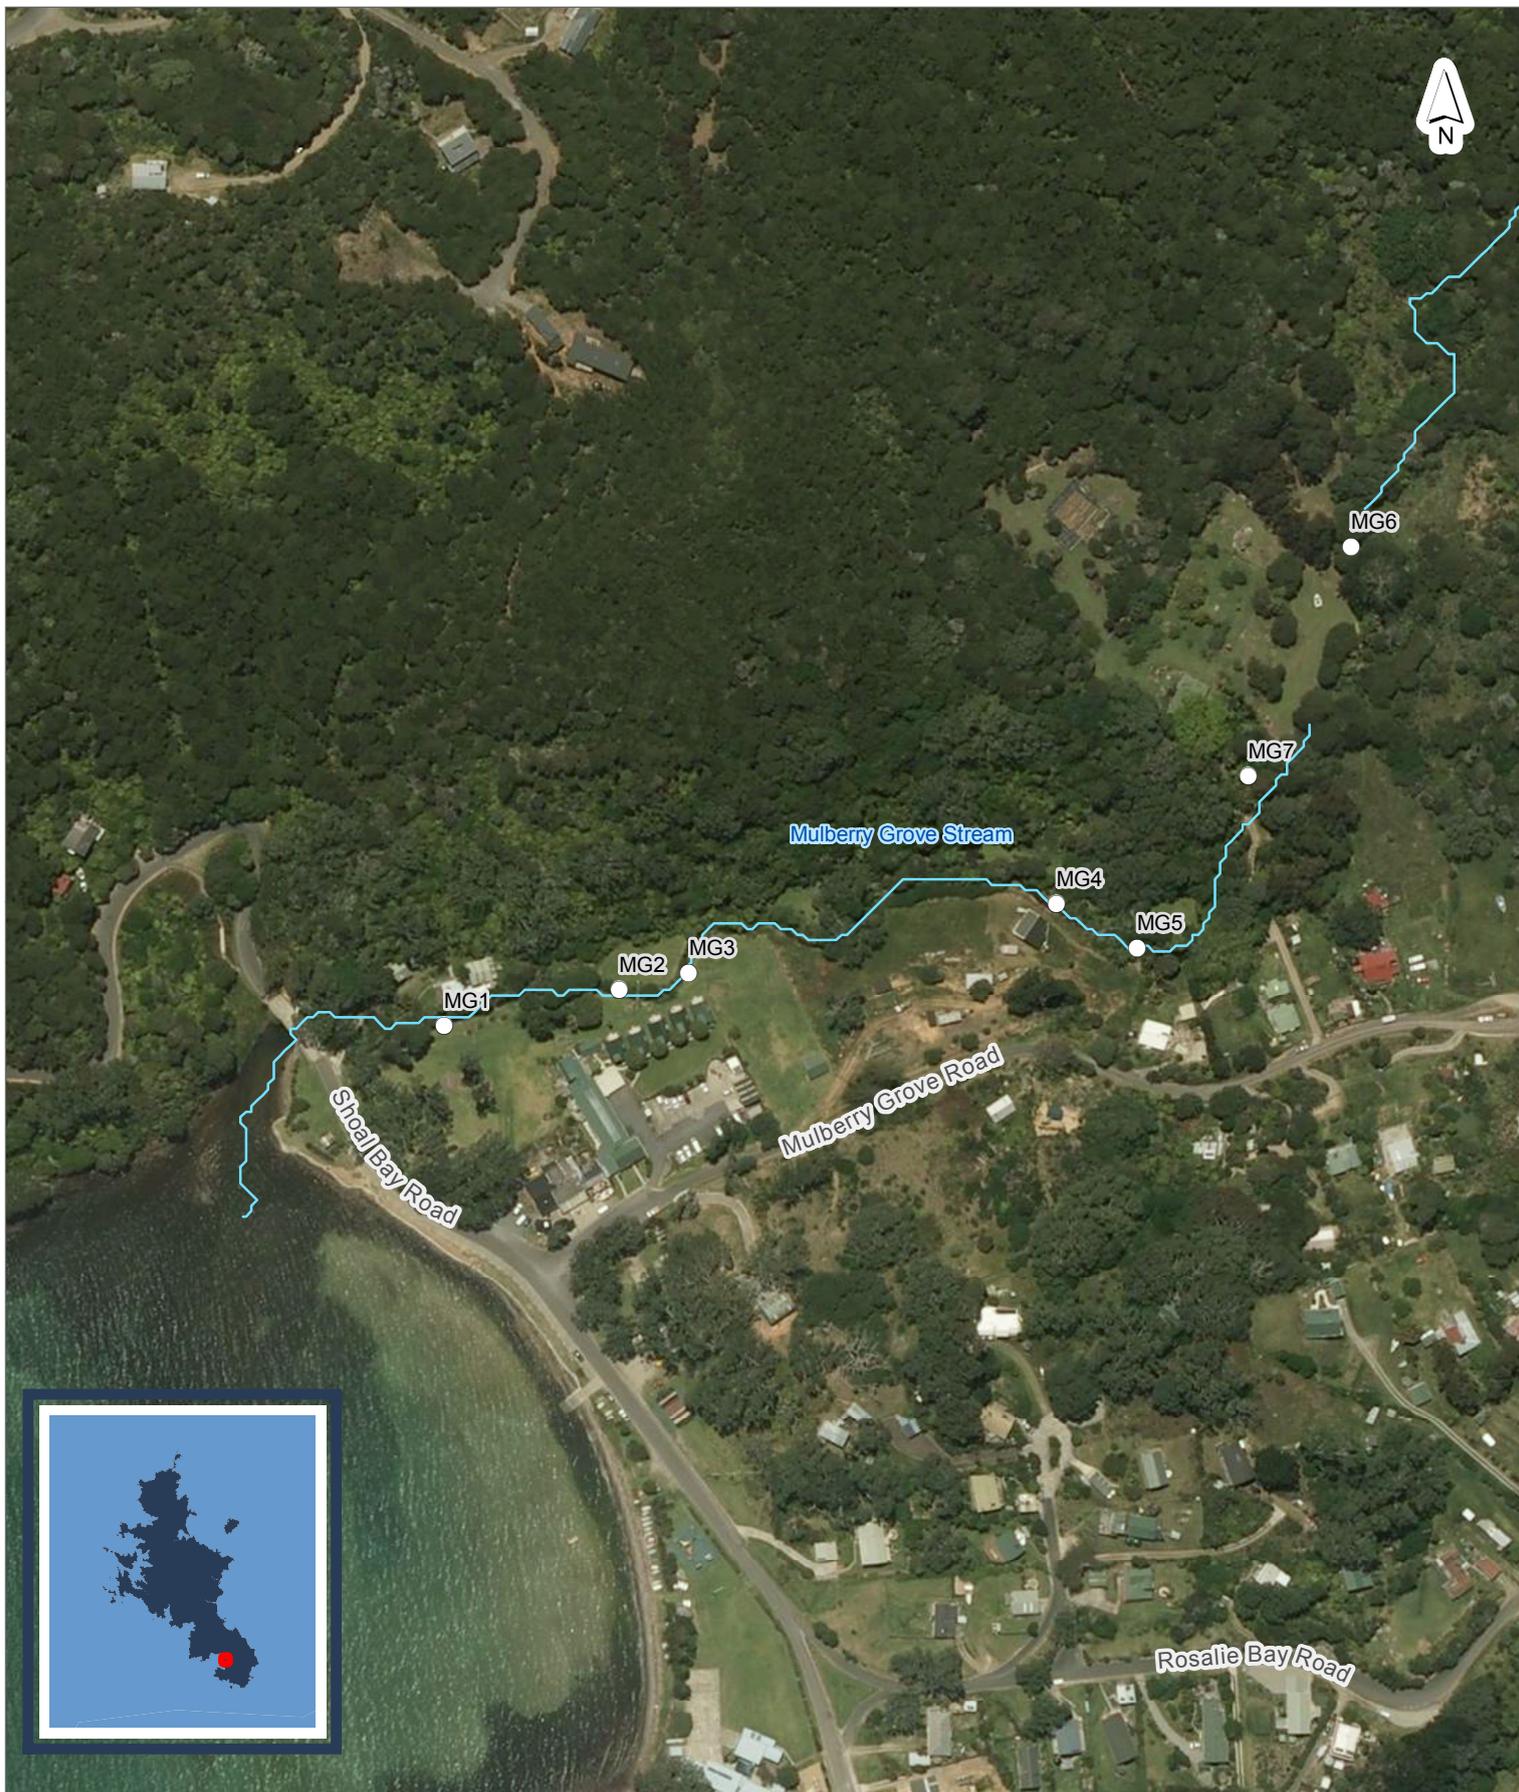
APPENDIX A3: Mulberry Grove Stream Site Location Map

Sample Locations Mulberry Grove Stream Great Barrier Island

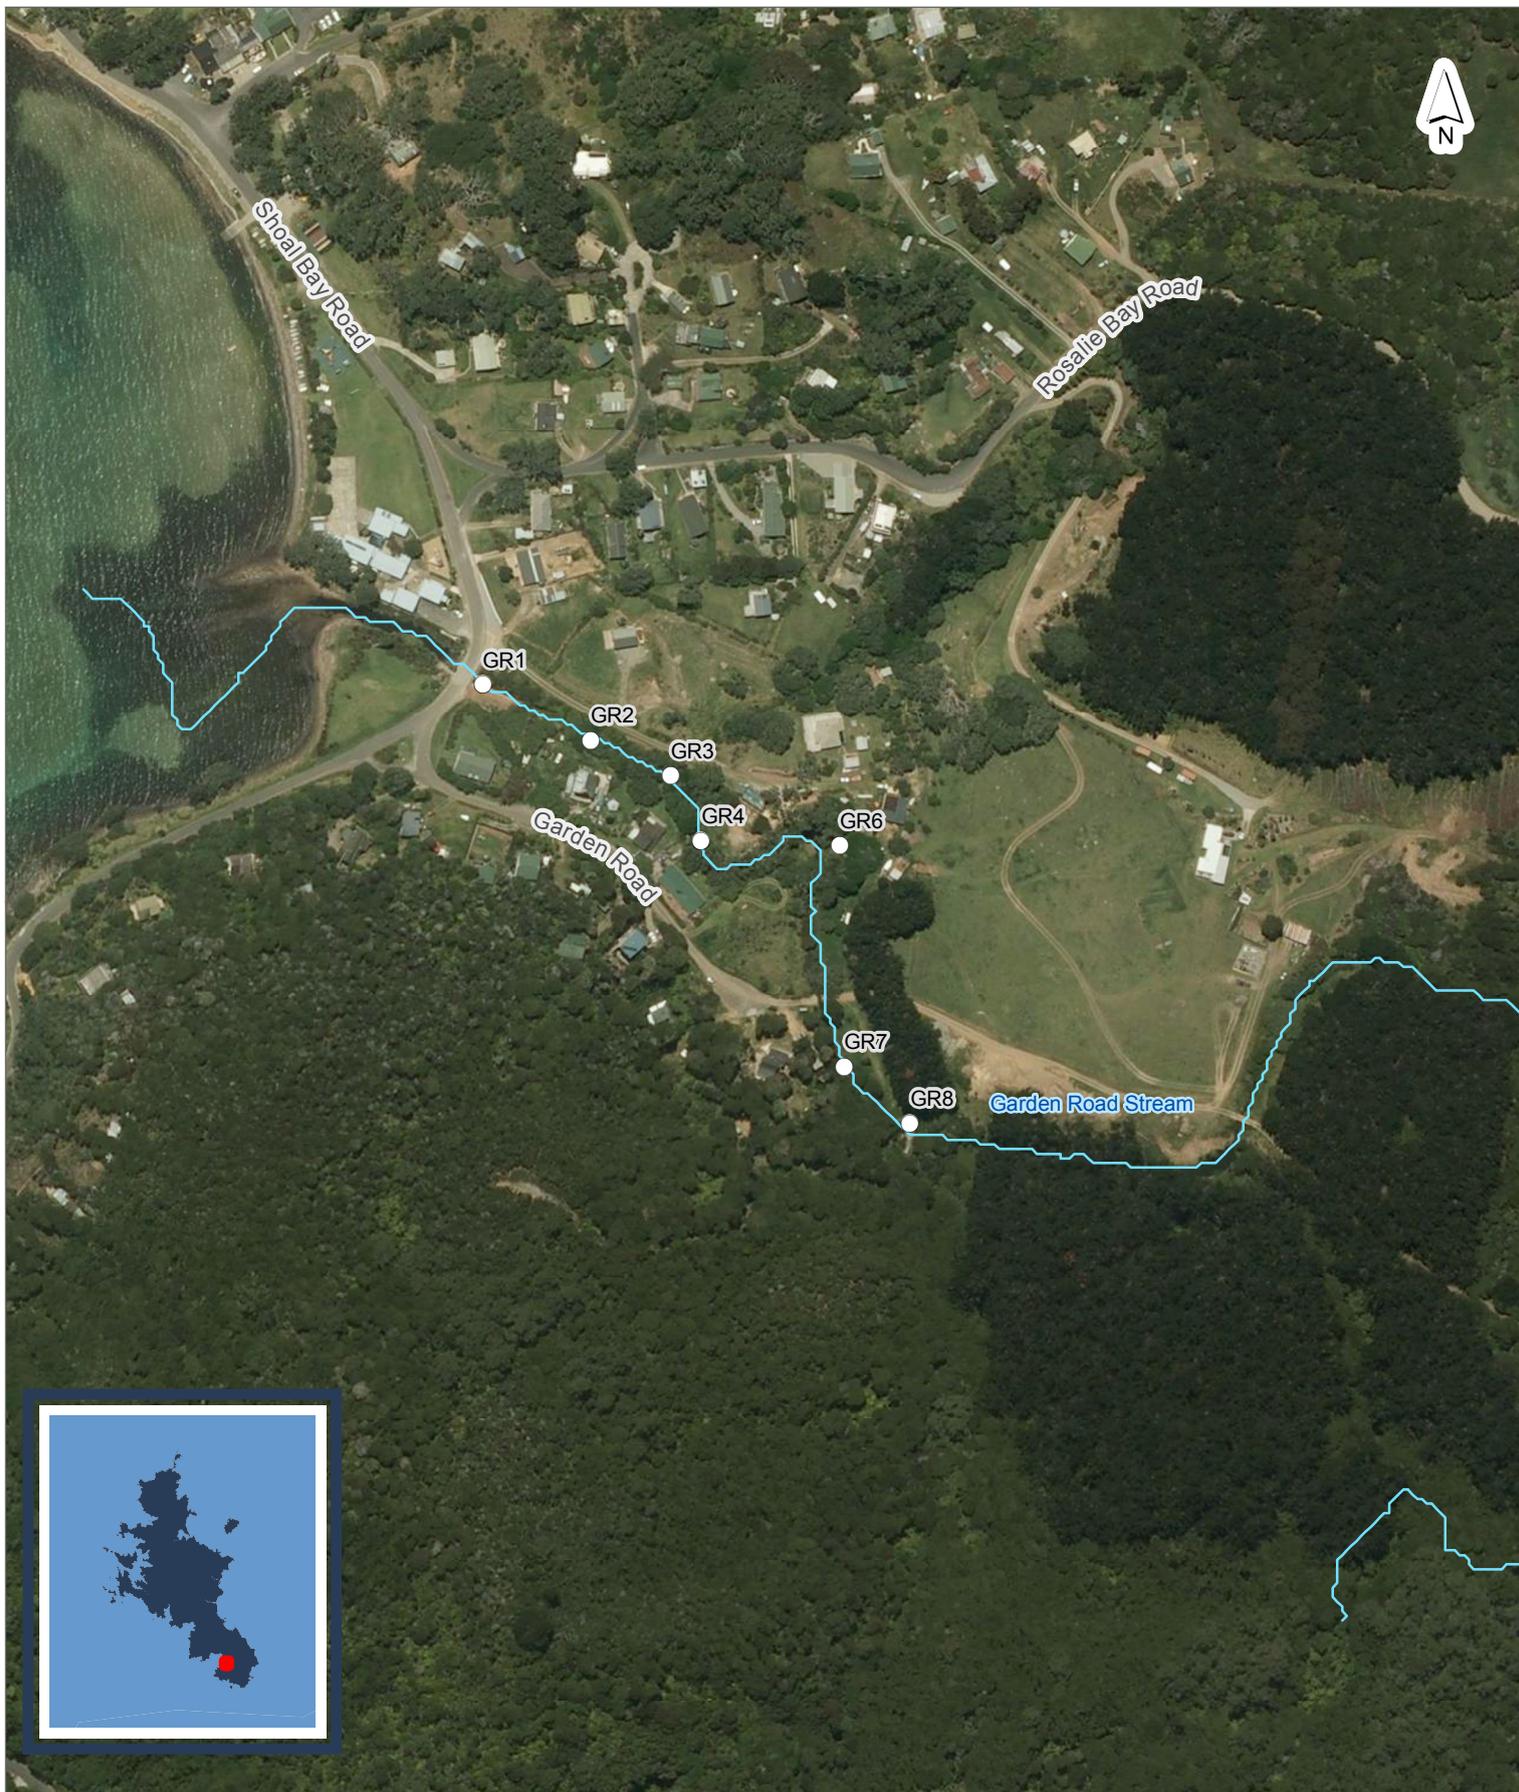
APPENDIX A4: Garden Road Stream Site Location Map

Sample Locations Garden Road Stream Great Barrier Island
