GREENSCENZ

Arboricultural Assessment

Tamaki Paths Project

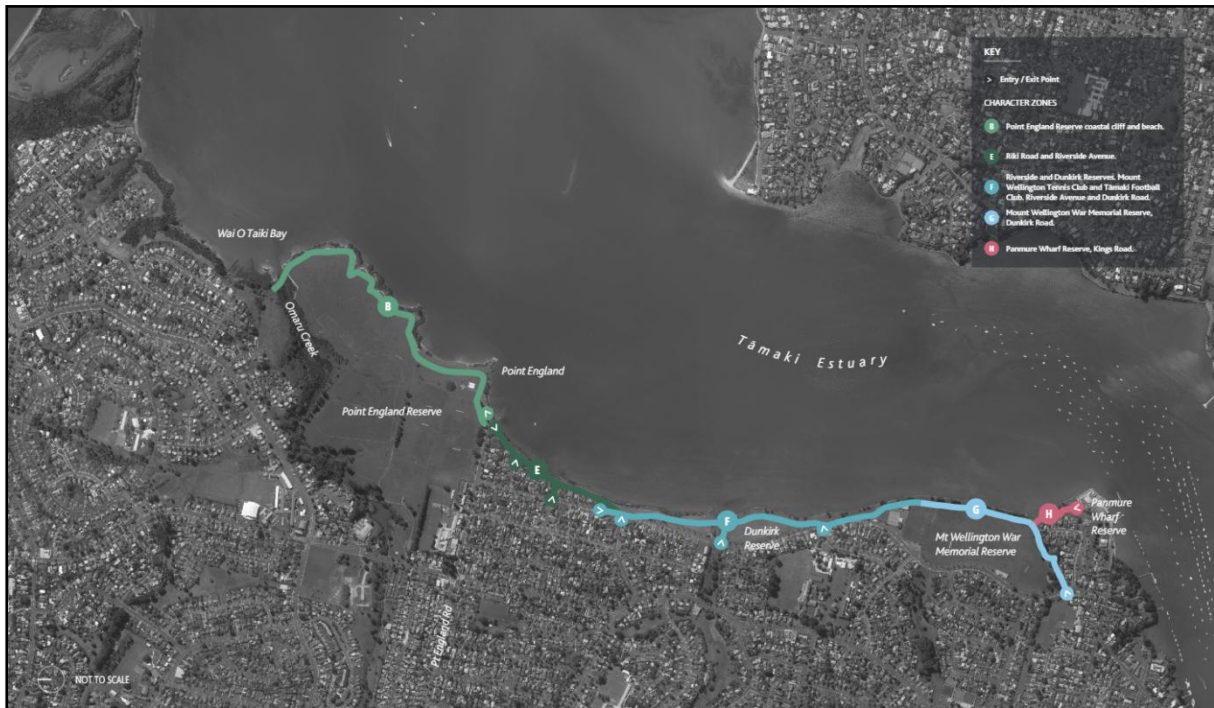
Figure 1 - Shows an aerial view of the subject site and the location of the proposed works area.

- 2.1 The subject site is located between Panmure Wharf, Point England and Wai O Taiki Bay. Figure 1 provides an aerial view of the site and the location of the proposed works area. Once complete, the Tāmaki Path will make a significant contribution to the Maungakiekie Tāmaki Greenways (Local Path) network which includes connections to the local centres at Glen Innes and Panmure with links to public transport, schools and parks.

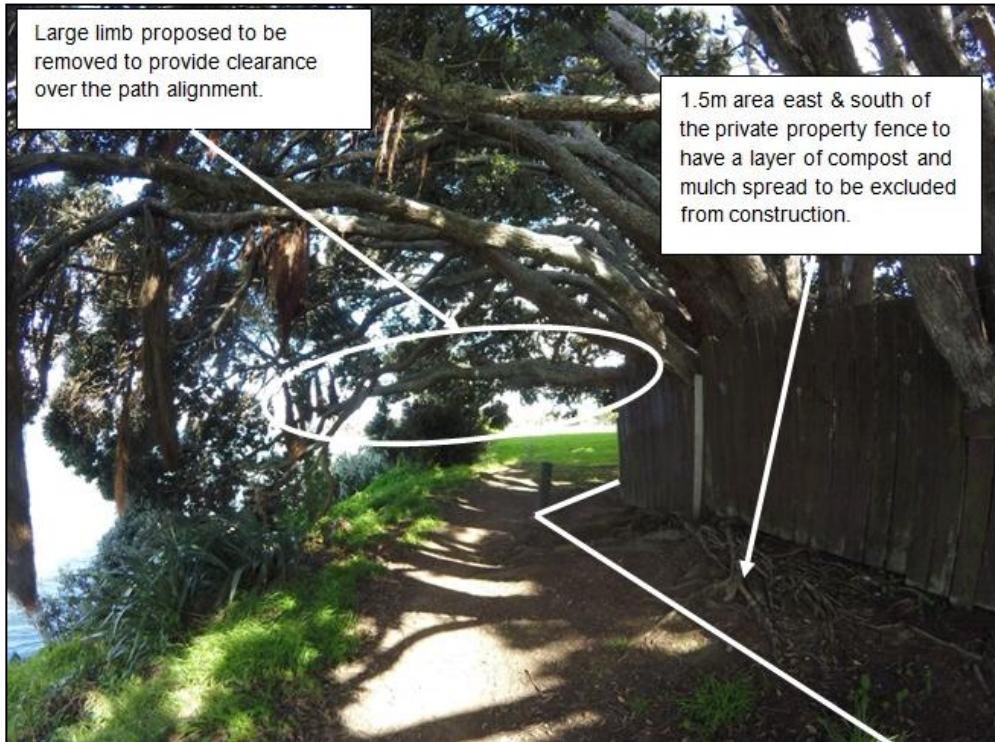
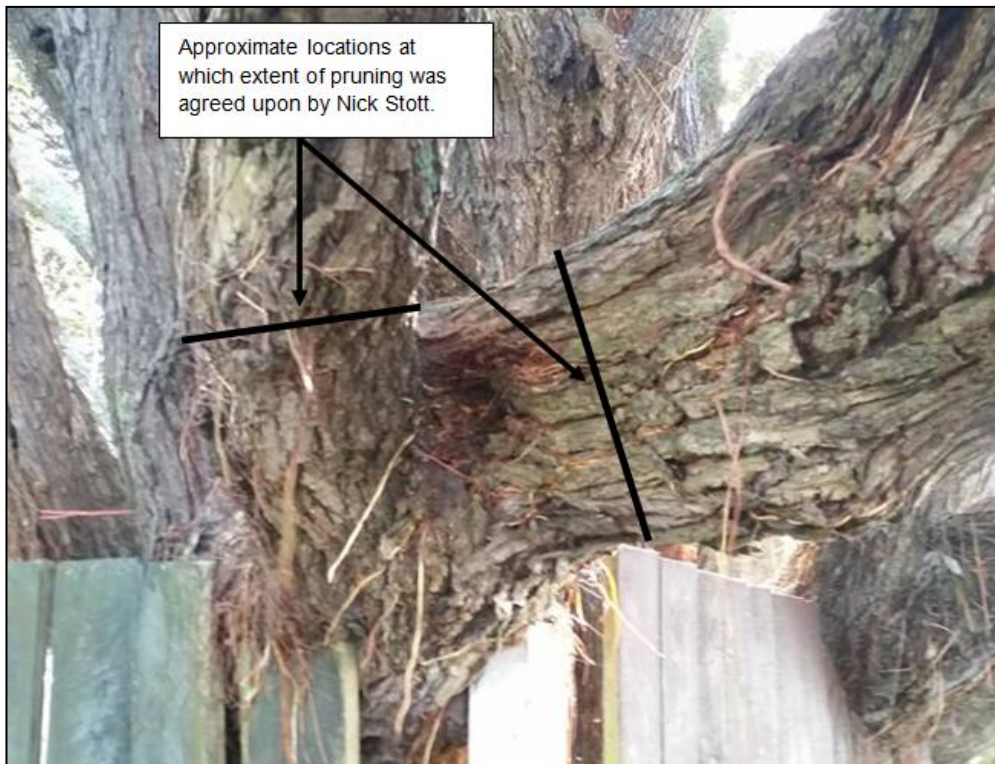
APPENDIX E - NOTABLE POHUTUKAWA

- 5.7 Of significance is the notable pohutukawa growing at No.194 Riverside Avenue (Appendix B, Tree 5). The tree is a large old specimen that was distinct on the 1940 aerial photos and is typical of coastal pohutukawa. The tree has a number of issues associated with high end weight failure, fibre buckling and historic mechanical damage to lower laterals. In order to provide the necessary overhead clearance the removal of small branches and two large limbs to the point of bifurcation will be required. The location at which the limbs (250 & 150mm diameter) would require pruning is displayed in Appendix E. The adjacent branch has a high reliance on the private fence as a weight support. Long term the exposure of the other branches could evidentially lead to the limb failing near the base.

- 5.8 It is anticipated the tree will continue dropping limbs (due to the high end weight) and layering (producing roots) off the stem into the ground on the downhill coastal side.

- All works associated with the protected root zone of the notable tree shall be undertaken by way of hand including the excavations of foundations.
 - The boardwalk width is to be reduced to 2.5m with 2-3m long spans.

- The boardwalk is to start at least 6 m from the trees trunk in a north and south direction
 - A 1.5m zone around the large exposed roots east and south of the private property fence is to be covered with compost and mulch and excluded from construction.

- The extent and location of the final point of severance for all pruning works is to be agreed at the pre construction meeting in conjunction with Mr Nick Stott.
