**TAMAKI PATH PROJECT,  
AUCKLAND:**

**ARCHAEOLOGICAL SURVEY AND  
ASSESSMENT**

*July 2017*

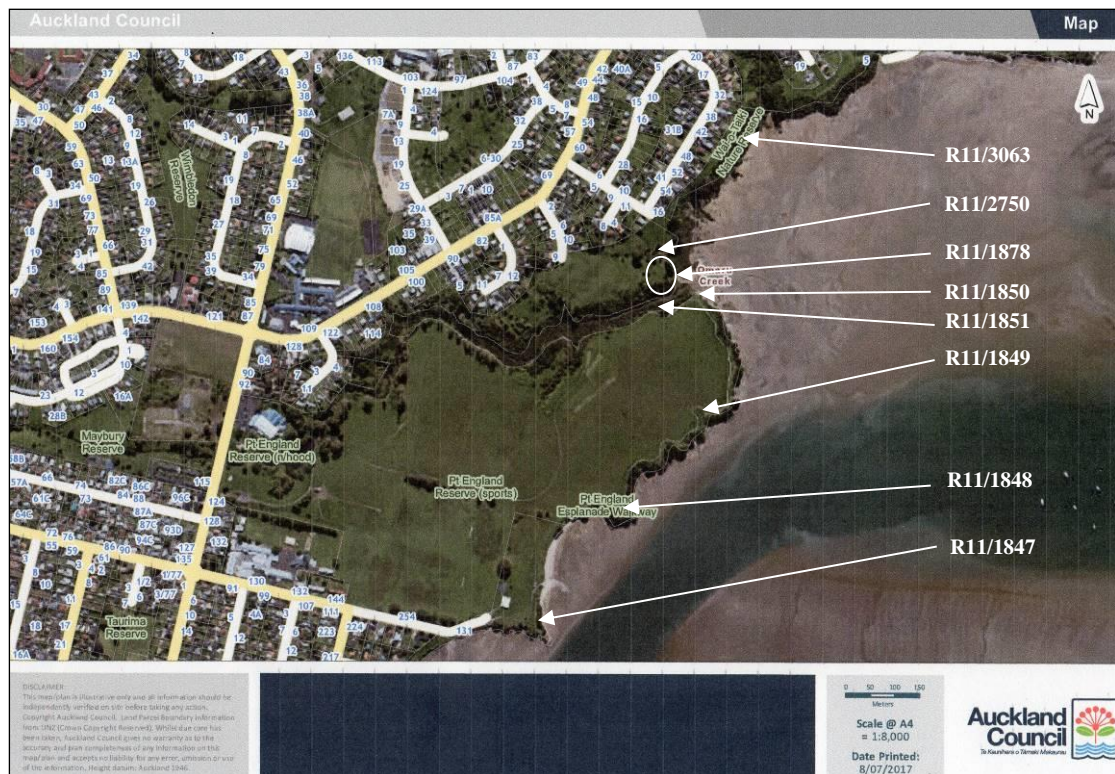
One archaeological site is located within this section – R11/3063 (Figure 3 and Table 1). The site consists of shell midden and terracing but will not be affected.

**Figure 3: Aerial of northern section showing approximate location of recorded archaeology (Auckland Council).**

Background research identified seven previously recorded archaeological sites within the section (Figure 3 and Table 1). The sites contain shell midden while one is described as a settlement site with midden and terraces recorded.

In 1996 Foster recorded a small patch of midden at the base of the cliff on the southern entrance to the Omaru Creek (Figure 3). Contained in slumped topsoil the site should be considered a secondary deposition and as it was not relocated during the current inspection it appears to have been washed away.

Remains of this site (a thin lens of shell) can be seen eroding out for 1m of the south bank of Omaru Creek on the inland side of existing bridge (Figure 3).

The current proposal is to divert the path east (Figure 3) thus avoiding the site and the future of the existing path and bridge is unknown. If its decommissioning requires ground disturbance a process of mitigation should be in place prior to their commencement.

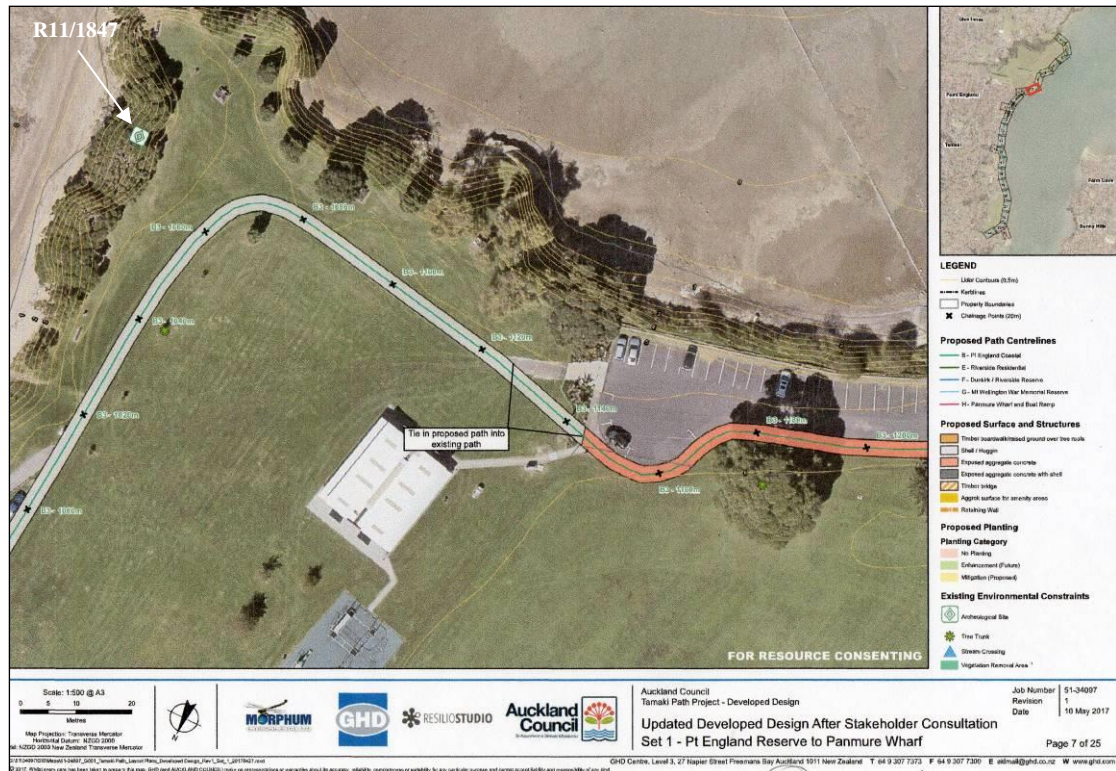
When recorded in 1996 by Foster this site was described as midden eroding from the edge of the foreshore escarpment while the surrounding landscape had been landscaped and post WWII the area was a market garden and unlikely that any associated archaeology would survived (Foster 1996 SRF R11/1847). During the current inspection, it was not possible to locate the eroding midden although minor surface scatters of shell could be seen on the small headland.

It appears highly unlikely that ground disturbance associated with the project will encounter intact archaeology.

Figure 5: Walkway route and location of archaeological site R11/1847 (GHD May 2017).

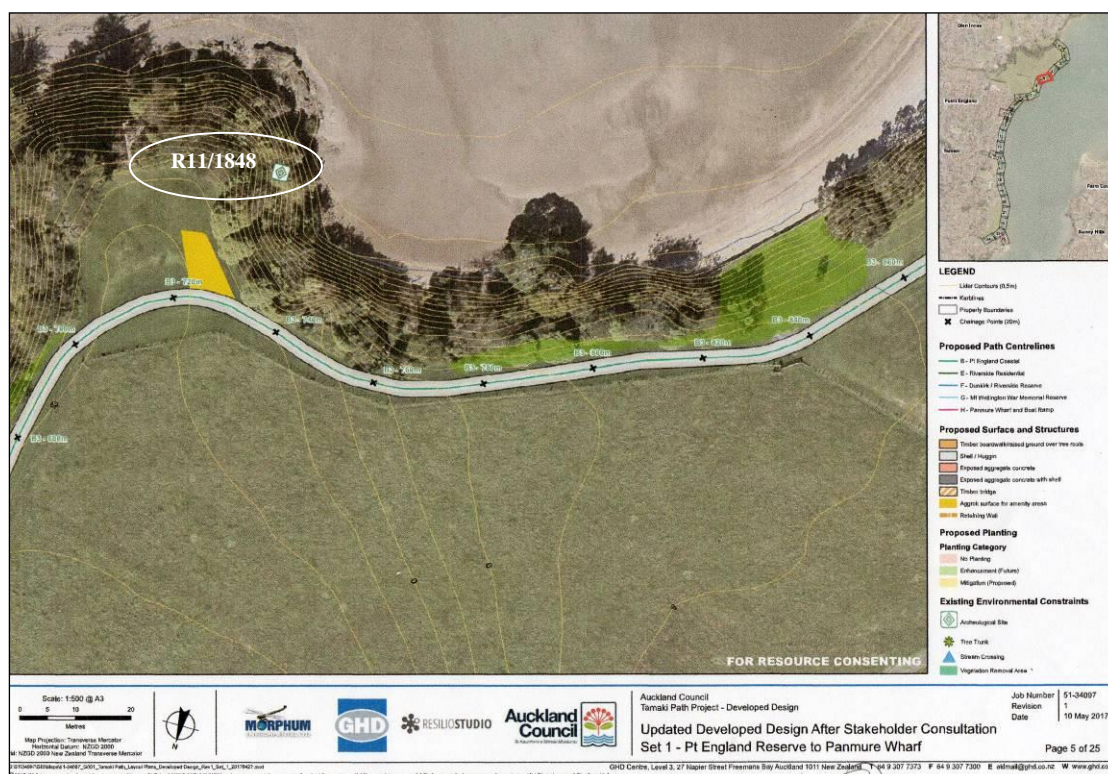
Among tree roots at the edge of the coastal cliffs (Figure 6) can be seen minor scatters of shell but it was not possible to identify any intact midden or related features.

The project route is located c.20m inland and poses no threat to the sites integrity.

**Figure 6: Walkway route and location and approximate extent of archaeological site R11/1848 (GHD May 2017).**
