# Ecological Impact Assessment

## Tamaki Path Stage 2

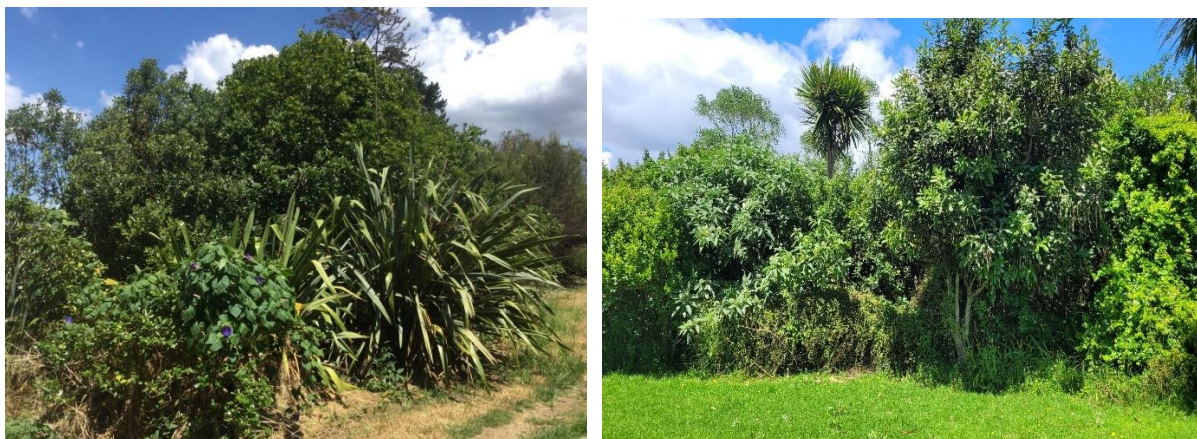
**Photo 2: Weeds such as blue morning glory, bindweed, woolly nightshade, and ginger present among and at the edge of the native vegetation.**

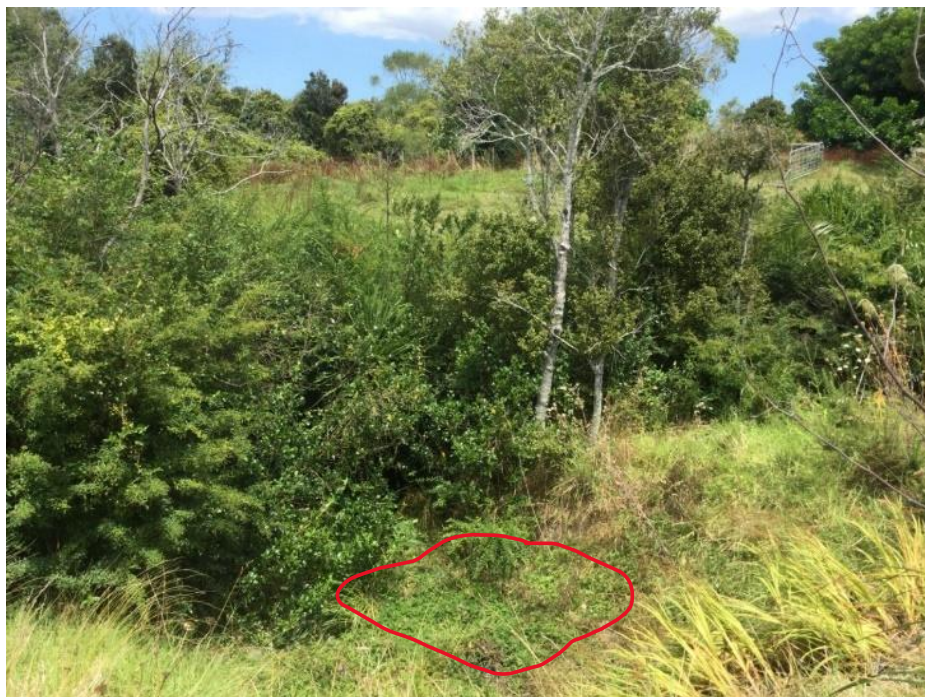
**Photo 4: Vegetation along the intermittent stream. The approximate area of the potential wetland at the lower bank is outlined in red.**

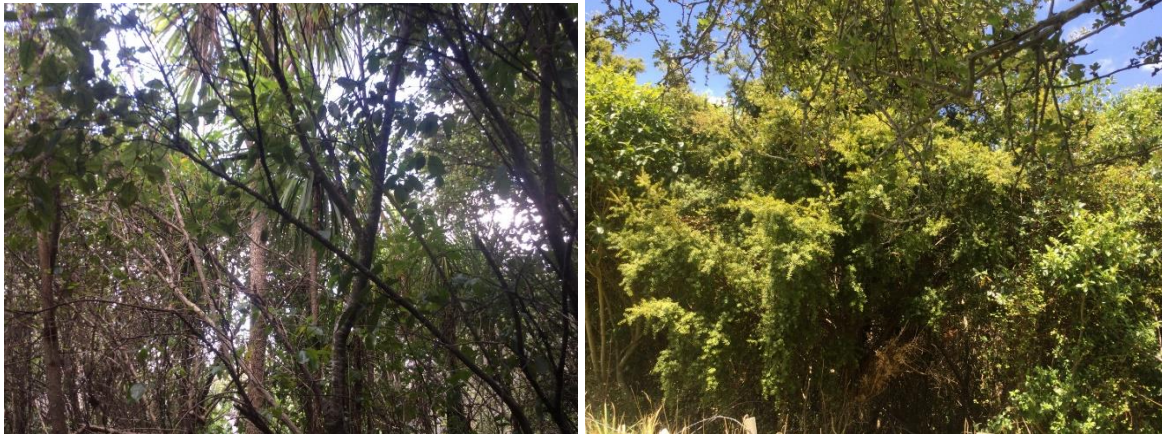
**Photo 10: Common vegetation feature within section TP2 (left) and the totara tree at ~ch450 (right)**

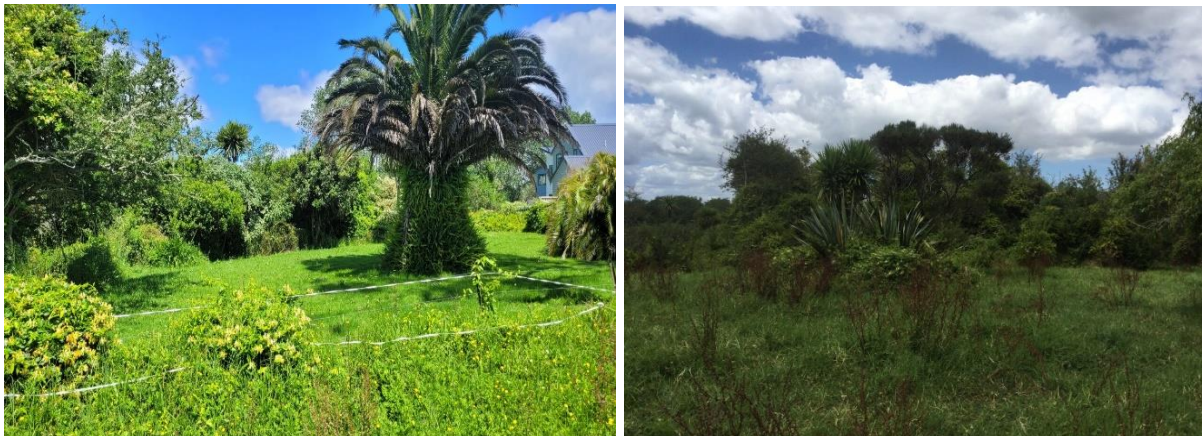
**Photo 13:** The location at TP3 appointed for the proposed 2-metre concrete pathway.

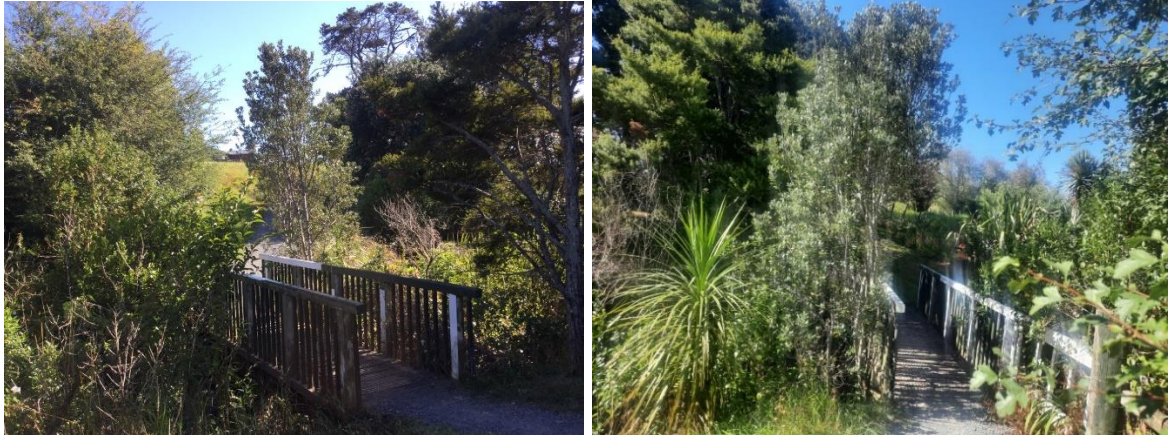
**Photo 14: Photos of vegetation requiring removal either side of the existing bridge.**

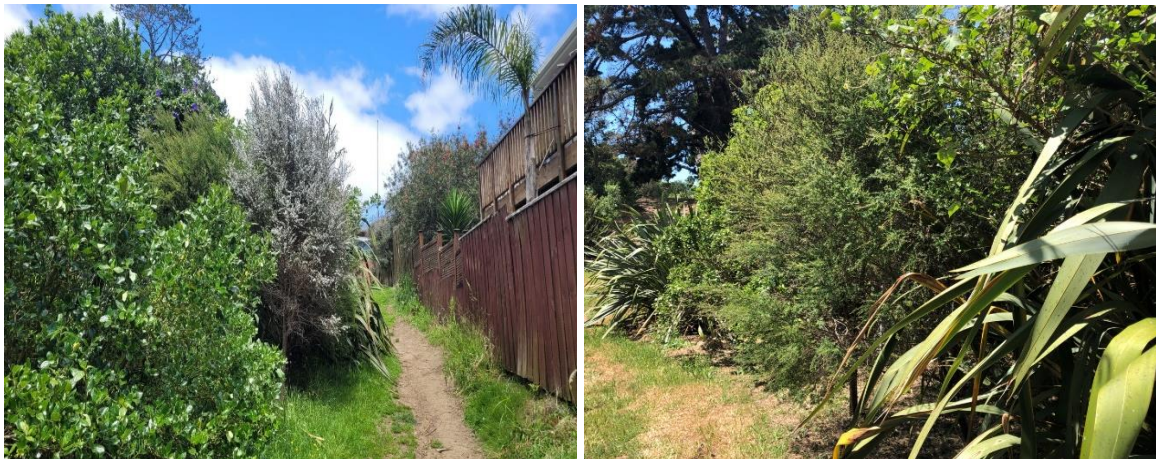
**Photo 16: The vegetation within the initial 100 meters of TP6 needing pruning or removal.**

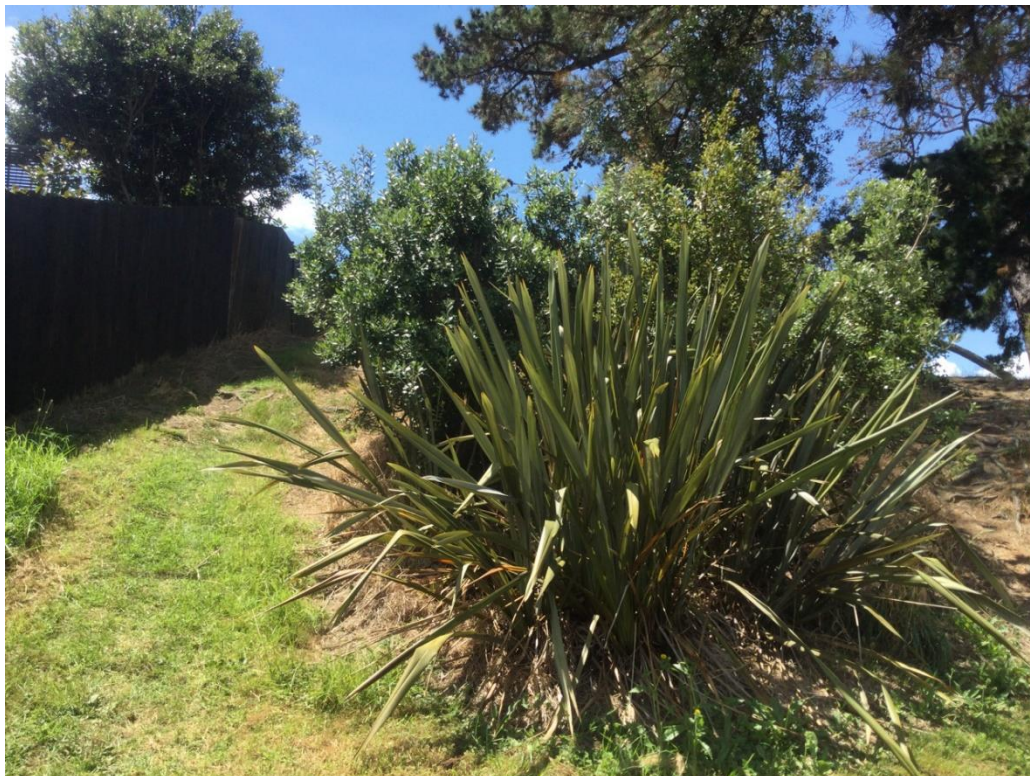
**Photo 17: The small native vegetation patch will be able to be retained if the track is aligned east to where the pines will be removed.**

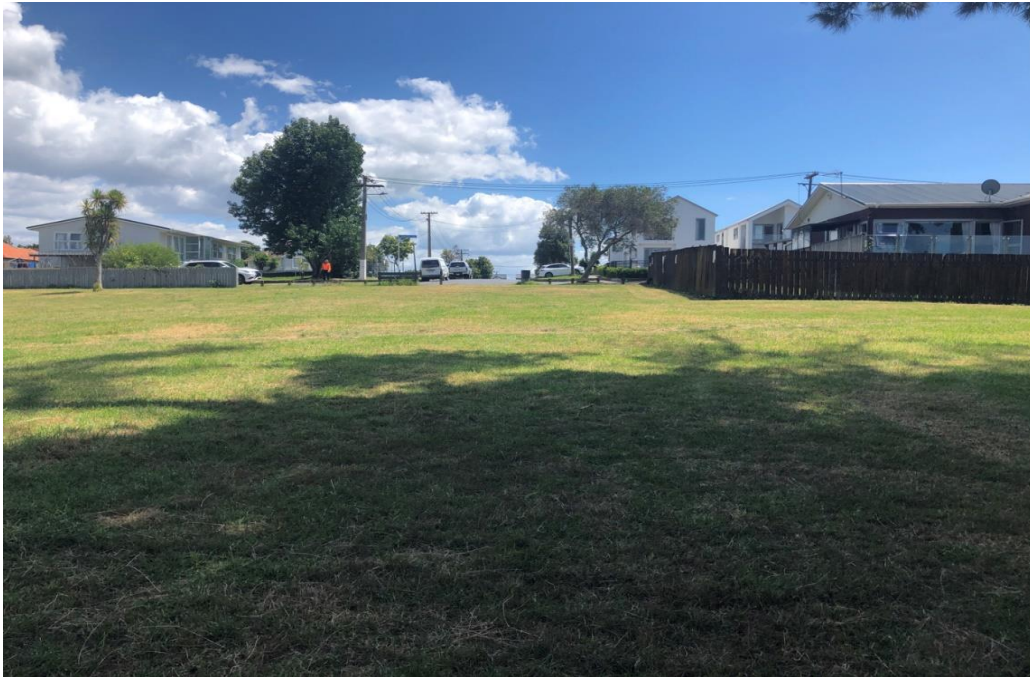
**Photo 18: Overview of the proposed concrete path intersection in mown kikuyu area within section TP5.**

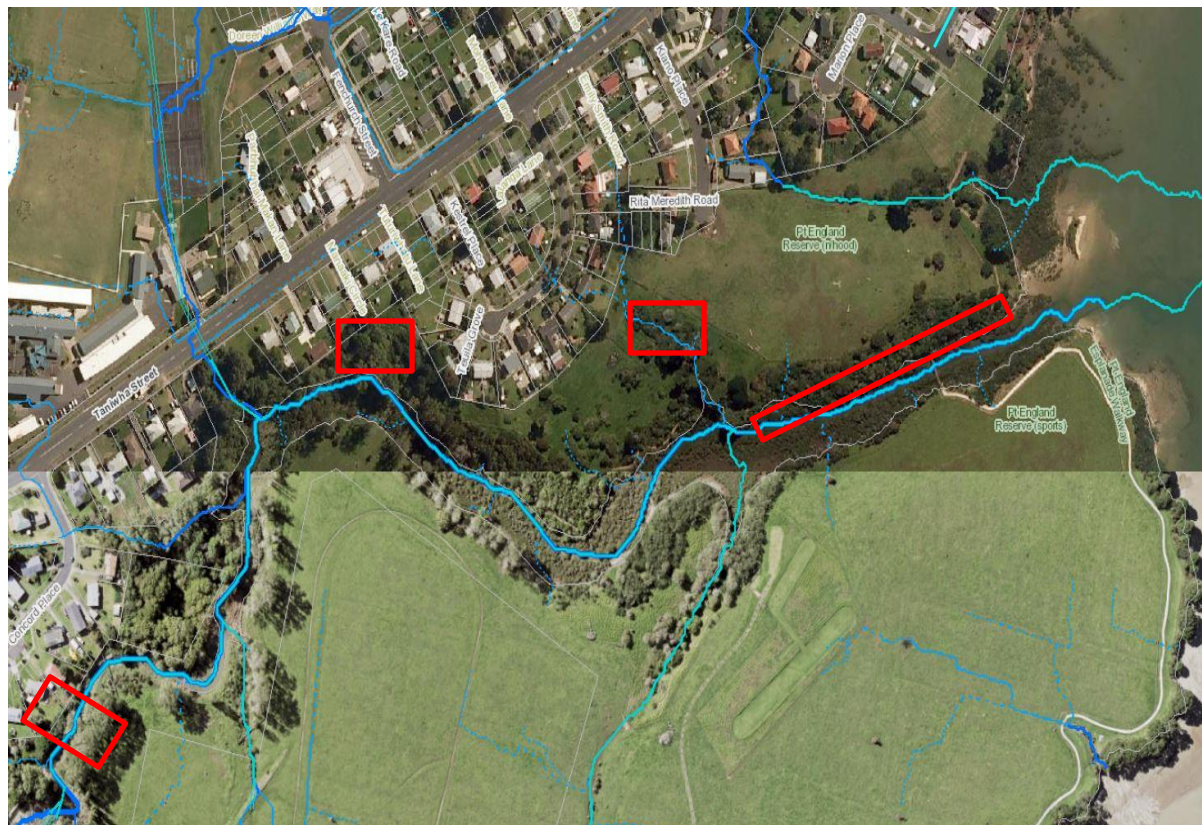
**Figure 4: Weedy areas proposed for clearance are outlined by red rectangles.**
