**TAMAKI PATH STAGE 2 UPGRADE,
AUCKLAND:**

**PRELIMINARY ARCHAEOLOGICAL SURVEY
AND
ASSESSMENT**

Prepared for
Renature & Auckland Council
by
Don Prince

February 2024

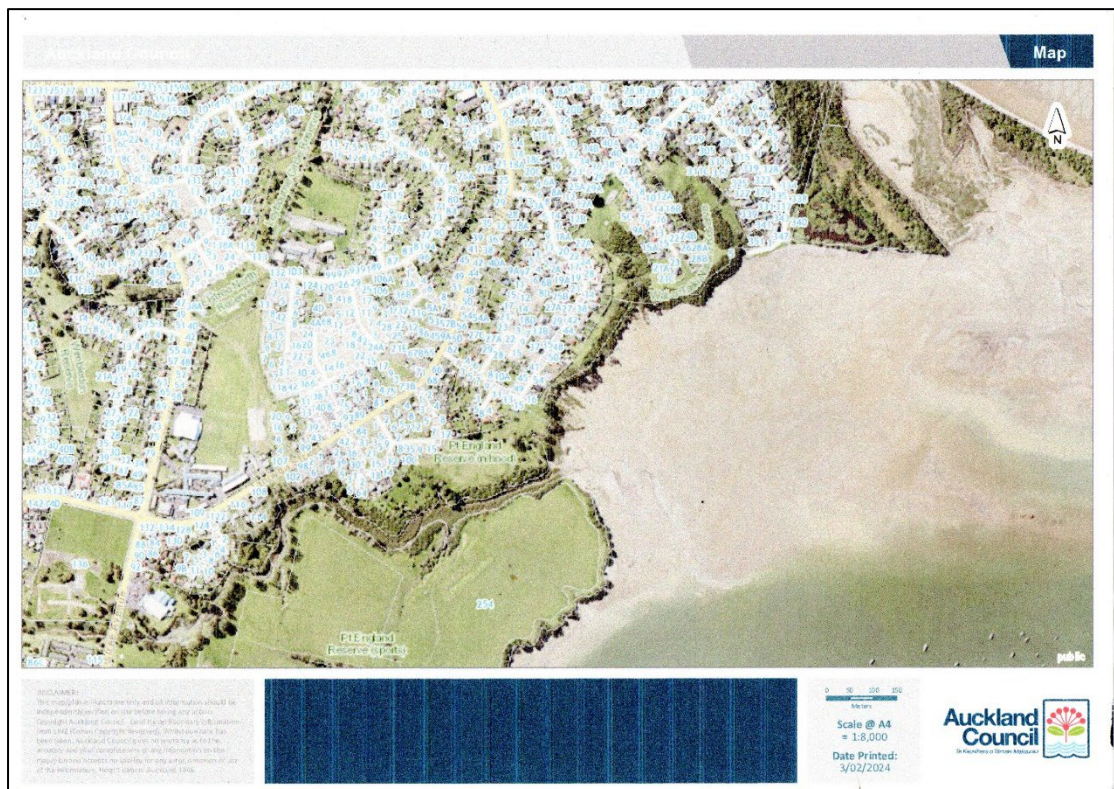
Figure 1: Point England Reserve and surrounds (Auckland Council Maps 2024).

The currently proposed upgrades include some re-alignment of the existing pathway and construction of new boardwalks and bridges from the grassed reserve adjacent to 32 Silverton Rd south to Concord Place (Figure 1). The pathway alignment consists of open grassed reserve north of Omaru Creek and regenerating bush along the south bank of the Omaru Creek (Figure 1).

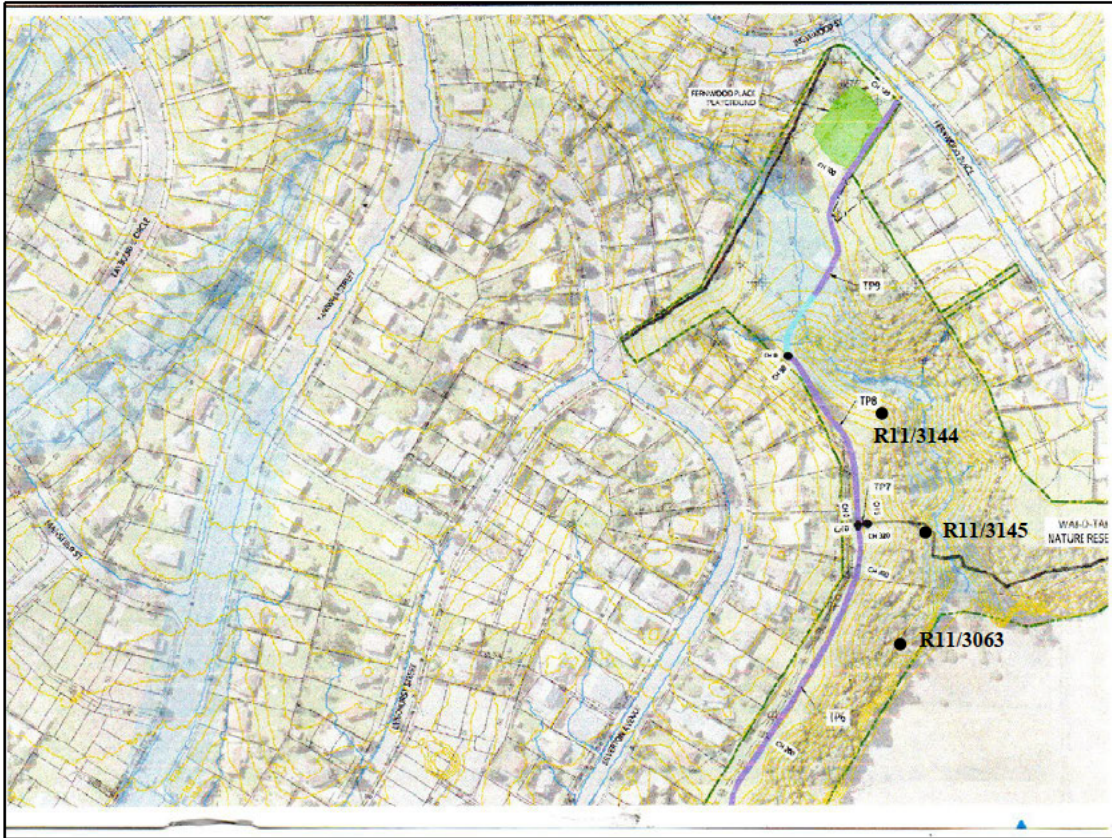
Figure 2: Northern section through open reserve from Fernwood Place (Renature 2024).

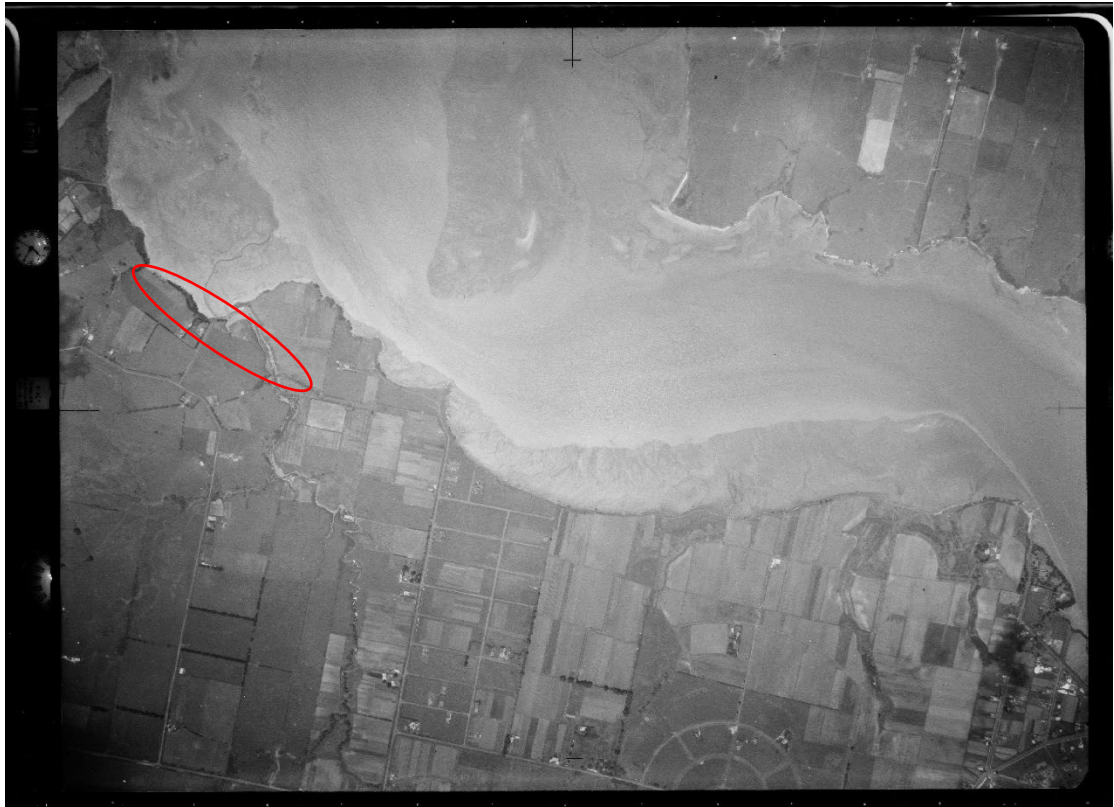
Figure 7: Aerial dated 1939 showing project area circled (Retrolens SN139 Run28 Photo1).

The reserve's topography is comprised largely of southeast slopes terminating in coastal cliffs under regenerating native bush. An examination of 1939 Retrolens NZ aerial (Figure 7) revealed coastal escapement and banks of the Omaru Creek largely in bush appears to be a homestead, out buildings and shelter belts in the vicinity of today's Marion Place. Further examination of archival aerial photographs found that landscape persevered through to at least 1951 (Figure 8) but by 1961 that rural landscape had been transformed by the Glen Innis residential development but, the track alignment, Omaru Creek and Point England Reserve remain largely unchanged (Figure 9).

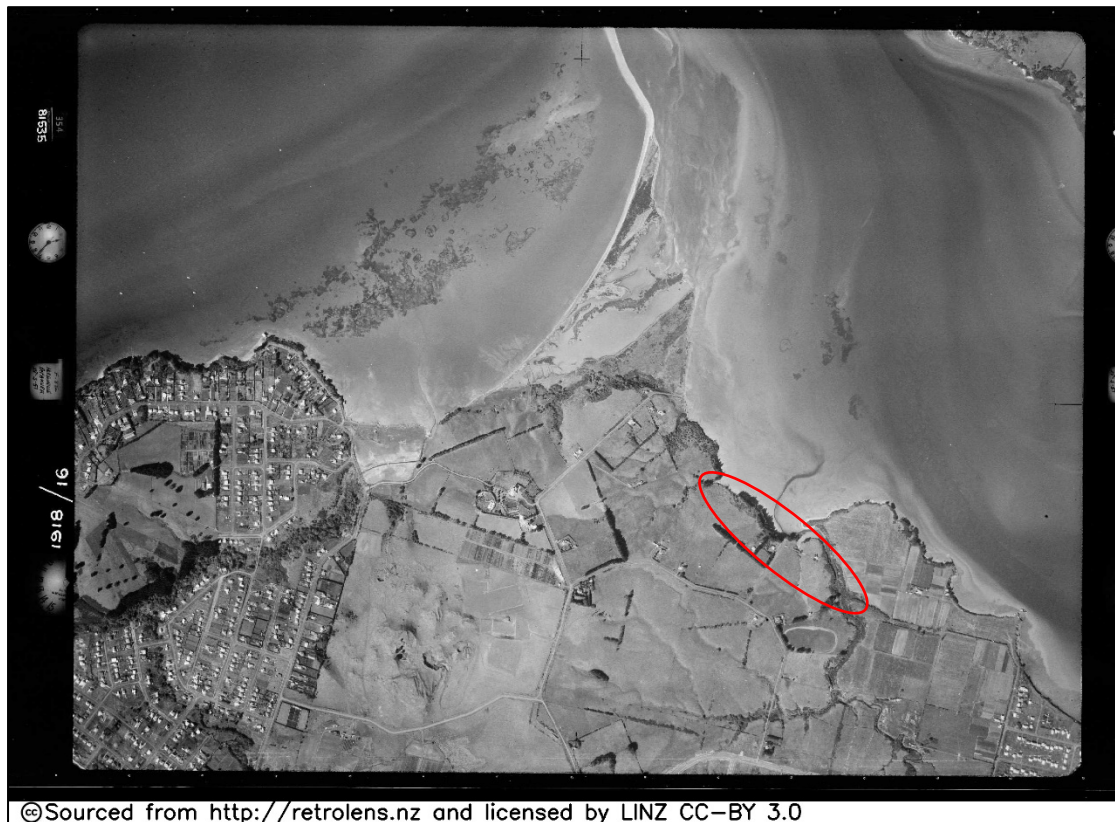
Figure 8: 1951 aerial of the survey area (Retrolens SN583 Run1918 Photo16).

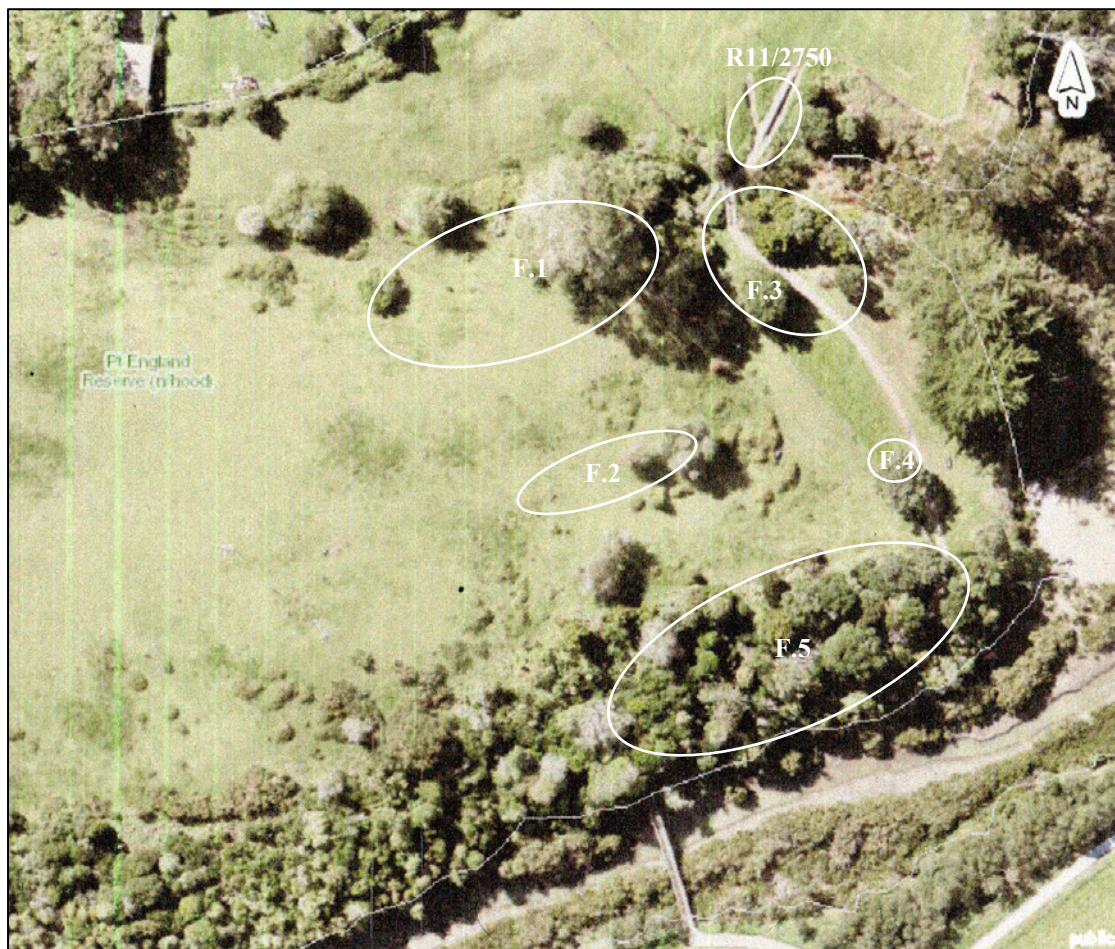
Figure 12: Archaeological features of R11/1878 identified in 2017/2018 (Prince 2018).

When originally recorded in 1996 by Foster the site was described as “a number of exposures of midden over headland and around cliff edges...[with] a terrace present on the northern side of the site, 16m x 4m... location of midden exposures suggests this

whole headland is a settlement site” (Foster 1996 SRF R11/1878). During the 2017 inspection by the author five deposits of shell midden and indistinct terracing were identified around the headland (Figure 12). The proposed bridging of the small watercourse on the northern side of the headland (Figure 4) has the potential to impact on three of the features (F.1, F.2 & F.3 Figure 12) and possibly unidentified subsurface features. On the positive the realignment will avoid future impact on features 4 & 5 and R11/2750 all through which the present track passes.

Therefore, it is recommended that a General Authority is sought and obtained from HNZPT prior to the commencement of works. Conditions of that authority will be that all topsoil removal be monitored by a suitably qualified archaeologist to determine whether archaeological features exist and the affected areas of identified archaeological features are investigated, recorded and sampled.
