362 Jones Road

Ecological Report
Prepared for Scarbro Civil Limited

7 October 2025

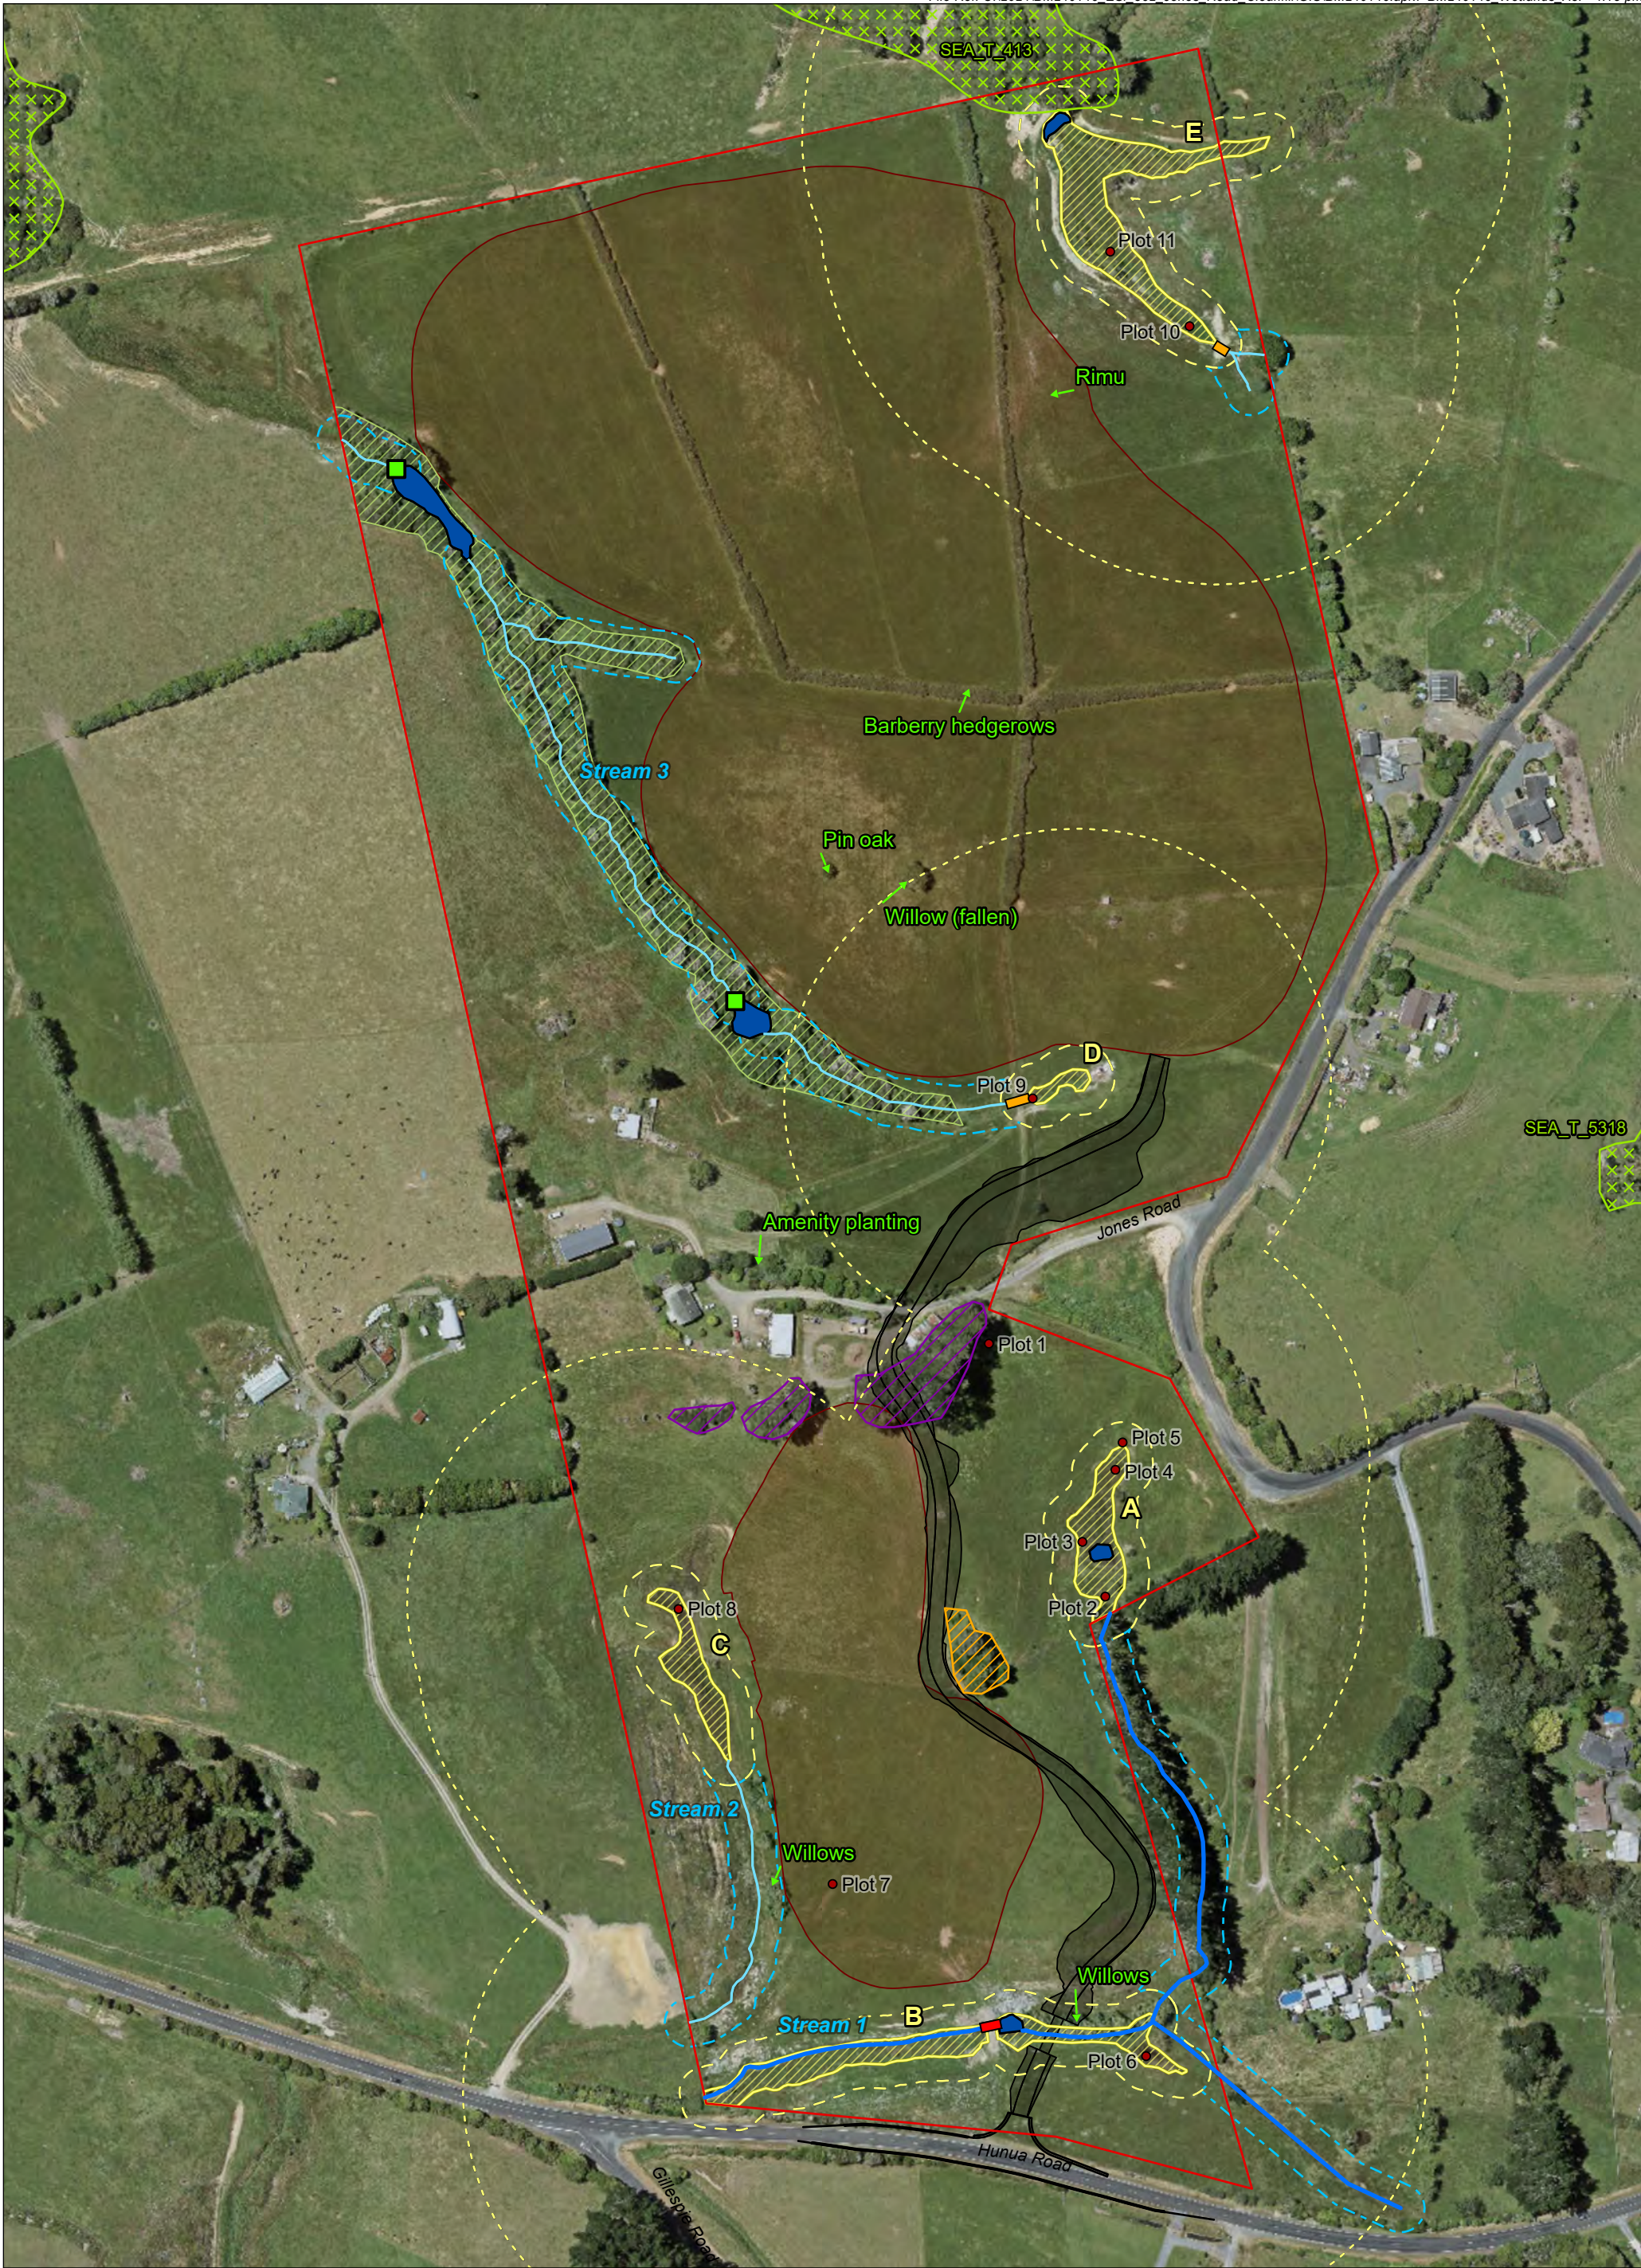
An SEV assessment was undertaken in the Permanent Stream at Stream 1, in the area of the proposed bridge crossing (Figure 1). No sampling was undertaken within the Intermittent Streams 2 and 3.

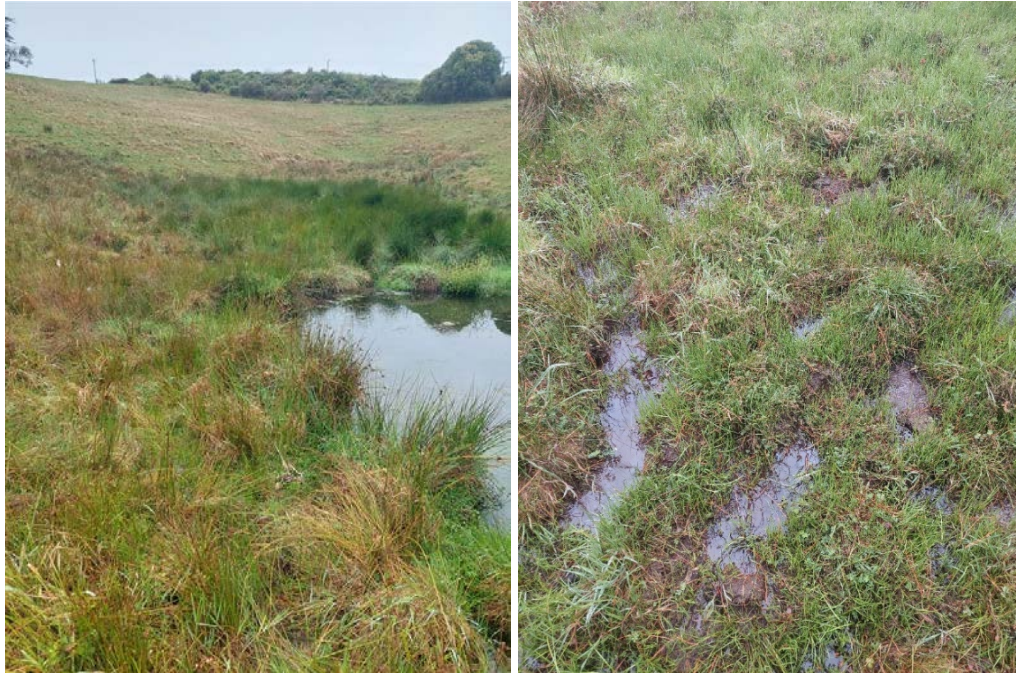
Wetland A (963 m²) is a low-lying, concave area located within the headwaters of an intermittent stream draining to the south of the property (Photo 1).

Photo 1: Wetland A Left: view upstream of feature, Right: Surface water and extensive pugging present.

This feature meets the criteria for a *natural inland wetland*, based on the Rapid test. The dominant vegetation cover within this wetland feature was jointed rush (*Juncus articulatus* - exotic), soft rush (*Juncus effusus* - exotic) and baumea (*Machaerina rubiginosa* - native). Surface water was present and flowing at the toe of the hillslope, forming a shallow pond that discharged to the watercourse. The presence of iron floc in the water indicates that the wetland is groundwater-fed. Extensive cattle damage (pugging) was also evident throughout the feature.

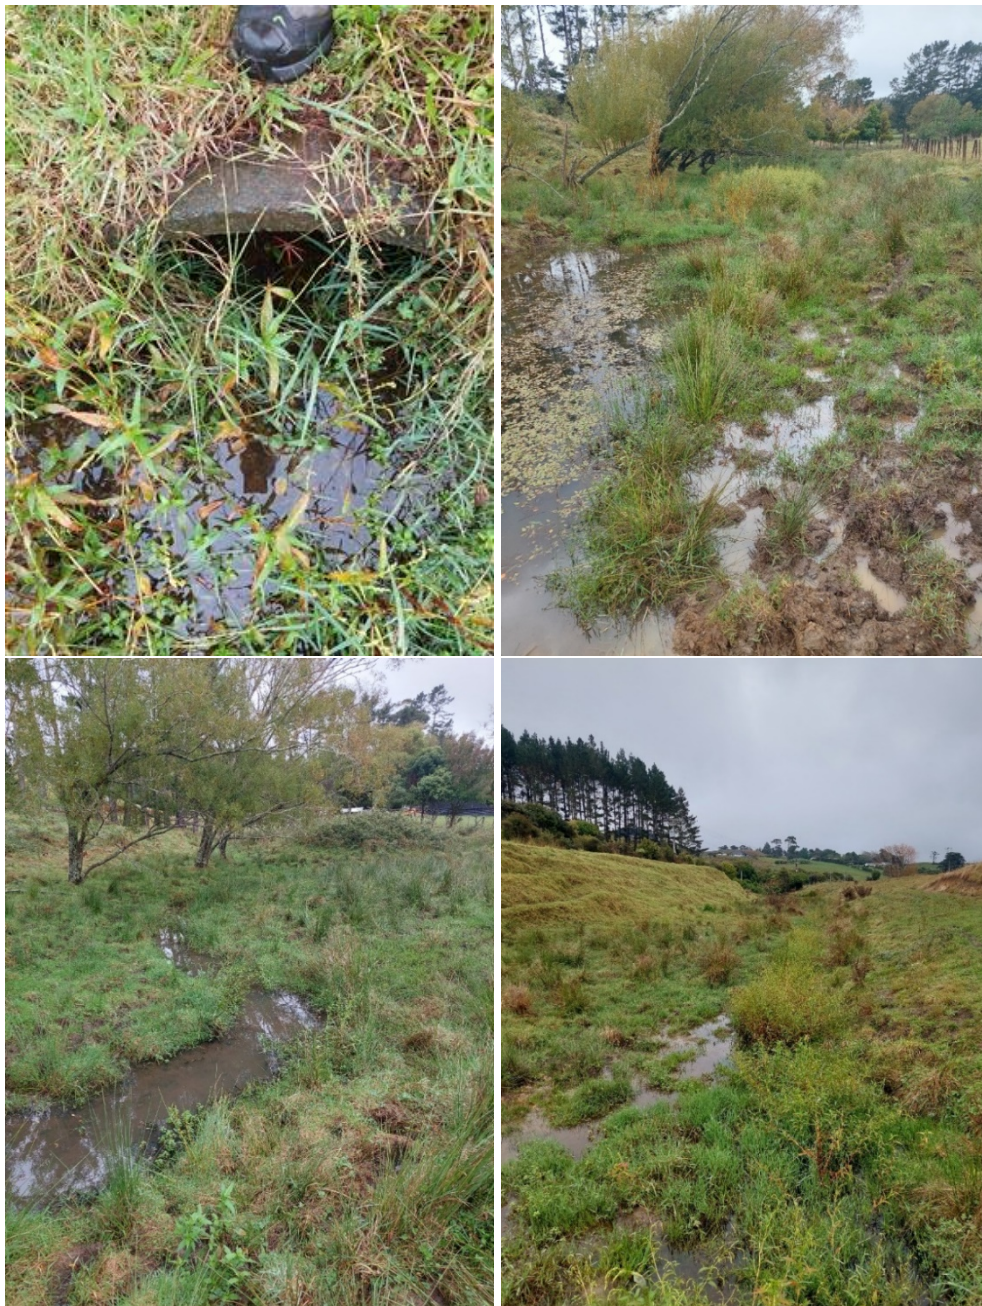
Wetland B (1,458 m²) is located within the low-lying riparian zone of Stream 1 (Photo 2).

Photo 2: Wetland B. Top Left: culvert beneath farm access track. Top Right: Ponding upstream of culvert. Bottom Left: Upstream wetland section. Bottom Right: Downstream Wetland section.

The culvert for the farm crossing in the lower stream reaches appears partially buried so that the access track acts as a bund, resulting in ponding and widening of the wetland feature immediately upstream. The stream channel is poorly defined, with low-lying floodplains overgrown with hydrophilic vegetation. Downstream of the farm crossing, flows are restricted, resulting in sedimentation and expansion of wetland vegetation dominated by *Isolepis prolifera* (native) and wiwi (*Juncus edgariae* – native) across the entire channel. Wetland B meets the criteria of *natural inland wetland*, passing the Rapid test. Surface water and extensive pugging was observed throughout the feature.

The culvert removal meets the conditions in the NESF restoration and is a Permitted Activity. The culvert removal will result in daylighting and restoration of c. 30 m² of wetland, representing a net gain in wetland habitat for the project.

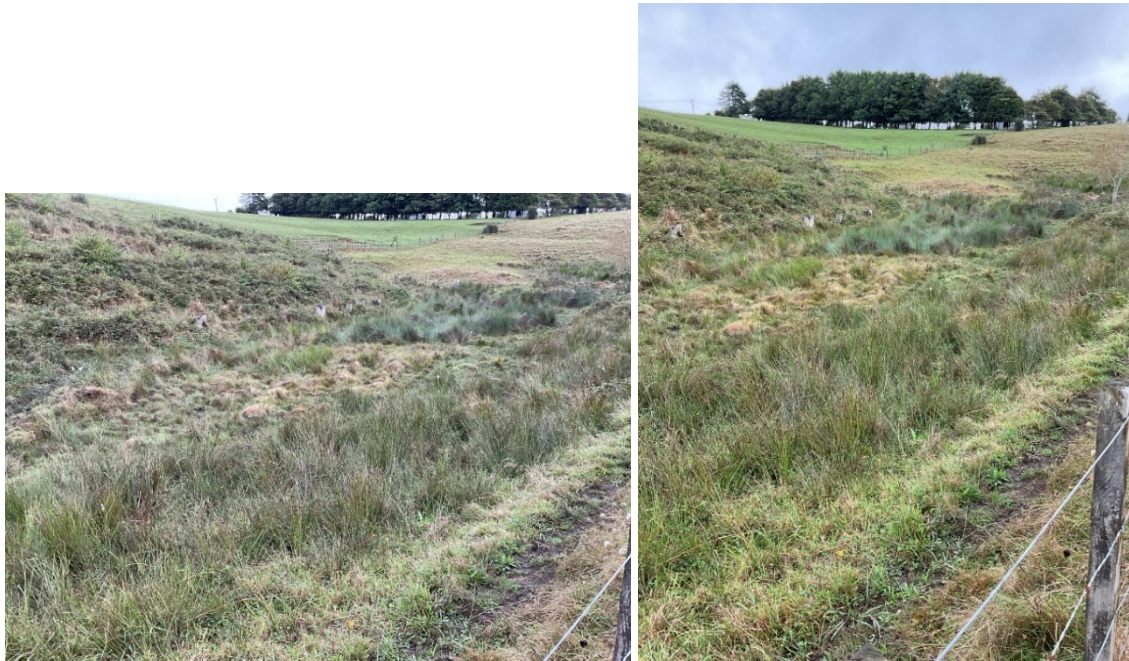
Wetland C (699 m²) is located within a flat headwater basin which drains into a gully system before discharging into a defined stream channel (Photo 3). Wetland C was assessed as *natural inland wetland* based on the Rapid test as OBL and FACW species (baumea, *Isolepis prolifera* and soft rush) were dominant. Surface water and extensive pugging was observed within the feature.

Photo 3: Wetland C feature within headwater basin of stream

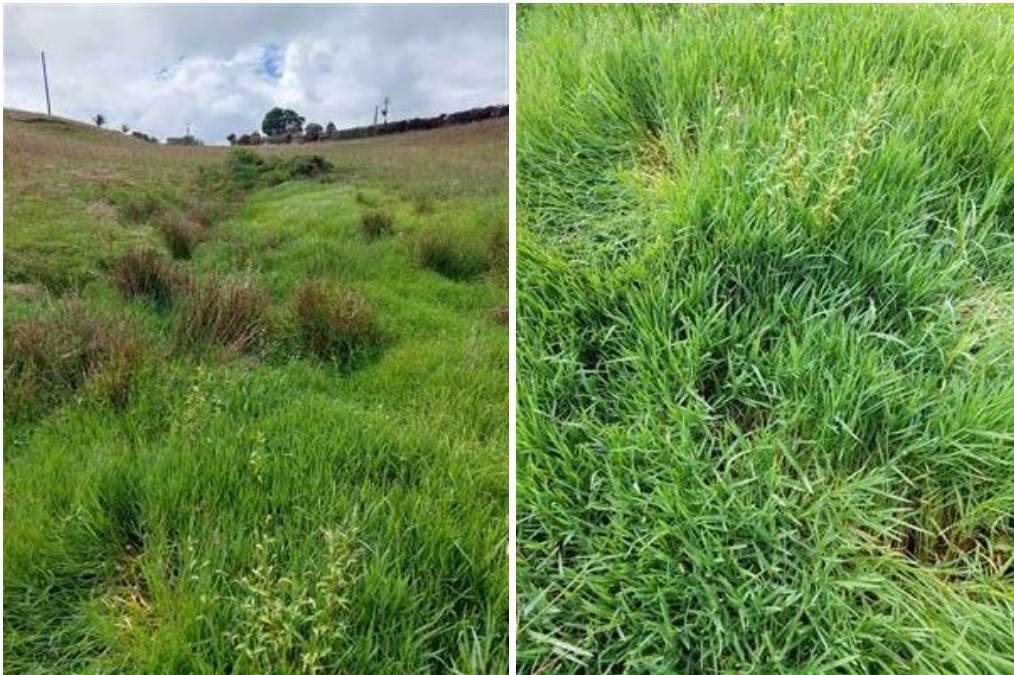
Wetland D is a small feature (158 m²) located within an overland flow path (OLFP) of Stream 3. The feature was dominated by Mercer grass (*Paspalum distichum* – exotic), a FACW grass which, though not recognised as pasture species for the purposes of the NPS-FW, is indicative of the agricultural landuse (Photo 4). The upper extent of the feature appeared to be truncated due to deposition of disturbed soils/ cleanfill in the upper section. The OLFP also appeared to have been deepened and straightened to increase draining efficiency. Wetland D met the criteria of *natural inland wetland* based on the Rapid test.

Photo 4: Wetland D within OLFP dominated by mercer grass.

Wetland D is a small feature at the head of Stream 3, with very low current and potential ecological values. It is close to the northern fill area, which is >10 m to the northern side of the feature and is not obstructing the most direct surface and groundwater flowpaths to the east. The fill here will load and compress the ground under the fill, and there is also likely to be less infiltration and recharge which may affect groundwater levels. The main upslope flowpath is eastward and is likely to provide surface flows and infiltrated flows. Directing surface water flows into this feature will also help maintain the wetland extent and ecological functions. Planting the feature would further enhance biodiversity values. Overall, with appropriate management measures, effects on this small wetland would be low, or potentially a net gain.

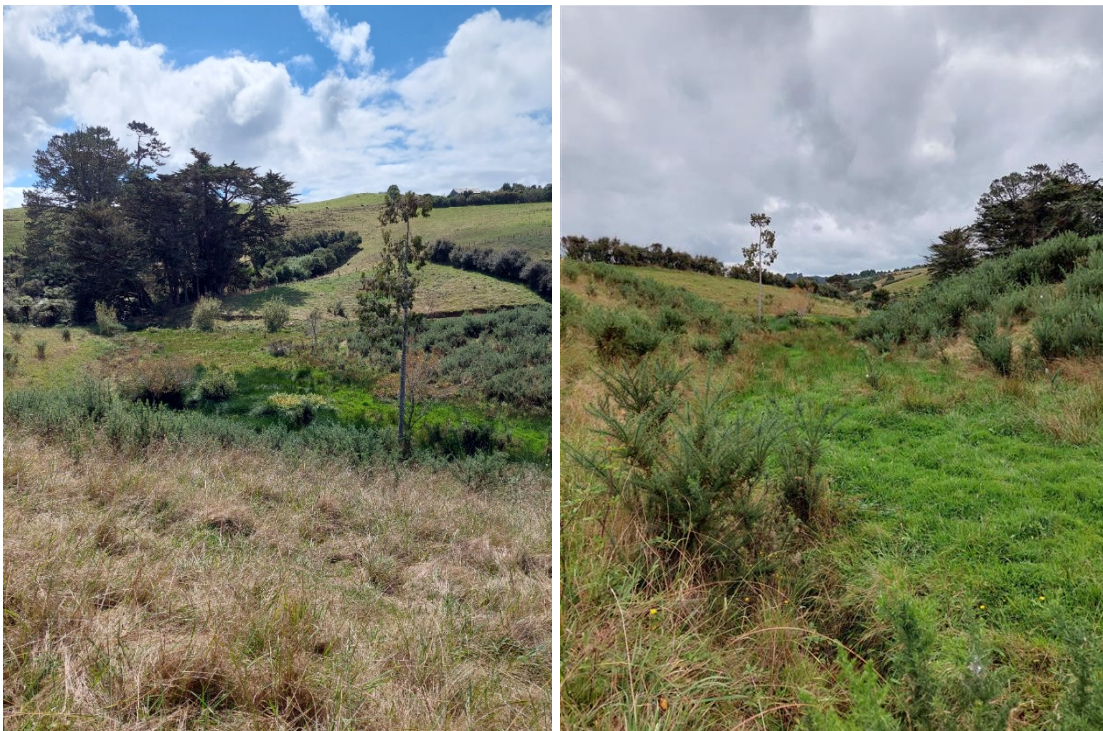
Wetland E is a large feature (2,171 m²) located in the low-lying basin in the far north-eastern section of the proposed managed fill footprint. The wetland feature is formed by two tributaries with a pond located at the confluence.

Photo 5: Left: Wetland E vegetation and single rimu on upslope; Right: upper gully, partly drained.

The wetland extends up the gully to the south. In this area a drain has been excavated and this has reduced ground saturation and affected the condition of the wetland. Mercer grass and soft rush dominated vegetation on the outer margins of the wetland, while the centre included patches of baumea, *Isolepis prolifera* and water pepper (*Persicaria hydropiper* – Exotic) (Photo 5). Wetland E was assessed as *natural inland wetland*, based on the Rapid test.

Wetland E will be fenced to protect it from future livestock grazing. The aim will be to reduce pressure from landuse activities. The hydrological functions appear to be relatively intact. The aim here is to maintain wetland functions. This will include fencing of the SEA area that adjoins the wetland. Fencing the SEA within the property will prevent livestock damage and allow the regeneration of native plant species, while the fencing of the adjacent wetland will provide a further buffer zone.

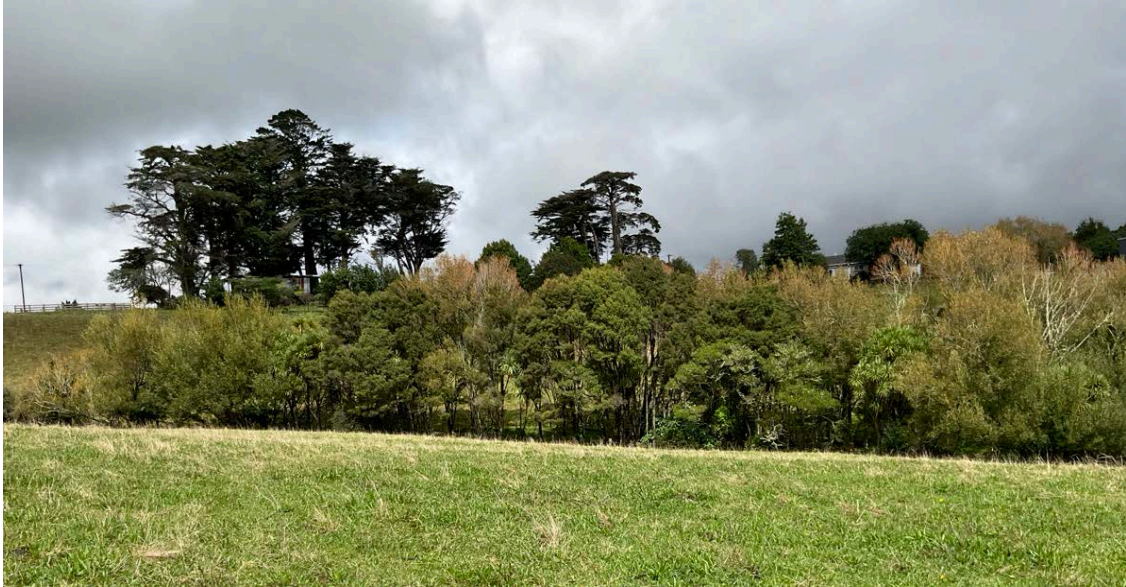
The riparian vegetation surrounding Stream 3 comprises willows (*Salix* spp.) and a variety of native trees and shrubs, including houhere (*Hoheria populnea*), tōtara (*Podocarpus totara*), kōwhai (*Sophora microphylla*), karaka (*Corynocarpus laevigatus*), karamu (*Coprosma robusta*), akeake (*Dodonaea viscosa*), kānuka (*Kunzea robusta*), tarata (*Pittosporum eugenioides*), pōnga (*Cyathea dealbata*), and tī kouka (*Cordyline australis*) (Photo 6 and 7). The groundcover was limited due to grazing, but included pasture grasses, buttercup (*Ranunculus repens*),

Juncus spp., kiokio (*Parablechnum novae-zelandiae*), and blackberry (*Rubus fruticosus*). From Google Earth imagery and Retrolens (<https://retrolens.co.nz/Map>), we determined that this vegetation was planted roughly 20-25 years ago.

Photo 6: Image of the riparian vegetation surrounding Stream 3.

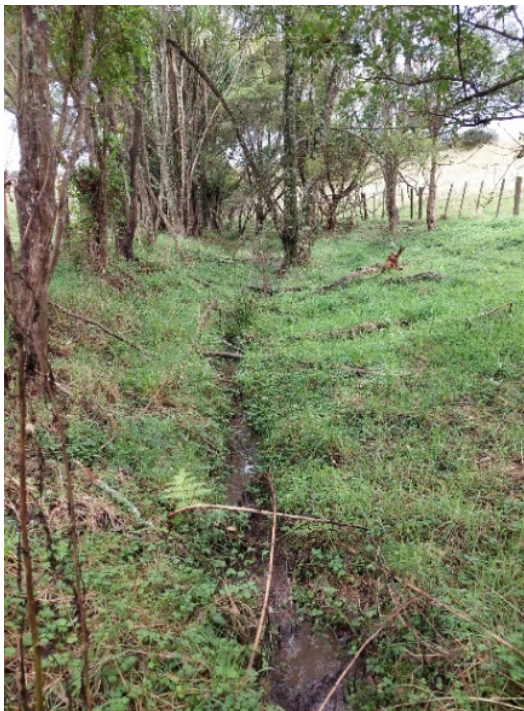
Photo 7: Riparian vegetation surrounding Stream 3.

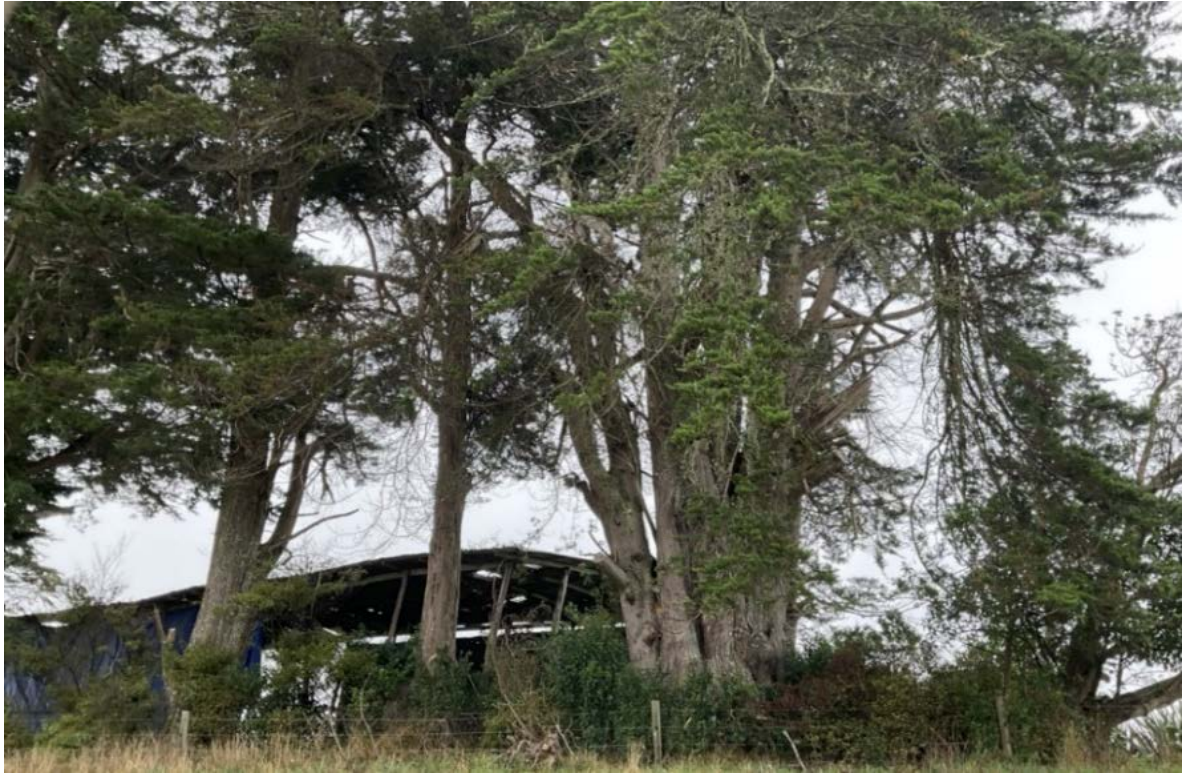
Exotic macrocarpa (*Cupressus macrocarpa*) trees and a *Pinus radiata* tree, all around 20-25m tall dominate the stand of trees nearest to the homestead (Photo 8), with a subcanopy of native and exotic shrubs including mapou (*Myrsine australis*) and Chinese privet (*Ligustrum sinense*).

An ~8m tall pūriri (*Vitex lucens*) tree is present on the eastern margin of the stand. The groundcover is largely composed of pasture grass.

Photo 8: *Macrocarpa* and undergrowth in the first southern vegetation patch.

We understand that the removal of the macrocarpas is a permitted activity (Vance Hodgson, *pers comm*), and that they may be removed prior to haul road construction. As the macrocarpa stand is potentially suitable for bat roosting, we recommend an acoustic monitor check prior to felling to ensure that no long-tailed bats are present. While the presence of bats is unlikely, this would be a good management practice to manage risk on a threatened species. We recognise that this recommendation is not enforceable by consent. The proposed vegetation removal would have low ecological effects, provided that no At-Risk or Threatened species are present.

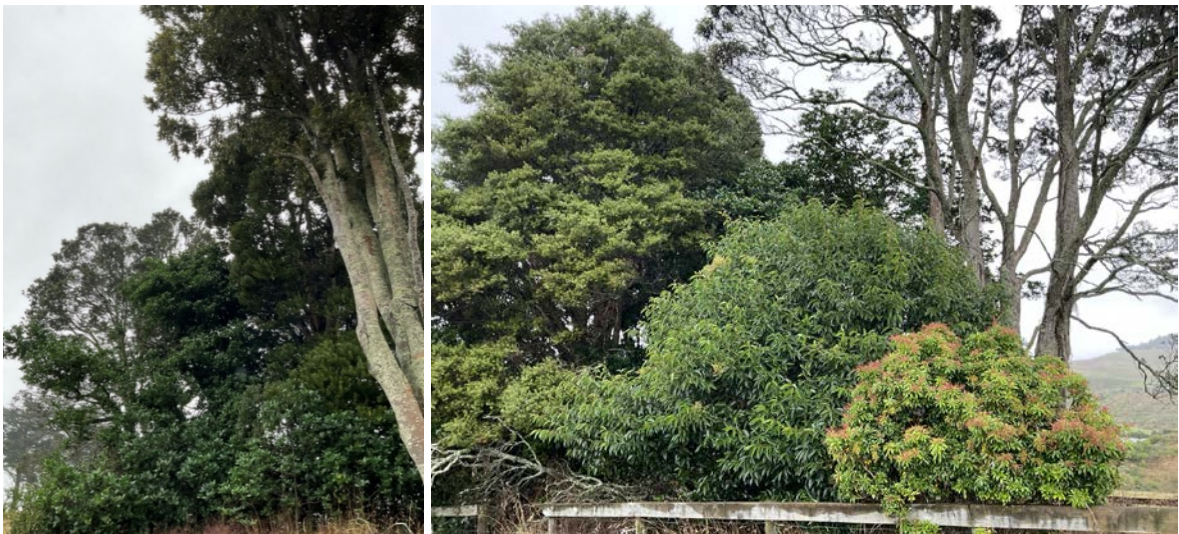
A small remnant stand of mature and regenerating native trees (5-12m tall) is present on the margin of the proposed managed fill footprint in the southern quarter of the property. Mature specimens of rewarewa (*Knightia excelsa*), tōtara, kauri (*Agathis australis*), pōhutukawa (*Metrosideros excelsa*) form the canopy, with a subcanopy of karaka, tree privet (*Ligustrum lucidum*) and mapou. Juvenile mapou, totara, karaka and Chinese privet form the understory.

Photo 9 and 10: Native forest remnant.

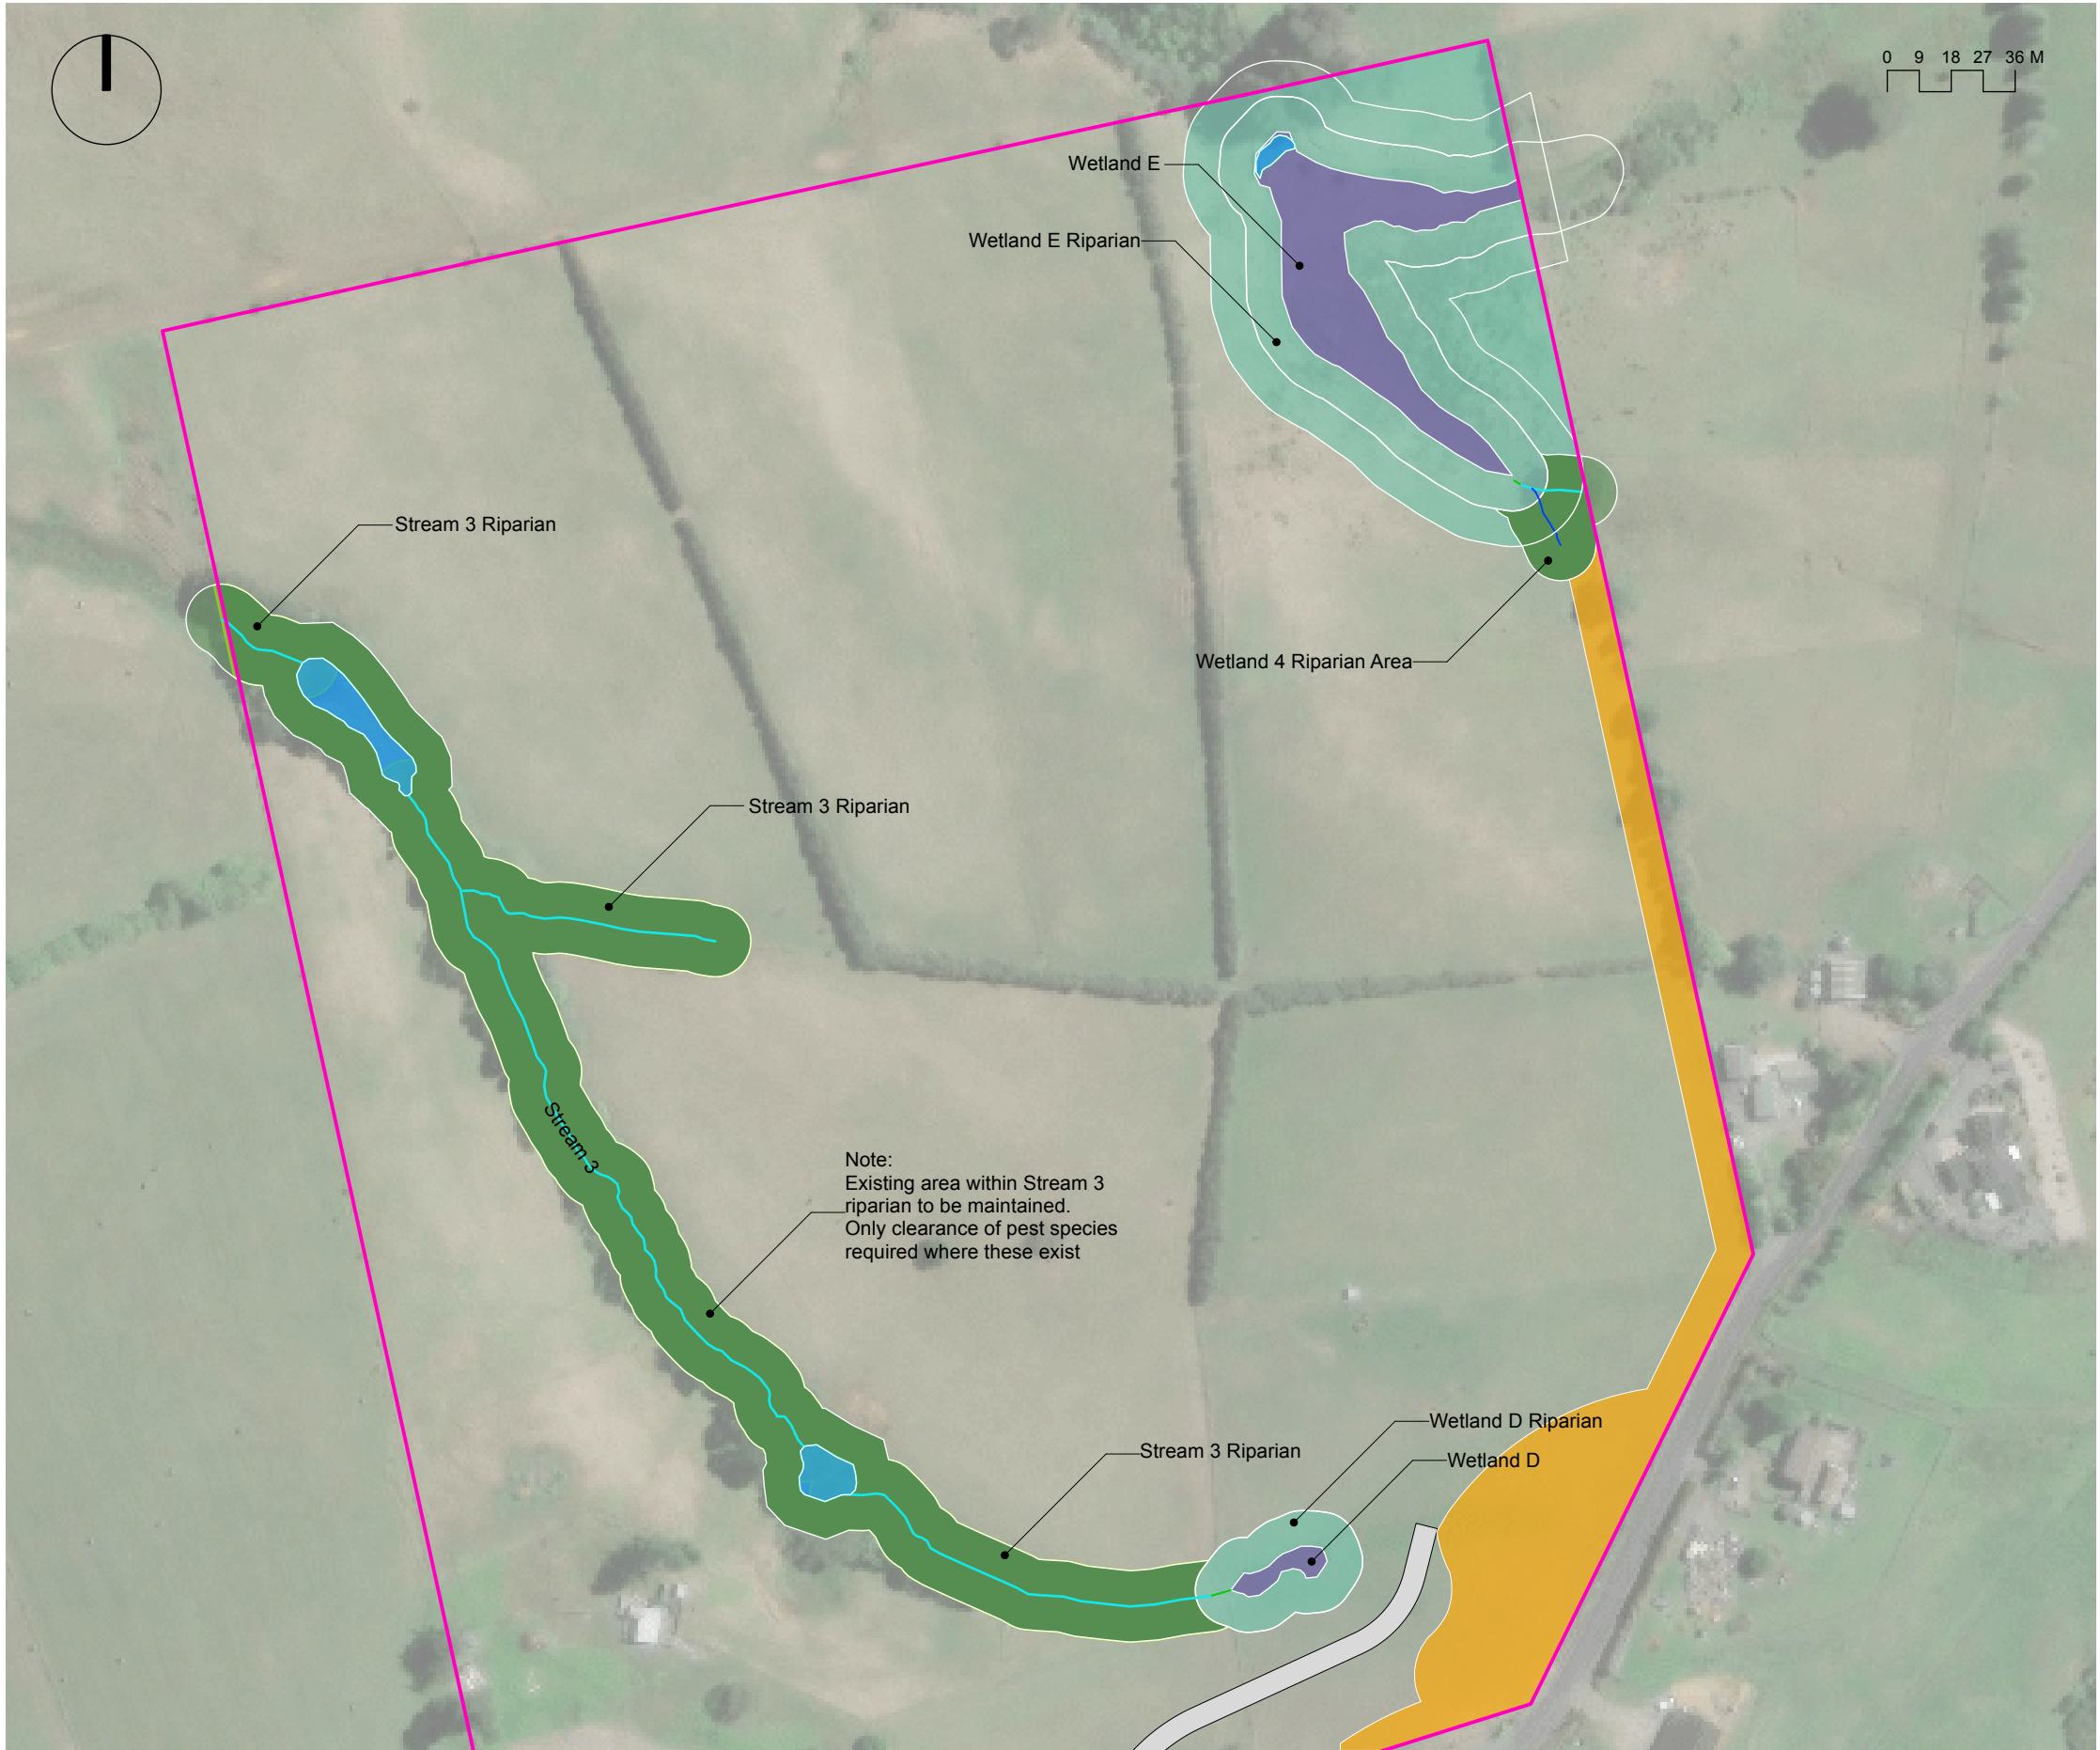
Jones Road Managed Fill
Riparian Planting Plan
362 Jones Rd Hunua
Scarbro Environmental Ltd

- Site Boundary
- Stream Riparian Planting
- Pond
- Wetland Planting
- Wetland Riparian Planting
- Indigenous Revegetation Planting

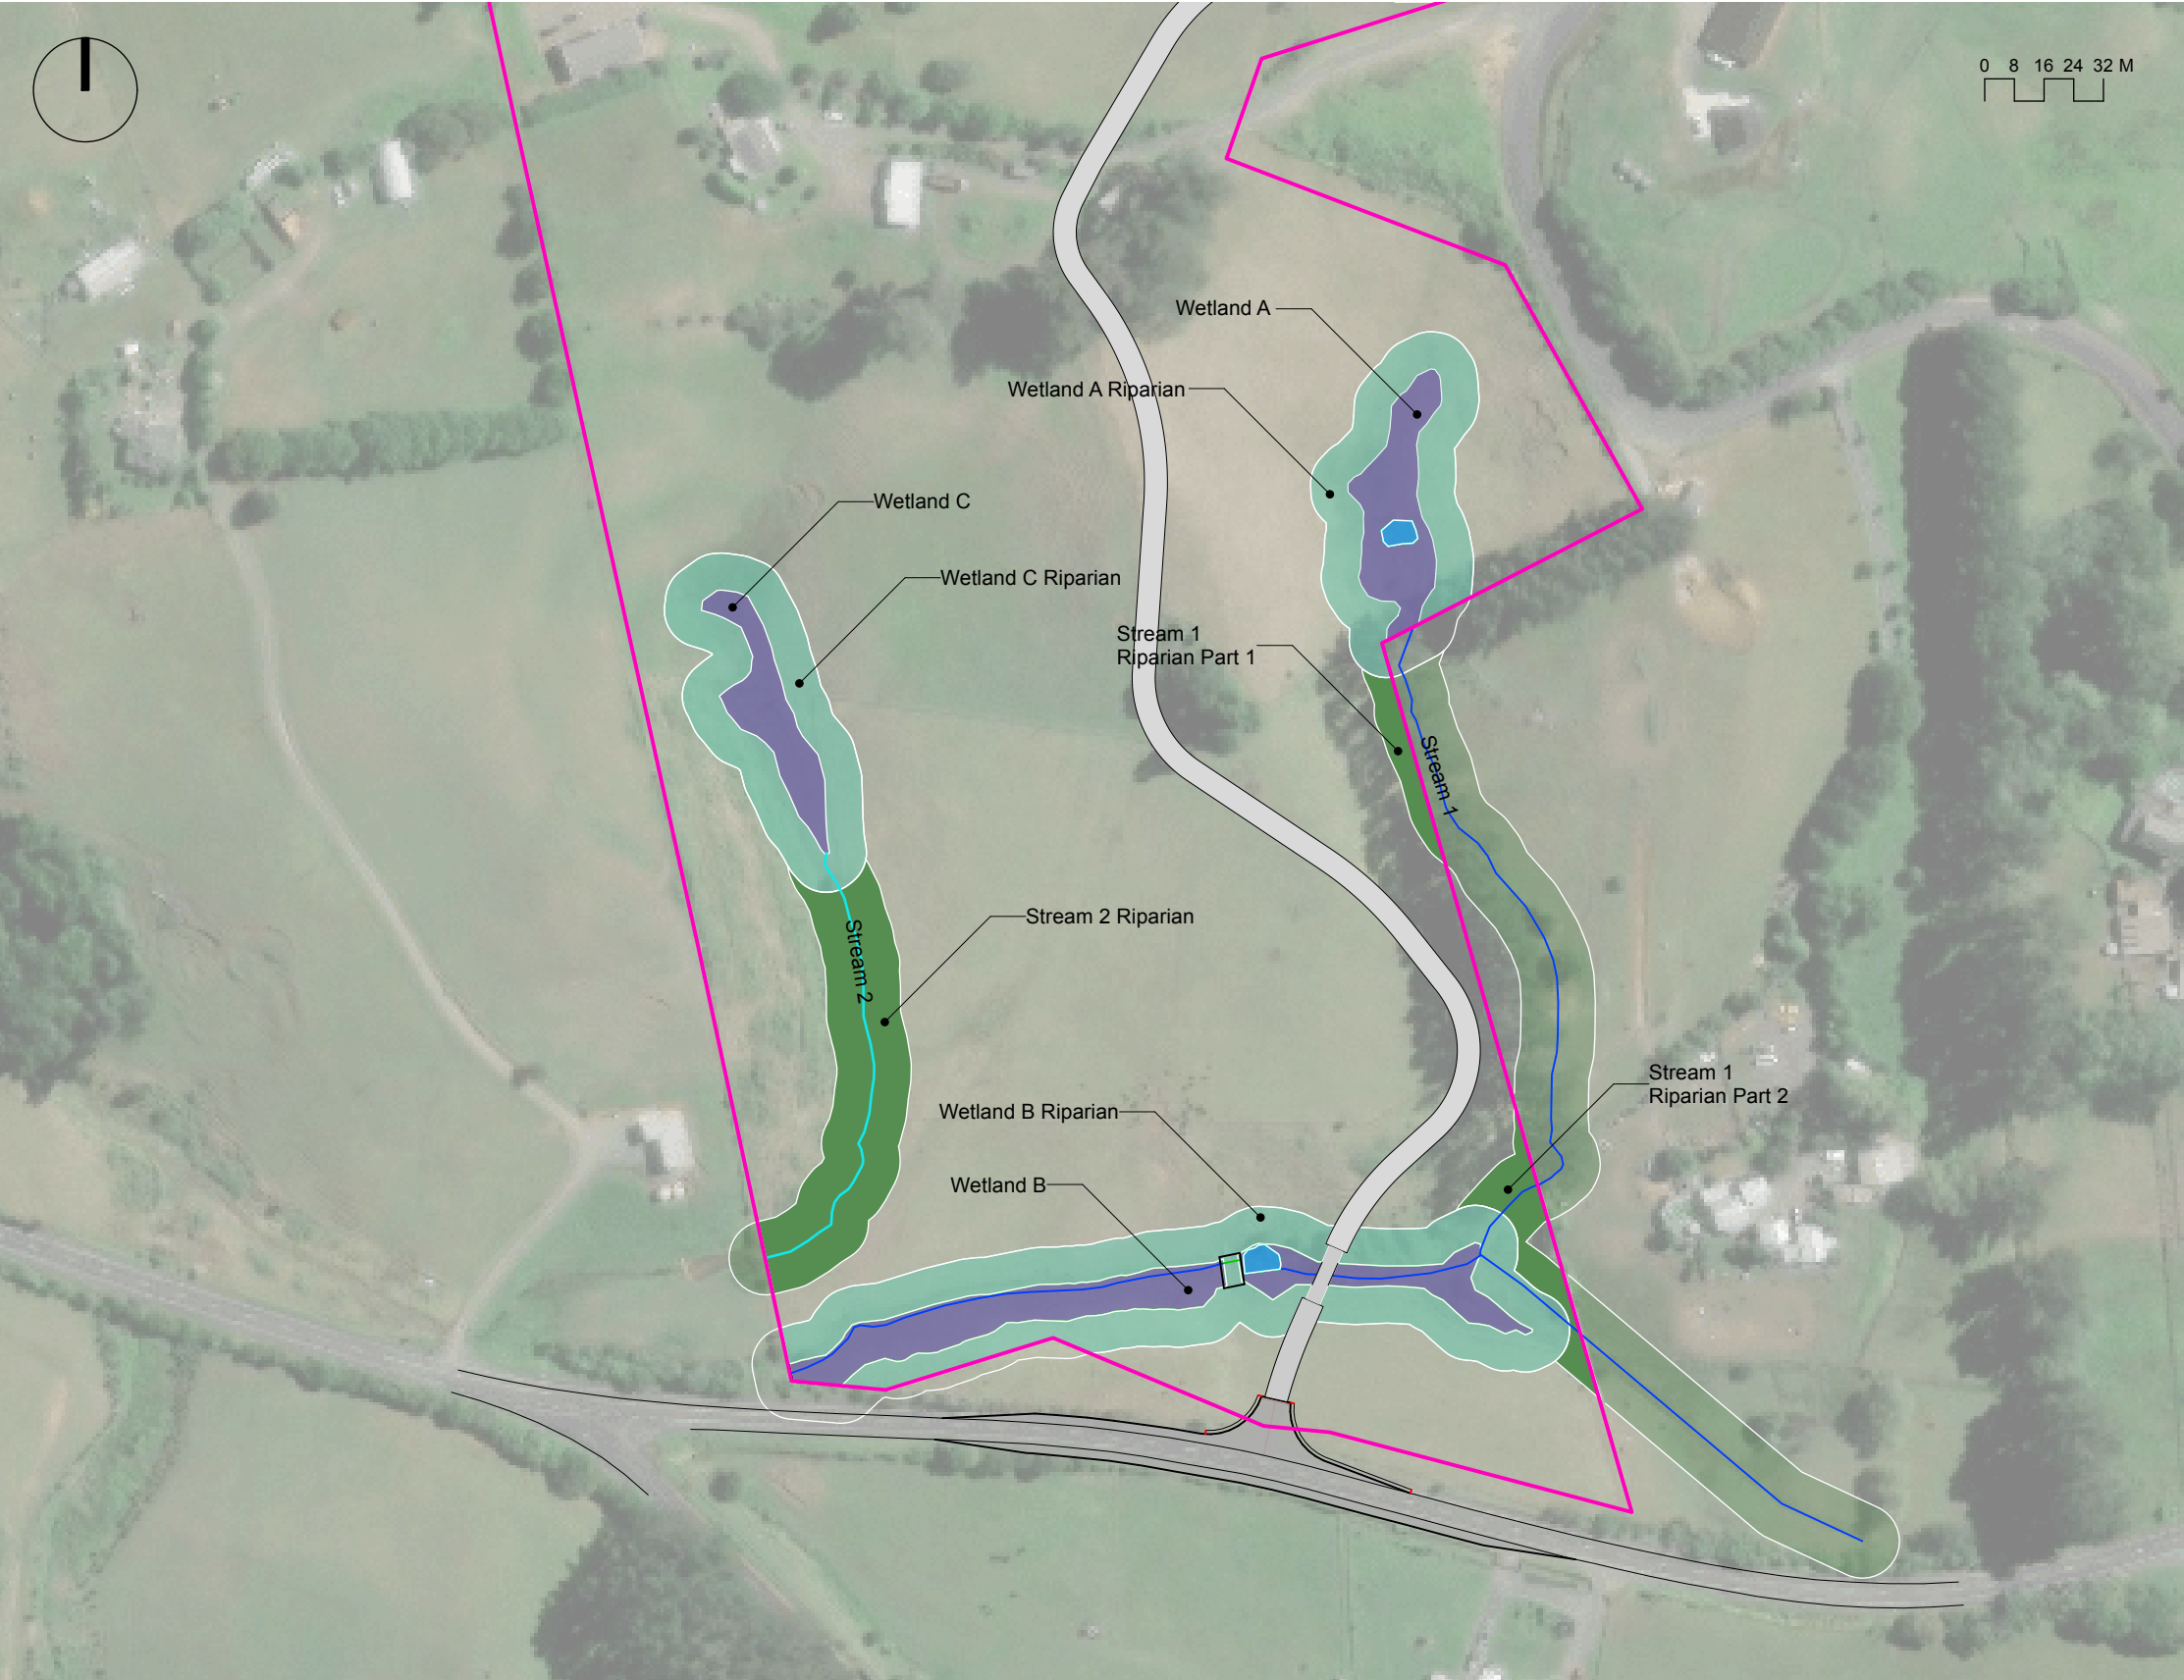
Jones Road Managed Fill
Riparian Planting Plan
362 Jones Rd Hunua
Scarbro Environmental Ltd

- Site Boundary
- Stream Riparian Planting
- Pond
- Wetland Planting
- Wetland Riparian Planting
- Indigenous Revegetation Planting
