A & L Sargeant Ltd

## **GEOTECHNICAL INVESTIGATION REPORT**

147 to 153 Edgewater Drive, Pakuranga

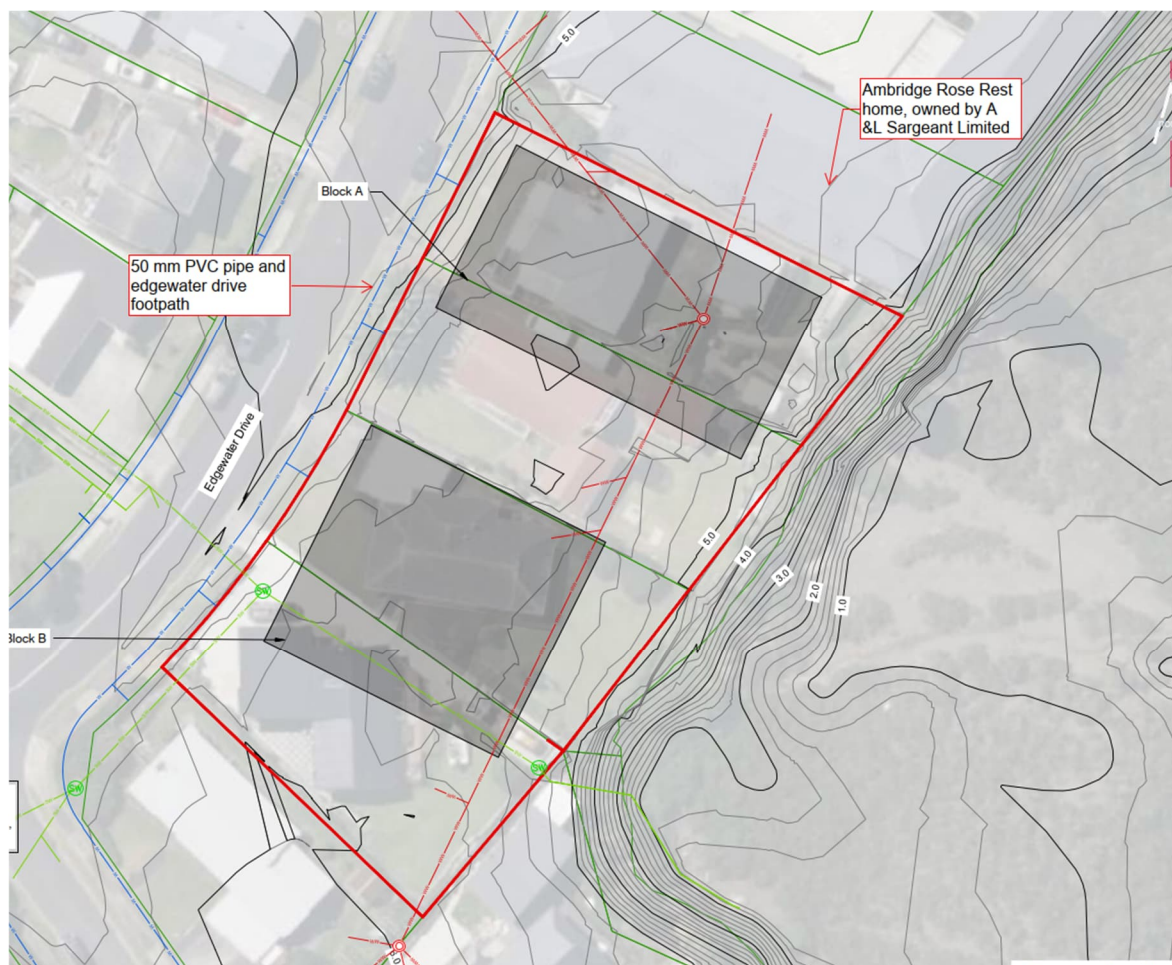
*Inset 2: Services and properties in the vicinity of the site*

Based on the information retrieved from Auckland Council Geomaps, referring to Inset 2 below, settlement consideration due to the basement excavation and the boundary earthwork cut is given to the following assets.

- Close edge of the Edgewater Drive footpath, approximately 1.5m from the site boundary.
- 50 diameter PVC water pipe runs along the far edge footpath of Edgewater Drive. Assumed to be buried 1m below current ground level. 6m horizontal offset to the proposed Block A basement excavation, and 3m offset from the boundary.
