Geotechnical Investigation Report

1695 Pohuehue Road, Warkworth

For Pohuehue Community Housing Ltd.

Haigh Workman Reference: 25 050-GEO

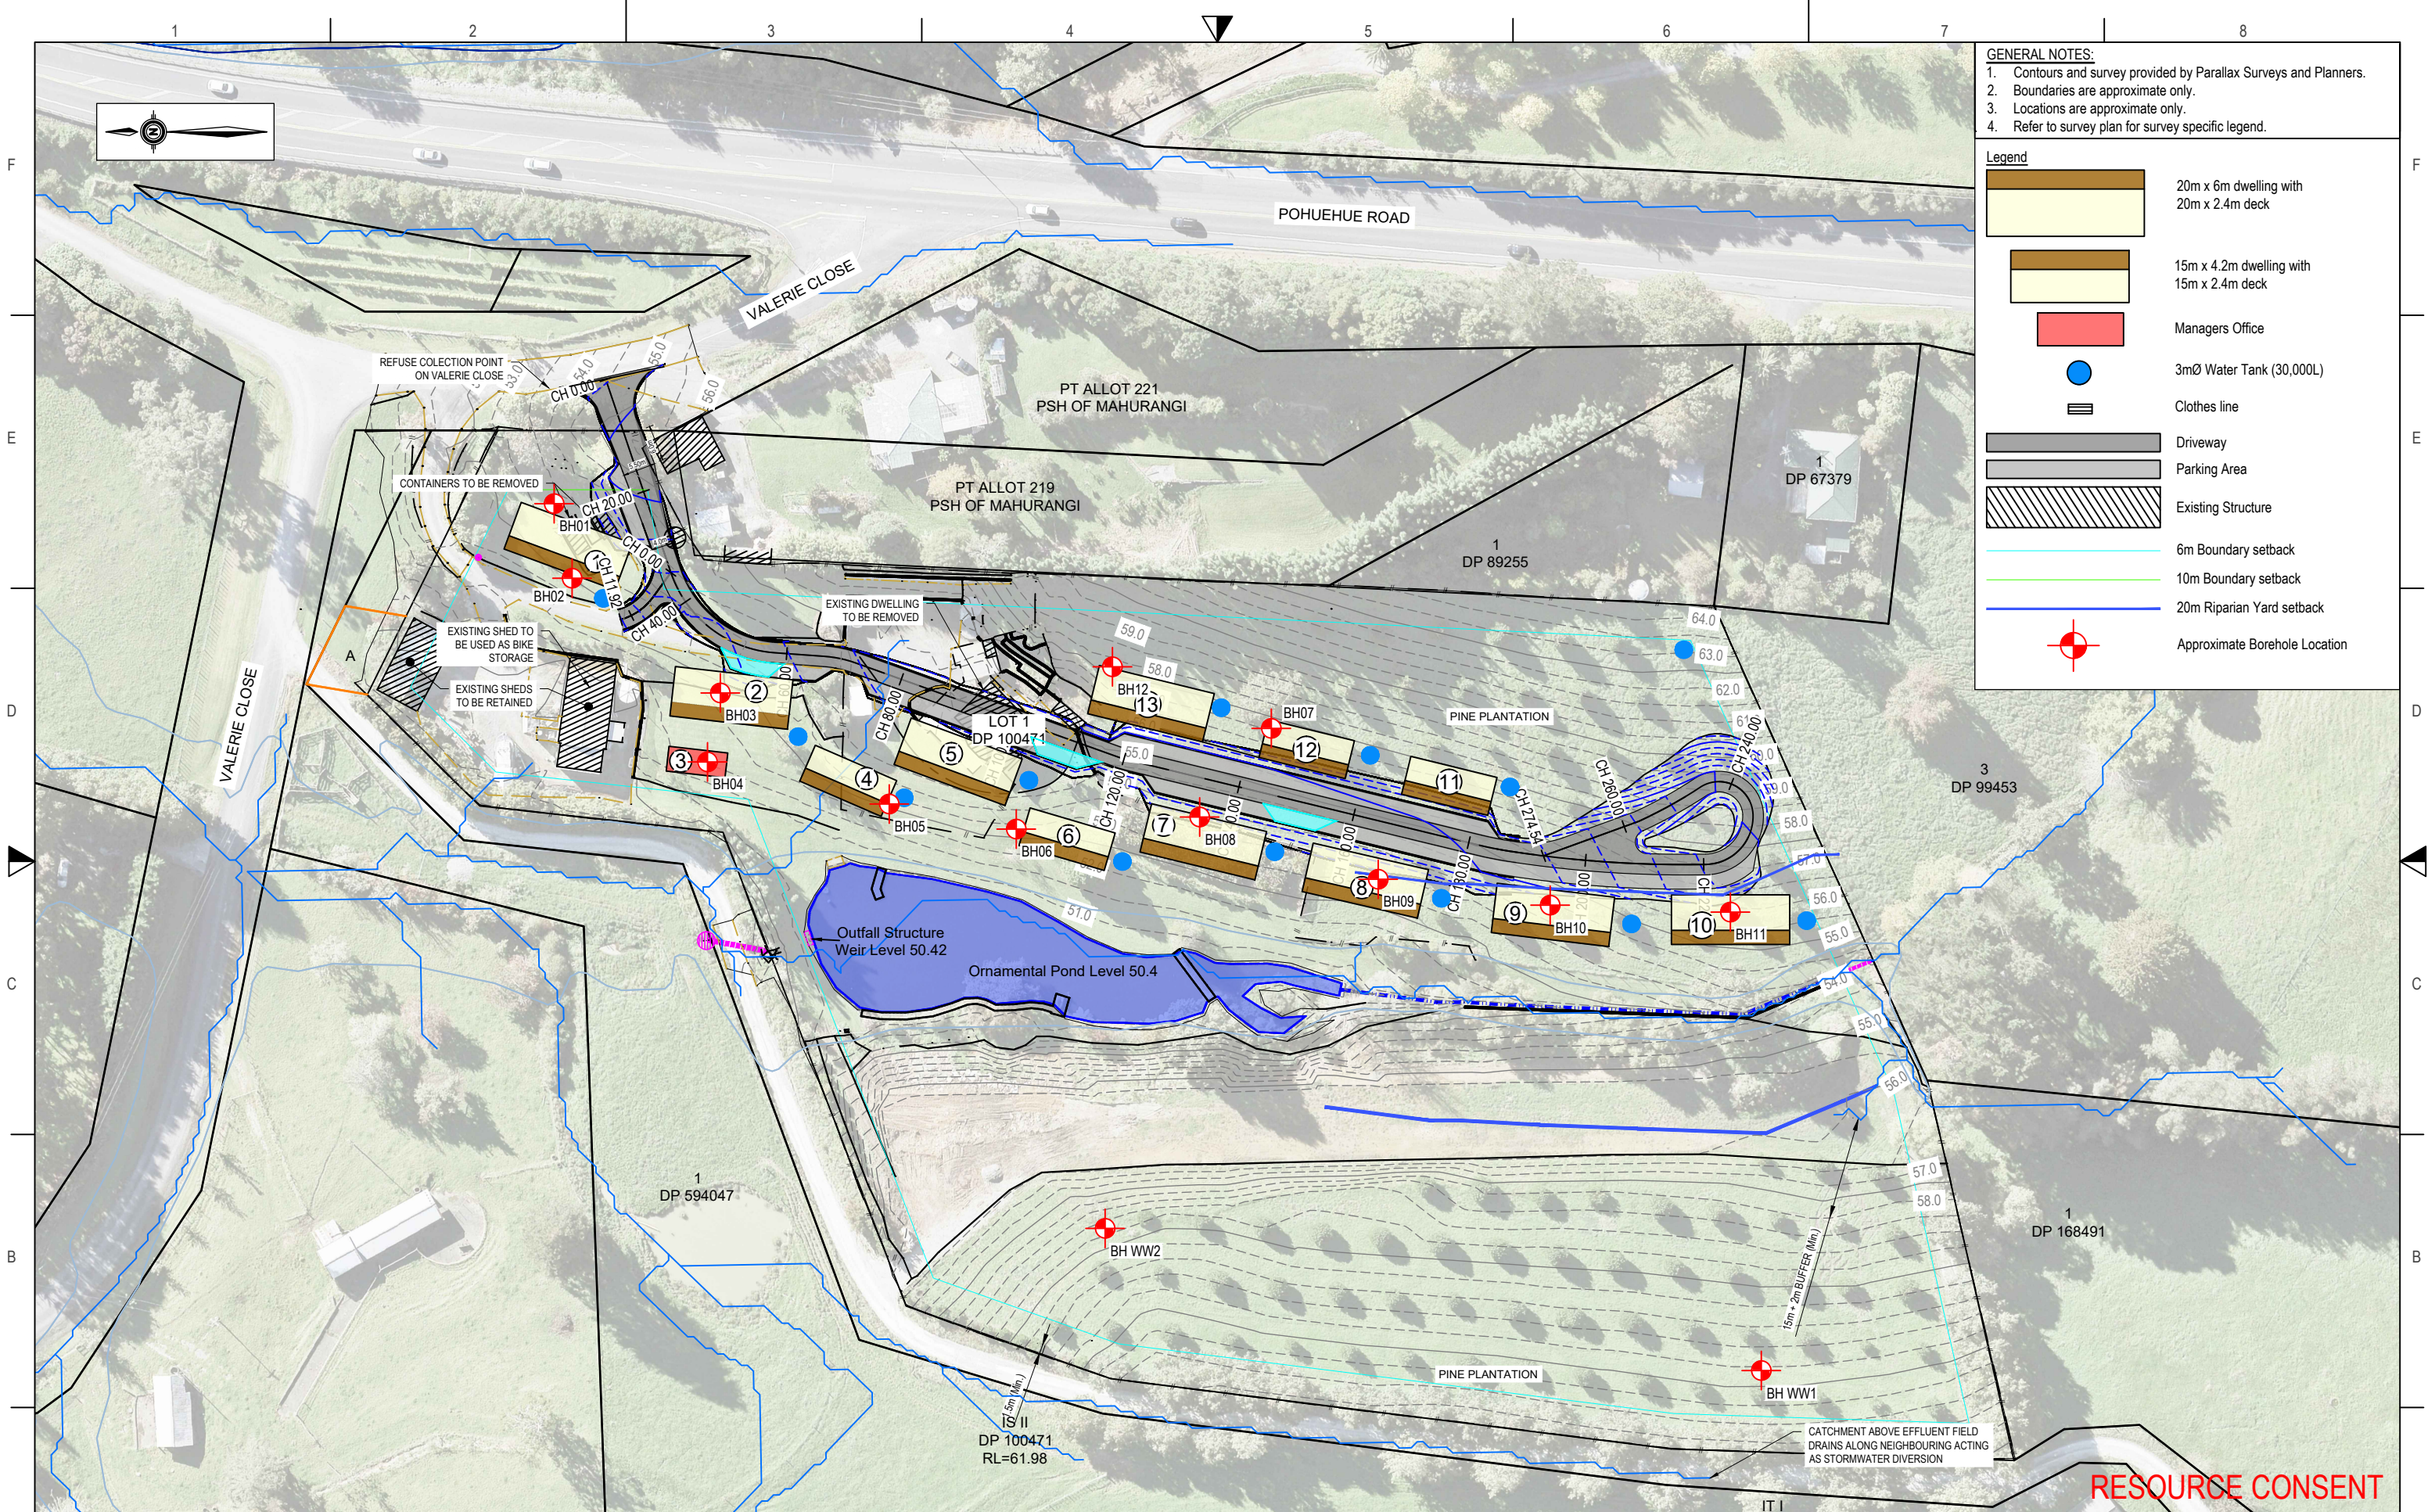
DWG SITE INVESTIGATION PLAN

Haigh Workman undertook a ground investigation during March and April 2025 comprising 14 hand auger boreholes designated BH1 to BH12, and BH WW1 to BH WW2. Hand auger boreholes were completed to depths of up to 3.0 m below ground level (bgl). The purpose of the hand auger boreholes was to visually log the soil conditions extracted from the ground within the proposed building footprints and to provide a geotechnical ground model. Two hand augers were also carried out within the proposed wastewater disposal area for the purposes of determining ground water depth and soil permeability rate for wastewater dispersion calculations. Exploratory hole locations are depicted on the Investigation Plan in Appendix A.

The site plans within Appendix A show the extents and locations of the proposed development. A gravel driveway is proposed to access the existing dwelling, the 12 new emergency housing buildings, and the manager's office. It is proposed to carry out minor earthworks consisting of cut and fill to create the driveway and parking areas. The proposed buildings are to be constructed on timber piles. Proposed building platform areas are on gentle slopes of less 14°. Should the development locations be subject to change, further investigation will be required. Refer to Appendix A for the site plans which assign the proposed buildings numbers 1 to 12.
