April 25th, 2025
Auckland Council

Watercourse Classification and Natural Inland Wetland Identification – 1799A Great South Road, Bombay – Lot 6 DP 156089

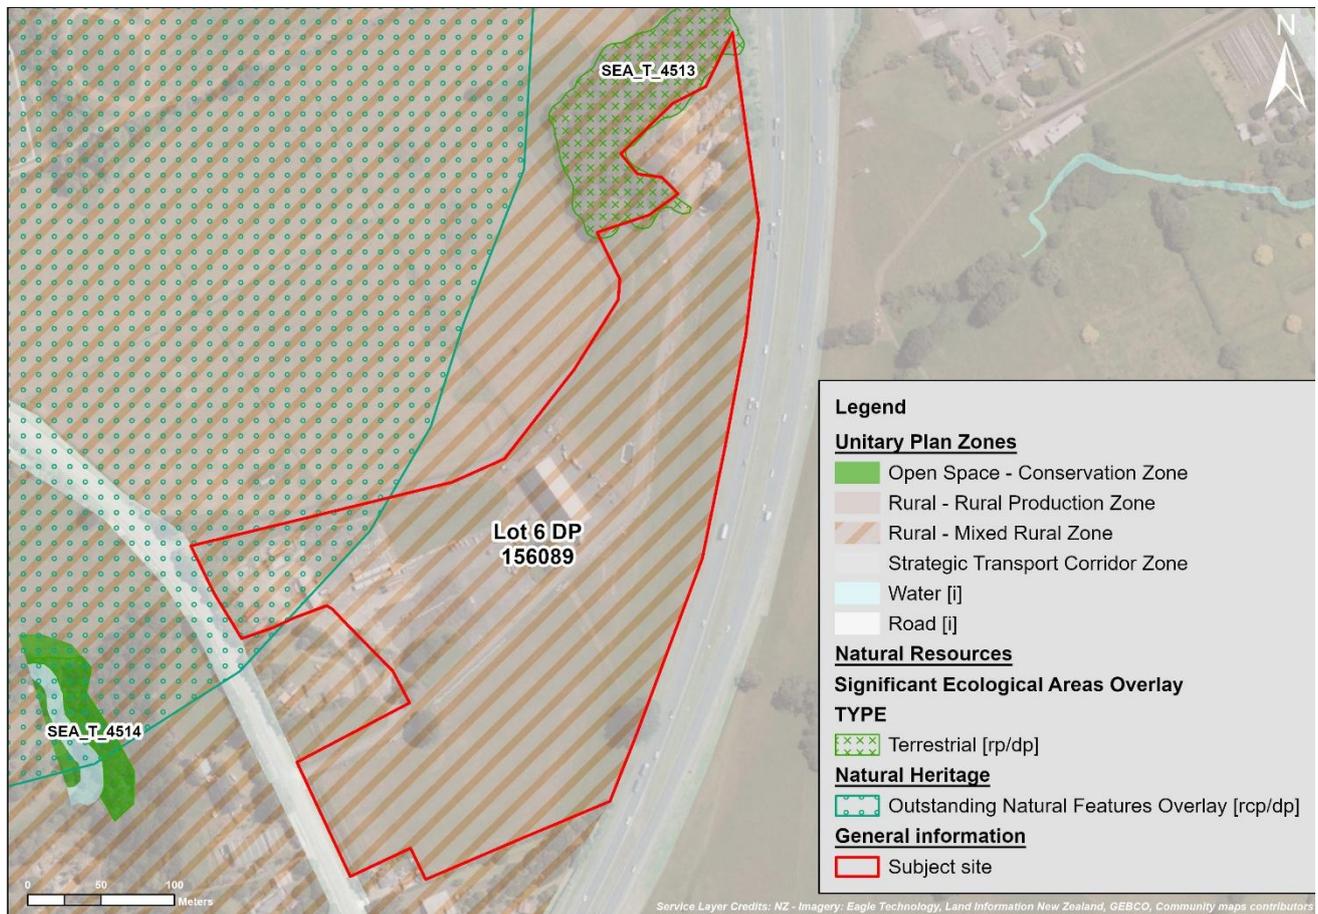
Vernon Development Ltd (‘the Client’) engaged Rural Design 1984 Ltd (RDL) to undertake a watercourse and wetland assessment at 1799A Great South Road, Bombay (Lot 6 DP 156089), hereafter referred to as ‘the subject site’ (as shown in Figure 1). The subject site is zoned ‘Mixed Rural Zone’ under the Auckland Unitary Plan (Operative in Part) [AUP(OP)], with a small portion of the western aspect of the property falling within an ‘Outstanding Natural Feature’ overlay. Additionally, the northern boundary adjoins an existing Significant Ecological Area (SEA_T_4513).

Figure 1: Showing the subject site and associated overlays (AUP(OP))

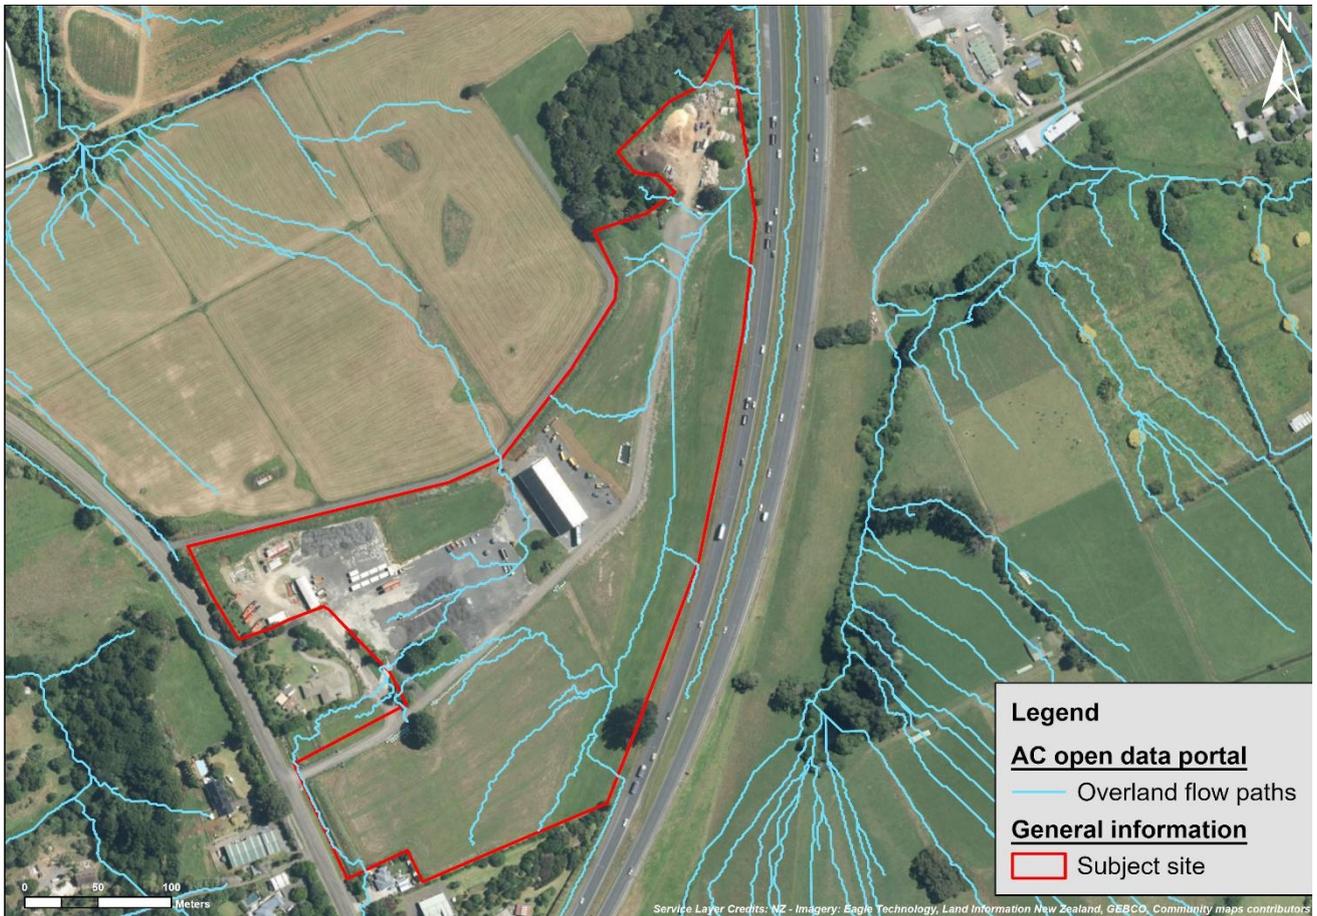
Auckland Council's Open Data Catchment and Hydrology dataset indicates that the subject site is overlain by several potential overland flow paths (refer to Figure 2). However, during the site visit conducted on 16 January 2025, it was observed that none of these mapped overland flow paths are present on-site; the areas in question are either in pasture with no obvious changes in topography or indication of any ephemeral flows or have been hardscaped (see Figure 3).

Figure 2: Showing the overland flow path and floodplain overlay from AC Open Data portal and RDL on-site assessment results

Based on the site assessment undertaken on 16 January 2025, it is concluded that the only watercourse within the site boundaries is an artificial watercourse (swale), which appears to have been constructed between 1971 and 1979, likely in association with nearby motorway development. No natural watercourses or overland flow paths, as mapped by Auckland Council's hydrology datasets, were observed within the site during the field visit.

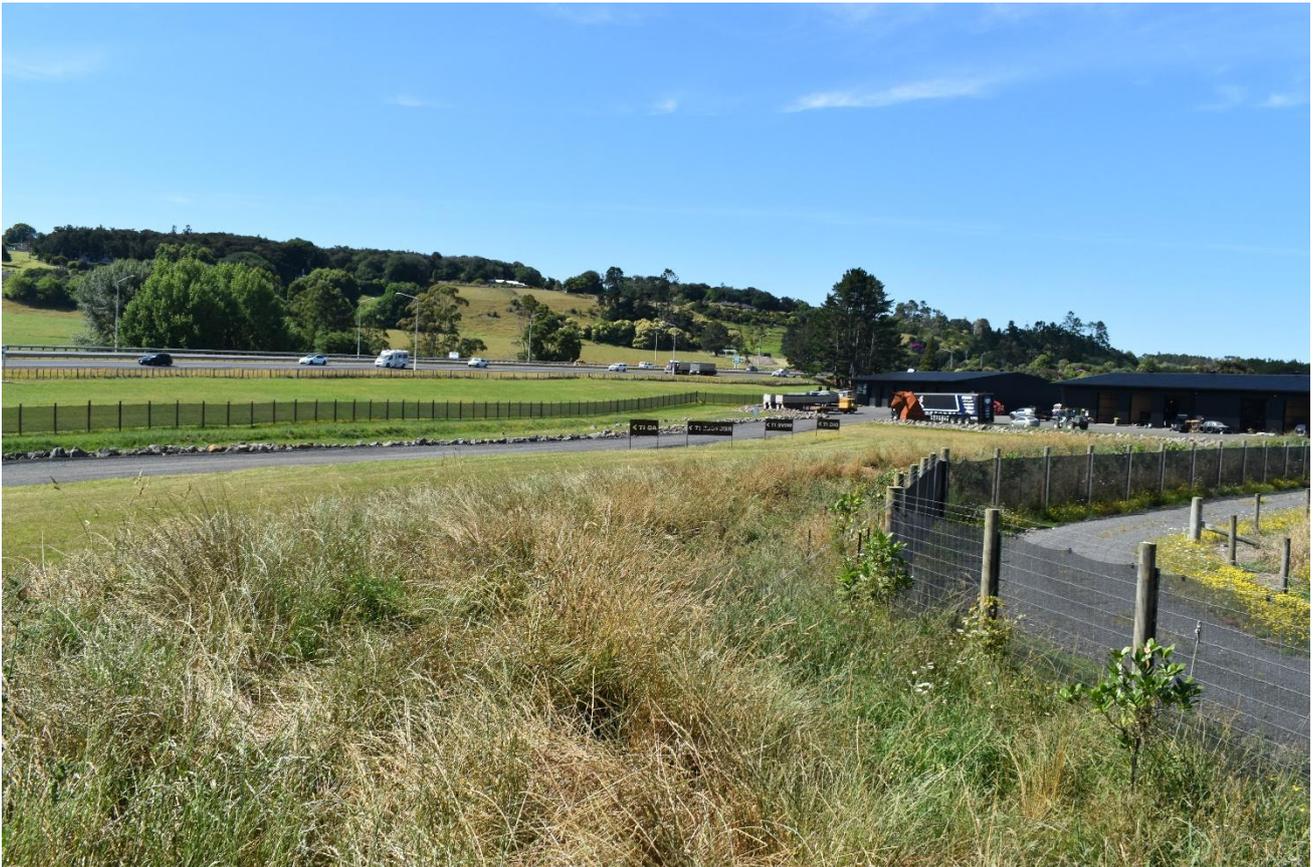
Figure 3: No distinctive overland flow paths were identified within the site boundaries as shown under Auckland Council's Open Data Catchment and Hydrology dataset

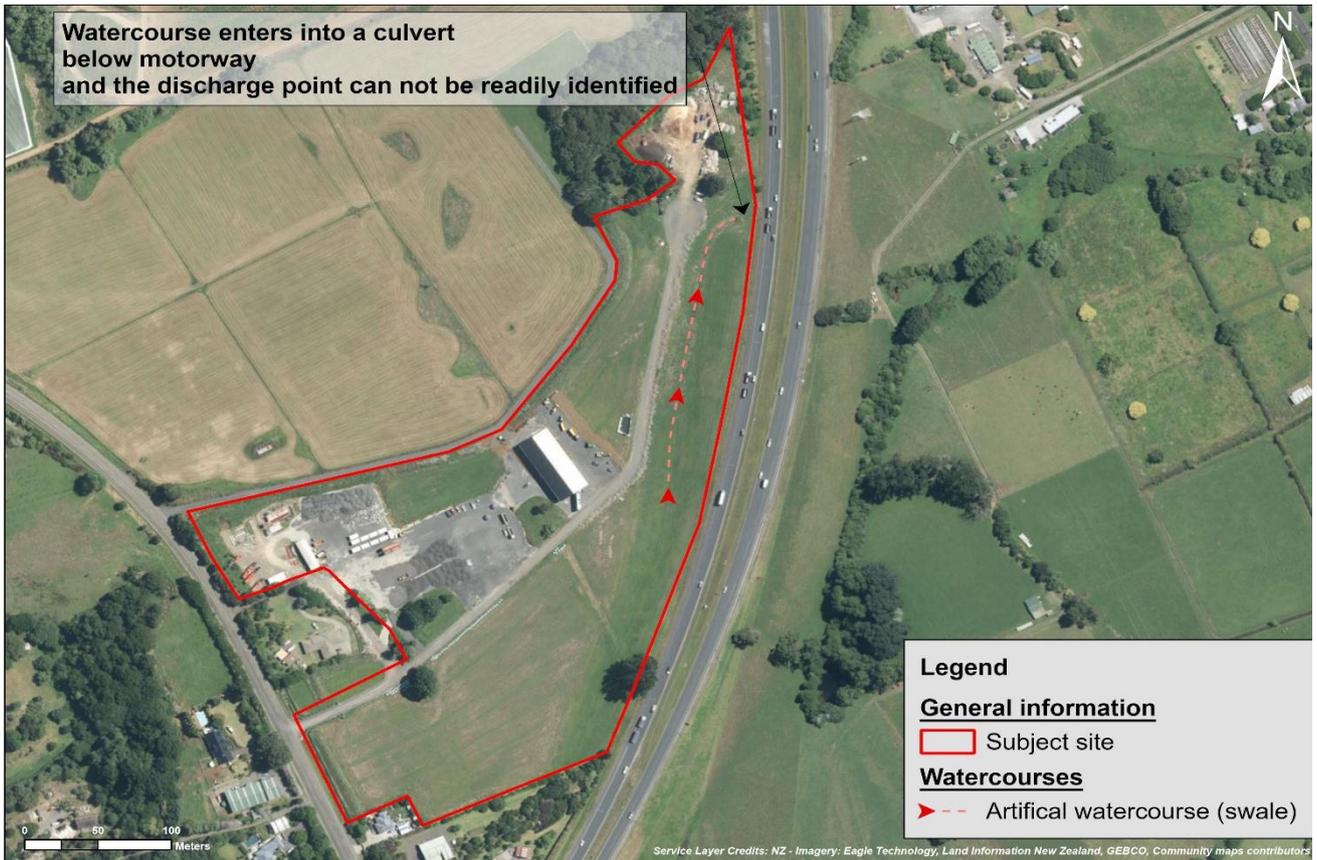
One artificial watercourse (swale) was identified on-site in a location that is not represented in Auckland Council's GeoMaps overland flow path data (Figure 4). Historical aerial imagery and topographic analysis suggest that this artificial watercourse was constructed sometime between 1971 (see Figure 7) and 1979 (see Figure 8), likely as part of motorway construction works immediately adjacent. A nearby small, likely natural stream channel (not aligned with the current artificial watercourse) appears to have been either infilled or piped during the motorway construction (see Figure 7 and Figure 8). No evidence of this watercourse is present on site today.

At the time of the site visit, the artificial watercourse/swale was dry and exhibited characteristics of a deliberately engineered channel, including rock lining along its base and walls. The channel exits the site at the north-eastern boundary, entering a culvert that likely conveys it beneath or along the motorway. Despite reviewing historic and current aerial imagery, a definitive downstream discharge point could not be identified. However, it is probable that the watercourse discharges into a roadside swale or drain located alongside the motorway.

Figure 4: Showing artificial watercourse (swale) identified on site – no other watercourses were identified within the site boundaries

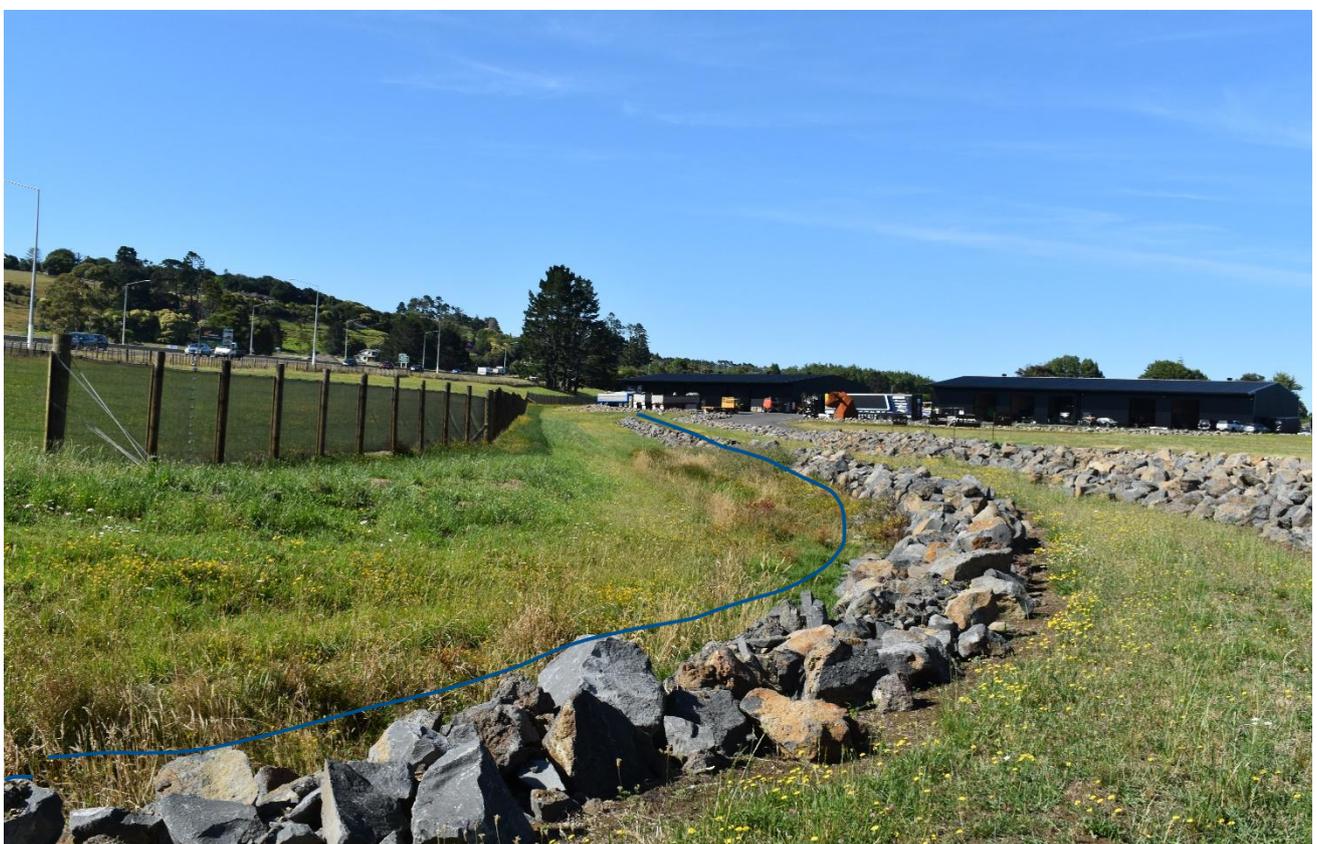
Figure 5: Showing the artificial watercourse (swale drain) on site – blue line indicates the centreline

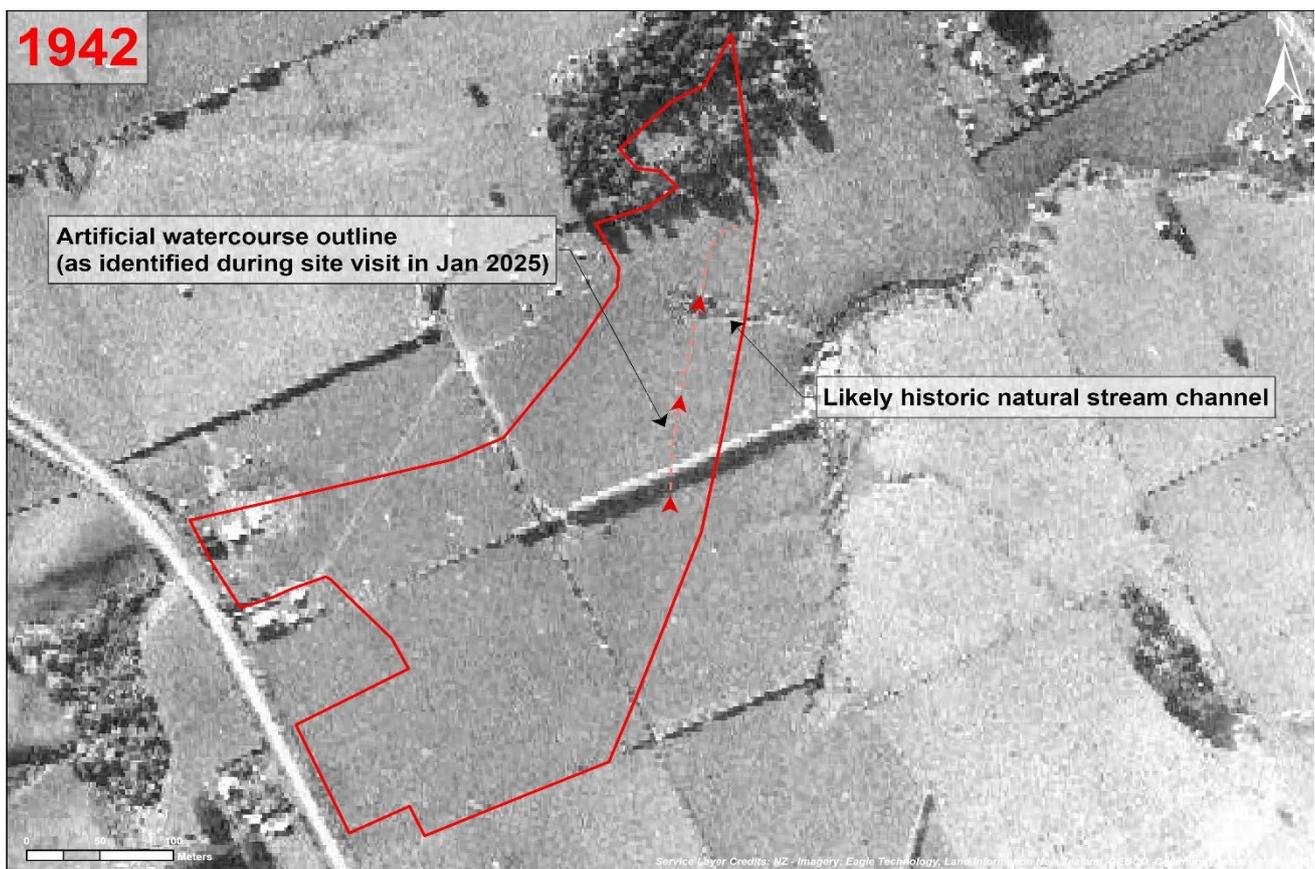
To further ascertain the correct classification of the watercourse, historic imagery analysis was carried out. For reference purposes, I have included the artificial watercourse outline as identified during site visit in January 2025 to confirm that this watercourse contains no natural portions from its confluence with a river or stream to their headwaters - please refer to Figure 6, Figure 7, Figure 8 and Figure 9 for analysis. The artificial watercourse is first visible in the 1979 historic aerial imagery, located in an area that was previously exotic pasture. It is therefore likely that the watercourse was originally constructed as part of the motorway development during that period. While the channel appears to have undergone subsequent modifications—potentially including extensions and widening—its general alignment has remained largely consistent with the originally constructed form observed in 1979.

Figure 6: Showing site imagery from 1942 (Retrolens)

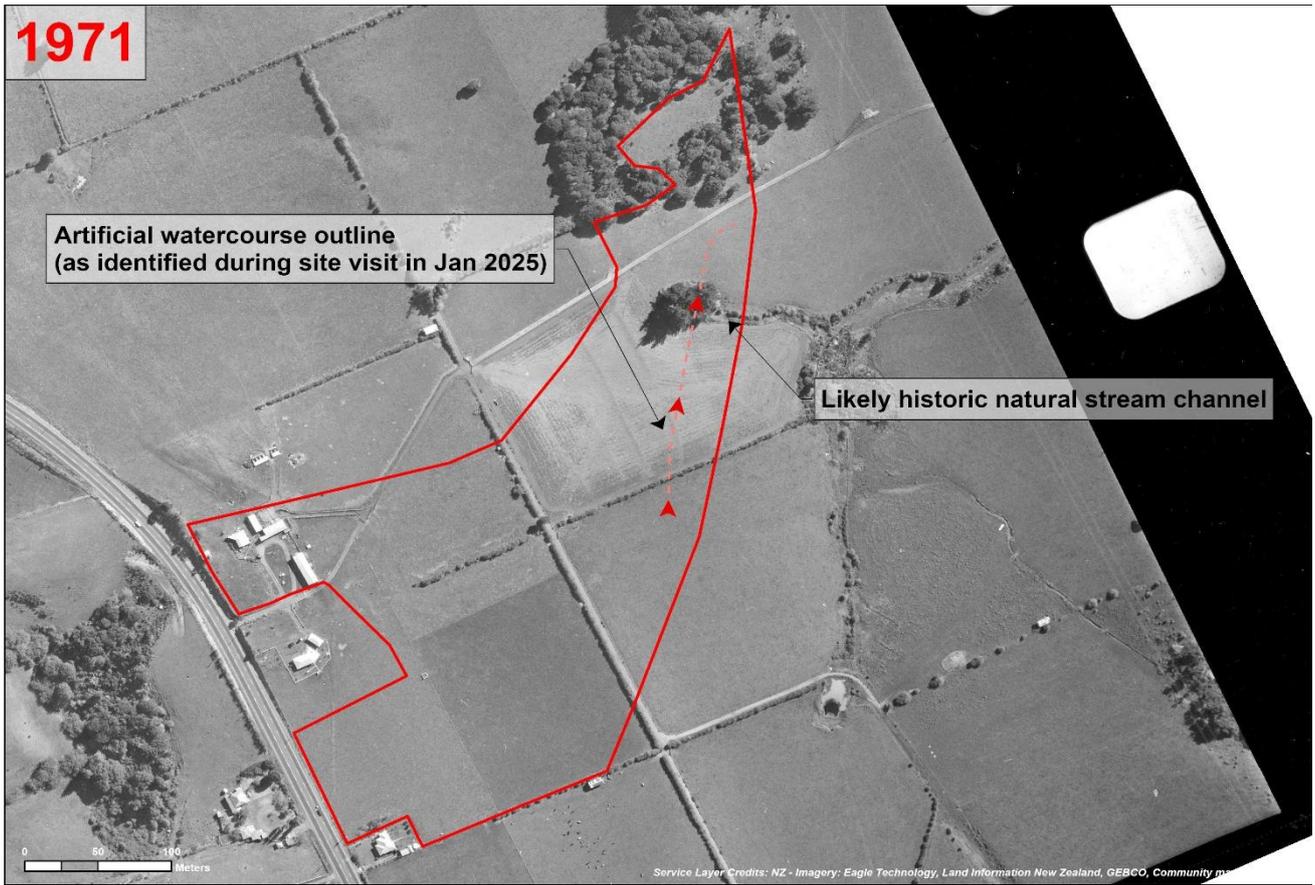
Figure 7: Showing site imagery from 1971 (Retrolens)

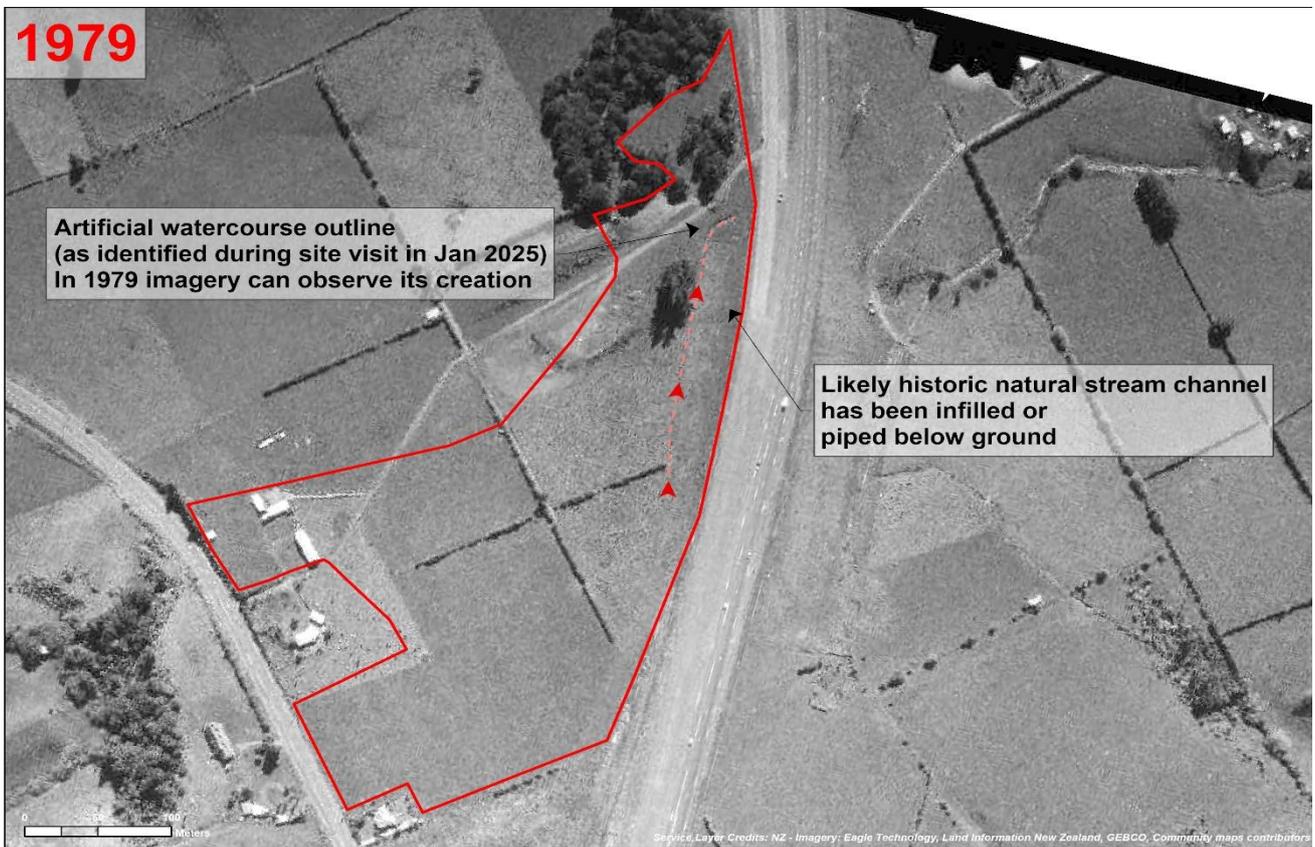
Figure 8: Showing site imagery from 1979 (Retrolens)

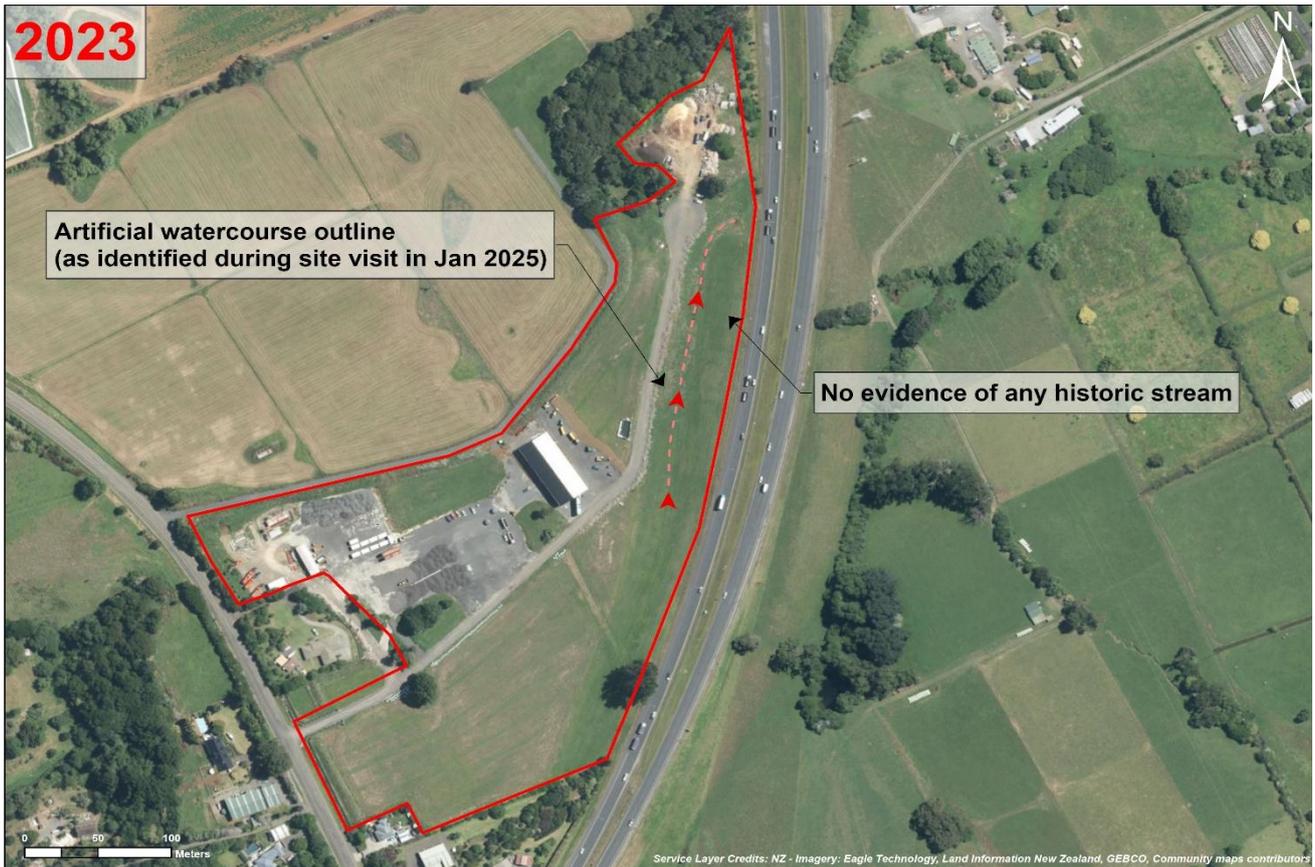
Figure 9: Showing site imagery from 2023 (LINZ)

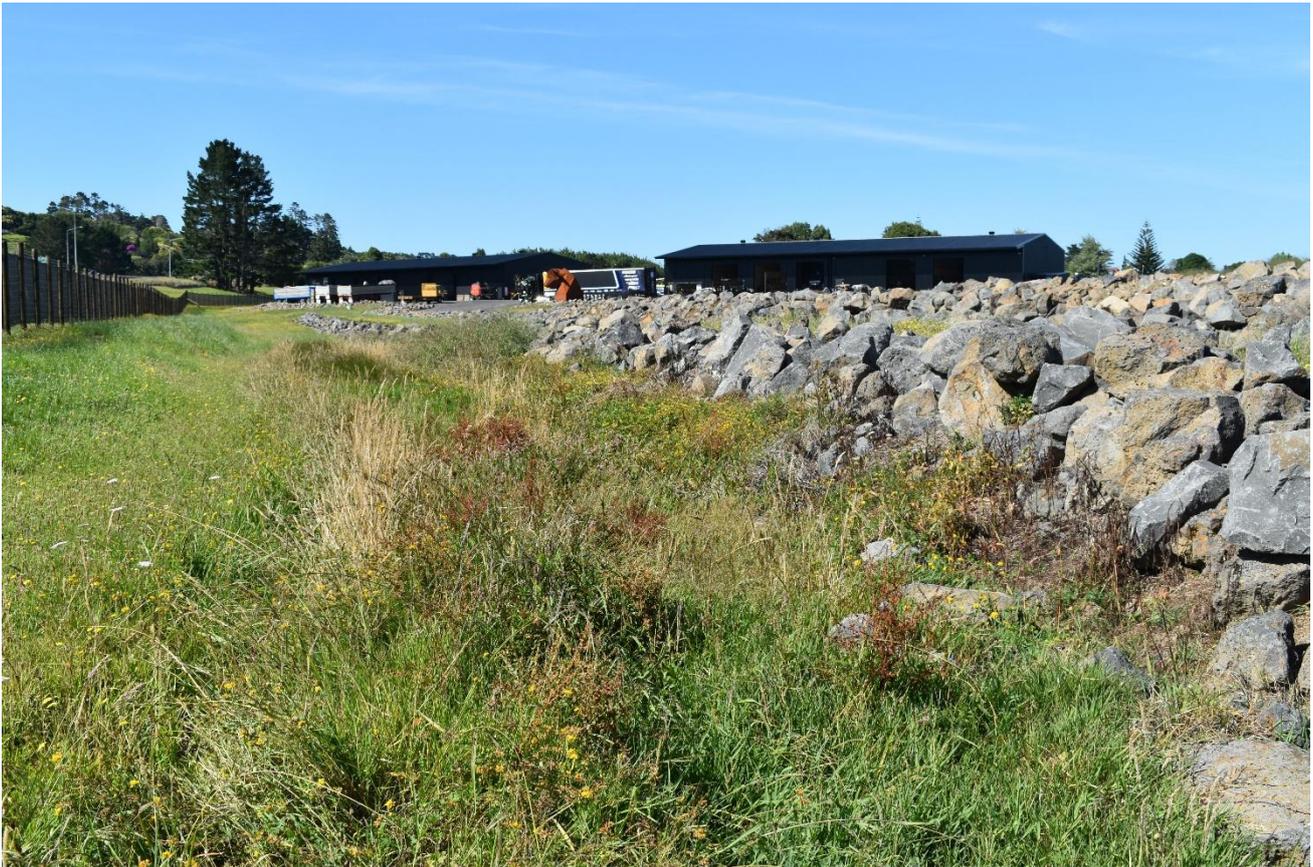
During the site visit, scattered patches of exotic hydrophytic vegetation were observed within the channel of the artificial watercourse/swale (see Figure 10). Species recorded included a mixture of kikuyu (*Cenchrus clandestinus*), mercer grass (*Paspalum distichum*), greater bird's-foot trefoil (*Lotus pedunculatus*), creeping buttercup (*Ranunculus repens*), and occasional clumps of soft rush (*Juncus effusus*). While these species are typically associated with periodically saturated environments due to their tolerance of wet conditions, their presence alone does not determine natural inland wetland status under the National Policy Statement for Freshwater Management 2020 (NPS-FM 2020).

Figure 10: Showing the general vegetation composition of the artificial swale

Following field assessment and consideration of historic aerial imagery, it was determined that the watercourse in question is artificial in origin. As such, any hydrophytic vegetation present within the channel is considered to have established within or around a deliberately constructed water body.

Under clause 3.21 of the NPS-FM 2020, and as clarified in the Resource Management (National Environmental Standards for Freshwater) Regulations 2020, an area does not meet the definition of a "natural inland wetland" if it satisfies exclusion criterion (c)—namely, *"a wetland that has developed in or around a deliberately constructed water body since its construction."* Based on this, the observed vegetation within the artificial watercourse/swale does not meet the threshold for classification as a natural inland wetland.

Scattered exotic hydrophytic vegetation was identified within the artificial watercourse/swale channel; however, this vegetation has established within a deliberately constructed water body. As such, in accordance with Clause 3.21 of the National Policy Statement for Freshwater Management 2020 (NPS-FM 2020), and the Resource Management (National Environmental Standards for Freshwater) Regulations 2020, this feature meets exclusion criterion (c) and does not qualify as a 'natural inland wetland'.

Consequently, a full wetland delineation was not undertaken, and no areas within the subject site meet the definition of a 'natural inland wetland' under the NPS-FM 2020. The artificial watercourse does not warrant classification as a natural feature under the current regulatory framework.
