Geotechnical Investigation Report

22 & 22A Summit Drive, Mount Albert
For Alan An

Reference: 5057
Date: 11th February 2025
Revision: B

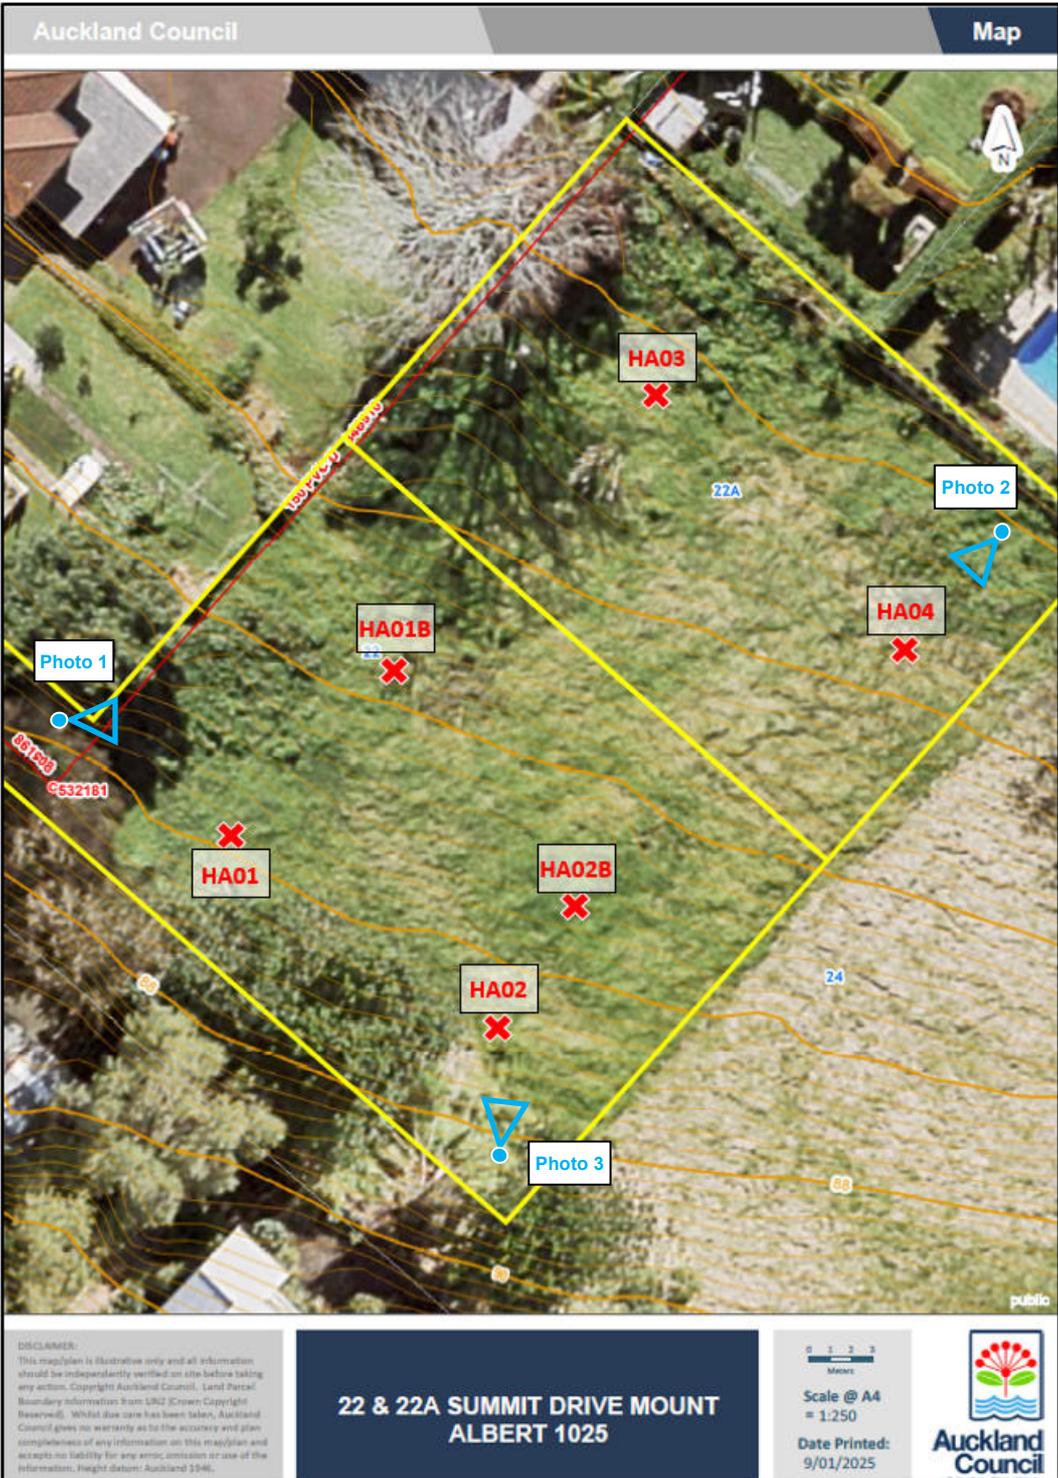
Figure 2: Site Layout and Investigation Plan (courtesy of Auckland Council Geomaps)

We carried out a site walkover on 9th January 2024. Six 50mm diameter hand augered exploratory holes were carried out in the areas of the proposed new dwelling. The locations of our exploratory holes

(labelled as HA01-HA04) are shown in Figure 2. In-situ Pilcon Shear Vane tests were carried out in the augered holes generally at 0.5m depth intervals.

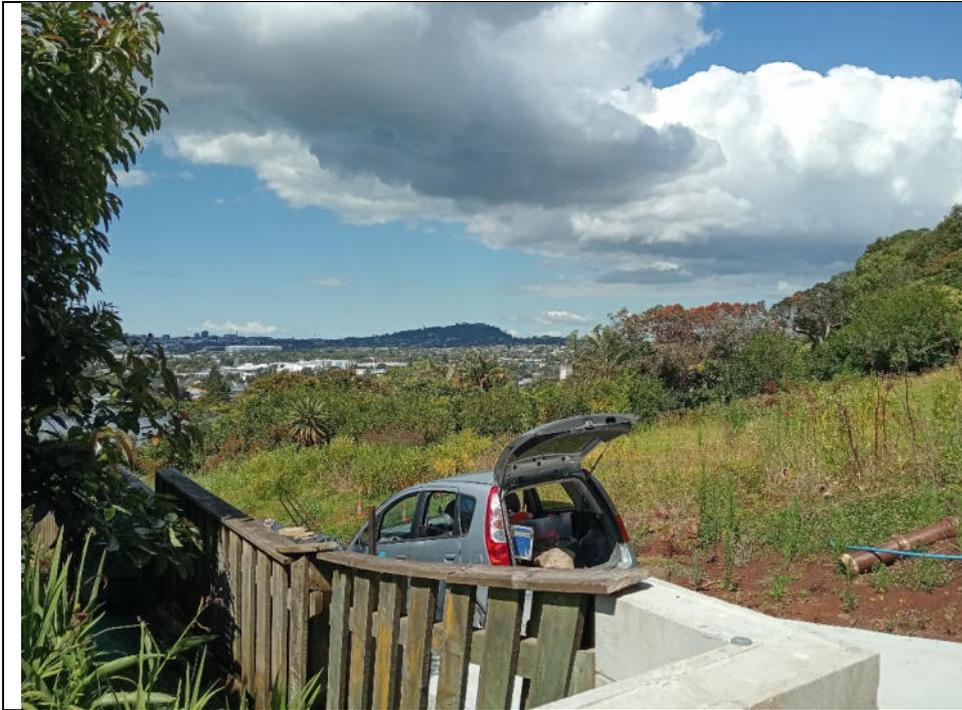
Photo 1: This photo was taken towards the western corner of the property facing east.

The property can be accessed directly from Summit Drive via common access driveway. At the time of our investigation the property consisted mostly of overgrown vegetation. The ground across the property slopes gently to moderately down to the north at approximately 10°-15°.

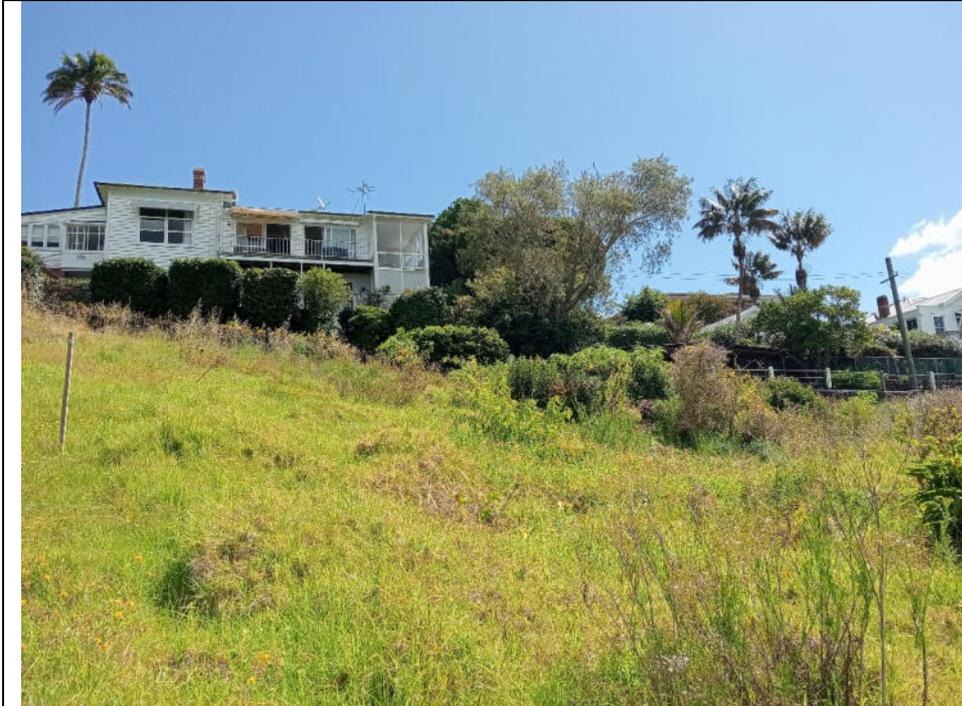
Photo 2: This photo was taken towards the easter corner of the property facing southwest.

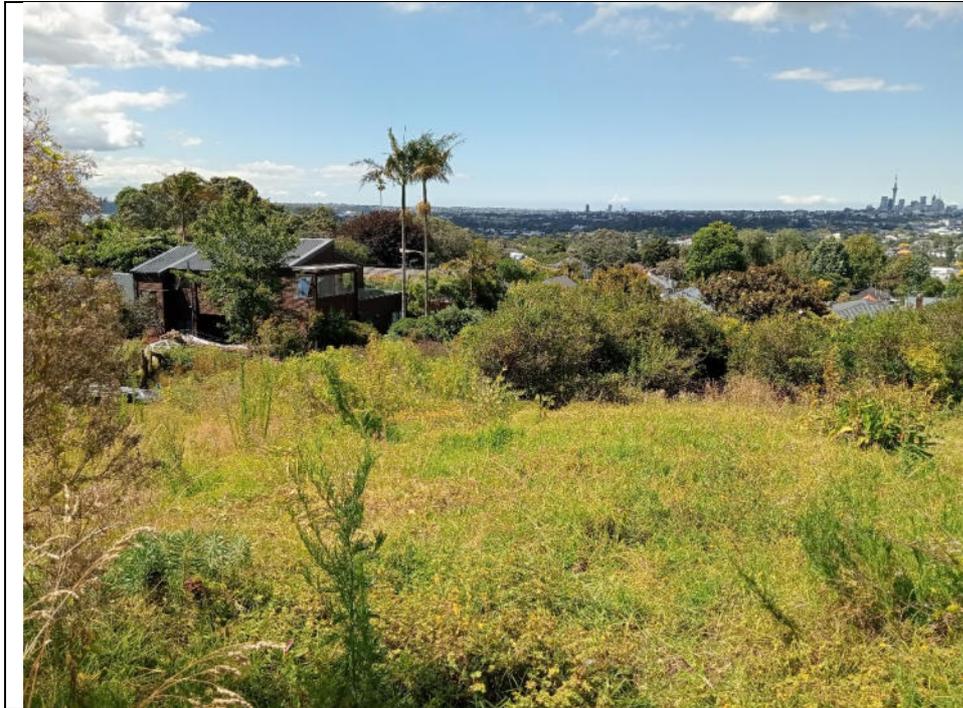
Photo 3: This photo was taken towards the southern corner of the property facing north.

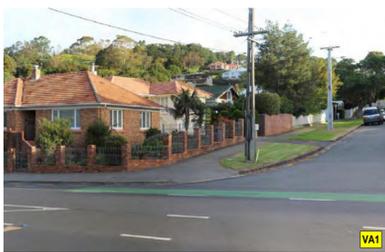
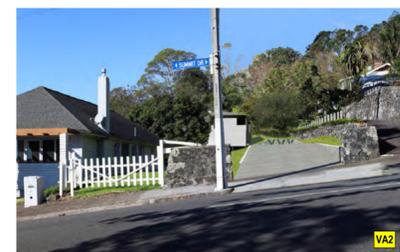
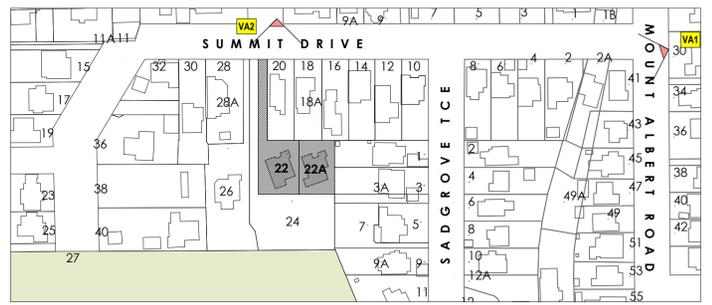
EC EARTH CUT STUDIES

According to the architectural plans prepared by 10x10 Architecture (Option 3B, dated 29/01/2025), there will be excavation of down to $\leq 1.4\text{m}$ and fill of up to $\leq 1.0\text{m}$, from the existing ground level, for the construction of two new two-storey dwellings.

The site is on moderately sloping ground. The current expected cut and fill depths of $\leq 1.4\text{m}$ & $\leq 1.0\text{m}$, respectively, are based off the provided survey & preliminary architectural plans. Based on our site investigation, the site is likely underlain by volcanic ash with medium to large basalt boulders which can be excavated using suitably sized excavators. Rock breaking using hydraulic hammer is unlikely required for achieving the proposed ground levels.
