# Blackpool Stormwater Improvements Stage One

## Ecological Impact Assessment

Prepared for Auckland Council

Prepared by Beca Limited

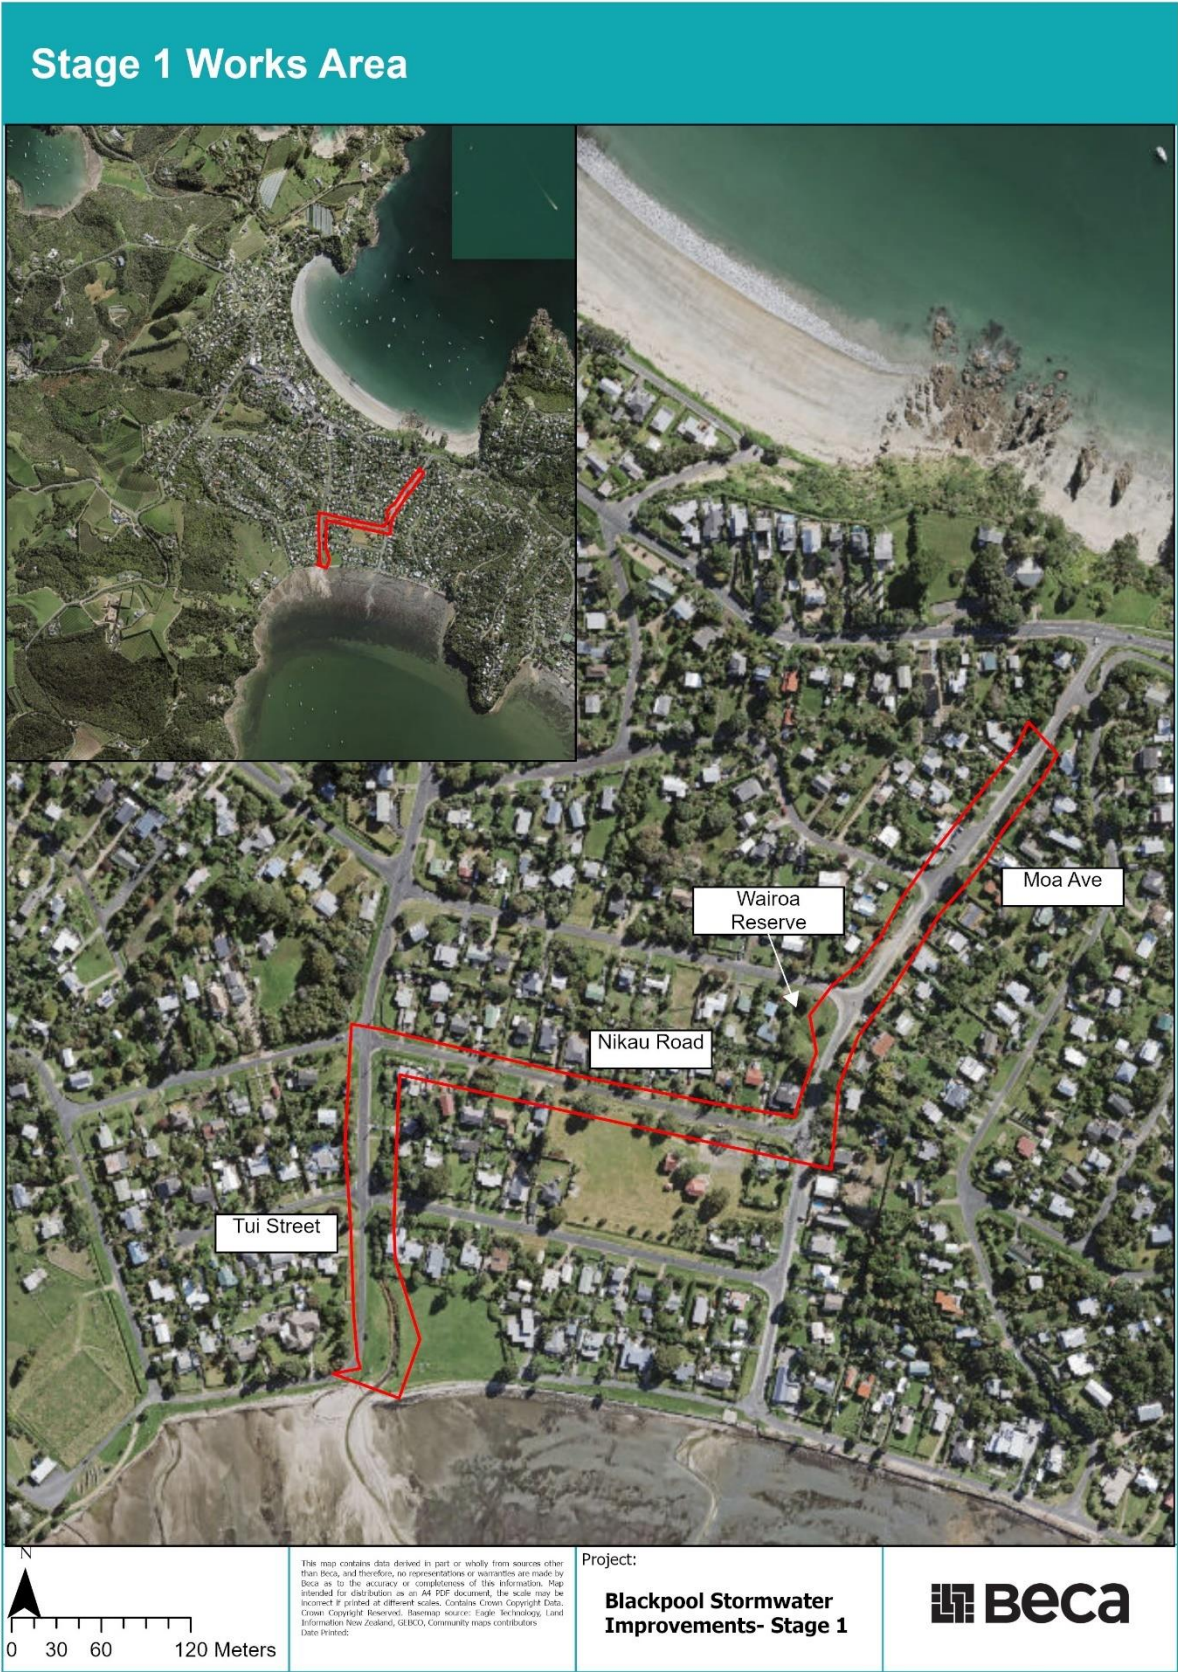
Figure 1. Overview of the Stage 1 works area (outlined in red), in relation to nearby streets and the wider context of the catchment.

The proposed works will be undertaken in the suburb of Blackpool on Waiheke Island, with Stage 1 taking place across Tui Street, Nikau Road, and Moa Avenue (referred collectively as “works area”) (Figure 1). The majority of the improvement works are occurring within natural streams that have been modified into stormwater drainage channels. The stormwater network discharges into the coastal environment at Blackpool Beach.

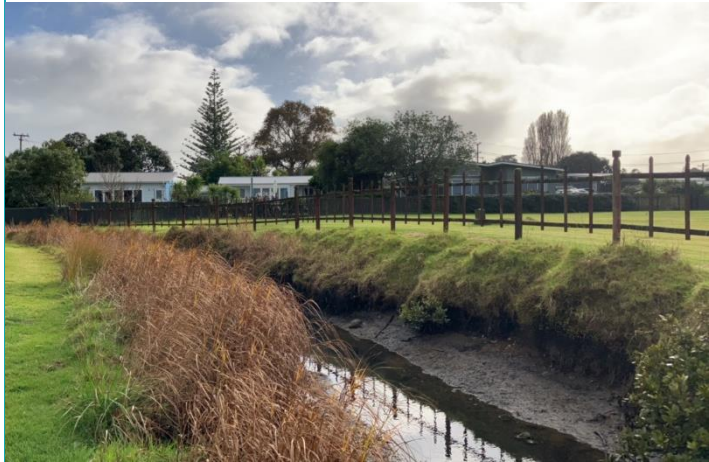
Watercourse ID	Assigned Ecological Value	Description of Feature	Classification	Photos
P1	Moderate	<p><b>Representativeness: Low</b> Permanent estuarine channel from a first order channel<sup>9</sup>. Channel has been modified to convey stormwater flows.</p> <p><b>Rarity/distinctiveness: Moderate</b> Grey mangroves (<i>Avicennia marina</i>; Not Threatened) present within the channel.</p> <p>eDNA sample detected shortfin eel and banded kōkopu within the channel (both Not Threatened), and a benthic community largely comprised by tolerant taxa.</p> <p>WL10 (oioi, m restiad rushland/reedland) ecosystem mapped, and the site visit confirmed the dominance of dominated by <i>Bolboschoenus fluviatilis</i>, a diagnostic species of this ecosystem type.</p> <p><b>Diversity/pattern: Low</b> Includes coastal vegetation that potentially supports native fish, invertebrates, and birds.</p>	Permanent stream under the AUP:OP with wetland riverine margins under the NPS-FM (2020)

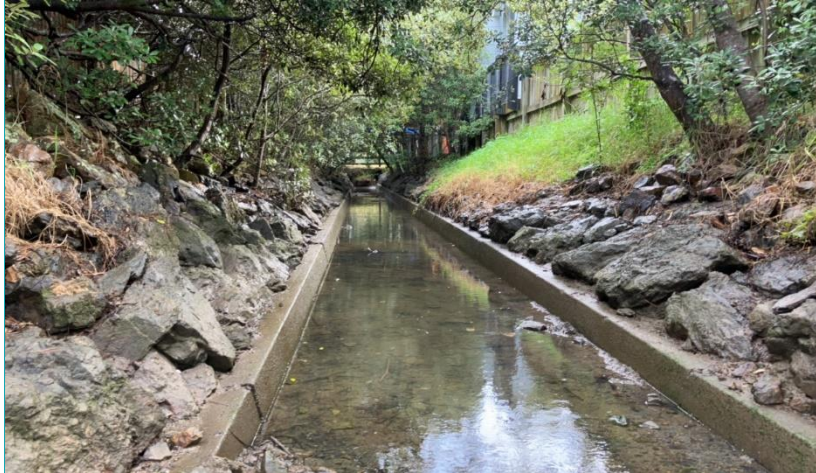
Watercourse ID	Assigned Ecological Value	Description of Feature	Classification	Photos
P2	Low	<p><b>Representativeness: Low</b> First order permanent stream channel</p> <p>Stream channel and morphology has undergone significant modifications including channel straightening, installation of culverts, and artificial lining and base.</p> <p><b>Rarity/distinctiveness: Low</b> Benthic community is expected to comprise of taxa predominantly tolerant to environmental changes and pollution.</p> <p><b>Diversity/pattern: Low</b> Low diversity and complexity.</p> <p><b>Ecological Context: Moderate</b> Provides limited habitat for native fish.</p> <p>This section of the channel with an upstream culvert that is partially embedded in the streambed.</p> <p>Riparian vegetation dominated by karo (<i>Pittosporum crassifolium</i>) in a well-established closed canopy, providing high shading and organic debris input into the channel.</p> <p>Channel forms part of the wider stormwater network, which retains nature characteristics,</p>	Permanent stream under the AUP:OP

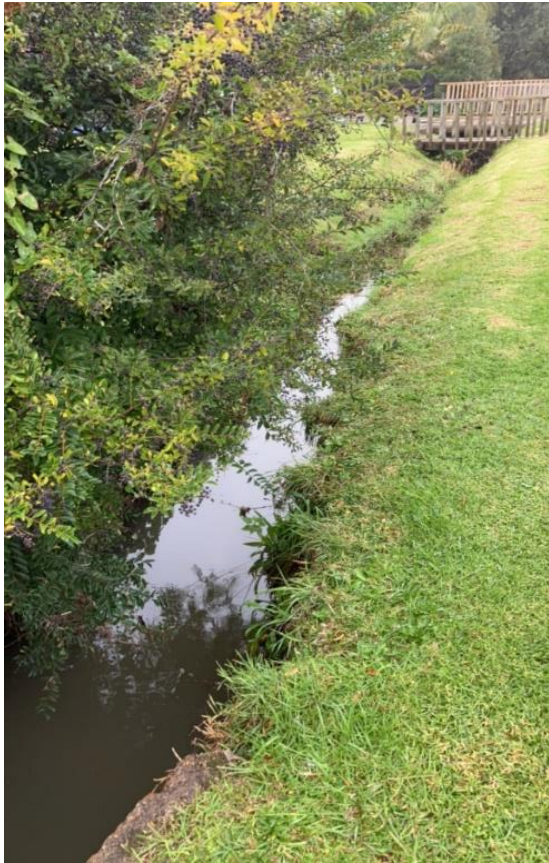
Watercourse ID	Assigned Ecological Value	Description of Feature	Classification	Photos
		however, has been highly modified to convey stormwater flows.		
P3	Low	<p><b>Representativeness: Low</b> First order permanent stream channel – represents the upstream section of Sites 1 and 2.</p> <p>Stream channel and morphology has undergone significant modifications including channel straightening and deepening</p> <p><b>Rarity/distinctiveness: Low</b> Benthic community is expected to comprise of taxa predominantly tolerant to environmental changes and pollution.</p> <p>Vegetation is only present along the true left bank and includes karo, scattered patches of woolly nightshade (<i>Solanum mauritianum</i>), flax (<i>Phoridium tenax</i>), Chinese privet (<i>Ligustrum sinense</i>), a large blue jacaranda (<i>Jacaranda mimosifolia</i>) and red mapou (<i>Myrsine australis</i>). The understorey comprises <i>Agapanthus praecox</i>, <i>Acanthus mollis</i>, arum lily (<i>Zantedeschia aethiopica</i>), and exotic grasses.</p> <p>Native fish community are expected to be typically low</p>	Permanent stream under the AUP:OP

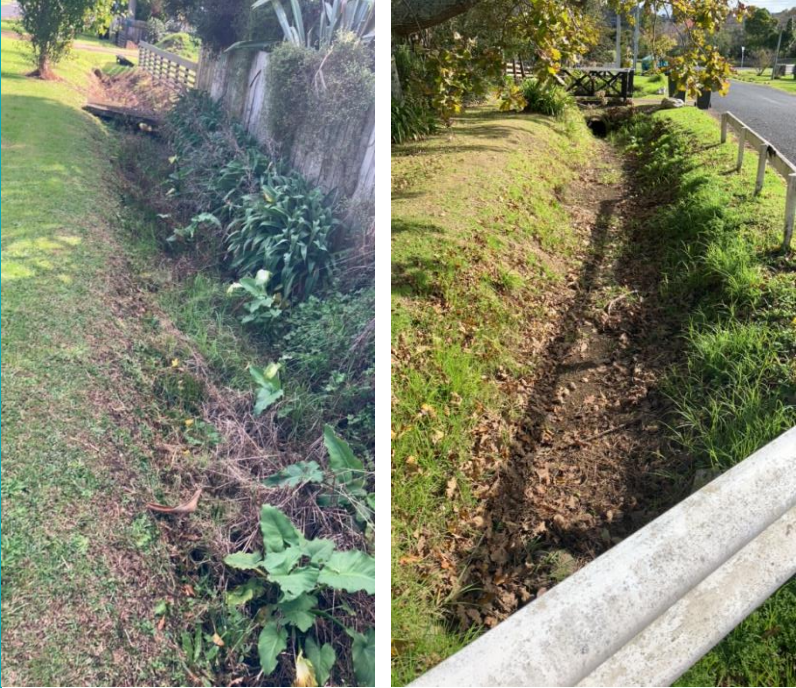
Watercourse ID	Assigned Ecological Value	Description of Feature	Classification	Photos
A4	N/A	<p>As detailed within the Wetland and Watercourse Assessment<sup>10</sup>, A4 typifies a constructed swale channel alongside the road, directed slightly against contour gradient. Therefore, A4 has been classified as an artificial watercourse under the AUP:OP.</p> <p>Given this, A4 not been assessed for ecological value and is not further addressed in this report.</p>	Artificial watercourse under the AUP:OP

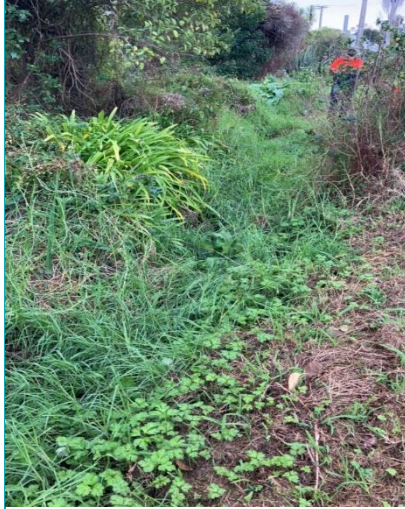
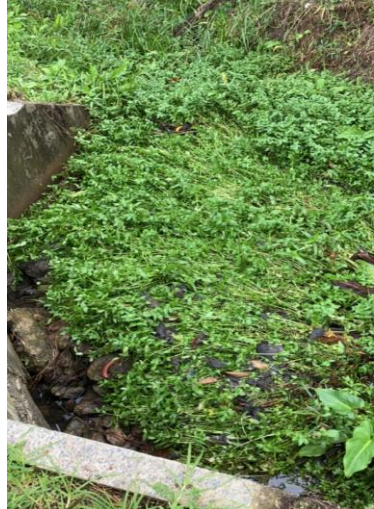
Watercourse ID	Assigned Ecological Value	Description of Feature	Classification	Photos
P6	Low	<p><b>Representativeness: Low</b></p> <p>The channel is mapped as an overland flow pathway but is more likely intermittent.</p> <p>Located within a highly modified catchment.</p> <p>Expected to support a low diversity of native fish only, given the modified nature of the system and the piped upstream end, and the perched culvert downstream.</p> <p>Channel has been modified with the installation of a culvert at the upstream and downstream end.</p> <p><b>Rarity/distinctiveness: Low</b></p> <p>Benthic community is expected to comprise of taxa predominantly tolerant to environmental changes and pollution</p> <p>The blocked culvert has allowed for water pooling, which has enabled the establishment of watercress, an obligate wetland species often found in shallow water ponds and drains. Given this, the establishment of watercress is considered to have established around an artificial structure (the culvert), and is excluded as a <i>natural inland wetland</i> under the NPS-FM.</p> <p><b>Diversity/pattern: Low</b></p>	Intermittent watercourse
