3 PIGEON MOUNTAIN ROAD,
HALFMOON BAY, AUCKLAND,
PROPOSED RESIDENTIAL
DEVELOPMENT

Geotechnical Investigation Report

Document Number: J00538AA

Prepared For: HND HMB Ltd

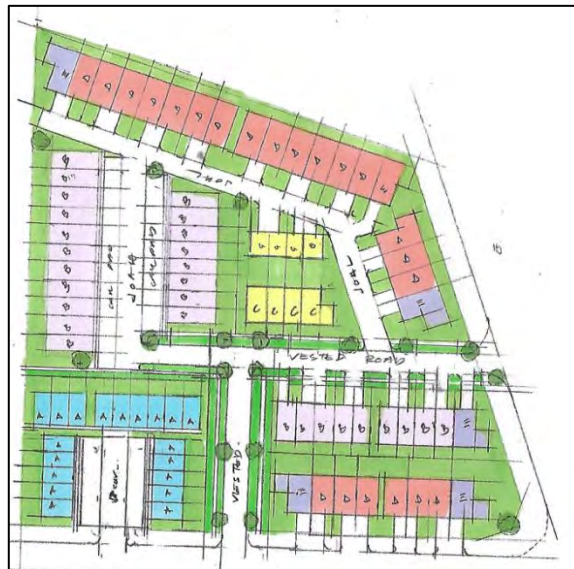
Figure 2, Hand sketched preliminary site plan.

Figure 2 shows a hand sketched scheme plan, extracted from (appendix A)

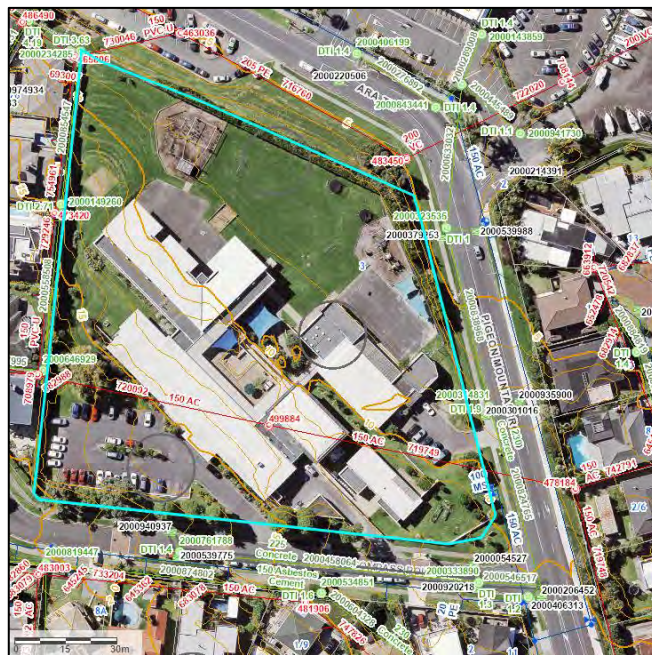
Figure 3, Aerial view of site (Source, AC Geomaps)

The site is currently occupied by a school comprising five large school buildings located centrally with playgrounds, basketball court and carparking elsewhere with the remainder of ground coverage consisting of sports grounds. A sanitary sewer transects the site east to west, in the southern side of the site as shown in Figure 3.

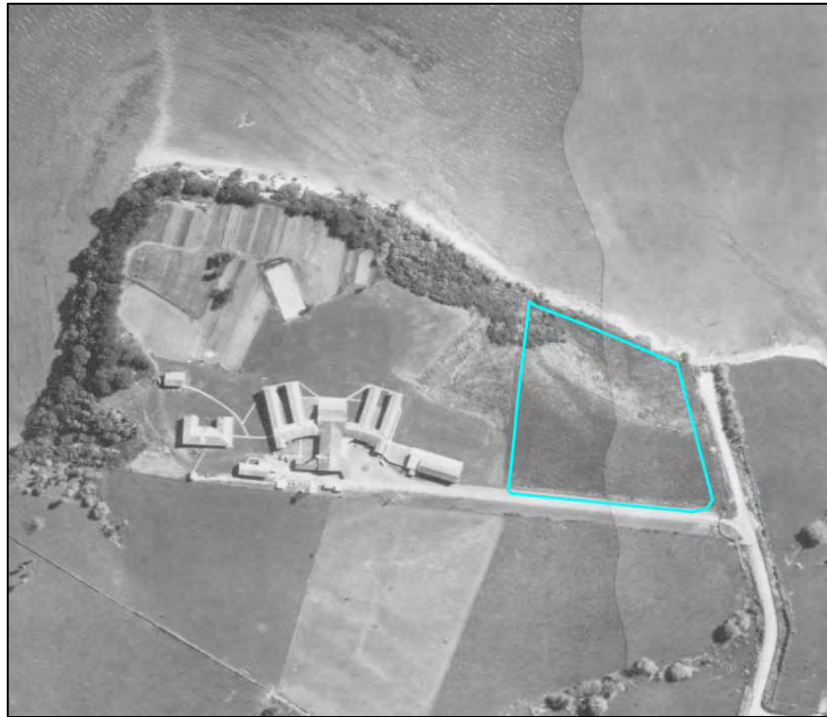
Figure 4, Aerial view of site in 1959 (Source, AC Geomaps)

In order to help interpret the borelogs, we have investigated the land use history of the site from Auckland Council Geomaps. Figure 4 shows that the site was grassland without any buildings with the northern boundary being the edge of the foreshore. The land reclamation work for the half moon bay marina was completed before 1996. The reclamation filling extended onto the northern lower-lying portion of the site to construct Ara-Tai Road as clearly shown in Figure 5. The provided property files indicate the school development was completed in 2002 and as shown in Figure 6.

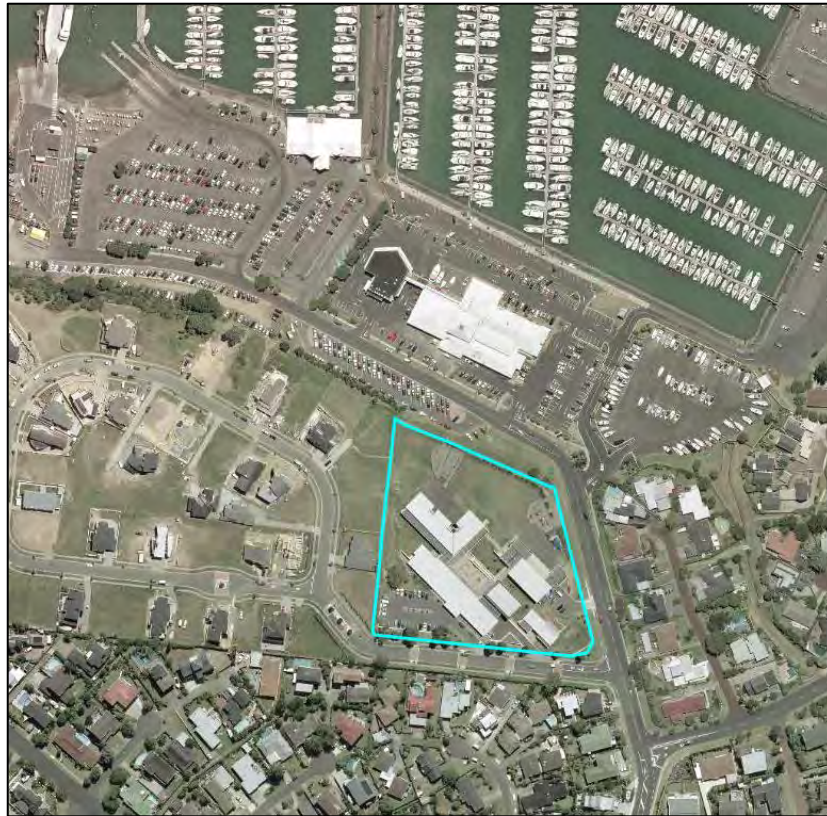
Figure 6, Aerial view of site in 2006 (Source, AC Geomaps)

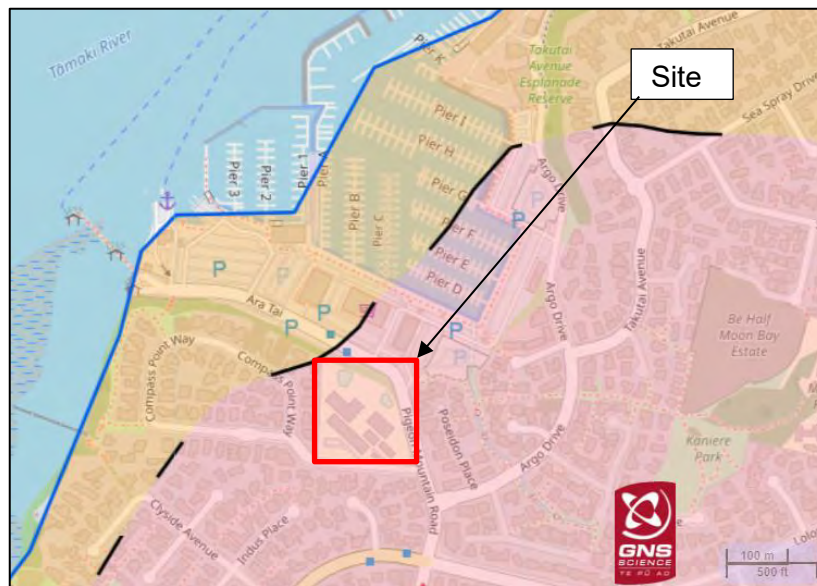
Figure 7, Snapshot of NZ Geological Map.

Reference has been made to the New Zealand Geology Web Map on the GNS website, <http://data.gns.cri.nz/geology/>, accessed on 10th June 2022 (refer Figure 7).

The maps indicate that the site is underlain by Tuff of the Auckland Volcanic Field (AVF, coloured purple in Figure 7). The AVF tuff comprises comminuted pre-volcanic materials with basaltic fragments, and unconsolidated ash and lapilli deposits. These volcanic materials can be spatially variable in terms of material types, often with abrupt end to ash deposits, with well sorted lapilli, tuff, ash and breccia at the margins.

The map indicates a geological boundary to the north of the site, mapped as East Coast Bays Formation (ECBF, coloured orange in Figure 7) of the Waitemata Group. The ECBF comprises alternating sandstone and mudstone with variable volcanic content and interbedded volcanoclastic grit beds.

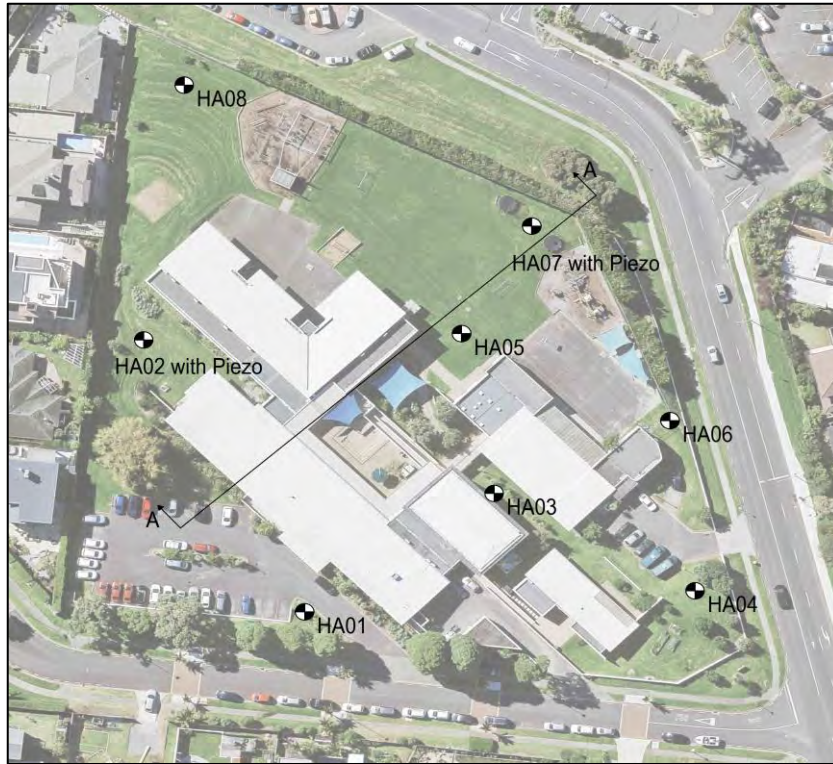
Figure 8, Investigation Plan.

The location of the hand augers and soil samples are shown in Figure 8 extracted from the *Test Location Plan* attached in Appendix B.

Our investigations generally confirm the geology reported in the available literature. We have developed a geological cross section AA along the alignment shown in Figure 8.

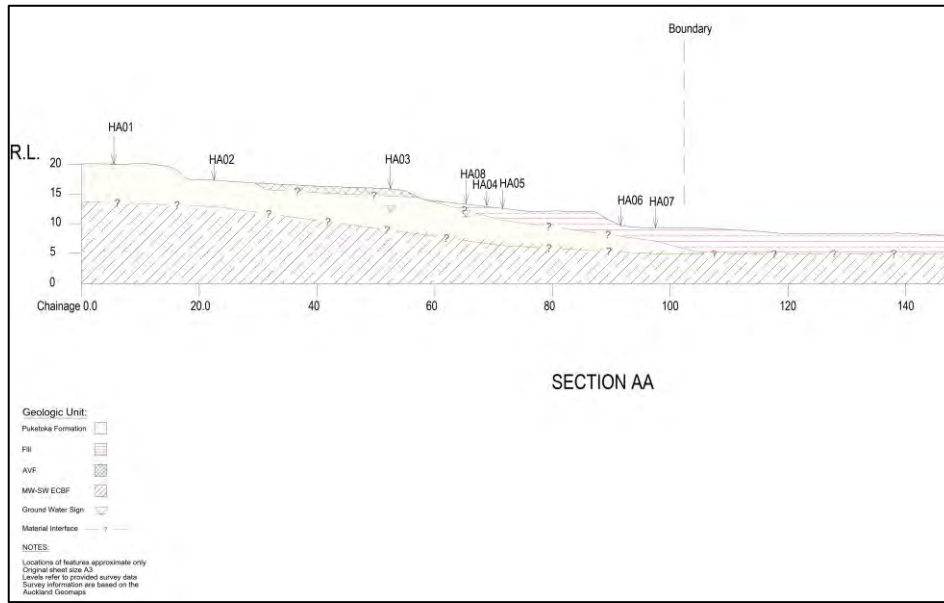
Figure 9. Geological Section AA.

Fill, associated with the marina reclamation, up to 4.0 m deep along the Pigeon Mountain Road boundary was encountered across the site. The composition and strength of the fill indicates that it can be considered as engineered fill.

AVF tuff was locally found in the southeast corner of the site (HA01, HA03 and HA04) and up to 2.5 m deep underlying the existing fill. The shear strength ranges from 100 kPa to 190+ kPa.

Puketoka formation, comprising stiff to very stiff silty clays and clayey silts, was encountered underlying the fill/AVF layer up to 5.0 m deep. This unit was not predicted by the geological maps. However, the engineering characteristics of the Puketoka Formation is similar to that of residually weathered ECBF.

The residual ECBF soils of sandy silt was only found in HA02 up to 5.0 m deep and not encountered in the rest of the investigation holes.

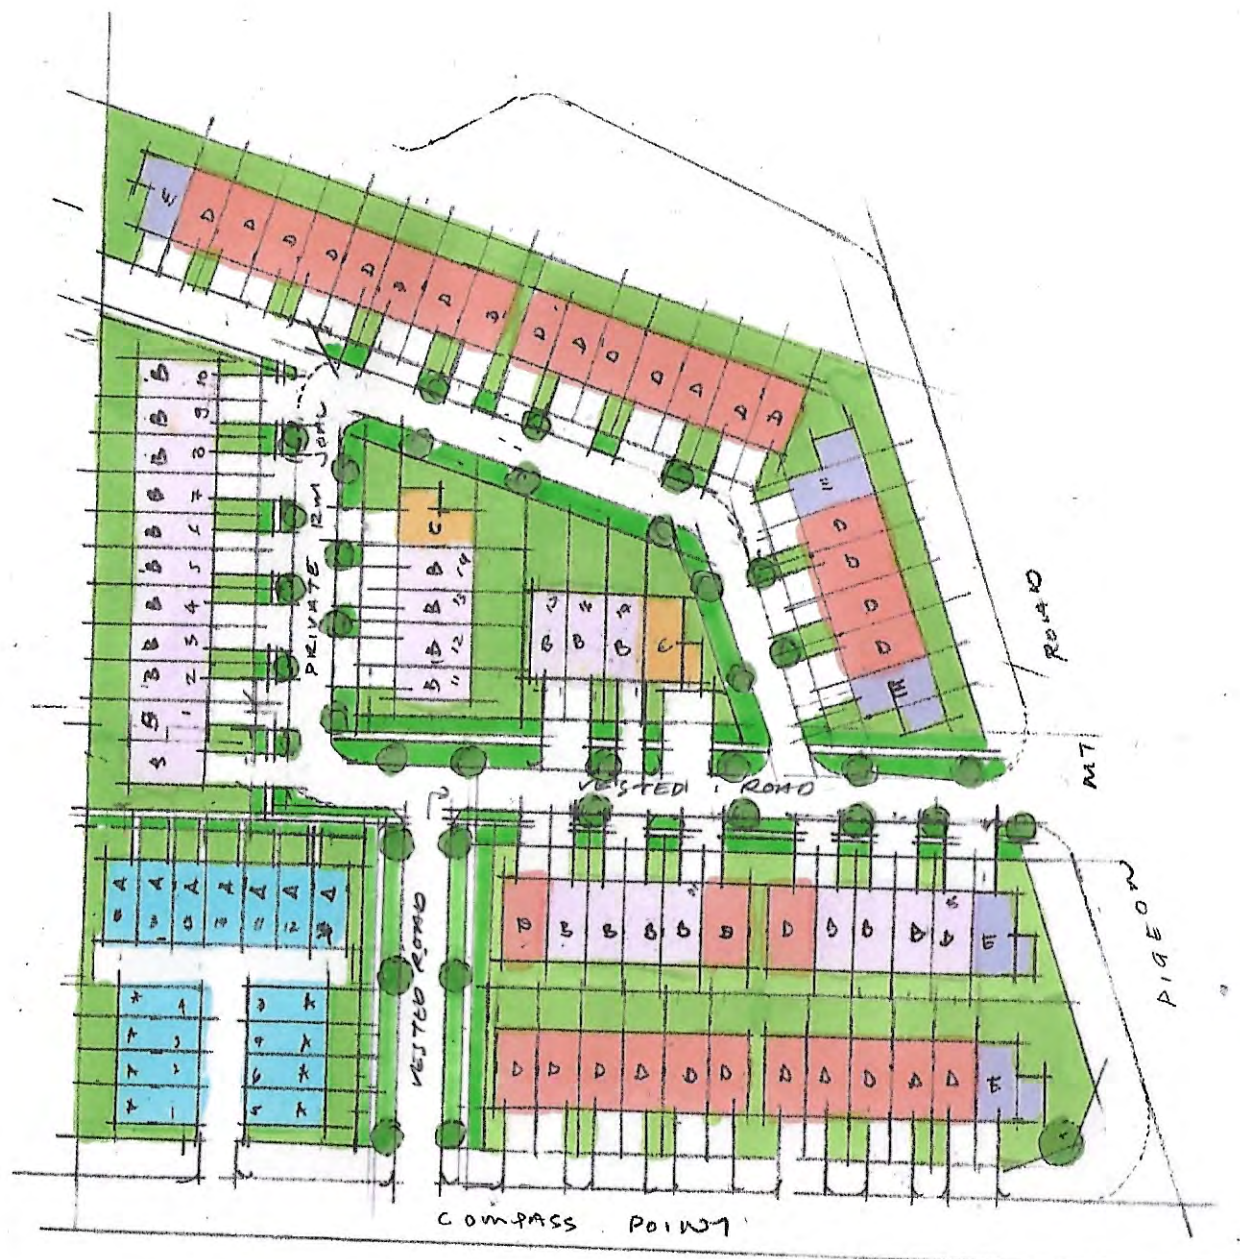
1.5M WIDE 3 STOREY - 3BRO + STUDY		
TYPE A	1 CAR GARAGE 120 SQ M	15	
TYPE B	5M WIDE 3 STOREY - 3BRO + 1STUDY 1 GARAGE + 1 CAR PAD 1140	27	
TYPE C	5M WIDE 160 3 STOREY - 4 BRO + FAMILY 1 GARAGE + 1 CAR PAD	2	
TYPE D	5.5M WIDE 150 3 STOREY 4BRO + STUDY 1 CAR GARAGE + CAR PAD	33	
TYPE E	5.5M WIDE 160 3 STOREY 4BRO DOUBLE GARAGE	4	
		81 units

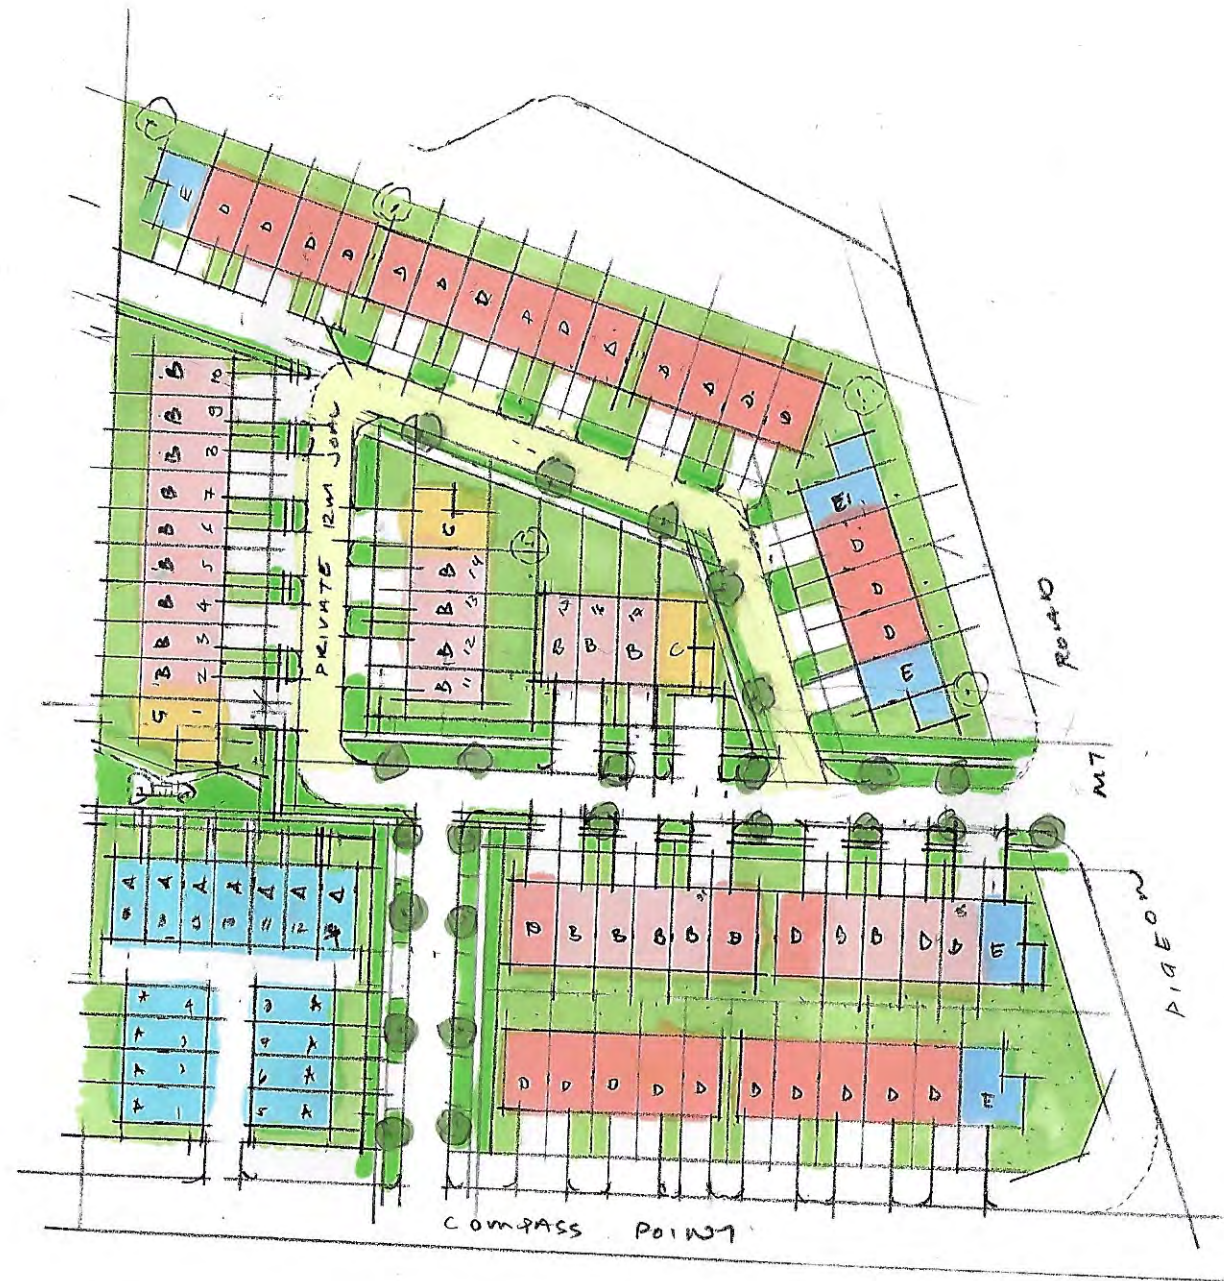
3 STOREY TERRACE
HOUSE TYPOLOGY

TYPE A	11.5M WIDE 3 STOREY - 3BBD + STUDY 1 CAR GARAGE 120 SQM	14	
TYPE B	5M WIDE 3 STOREY - 2BBD + 1STUDY 1 GARAGE + 1 CAR PAD 1140	25	
TYPE C	5M WIDE 3 STOREY - 4 BBD + FAMILY 1 GARAGE + 1 CAR PAD 160	3	
TYPE D	6M WIDE 3 STOREY 4BBD + STUDY 1 CAR GARAGE + CAR PAD 160	30-	
TYPE E	6M WIDE 3 STOREY 4BBD DOUBLE GARAGE 180	5	
		77 units

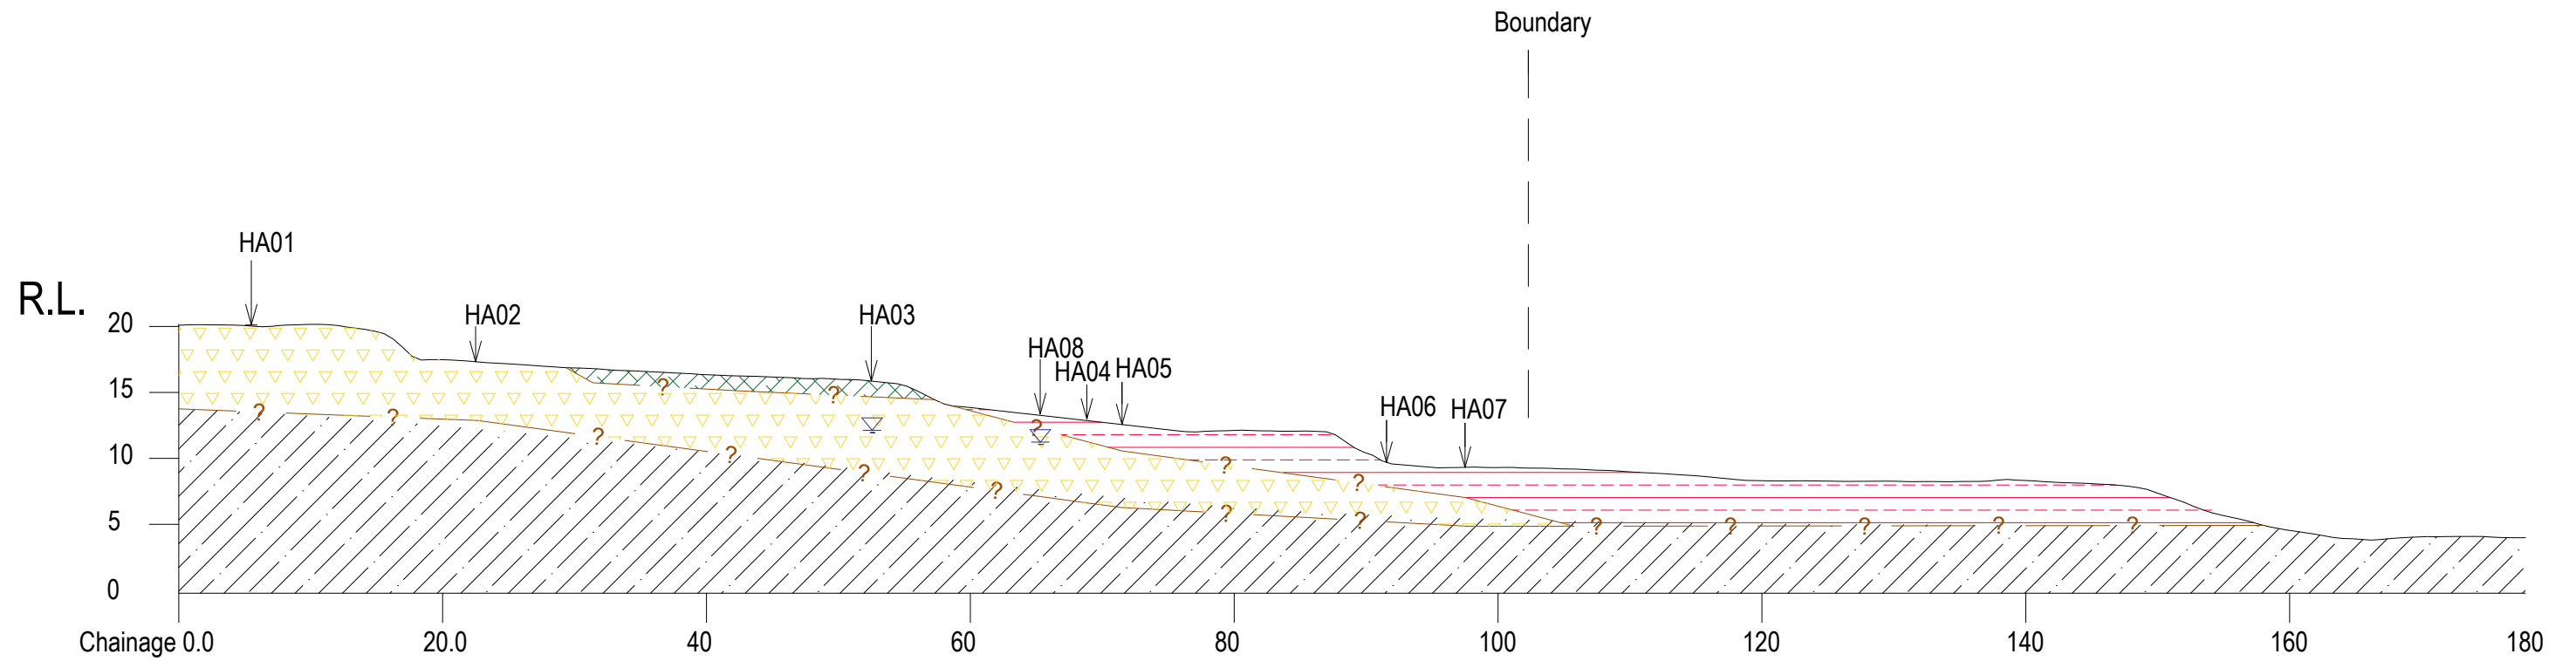
DRAWING TITLE
 GEOLOGICAL SECTION AA

SECTION AA

- Puketoka Formation
- Fill
- AVF
- MW-SW ECBF
- Ground Water Sign
- Material Interface
