## Shoreline Adaptation Plan

Manukau North

Volume 3: Adaptation Strategies

August 2025, Version 1.0

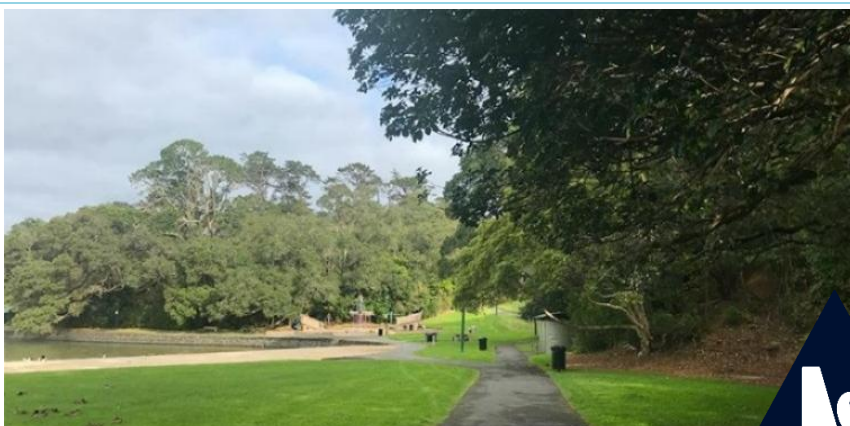
Āmio / Blockhouse Bay Beach Reserve with the various parks assets in view including the masonry seawall.

Āmio / Blockhouse Bay Beach Reserve – View from Endeavour Street looking into the park (Source: Auckland Council)

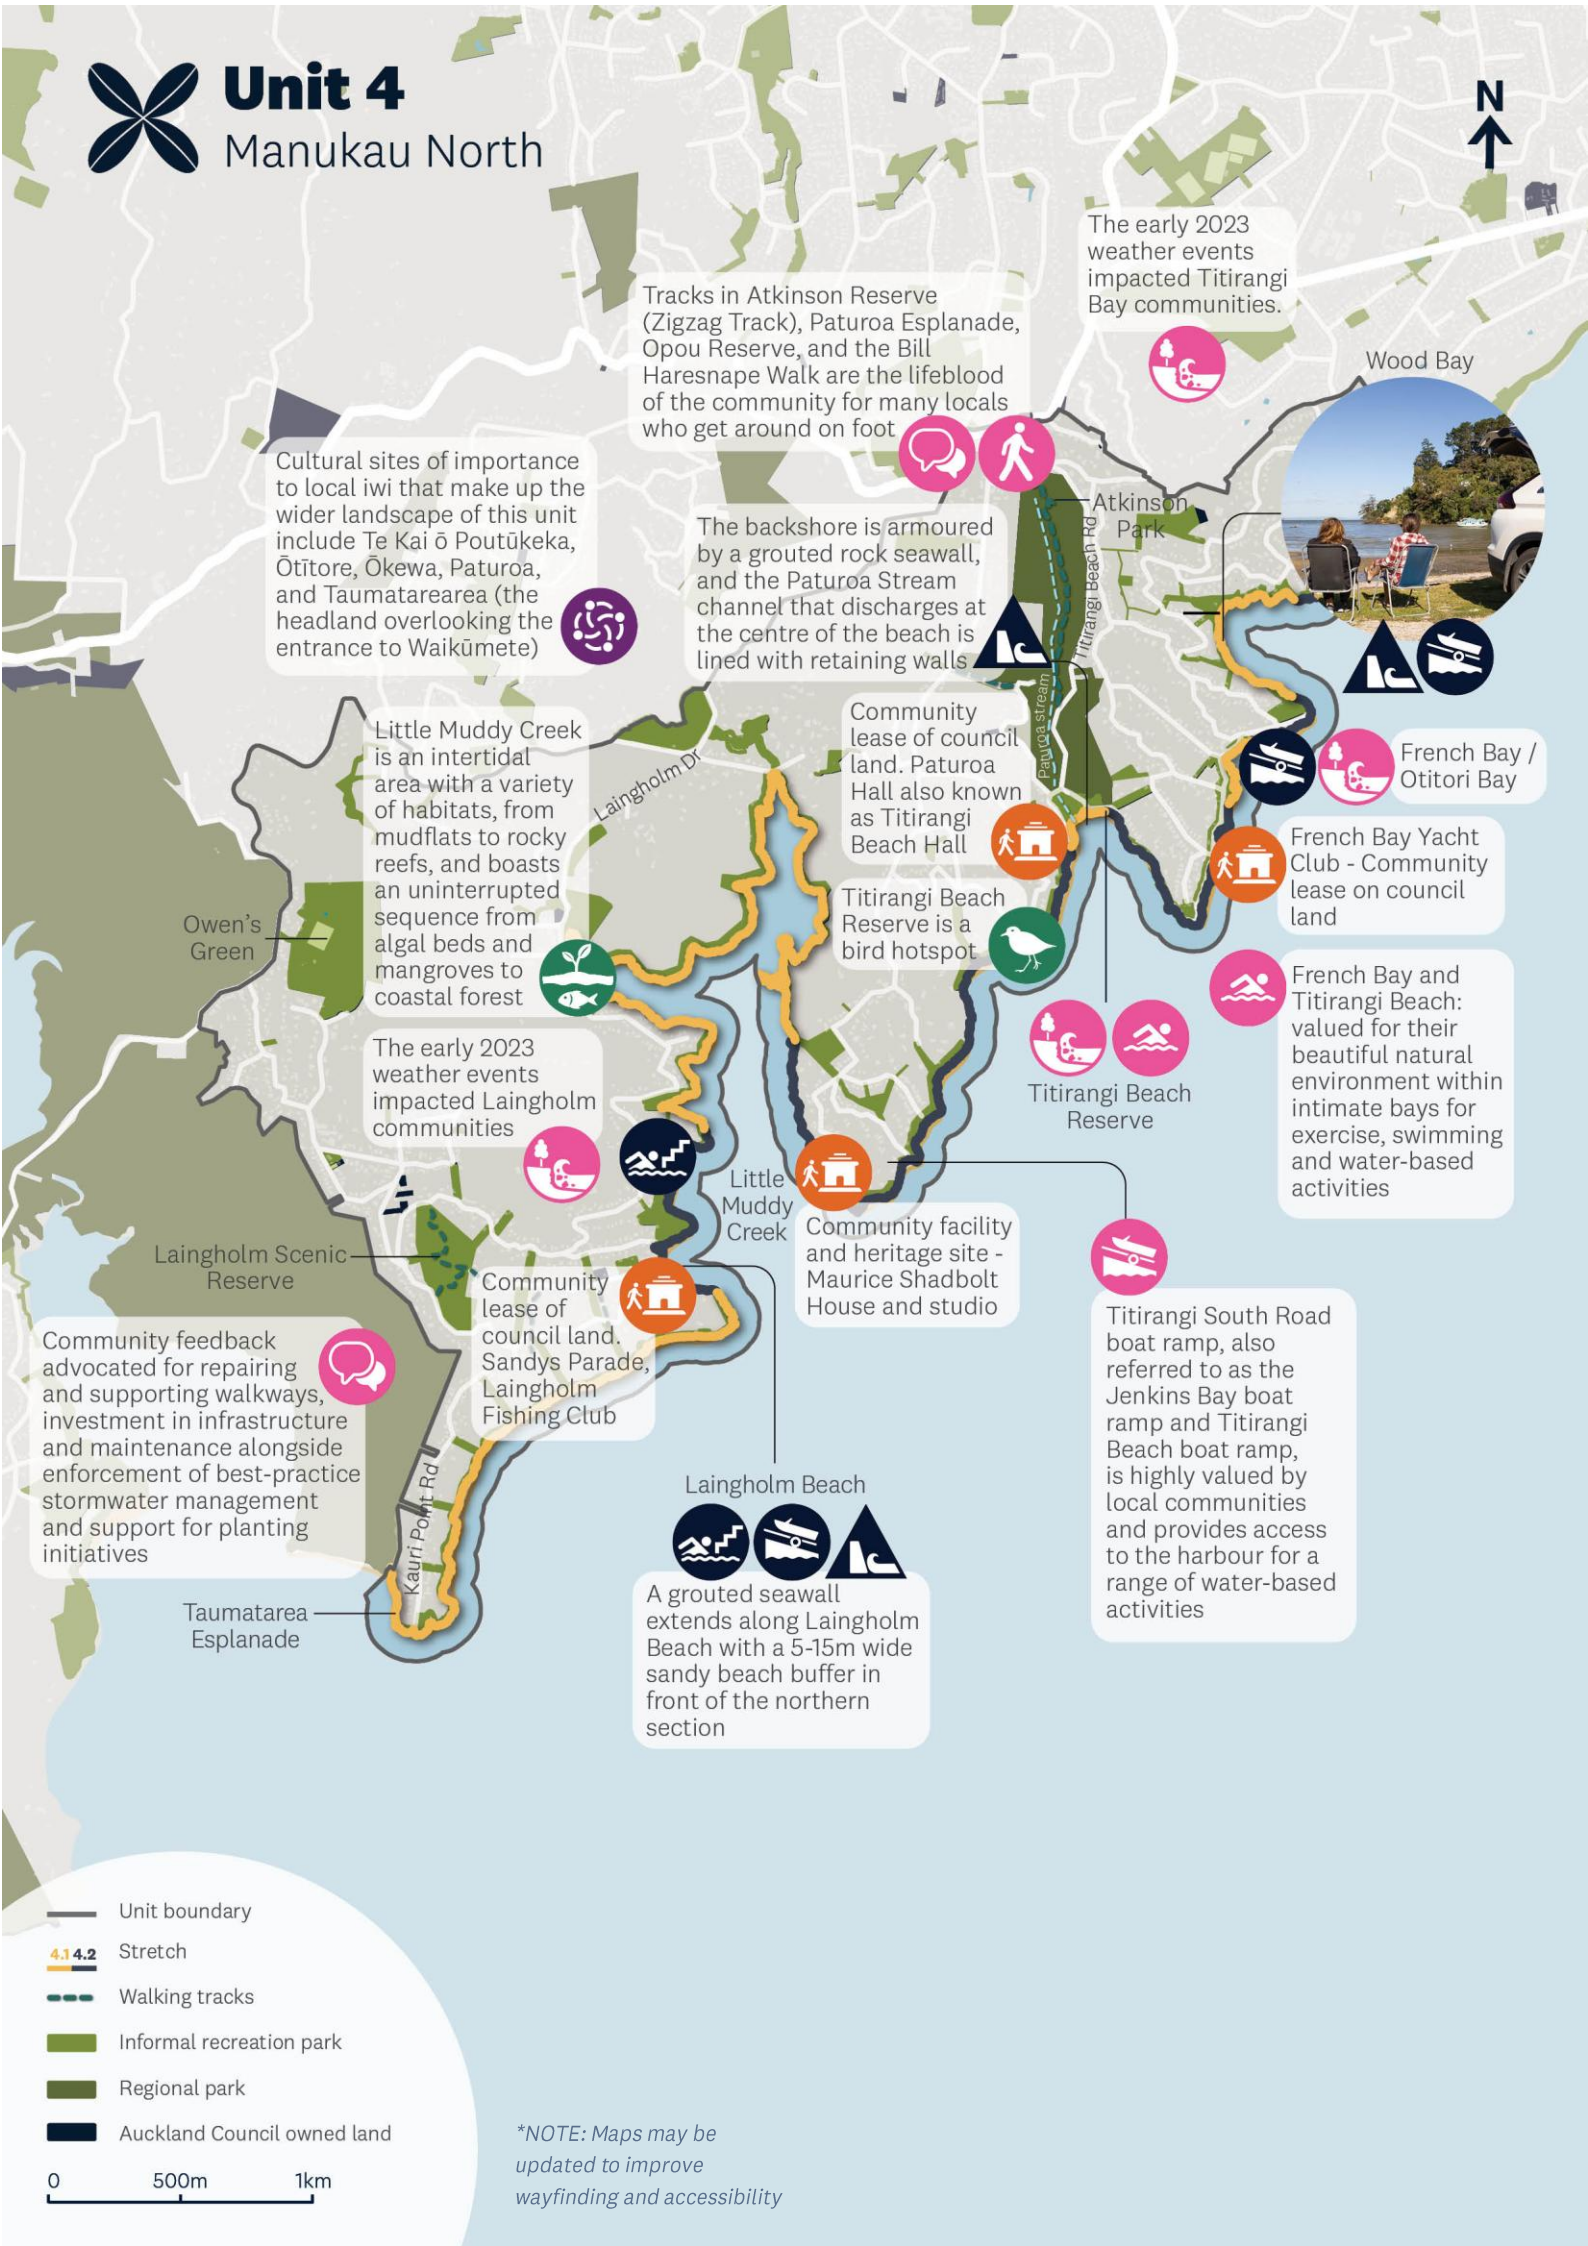
# Unit 4 Manukau North

- Unit boundary
- 4.1 4.2 Stretch
- Walking tracks
- Informal recreation park
- Regional park
- Auckland Council owned land

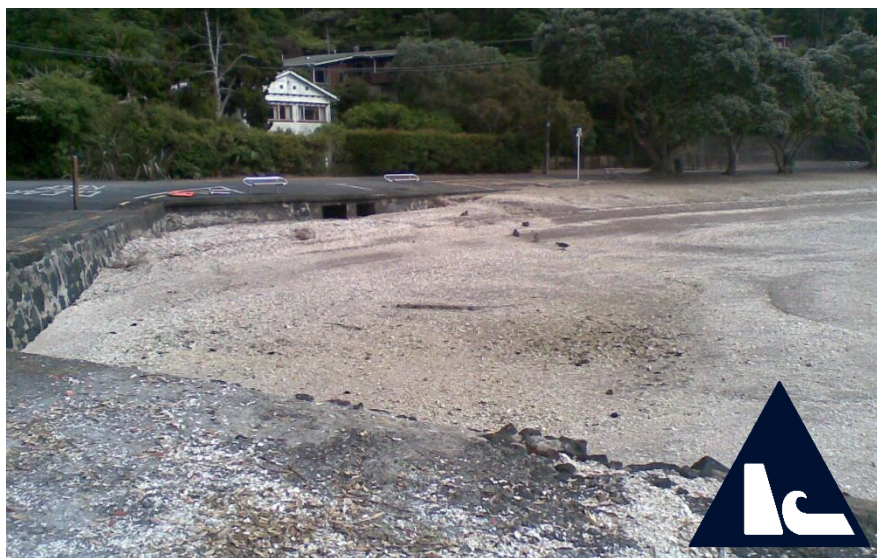
French Bay – low grouted seawall  
armouring Otitori Bay Road.

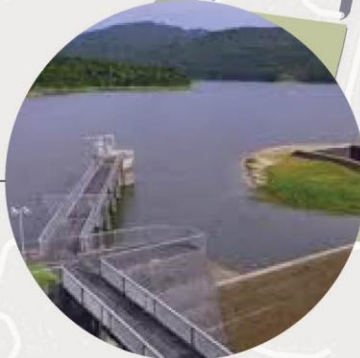
Lower Nihotupu Dam

The lower Nihotupu Dam is a significant water asset supplying around 5% of Auckland's water

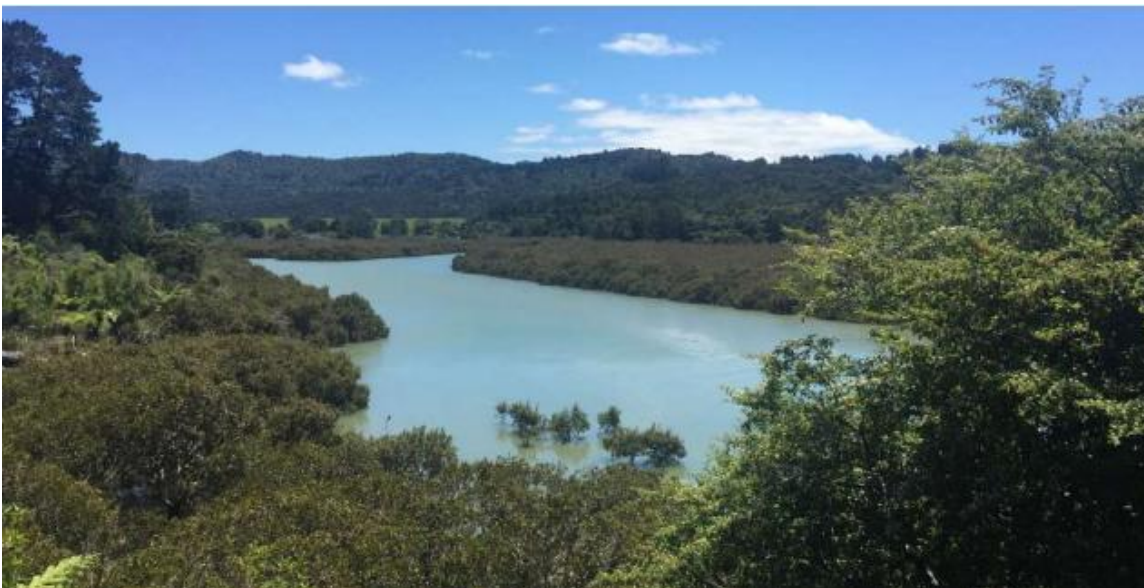
*Figure 7: Big Muddy Creek looking landward from Takaranga Reserve, showing a gradient of mangrove to native bush.*  
Source; Cat Davis.

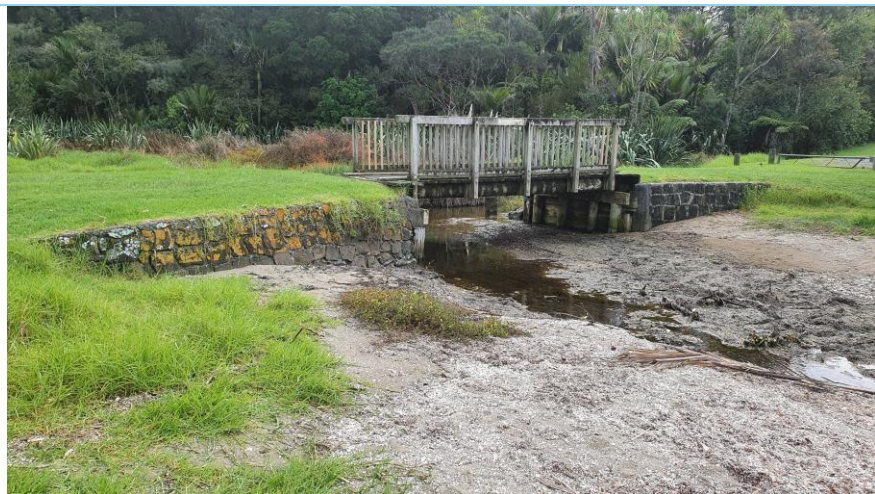
Footbridge and masonry abutments at Mill Bay. The abutments were renewed by Auckland Council in 2022.

*Mill Bay Footbridge (Source: Auckland Council)*

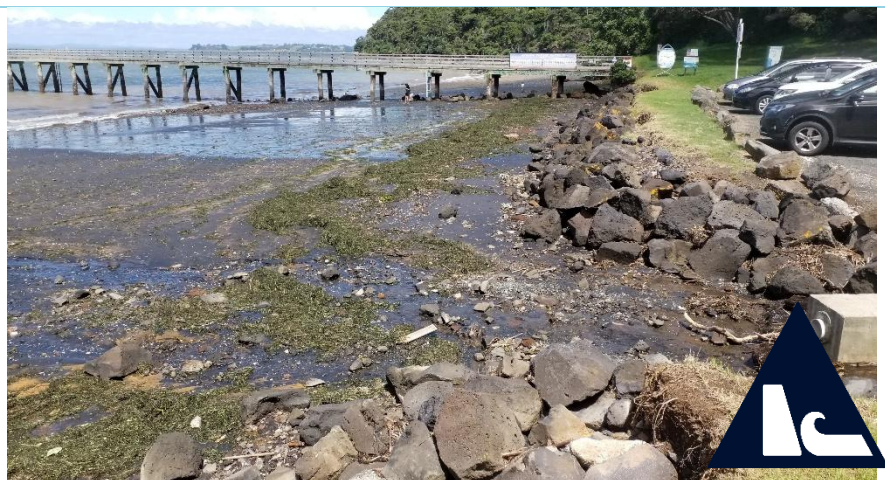
Rock armouring of carparking area at Cornwallis, with Cornwallis Wharf in the background.

*Cornwallis Wharf Carpark (Source: Auckland Council)*

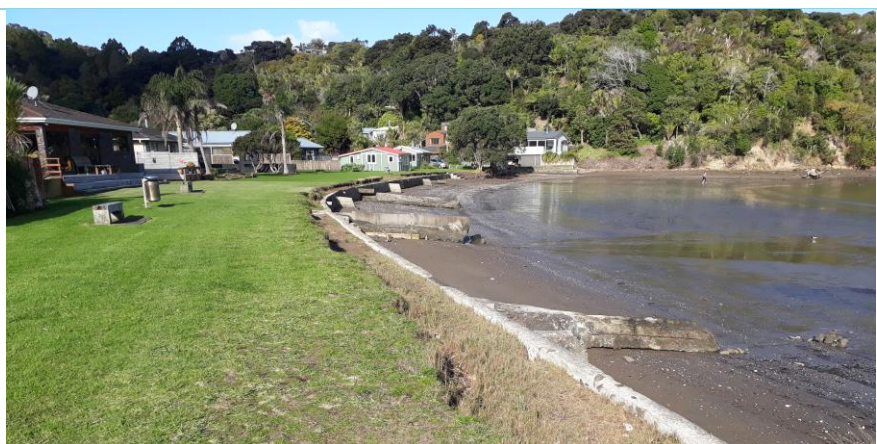
Coastal defences at Foster Bay Reserve, including a number of abutments and stormwater outfalls encroach on the narrow beach at this location. The seawall is currently an active renewal project on Council's Regional Coastal Asset Renewals Programme scheduled for completion in 2026.

*Seawall and associated coastal structures (abutments and stormwater outfalls) protecting the reclaimed edge of Foster Bay Reserve (Source: Auckland Council)*

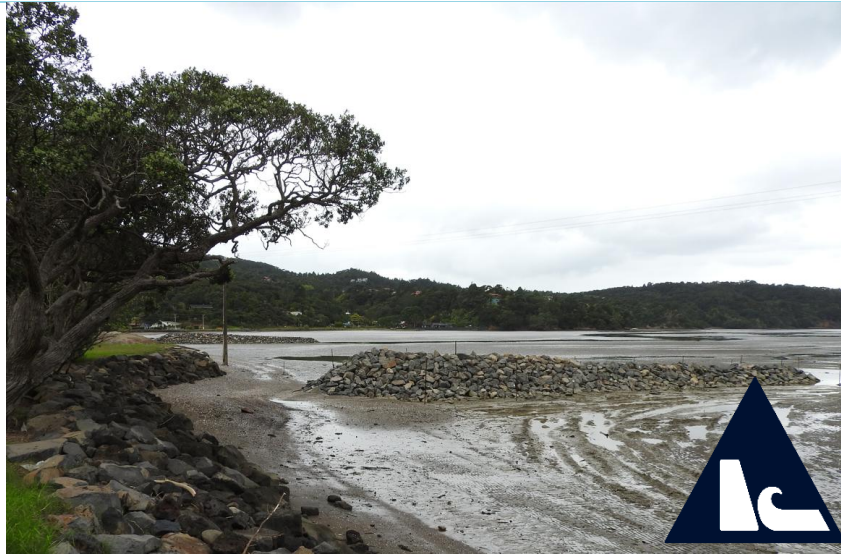
Following failure of the legacy masonry seawall fronting Huia Domain. A project was completed to construct two 45 m detached rock groynes and replenish the beach with imported and intertidal sand to protect the toe of the wall and create a more resilient coastal edge. The project was completed following extensive engagement with the local community and Waitākere Ranges Local Board on the preferred management option.

*Recently completed detached rock groynes and sand replenishment at Huia Domain (Source: Auckland Council, 2018)*

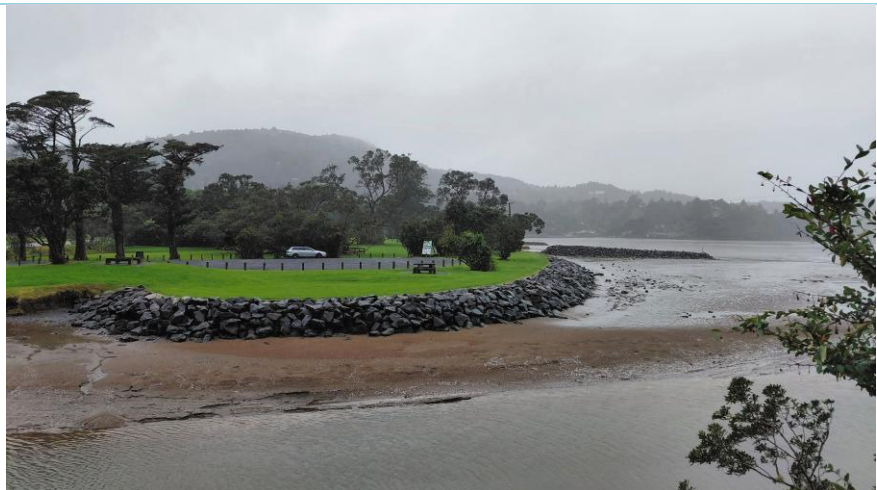
To the west of Huia Domain, a section of engineered rock revetment was constructed to protect coastal pōhutukawa trees, the western carpark and reserve land. The revetment stops short of Huia Road Bridge.

*Rock revetment to the west of Huia Domain extending into Huia Stream (Source: Auckland Council)*

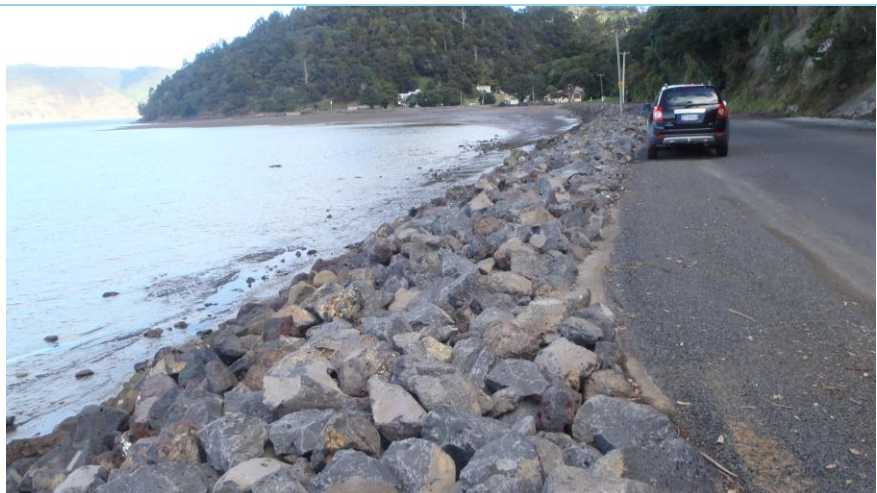
Huia Road between Huia and Little Huia is armoured by sections of rock revetment and tipped rock, owned by Auckland Transport.

*Rock revetment protection the edge of more exposed sections of Huia Road (Source: Auckland Council)*
