Shoreline Adaptation Plan

Snells Beach to Ōrewa Hibiscus Coast Volume 3: Adaptation Strategies

July 2025, Version 1.0

Auckland Council

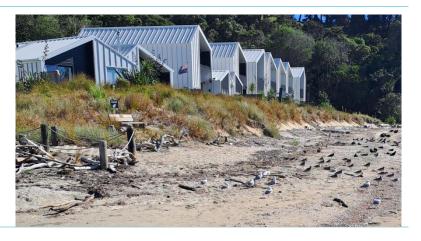
Timber retaining seawall at Sunburst Avenue, Snells Beach (Source Auckland Council).

Previous dune planting has occurred along Snells Beach, however this has not always survived storm events. The February 2023, Cyclone Gabrielle event resulted in failure of the timber seawall armouring the reserve edge adjacent Sunburst Avenue, Snells Beach. The seawall has since been renewed and realigned further landward in December 2023 (see figures below).

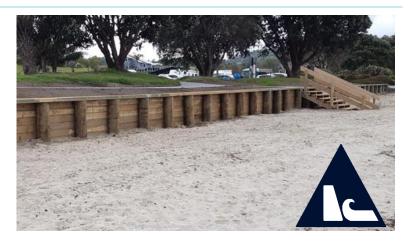
Sloping masonry seawall and tiered timber retaining, Algies Bay Reserve (Gordon Craig Place).

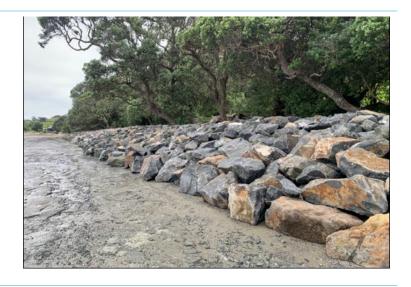
Willjames Avenue Esplanade rock revetment completed 2025).

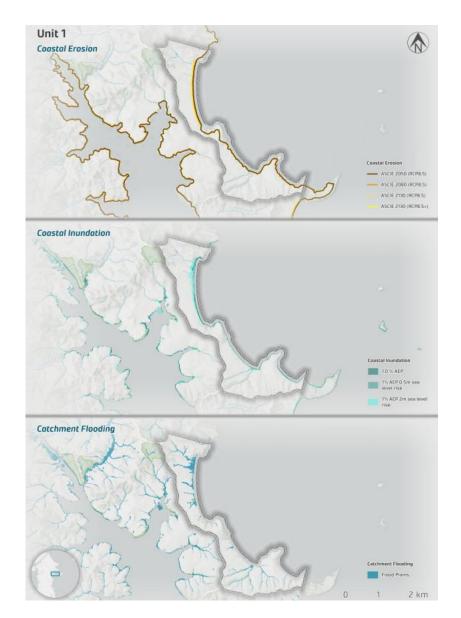
Coastal inundation flooding is predicted to have the most significant impact at the northern end of Snells Beach, with the flooding extent increasing landward in the high change scenario to impact coastal reserves, assets and existing uses.

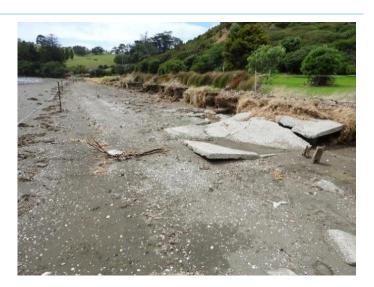
Post-storm erosion, Scandrett Regional Park (January 2018)

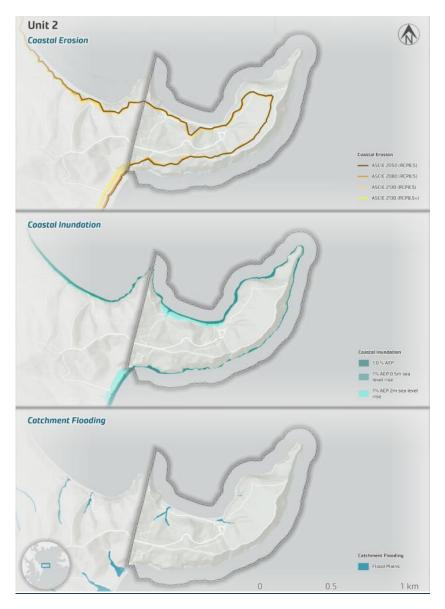
Coastal flooding inundation risk is greatest to the low-lying land along the backshore of the northern beach embayment. This is predicted to impact park assets (baches, implement sheds and sealed accessways) in the high change scenario. The fringe of steep vegetated cliffs around the headland will be exposed with minimal impact due to the lack of assets with walking trails adequately elevated.

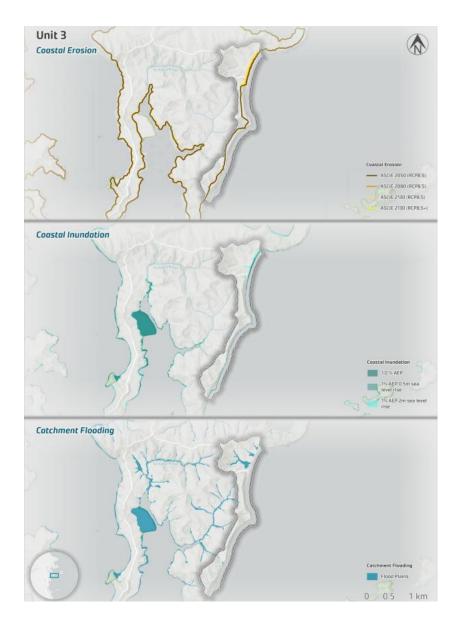
Within this unit, the northern part of Martins Bay is most at risk of coastal inundation flooding, with the greatest impact in the high change scenario and flooding extent increasing within the Holiday Park area and private landholdings to the north.

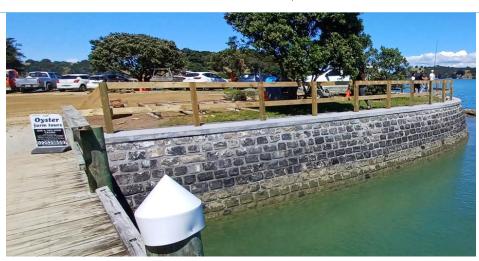
Rock masonry seawall armours Scotts Landing carpark reclamation. The seawall retains this important accessway to the coast including access to the jetty and mussel barges.

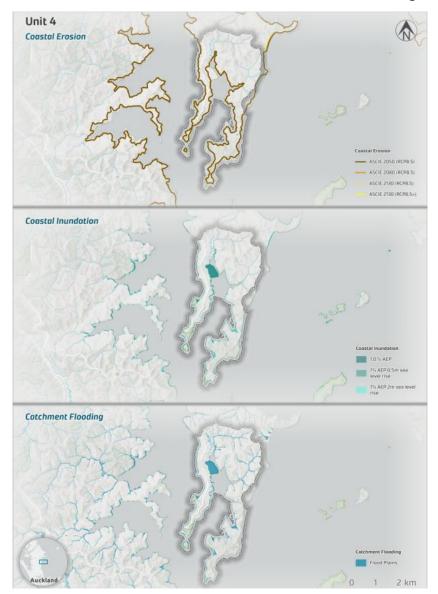
Most of this unit is elevated, with fringing areas of low-lying saltmarsh in the Te Kapa inlet exposed to increasing coastal flooding inundation with future sea-level rise scenarios. Areas where there is most risk to Council assets include the reclamation at Scotts Landing and the nearby historic homestead.

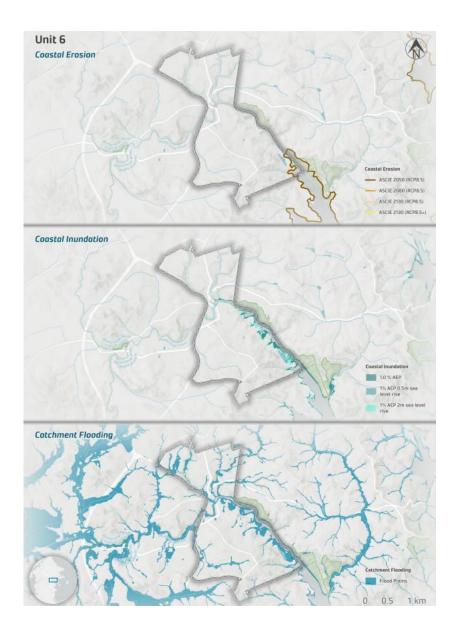
Coastal inundation flooding is predicted to impact the majority of the Warkworth town basin shoreline including the wharf area and adjacent carparking in the low change scenario. In the moderate to high change scenario, the extent of coastal inundation flooding will impact lower-lying sections of existing walkways and reserves along the western shoreline, including areas of private landholding utilised for marine activities.

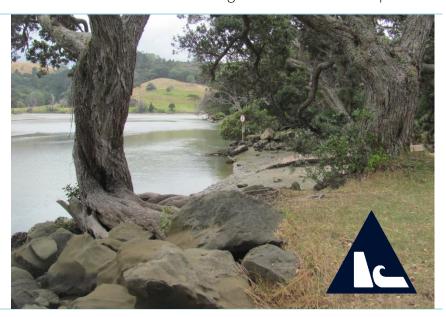
Tipped rock armouring the inlet shoreline of Wenderholm barrier spit (Source Auckland Council).

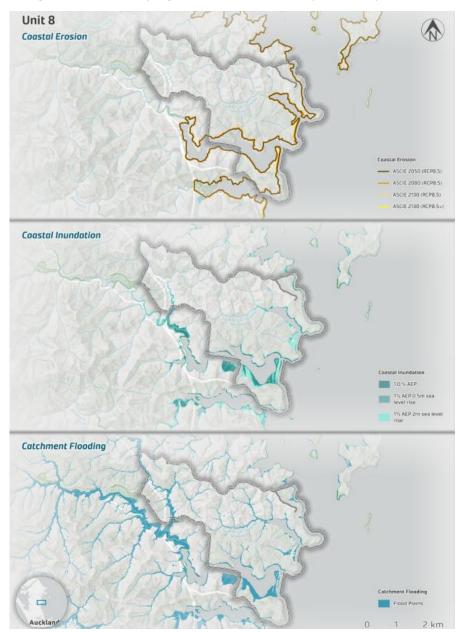
Wenderholm Spit and the low-lying land fringing the southern shoreline of Pūhoi River are predicted to be significantly impacted by coastal flooding inundation. Te Muri Beach will also be impacted, along with the lower-lying parts of Otuawaea Bay (Mita Bay) and Otarawao Bay (Sullivans Bay).

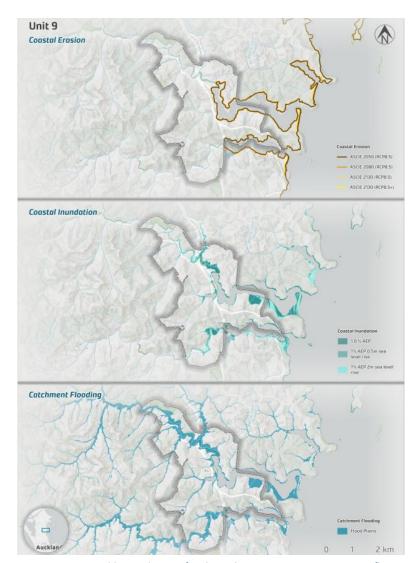
There is low erosion risk in the upper estuarine area, reflective of the sheltered environment. There are no existing coastal protection structures, e.g. seawalls, for erosion management along this section of coastline.

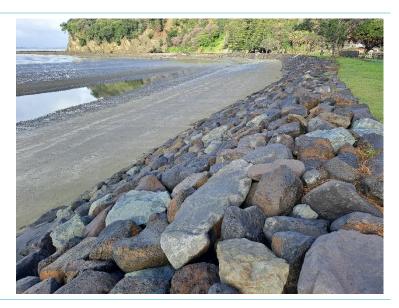
Waiwera Beach is armoured with a rock revetment seawall that was recently renewed (2024).

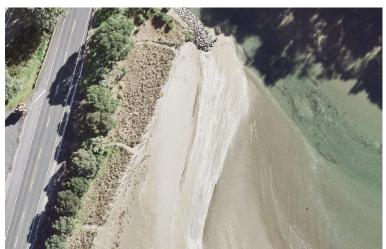
The stream mouth at the northern end of Hatfields Beach is controlled by a rock groyne that armours the southern channel stream bank.

Dune fencing is installed around the dunes at Waiwera Beach, with defined accessways through the dunes. Dune fencing and accessways are periodically adjusted in response to dune erosion or accretion.

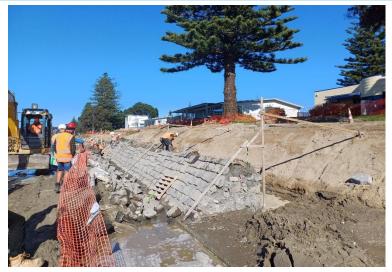
Installation of a new rock masonry seawall is currently underway (2025) to protect the esplanade reserve and provide beach access between Kohu Street in the north and Marine View in the south.

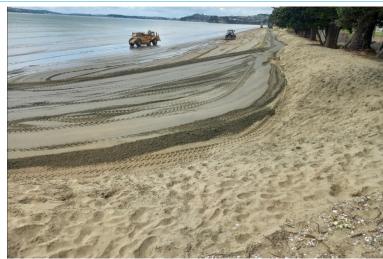
Operational sand transfer involves taking sand from the intertidal area at the southern end of Ōrewa Beach (where it builds up north of the estuary mouth groyne) and placed along the upper beach adjacent the unarmoured section of Ōrewa Reserve, and towards the centre of the beach adjacent Kinloch Reserve.

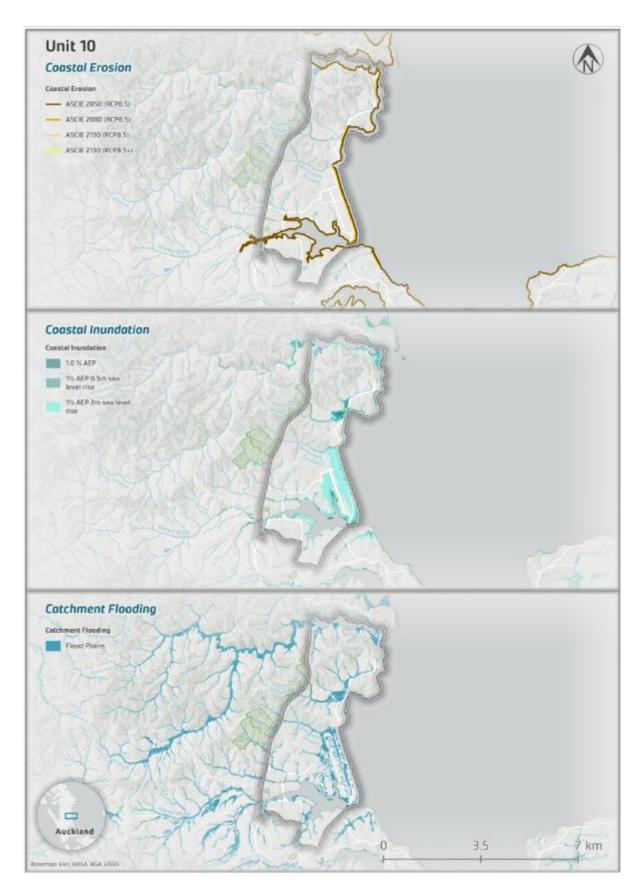
Coastal inundation flooding is predicted to have the most significant impact at Ōrewa Beach, with the flooding extent increasing landward in the high change scenario to impact coastal reserves, assets and existing uses.
