# Shoreline Adaptation Plan

Whatipu to South Head Te Korowai-o-te-  
Tonga Peninsula

Volume 3: Adaptation Strategies

August 2025, Version 1.0

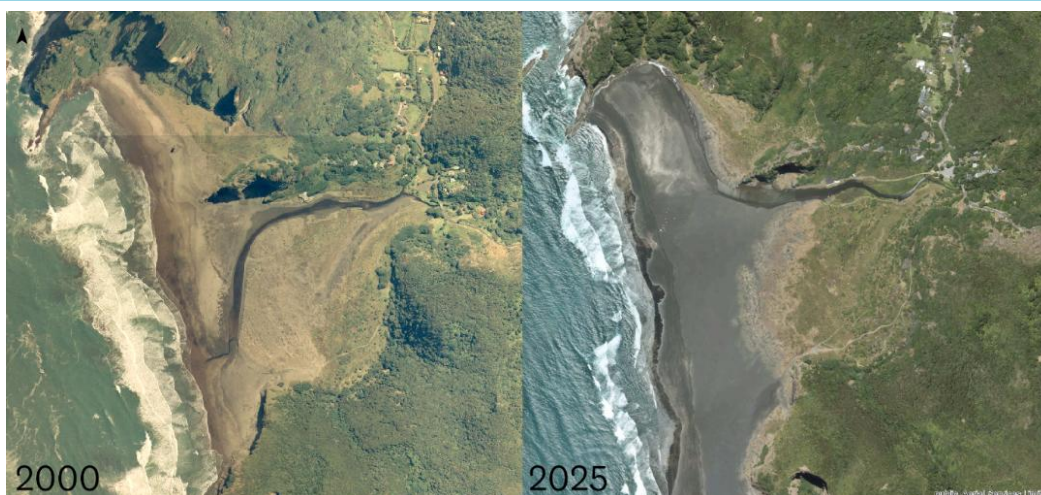
*Karekare Beach (Source: GeoMaps, Auckland Council)*

**Accretion:** At Karekare Beach, sediment accretion has resulted in a significantly increased high-tide beach width. Aerial imagery from 2000 (left) and 2025 (right) demonstrates the sand accretion and the changing alignment of the Company Stream discharges to the coast, where the channel now aligns to the north where it crosses the beach beyond The Watchman.

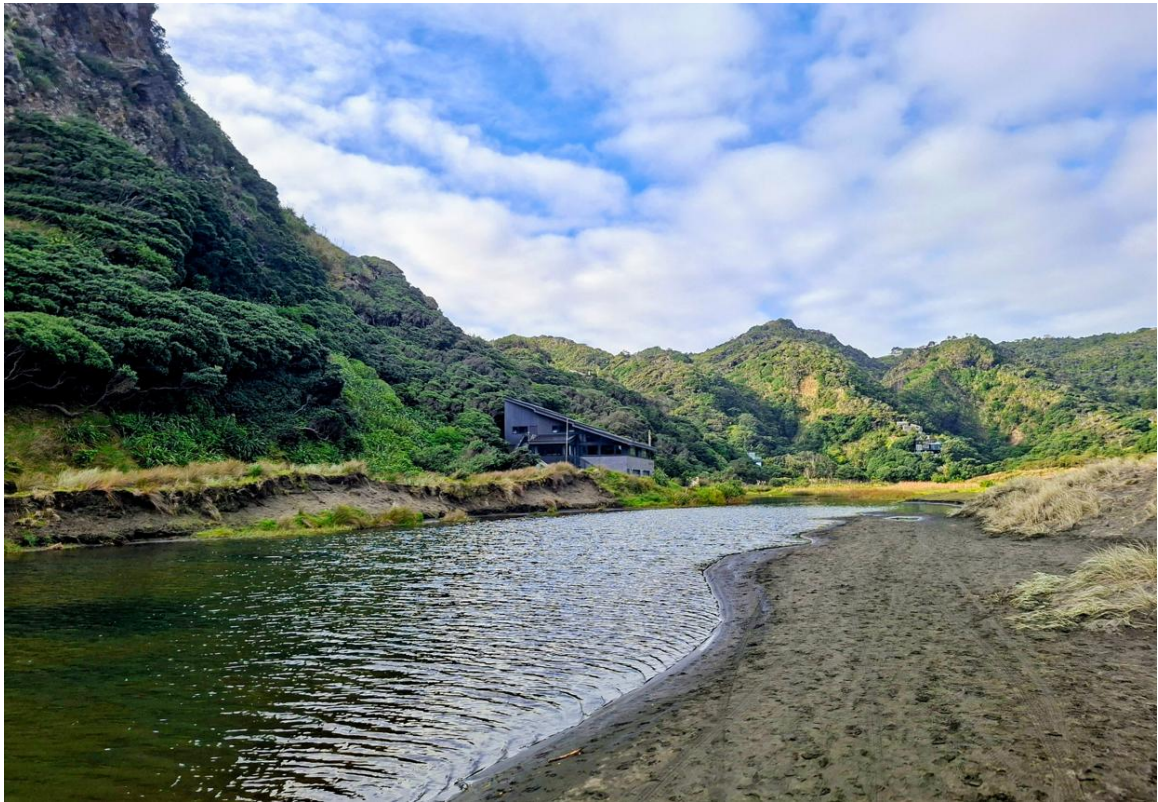
*Stream channel in proximity to Karekare Surf Lifesaving Club (source: Auckland Council)*

**Stream impoundment:** The Karekare Stream mouth is highly dynamic; influenced by both catchment input, resulting stream flow and beach sand levels across which the stream mouth discharges. Significant beach accretion has occurred at Karekare over the last 20 plus years. There is currently an extensive width of ‘dry high tide’ beach space, and a wide upper beach berm for the stream mouth to discharge across. As a result, the stream mouth has been constricted. An effect of the stream mouth constriction is the impoundment of upstream water levels. This results in a wider and deeper stream channel, or ‘lagoon’, adjacent to the Karekare Surf Lifesaving Club building and back to the road bridge.

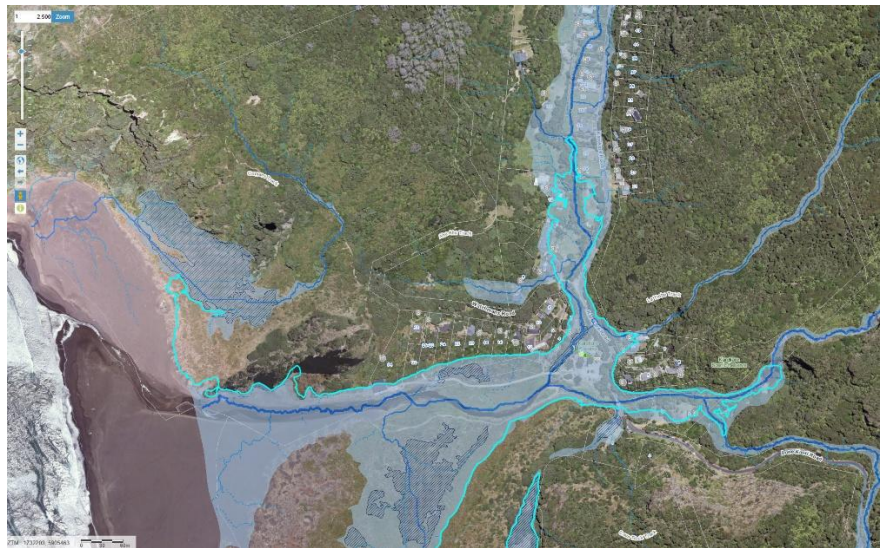
*Modelled floodplain during a 1% AEP event at Karekare (Source: Auckland Council)*

The flood plain area higher up the catchment is associated with stream flows.

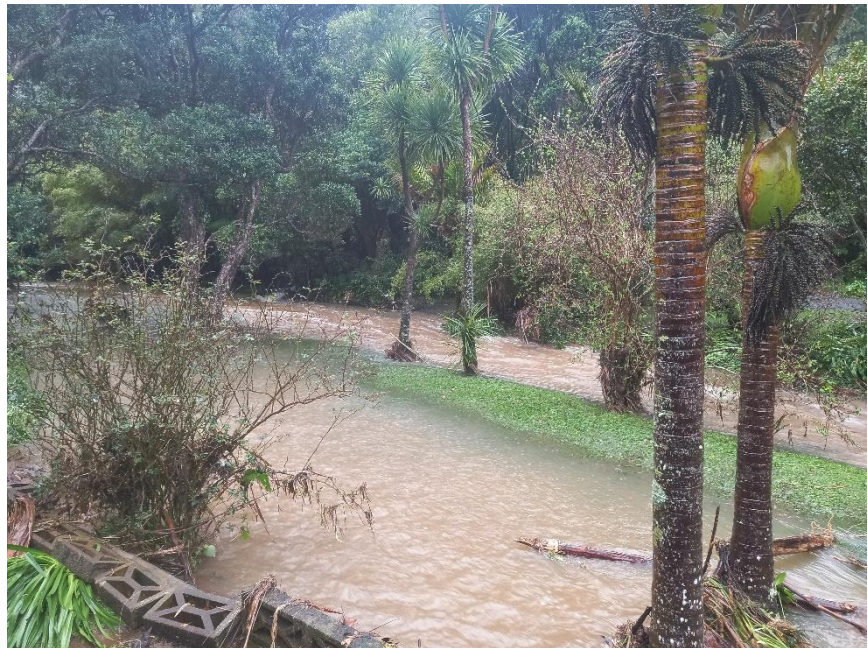
*Photo of flooding taken at a private residence on Karekare Road, 31<sup>st</sup> August 2021 (Source: Auckland Council)*

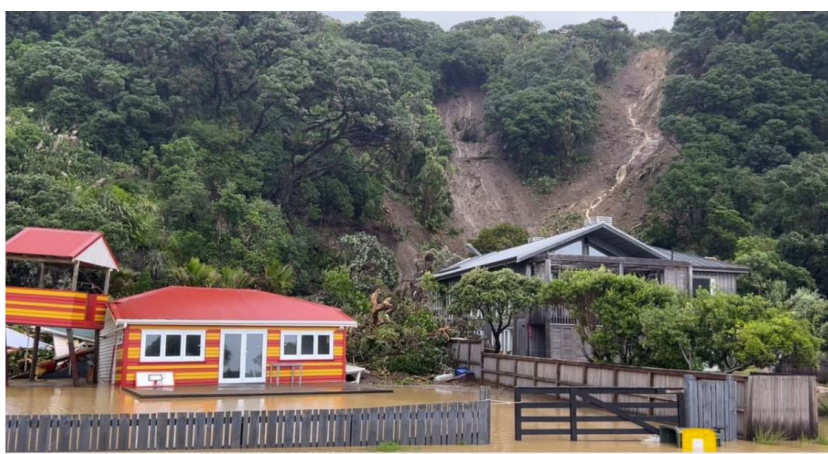
*Figure 2-1: Flooding and land instability as a result of Cyclone Gabrielle at South Piha (source: Newsroom)*

The Piha community was significantly affected by the 2023 storm events and prior flood events (such as those experienced in 2018). This impacted road access and caused significant damage and loss to many private properties and Auckland Council facilities (camping facilities, roads and walking tracks). 2023 storm recovery efforts are ongoing.

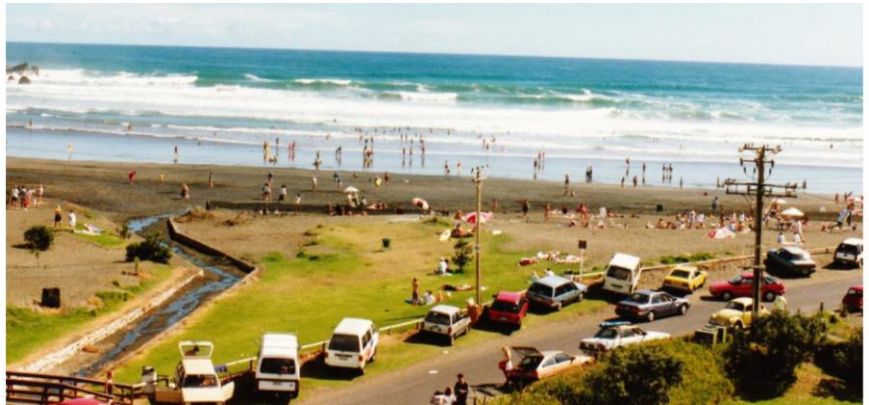
**Moana Stream:** The Moana Stream in 1991 following training of the stream in the 1980s and prior to construction of the seaward dunes present today.

*Moana Stream in 1991 (Source: Economos, 2013)*

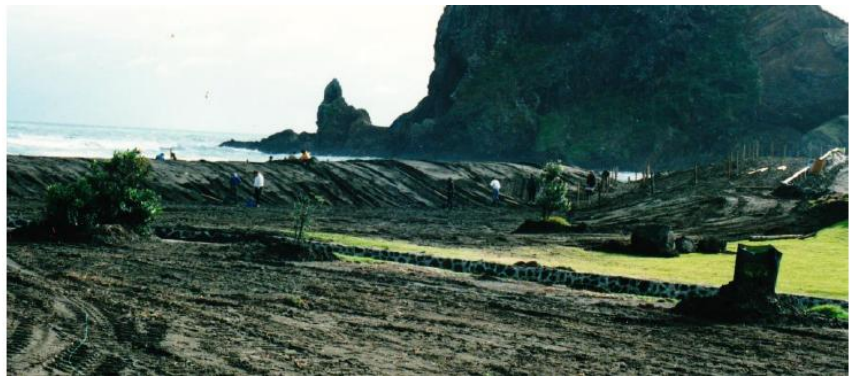
**Moana Stream/ Piha South:** Dune construction in 1991 across the seaward margin of Moana Stream.

*Dune construction in 1991 (Source: Economos, 2013)*

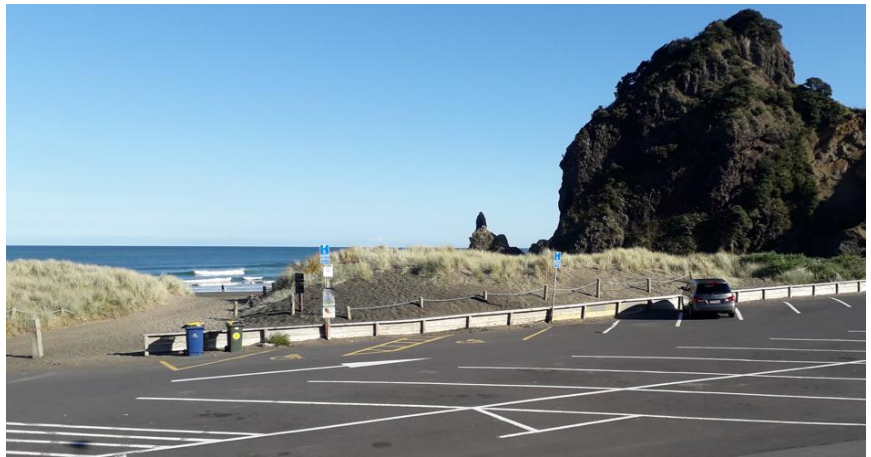
Management of the accessways, dune height and windblown sand into the carpark have been managed in the past by Auckland Council to preserve view shafts and ATV access to the beach for emergency response.

*Marine Parade South Carpark (Source: Auckland Council)*

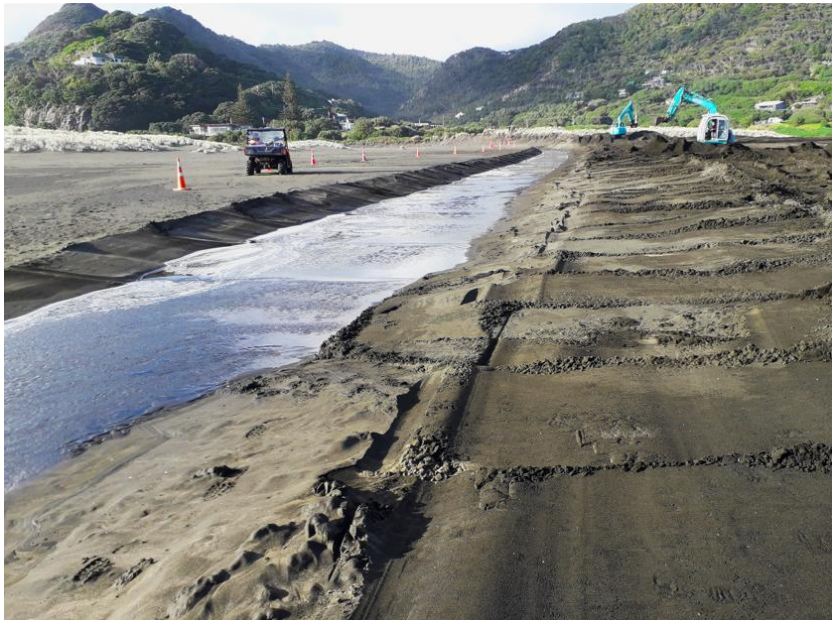
**Stream realignment:** Mechanical realignment of the Marawhara and Wekatahi stream mouths is undertaken as an operational activity by Council when established triggers are met to mitigate erosion of the adjacent sand dune that provides a buffer to the Marine Parade North Road. This is the main roading connection serving the northern areas of Piha.

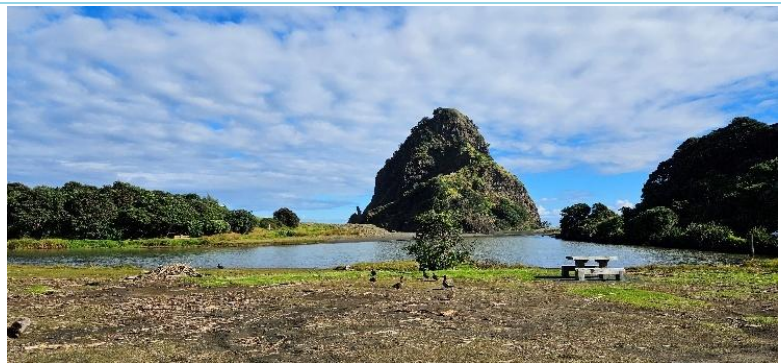
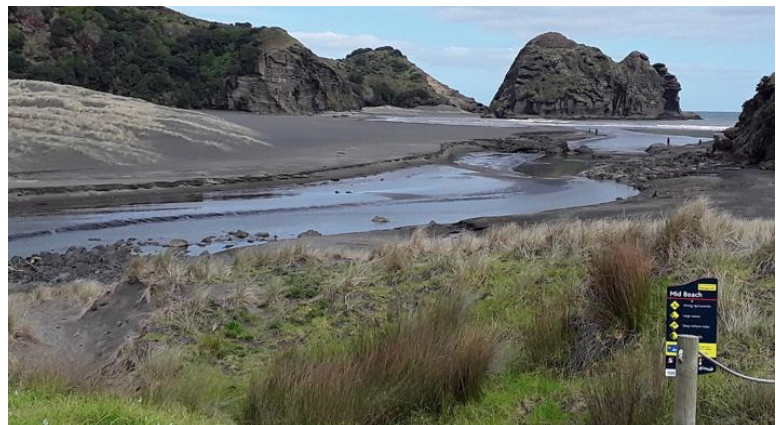
**the coast:** The highly dynamic beach sand levels at the mouth of the Piha Stream means that mechanical opening of the stream lagoon can be rapidly reversed by natural processes.

For this reason, Council has not invested in proactive management of the lagoon discharge. Water quality monitoring for the lagoon is an ongoing exercise with improvement in water quality remaining a community and Council objective.

*Piha Lagoon, viewed from car park area (upper), Piha Stream mouth, post flood event August 2021 (lower)*

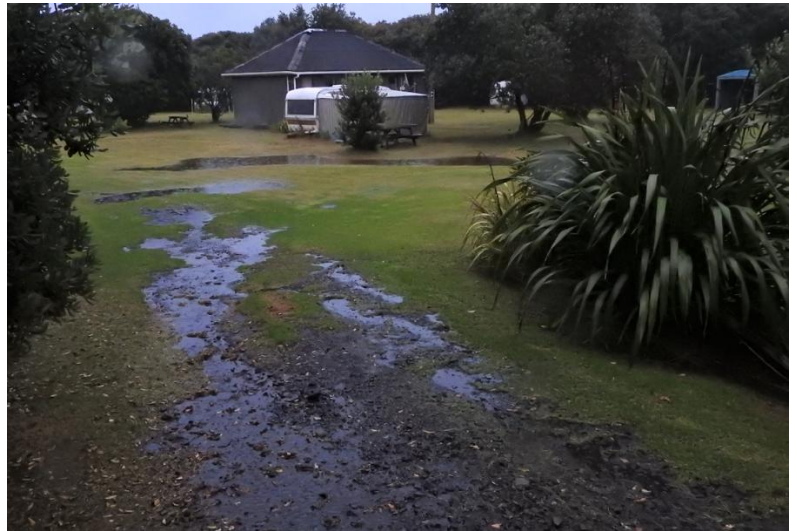
**Les Waygood Campground:** Following a severe flood event in June 2020 that impacted the Les Waygood Campground, a flood risk assessment of this activity was undertaken. Auckland Council Healthy Waters recommended this site no longer be used for overnight camping. Summer camping associated with the North Piha Surf Club operations has since been relocated to the higher ground on the adjacent back dune area.

*Site of the previous Les Waygood Campground (Source: Auckland Council)*

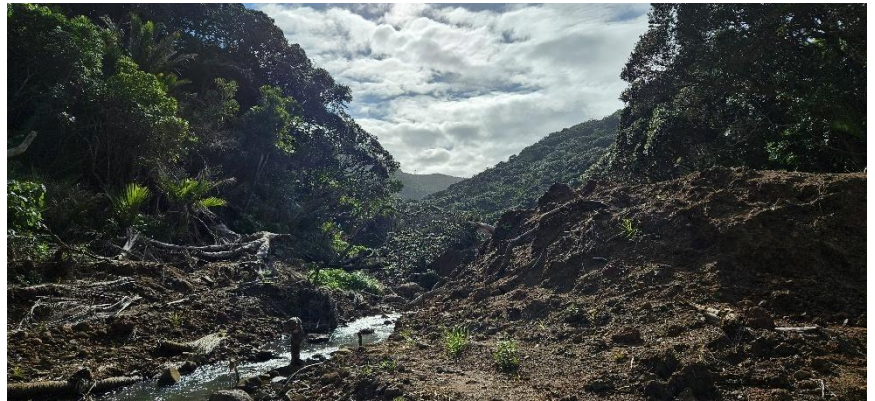
**Marawhara catchment** was impacted by the 2023 storm events. Recovery efforts have seen the reinstatement of walking tracks within this catchment. Associated infrastructure services are impacted by flood flows within this catchment, which can impact water supply to Council toilets and private dwellings.

*Marawhara stream post 2023 flood events. (Source: Auckland Council)*

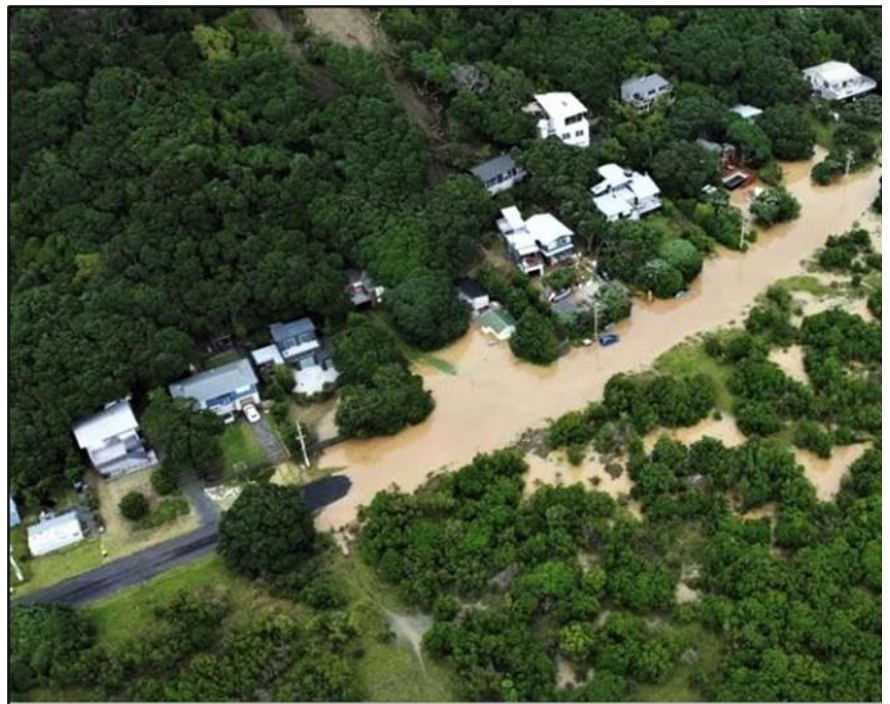
**North Piha:** The image to the right shows flooding to some residential properties and the road during Cyclone Gabrielle. (source: Auckland Council 2023).

There are ongoing issues of road flooding due to soakage through sand being reduced following siltation and landslides which occurred during Cyclone Gabrielle.

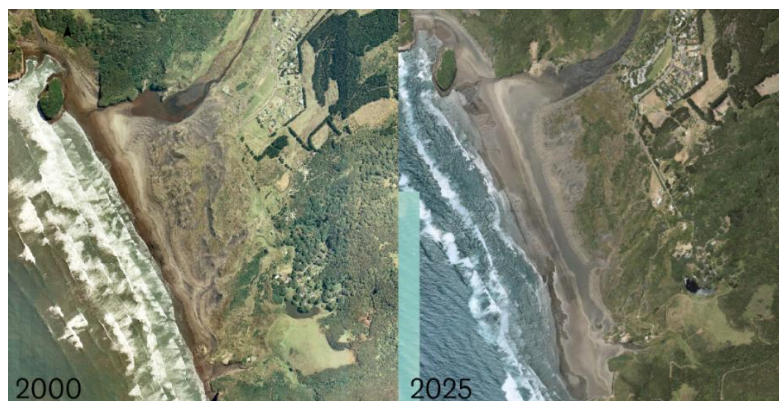
**Coastal change:** As demonstrated by aerial imagery for Te Henga/ Bethells including dune progradation and widening of the lagoon area before the stream mouth.

*Te Henga/ Bethells 2000 (left), 2025 (right) (Source: Auckland Council)*

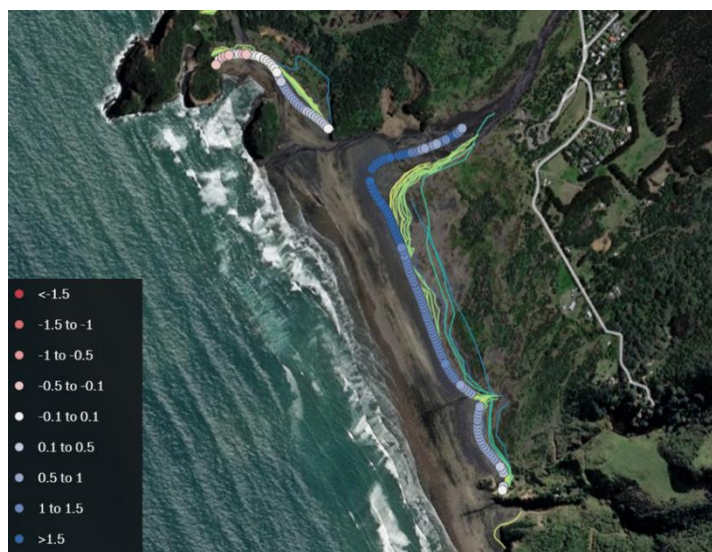
**Accretion:** While there are currently no Auckland Council dune monitoring profiles at Te Henga/Bethells, trends in accretion are demonstrated by the recent analysis of aerial photography and satellite imagery completed by the Aotearoa coastal change project.

*Analysis of rates of coastal change at Te Henga/ Bethells  
(Source: <https://coastalchange.nz/>)*

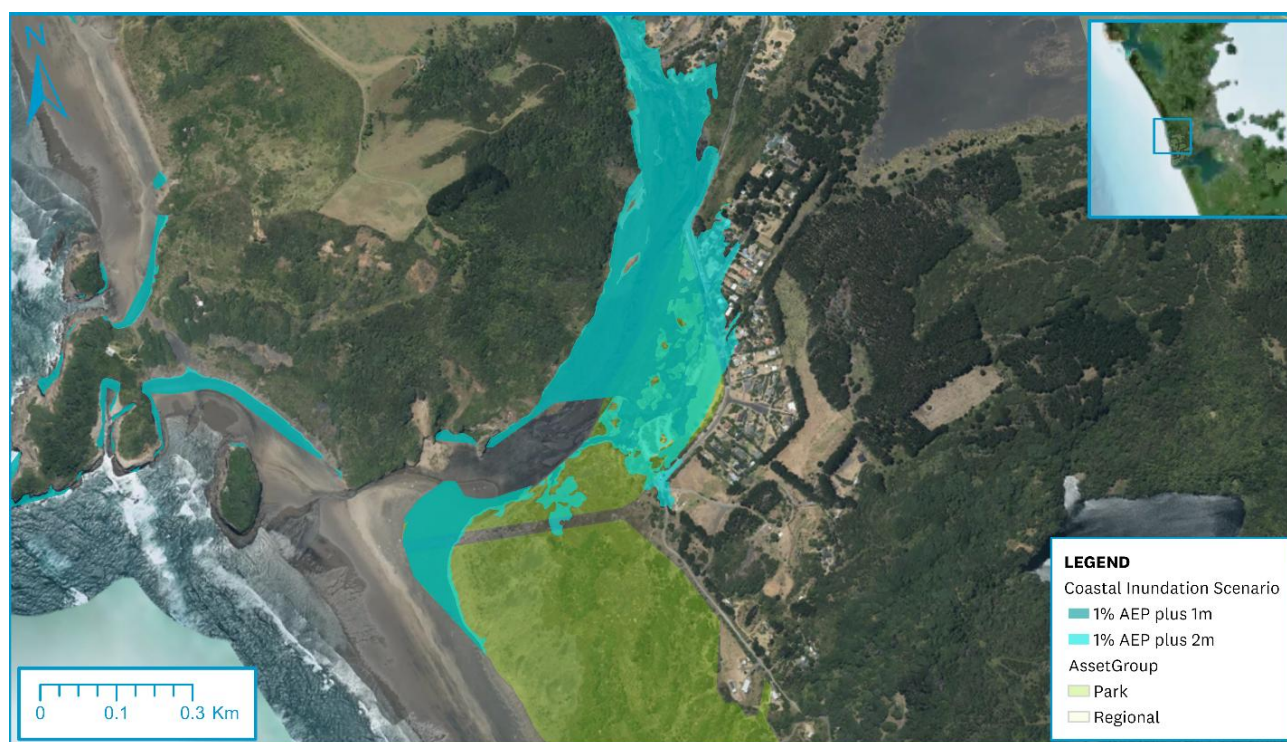
Figure 3-2: Map showing moderate and high coastal inundation scenarios at Te Henga/Bethells Beach

As indicated for Units 1 and 2 previously, the relationship between current accretionary processes, sediment availability and sea-level rise will be key to the extent of future coastal inundation that is realised.

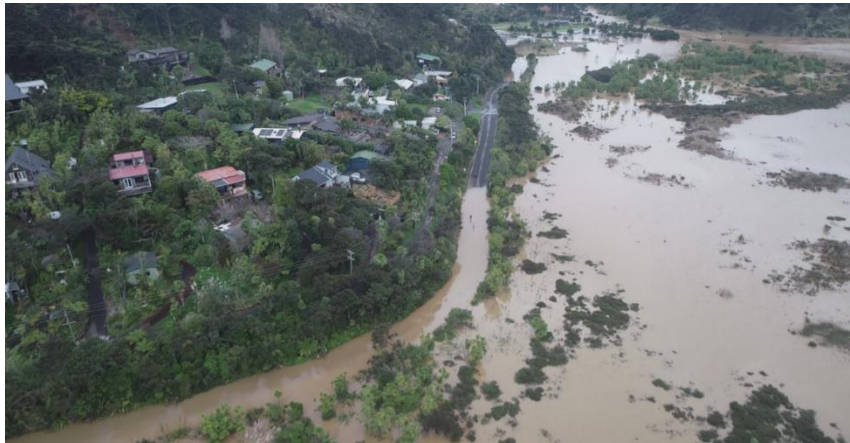
**Flood extent:** Te Henga wetland and Waitākere River flooding inundating Bethells Road, cutting off access to Bethells Beach, August 2021.

*Flood extent at Te Henga as a result of the 2021 flood event (Source: Peter Quilter)*

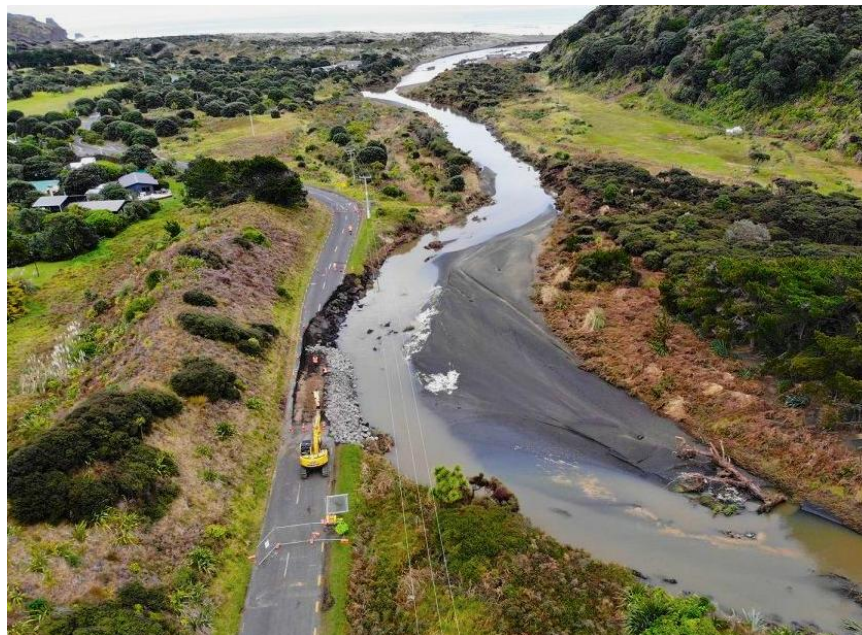
**Flood damage:** The Waitākere River and impacted Bethells Road following the August 2021 flood event. Source: Peter Quilter (Tonkin & Taylor)

*Waitākere River post the 2021 flood event (Source: P Quilter)*

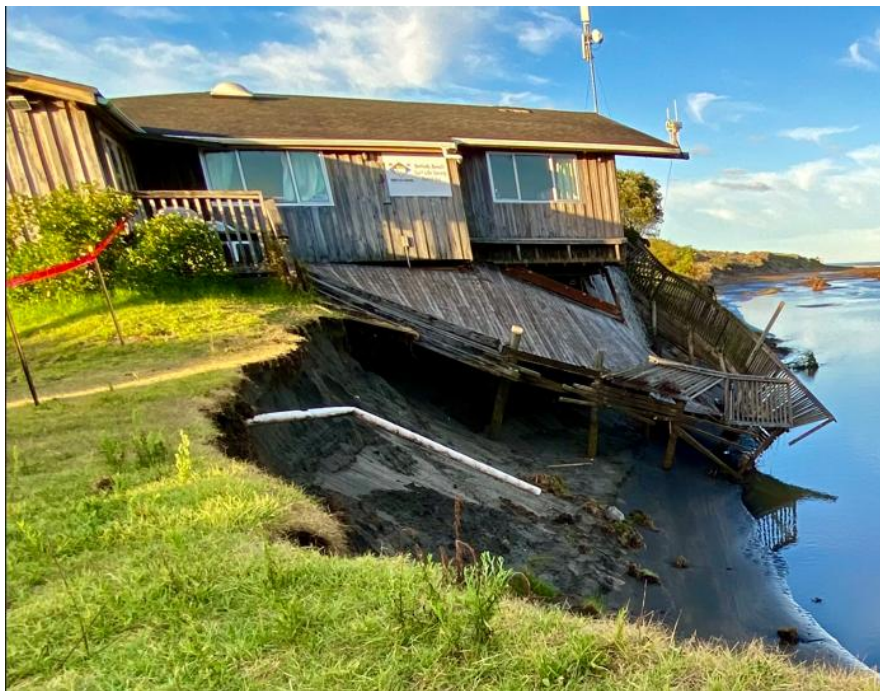
**2023 Storms:** Damage to the Bethells Beach Surf Lifesaving Patrol Club caused by high river flows at the Waitākere River outlet Council and resulting erosion of the sandy river banks during Cyclone Gabrielle.

*Bethells Beach Surf Lifesaving Club following Cyclone Gabrielle (Source: Auckland Council)*

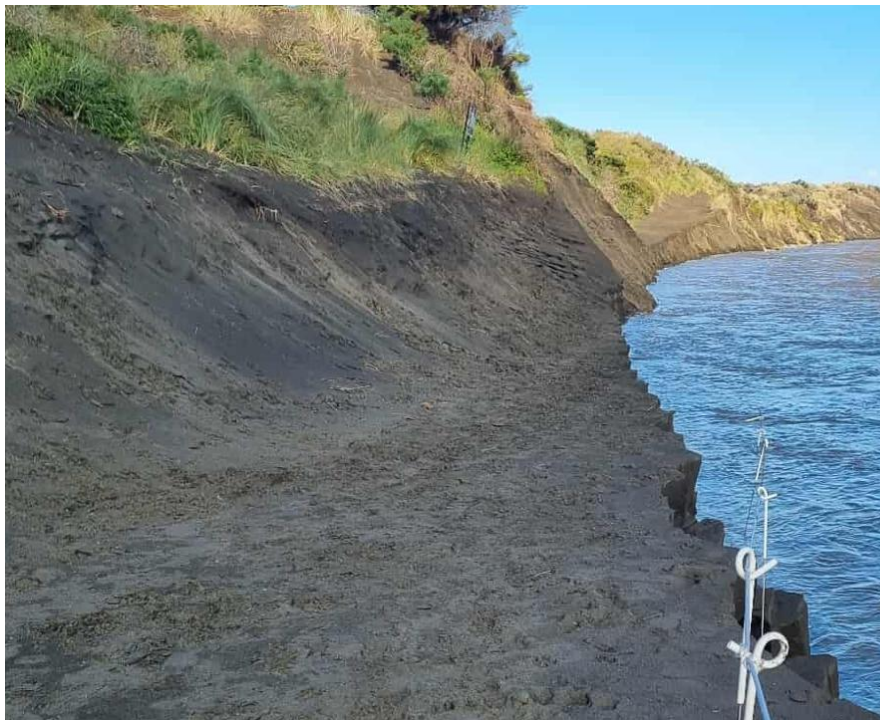
**Beach Access:** The previous beach accessway has been lost to stream bank erosion and the widened lagoon post heavy rainfall, July 2025. (Auckland Council).

*Restricted beach access following heavy rainfall (Source: Auckland Council)*

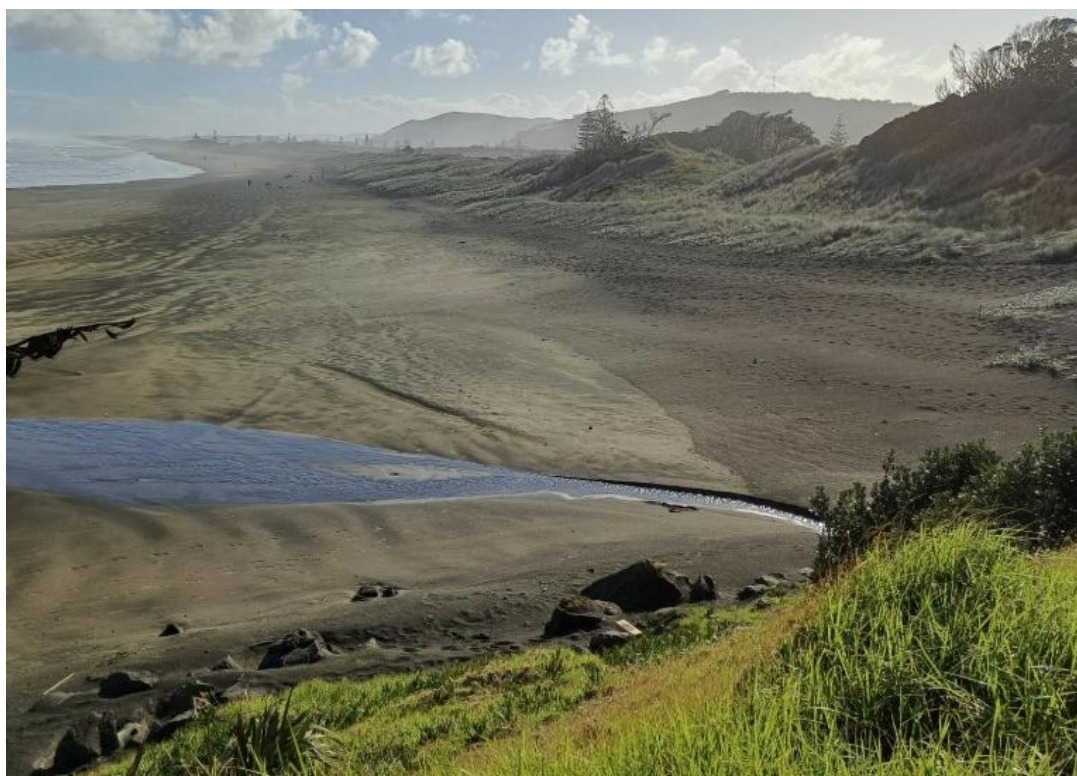
Figure 4-1: Restored dunes, southern end of Muriwai Beach (Source Aidan McLean)

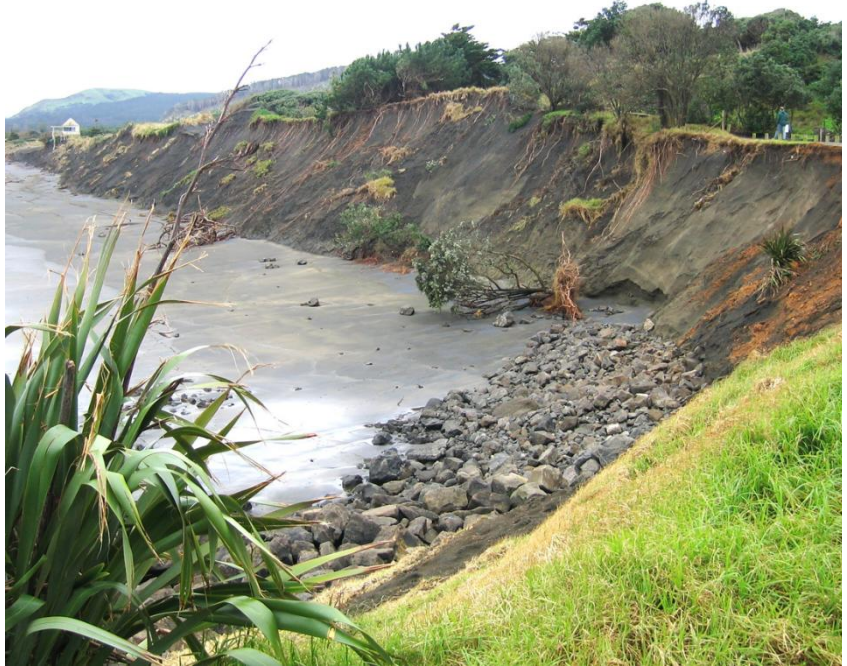
*Erosion at the southern end of Muriwai Beach (Auckland Council, 2008)*

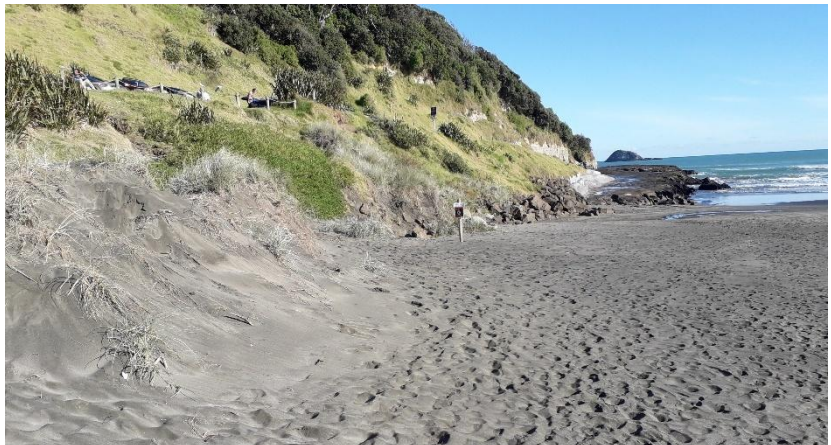
A rock revetment seawall and gabion baskets owned by Auckland Transport exists on the seaward edge of the bank supporting the edge of Motutara Road. This provides vehicle access to the beach for emergency services and authorised vehicles from the Muriwai Surf Club and Muriwai Sports Fishing Club (Auckland Council, 2024).

*Looking south-west along the end of Motutara road access to Muriwai Beach, (Auckland Council, 2018)*

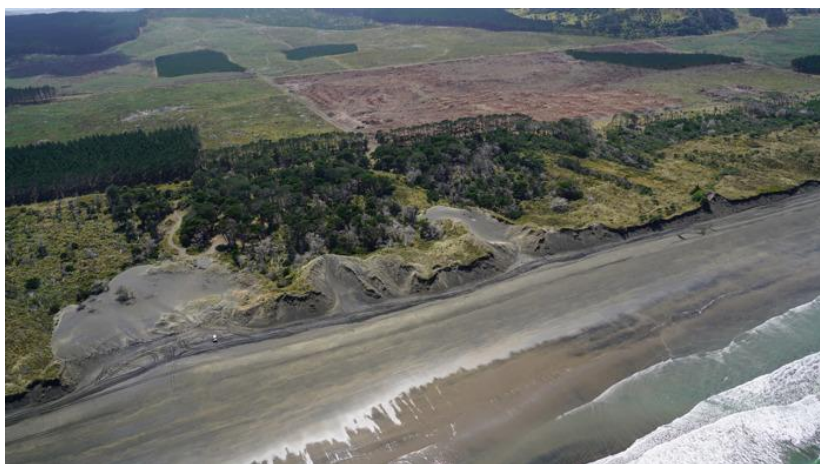
A cross-section of the ecosystems at Muriwai Regional Park (Five Mile Strip) including active dunes, coastal sedge, and native forest and scrub.

*Five Mile Strip (Andrew Macdonald, Biospatial Ltd 2018)*

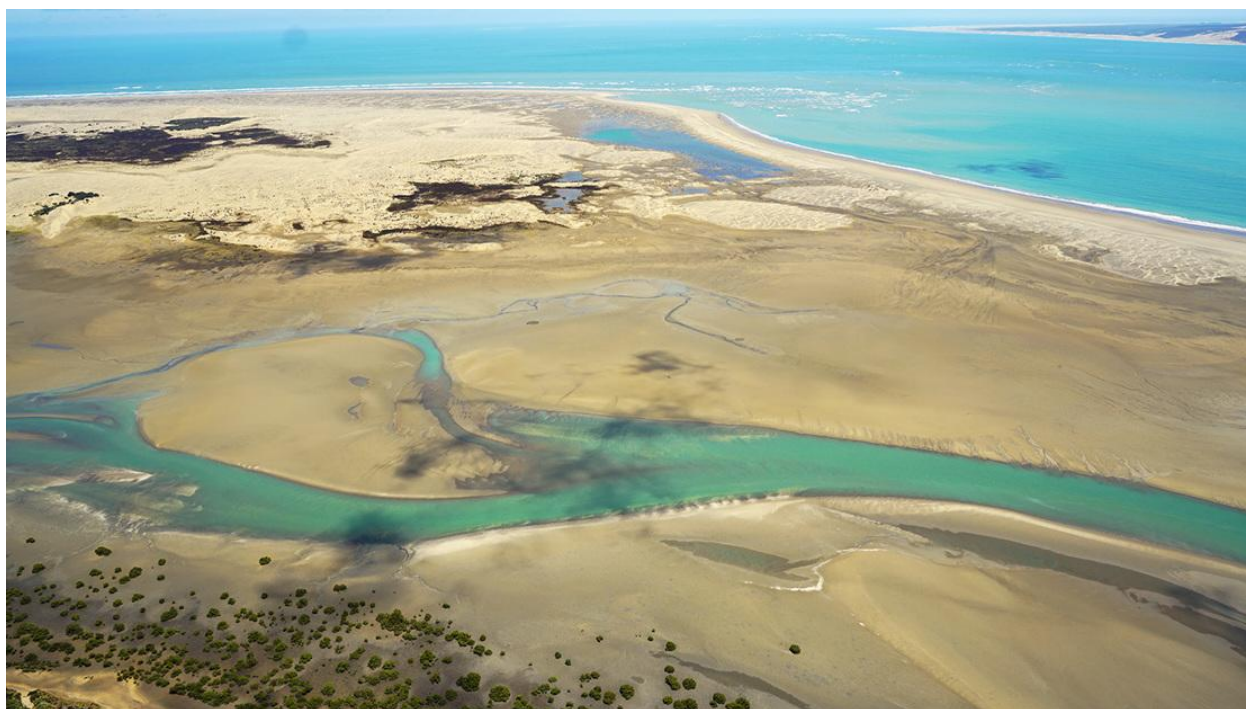
At the north of the unit, the Papakanui Spit extends from South Head at the harbour entrance. This section of the Kaipara Moana (Harbour) coastline is characterised by sandy pocket beaches backed by coastal cliffs. The Papakanui-Waionui biodiversity focus area is located at the northern end of the South Head peninsula.

*Figure 5-1: Looking north over the Papakanui Spit and Waionui inlet at the entrance to the Kaipara Harbour. Source: Andrew Macdonald, Biospatial Ltd 2018.*

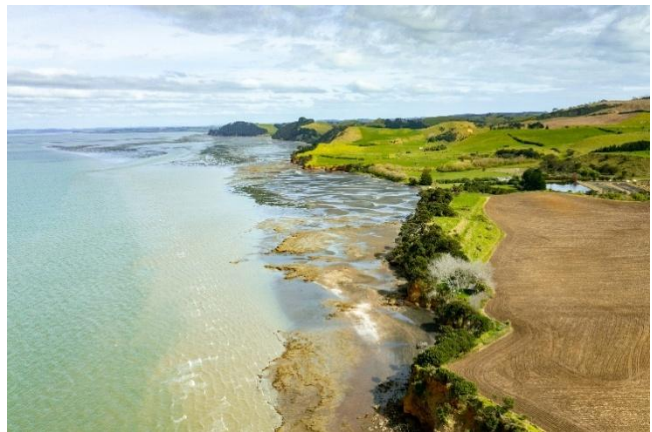
On the leeward side of South Head from Waionui Inlet to Mānunutahi Bay/ Mosquito Beach, the coastline transitions to steep coastal cliffs prone to weathering and ongoing coastal erosion and instability. These processes are irreversible and provide a source of sediment for the wider coastal system. However, because of the more sheltered, harbour location, predicted rates of coastal erosion are comparably lower than for the more exposed open coast.

The secluded Mosquito Beach/ Ōmokoiti Bay on the northern tip of South Head.

*Mosquito Beach / Ōmokoiti Bay (Auckland Council, 2024)*
