## 40 Mahi Road: Ecologist s92 Comment

<b>To:</b>	Lance Hessel / Senior Planner / Civix Ltd.
<b>From:</b>	Karien Killian / Ecology Lead / Thomas Consultants
<b>Date:</b>	24/07/2025
<b>Subject:</b>	40 Mahi Road: Ecologist s92 Comment (updated)
<b>Attachments</b>	Revised Ecological Assessment and Maps

# Updated Ecological Assessment in Response to Council's Further Information Request

Property Address: 40 Mahi Road, Helensville

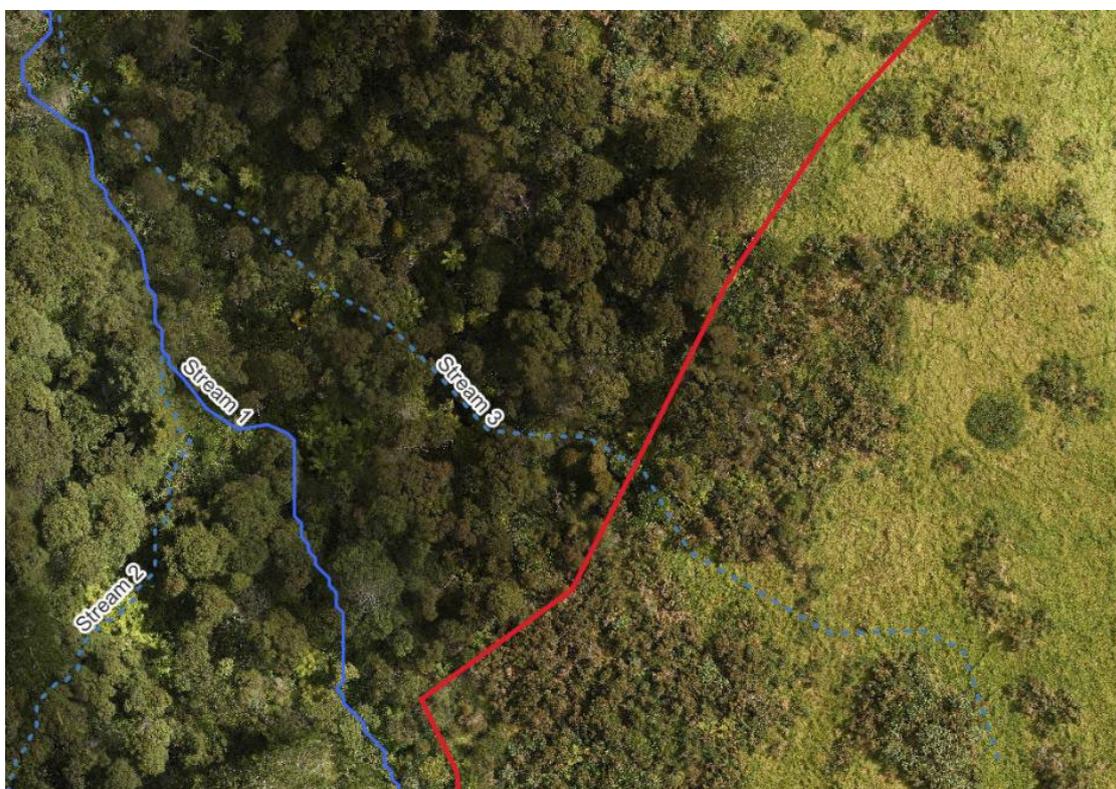
Figure 1: Within the proposed Single House Zone, Stream 3 flows through exotic grassland and a small area of exotic scrub. From there, it flows into VS3 manuka/ kanuka scrub within the Countryside Living Zone.

Due to steep slopes and dense vegetation, the lower reaches of Stream 3, where it flows into the proposed Countryside Living Zone (CLZ) could not be accessed during the site visits. High resolution drone imagery taken on 4 February 2025 confirms that Stream 3 originates in an area of exotic grassland (ES) (Figure 2) transitioning into exotic scrub and ultimately VS3 manuka/ kanuka scrub towards the northwest. This vegetation was still intact at the time of the drone survey (see Fig 1 below). Classification for the lower reaches of Stream 3, could therefore not be

confirmed (even with drone imagery) and it is possible (although unlikely) that part of the stream flowing through the CLZ is intermittent.

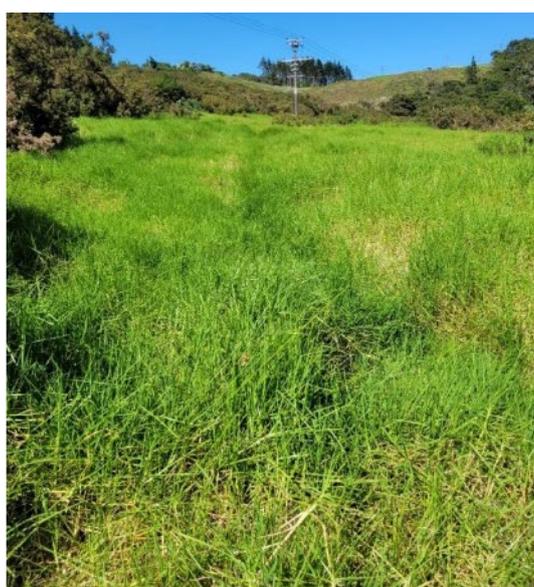
Figure 2: Snip from ecology assessment, showing the characteristics of Stream 3.

Photo 14: Stream 3 shows as a shallow depression in the landscape with no channel or water at the time of the site visit.

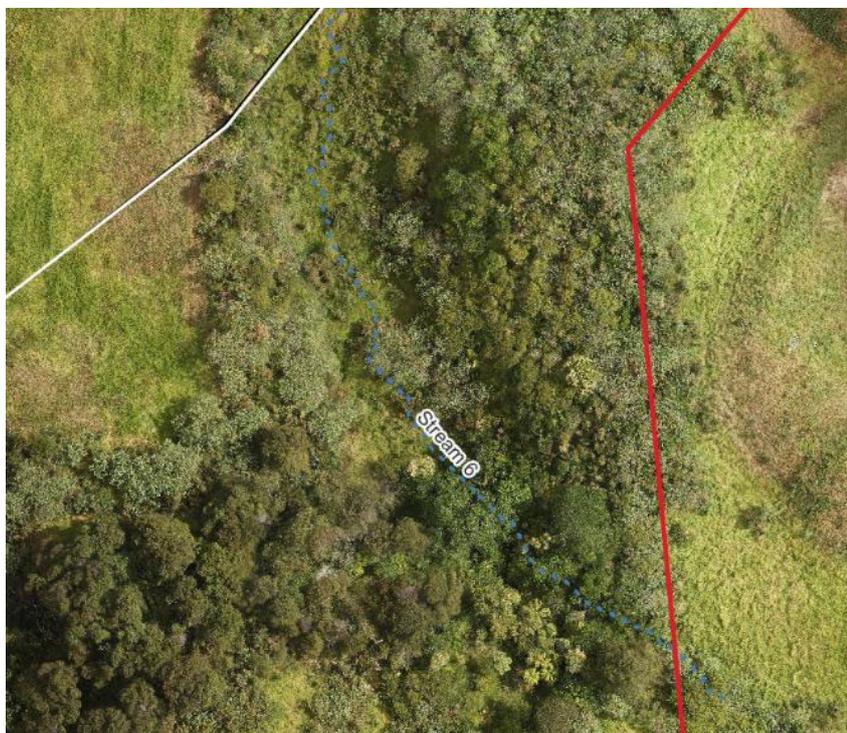
*Figure 3: Stream 6 originates in an exotic grassland/ scrub mix in the proposed SHZ, and then flows into an area of VS3 manuka/ kanuka scrub in the CLZ.*

The headwaters of Stream 6 originate in exotic scrub (ES) transitioning into VS3 manuka/ kanuka scrub (Figure 3), where the dense vegetation and steep slopes made it difficult to assess during the site visits. Further north in the proposed CLZ, the stream flows into a wider gully with wetland vegetation visible along its margins, mostly outside the site boundary (as seen in Figure 4).

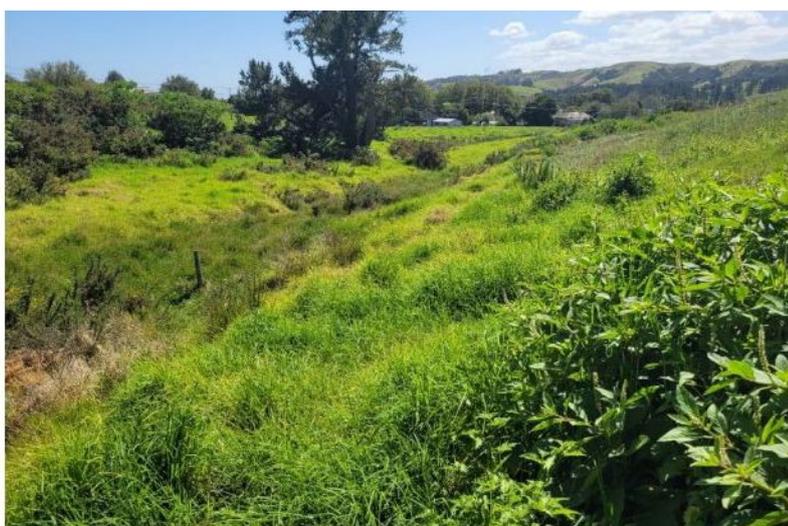
*Figure 4: Snip from ecology report showing the northernmost extent of Stream 6.*

*Photo 15: View of Stream 6, at the northern property boundary looking further north.*

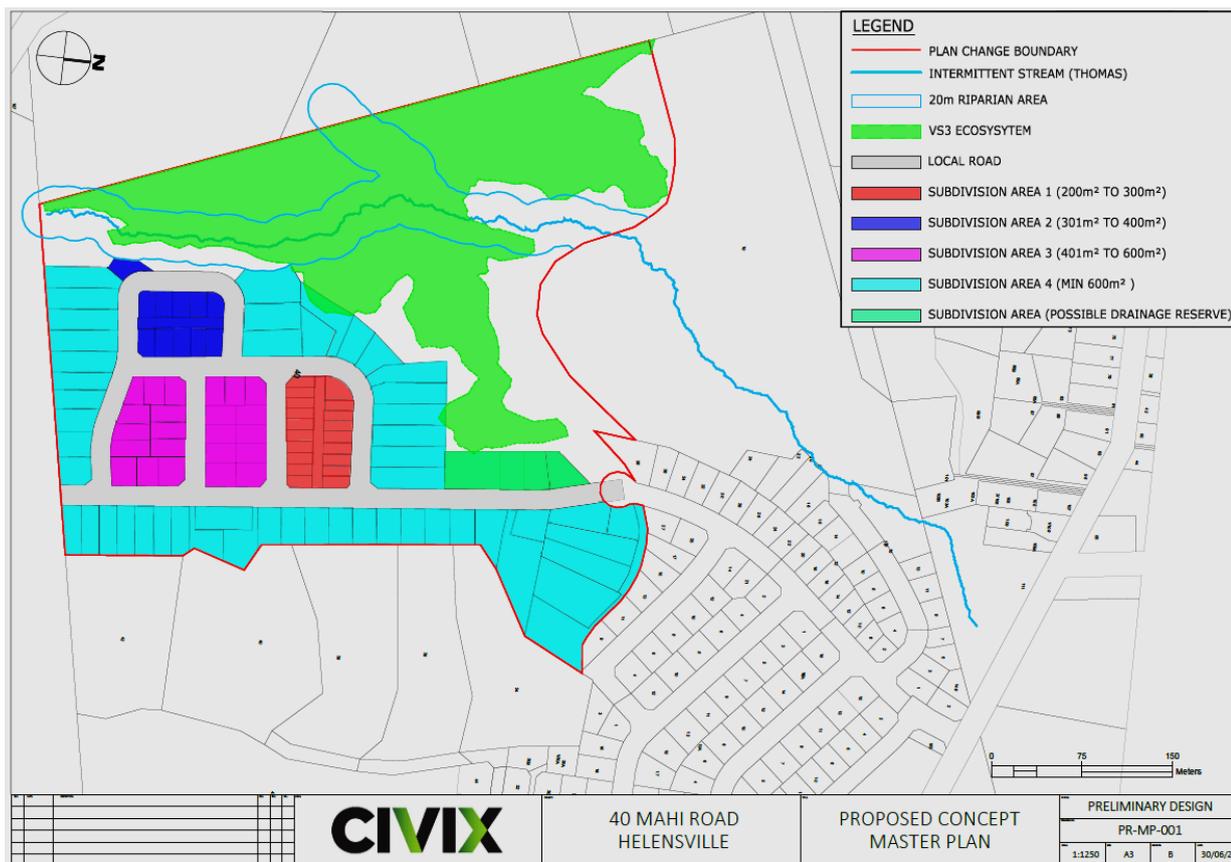
Figure 5: Concept Master Plan

We note here that the referred Precinct Plan is no longer proposed, and the proposed updated concept Master Plan (indicative only to demonstrate possible development) is being submitted to show no riparian margins in relation to these ephemeral streams, and also to show the 20m riparian margin for Stream 1 as being wholly outside of the proposed Single House Zone and Mixed Housing Suburban Zone, and within the Countryside Living Zone. Refer to Figure 5 below.

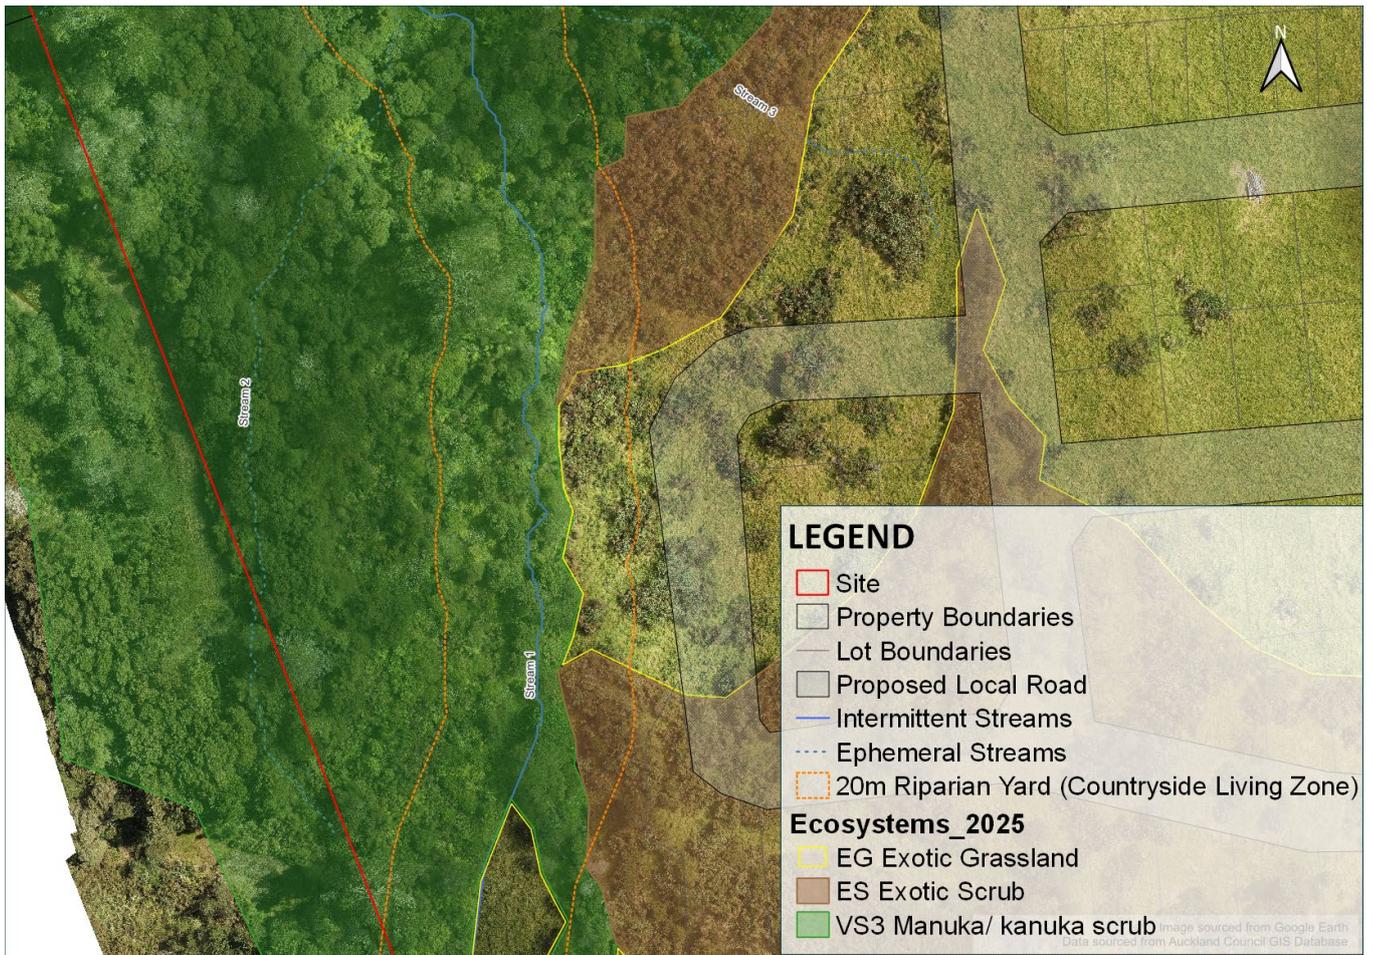
Figure 6: Existing riparian vegetation along part of Stream 1, comprising of exotic scrub and grassland adjacent to kanuka/ manuka scrub.

As part of the proposal amendment to rely on zoning only and AUP provisions with no precinct applicable, the boundaries of the Countryside Living Zone and Single House Zone have been adjusted to ensure the 20m riparian margin under the Countryside Living Zone applies to Stream 1. This amendment is shown in Figure 6 provided below.

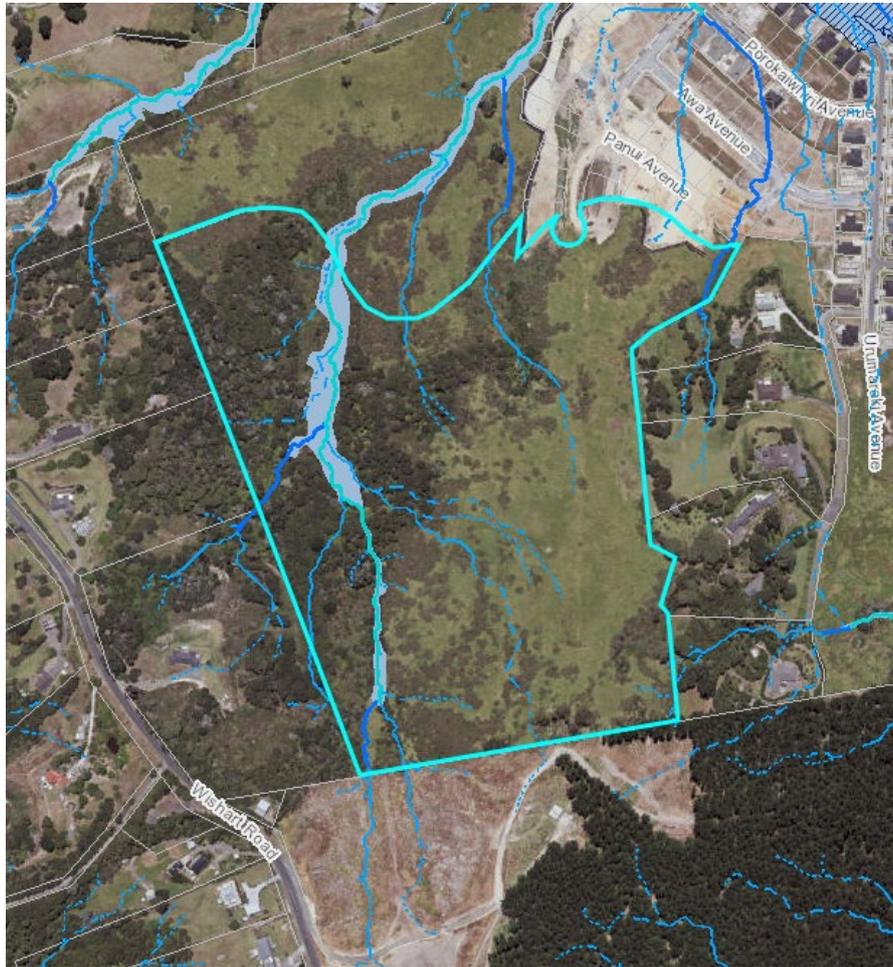
Figure 1: Site locality and sensitivity overlays. Source: Geomaps

A stream with associated floodplain is indicated on Auckland Council Geomaps as flowing through the site from south to north. Overland flow paths are also modelled throughout the site which join the stream at various points. No wetlands are indicated as present on the site. The site is not affected by any Significant Ecological Areas (SEA) or covenants. Refer to Figure 1 for the sensitivity map according to Auckland Council GEOMaps<sup>1</sup>.

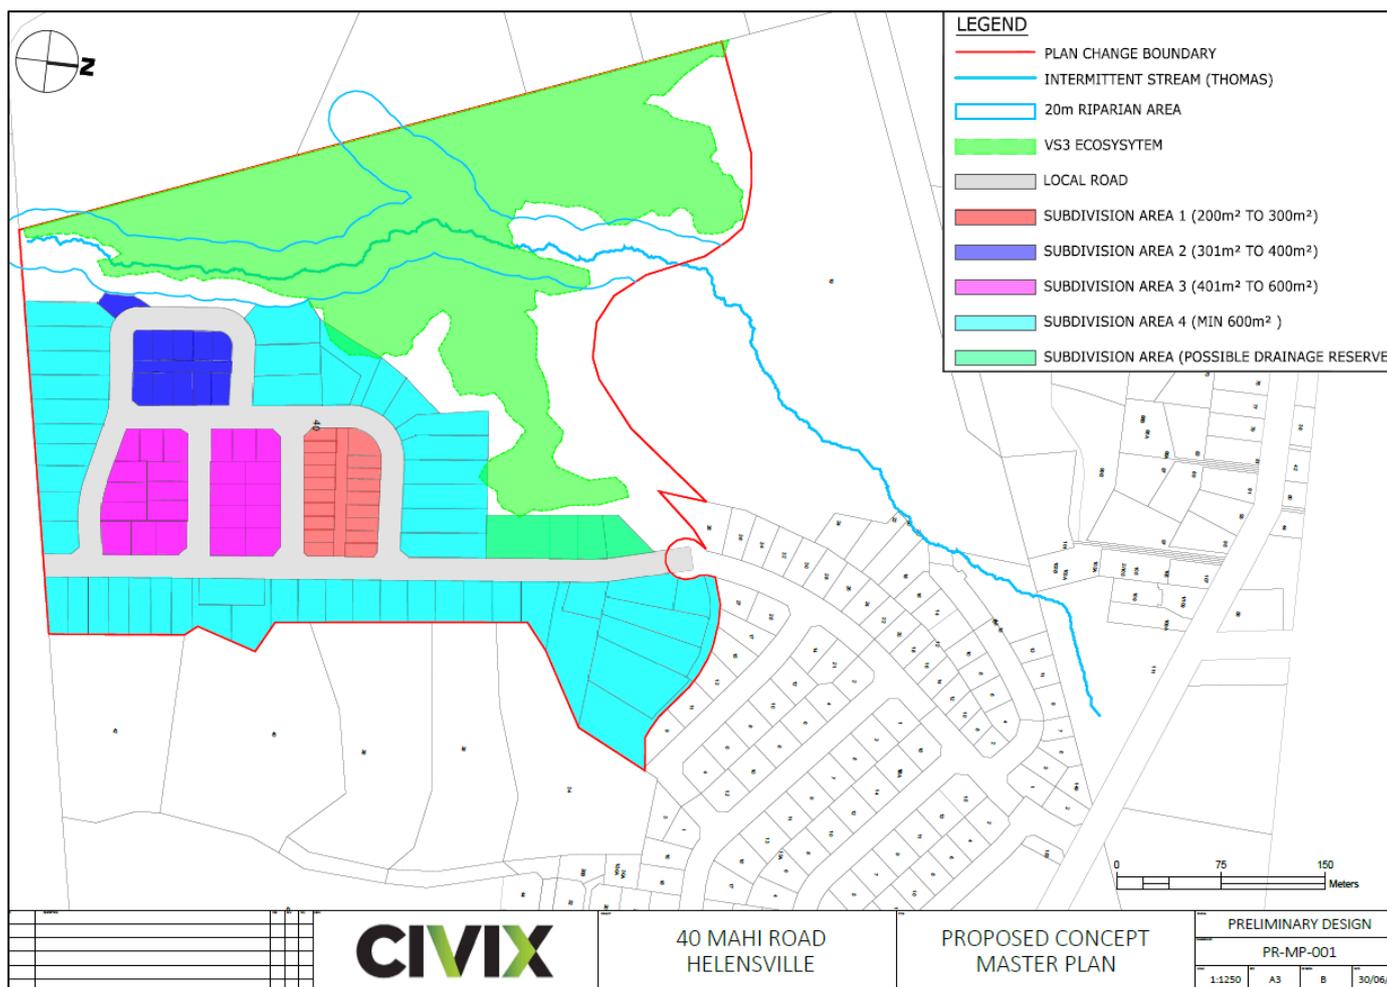
Figure 2: Proposed concept master plan by Ian Munro and Civix, updated 30 June 2025.

In order to demonstrate potential development and subdivision of the Proposed Private Plan Change (PPC) area, a Concept Master Plan has been prepared. This is purely for demonstrative purposes to illustrate how the proposed zoning could potentially deliver development, access, and subdivision. Later resource consent applications will enable more detailed proposals and assessments in relation to the proposed zonings. Three 'subdivision areas', each with different sized lots, are demonstrated in the proposed Mixed Housing Suburban Zone, and the balance is identified as potential Single House Zone lots. Lot sizes range from 200m<sup>2</sup> to 600m<sup>2</sup> in the Mixed Housing Suburban Zone, and start at 600m<sup>2</sup> in the Single House Zone. In addition, a drainage reserve is also indicated as well as a local road which has been assessed in terms of suitable grades and widths in compliance with Auckland Transport standards See Figure 2 below.

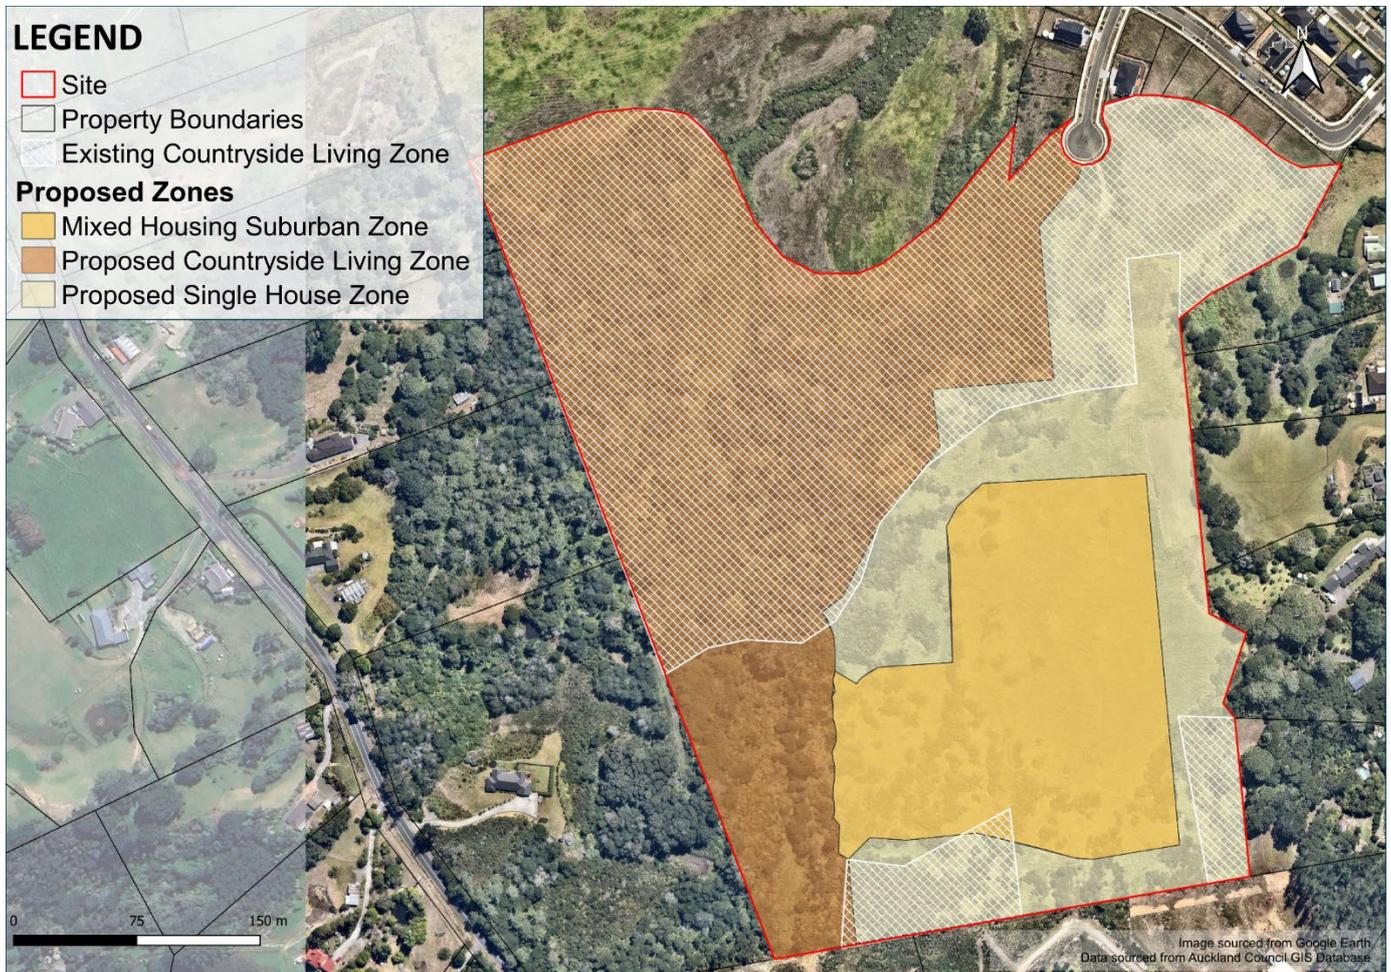
Figure 3: Proposed zonings including amended Countryside Living Zone

The proposal is to rezone the 'Future Urban' and part of the 'Countryside Living' to 'Single House' and 'Mixed Housing Suburban' zones in order to allow future subdivision and development of the site. It is also proposed to amend some of the Countryside Living areas to better rationalise the proposed urban zones and to align with ecological features, predominantly the intermittent stream and associated margins in the south-west area of the site.

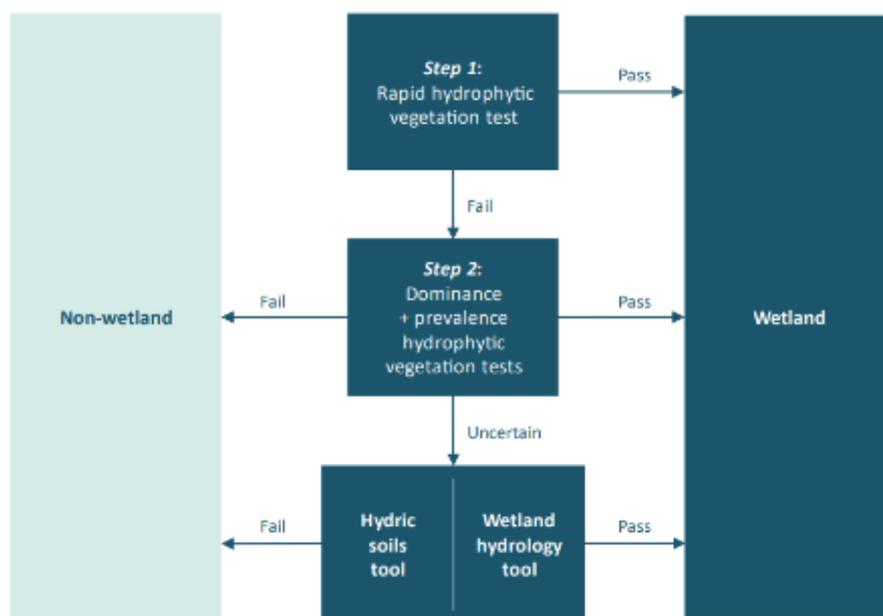
Figure 4: Simple flow chart of steps for determining an RMA wetland using the hydrophytic vegetation, hydric soils and wetland hydrology tools<sup>5</sup>.

The New Zealand Wetland Delineation Protocols (2022)<sup>4</sup> outlines four main steps that should be followed when assessing wetlands (Figure 6). The procedure involves assessing hydrophytic vegetation, hydric soils and wetland hydrological characteristics.

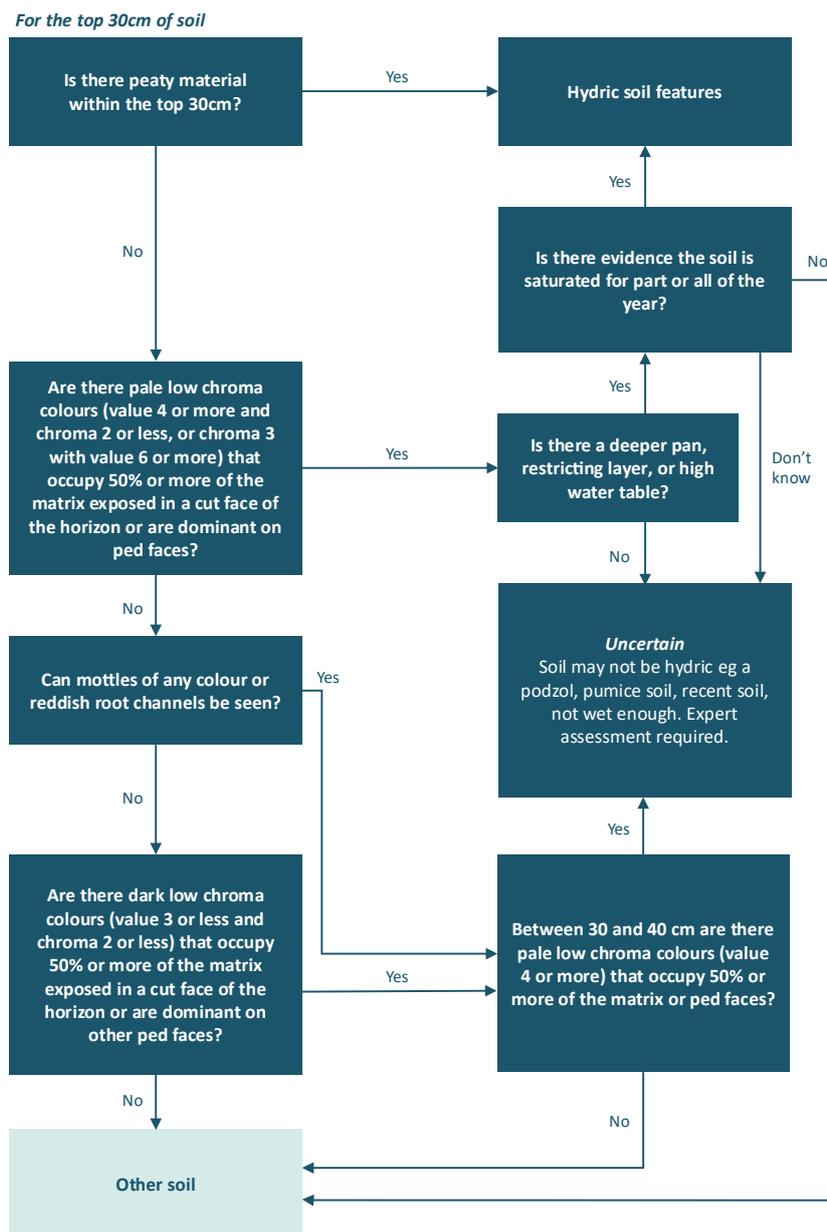
Figure 5: Simple key to identify hydric soil features (Fraser *et al.*, 2018)

Soil samples should be taken in any wetland areas dominated by hydric vegetation, with a hand auger up to a depth of 40cm, and assessed for hydric conditions in accordance with Figure 7 below, using Fraser *et al.* (2018)<sup>7</sup> and the Munsell Soil Colour Book.

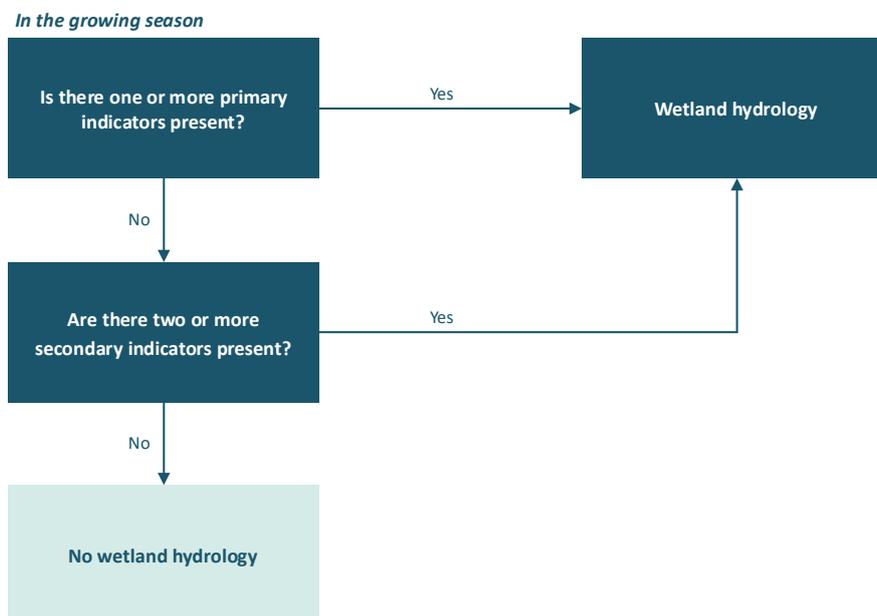
*Figure 6: Simple key to describing wetland hydrology*

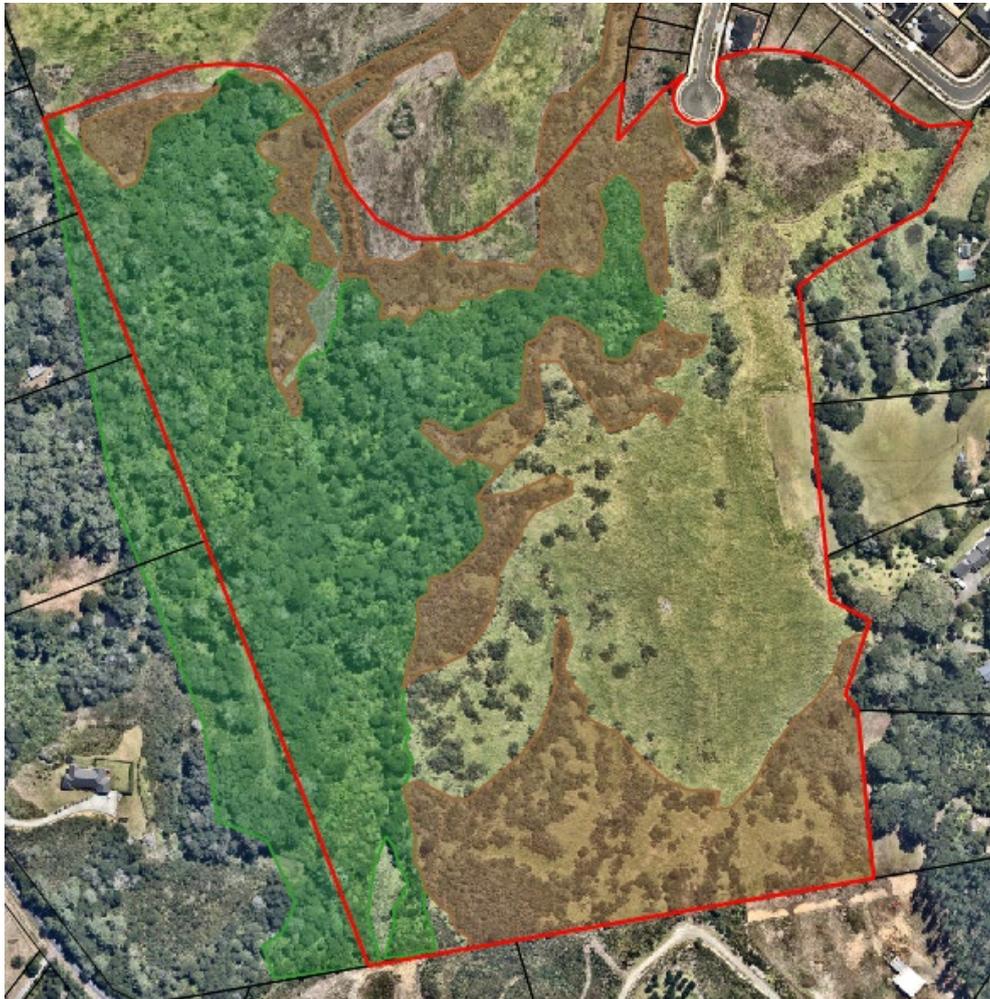
Figure 7: Mapped ecosystems on site (updated February 2025). Manuka/ kanuka scrub (VS3) shown in green and Exotic Scrub (ES), consisting of predominantly gorse, shown in brown. The remainder of the site is covered in kikuyu grass (Exotic Grassland (EG)).

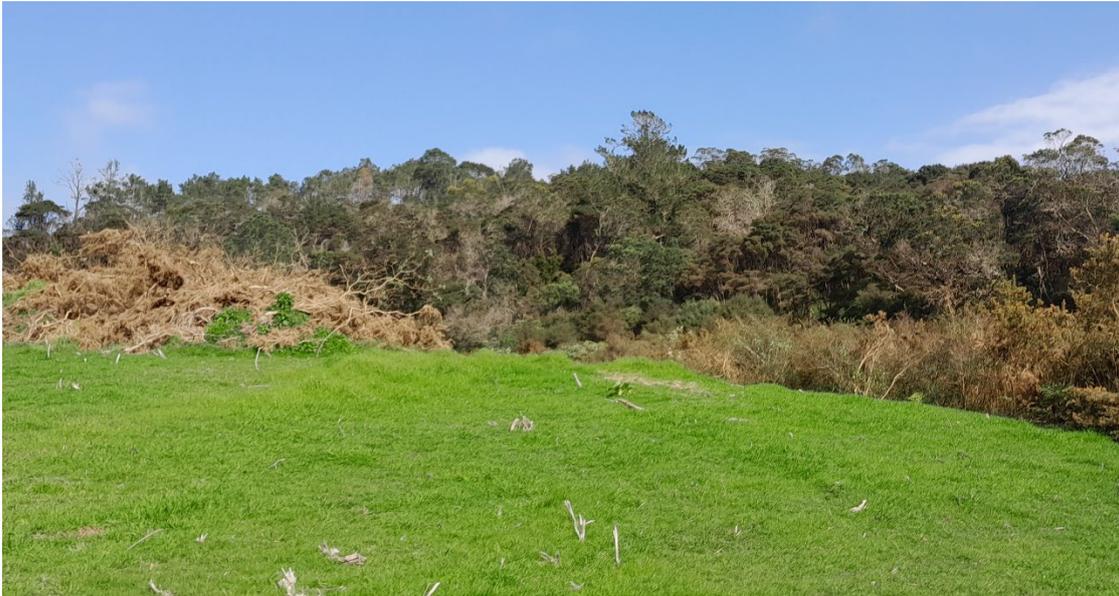
*Photo 1: Some of the areas mapped as Exotic Scrub (ES) has been cleared since the time of the ecology site visit. Cleared areas are shown in an updated photo from September 2024 (taken by our soil contamination team).*

It is worth noting that a lot of the gorse existing on site at the time of the site visit (May 2023) has since been cleared (Photo 1 below). A high-resolution drone survey completed on 4 February 2025 was used to update the vegetation map (Appendix A). Areas of exotic scrub (ES) and kanuka/ manuka scrub (VS3) appears to be quite similar as to what was mapped during the site visits with only minor adjustments made to the boundaries of these vegetation types. In addition, exotic grassland (ES) areas have also been added to the updated vegetation map in Appendix A.

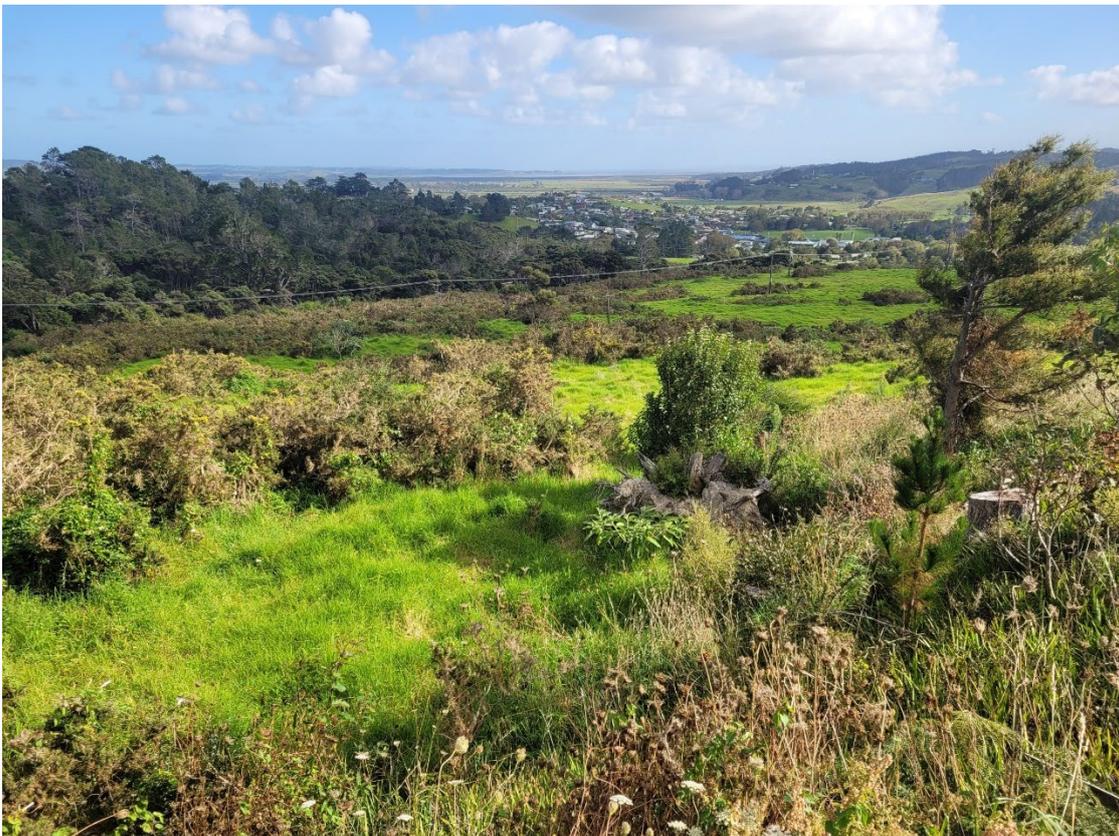
*Photo 2: Site overview of the landscape looking towards the north (from the southern boundary). Dense kikuyu and gorse growth is visible throughout, with regenerating native bush visible in the background.*

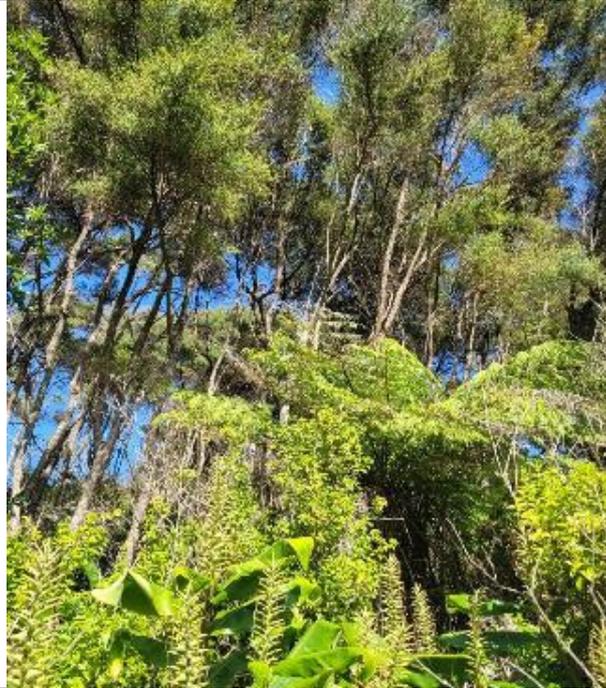
*Photo 3: Wild ginger (pest plant in the front) occurs along the outer edges of the forest of taller kānuka.*

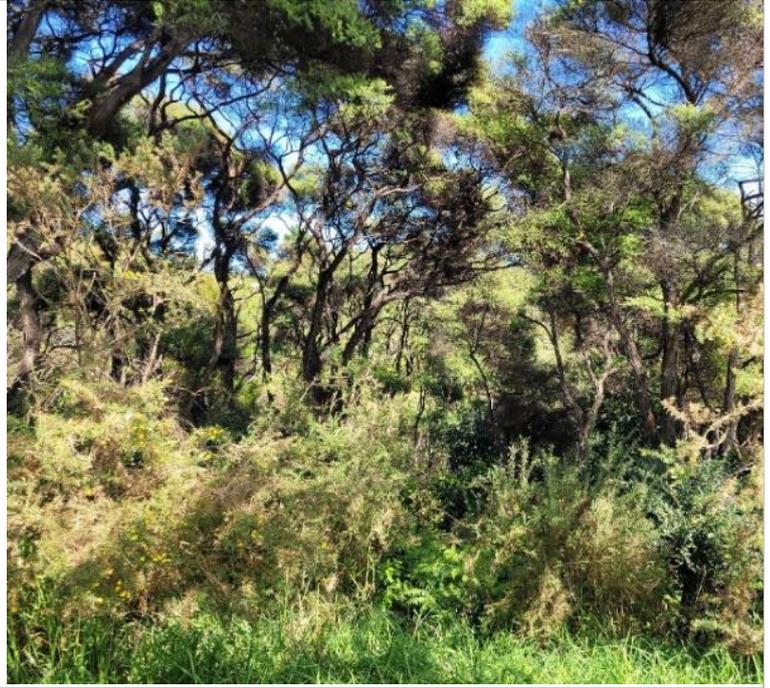
*Photo 4: Bush edge vegetation consisting of gorse, karamū and kikuyu. Taller pine trees and kānuka are visible in the background.*

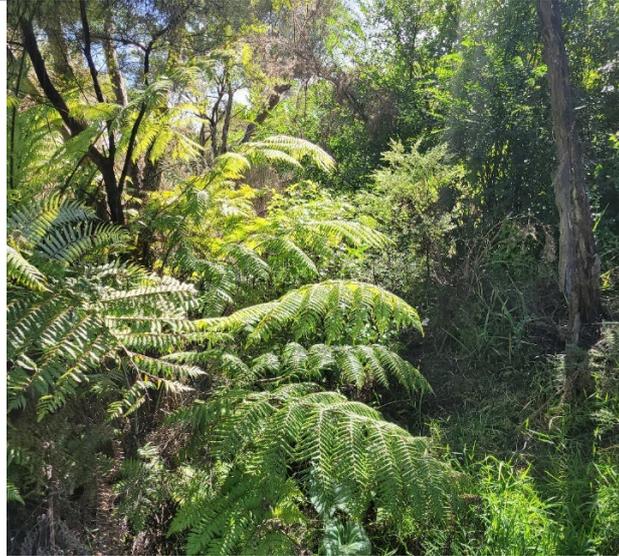
*Photo 5: Bush understory contains silver fern, hangehange, supplejack and cabbage trees, amongst other species.*

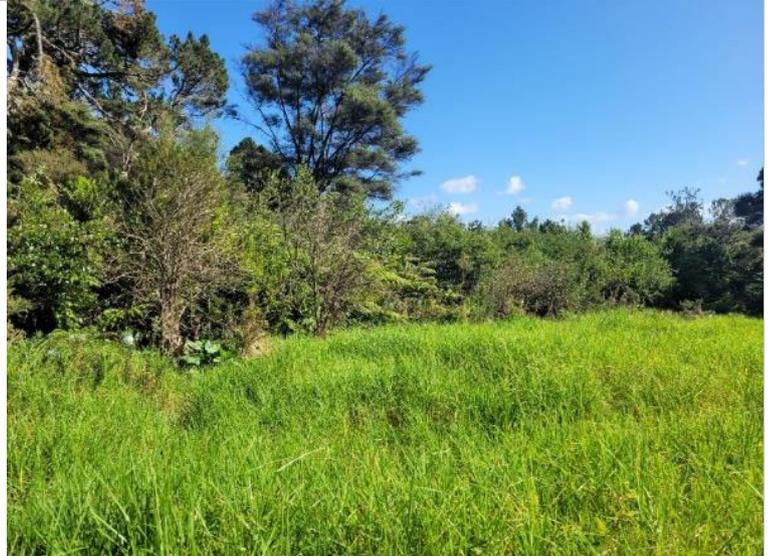
*Photo 6: Semi-mature kānuka trees forms the main canopy layer. Gorse and karamū form the outside/ edge scrub layer before giving way to kikuyu grasslands.*

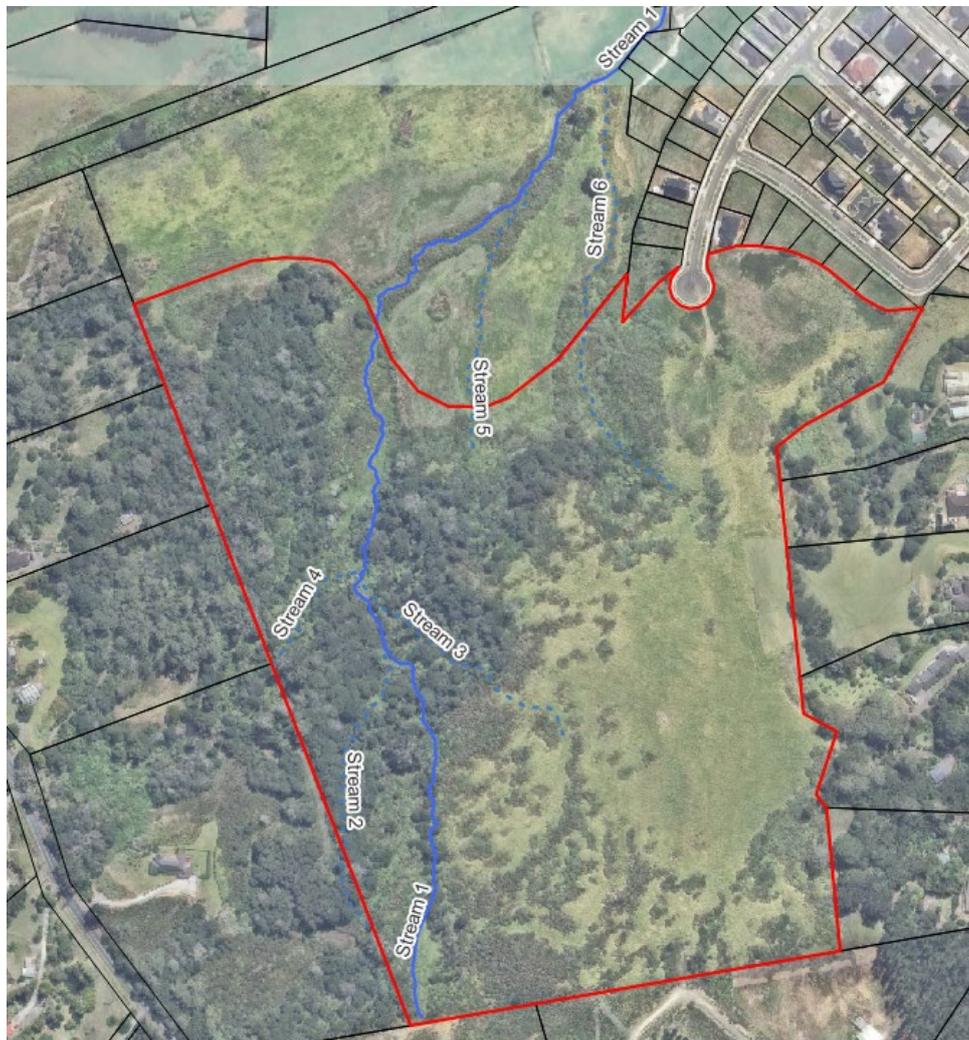
Figure 8: Watercourses identified and mapped on site. Stream 1 is intermittent/permanent, Streams 2-6 are ephemeral.

The main watercourse on site is a headwater tributary of the Awaroa Stream, and is located towards the site's western boundary, labelled Stream 1. Five additional overland flow paths were identified on the site, labelled as Stream 2 to Stream 6 on the map below. These are shown in Figure 10 below and discussed in this section.

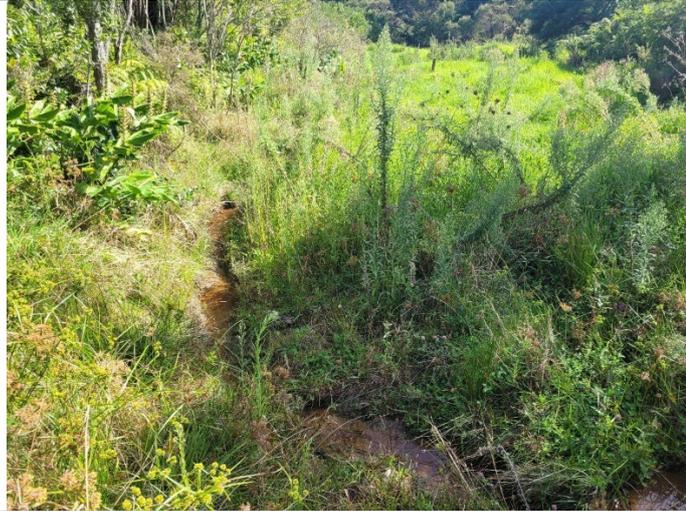
*Photo 7: Surface and groundwater flow south of the site at the headwaters of the intermittent stream.*

Stream 1 is the main water course present. To the south, Stream 1 flows in a steep, densely vegetated gully which gradually opens up into a wider valley towards the north. The watercourse is shallow, with water depth less than 10cm where it enters the site from the south, gradually increasing up to a depth of ~30cm where it enters the neighbouring property to the north. Channel width is between 30cm and 2m with the widest section where the stream flows closest to the eastern boundary. Throughout its length, the stream channel varies from shallow and wide to more incised in places. This watercourse was classified as intermittent to permanent, based on the presence of pools and flowing water, a defined channel in places, and catchment size.

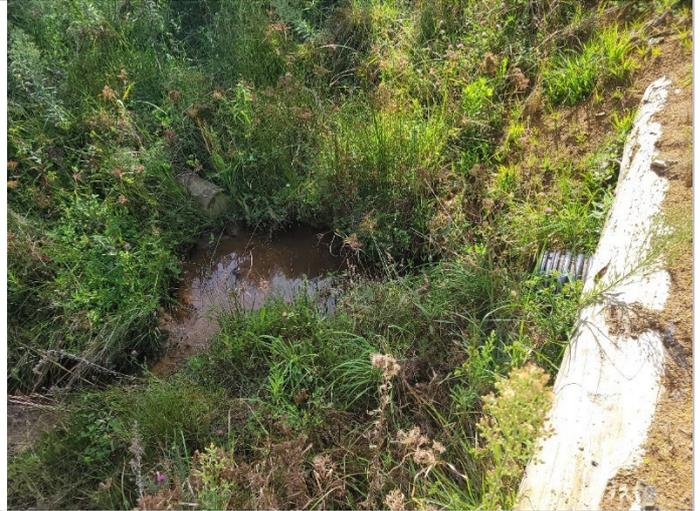
*Photo 8: Section of the intermittent stream entering the southern site boundary through a culvert.*

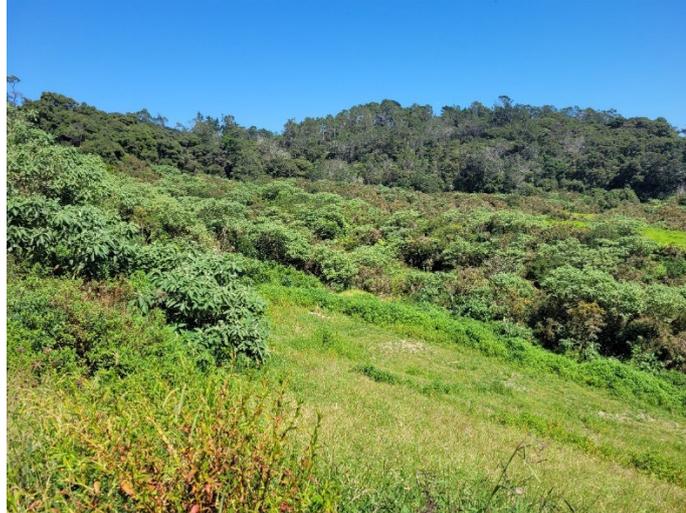
*Photo 9: The upper hillslopes/ southern part of the intermittent stream, has densely vegetated riparian margins consisting of exotic/ native scrub mix.*

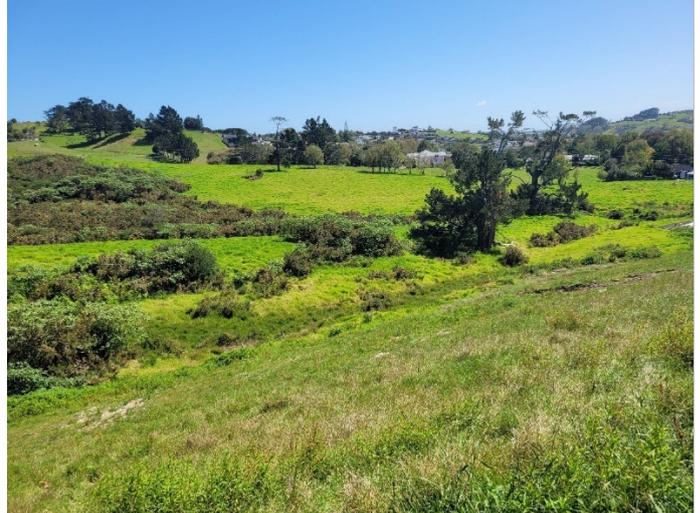
*Photo 10: Further downstream, to the north, the intermittent stream flows into a more open valley floor, with associated (potential) wetland along its margin.*

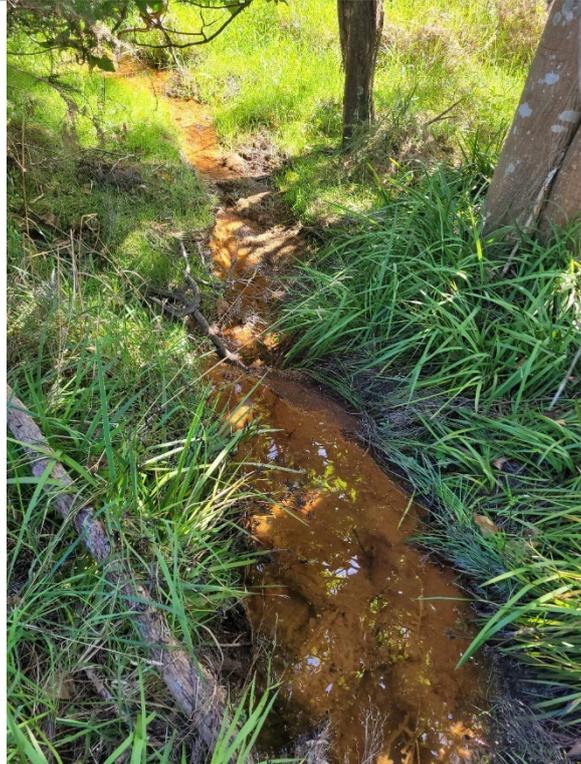
*Photo 11: The stream widens slightly as it enters forested areas and water flow is more evident.*

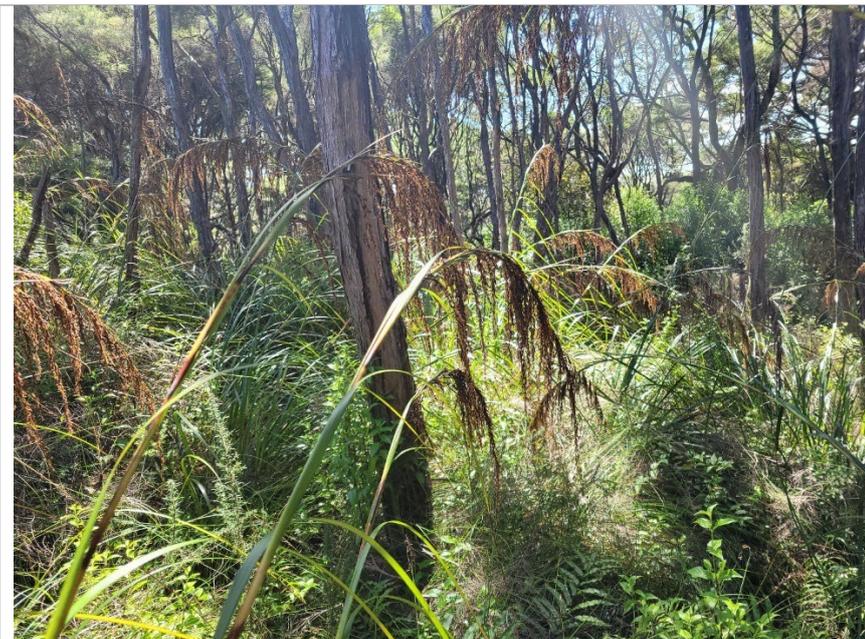
*Photo 12: Stream 2 where it flows through more forested areas.*

This stream enters the site along the eastern boundary to the south. It flows from south to north where it joins Stream 1 toward the centre of the site. Stream 2 is located in a densely vegetated area and did not have a defined channel throughout its length, nor did it have flowing water, although some shallow ponding was visible in places. It has been classified as ephemeral.

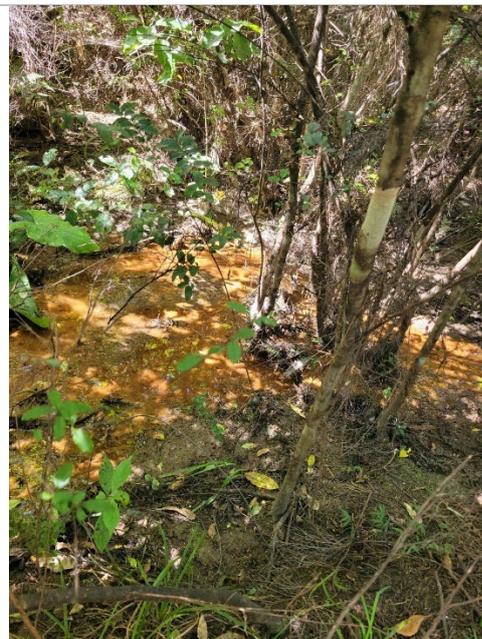
*Photo 13: Ponding visible along some parts of Stream 2, within the forested areas.*

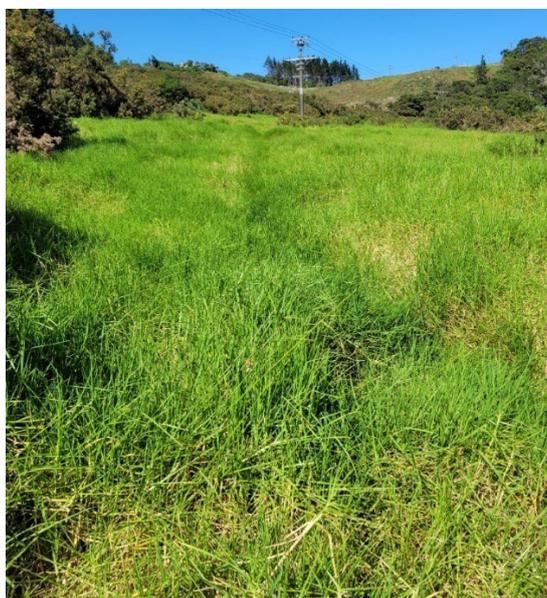
*Photo 14: Stream 3 shows as a shallow depression in the landscape with no channel or water at the time of the site visit.*

Stream 3 is mapped as an overland flow path on AC Geomaps. No water was present along the upper reaches at the time of the site visit, however, a shallow depression was visible in the landscape (see photo 13 below). No defined channel could be distinguished, and terrestrial vegetation was growing throughout its width. No ponding or damp areas were present at the time of the site visit. Stream 3 has been classified as ephemeral. The stream connects to Stream 1 further northwest, where it enters the more forested areas.

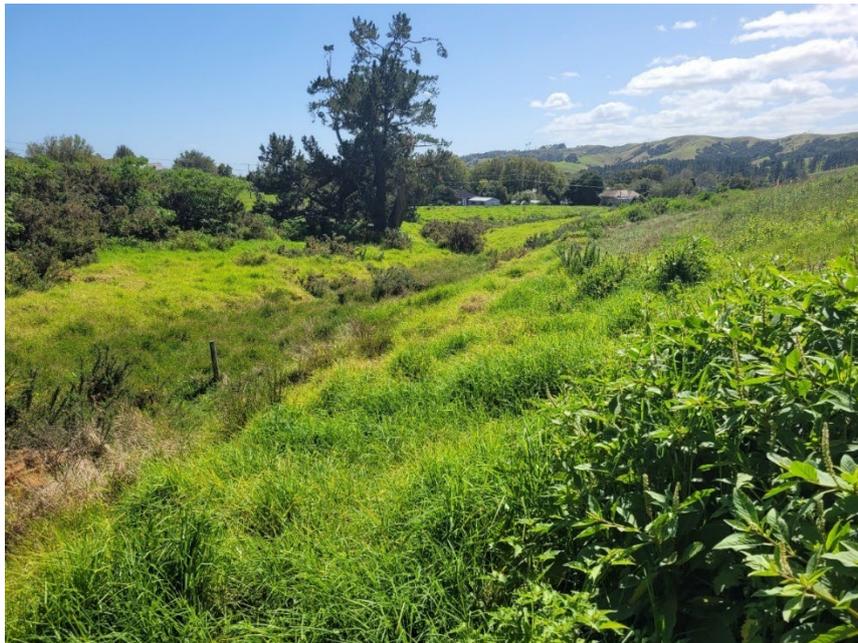
*Photo 15: View of Stream 6, at the northern property boundary looking further north.*

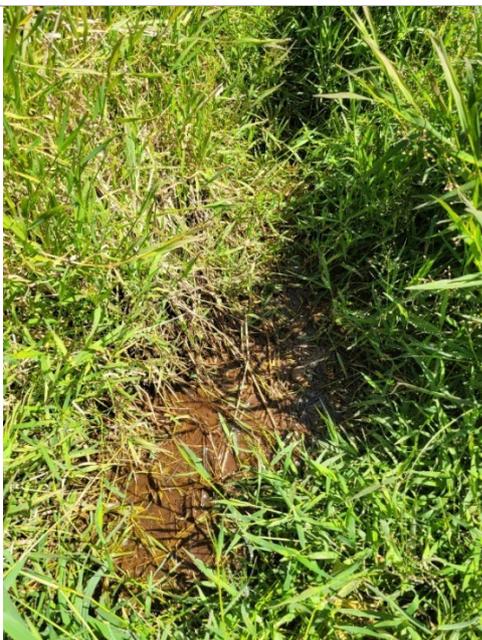
*Photo 16: Stream 6 downstream, just outside the property boundary.*

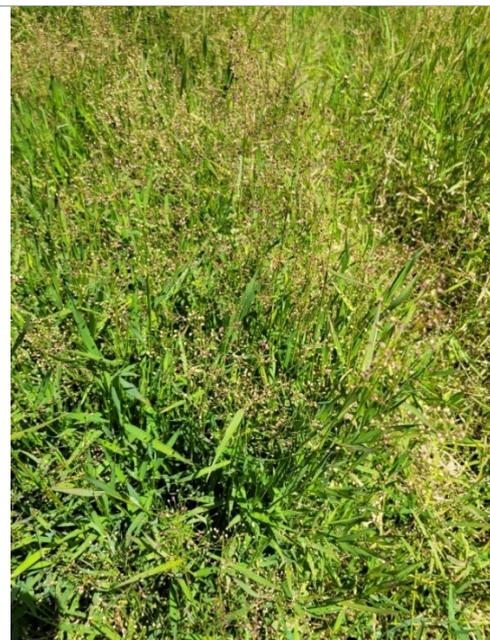
*Photo 17: Swamp millet along Stream 6 (outside northern site boundary)*
