## 40 Mahi Road: Ecologist s92 Comment

<b>To:</b>	Lance Hessel / Senior Planner / Civix Ltd.
<b>From:</b>	Karien Killian / Ecology Lead / Thomas Consultants
<b>Date:</b>	24/07/2025
<b>Subject:</b>	40 Mahi Road: Ecologist s92 Comment (updated)
<b>Attachments</b>	Revised Ecological Assessment and Maps

# Updated Ecological Assessment in Response to Council's Further Information Request

Property Address: 40 Mahi Road, Helensville

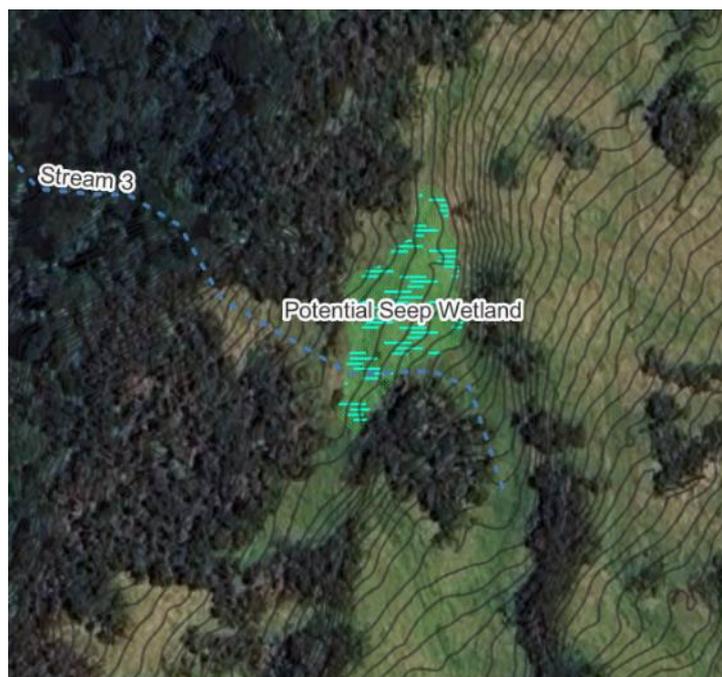
Figure 9: Small area of rushes at the base of a slope, amongst predominantly kikuyu grass.

During the site visit, an area of approximately 300m<sup>2</sup> was noted where rushes (*Juncus effusus*) were growing between the kikuyu grass. The area had not been grazed for some time (as is evident by the dense growth of kikuyu) and is in an area of the hillside that forms a shallow depression, and it was thought possible that seep wetland conditions could be present. Species cover consisted of more than 50% kikuyu grass (a facultative upland pasture species), however, in order to confirm whether the area required further investigation, a 2m x 2m vegetation plot, with Dominance and Prevalence tests were conducted to determine if this area is a natural inland wetland or not. The results of both Dominance and Prevalence tests indicated that this area is not a natural inland wetland.

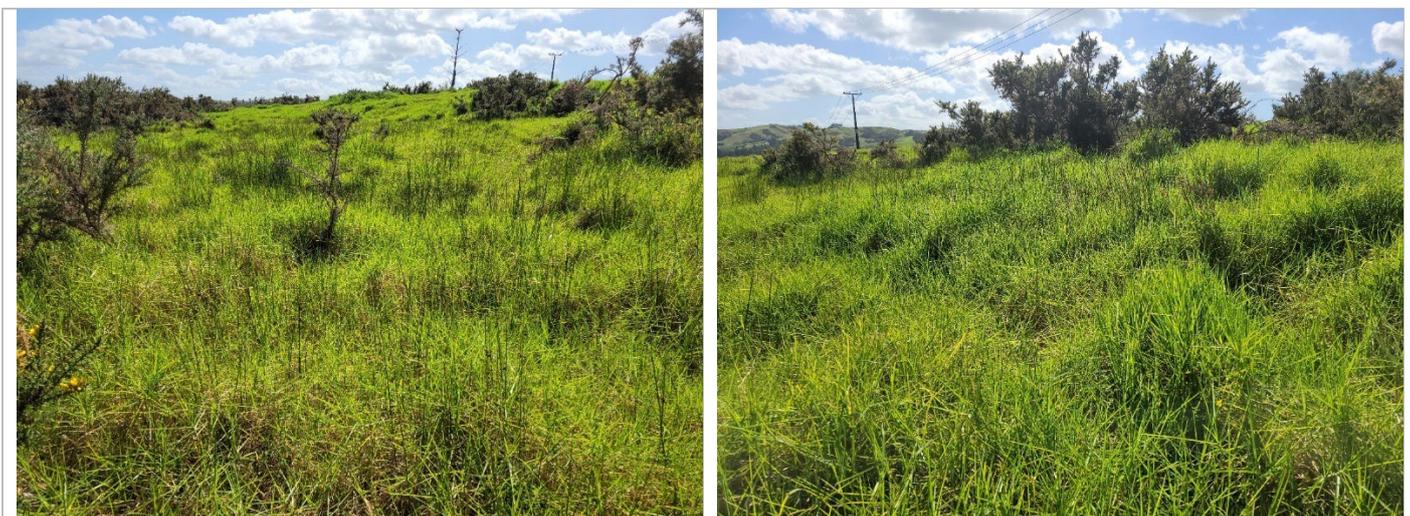
Photo 18 and 19: Potential hillside seep area with rush growth amongst the kikuyu.

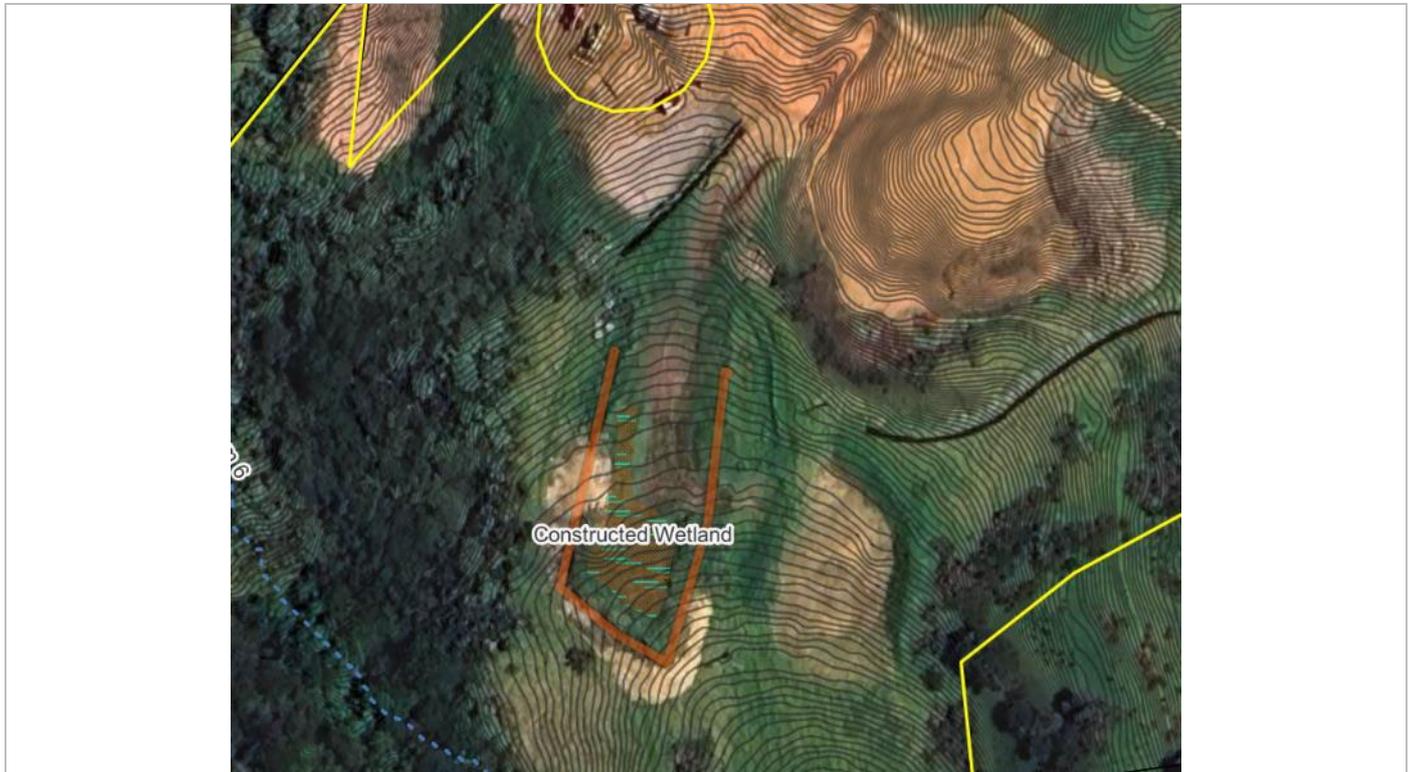
Figure 10: Small area of wetland habitat has formed in association with the surrounding dam wall (indicated in brown lines).

An artificial dammed area is present approximately 70m south of Mahi Road. The earthen walls are 2m high at maximum and only border the west, south and north of the area. In addition, the eastern wall has a 2m wide gap. The reason for this walled area is unclear as the surrounding slope will not allow water to exit through the gap. Water pools in the southern section, providing damp conditions for the growth of rush species.

This area meets the constructed wetland exclusion “h) a wetland that has developed in or around a deliberately constructed water body since the construction of the water body.”

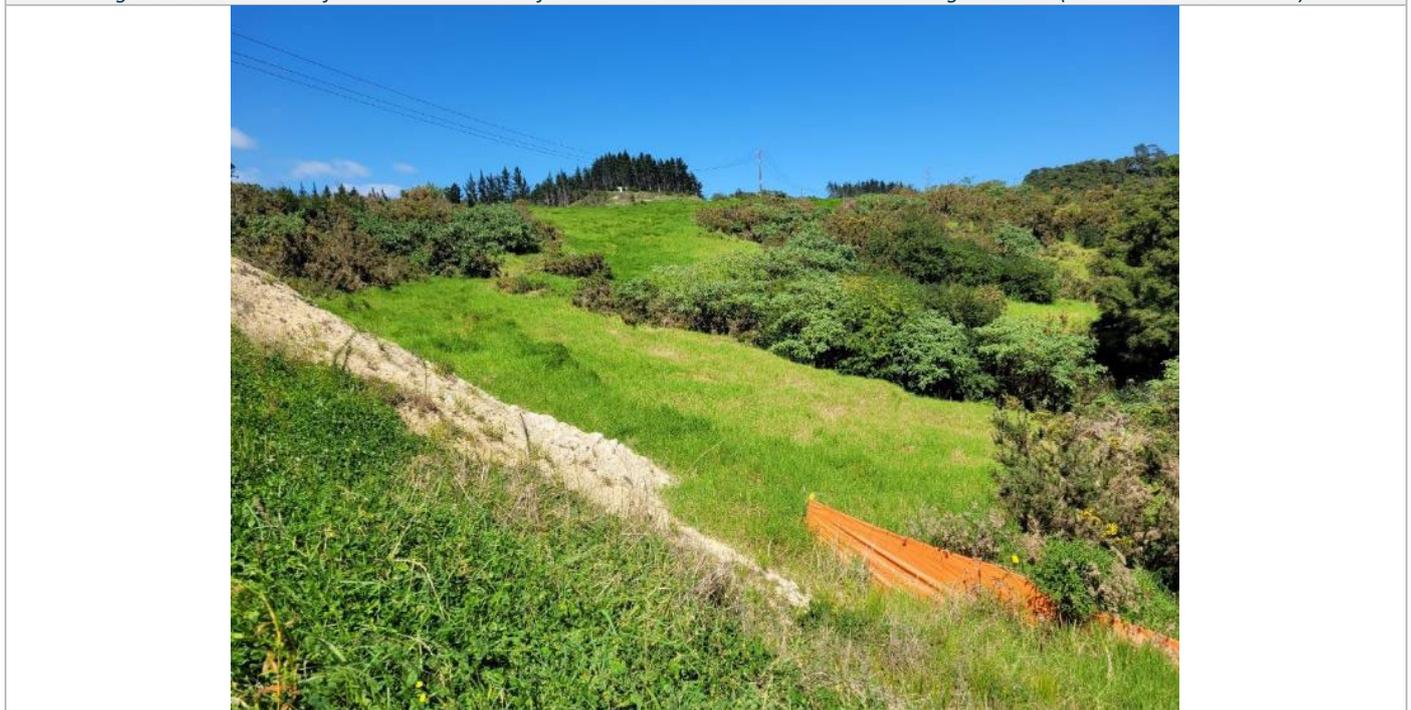
Photo 20: Constructed dam wall up to 2m high

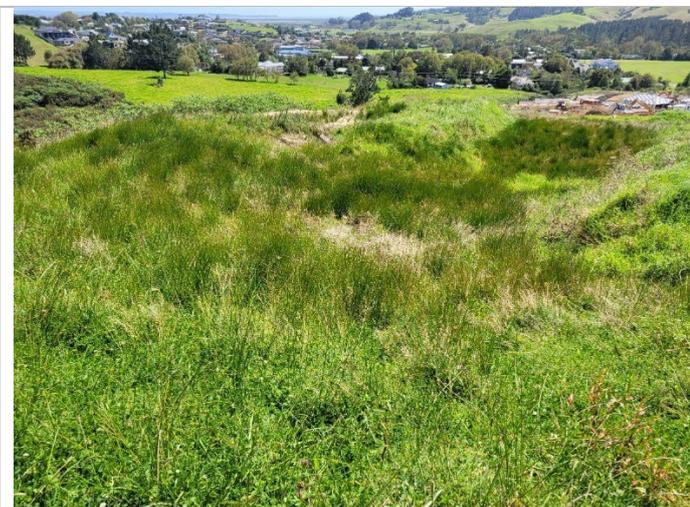
Photo 21: Constructed dam walls where ponding from recent summer rainfall has provided suitable conditions for sedges to grow. No wetland conditions occur on the site in terms of soils, landscape and hydrology.

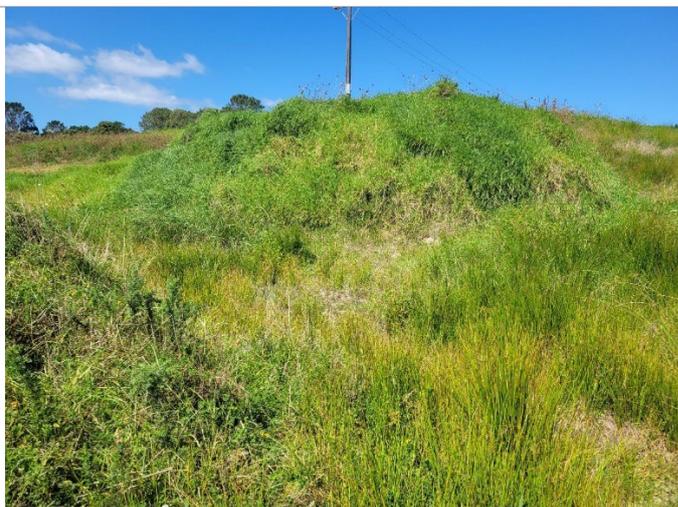
Photo 22: Opening in the eastern wall. It is unknown what the purpose of the walled area is or when it was constructed.

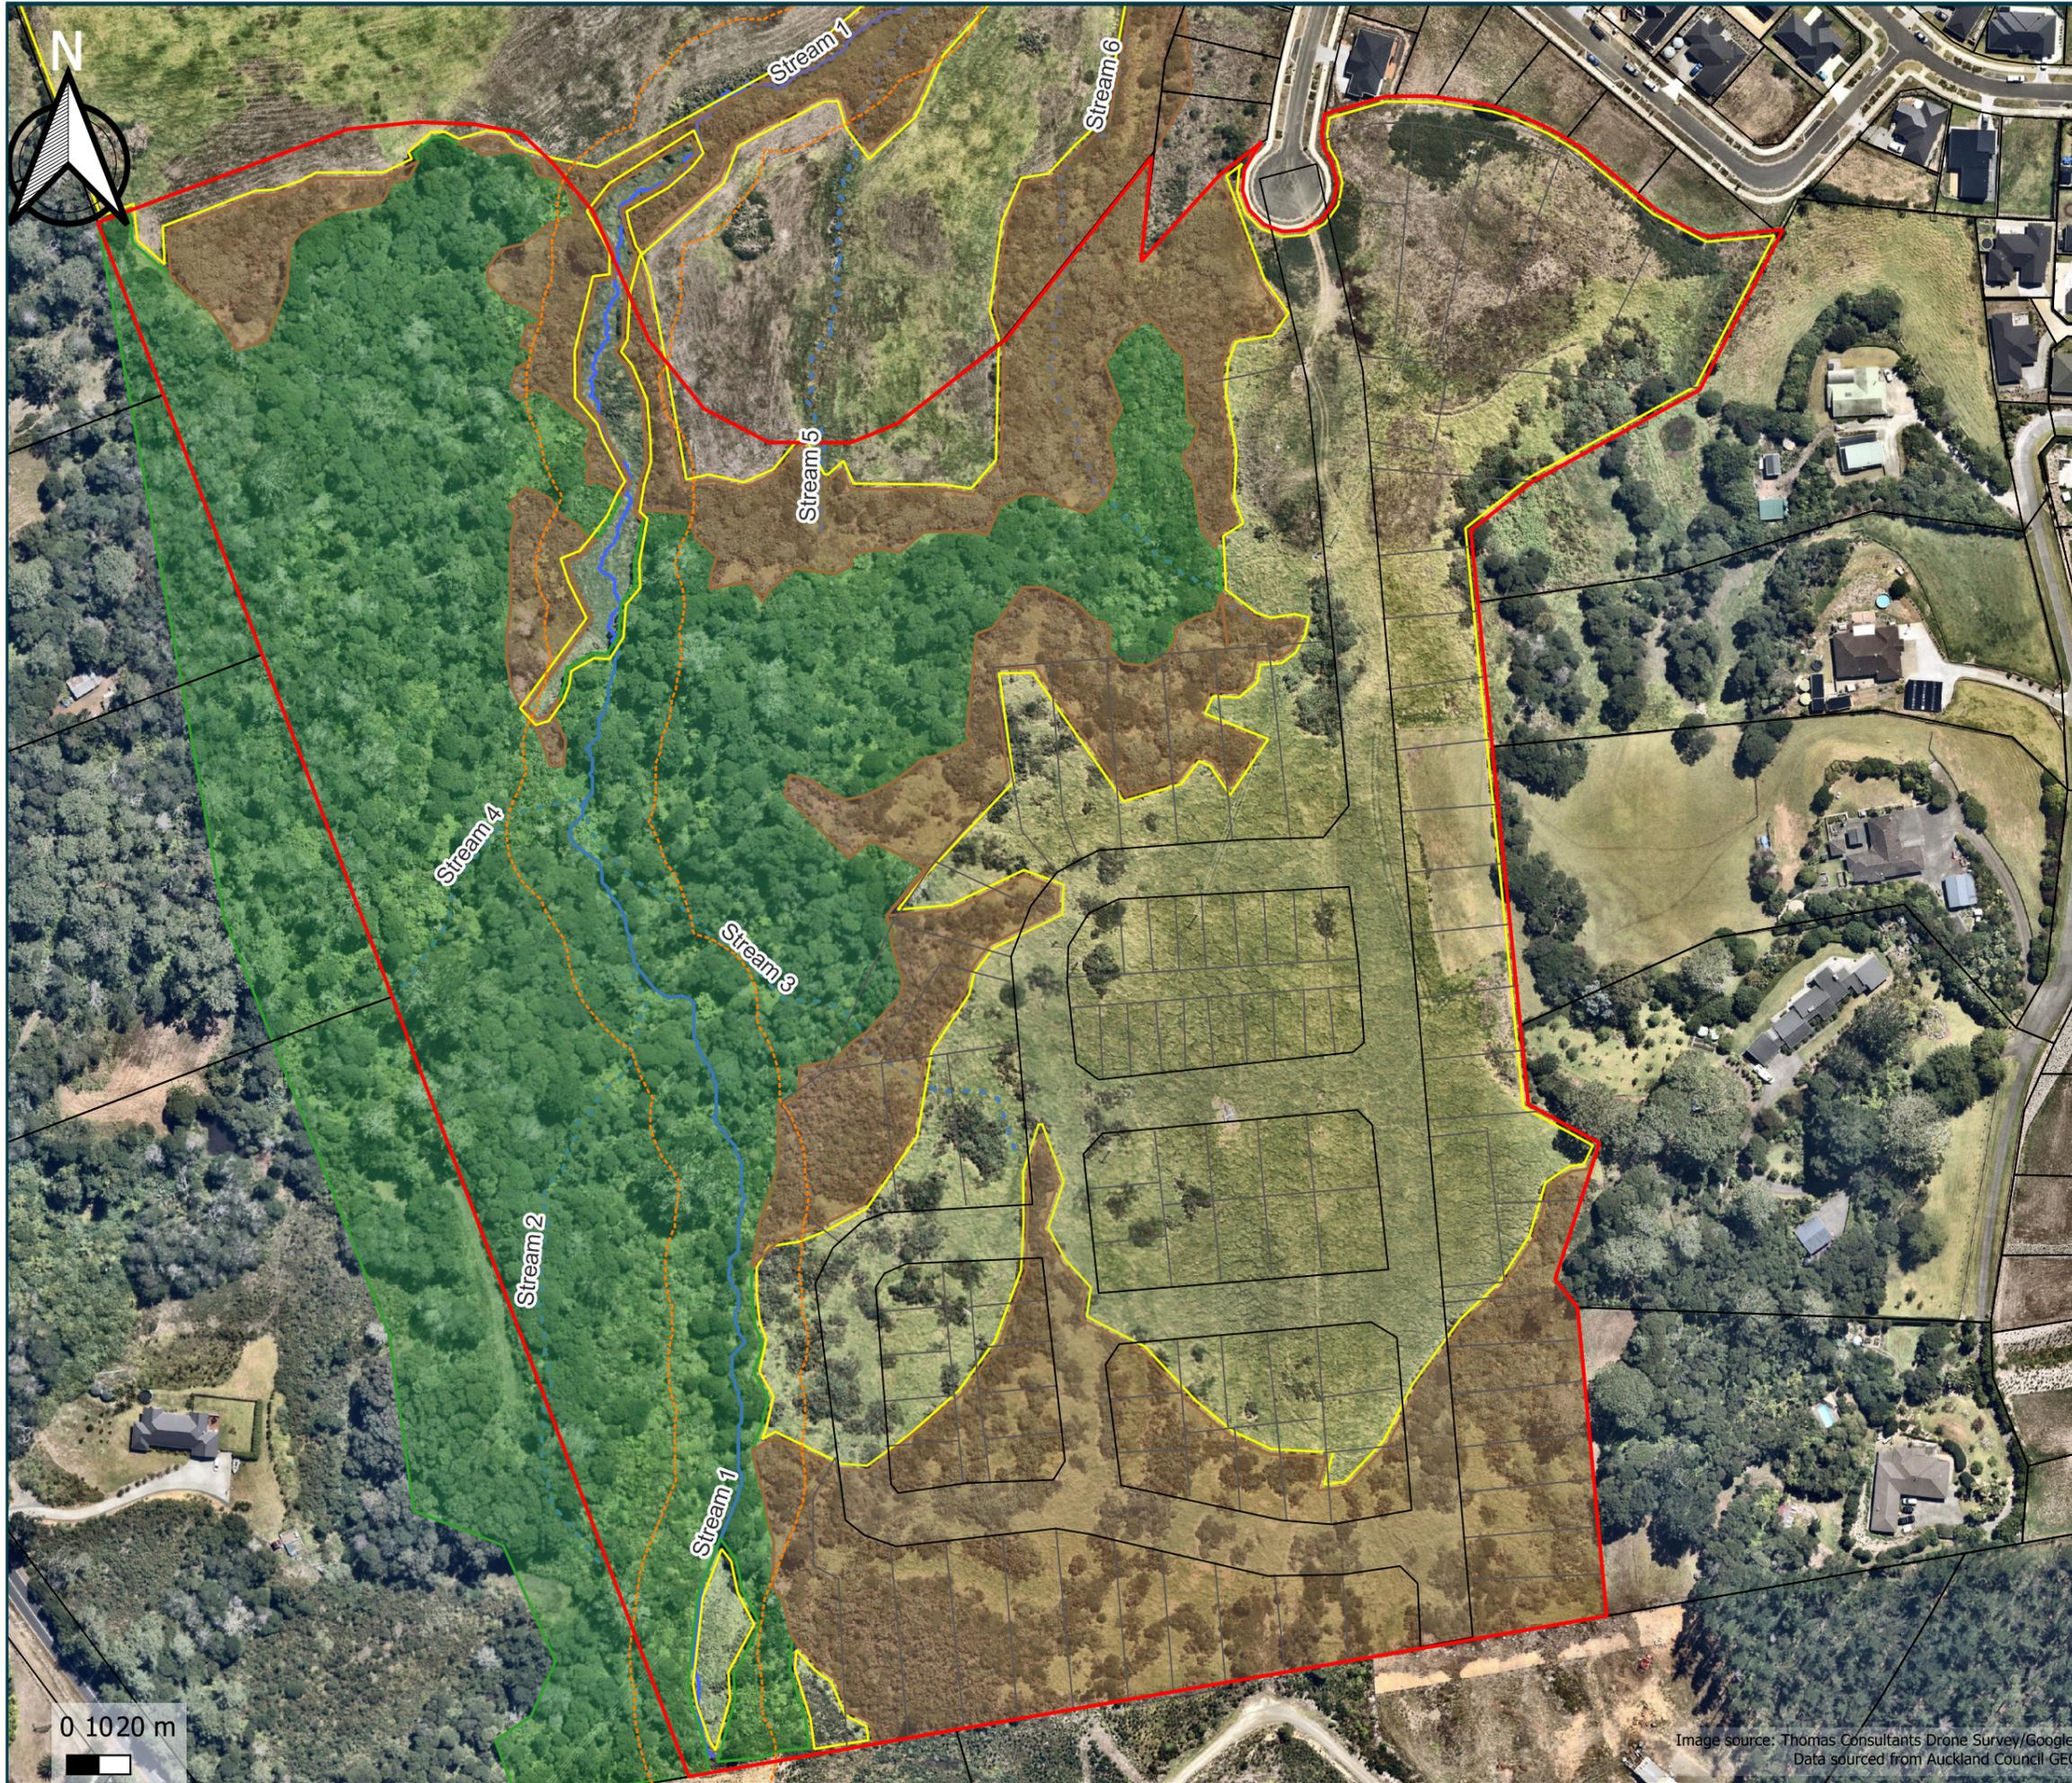
MAP TITLE:  
**UPDATED VEGETATION MAP**

- Property Boundaries
- Site
- Proposed Local Road
- Lot Boundaries
- Ecosystems\_2025**
- VS3 Manuka/ kanuka scrub
- ES Exotic Scrub
- EG Exotic Grassland
- Intermittent Streams
- Ephemeral Streams
- 20m Riparian Yard

An updated map is attached as Appendix A of the updated Ecological Assessment.
