Ref: 20230033

TECHNICAL MEMORANDUM: 40 MAHI ROAD, HELENSVILLE

TITLE: Technical Memorandum
Figure 1: Site Plan

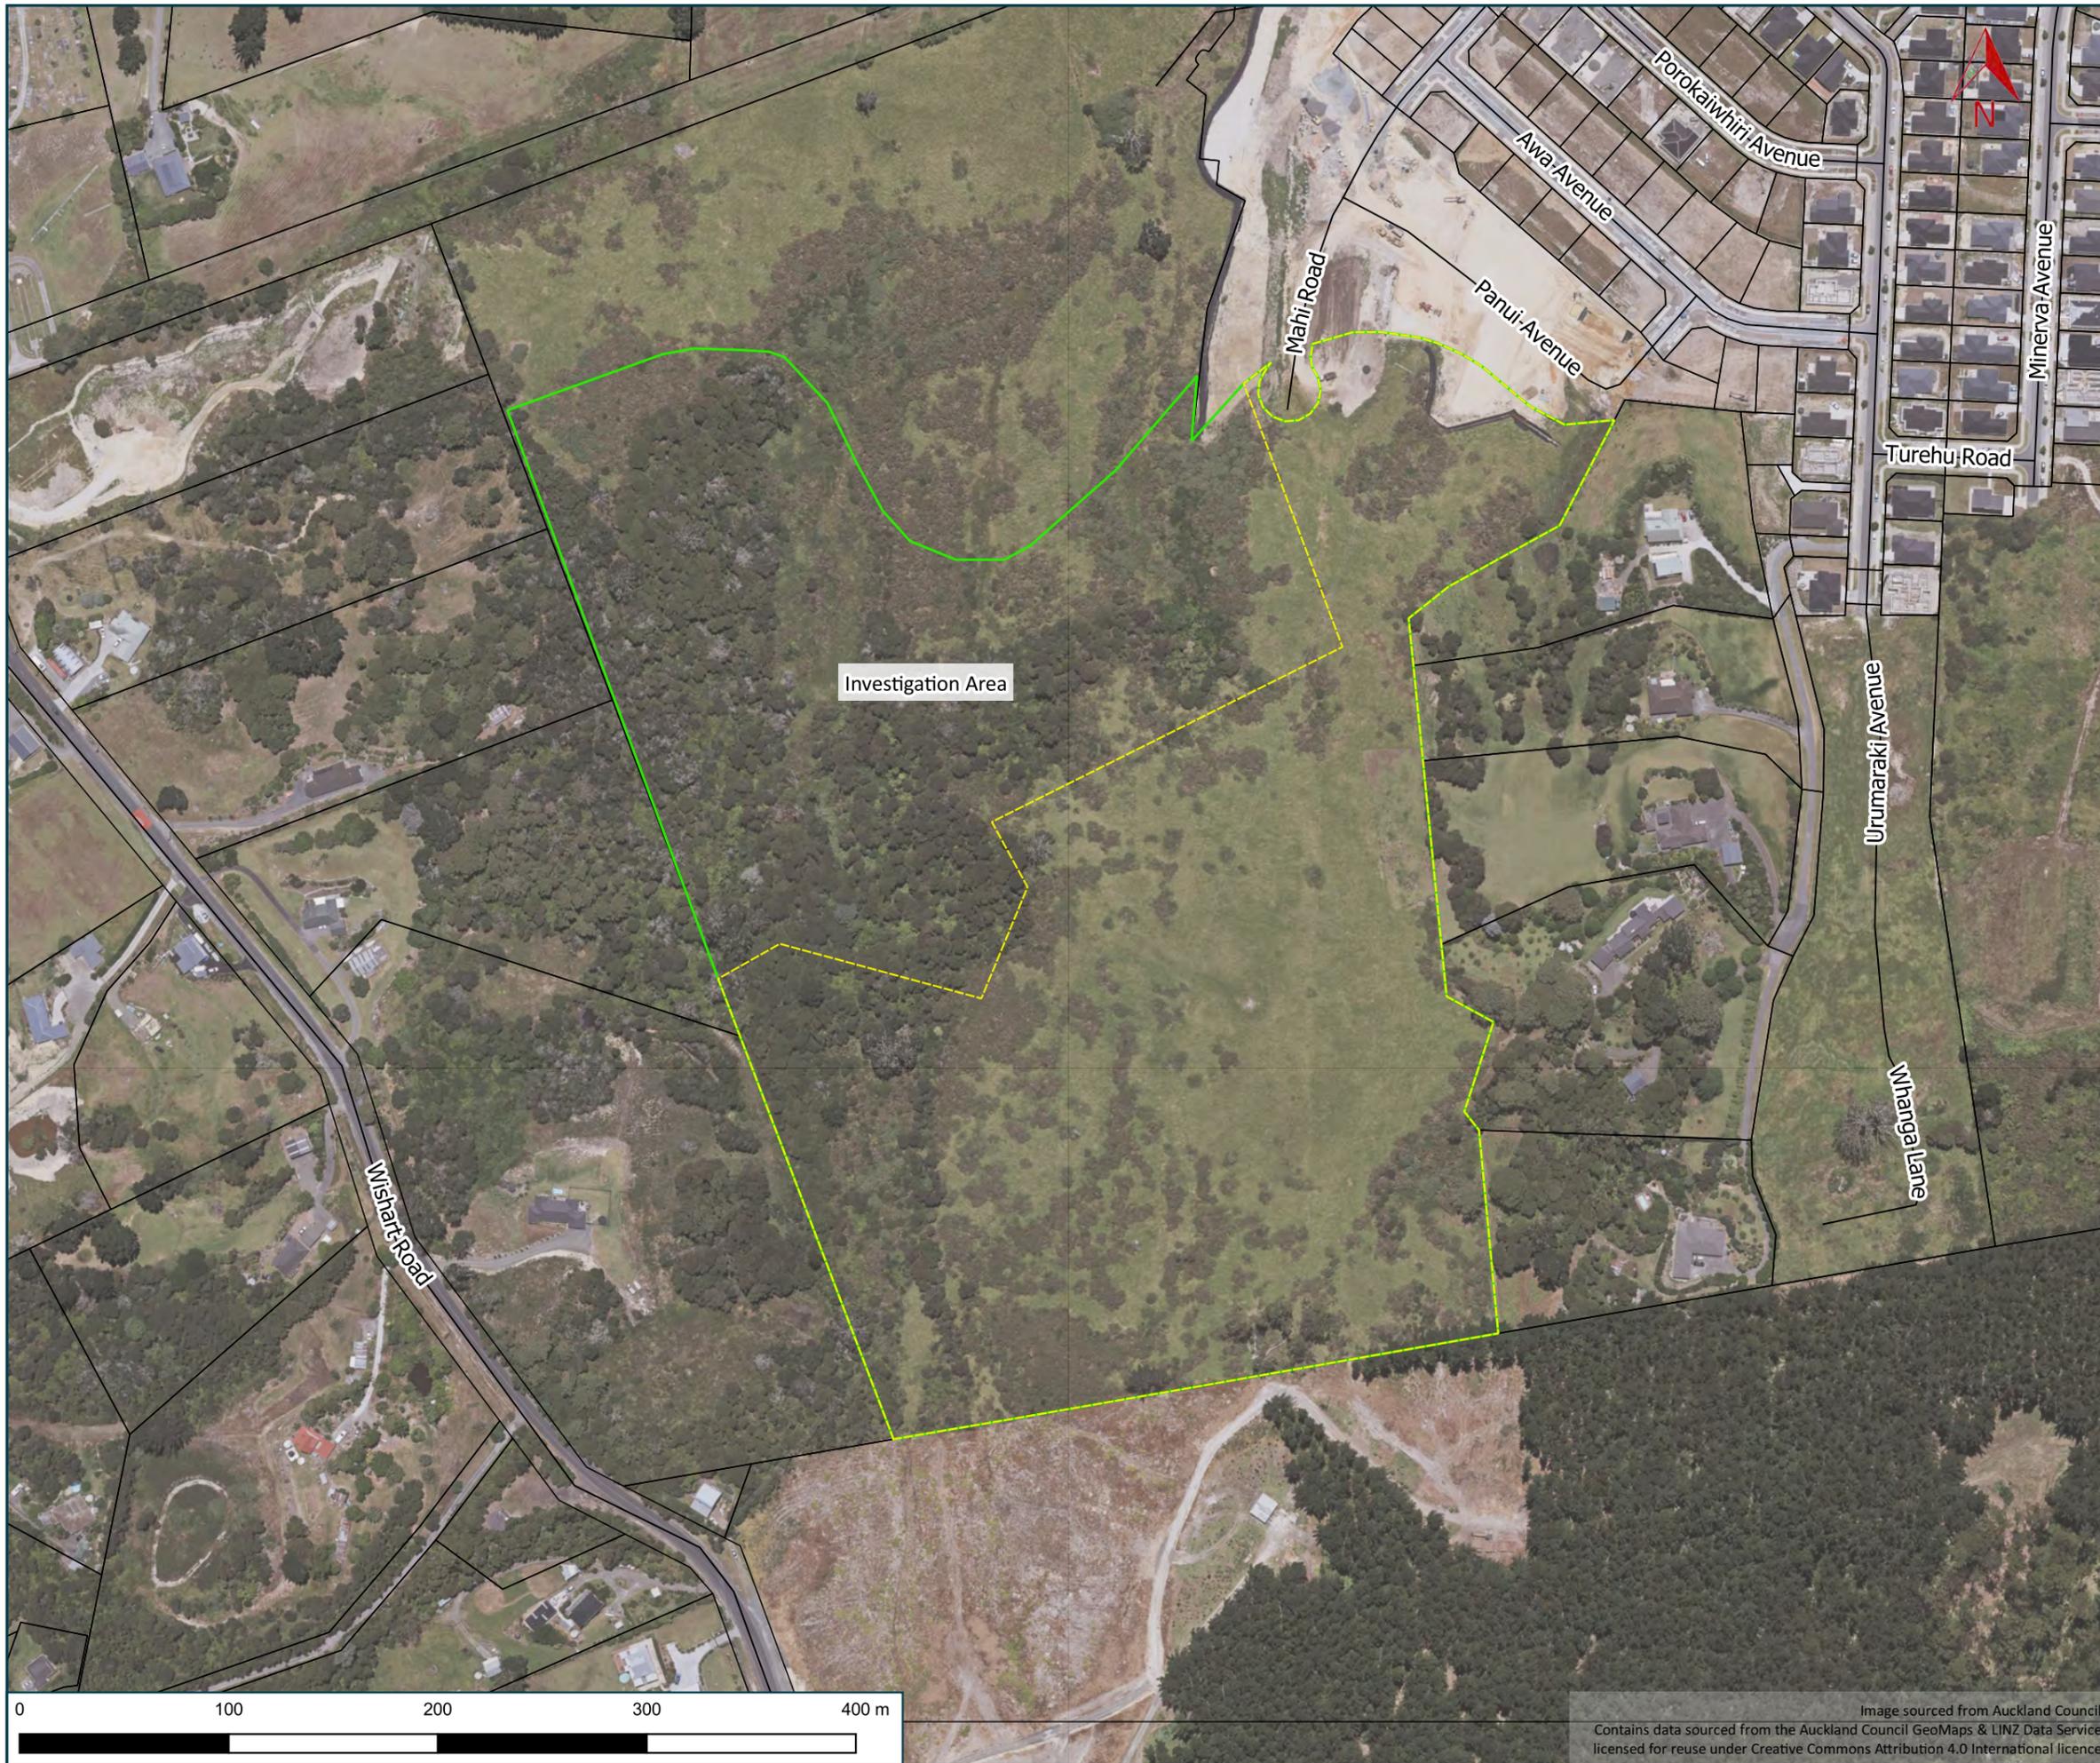
The former site boundary, as referenced in the PSIA, and the new site boundary are presented in Figure 1, appended to this report. The focus of this investigation is the northern area of the site and will be referred to as the “Investigation Area” hereafter.

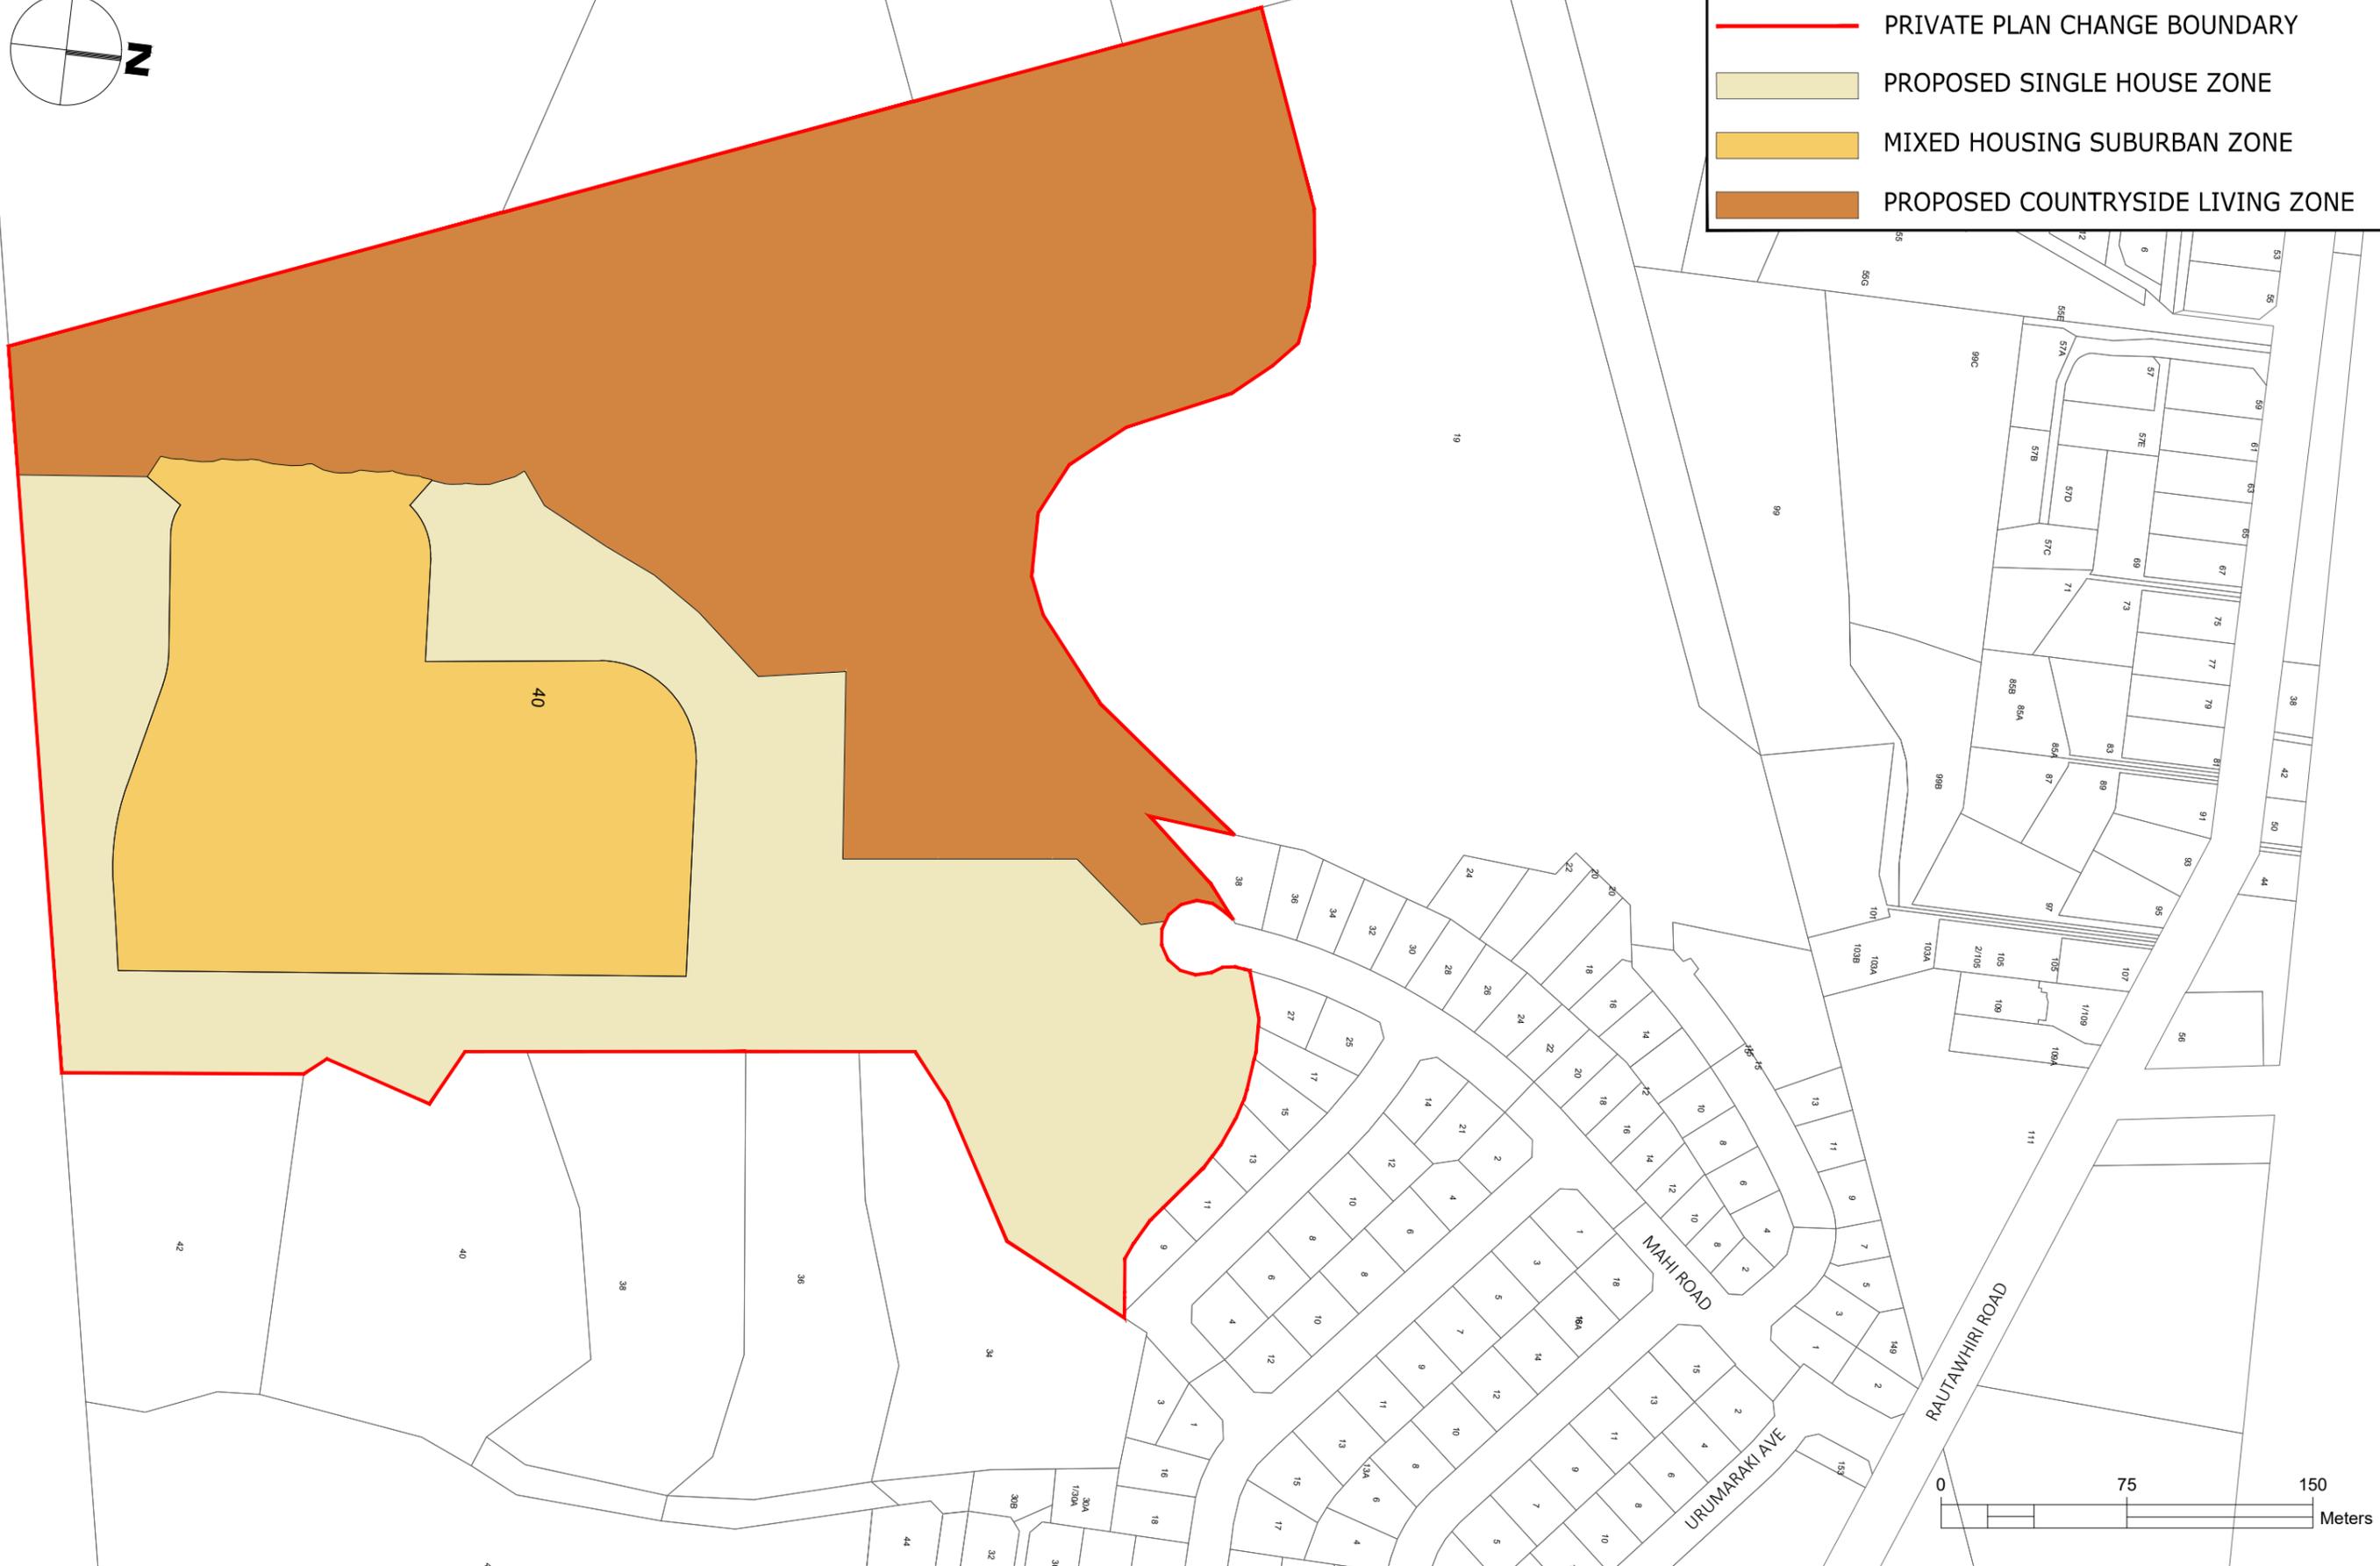
PROPOSED ZONING
PLAN

Hounslow Holdings Limited (the client) proposes to undertake a private plan change for the property located at 40 Mahi Road, Helensville (Formerly part of 151B Rautawhiri Road) in the wider Auckland suburb of Helensville (the site). The proposed private plan change will change the zoning of the property from countryside living, to a mix of single house and countryside living zones.

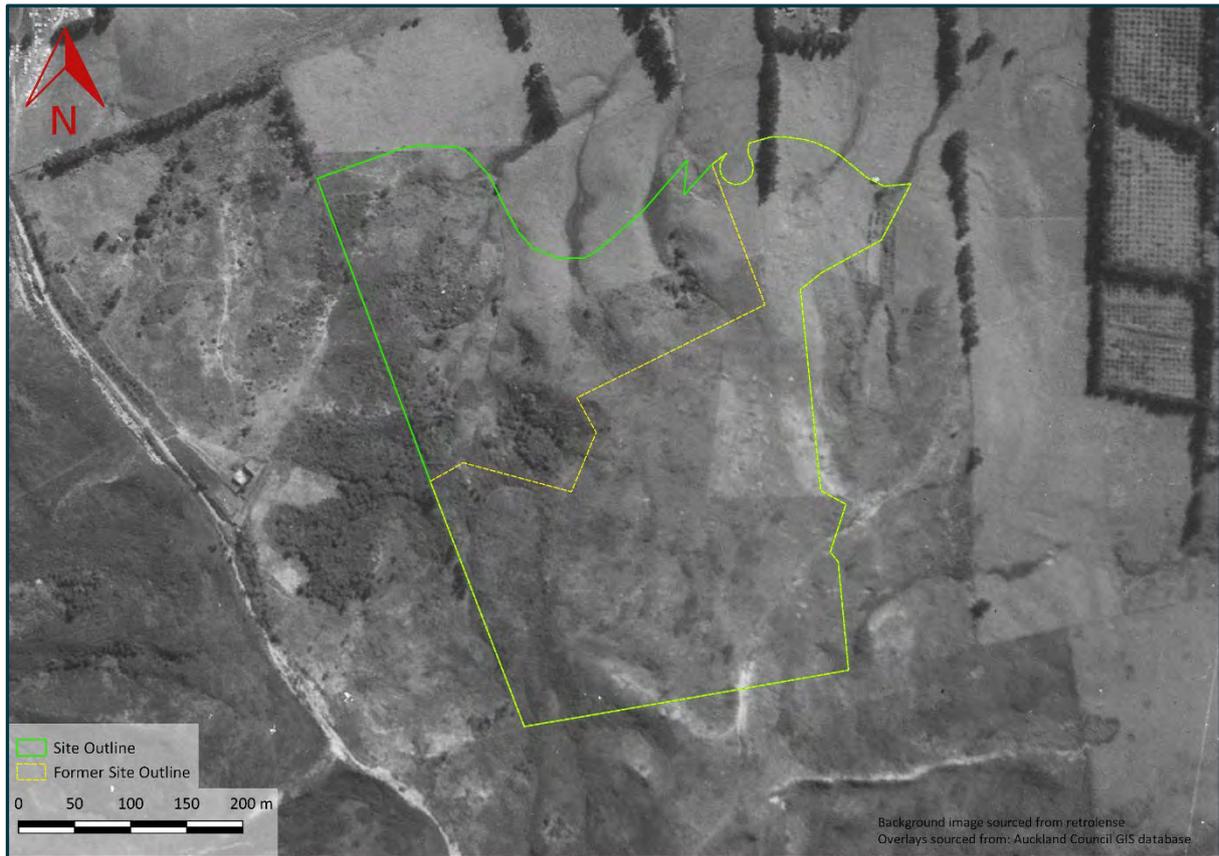
1940 Aerial Photograph

The investigation area was in use for a mix of agricultural grazing and native bush between 1940-2022, with no potentially contaminating activities identified during this time. In addition, no potentially contaminating activities were identified in close proximity to the investigation area or in an area where they may have adversely impacted site soils.

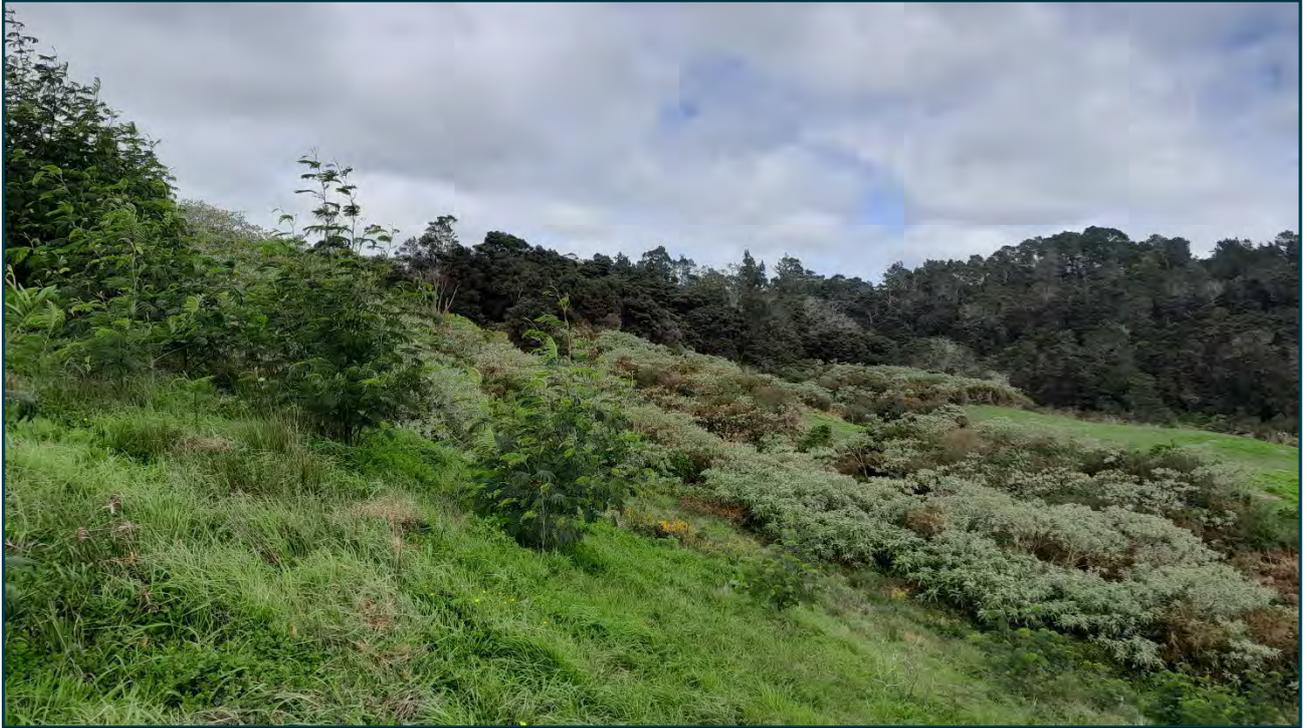
- The site was covered in a mix of grass, gorse and native bush.

No staining or odours that could indicate spillage of potentially hazardous substances, or hazardous materials, including potential asbestos-containing materials on the site were noted during the inspection.

Photograph 1: View of the eastern portion of the investigation area, looking west.

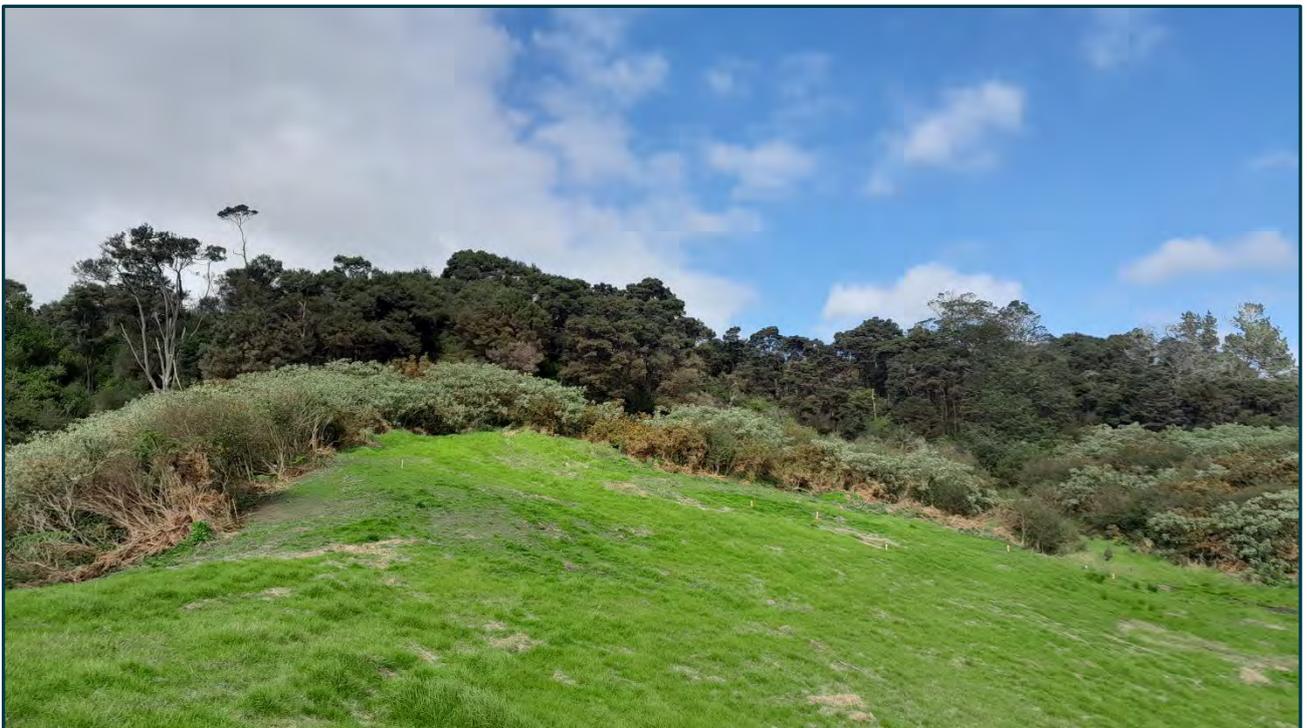
Photograph 2: View of the central northern portion of investigation area, facing south.

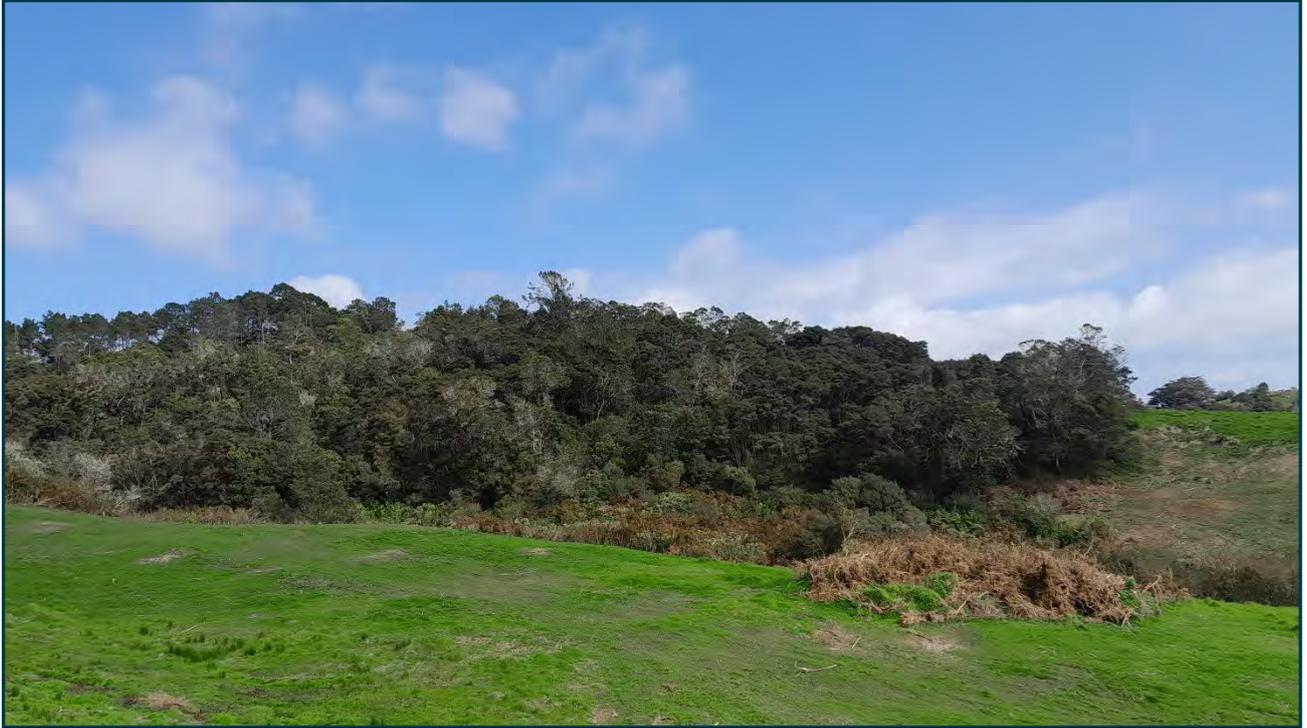
Photograph 3: View of western portion of the investigation area (background), facing west.

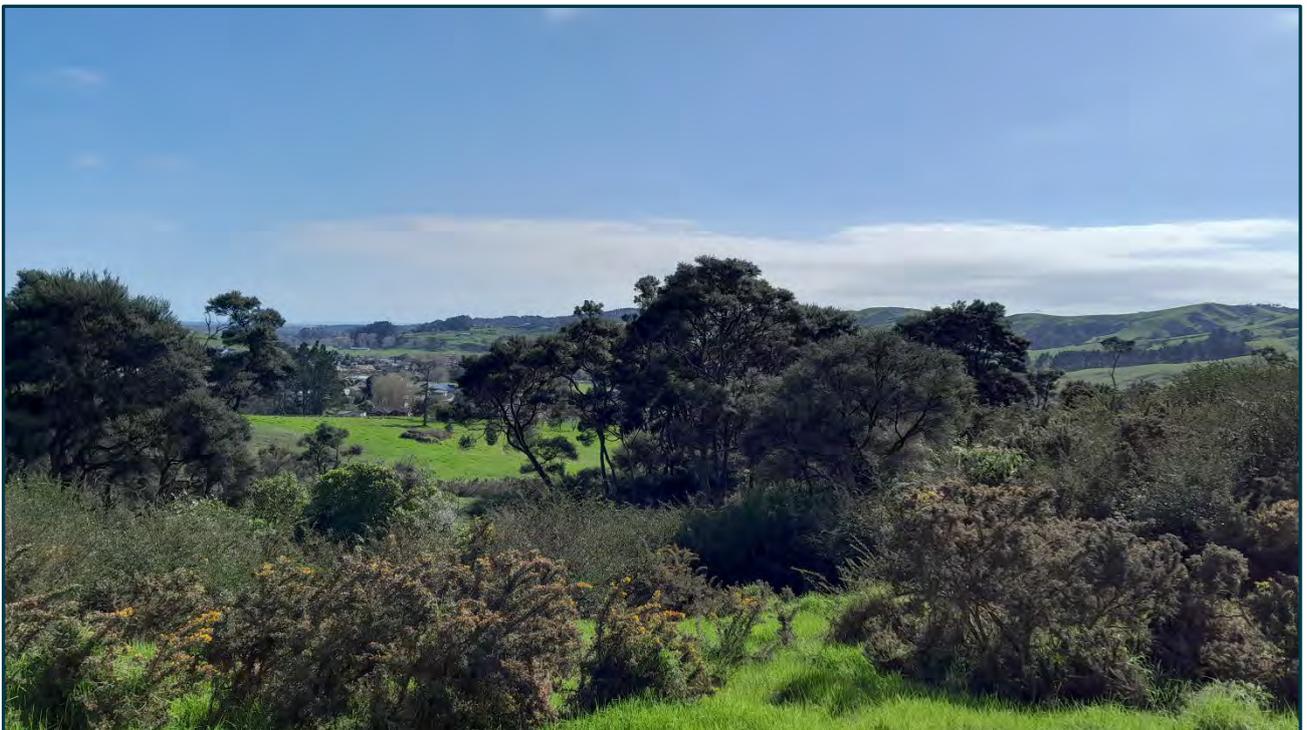
Photograph 4: View of southern portion of the investigation area, facing north.
