Ref: 20230033

PRELIMINARY SITE INVESTIGATION REPORT ADDENDUM: 151B RAUTAWHIRI ROAD, HELENSVILLE

**PSI Addendum
 Figure 1: Site Plan**

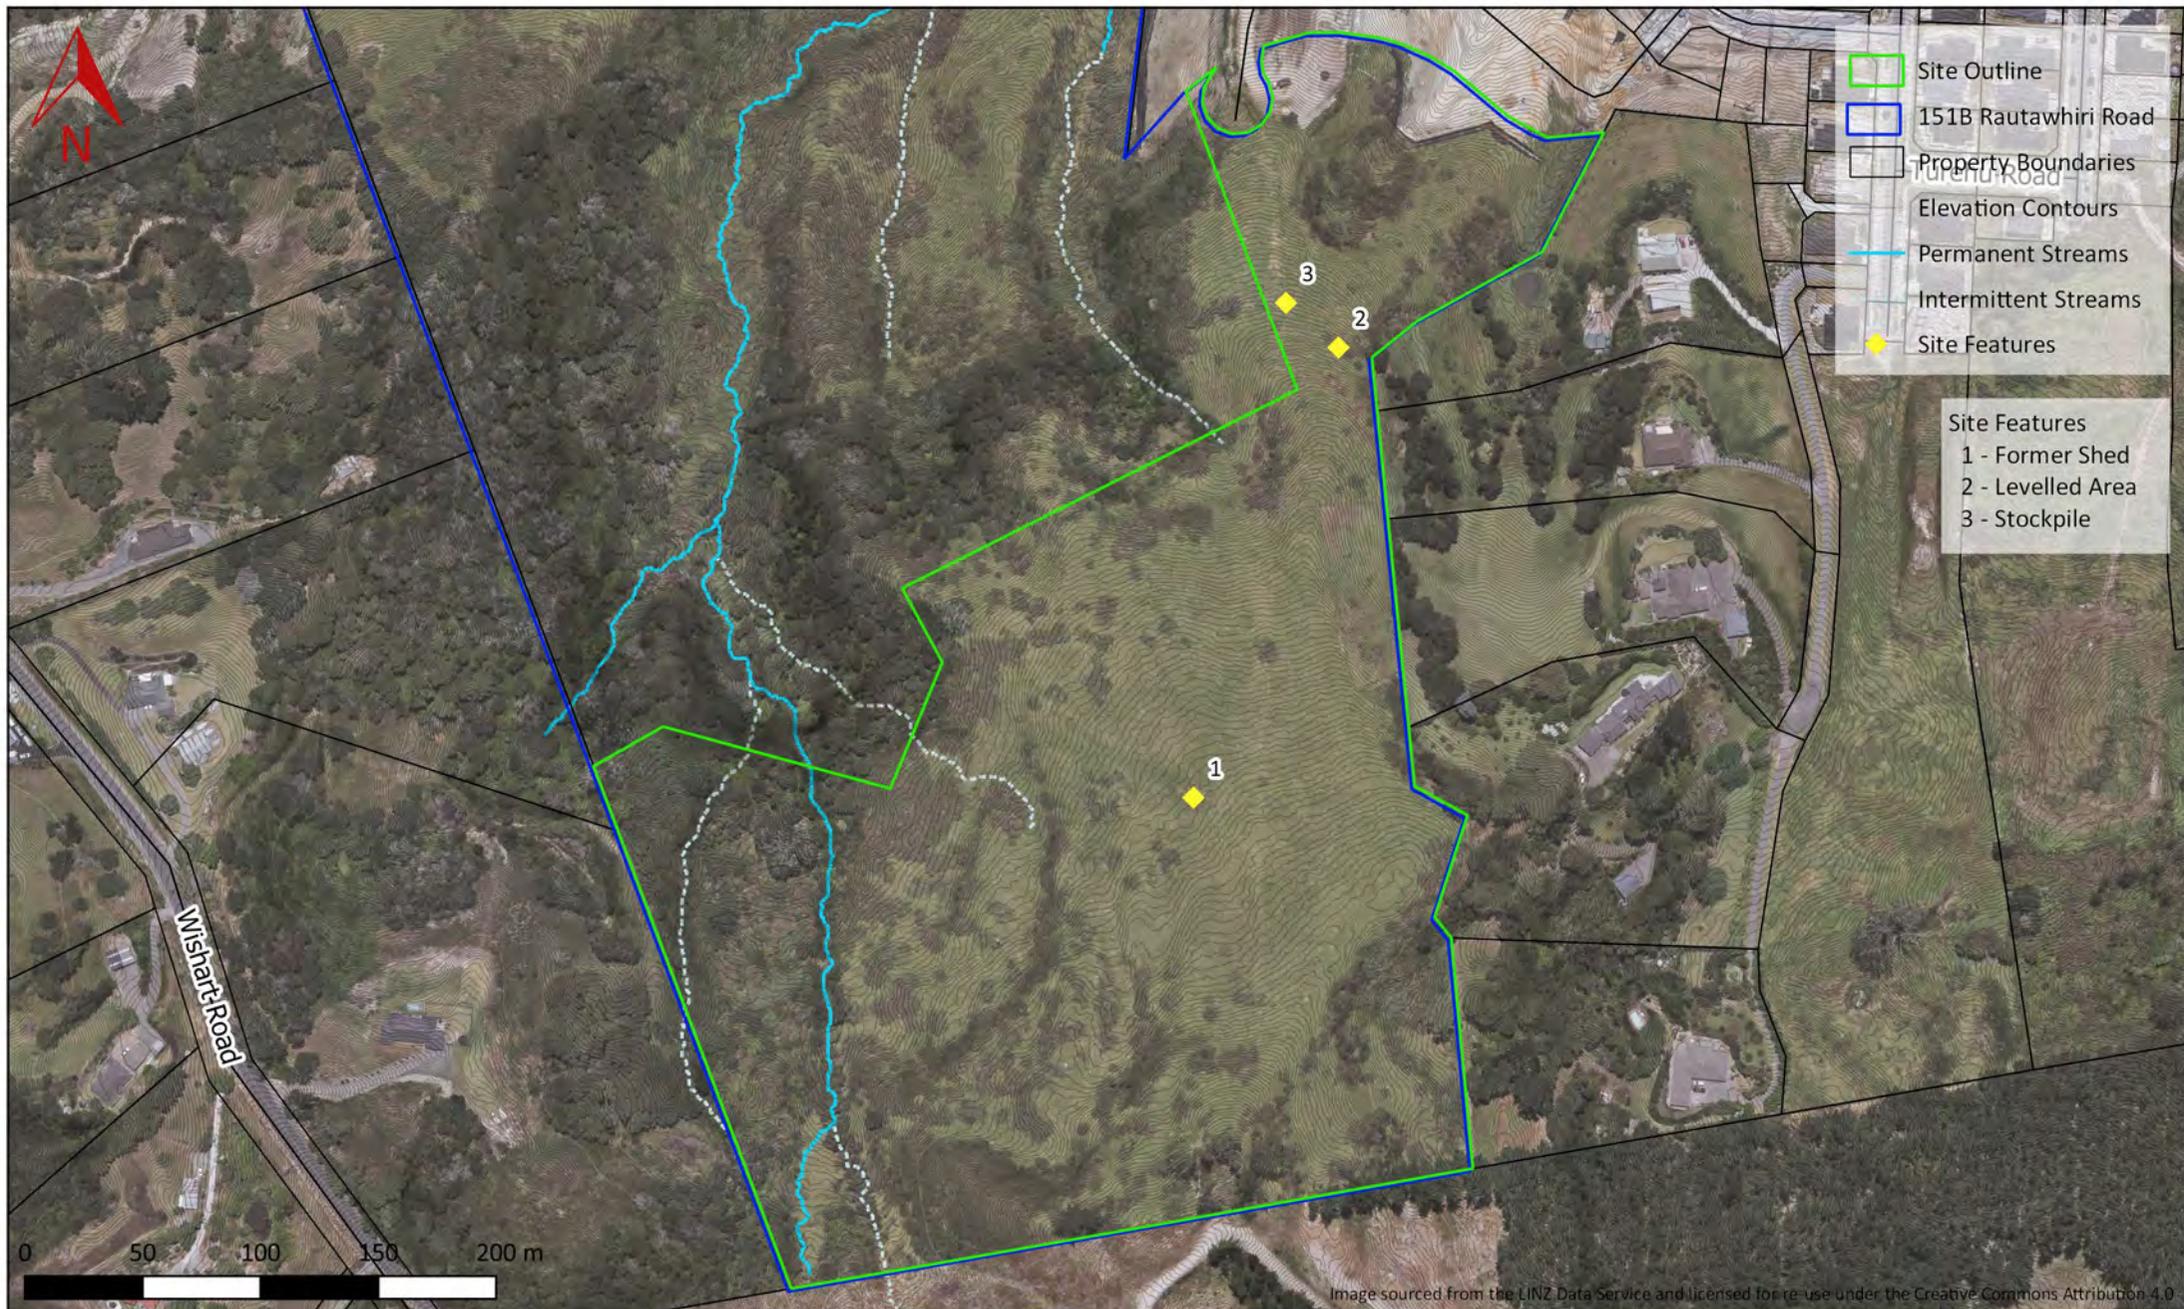
- Site Outline
- 151B Rautawhiri Road
- Property Boundaries
- Elevation Contours
- Permanent Streams
- Intermittent Streams
- ◆ Site Features

- Site Features**
- 1 - Former Shed
 - 2 - Levelled Area
 - 3 - Stockpile

Site photographs are presented in Appendix C, and site features are depicted in Figure 1, presented in Appendix A.

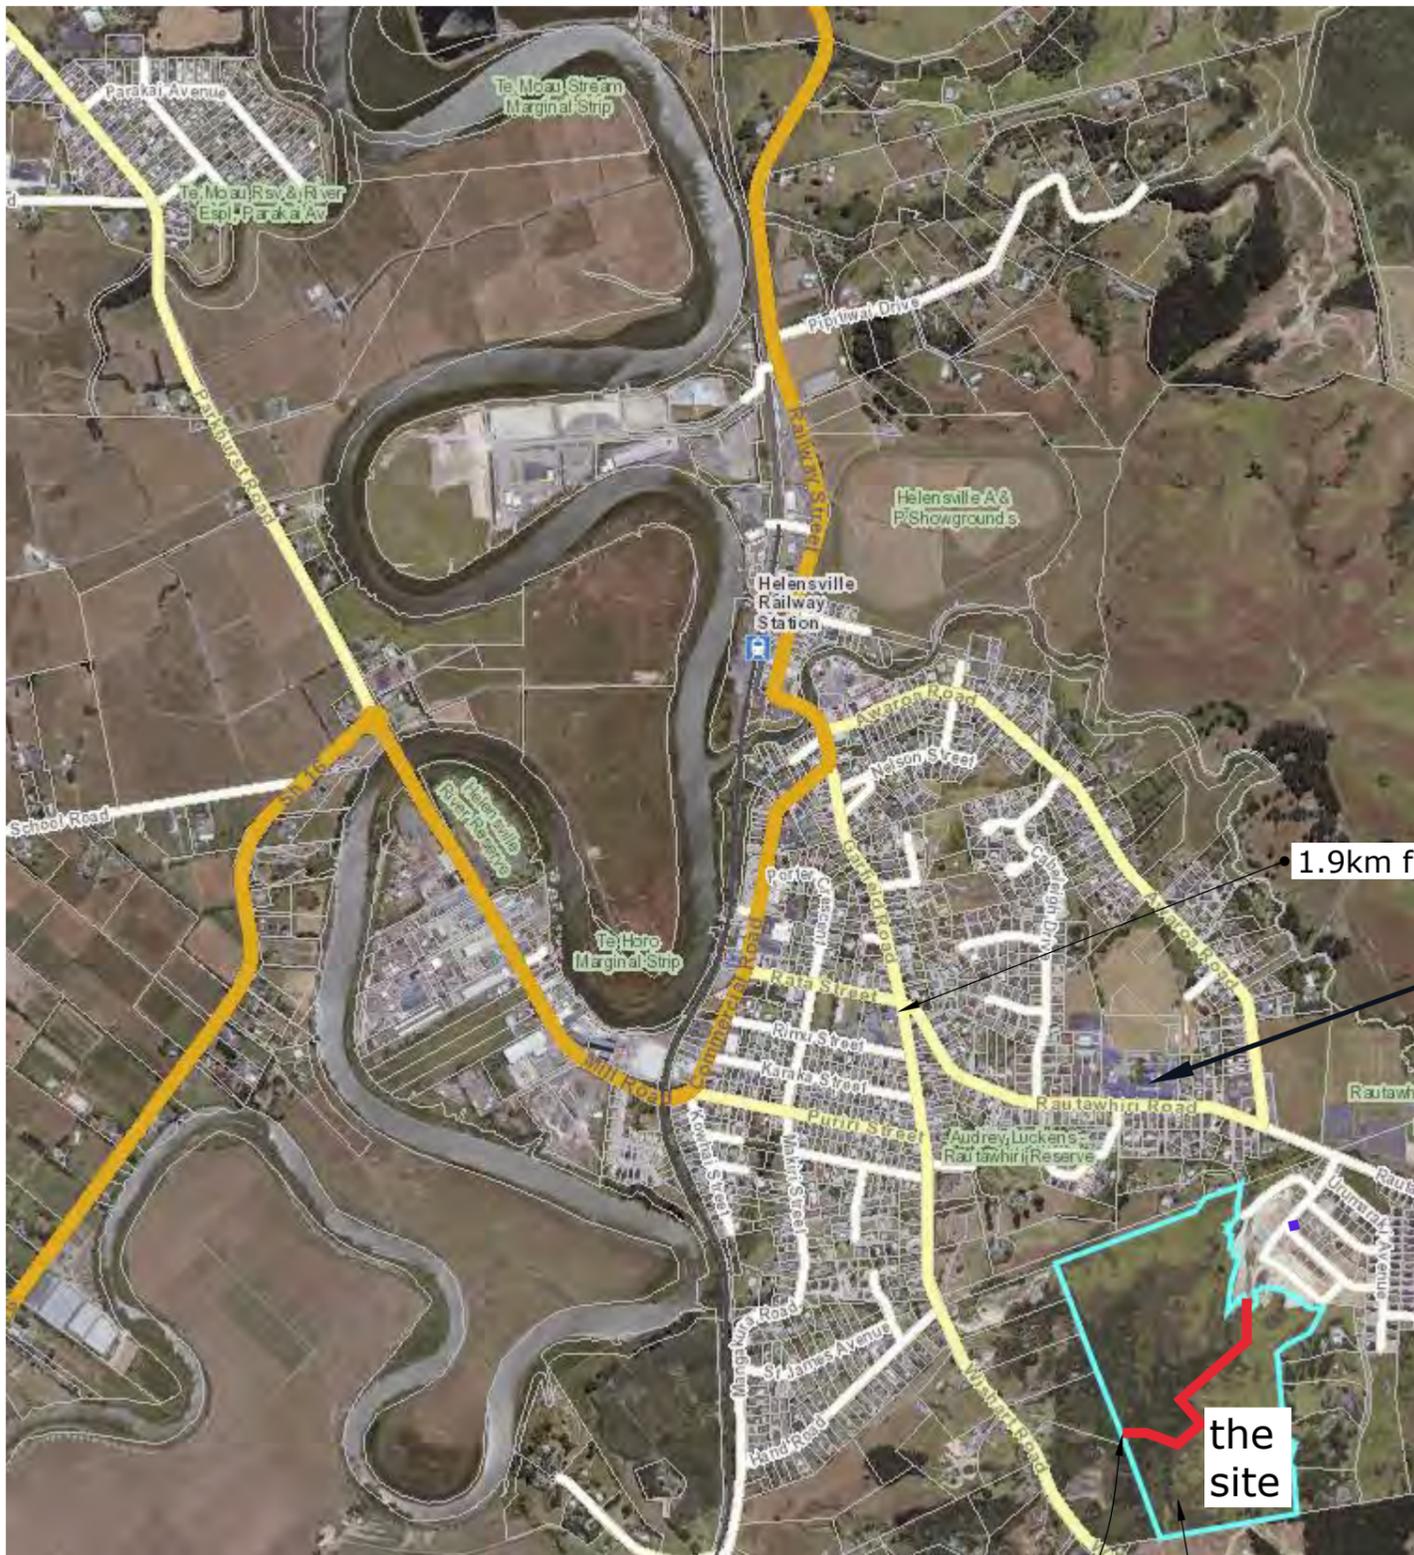
APPENDIX B: SCHEME PLAN

Zone boundary sought

rezone this area to Residential Single House

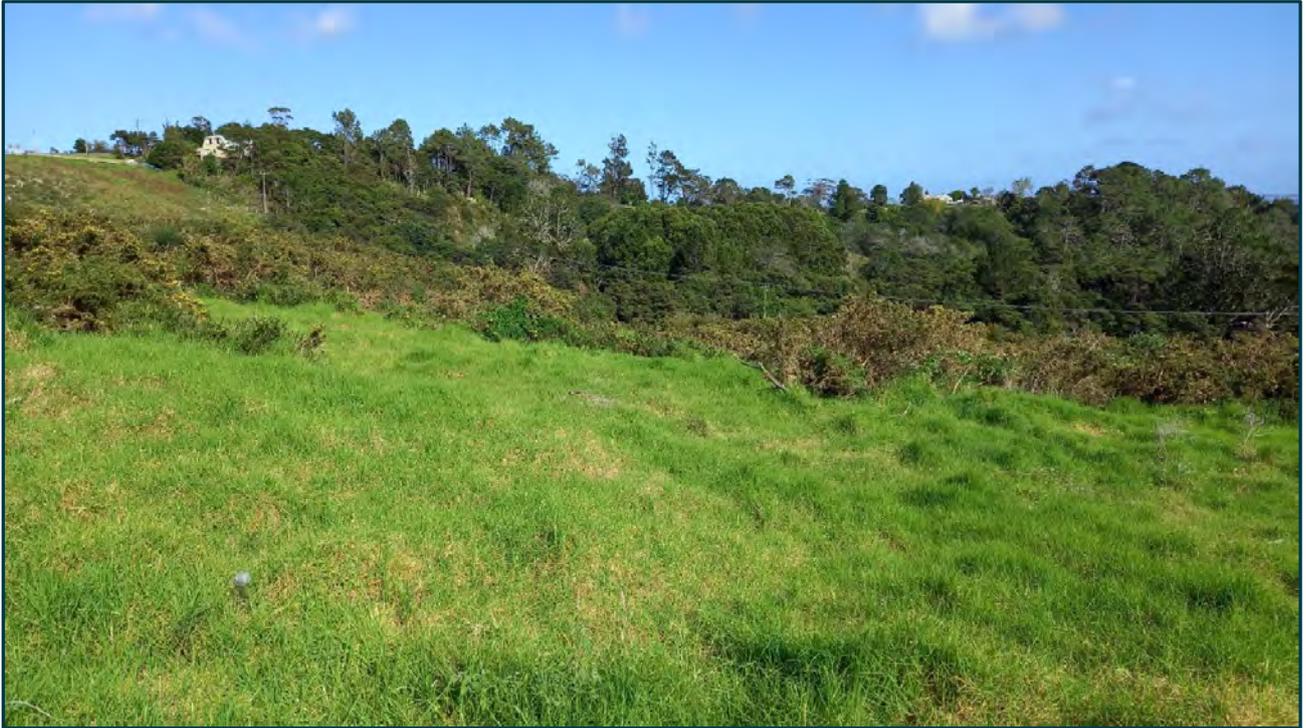
Photograph 1: View of southern portion of the site, facing west.

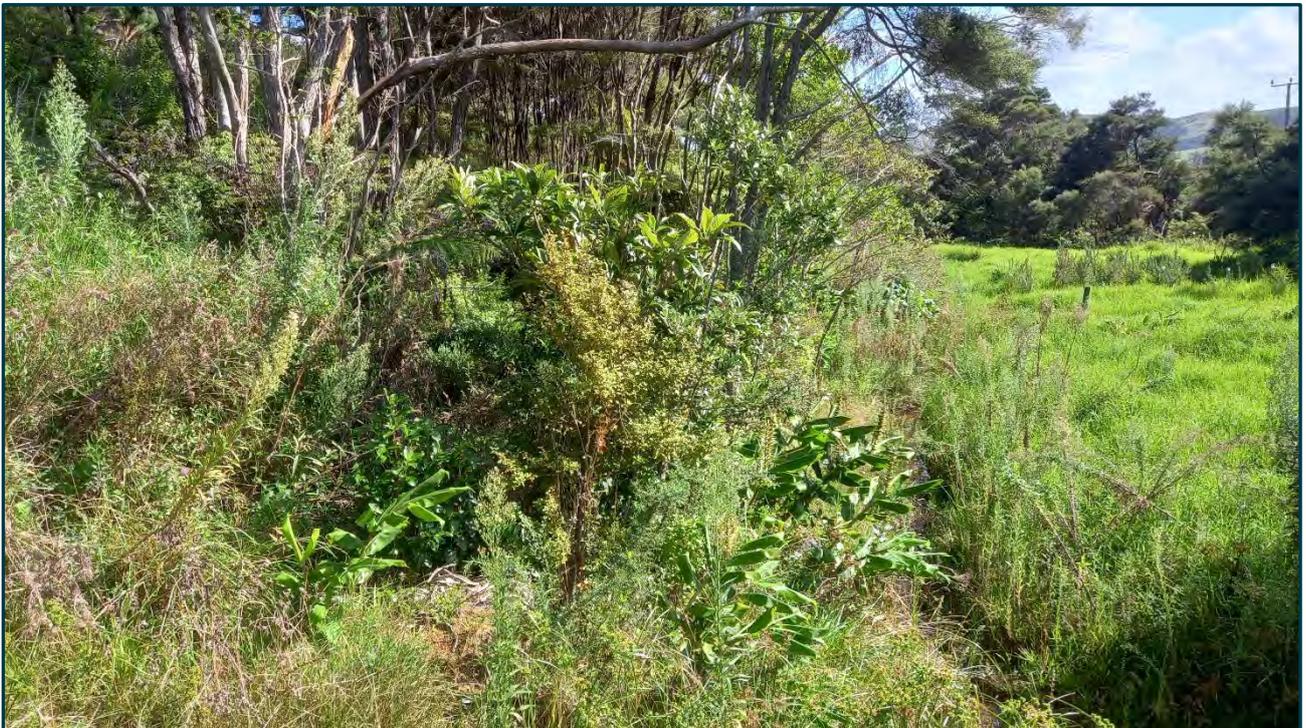
Photograph 2: View of vegetation and stream in south-western site corner, facing northwest.

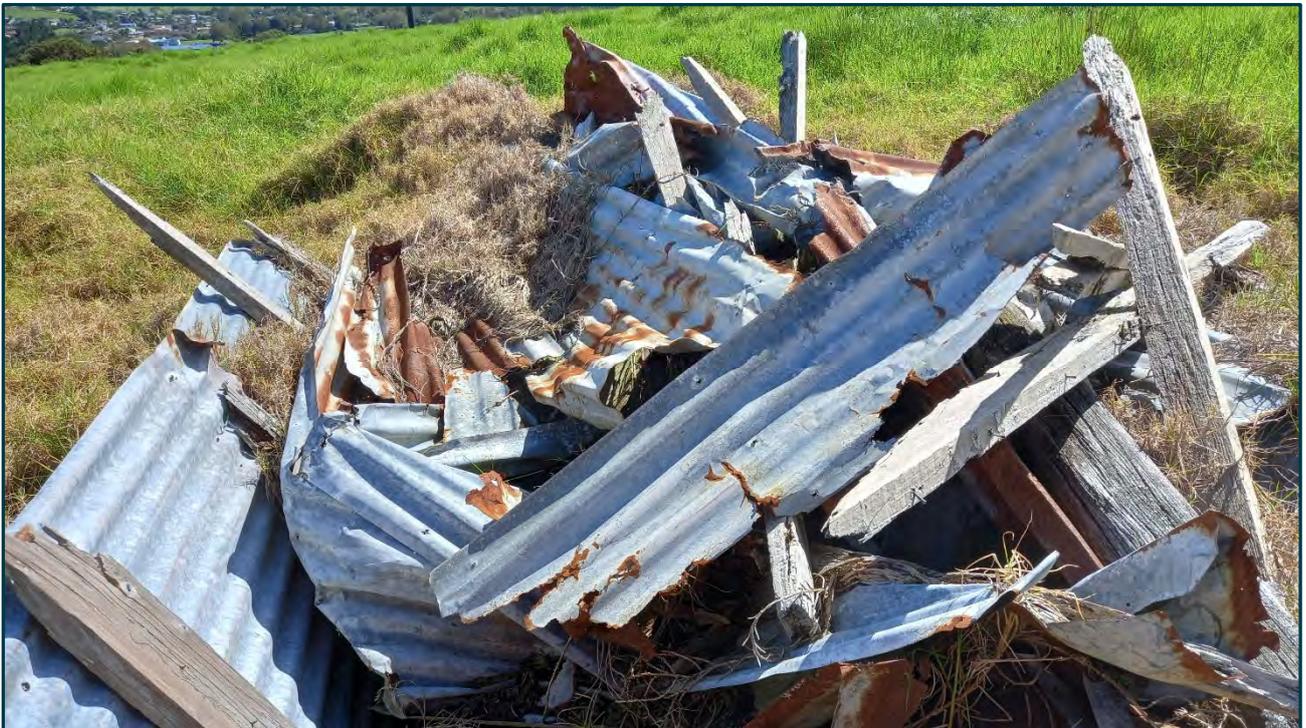
- The remnants of a former shed were located in the centre of the subject site. The building materials consisted of timber and unpainted metal, and no signs of potentially hazardous substances (e.g. containers, asbestos, staining) were noted.

Photograph 6: View of remnants of former shed, facing north.

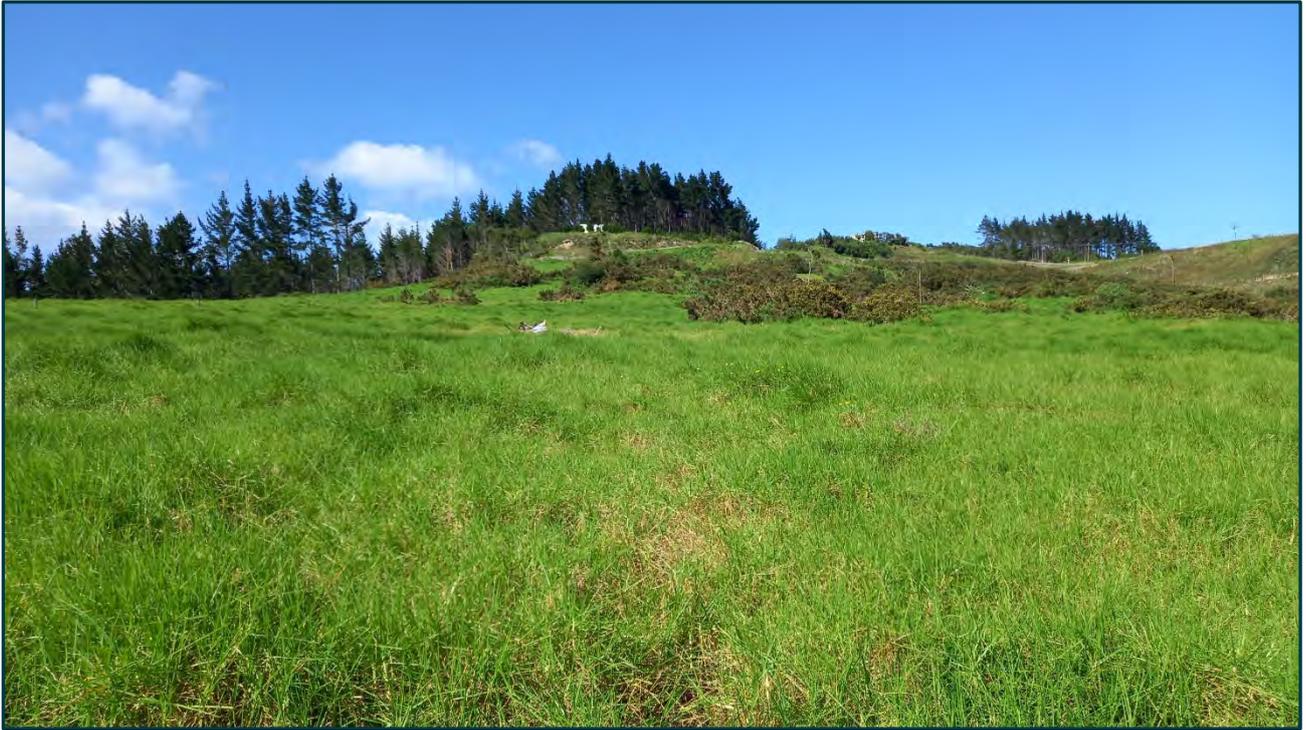
Photograph 7: View of central portion of the site and former shed (centre), facing southeast.

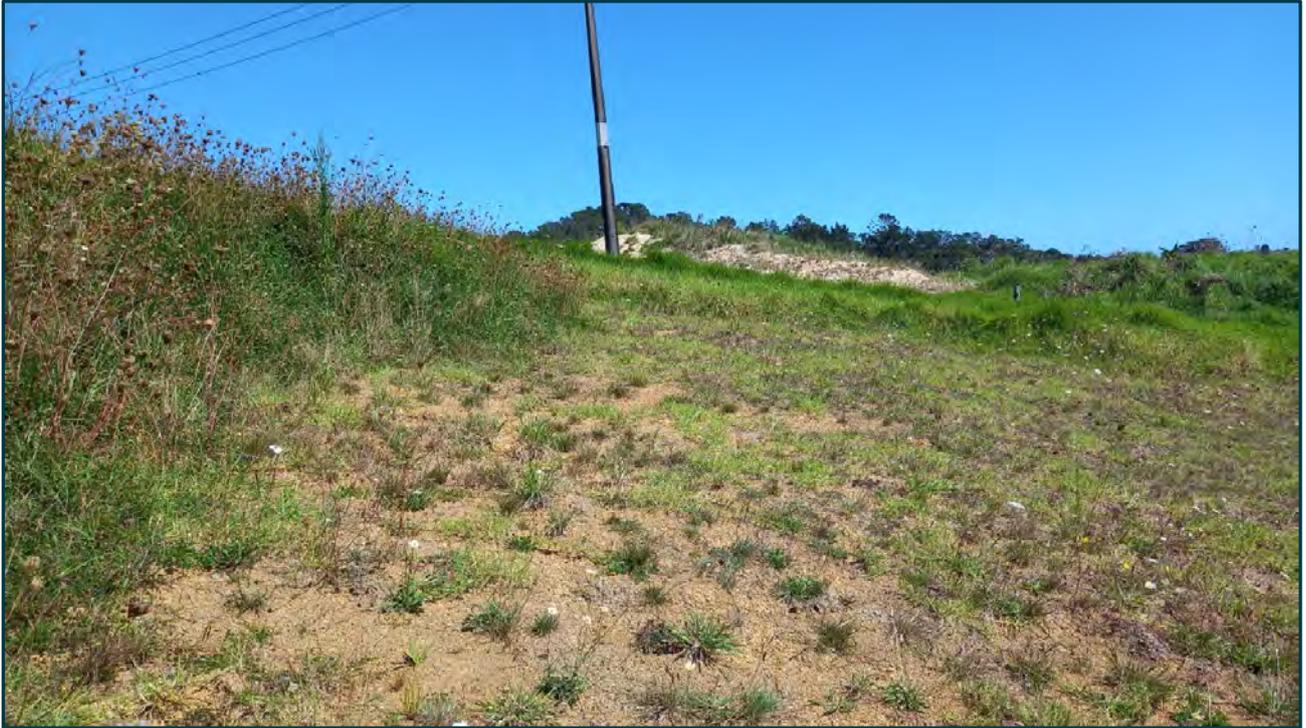
- A small area in the north-eastern corner appeared to have been cut to level.
- A medium soil stockpile was located northwest of the levelled area. The material generally comprised light grey to yellow/brown silty clay materials, and no signs of anthropogenic materials or signs of contamination were noted. This material was likely associated with the levelled area.

Photograph 9: View of the cleared area in the north-eastern portion of the site, facing west.

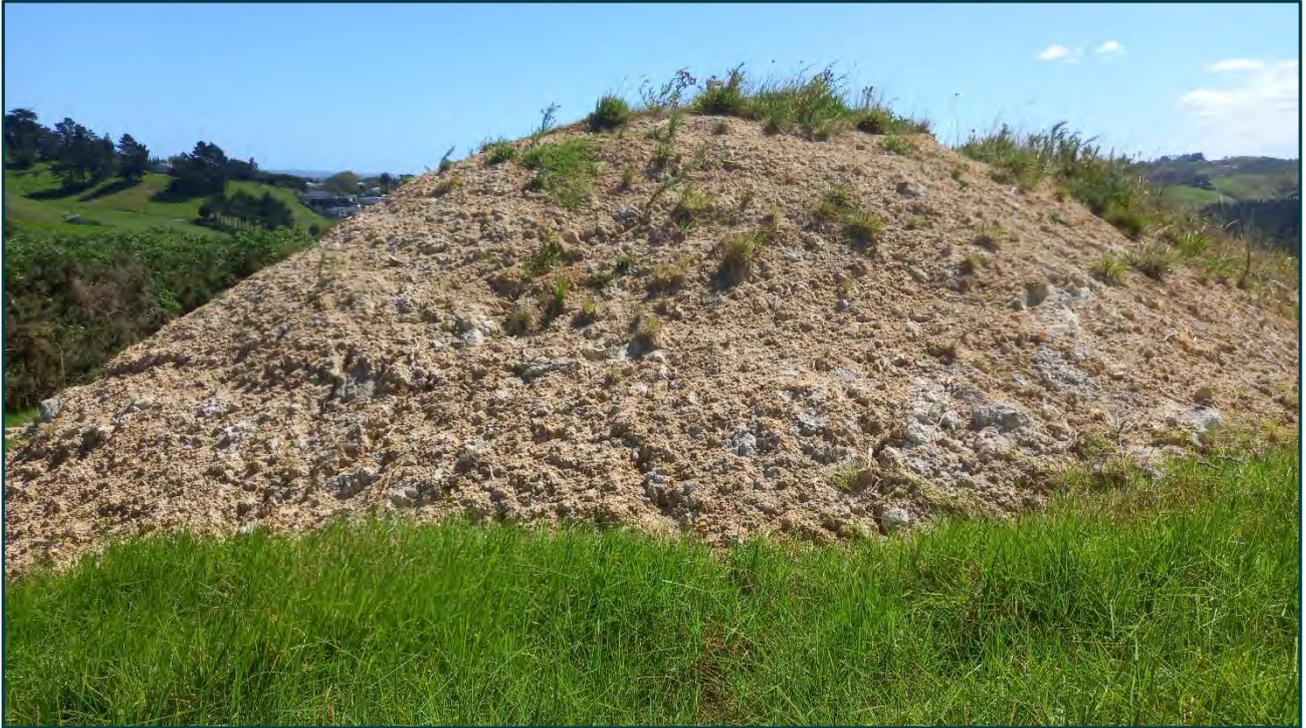
Based on the information available, there is no reason to suspect that the stockpiled material contained elevated levels of contaminants, and further investigation of the stockpile was therefore not considered necessary.

Photograph 11: View of the stockpile, facing northwest.

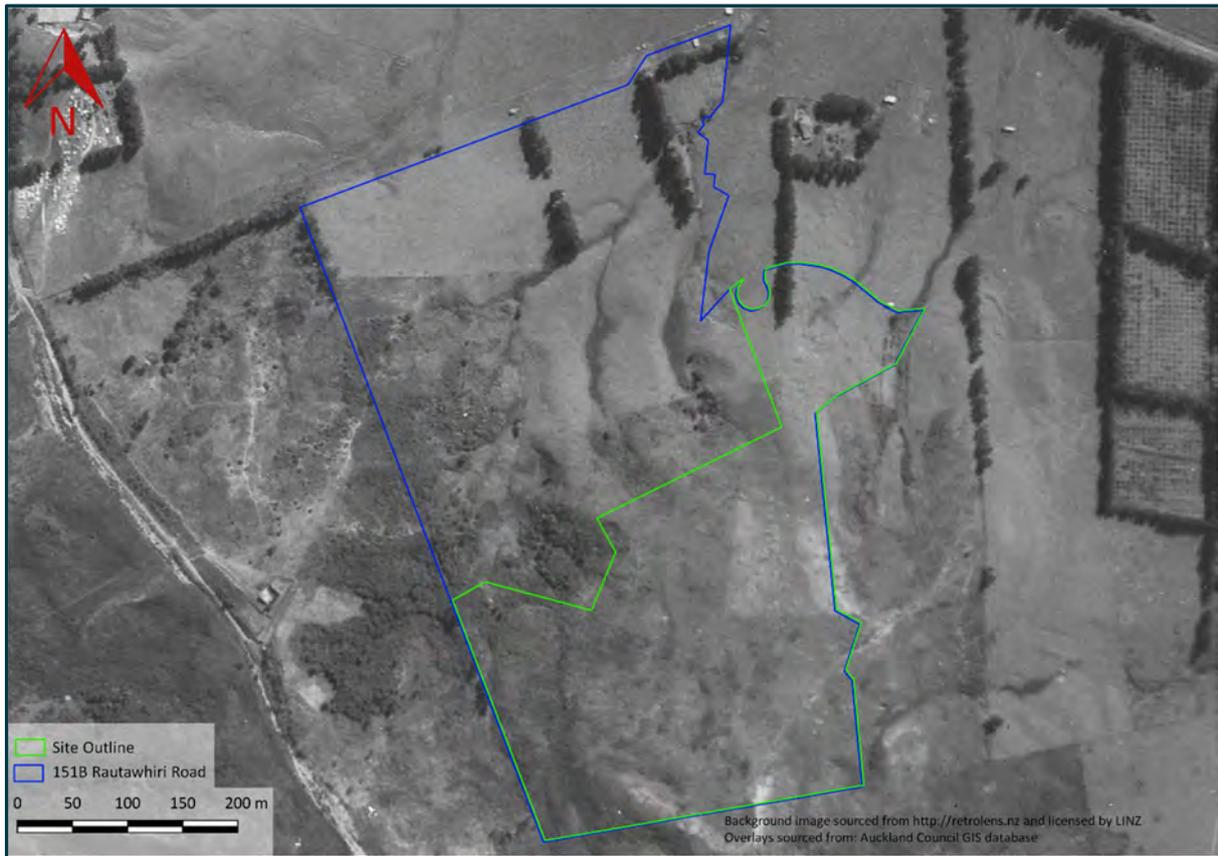
- **1940-1950:** The site forms part of a larger parent property which appears to be vacant and undeveloped. Shelterbelts are present in the northern portion of the property, which appears to be pastoral in use. Horticultural activity (pip and stone orchards) are apparent on the neighbouring property to the east. A suspected access track extends through the southern end of the site, and vegetation clearance in the southern portion of the property is evident from 1950.

1940 Aerial Photograph

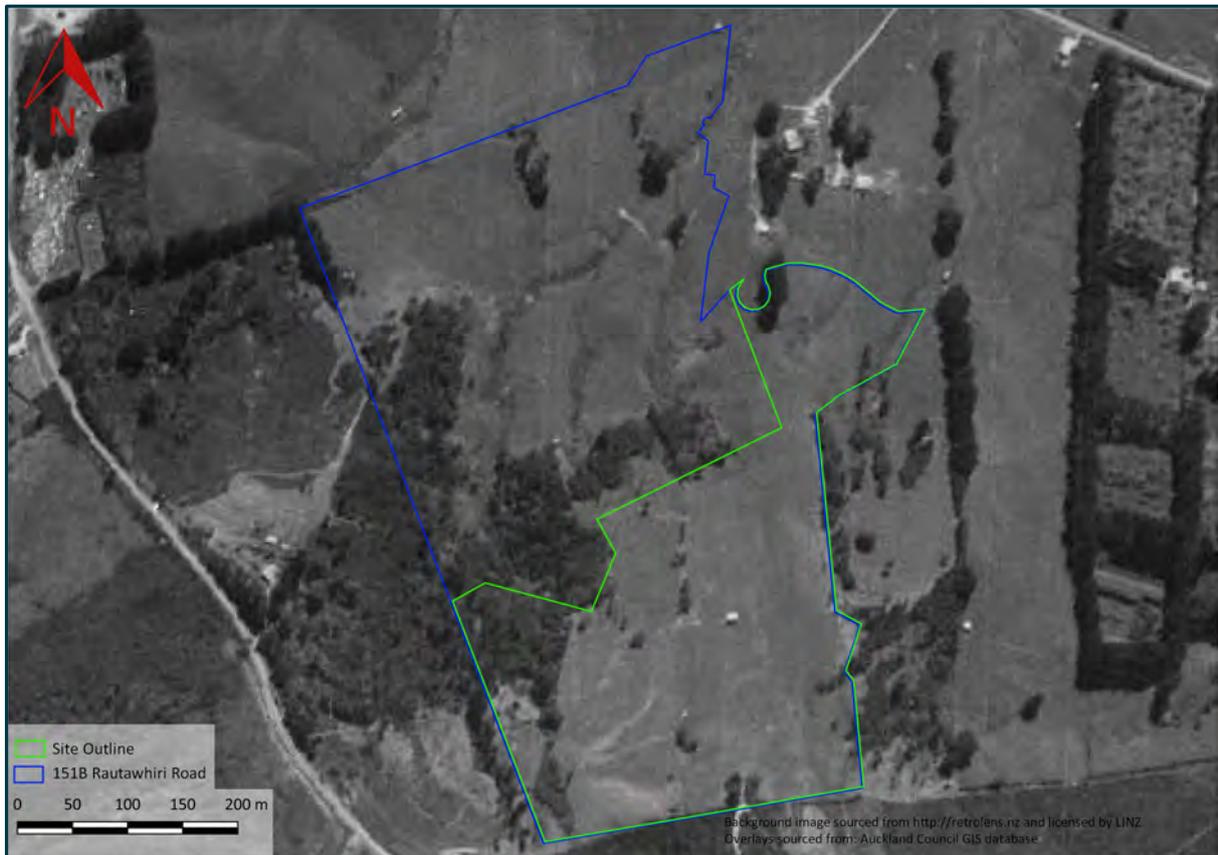
- **1968-2022:** Further vegetation clearance is now apparent across the majority of the subject site, which now appears in use as paddocks, and a former shed is evident in the centre of the subject site. The horticultural activity on the neighbouring property to the east appears to have ceased. Further residential development is evident to the east and west from 2010, with high-density development apparent to the northeast from 2017. It is noted that the earthworks associated with the adjacent development encroaches into the northernmost end of the site. No further significant changes to the site or surrounding area are noted.

1968 Aerial Photograph
