Private Plan Change - 222-250 Manukau Road, Pukekohe, Auckland
(Our Reference: 25208.000.001_17)

1 Introduction

ENGEO Ltd was requested by Auckland Thoroughbred Racing Incorporated to assess the geotechnical suitability of a portion of the property at 222-250 Manukau Road, Pukekohe, Auckland for future residential housing. We understand this letter will be used in support of the private plan change application by Auckland Thoroughbred Racing Incorporated (ATR) seeking to rezone a portion of the property.

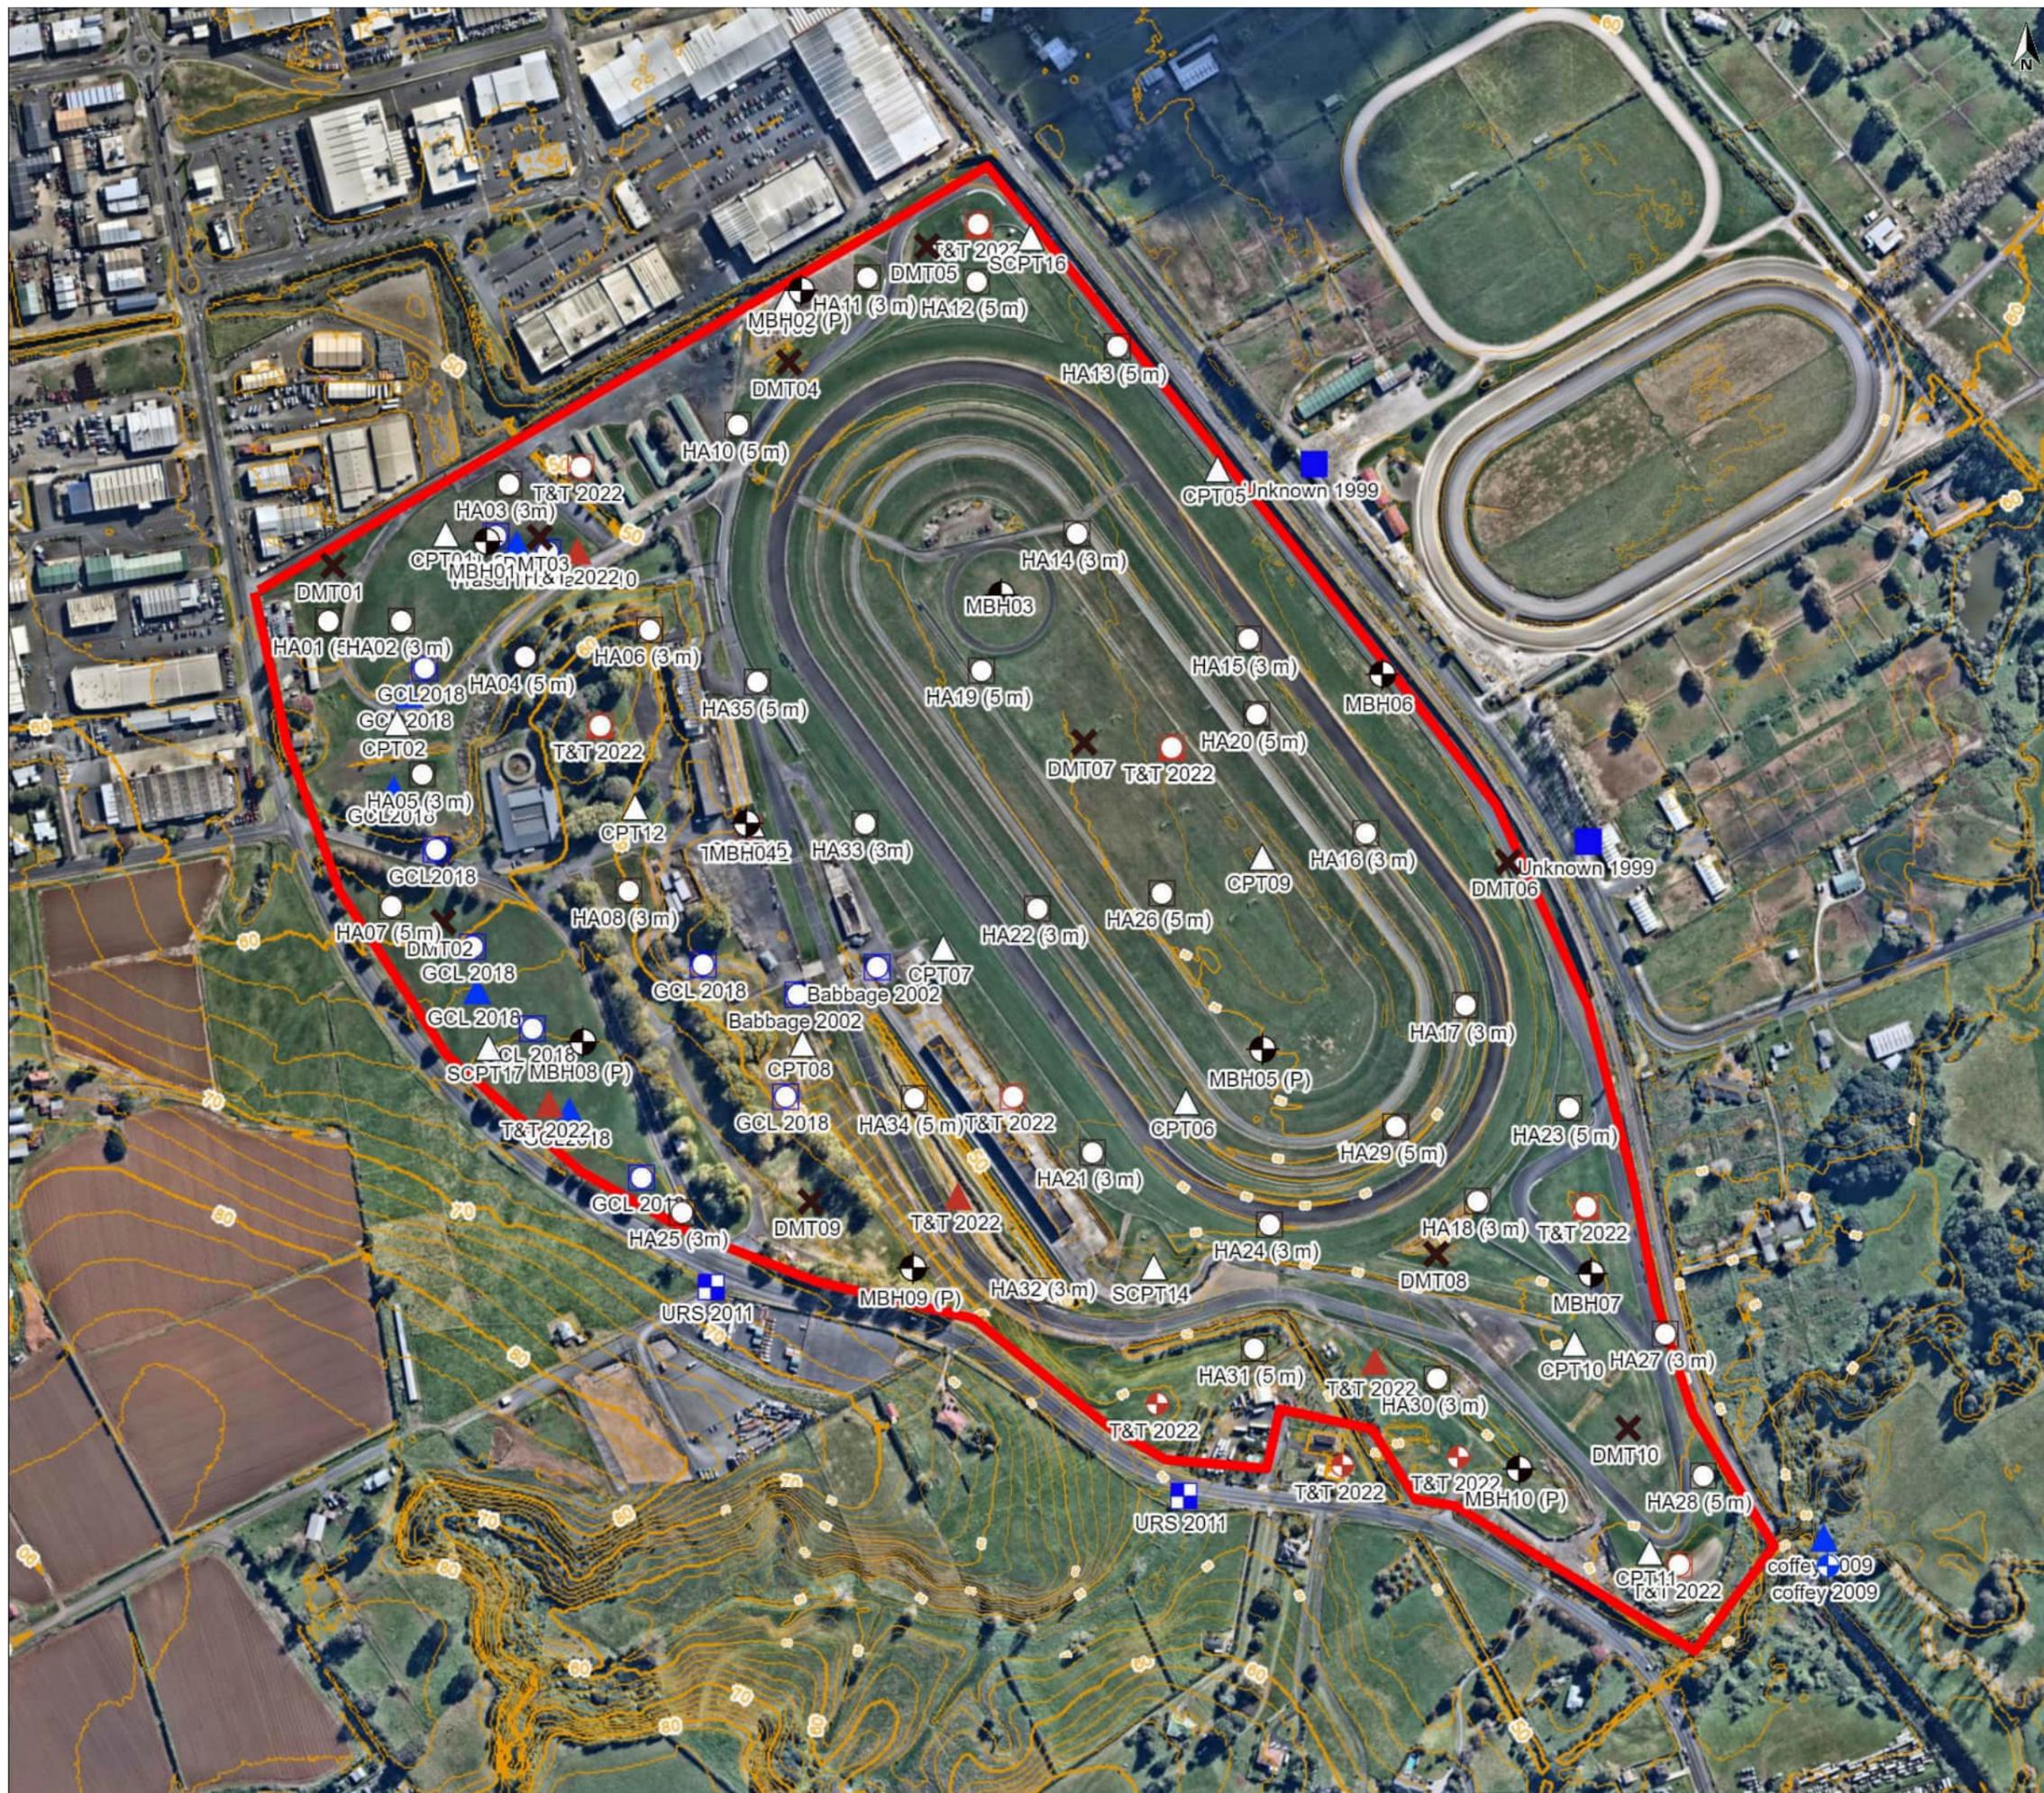
Title: Site Investigation Location Plan		
Client: Auckland Thoroughbred Racing Incorporated		Size: A3
Project: Pukekohe Park	Drawn: KE	Figure No.: 1
Date: 11-04-2024	Checked: MM	
Proj No: P25208.000.001	Scale: 1:5000	Version: draft

- Legend**
- ENGEO Machine Drilled Boreholes
 - △ ENGEO Cone Penetration Tests
 - ENGEO Hand Augured Boreholes
 - ✕ ENGEO Dilatometer Tests
 - T&T Machine Drilled Boreholes
 - T&T Hand Augured Boreholes
 - ▲ T&T Cone Penetration Tests
 - Third Party Machine Drilled Boreholes
 - Third Party Hand Augured Boreholes
 - ▲ Third Party Cone Penetration Tests
 - Third Party Test Pits
 - Third Party Water Bores
 - Site Boundary
